# NATIONAL TRANSPORTATION SAFETY BOARD

## MATERIALS LABORATORY FACTUAL REPORT

Report No. 22-040

Place : Sacramento, CA  
Date : February 15, 2020  
Vehicle : Airbus A319-132, N521NK  
NTSB No. : ENG20LA016  
Investigator : Michael Hauf (AS-10)

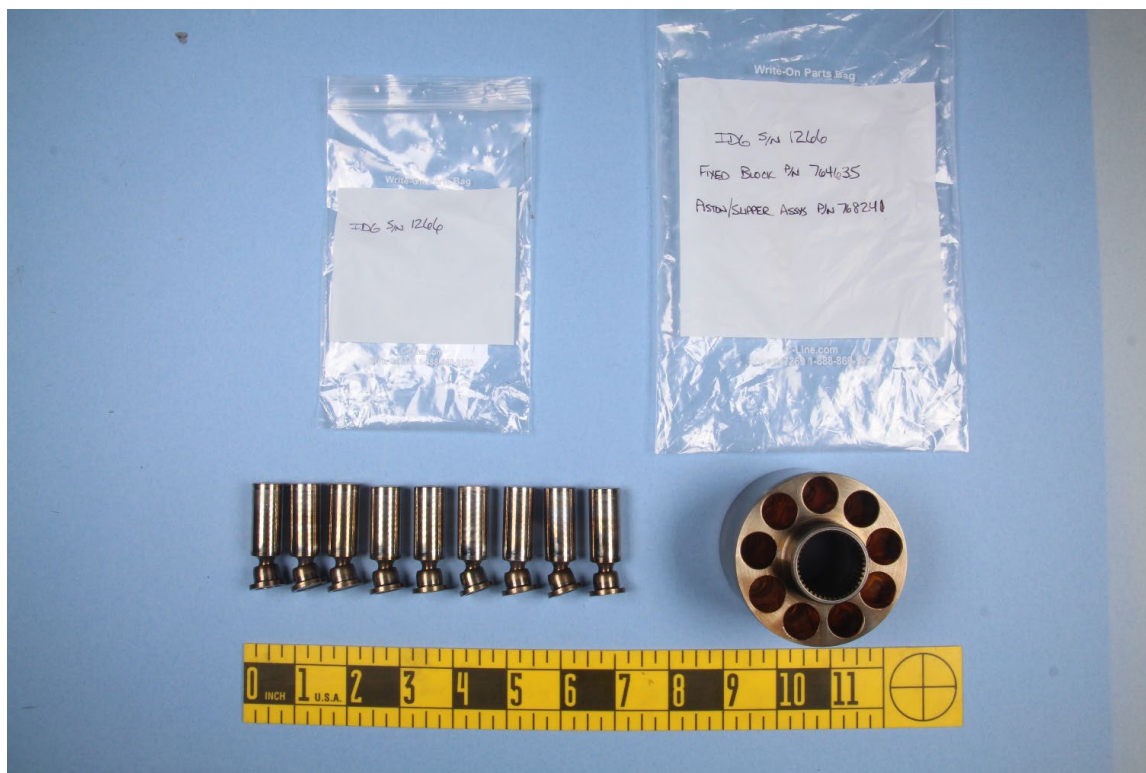
Figures 1 and 2 show the fixed cylinder block S/N Y10-245-19 and mating piston assembly. Figures 27 and 28 show the fixed cylinder block S/N Y04-232-49 and mating piston assembly.

Figure 1: Overall photo showing the packaging with identifying information and the components from the IDG from engine S/N 1266.

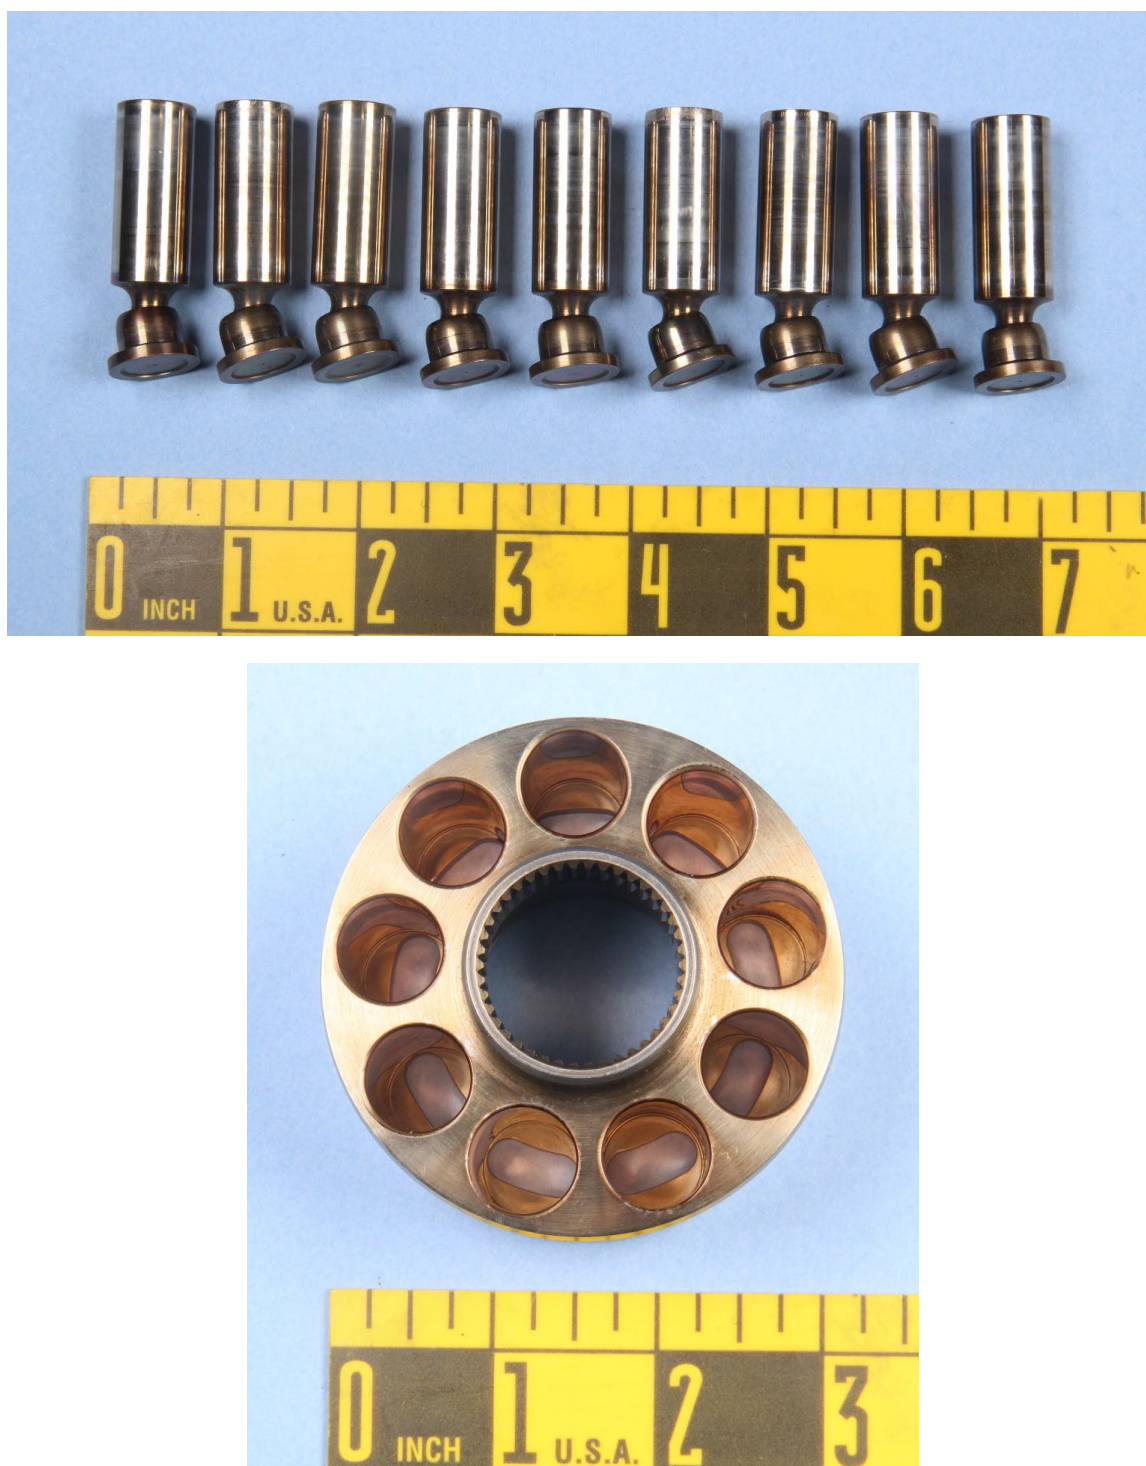
Figure 2: Close up photos of the pistons (top) and fixed cylinder block from engine S/N 1266. The fixed cylinder block was labeled S/N Y10-245-19.

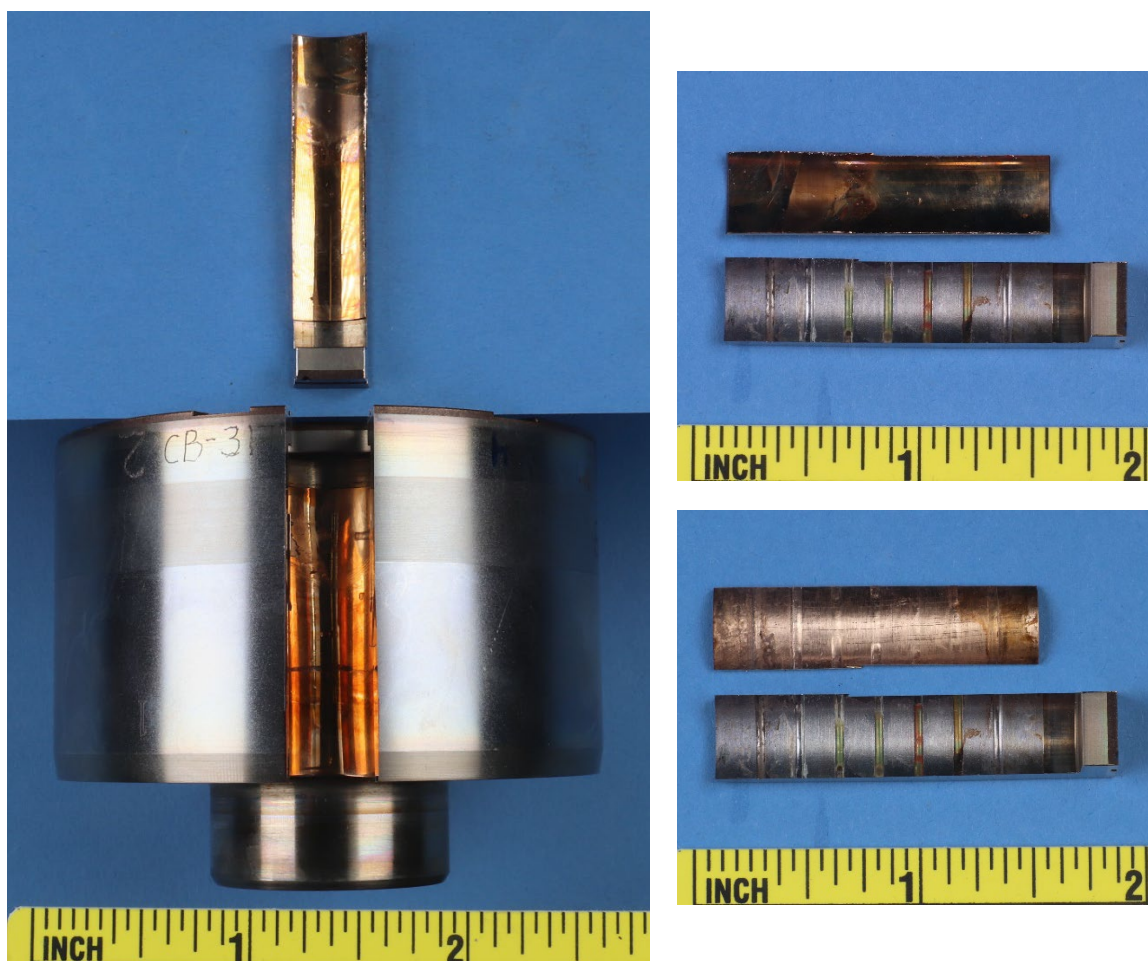
The two additional bores with heavy liner wear, bores 3 and 6, and one bore with a lesser amount of wear, bore 8, were destructively examined. Cuts were made through the OD side wall of the block and the mating liner from each bore, as shown for bore 3 in Figure 13. After sectioning, the liners were not attached to the block pieces and the mating parts could be easily separated.

Figure 13: Overall and close-up photos of the pieces of liner and OD block side wall sectioned from bore 3 in fixed cylinder block S/N Y10-245-19.

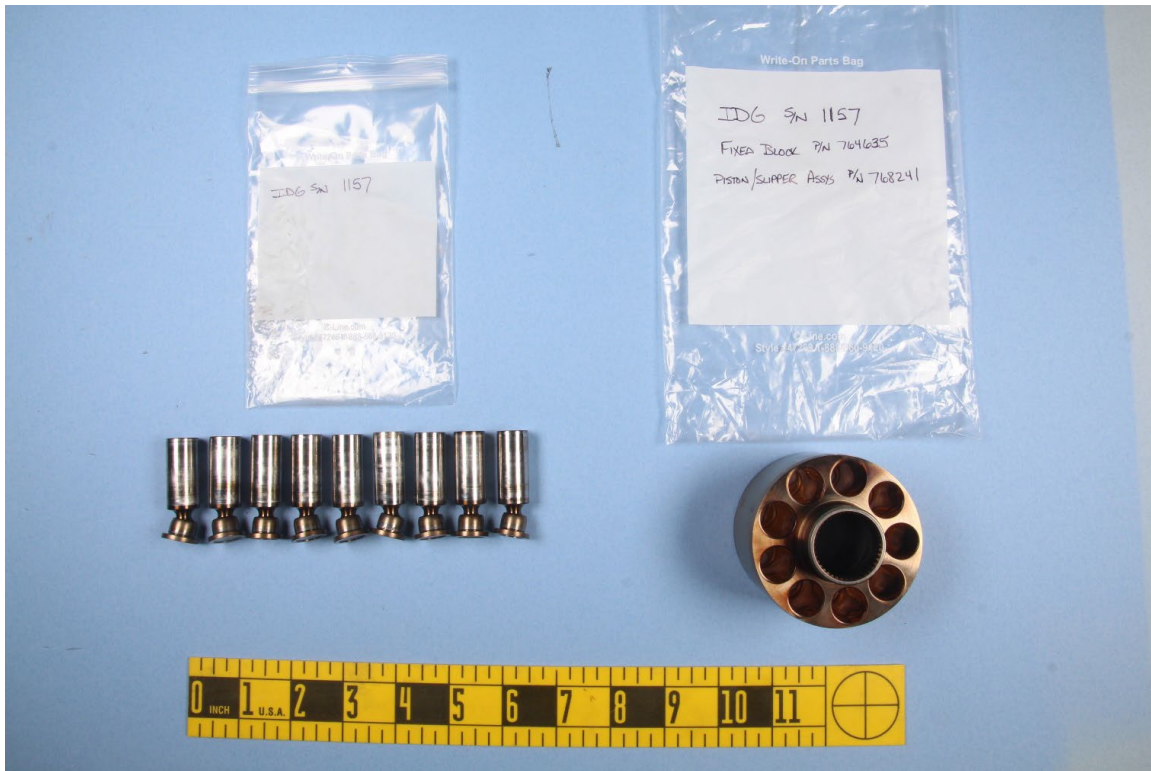
Figure 27: Overall photo showing the packaging with identifying information and the components from the IDG from engine S/N 1157.

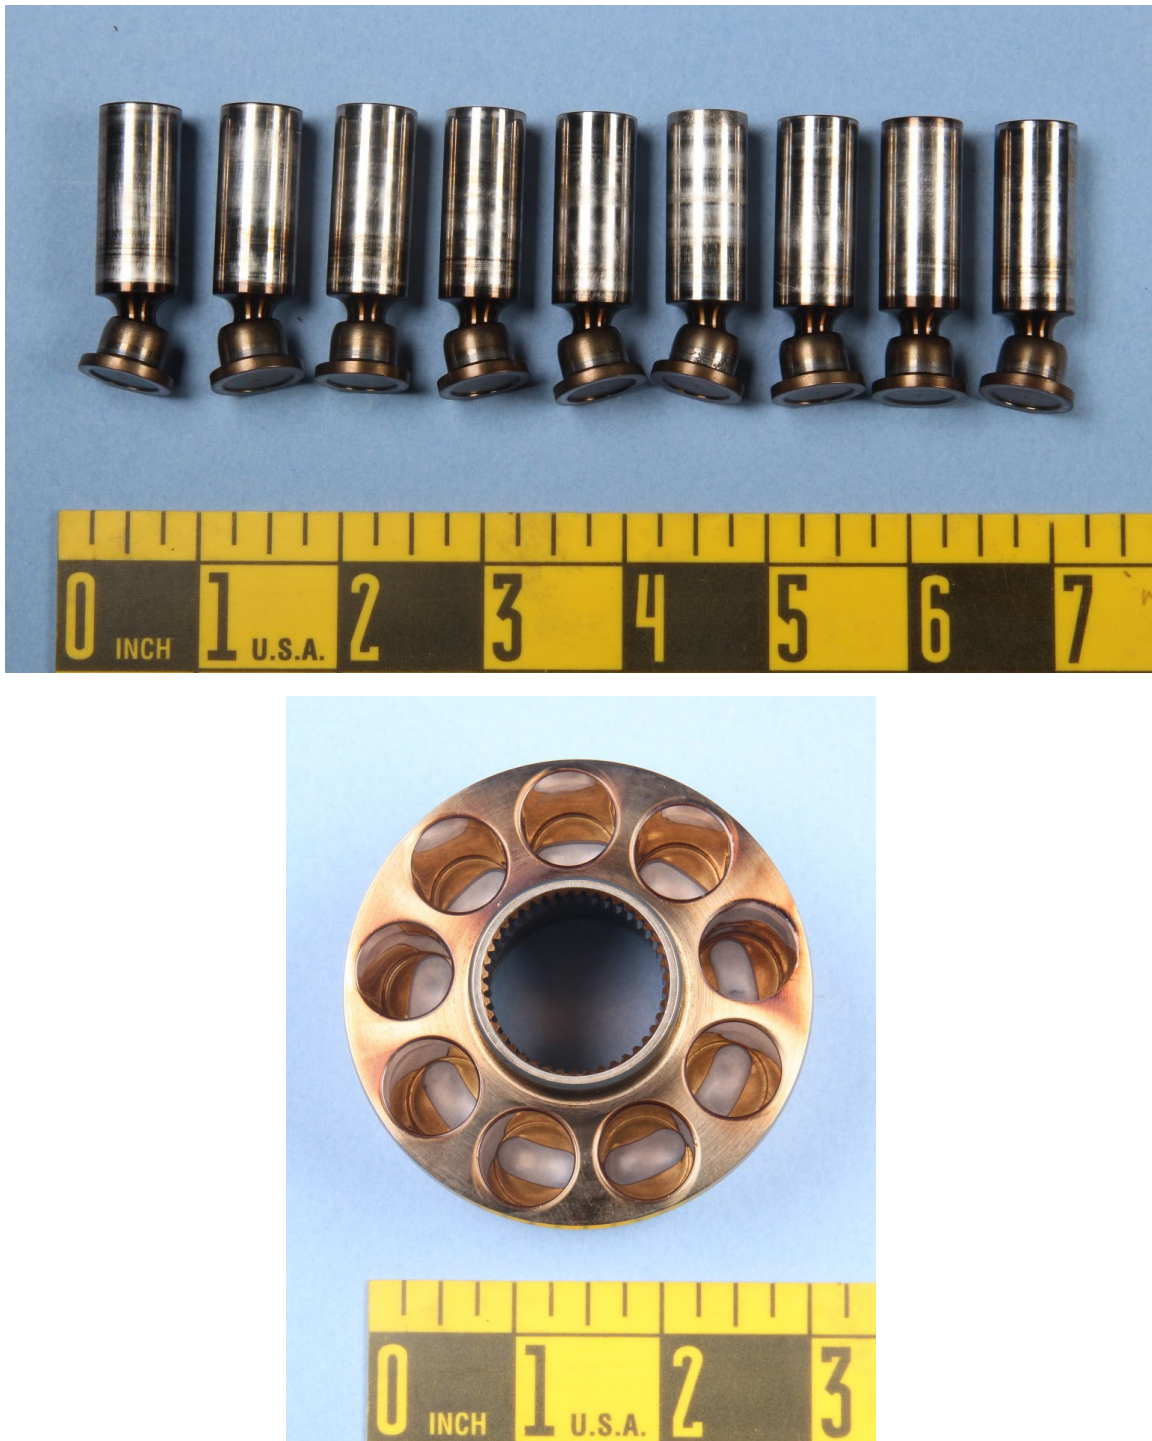
Figure 28: Close up photos of the pistons (top) and fixed cylinder block from engine S/N 1157. The fixed cylinder block was labeled S/N Y04-232-49.

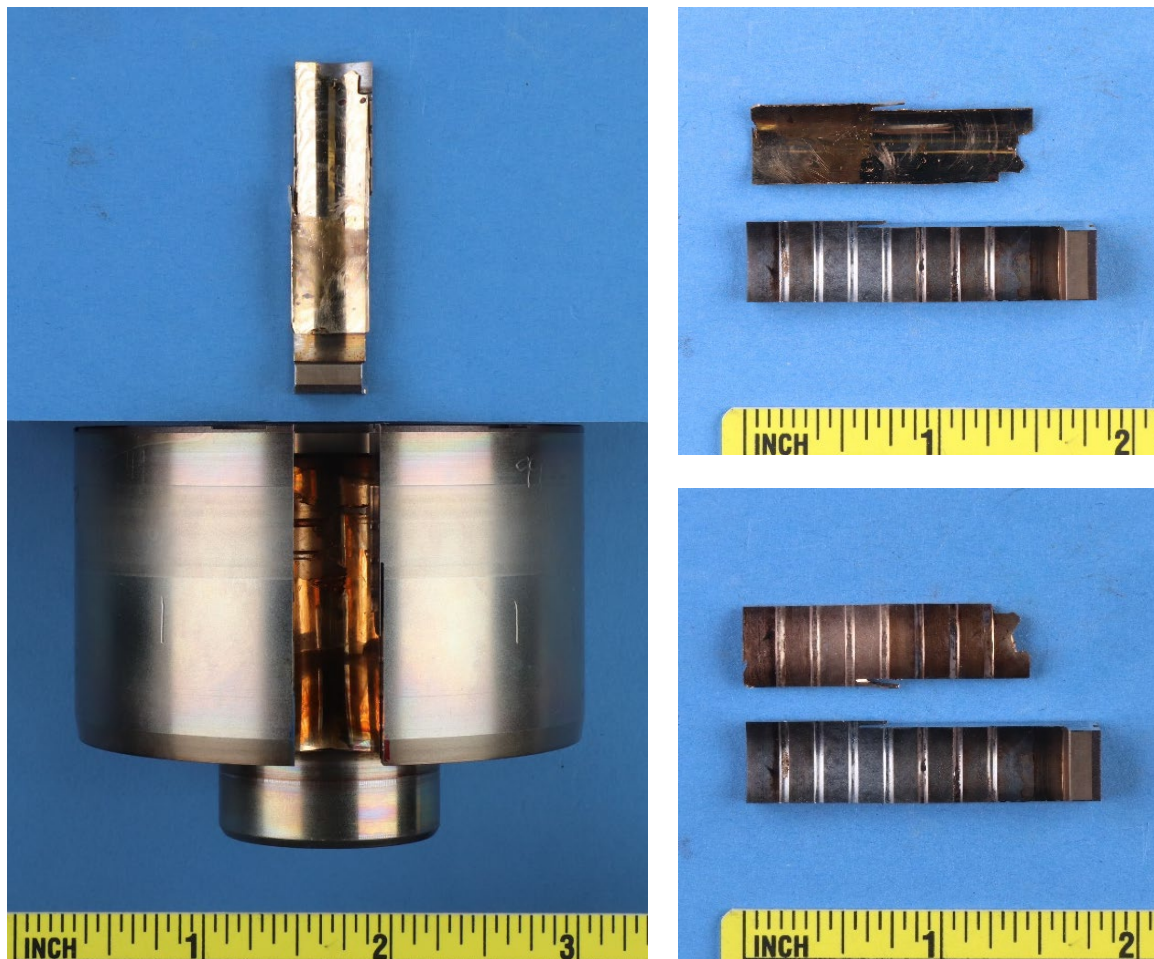
Bore 3 after sectioning is shown in Figure 29. The ID of the block piece and the ID and OD of the liner piece are shown in Figure 30. The bottom 0.1 inches of the sectioned piece of liner was missing, and the edge of the liner adjacent to the missing portion had thinned. The ID surface of the block piece and OD surface of the liner had a substance on it consistent with the bores examined from the other fixed block. The substance along the bottom half of the liner OD had darkened in color, along with several areas on the ID of the block piece. Debris was visible adhering to the substance inside some of the machined grooves in the ID of the block.

Figure 29: Overall and close-up photos of the pieces of liner and OD block side wall sectioned from bore 3 in fixed cylinder block S/N Y04-232-49.

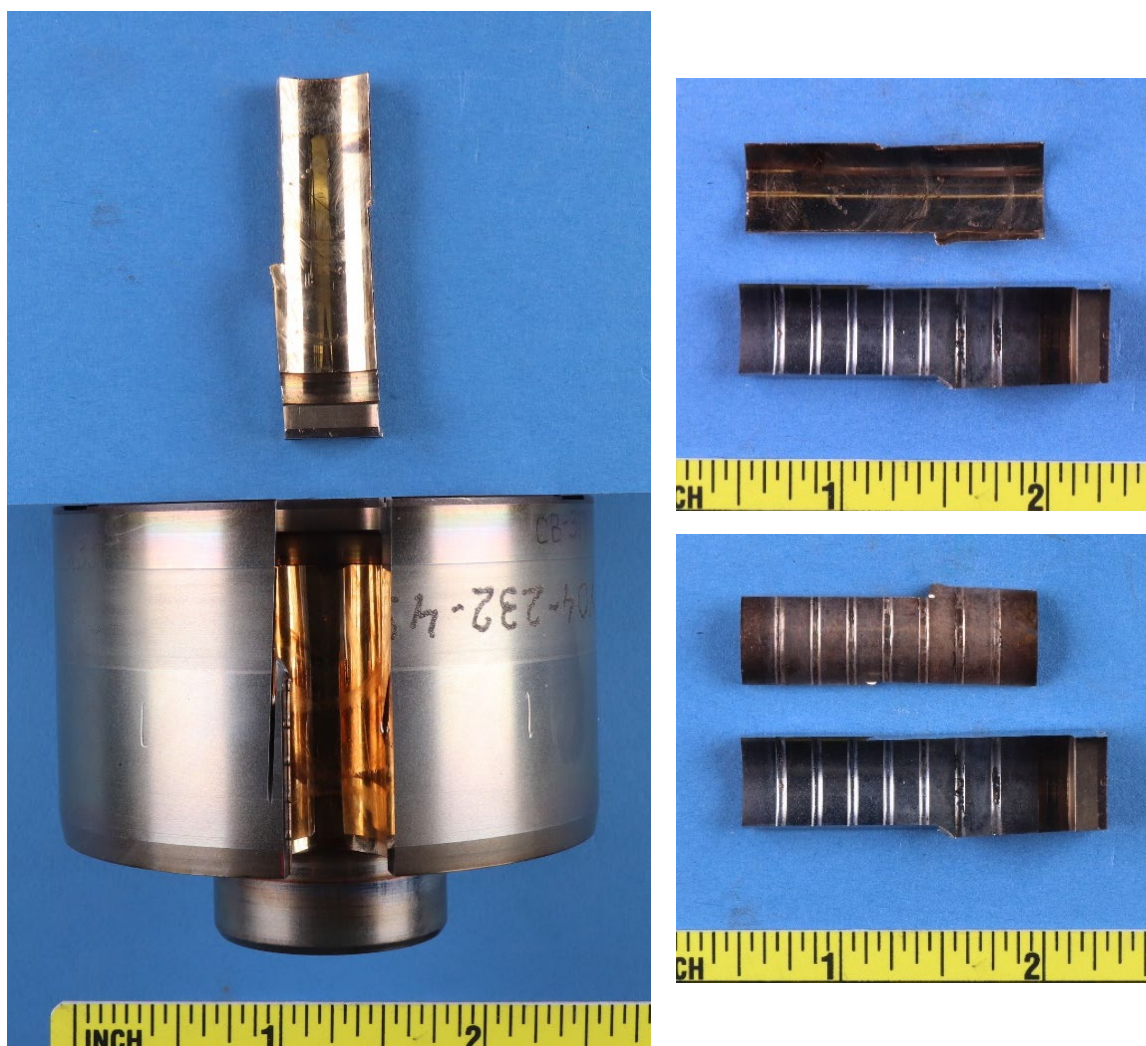
Bore 7 after sectioning is shown in Figure 32. The sectioned piece of liner was whole and intact. The ID of the block piece and the ID and OD of the liner piece are shown in Figure 33. The ID surface of the block piece and OD surface of the liner had a substance on it consistent with the bores examined from the other fixed block, and a few areas of substance within the grooves in the block ID had darkened in color.

Figure 32: Overall and close-up photos of the pieces of liner and OD block side wall sectioned from bore 7 in fixed cylinder block S/N Y04-232-49.

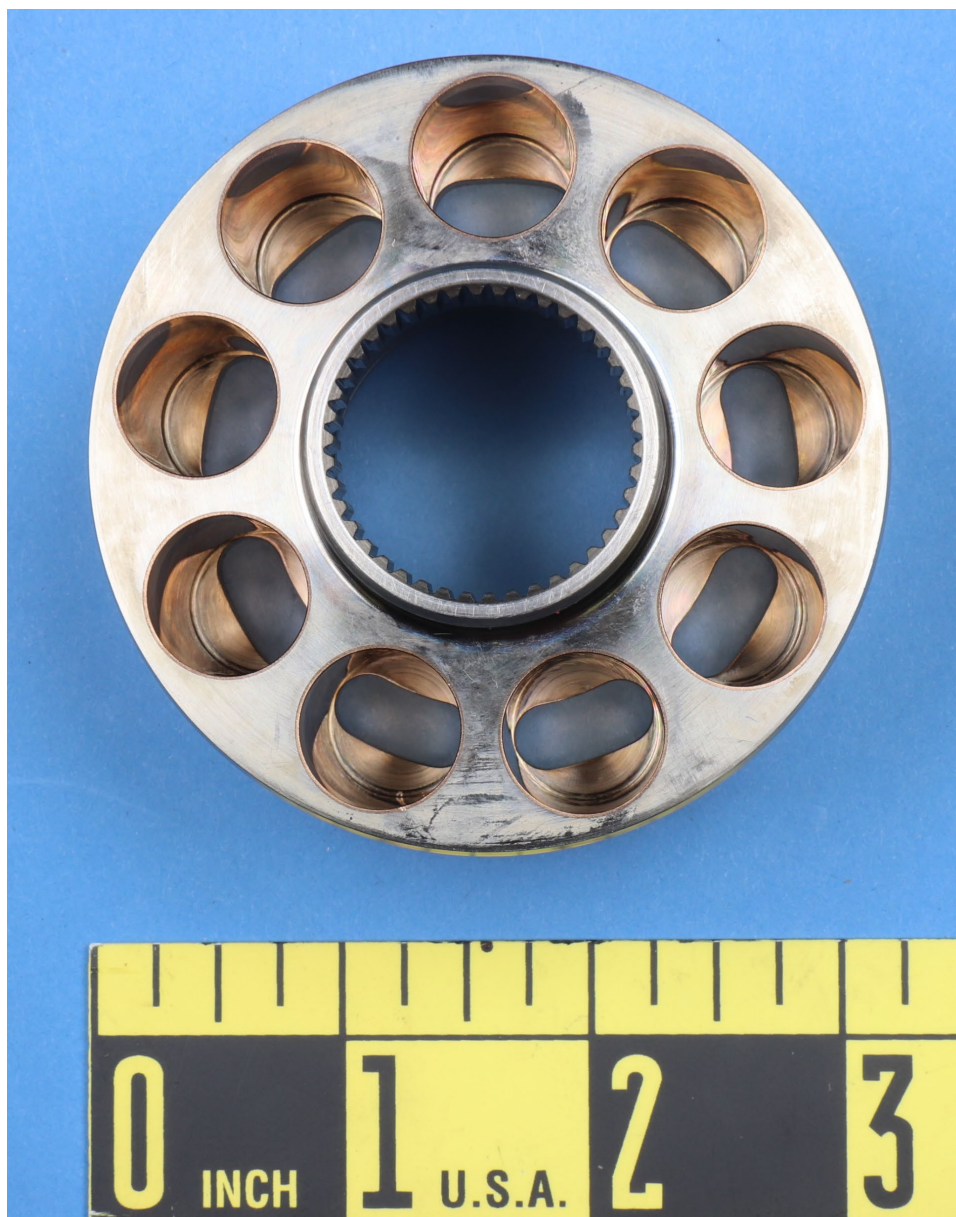
The exemplar fixed block is shown in Figure 35. The exemplar fixed block was visually examined photo documented. Images of two representative bores are shown in Figures 36 and 37.

Figure 35: Overall photo of the exemplar fixed cylinder block submitted by the OEM.
