# **NATIONAL TRANSPORTATION SAFETY BOARD**

## **Attachment 1 - Metallurgical Report**

**ENG20LA046**

**Spring Creek Aviation LLC / Donalsonville GA, USA / Thrush Aircraft 510G (registration N6216K)**  
**METALLURGICAL REPORT**

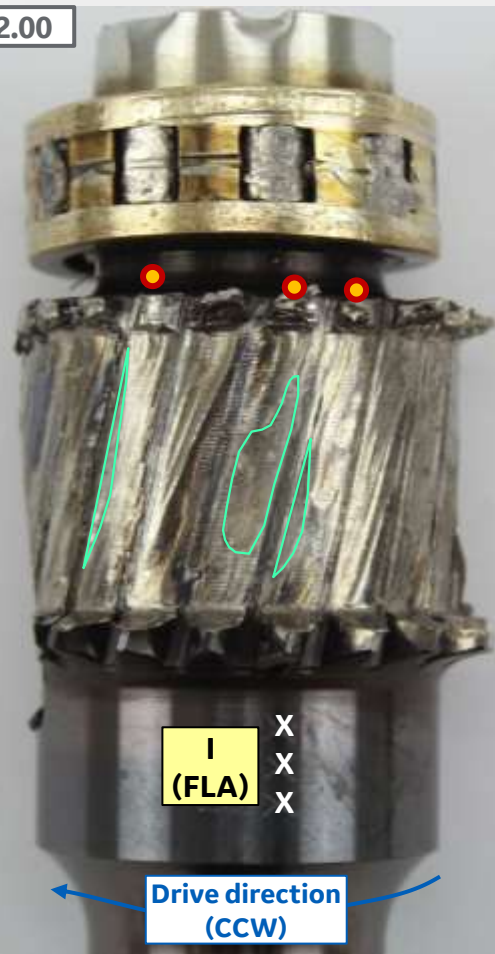
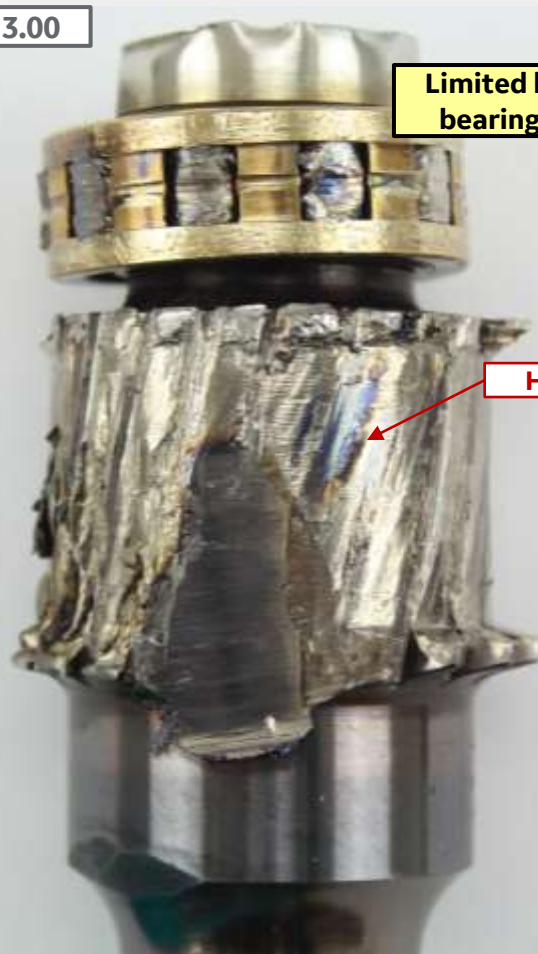
Limited heat tint of  
bearing elements

Heat tint

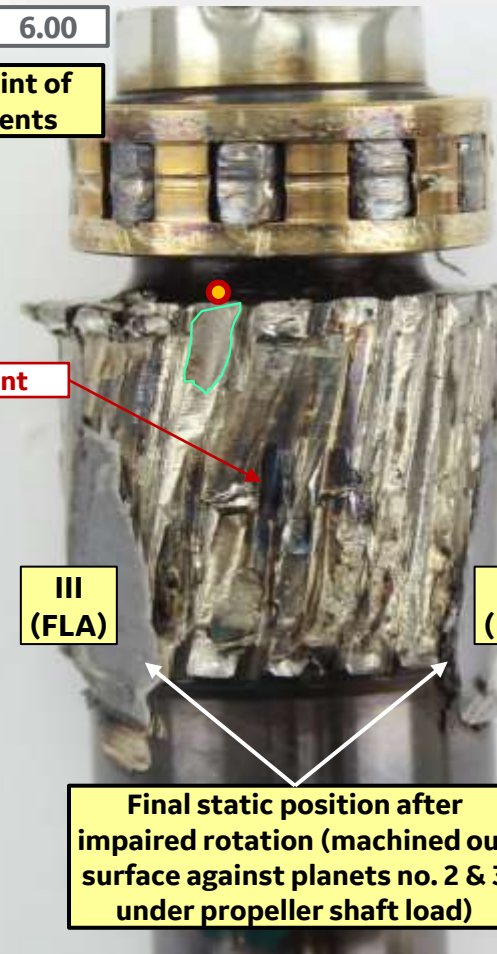
Final static position after  
impaired rotation (machined out  
surface against planets no. 2 & 3  
under propeller shaft load)

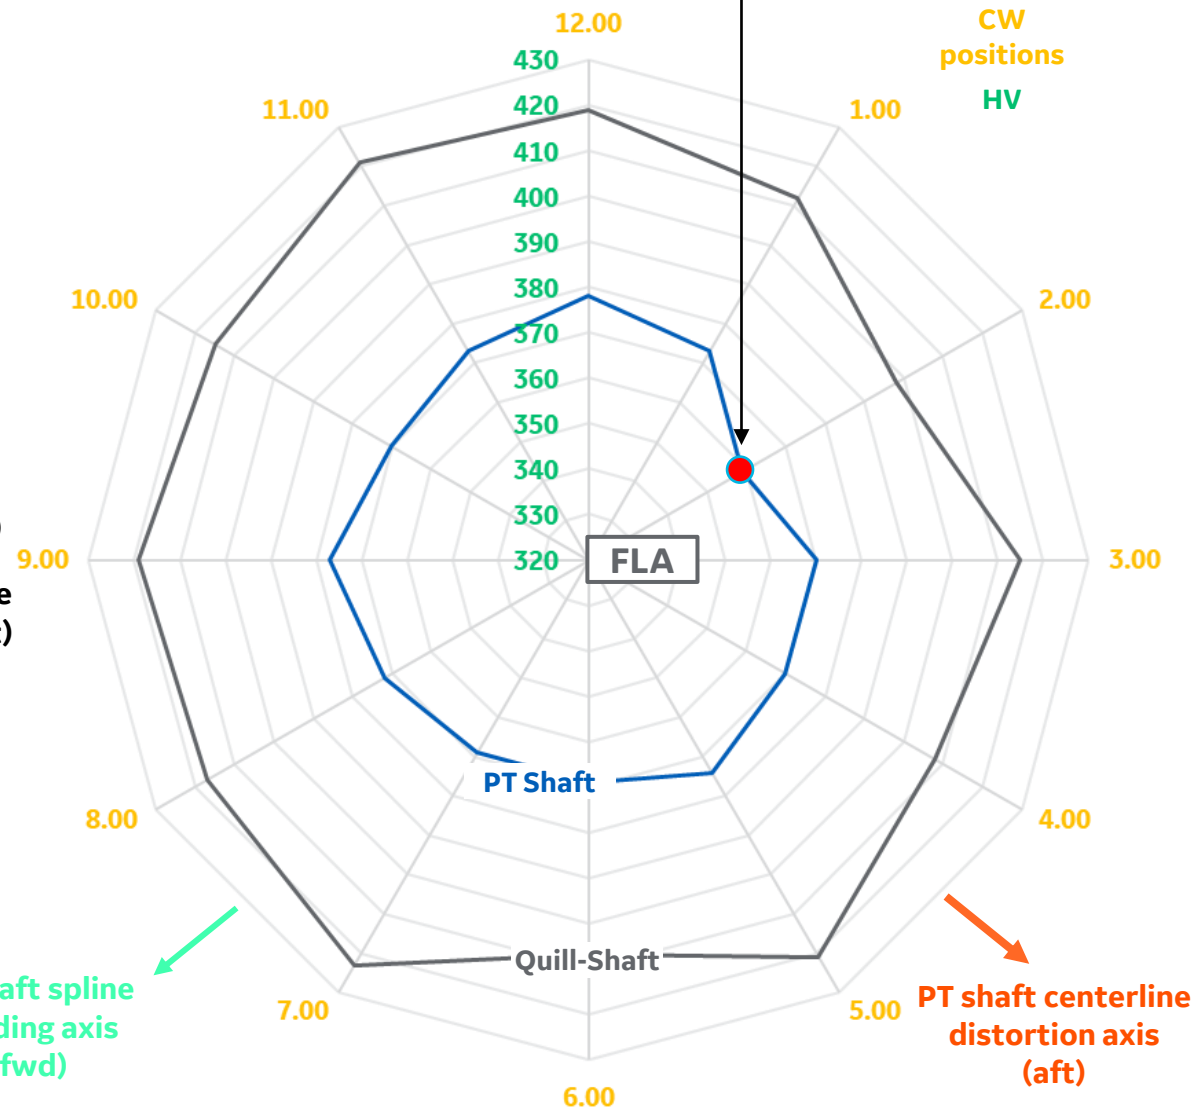
PT disk pin  
shear axis (fwd)  
←  
Quill-shaft Spline  
bending axis (aft)

PT shaft spline  
bending axis  
(fwd)

PT shaft centerline  
distortion axis  
(aft)

Significance of clocked micro-hardness drop at 2.00 & PT shaft HV30 < LSL (363HV) likely related to bending axis

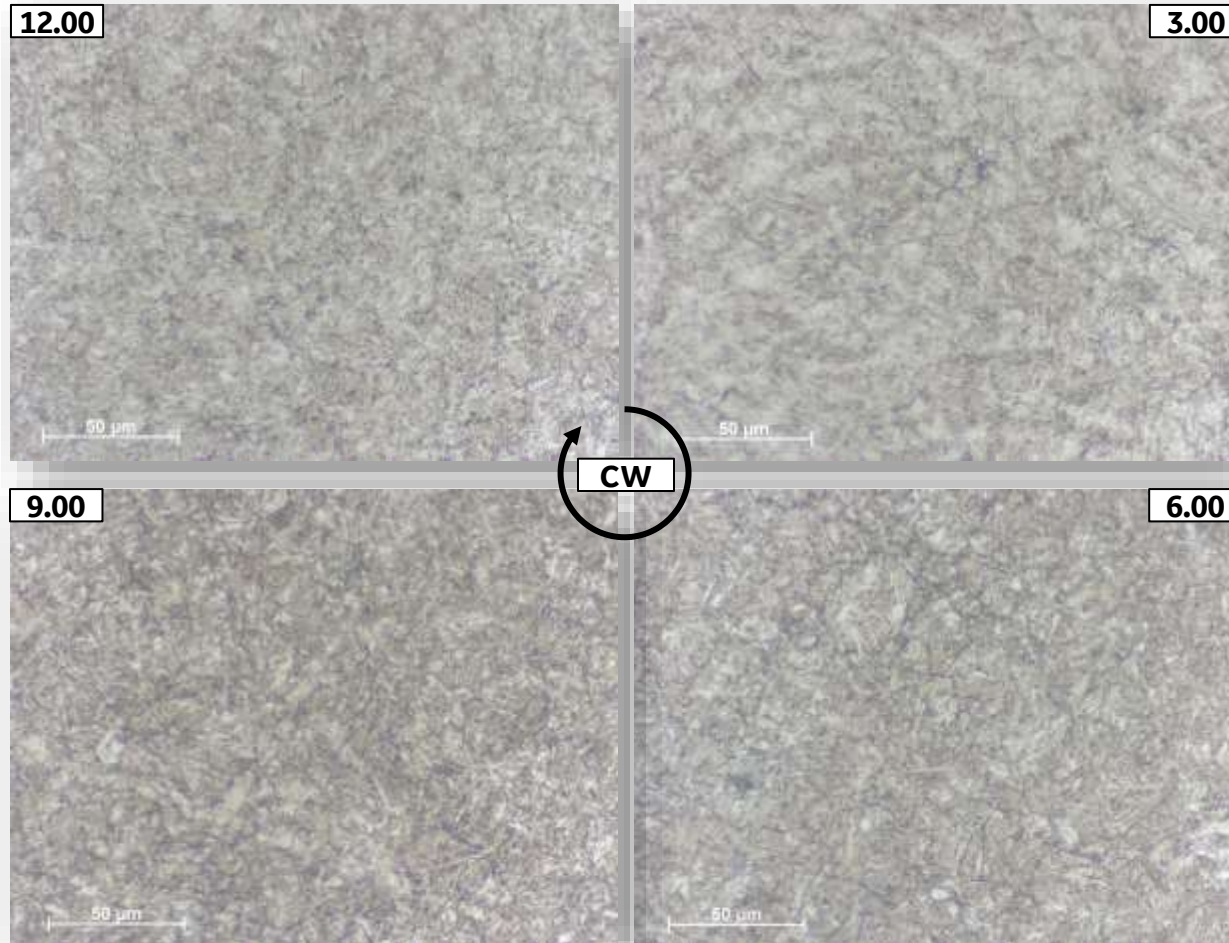
Quill-Shaft M601-6172.6 (L-TER.4 alloy)

Homogeneous martensitic structure containing  
tempered martensite & partially retained austenite  
ASTM E112 finer than GS 5.0 min. requirement

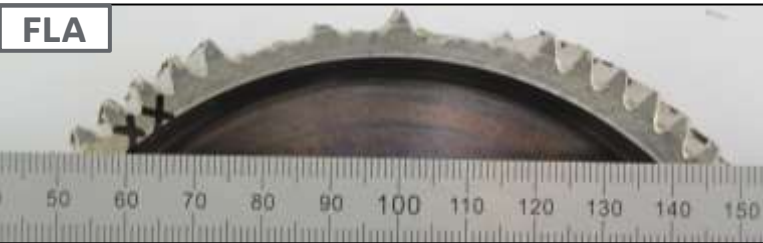
# Visual Inspection (as-cleaned, A1815, pos. I)

Visual examination revealed **8 consecutive fractured teeth (numbered from  $N_0$  to  $N_7$ )** in the vicinity of root land/radius area with apparent **fatigue macro-features indicating primary origin on active/loaded teeth face**.

Among the pool of consecutive fractured teeth, the **tooth N<sub>0</sub>** adjacent to the 1<sup>st</sup> “damage-free” tooth displays peculiar features, i.e. smoother fatigue region with absence of apparent macro-beachmarks.

- Macro-fractographic features indicating fatigue fracture emanating from root area on active faces of teeth (multiple origin) – note flatter fracture on  $N_0$
- Smoother initiation region & transition to greater apparent topographical changes along crack propagation ( $\Leftrightarrow$  cycles)

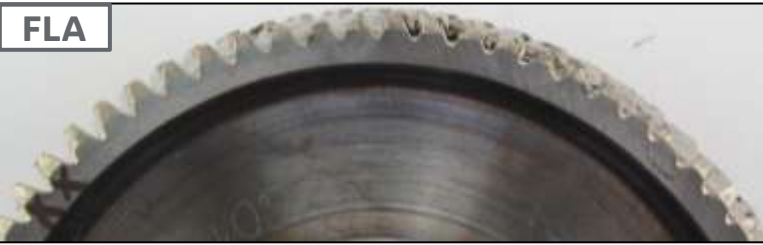
# Visual Inspection (as-cleaned, A1818, pos. II)

- **Planetary Gears S/N 1818 and S/N 1838** respectively at 8.00 o'clock (RGB position 2, FLA) and 4.00 o'clock (RGB position 3, FLA) only exhibited secondary damages with locally embedded teeth debris without apparent fatigue indicators.
- **Two (2) small MPI indications** ~ 3mm length were also reported on **Planetary Gear S/N 1818** on both active and inactive face root radii of the only partially damaged tooth (secondary).

- Expanding span of teeth damages towards forward direction  
⇔ wheel rotation direction
- Secondary damages

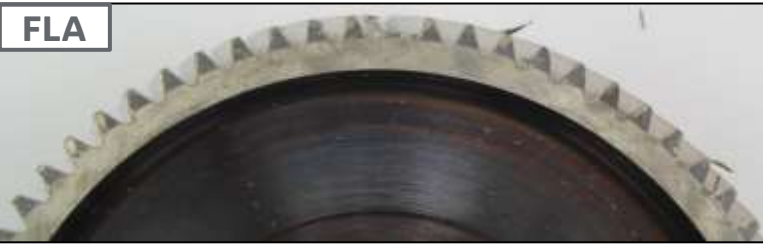
# Visual Inspection (as-cleaned, **A1838**, **pos. III**)

- Partial tooth liberation under mid-chord plane ( $>$  root radius) surrounded by teeth with minor distresses comparatively
- Secondary damages

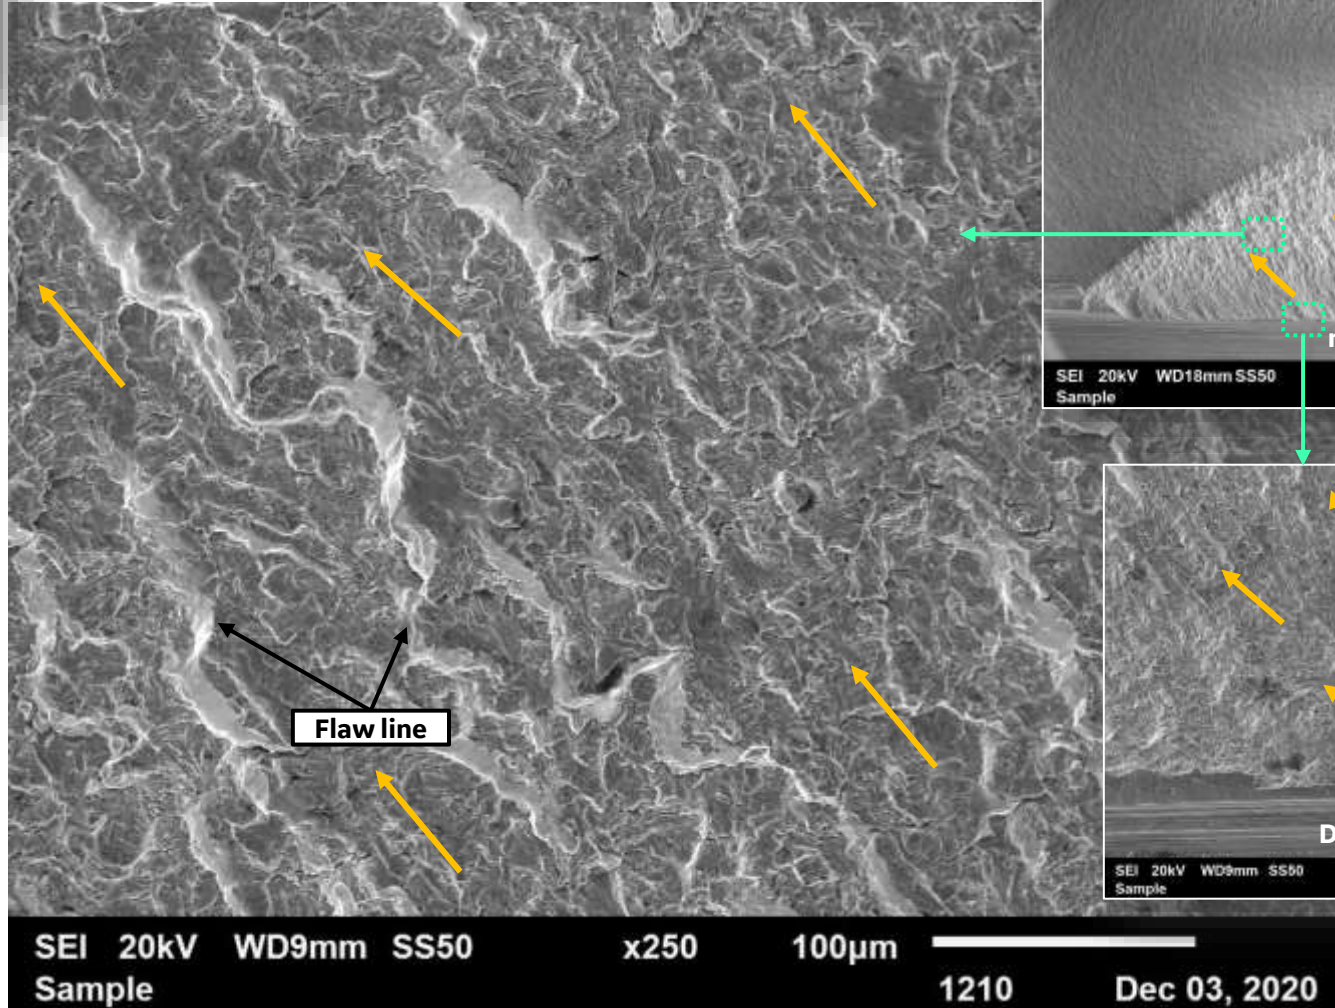
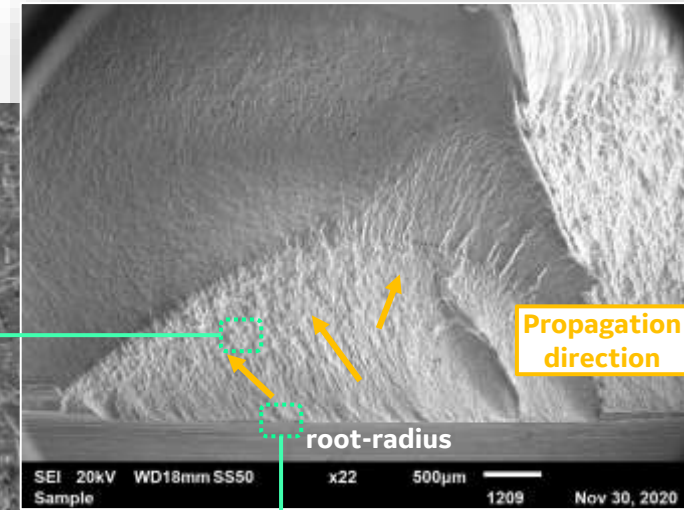
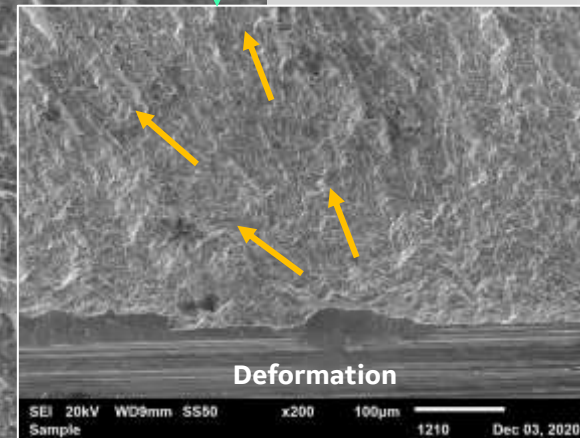
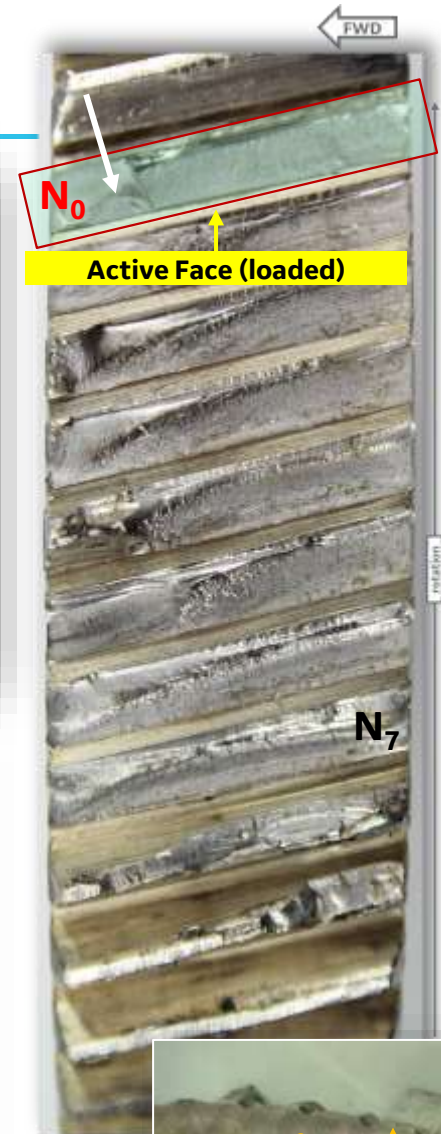
# Fractography (wheel S/N A1815, tooth N<sub>0</sub>)

- **Fractography** demonstrated **multiple surface-initiated cracking on teeth active faces span in the vicinity of root radius**.
  - Fatigue region morphological features indicate a **high alternating stress propagation** with **coarser fatigue striation pattern** and **secondary cracking** along the propagation direction towards inactive face of the teeth.

- The **striation density** was assessed and determined to **vary between 50-70k striations/inch** (resolved beyond ~ 0.5mm from crack edge) to **20-30k striations/inch** as the crack progresses, hence **within the range of a higher alternating stress propagation condition**.

- ❑ Multiple surface initiation (depicted by orange arrows) along original machined line in the vicinity of root-land radius to contact face lower region (red arrows underline ratchet marks)
- ❑ Relatively coarse striation pattern (high alt. stress condition) & apparent secondary cracking

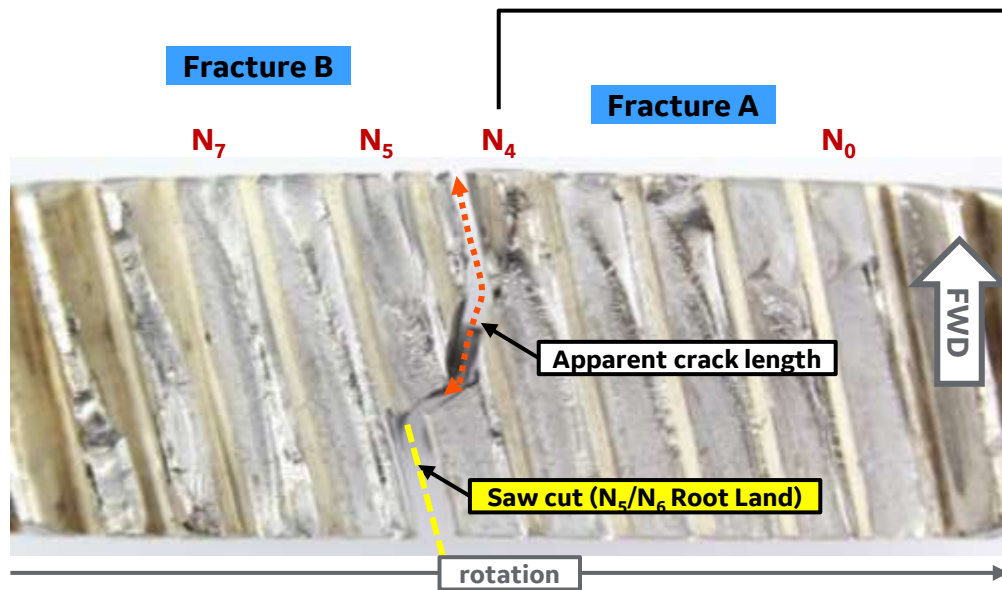
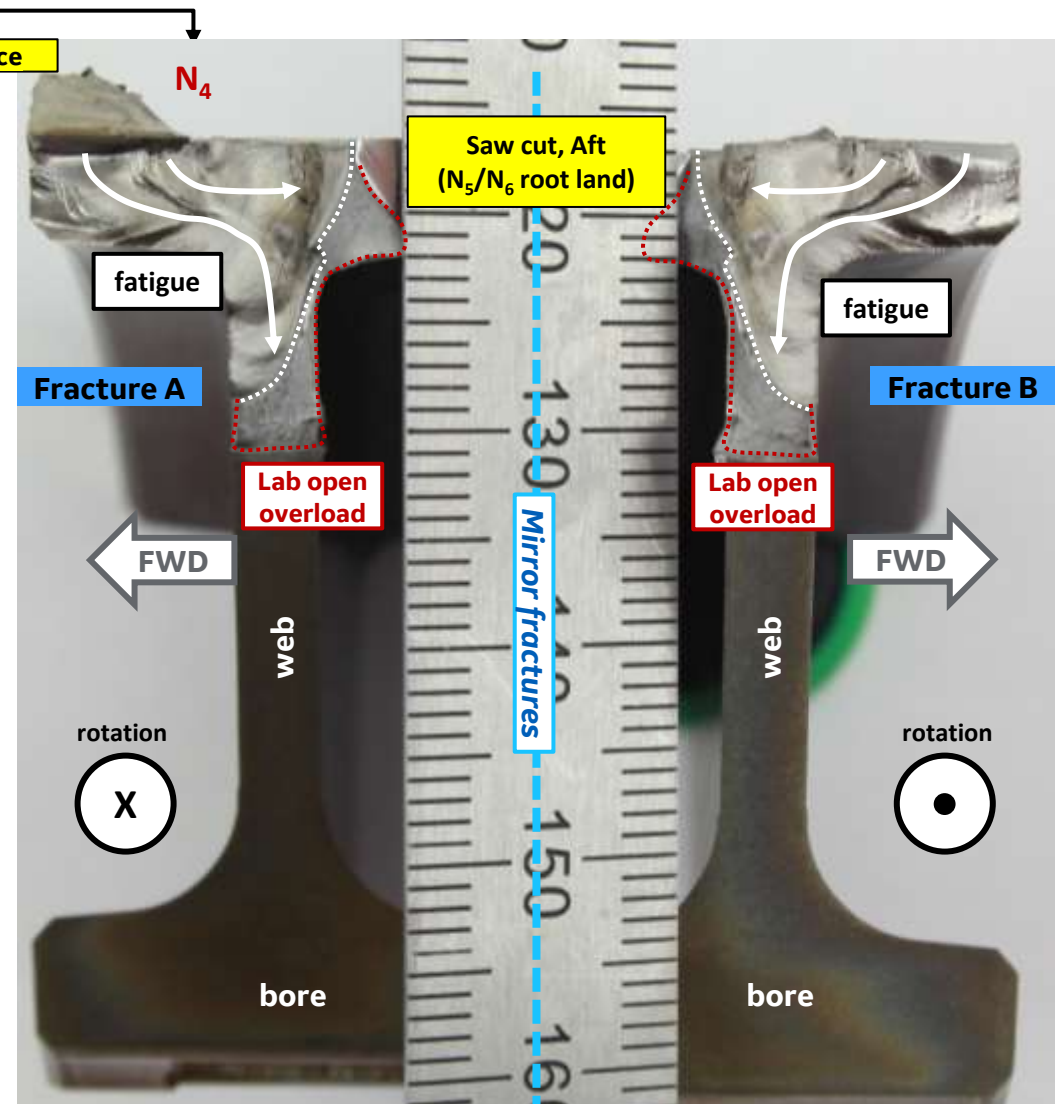
# Fractography (wheel S/N A1815): Break Open

- Saw cut carried out on N<sub>5</sub>/N<sub>6</sub> aft root land region & force open
- Fatigue Propagation Inboard Wheel Web ~12 mm from Tooth Fwd End

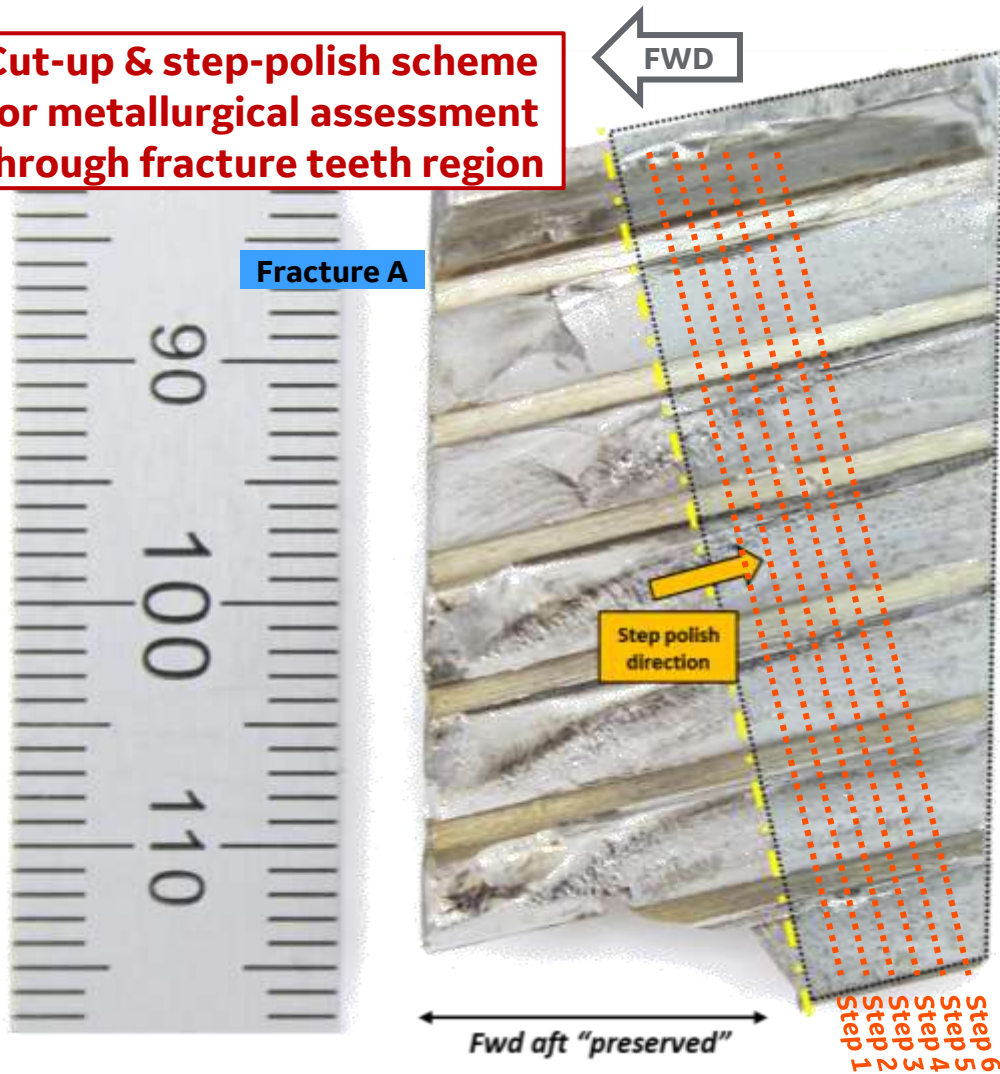
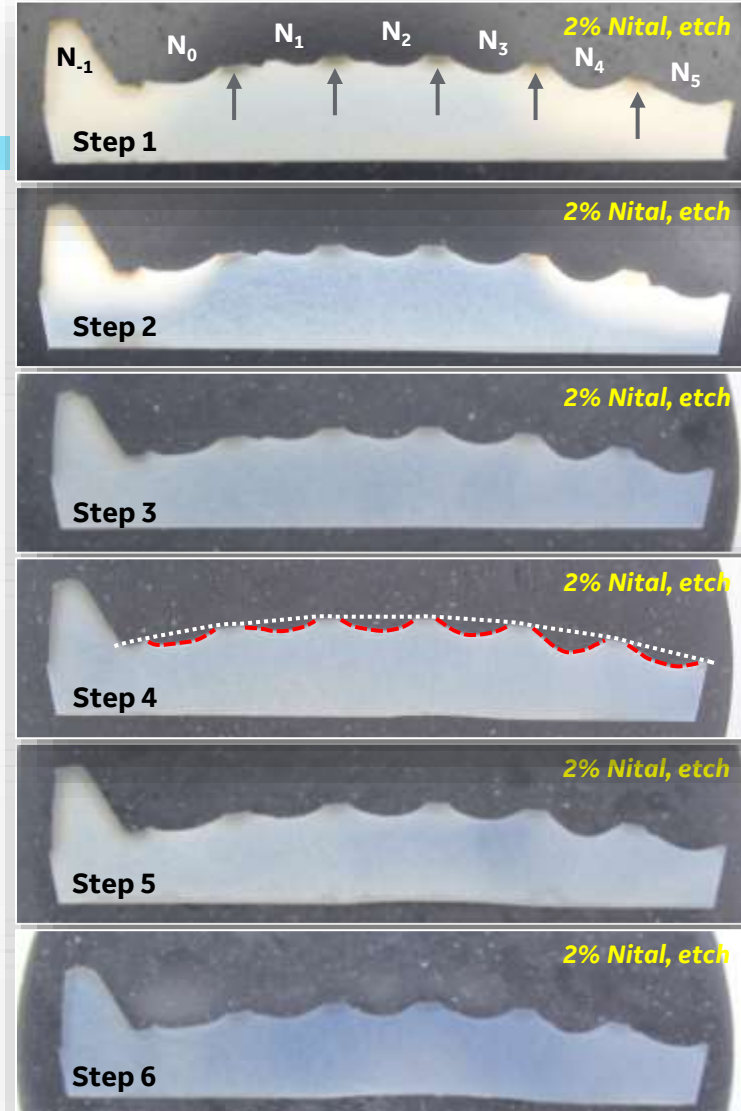
# Metallurgical Examination: fracture A step polish

Cut-up & step-polish scheme for metallurgical assessment through fracture teeth region

Darker contrasted  
root-land indicated by  
arrows underlines  
remnant of carburizing

Increased fracture  
steepness with teeth  
liberation progression  
 $N_0 \rightarrow N_5$

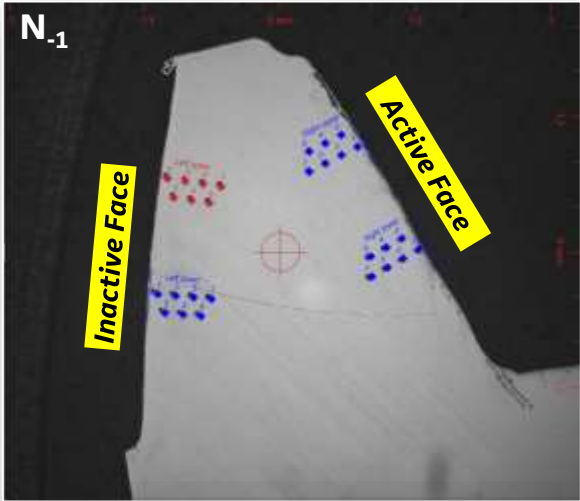
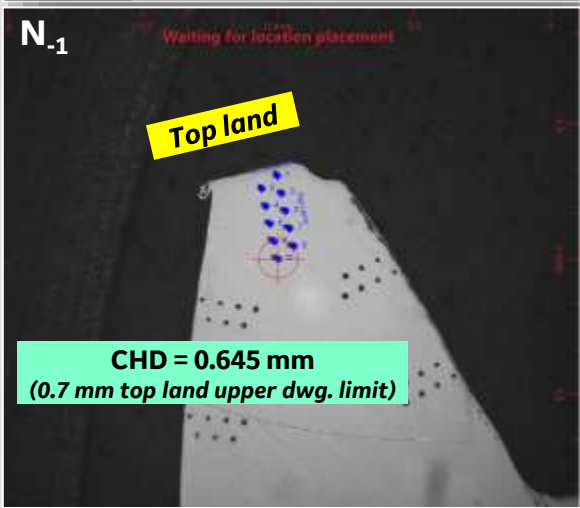
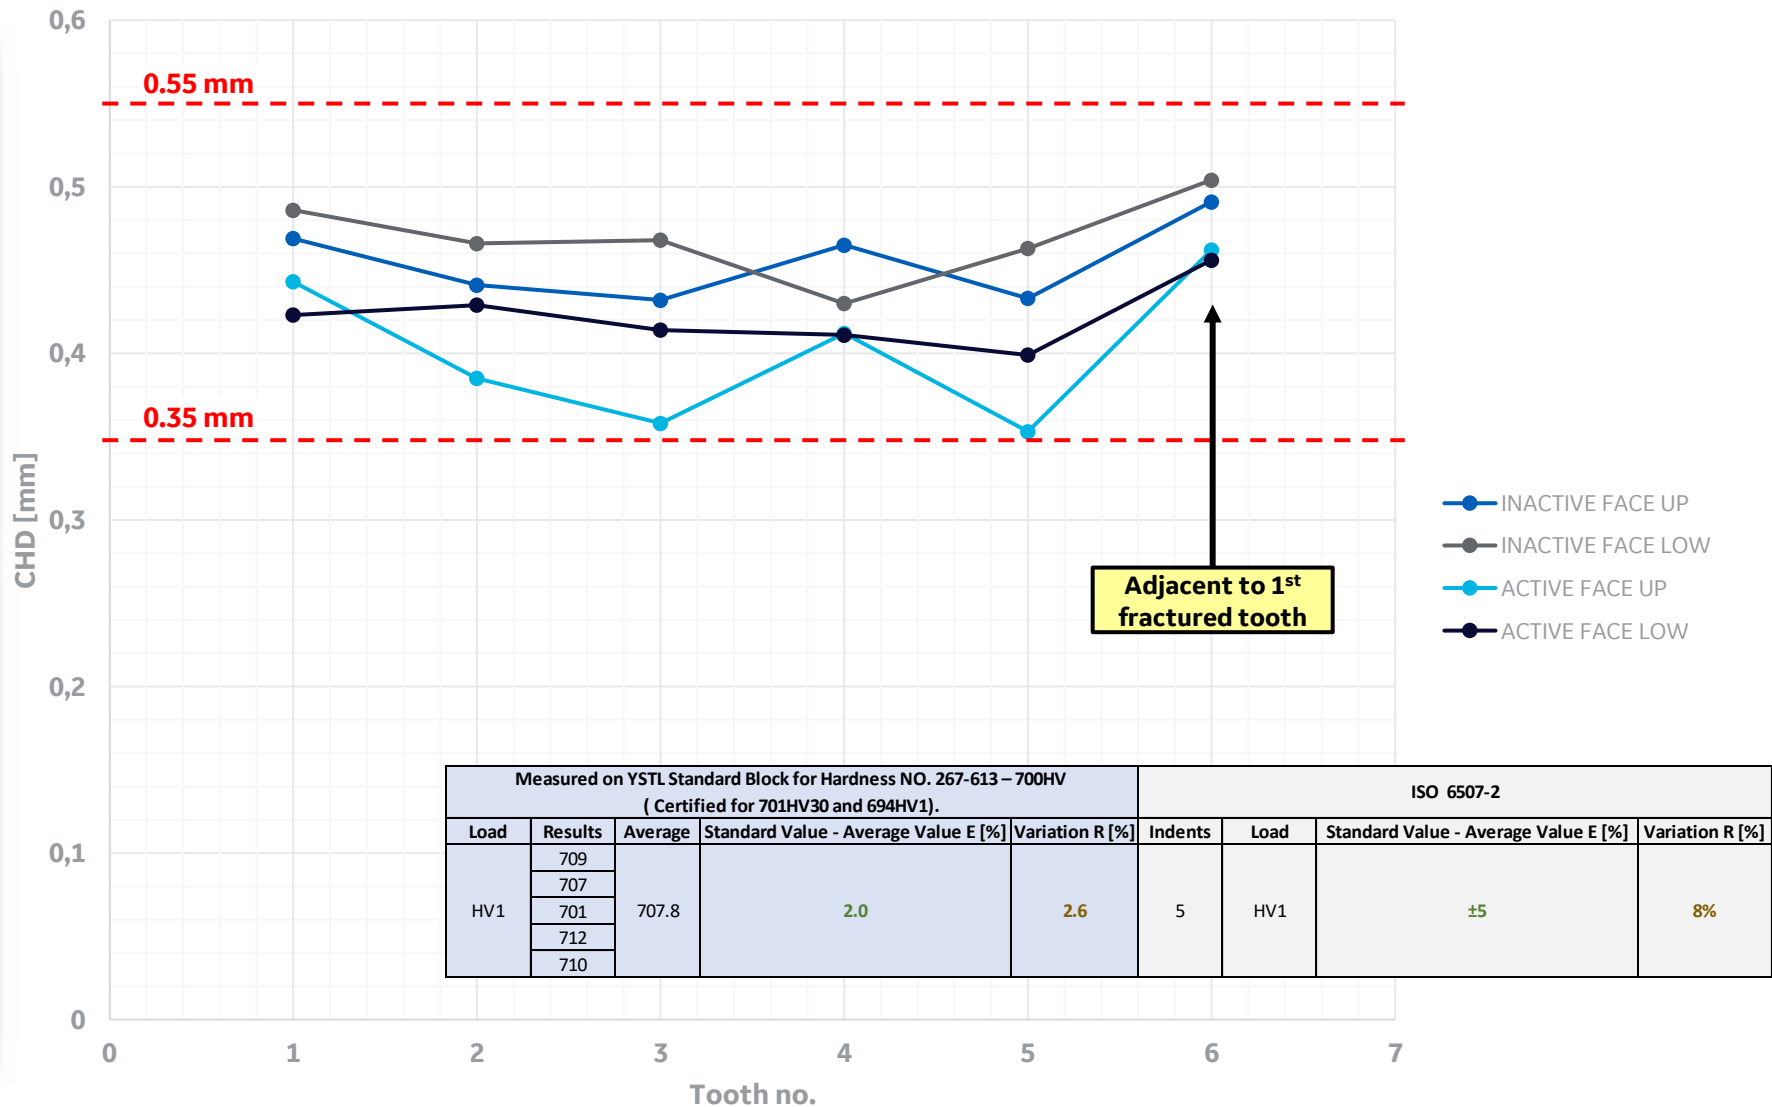
# Metallurgical Examination: CHD

Teeth no. 1 to 5 (4.00 – 5.00 CW)  
Tooth no. 6 = N<sub>-1</sub> (12.00 CW)

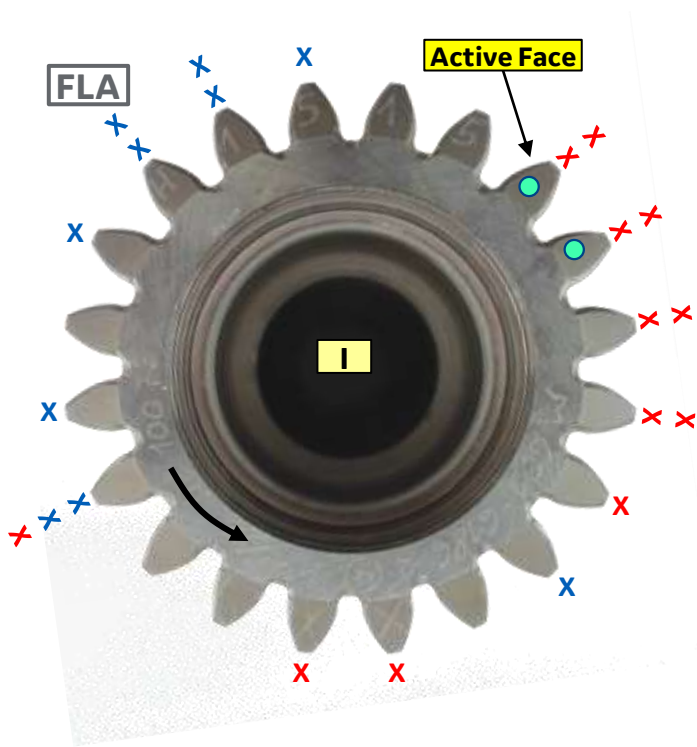
# Stereo-micrographs (gear H1515, pos. 1)

- x AFT
- x FWD
- AFT (biased contact feature)

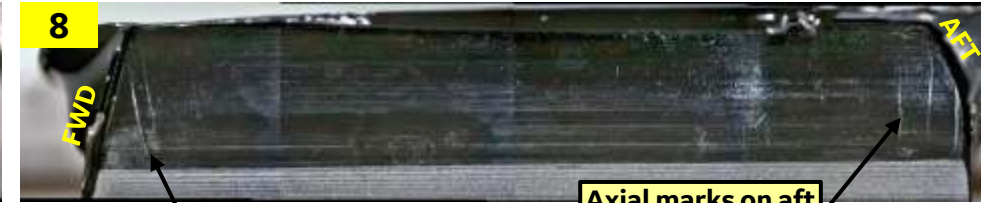
Axial marks on aft face portion

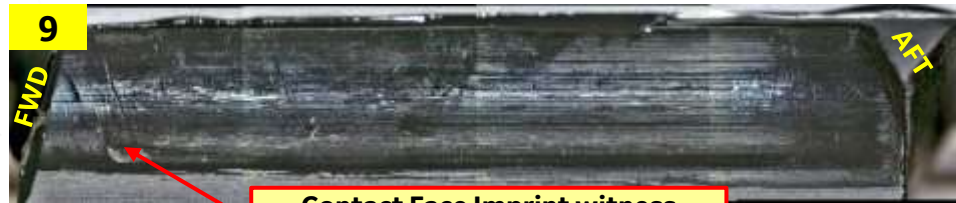
Contact Face Imprint witness comparable to observation on hdw.

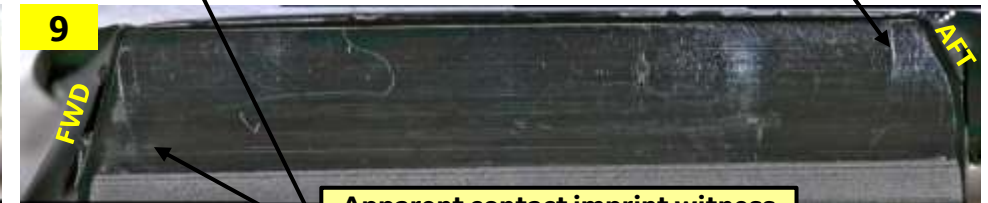
Apparent contact imprint witness (compatible with crown wheel teeth fwd end shape)

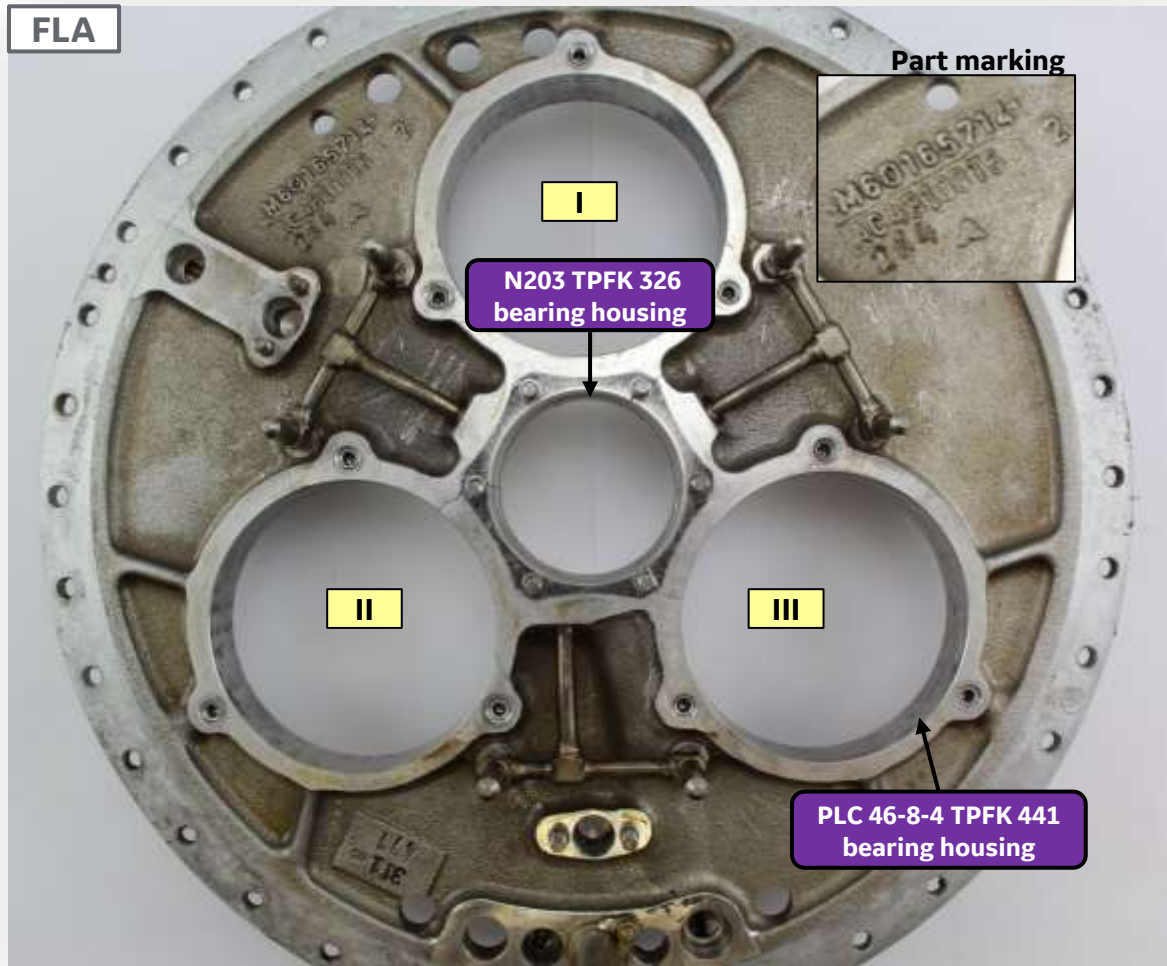
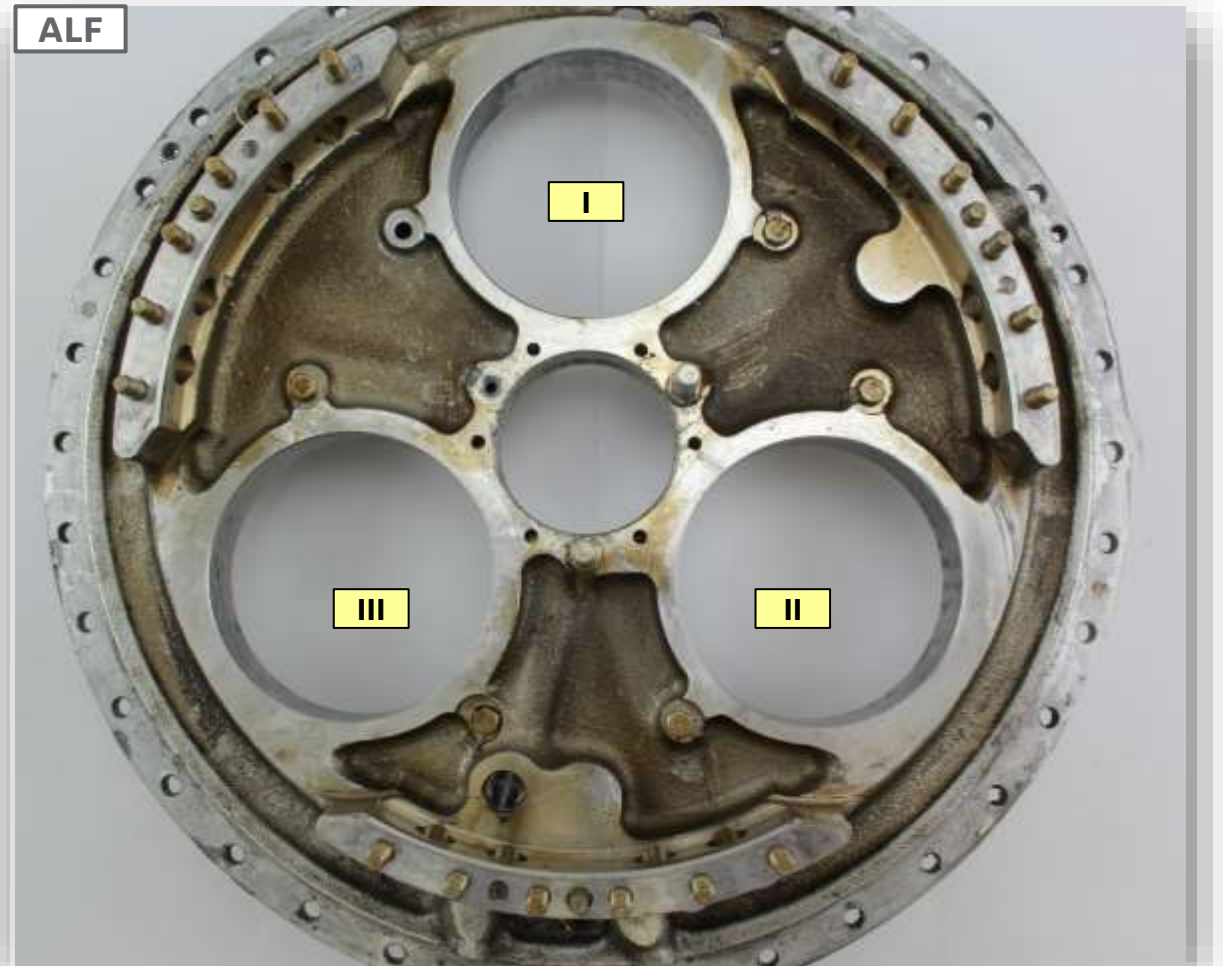
**All four (4) other M5 nuts, of which two (2) washer big securing tab displays a fracture, reported loose during RGB disassy**

**Fractured washer tab at 1.00 & 9.00 positions documented in Appendix 6**

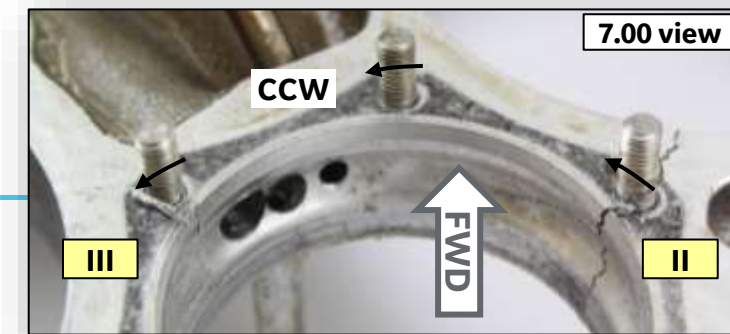
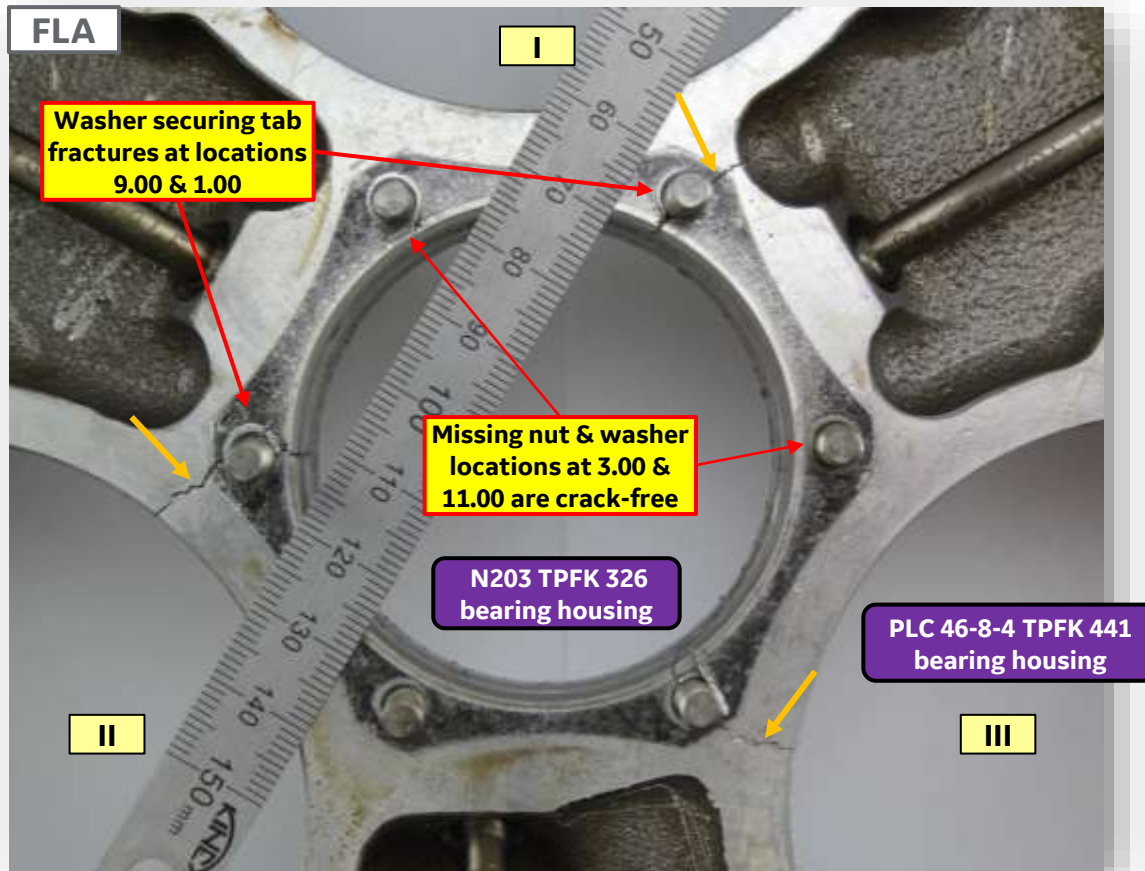
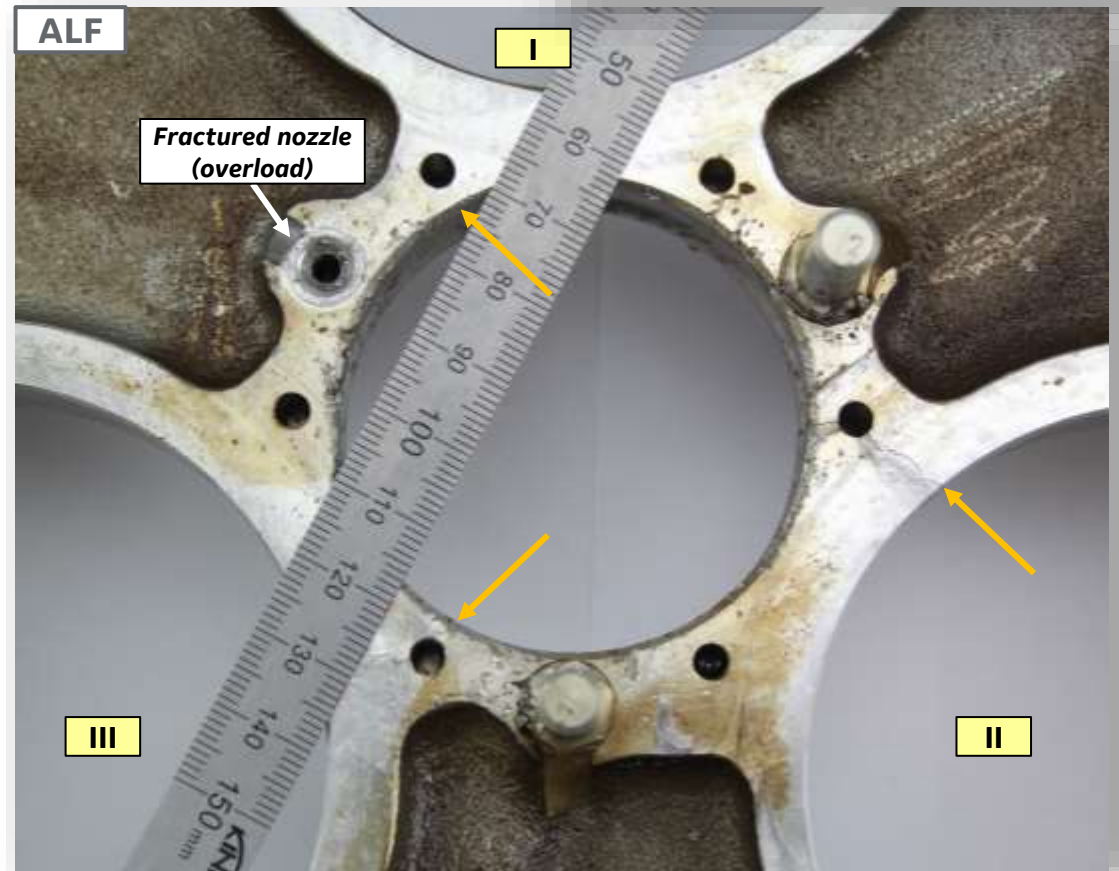
→ Apparent through cracking across pin location

Fractured washer tab at 1.00 & 9.00 positions documented in Appendix 6

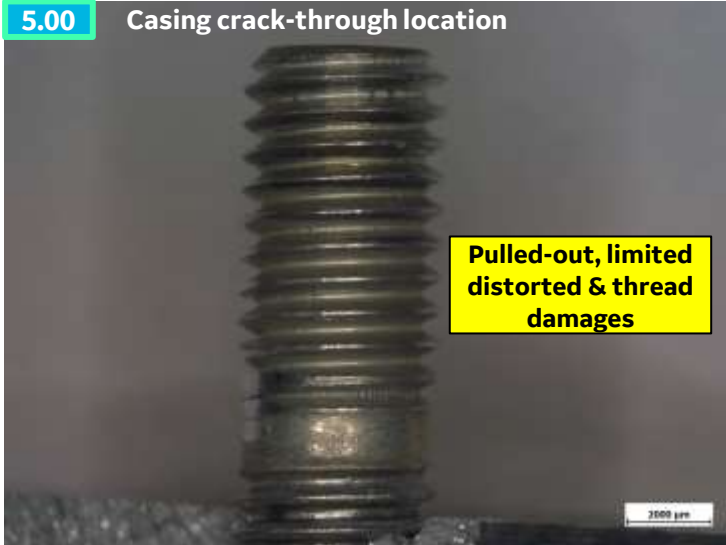
5.00

Casing crack-through location

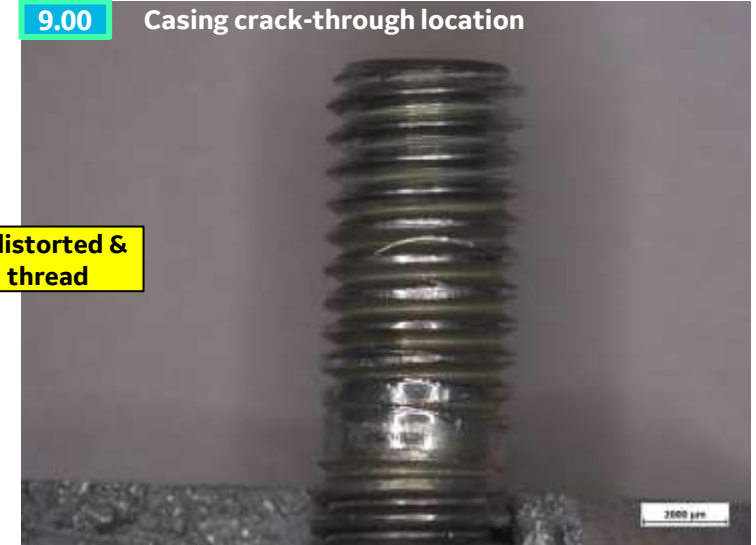
9.00

Casing crack-through location
