**NATIONAL TRANSPORTATION SAFETY BOARD**  
**Office of Aviation Safety**  
**Washington, D.C. 20594**

**POWERPLANT GROUP CHAIRMAN'S FACTUAL REPORT**

**NTSB No: ENG21LA013**

**Aircraft:** Aerotransportes Mas de Carga, S.A. de C.V (Mas Air Cargo), Boeing 767-338F, registration number N363CM, Flight MMA6853

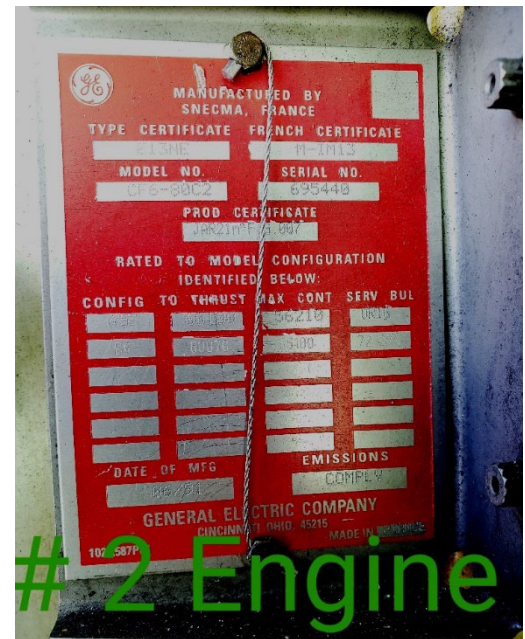
**PHOTO 1: No. 2 ENGINE DATA PLATE  
ESN 695440**

The No. 2 engine installed on the incident airplane, N363CM, was a GE CF6-80C2-B6 turbofan engine, engine serial number (ESN) 695440 (**PHOTO 1**). At the time of the engine fire event, ESN 695440 had accumulated 54,187 hours time since new (TSN), 20,656 cycles since new (CSN), 1,649 hours time since last shop visit (TSLSV), and 669 cycles since last shop visit (CSLSV).

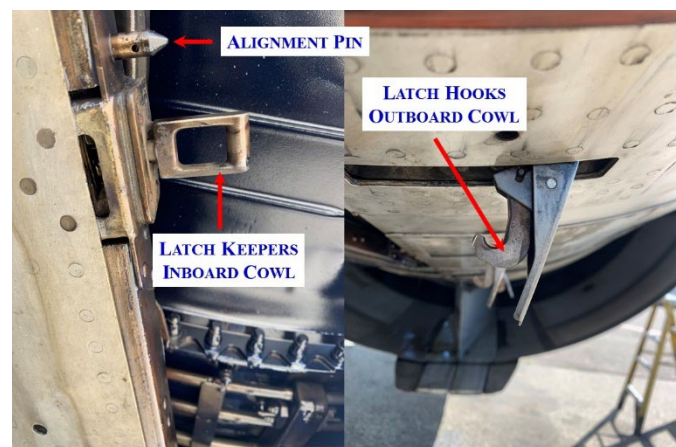
**PHOTO 4: CORE COWL LATCHING MECHANISM**  
PHOTO COURTESY OF BOEING

The fan cowl, thrust reverser cowls, and the core cowls were closed, fully latched, and secure; the pressure relief door<sup>6</sup> on the outboard core cowl was open and still attached (**PHOTO 3**), and the IDG access door was closed. When all the cowls were unlatched, all the latch hardware - latch hooks and latch keepers - appeared to be intact and in good condition (**PHOTO 4**). No debris exit penetrations holes or burn-through holes were observed on any of the cowls.

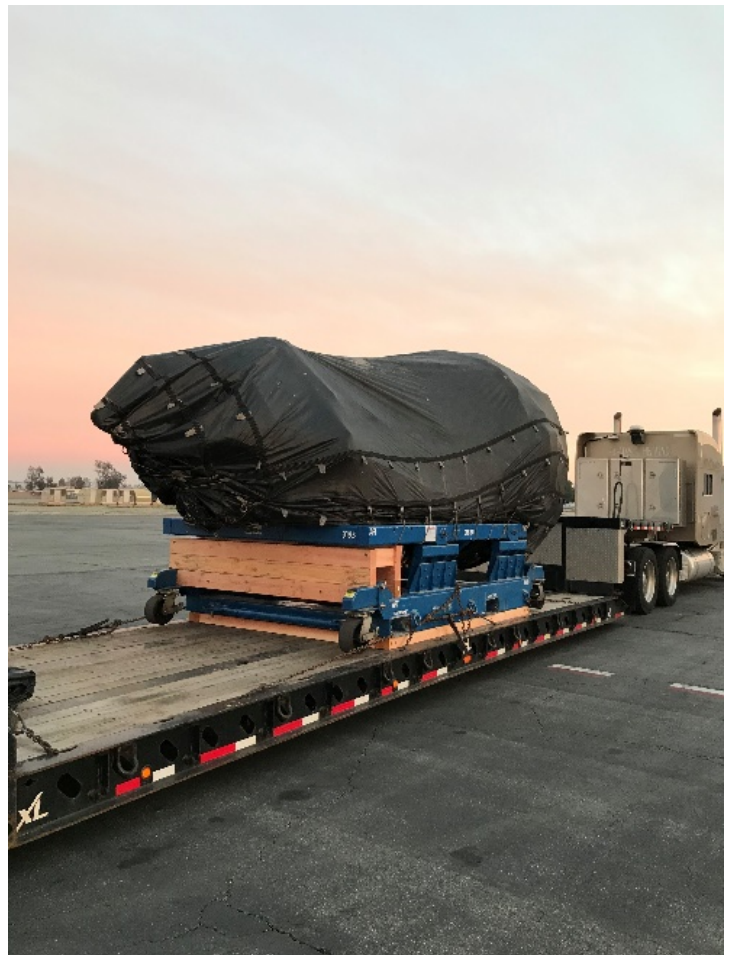
**PHOTO 23: ENGINE NO. 2 READY FOR TRANSPORT**

After the on-scene examination was completed, the engine was dropped from the airplane and placed in a transportation stand. A GE field representative aided and provided guidance on how to properly transport the engine based on the damage observed to the TRF. The TRF is equipped with two ground handling rails/sockets located at the 3:00 and 9:00 o'clock positions with holes for mount pins. Due to the extensive damage to the TRF, additional support was provided underneath the engine to ensure that the engine could be transported safely (**PHOTO 23**).

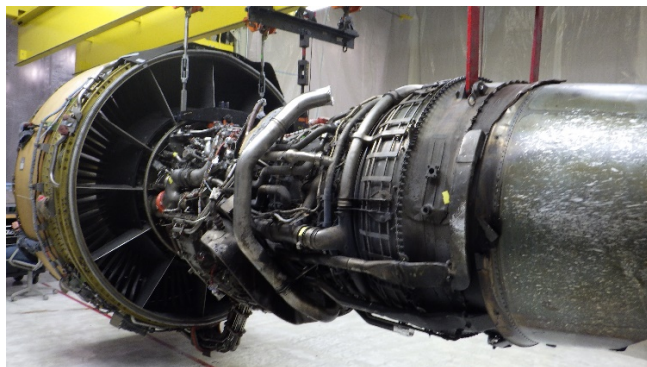
**PHOTO 24: LEFT SIDE OF ENGINE**

When the engine arrived at the GE facility, the engine was placed in a secure quarantined area and the NTSB authorized GE to remove several external components/parts for the engine to be hung in a gantry (**PHOTOS 24** and **25**).

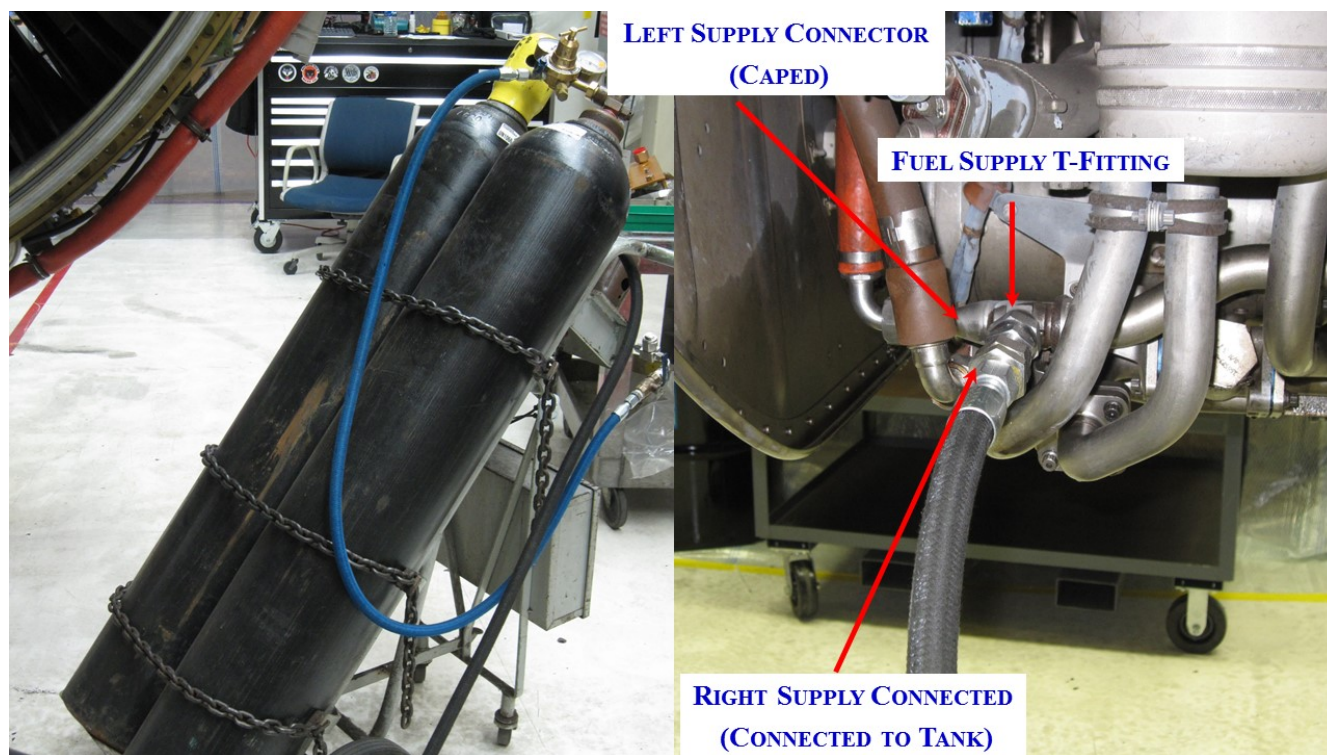
**PHOTO 31: FUEL LEAK CHECK SETUP**

Prior to disassembling the engine, a leak check of the fuel system forward of the heat shield (heat exchanger, fuel pump, MEC, etc.) was performed; no fuel leak check was performed on the fuel manifolds or fuel nozzles since no indication of fuel wetting of the compressor rear frame was noted. Fuel was first drained from the fuel system and the fuel supply lines to the left and right fuel manifold rings were disconnected from the common fuel supply T-fitting forward of the heat shield. The left fuel manifold supply fitting was capped, and a nitrogen tank was attached to the right fuel manifold supply fitting (**PHOTO 31**). Nitrogen was slowly introduced into the fuel system and after fifty (50) pounds per square inch (psi) was applied the supply valve was closed; the needle on the pressure gage of the nitrogen tank stayed steady and did not drop. The supply pressure was then increased to 80 psi and again the supply valve was closed and the needle on the pressure gage did not drop, consistent with no leak in the fuel system forward of the left and right manifold fuel supply T-fitting.

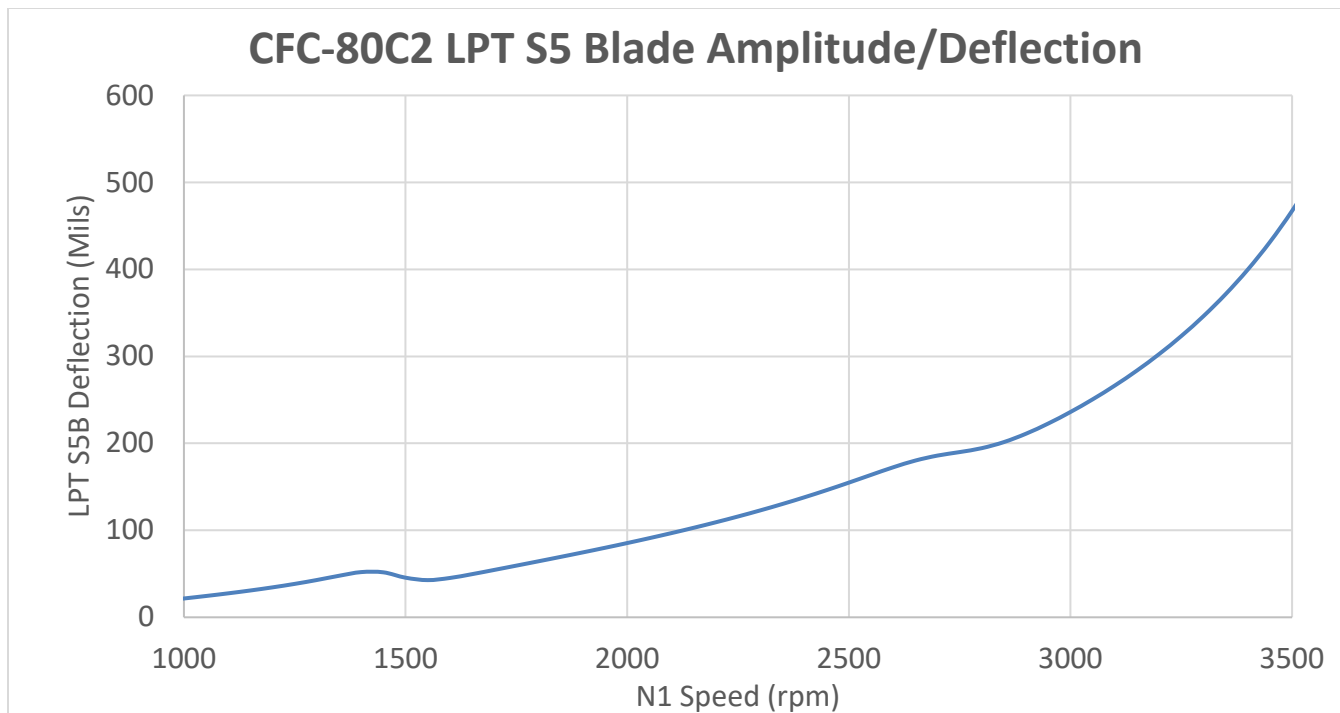
**CHART 1: LPT STAGE 5 AMPLITUDE AND DEFLECTION CURVES FOR VARIOUS N1 ROTOR SPEEDS**

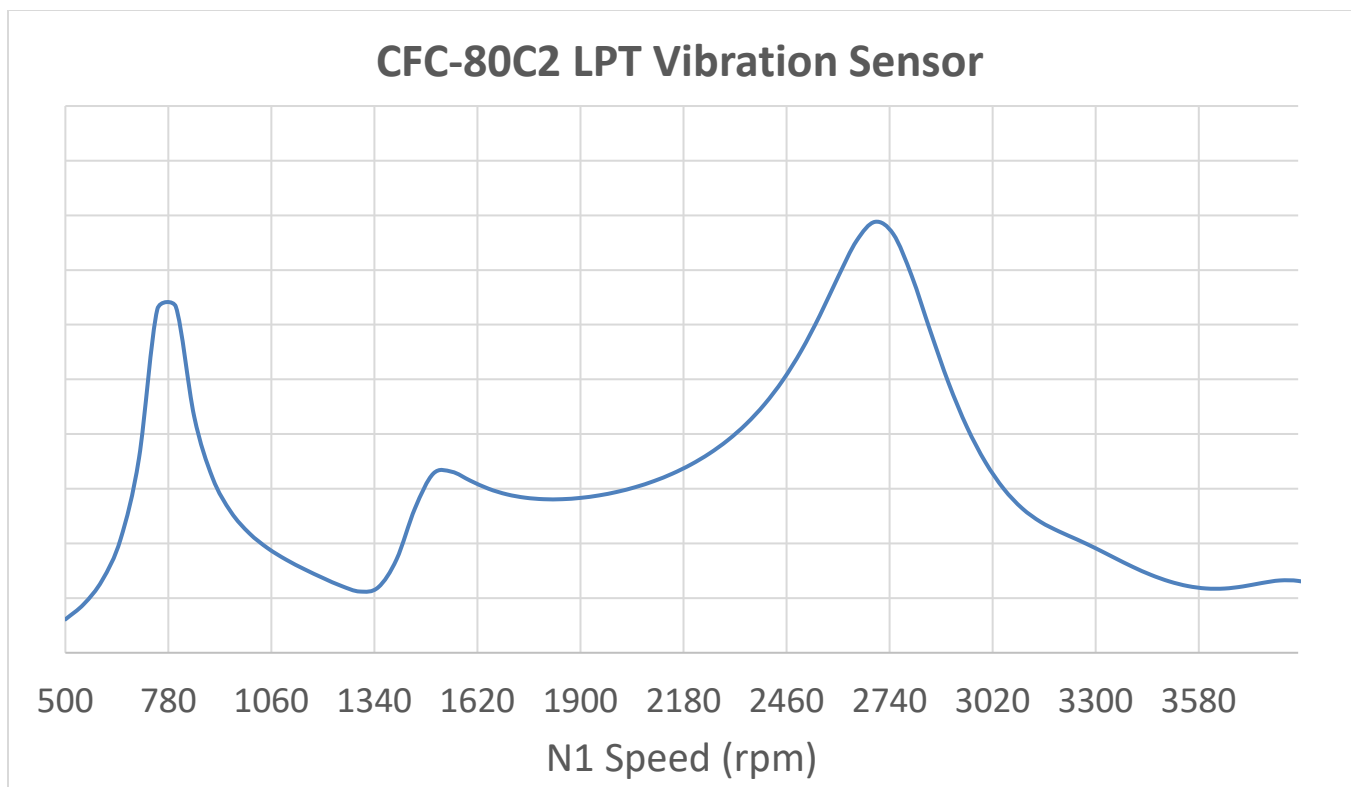
The airplane was equipped with an airborne vibration monitoring (AVM) system that continuously monitors the engine vibration levels and provides an early warning of engine malfunction to permit corrective actions to be taken before extensive damage results. The system consists of two accelerometers (vibration pickups) for each engine; one is mounted on the No. 1 bearing housing in oil sump “A” with its external lead connector on the No. 8 fan strut and the other is mounted on the forward side of the flange between the compressor rear frame (CRF) and the compressor stator case at the 11:00 o’clock position; the vibration sensor on the CRF is also commonly referred to LPT vibration sensor. As part of the imbalance calculation work that GE performed (See Section 5.0), GE calculated deflection values that the CFR/LPT vibration sensor would have experienced during this event. Based on their calculations, the largest rotor deflections were not at the event rotor speed of roughly 3,450 N1 rpm but as the engine decelerates and passed through about 2,700 N1 rpm which is about 82% N1 speed ([CHART 2](#)). The amount of deflect calculated for the LPT event was, according to GE, comparable to the deflection data for a CF6-80C2 engine fan blade out test and is well above the AVM limit of 5 CUs.

**CHART 2: CFR/LPT VIBRATION SENSOR DEFLECTION CALCULATION VARIOUS N1 ROTOR SPEEDS**  
 CHART COURTESY OF GE
