Subject: Boeing Equipment Quality Analysis Report on Right Main Landing Gear – Sun  
Country 737-800 N817SY Landing Gear Collapse in Las Vegas 04 February  
2022

## Equipment Quality Analysis Report

**SUBJECT:** *Right Main Landing Gear Collapse*

**SUBJECT:** Metallurgical Fracture Analysis of Main Landing Gear Outer Cylinder

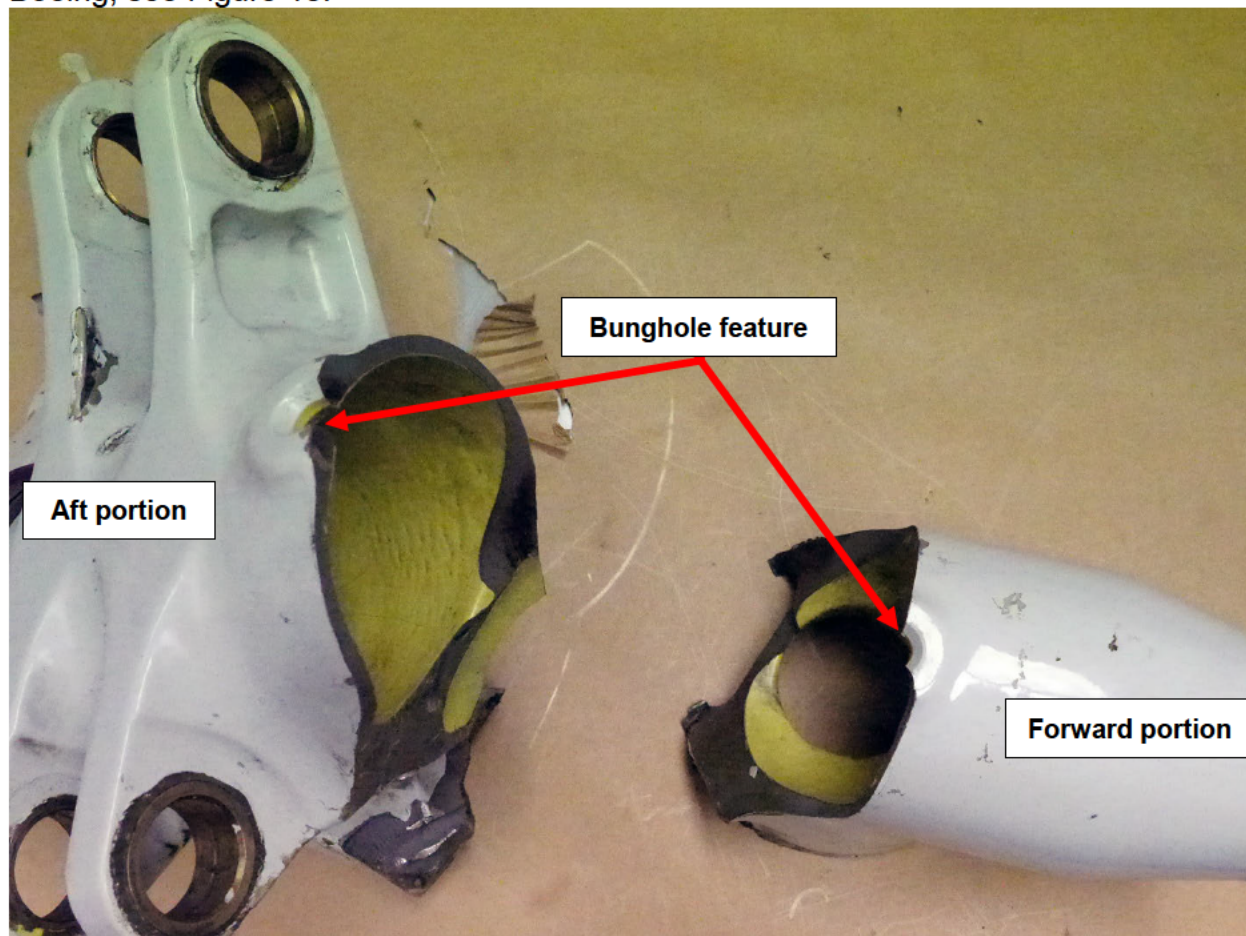
Figure 10: Aft and Forward portions during examination

Aft and Forward fractured areas around the bunghole feature. The parts were previously cleaned of grease and Corrosion Inhibiting Compound by the NTSB before shipment to Boeing, see Figure 10.

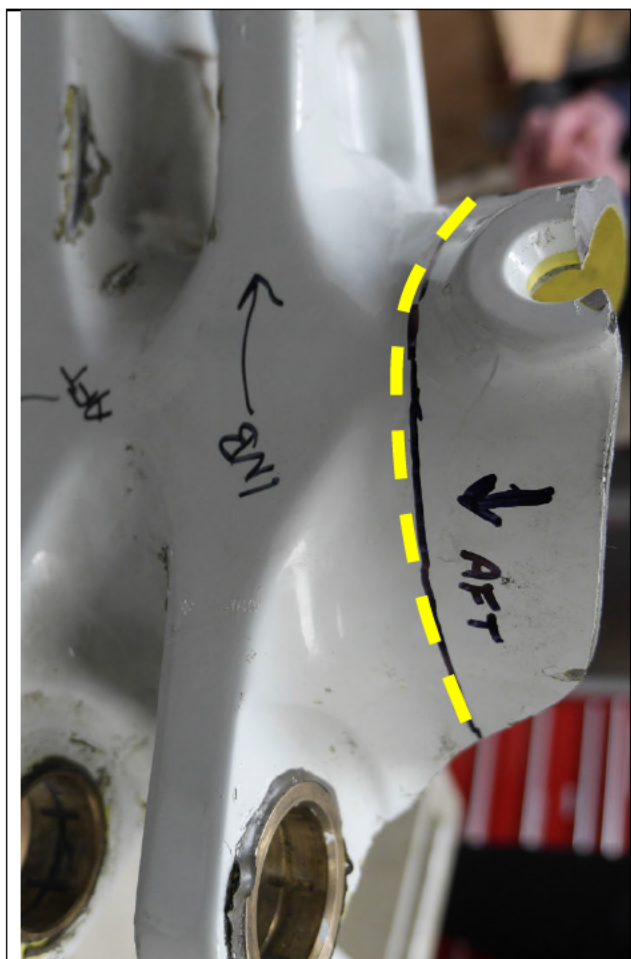
**Figure 13: Aft portion with cut line**

The examination team decided to cut the areas of interest from the larger parts of the Aft and Forward portions. Arrows indicating the original orientation on the aircraft and cut lines are seen in Figure 13 and Figure 14.

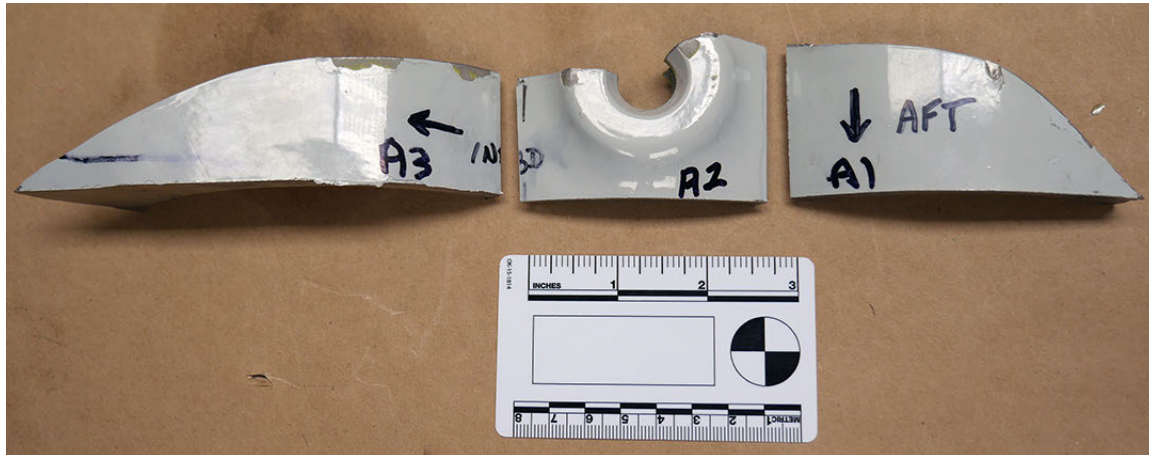
Figure 21: Aft portion sectioned to allow further examination

The Forward and Aft portions were further sectioned to allow detailed examination, Figure 21 and Figure 22. Portions were labeled as seen in the figures.

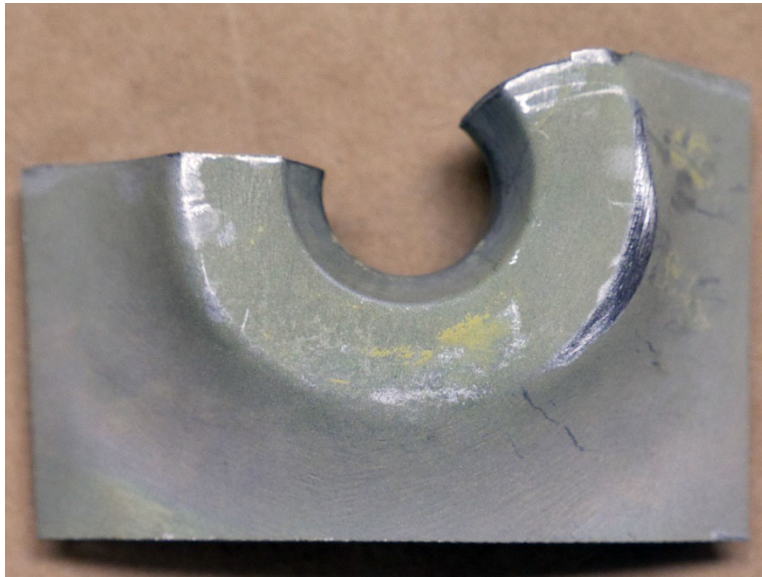
**Figure 23:** Portion A2, outer surface, after paint and primer removed

The A2 portion was stripped of paint and primer at the BR&T paint lab. See Figure 23 and Figure 24.

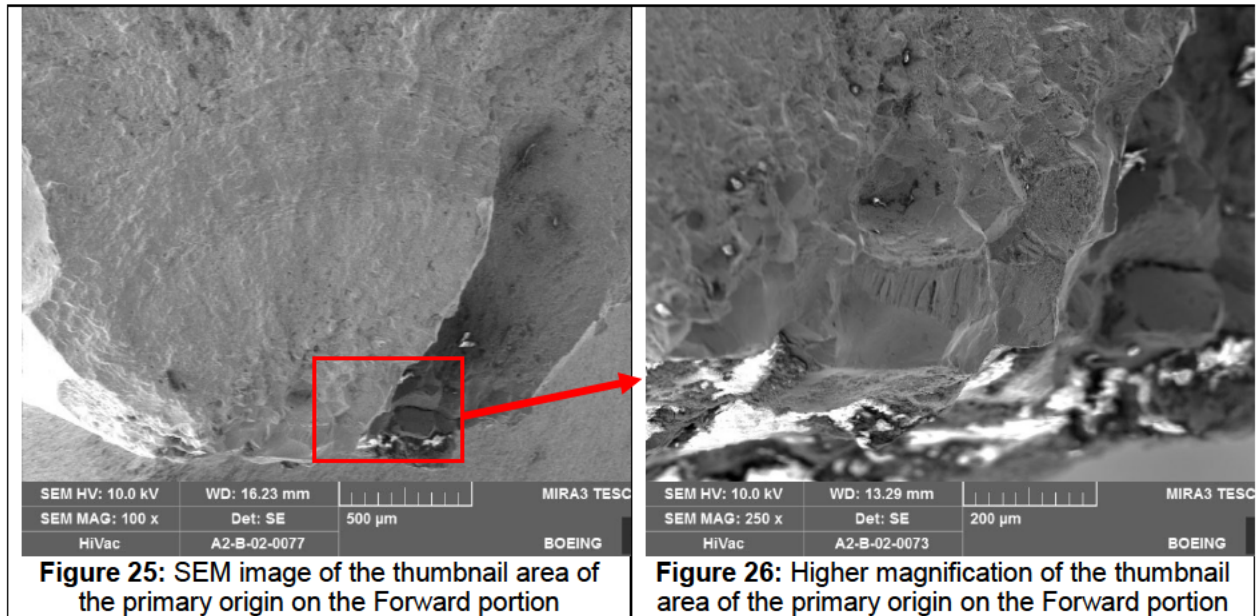
BR&T used Scanning Electron Microscopy (SEM) to further evaluate the fracture origins. Figure 25 and Figure 26 show the primary origin on the Forward portion.

The fracture originated at two locations along the corner feature that is formed between the inner diameter of the bung hole and the inner surface of the trunnion. The initiation occurred by an intergranular separation mechanism characteristic of cadmium embrittlement to a depth of .02 inches.

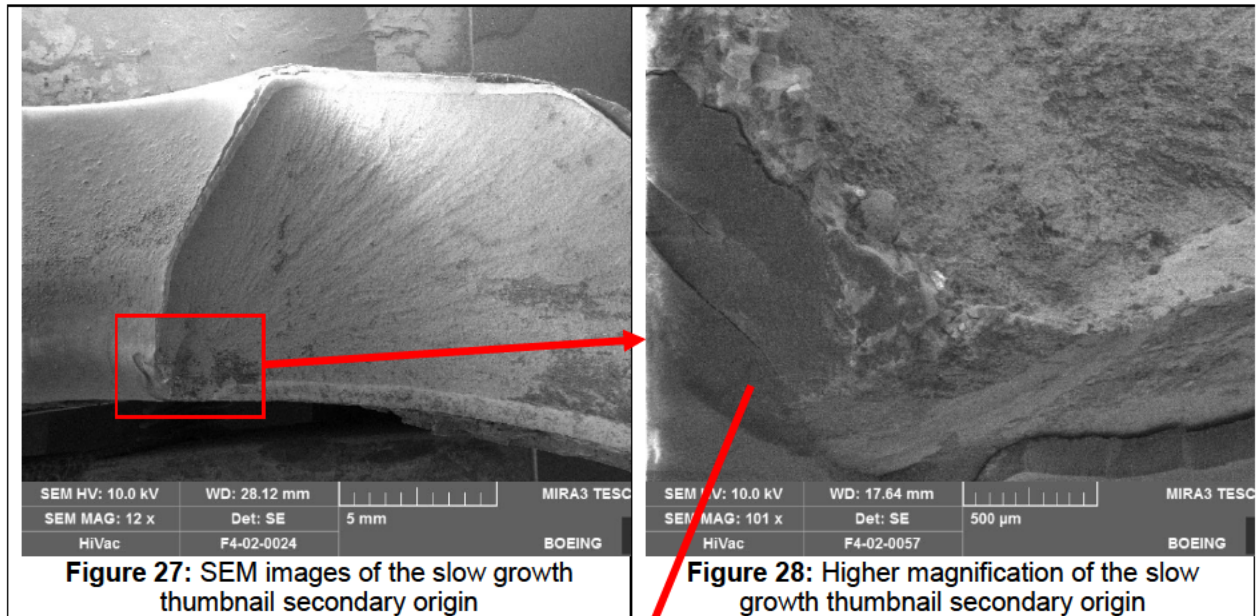
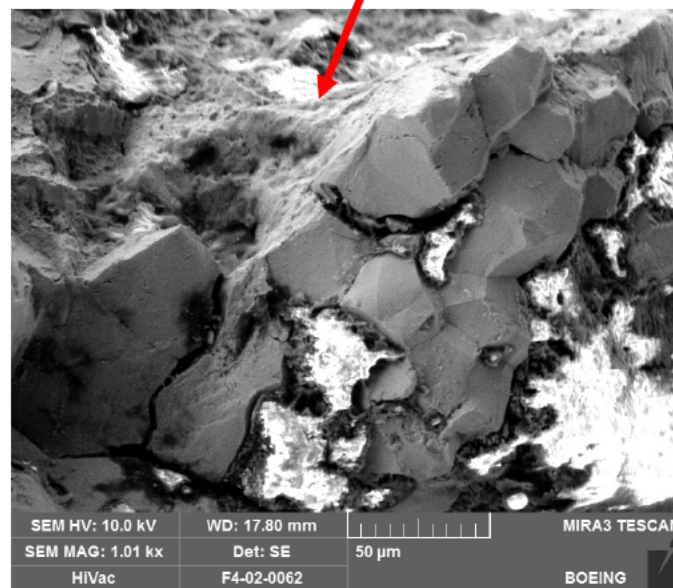
SEM examination of the secondary origin are shown in Figure 27, Figure 28 and Figure 29.

Figure 29: Higher magnification of the slow growth thumbnail secondary origin

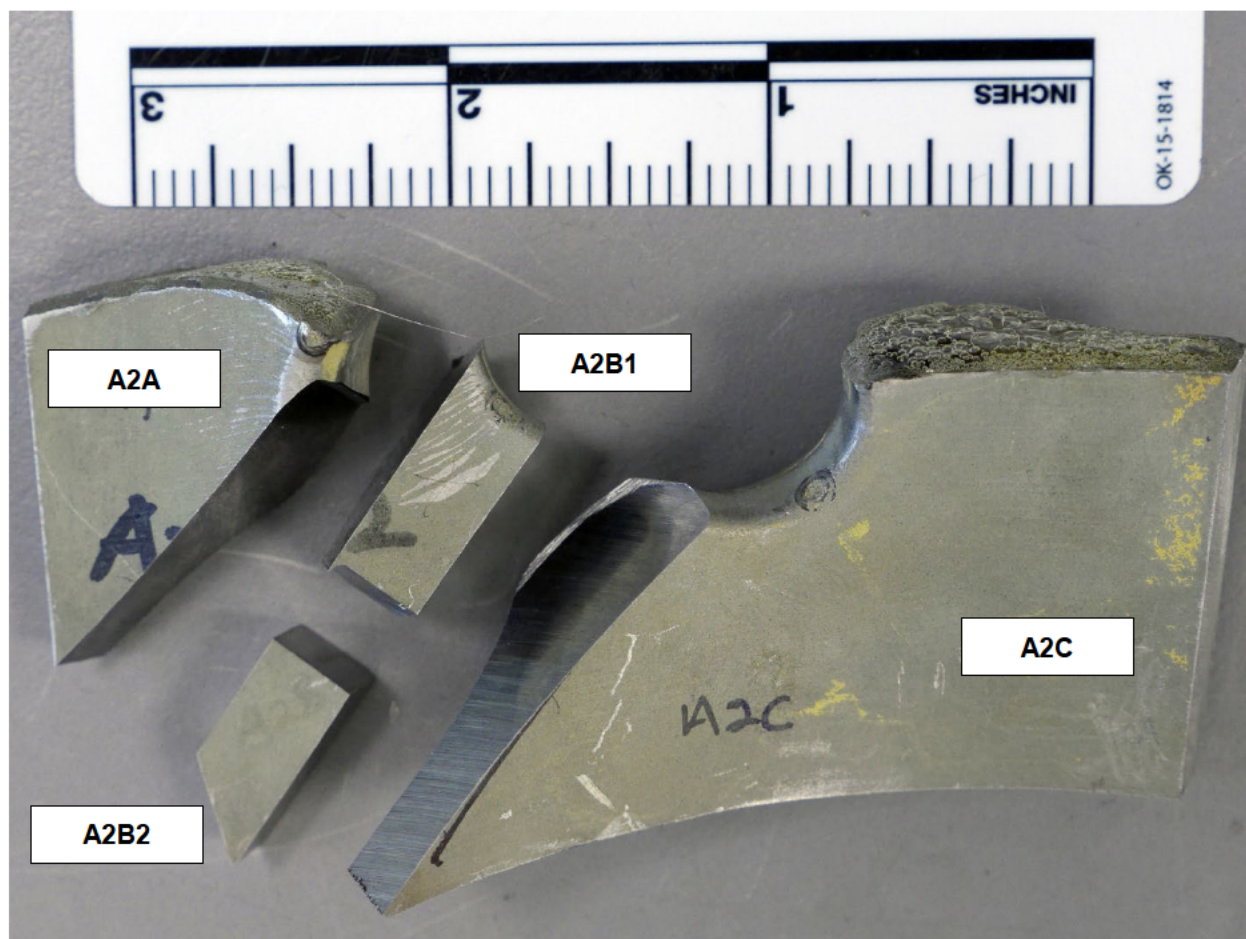
To facilitate further examination and testing, the examination team determined that portion A2 was to be cut into smaller sections, see Figure 33.

Figure 33: Portion A2 cut into smaller sections to continue the examination

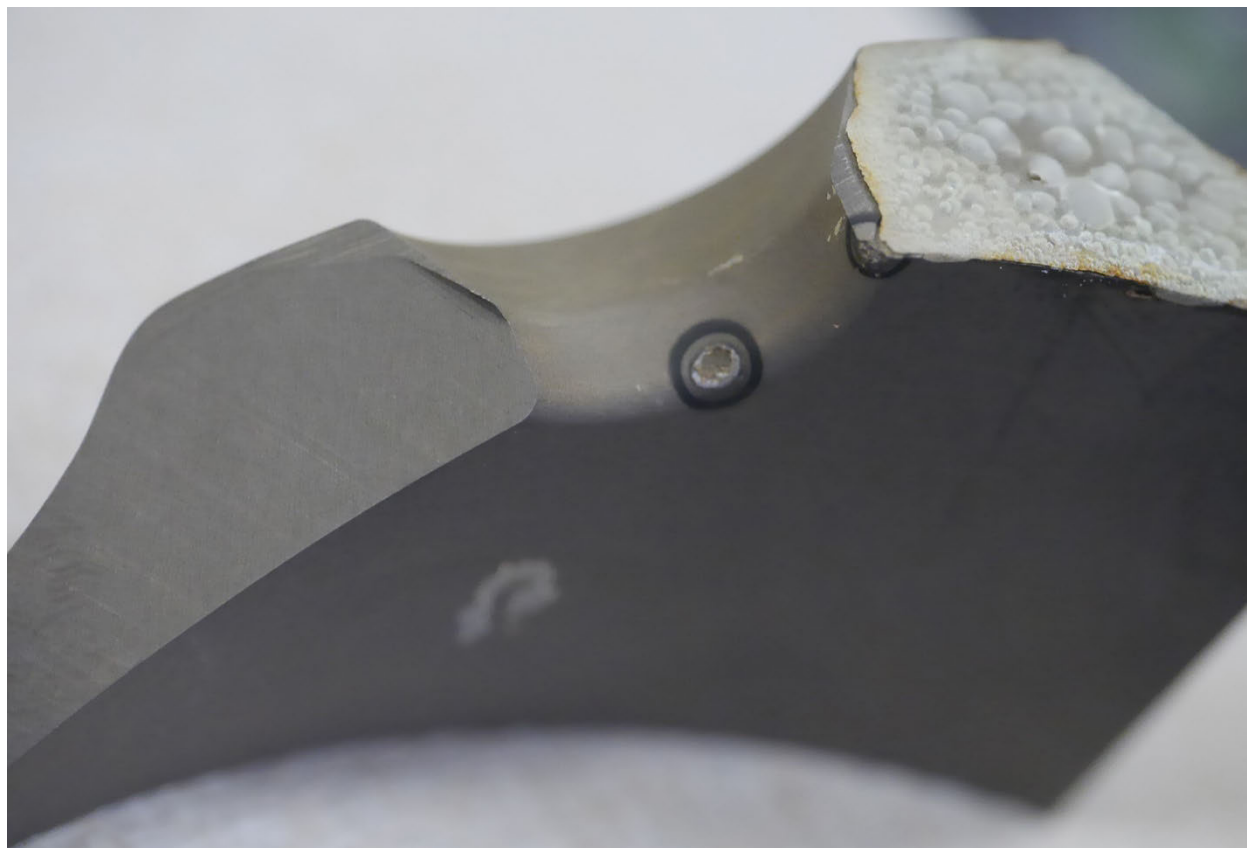
Items A2C and F4 were stripped of paint and primer and subjected to a nitric acid and alcohol (nital) etch inspection, see Figure 34 and Figure 35.

**Figure 34:** A2C portion after stripping and nital etch

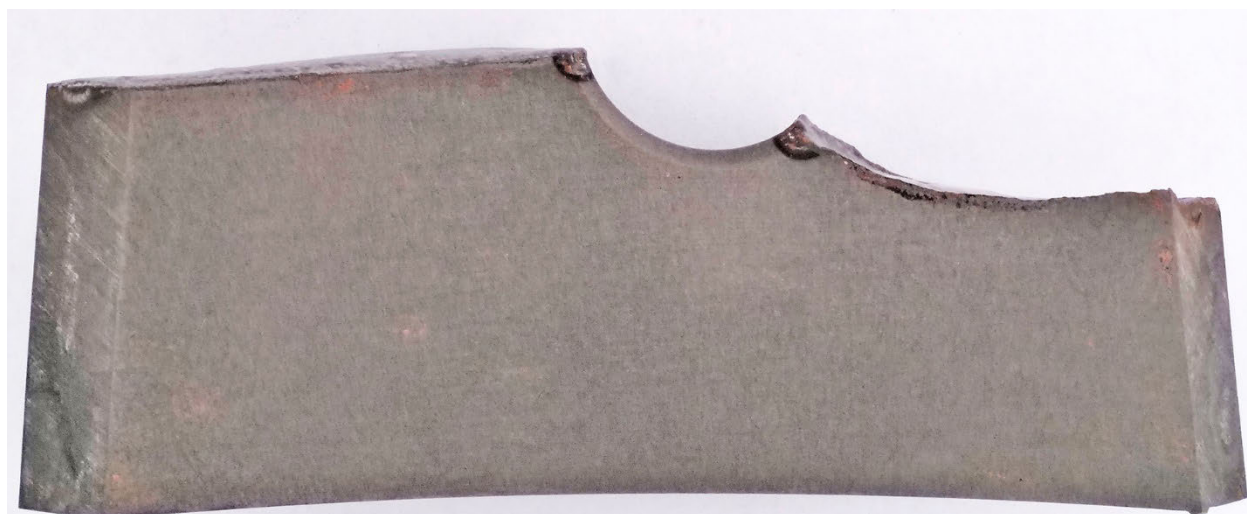
**Figure 35:** Portion F4 after stripping and nital etch

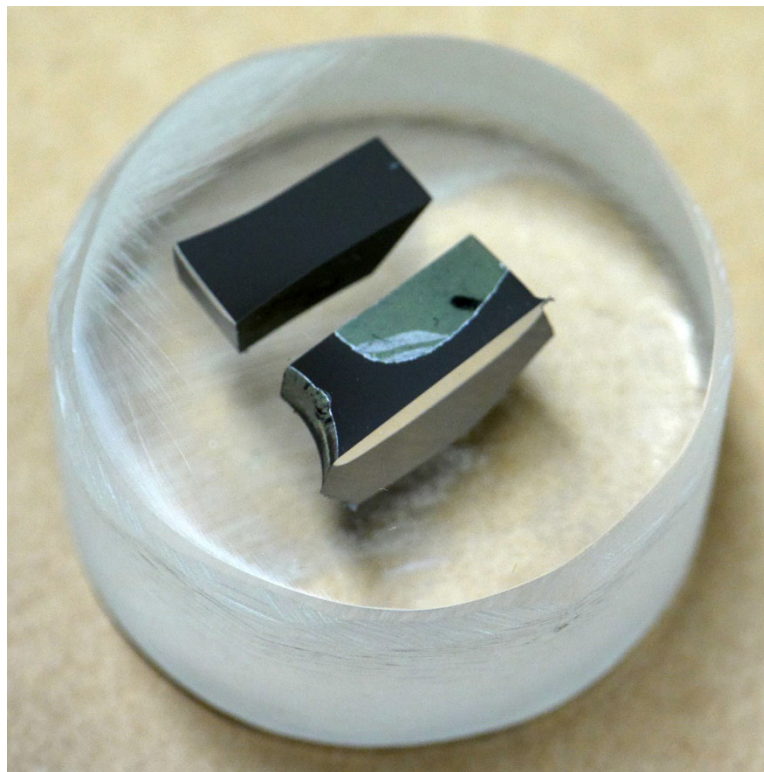
The area of interest on portion A2B was mounted and polished for further SEM examination, see Figure 37 and Figure 38

**Figure 37:** Portions A2B1+A2B2 mounted and polished

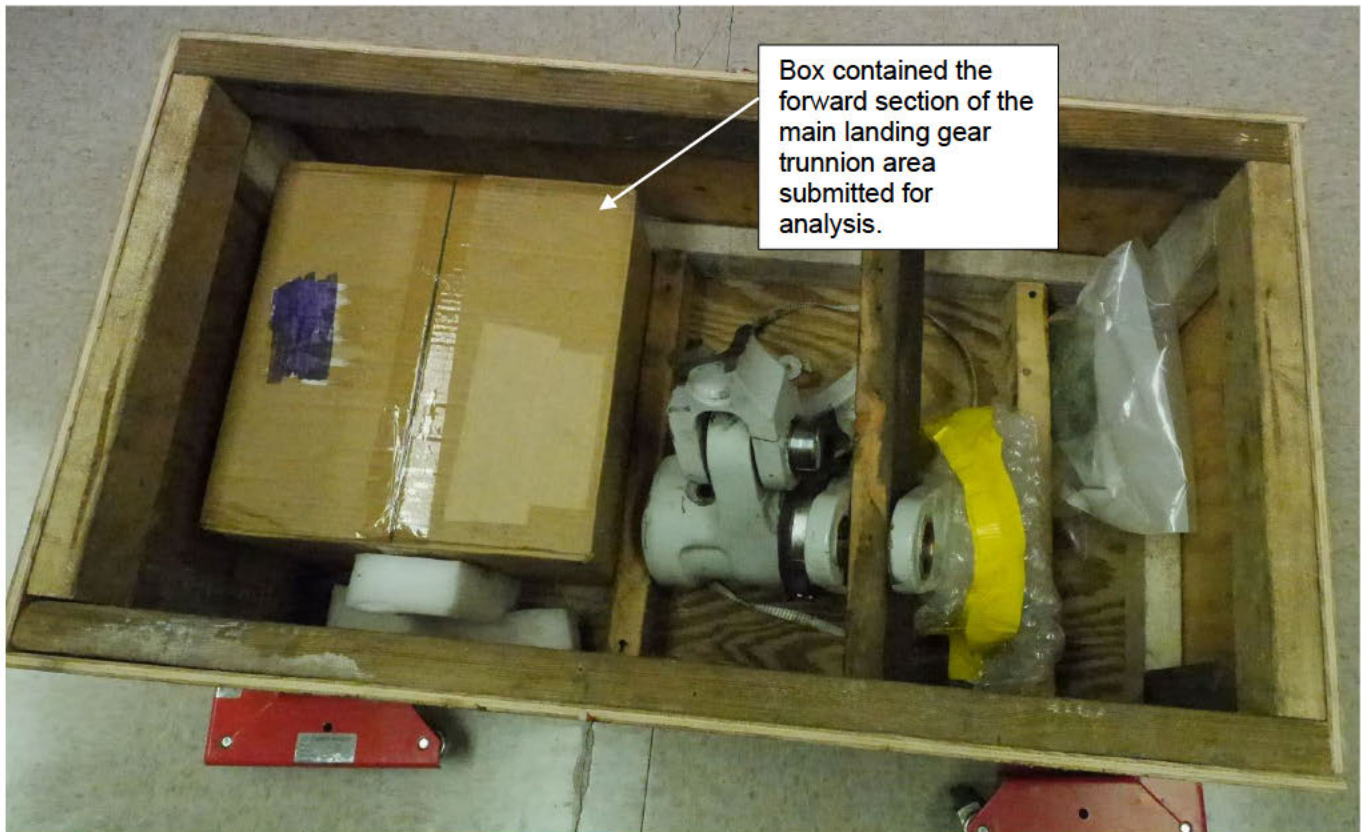
Figure 1. The opened shipping container with the aft section of the main landing gear outer cylinder submitted for fracture analysis. The enclosed cardboard box contained the forward section of the trunnion.

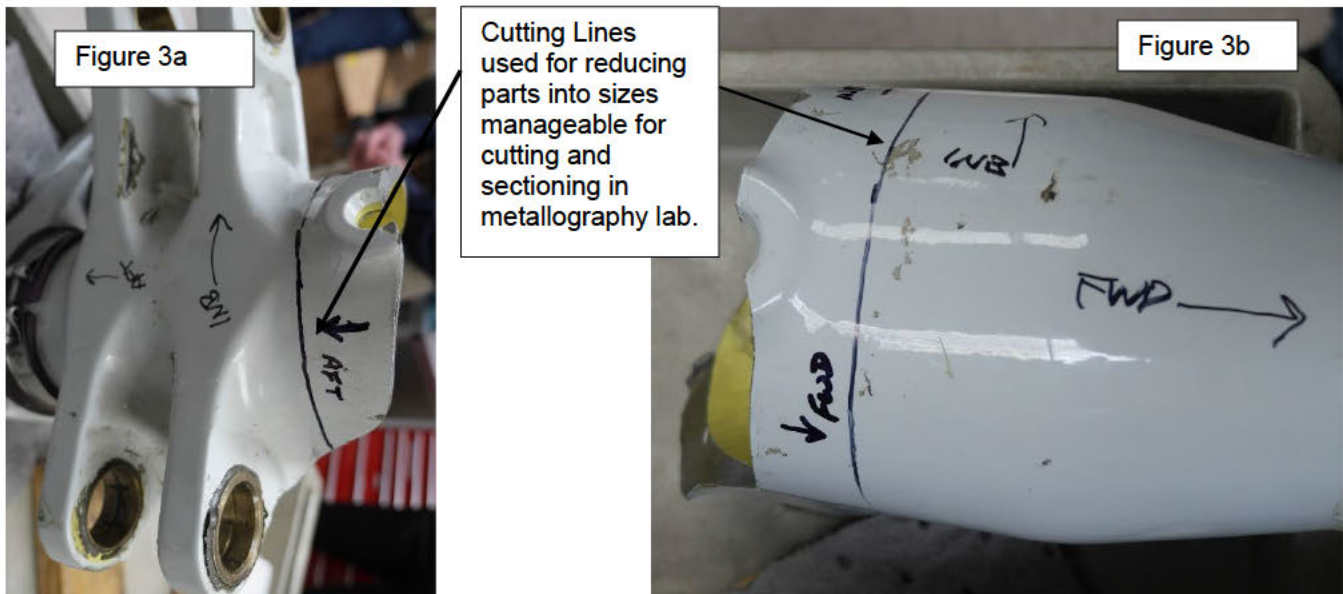
After the fractured parts were removed from the shipping container and photographed, under the direction of the NTSB, the parts were cut into sections manageable for further dissection in the metallographic laboratory and labeled consistent with their orientation on the landing gear. (Figure 2, 3a and 3b.)

Figure 3a and b. Sections identifying of their orientation on the airplane as well as showing locations for sectioning.

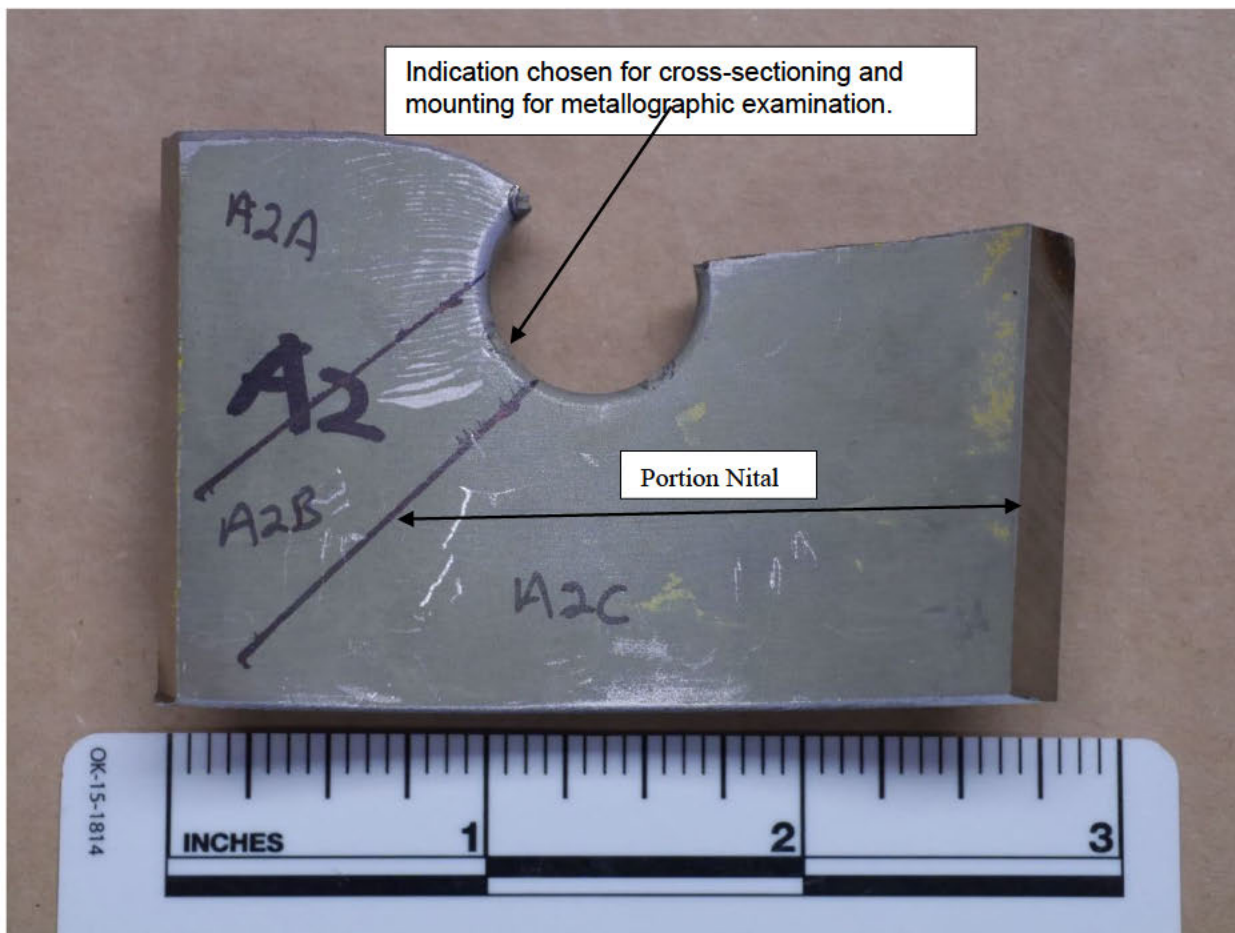
Figure 11. Sectioning plan for Aft section of fracture.

Magnetic particle inspection was performed on the stripped Aft Fractured part and magnetic particle indications were coincident with the spherical burn areas on the radius, with one of these areas also showing a linear indication for a crack (Figure 10). This piece was further sectioned to enable cross-sectioning of one of the arc burns for metallographic examination and nital etch inspection (Figure 11). Two dark etched rings were present on the intersection of the inner diameter of the cylinder and the bung hole feature (Figure 12a and b). These indications were coincident with the locations that had magnetic particle inspection indications. These darker etched areas were characteristic of overtempered martensite (OTM) and consistent with heat damage created during arc burning. Figure 13 shows a magnified image of an arc burn observed on the bung hole.
