ENG22LA049

Group Chair's Factual Report - Attachment 1

GE Passport 20 Core Compartment Fires In Service, dated March 14, 2023

# GE Passport 20

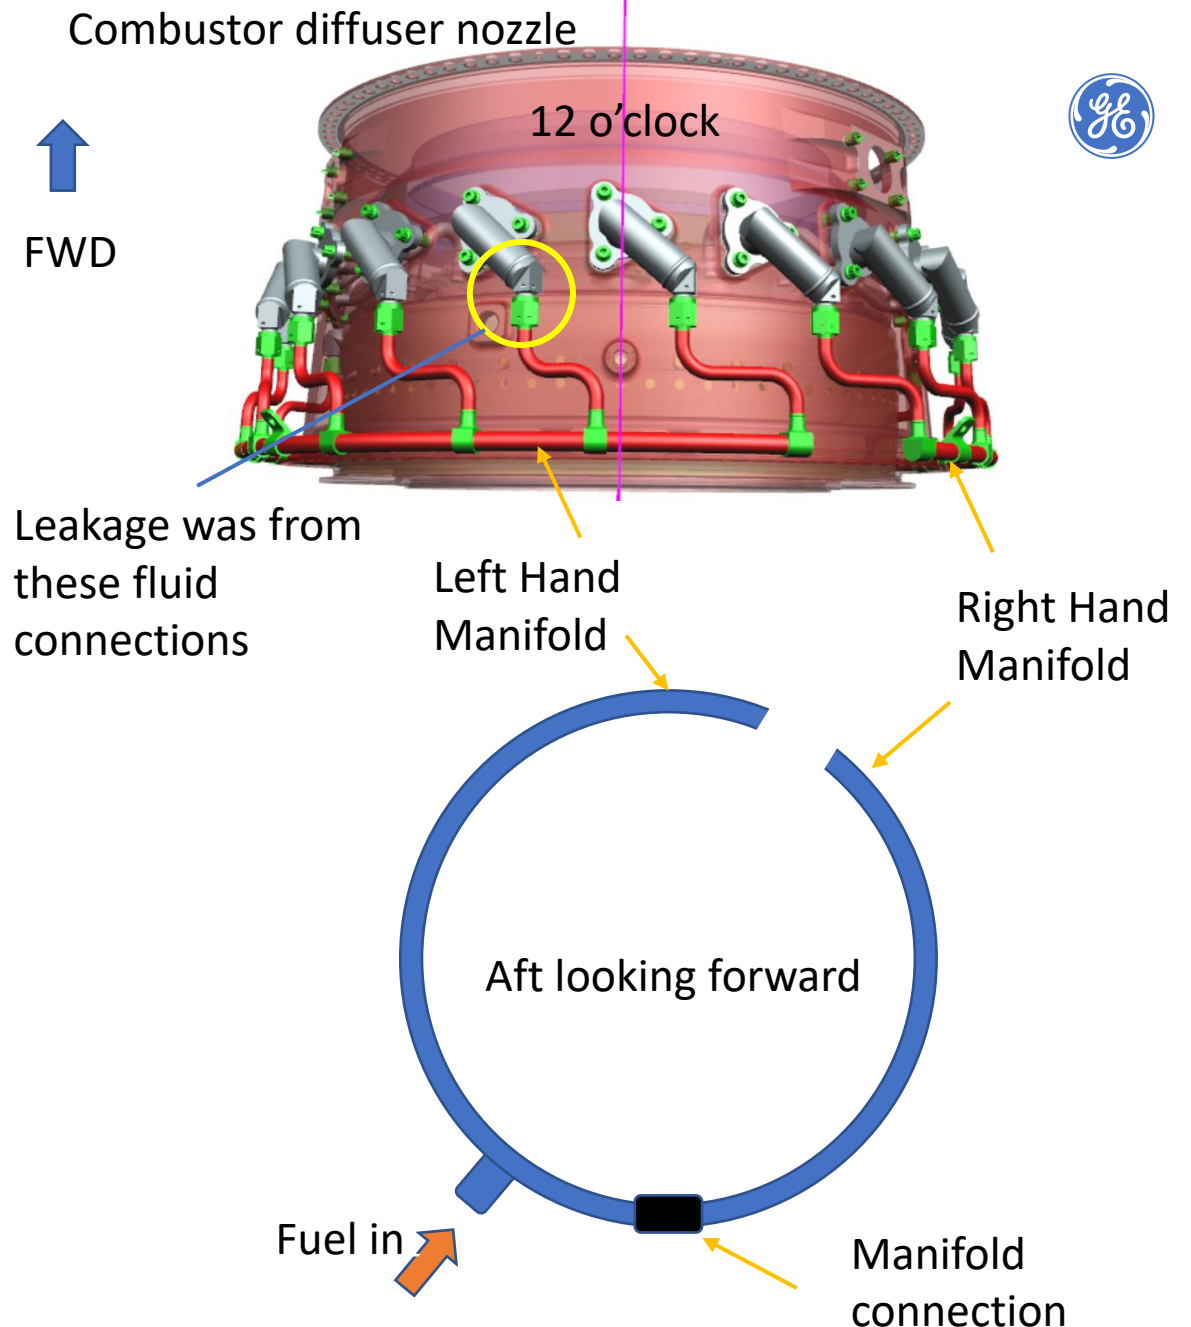
# System Description

- The combustor diffuser nozzle is a structural case where fuel is injected into the engine
- Fuel is delivered externally through a two-piece fuel manifold (left hand & right hand)
- Fuel manifolds are connected to the fuel nozzles with a threaded nut connection that holds male (ball nose) and female (ferrule) together
- Manifolds are connected at 6 o'clock with a threaded connection
