**NATIONAL TRANSPORTATION SAFETY BOARD**  
**Office of Aviation Safety**  
**Washington, D.C. 20594**

**POWERPLANT GROUP CHAIRMAN'S FACTUAL REPORT**

**NTSB No: ENG22LA049**

**NTSB No: ENG22LA020**

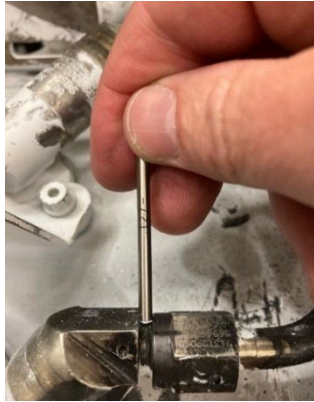
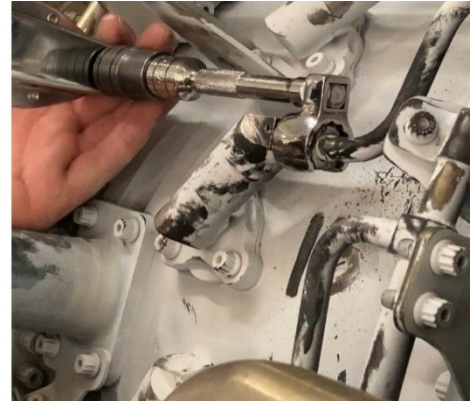
**PHOTO 5: B-NUT GAP CHECK AND TORQUE MEASUREMENT**

Gap checks on each fuel manifold b-nut connection were measured in the as-received condition using a pin gage at two locations 180° part - they were referred to as the clockwise (CW) and counterclockwise (CCW) sides of the b-nut connection. The intent was to measure and access the overall gap and any tilting (misalignment) of the fuel manifold b-nut connection (**PHOTO 5**, left side). The FN and fuel manifold assembly instructions do not

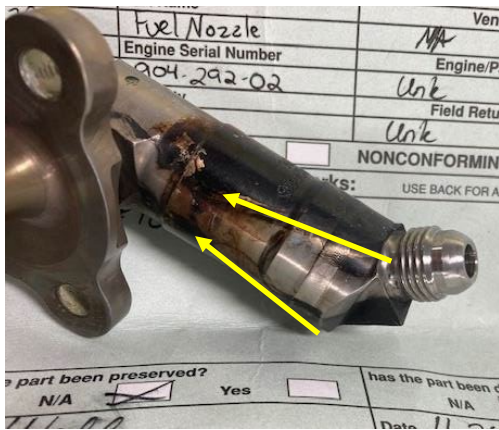
**PHOTO 15: FN No. 18 FLUID FLOW PATTERN**

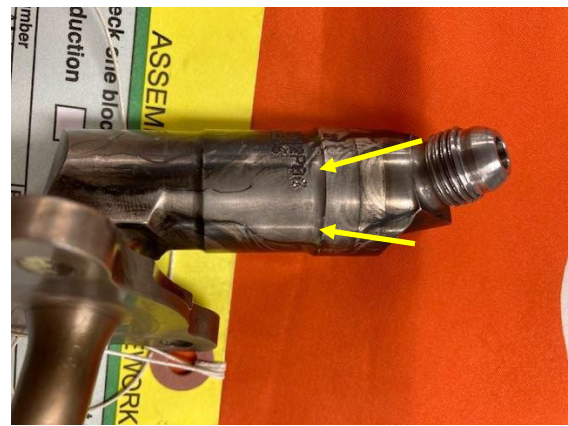
**PHOTO 16: FN No. 16 FLUID FLOW PATTERN**

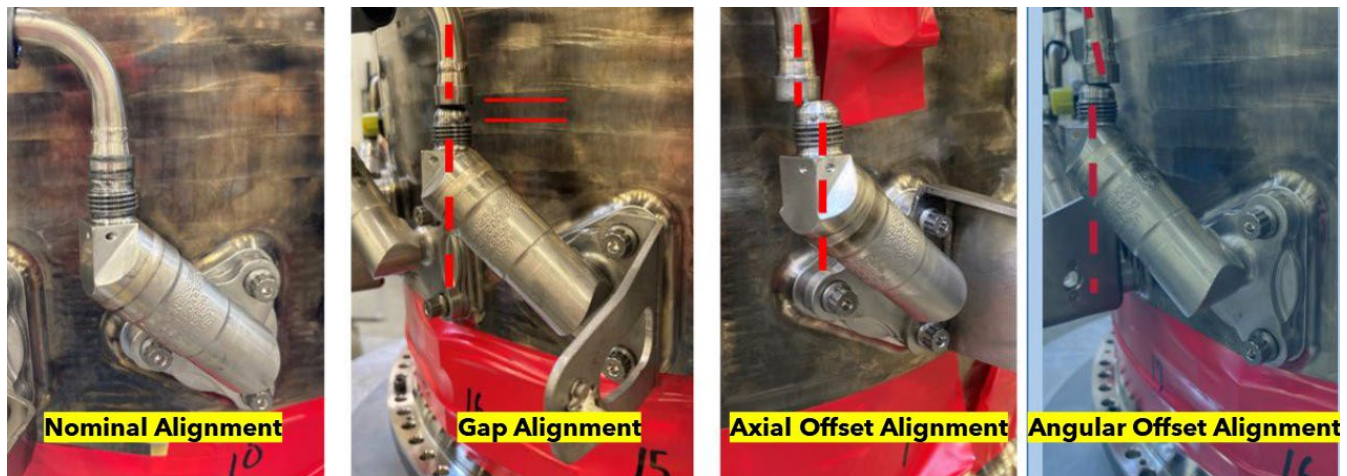
One of the static component rig tests attempted to bound the amount of FN male bullnose-to-fuel manifold female ferrule/b-nut misalignment as a function of angular offset, axial offset, gaps between fuel manifold b-nut connection and the FN shoulder (**PHOTO 24**), the amount of torque (clamp) relaxation of the fuel manifold b-nut to induce a leak, and captured assembly loads for different FN and fuel manifold b-nut connection torque sequences. The hardware used were a combination of FNs from a previous certification test (the male bullnoses of the FNs are identical to the current production configuration), and new fuel manifolds from current engine production supply.

**PHOTO 24: EXAMPLES OF DIFFERENT ALIGNMENTS/MISALIGNMENTS**

The values used for the fuel manifold b-nut misalignment were consistent with those observed during the torque and gap checks previously performed on ESNs 904285 and 904292. Variations in angular offset were between 1° to 5° (See **PHOTO 7**, bottom row for example), and the gaps and axial offset ranged from 0.100 to 0.150 inches. All the FN manifold b-nuts were torqued to the nominal installation value of 285 in.-lbs. After a leak was induced, the amount of torque of the fuel manifold b-nut necessary to stop the leak was applied and recorded. The main takeaway was that misalignment between the fuel manifold pigtail and the fuel manifold b-nut connection can induce stresses that can lead to low effective clamping at the fluid seal surface during initial assembly and a reduction of that clamping during operation. Furthermore, when a leak was intentionally induced, the leak

could easily be arrested by adding some additional torque to the joint. GE concluded that along with reduction of the clamping force at the fluid sealing surface, surface distress on the FN male bullnose sealing surface, like what was observed on all three leaked engines, was also a contributor to induce the fuel leak.

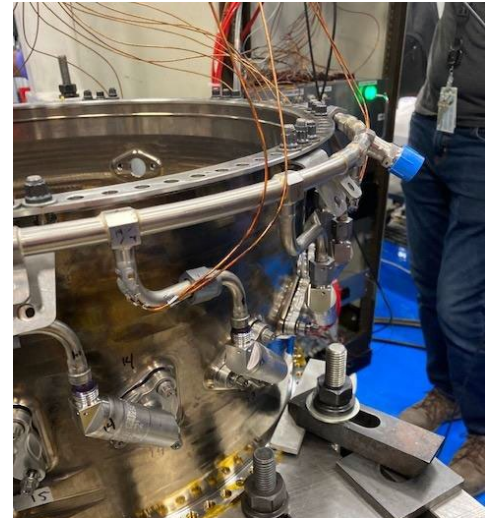
Several static component rig tests were performed using production hardware, some of which came from a previous component test, to capture stress data under various iterative FN and fuel manifold installation and torque sequences to: 1) assess assembly effects on the fuel manifold pigtail preload, 2) determine assembly variables that impact fuel manifold alignment and loading, and 3) develop fuel system component installation and torque sequences to minimize factors that may create a condition that could lead to a significant loss/relaxation of torque in the fuel manifold b-nut connection (**PHOTO 25**). The testing showed that the assembly process influenced alignments and that fuel nozzle position relative to the engine case can be modified to reduce in-process assembly stress. All stress values measured were well below yield strength of the materials.

**PHOTO 25: INSTRUMENTED  
COMPONENT RIG TEST**

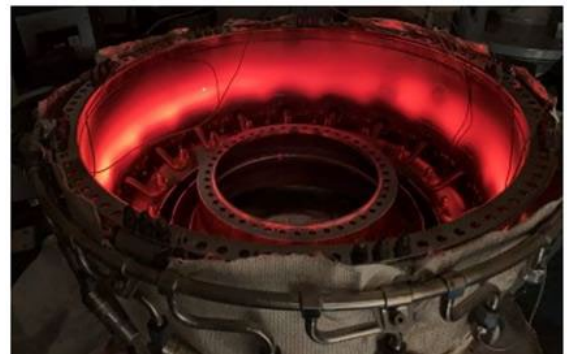
The intent of the thermal cyclic test (**PHOTO 26**) was to match thermal cycles of the engine, for example hot combustion chamber case and lower/cooler fuel manifold temperatures, to: 1) replicate the fuel manifold and fuel manifold-to-fuel manifold b-nut connection torque (clamp) relaxation and the gap effects observed on the No.1/left (M44) fuel manifold on the two event operational engines (ESNs 904265 and 904292), 2) prove the effectiveness of the retorque operation and 3) determine the cyclical capability of the retorqued connection. The thermal rig testing was completed but the test was not able to duplicate the fuel manifold b-nut connection torque (clamp) relaxation. GE hypothesized that more than just thermal induced stresses were needed to cause torque (clamp) relaxation. Therefore, GE proposed a test plan to induce vibration levels consistent with normal operational vibration levels and duration times to determine effect of vibration on the b-nut joint. The vibration testing and pressure cycling on the rig were completed but were unable to replicate the b-nut relaxation.

**PHOTO 26: THERMAL RIG TEST**

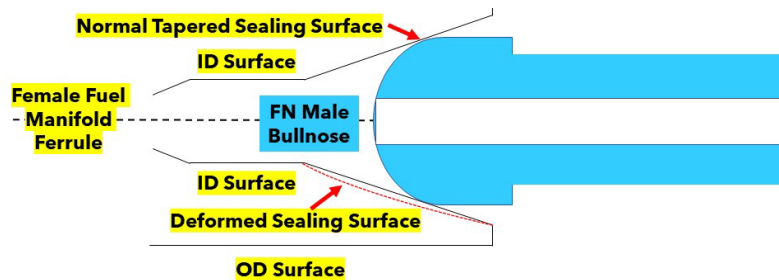
**FIGURE 9: FERRULE SEALING SURFACES**

**FIGURE 9** is a general representation of the FN male bullnose-to-fuel manifold female ferrule connection and nomenclature. The fuel manifold female ferrule is designed to deform slightly both elastically and plastically during assembly to ensure the proper grip and increase sealing surface area on the FN male bullnose (**PHOTOS 27** and **28**). The conical female ferrule surface is designed to match the spherical male bullnose to ensure a reliable compression seal as the nut that secures the two is tightened to maintain alignment. The relative angle of the female ferrule and the FN male bullnose sealing surfaces will determine the amount of linear (axial) movement that is converted into radial compression of the female ferrule sealing surface. A good and reliable seal is when there is a light, level, and uniform mark around the entire sealing surface and a slight compressive deformation of the sealing. **PHOTOS 6, 7, and 18** showed examples of these marks that were not uniform and level. Examination of all the female and male sealing surfaces found that there was a lack of deformation of the female ferrule sealing surface at the leak locations. There were no examples found of deformed female ferrule sealing surfaces leaking. Furthermore, the plastic deformation was inconsistent amongst on the ferrules examined; some had more than others, even if the installation torque was the same.

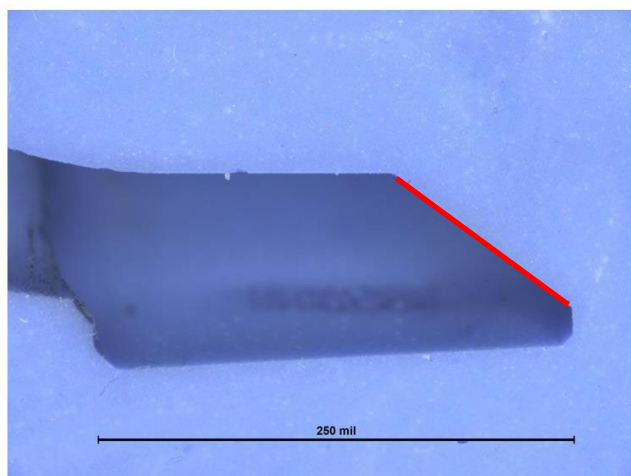
**PHOTO 27: NON-DEFORMED SEALING SURFACE**

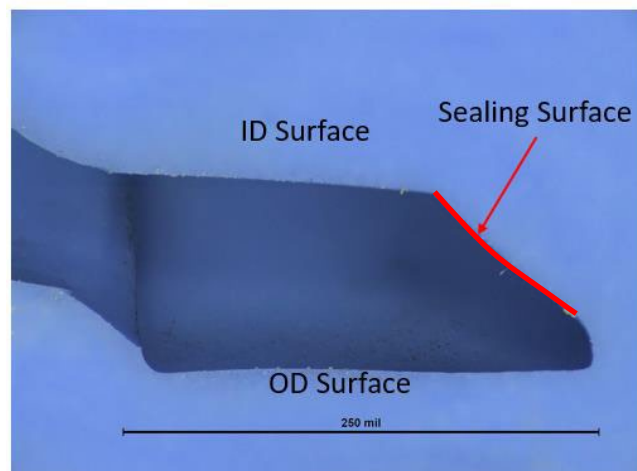
**PHOTO 28: SLIGHT DEFORMED SEALING SURFACE**

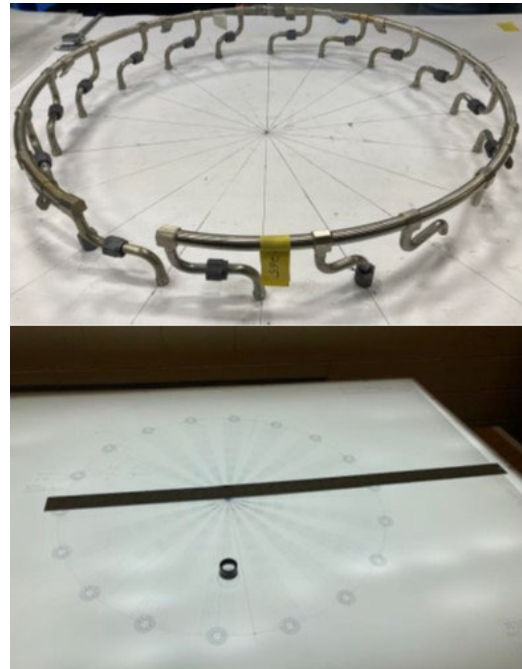
**PHOTO 29: FUEL MANIFOLD PIGTAIL ALIGNMENT TEMPLATE**

GE created a template to show the relative circumferential and radial displacement/misalignment of the fuel manifold pigtail connections. Lines at 20° angles were drawn from a center point representing the radial centerline locations of the eighteen fuel manifold pigtail ferrule connections (**PHOTO 29**, top). For more accurate angular measurements, a transparent mylar sheet with finer graduated radial lines representing smaller angular displacement from the centerline were created and was backlit for easier interpretation (**PHOTO 29**, bottom).
