ENG23LA031

Metallurgical Evaluation of LEAP-1B Fuel Nozzles, Fuel Manifold, and Fireproof Plate

# Metallurgical Investigation Report DRB AvEng-548136

## METALLURGICAL EVALUATION OF LEAP-1B FUEL NOZZLES

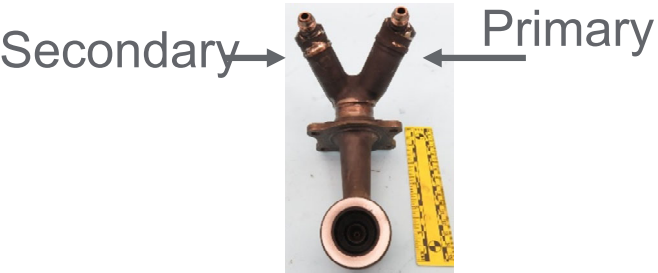
**Figure 3:** Well-defined coking only present around nozzles in fire with zero break-away torque (secondary on nozzle 17 and 18, indicated by red arrows). All nozzles in fire show discoloration (yellowing) at threads and coking about nozzle.

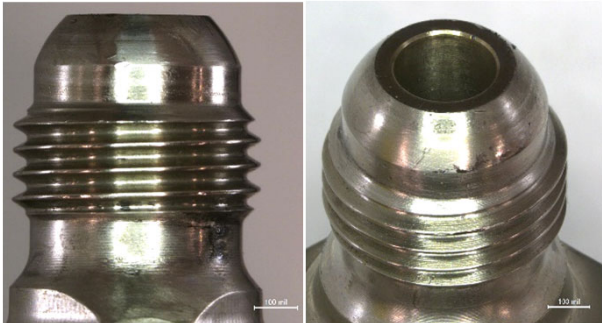
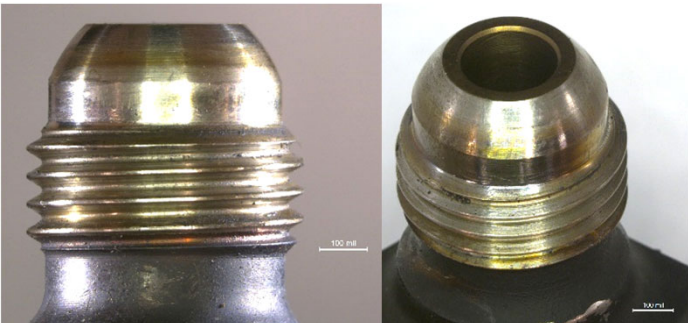
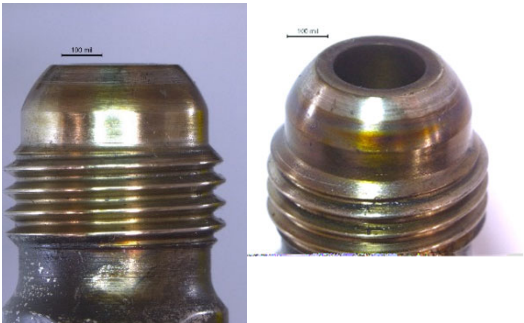
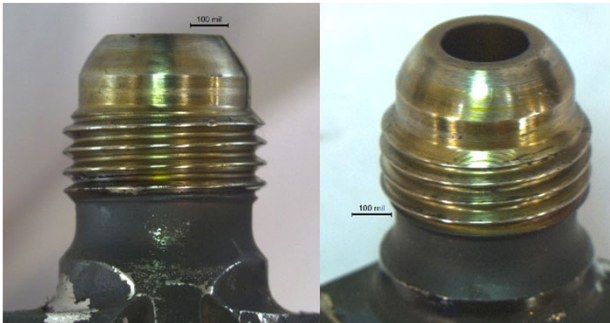
Primary Inlet

- Coking was observed around the mating surface of the secondary inlet of fuel nozzles #17 and #18.
- FTIR was performed for the varnish on the 12 o'clock bifurcation heat shield. The varnish was a 40% match for coke but did not match well to other signatures in the GE library.

**Figure 4:** Images show top-down view of mating surfaces of the fuel nozzles, as well as coking present around the secondary mating surface of nozzles #17 and #18. No wear was noted about the mating surface of the fuel nozzles.

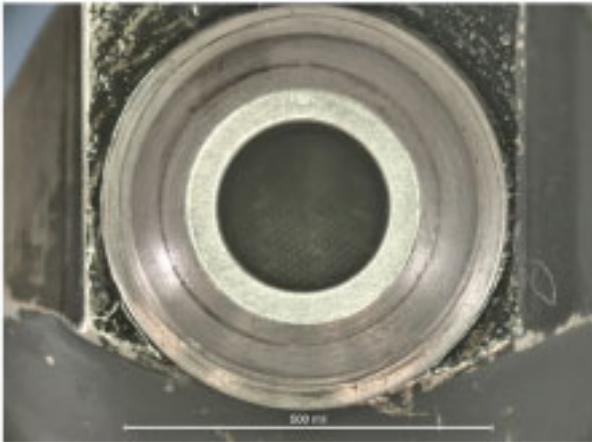
Nozzle #16

Figure 7: The bullnose from fuel nozzle #16 is shown. A witness mark from contact between the bullnose and the ferrule on the pigtail is clearly visible. From the end, the mark is slightly off center from the centerline of the hole. Viewed from the side, the witness mark is clearly at an angle. These observations are consistent with a slight misalignment of the centerlines of the nozzle and the pigtail – they are not parallel.

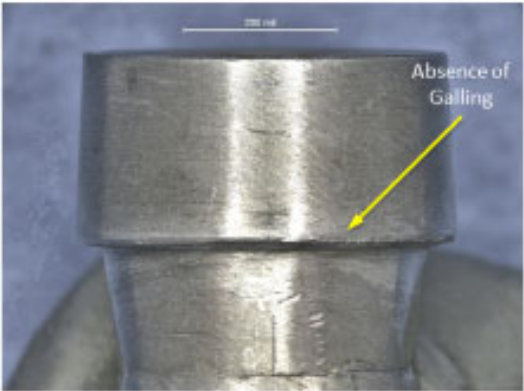
Figure 22: The OD surface of the ferrule from pigtail #16 is shown at the 6 o'clock (inboard) and 12 o'clock (outboard) locations. At the 12 o'clock position, galling from contact with the threads (on the inside) of the B-nut was noted. This is consistent with a rotational misalignment of the bullnose to the pigtail ferrule. A radial or circumferential misalignment could also cause the B-nut threads to contact the ferrule. (The centerlines of the parts are not concentric and parallel.)

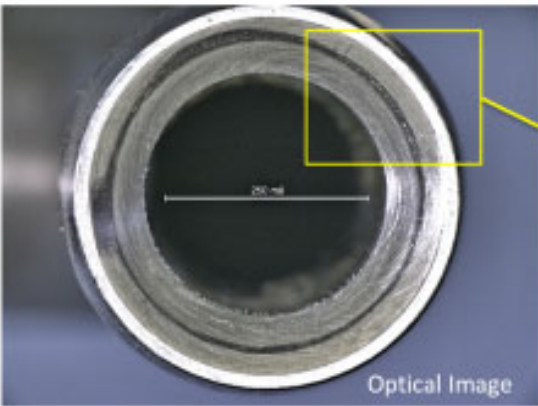
Pigtail #16

Figure 15: On the ferrule sealing surface of pigtail #16, some surface distress was noted. This is shown here and in the following figures. The location was within the witness mark on the ferrule surface and appeared to be galling with metal loss.

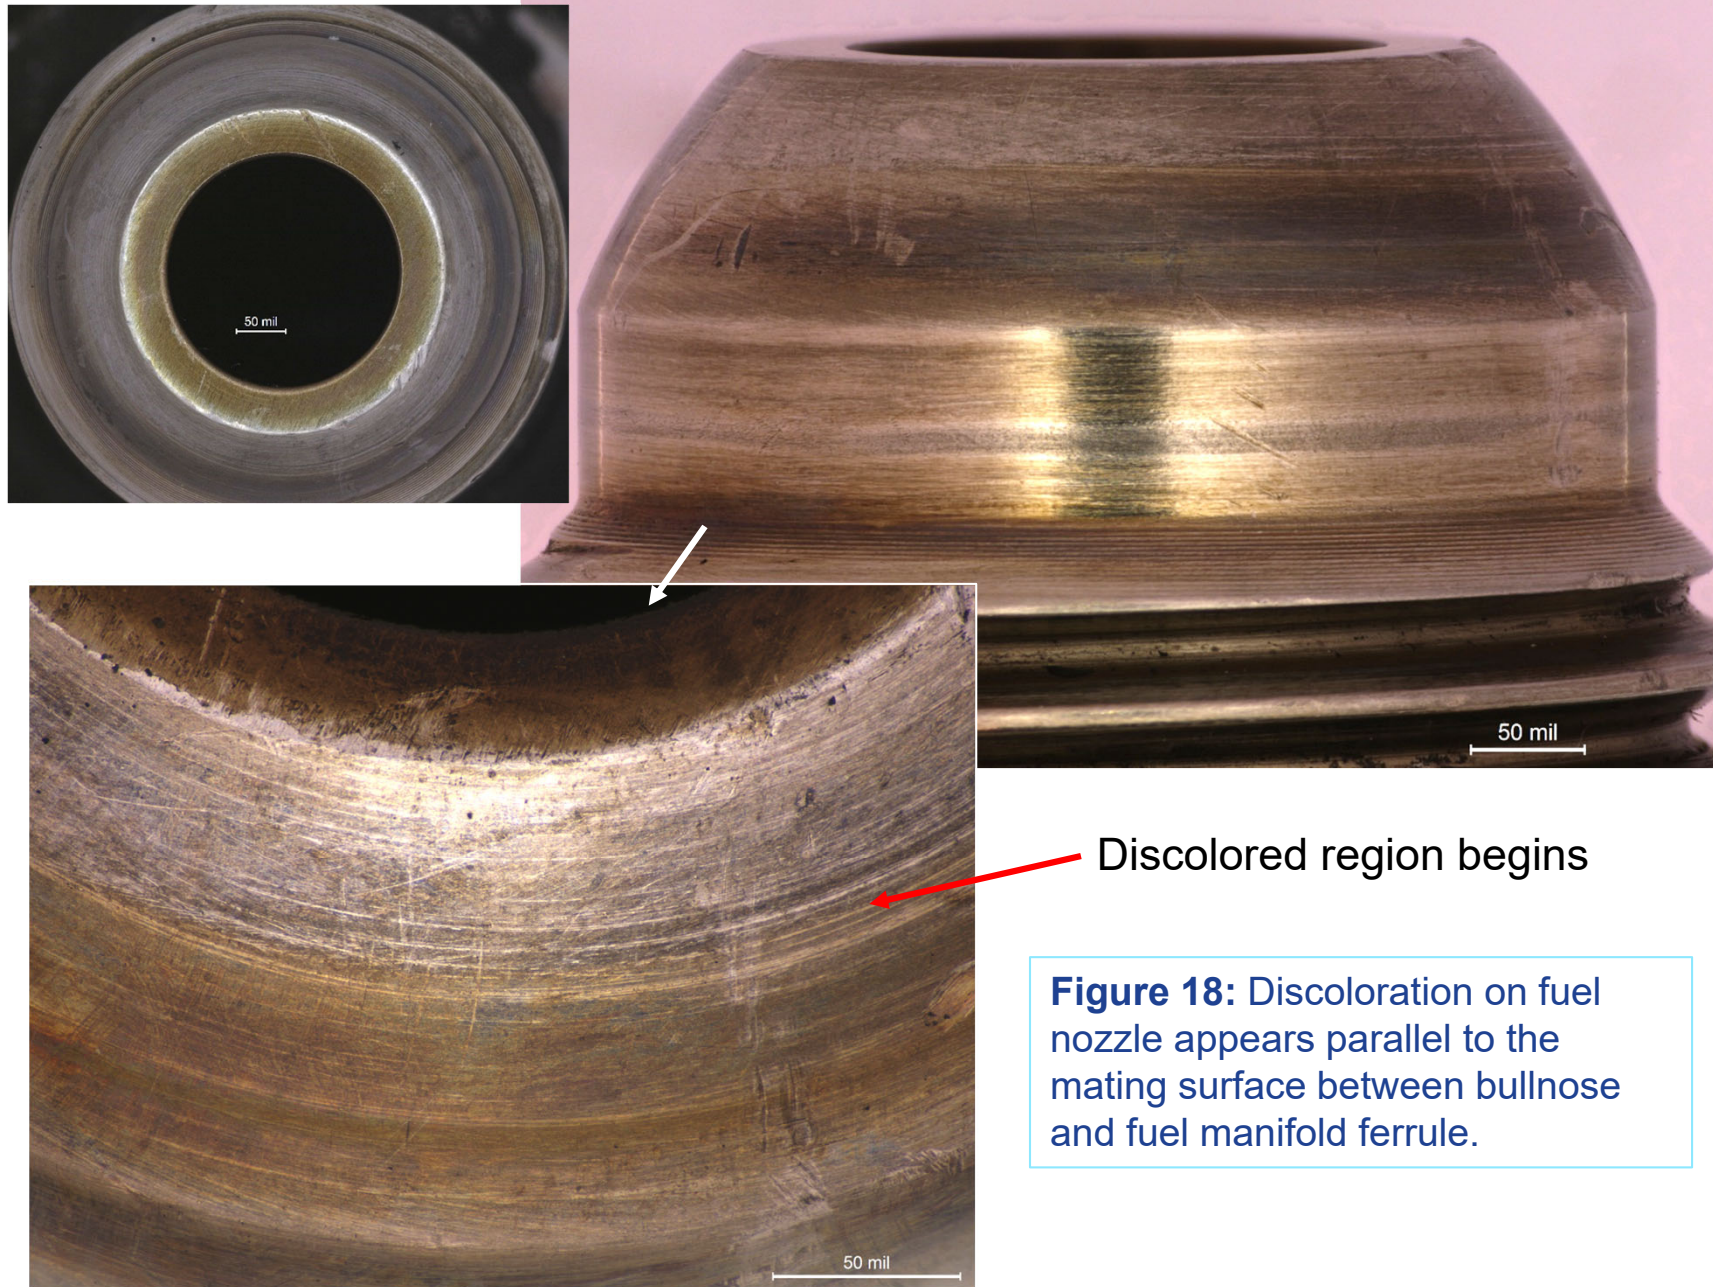
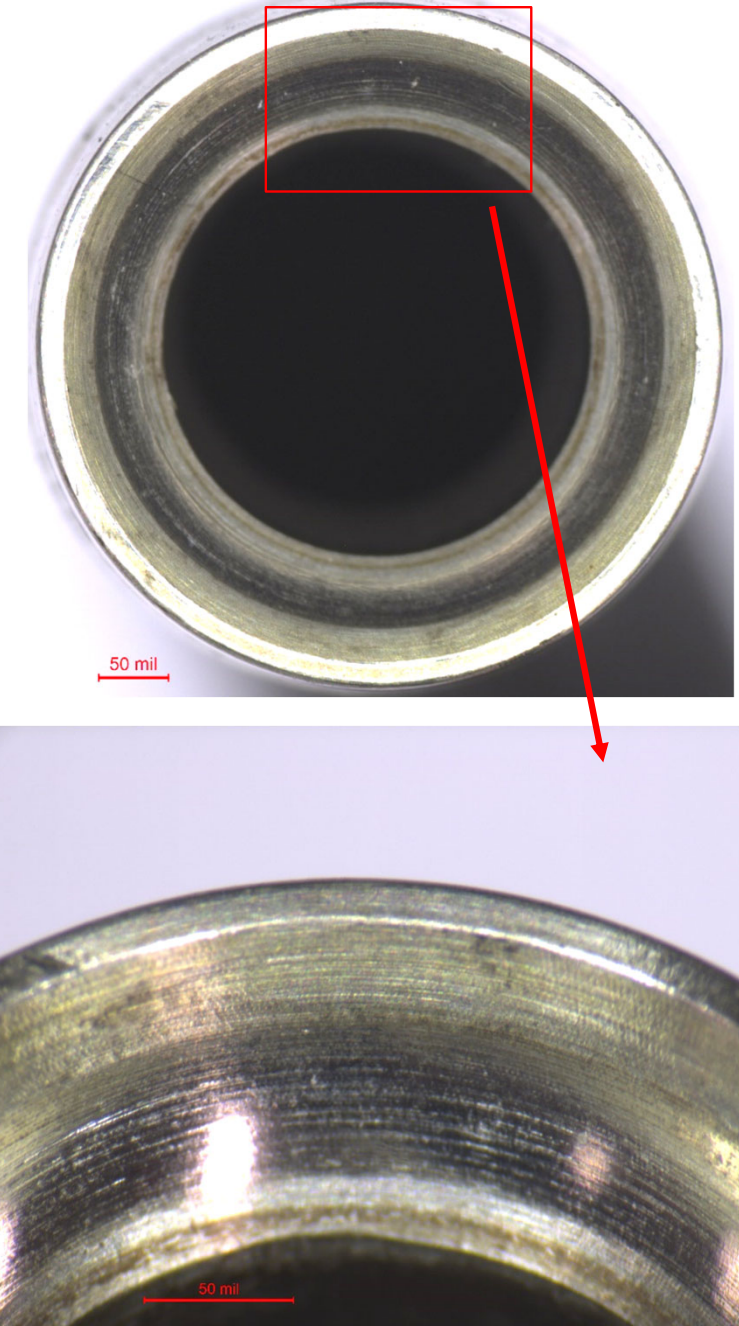
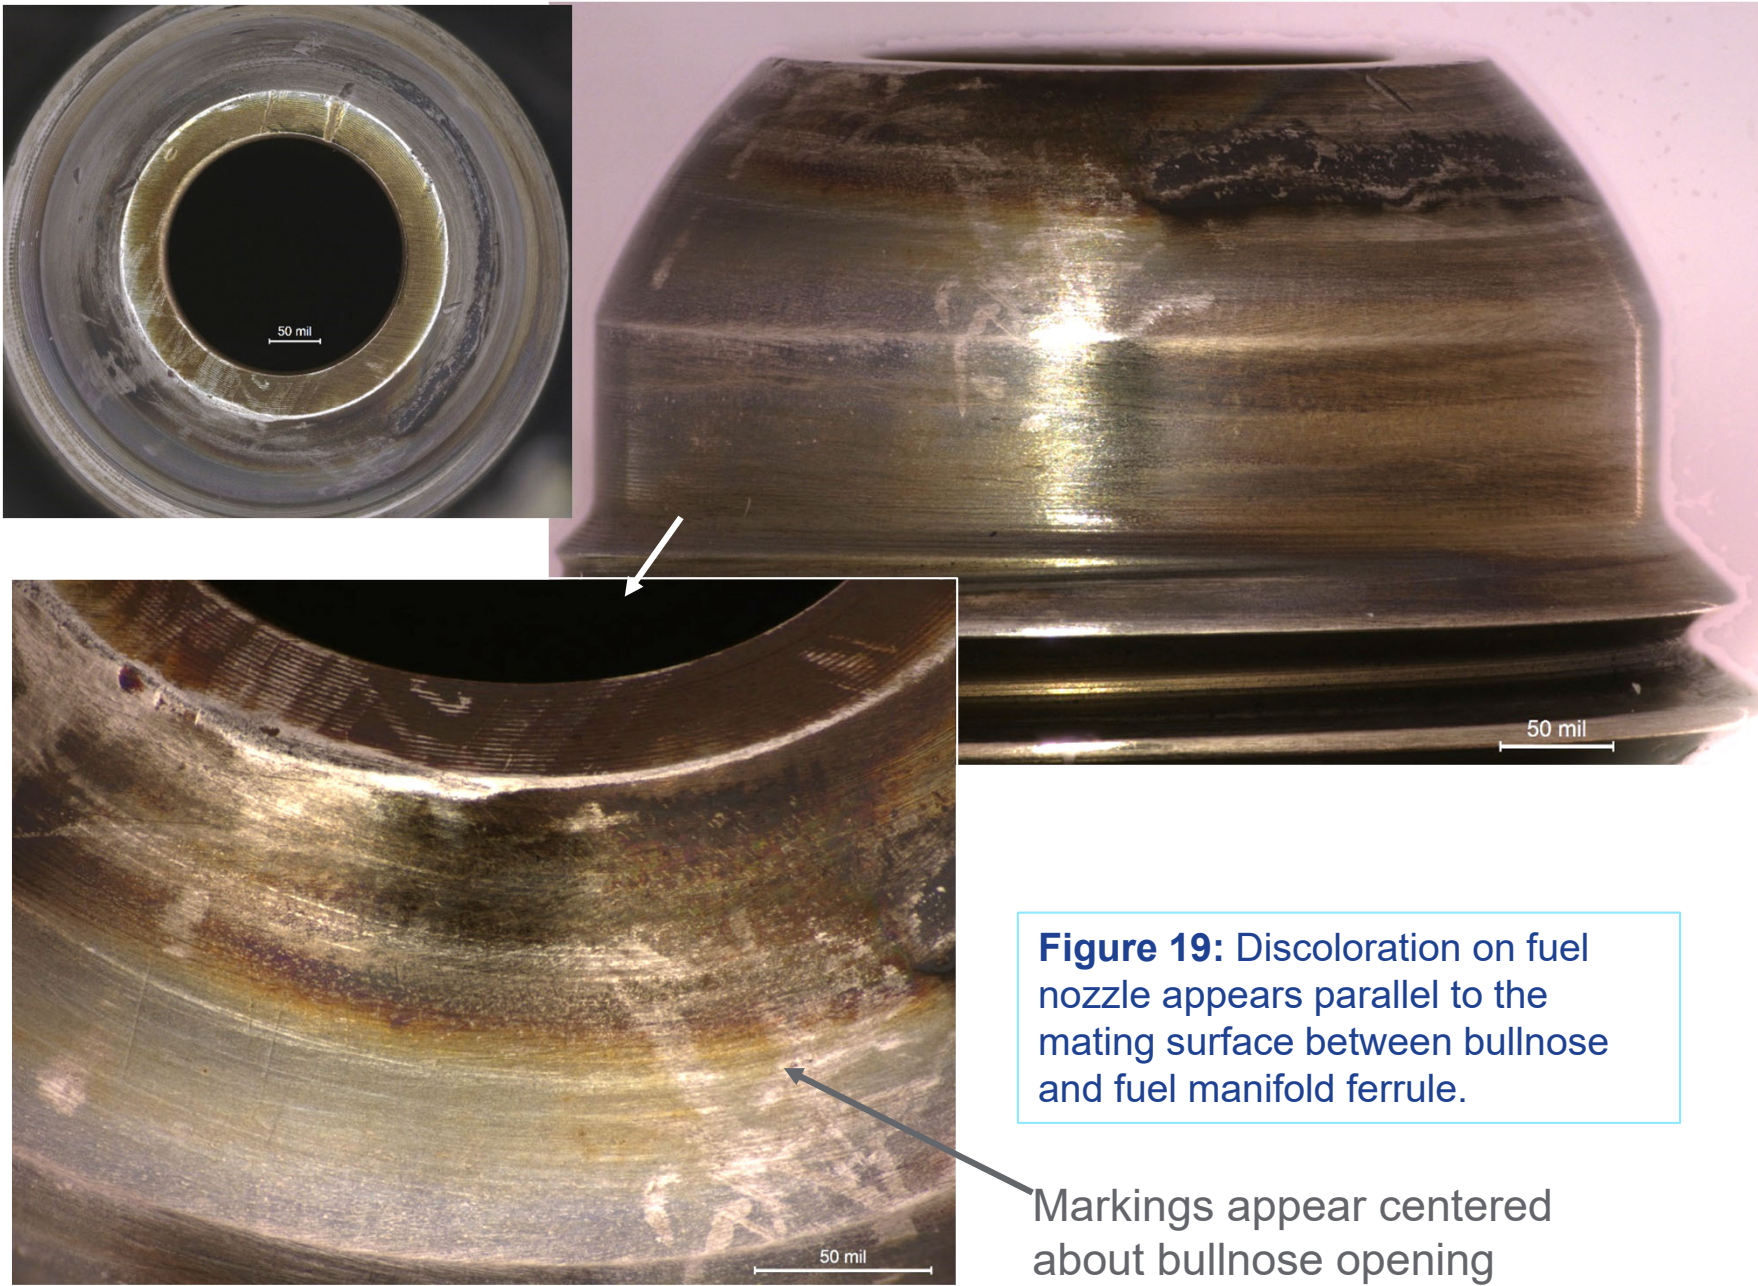
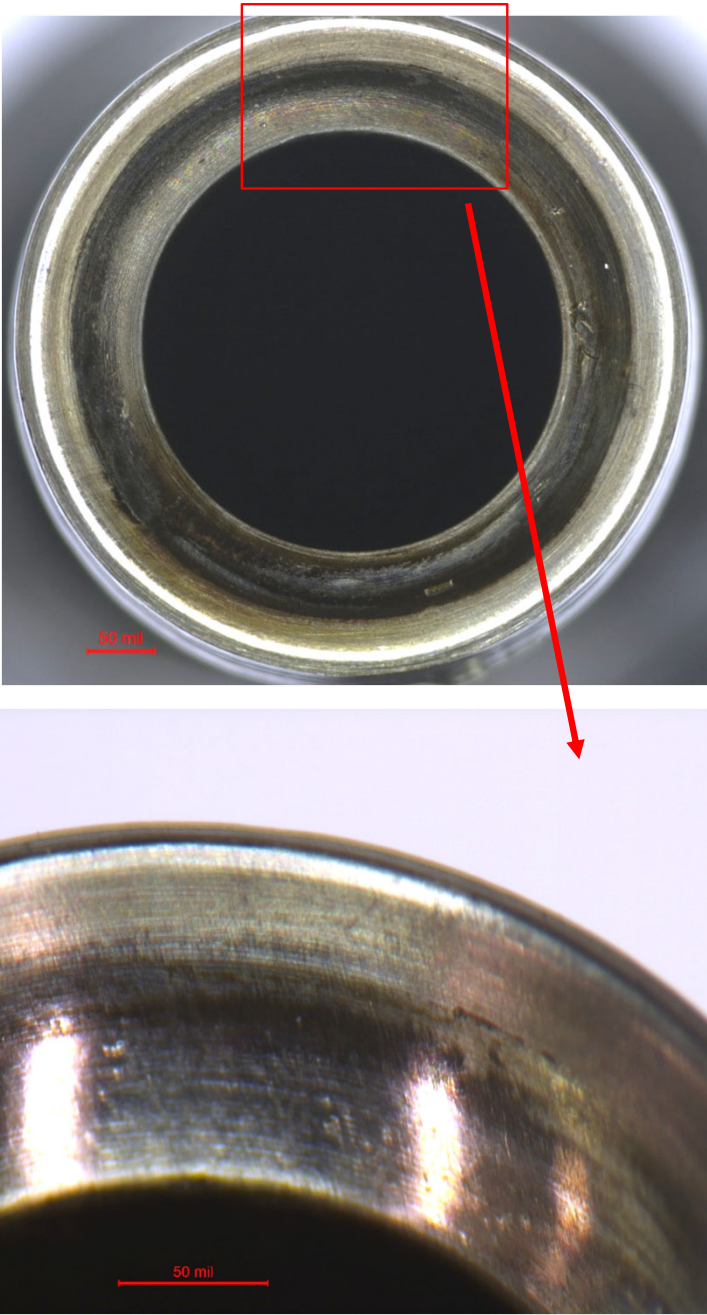
- Repo-rubber castings of the secondary manifold ferrules #4, #16, #17, and #18 were made. The sealing surfaces of each ferrule appeared slightly concave, consistent with plastic deformation from installation against the fuel nozzle bullnoses. These results are included in Appendix A.

**Figure 20:** Repo-rubber castings were made of the secondary fuel manifold #4, #16, #17, and #18 ferrules. The sealing surfaces are no longer straight, consistent with plastic deformation from contact with the bullnose of the fuel nozzle during installation. The degree of deformation is greater for ferrules 4, 16, and 18 than 17.
