# National Transportation Safety Board

ENG23LA031

## **POWERPLANTS**

Group Chair's Factual Report

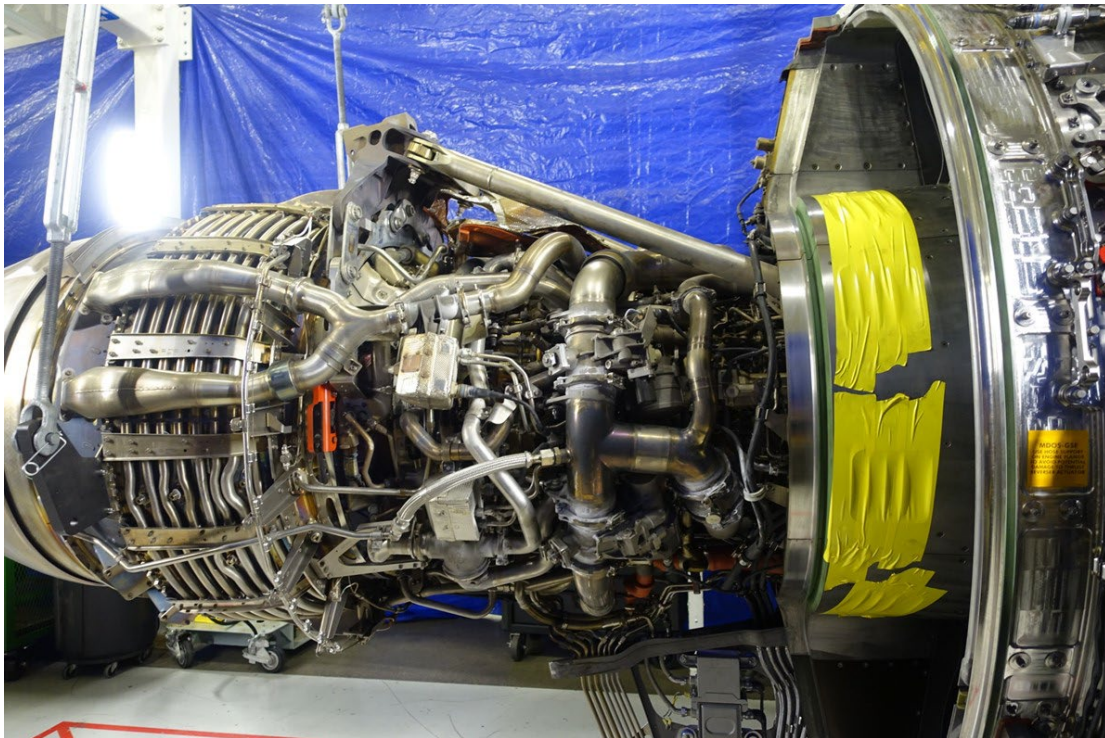
**Photo 3- Engine Right Side, as Received**

The right side of the engine was in good condition and there was no evidence of thermal damage observed.
