# National Transportation Safety Board

**ENG23LA033**

## **AIRCRAFT SYSTEMS**

Group Chair's Factual Report

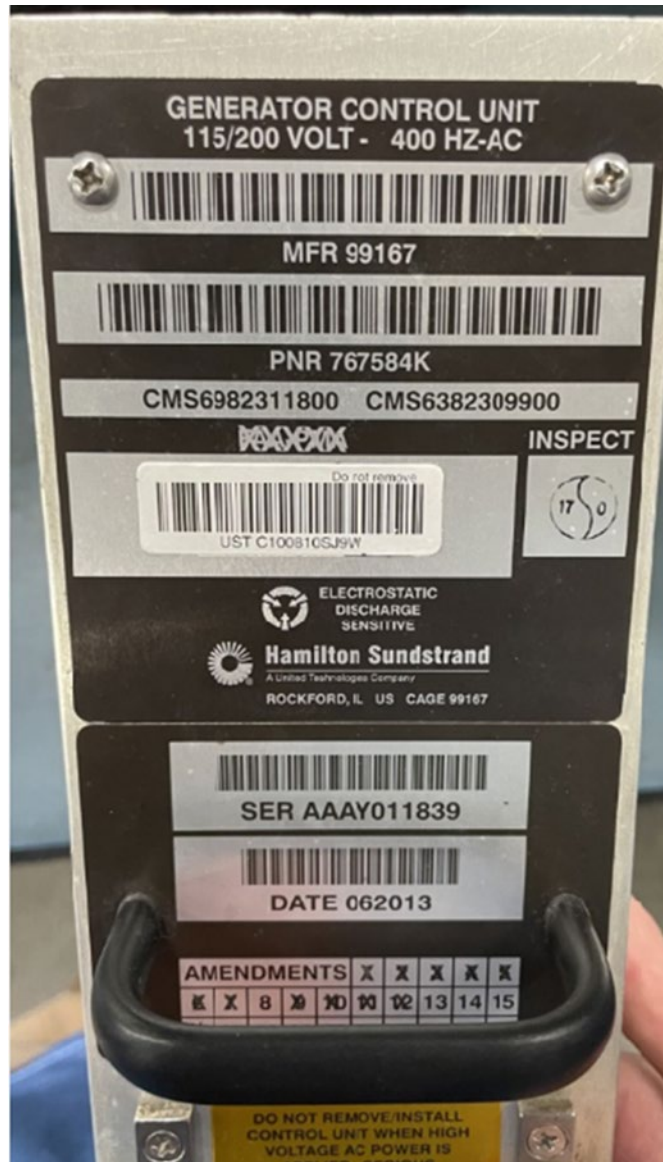
The GCU was examined and photographed for a general assessment of its condition. The unit passed the visual inspection with no anomalies noted. An unbroken Lufthansa Technik square anti-tamper seal was found on the side of the unit.

**Figure 1.** The number 1 GCU, front data plate. (Photograph courtesy of Collins Aerospace)

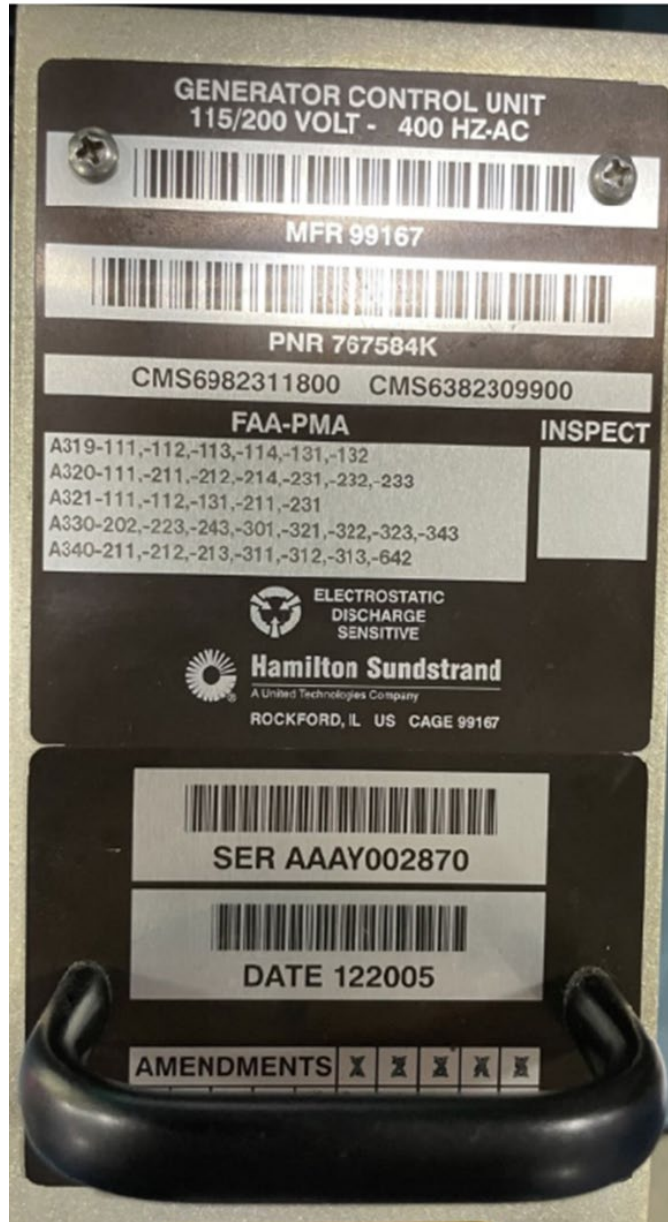
The GCU was examined, the general condition of the unit was visually assessed, and photo documented, as necessary. The unit passed the visual inspection with no anomalies noted. A Collins anti-tamper seal on the side of the unit was found unbroken.

**Figure 2.** Front data plate of the number 2 GCU. (Photograph courtesy of Collins Aerospace)

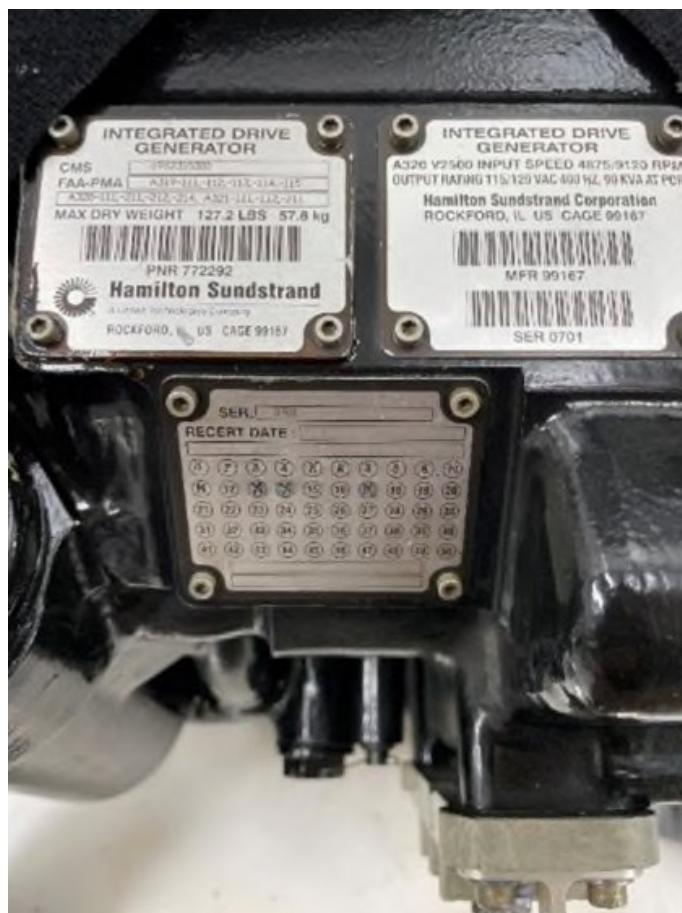
**Figure 4.** The number 1 IDG, Serial Number 0701 nameplate. (Photograph courtesy of Collins Aerospace)

- The DPI indicator had been reset (pushed in)
- The electrical connectors had plastic caps installed
- Electrical connector A was deformed such that the electrical connector could not be installed. The connector rim was adjusted and the connection made.
- No other visible leaks, cracks or other physical damage noted
- The grommet was missing in the base of connector C

The group also examined the previously removed filters. Debris was noted in both filters. A piece of bronze-colored metal, approximately 1/8<sup>th</sup> inch square in size, was found in the scavenge filter. In addition, portions of silver stringers, and large black flakes of an unknown material, possibly electrical impregnating compound, were found in the filters.

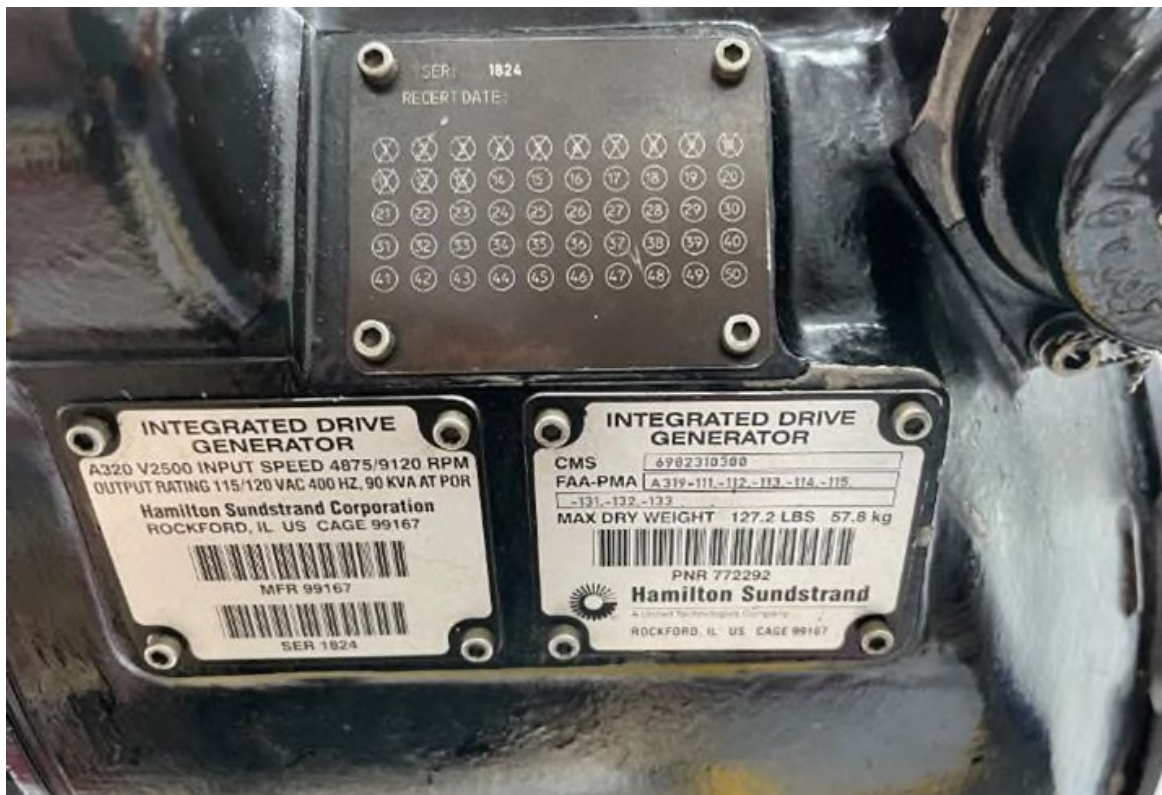
The IDG had been misplaced during the shipping movement to the Collins Miramar, Florida facility. Several weeks later it was located and then shipped to Miramar. The IDG was originally shipped in a standard shipping container but had been removed during shipment. As received at Miramar, the IDG was in a cardboard box on a wood pallet. The IDG was wrapped in a plastic garbage bag.

**Figure 9.** IDG #2 (Serial Number 1824) nameplate. (Photograph courtesy of Collins Aerospace)
