# National Transportation Safety Board

ENG23LA034

## **POWERPLANT FACTUAL REPORT**

Location: Rochester, Minnesota  
Date: January 24, 2023  
Time: 1:42 central daylight time  
Airplane: Lancair Legacy, Registration Number N707MM

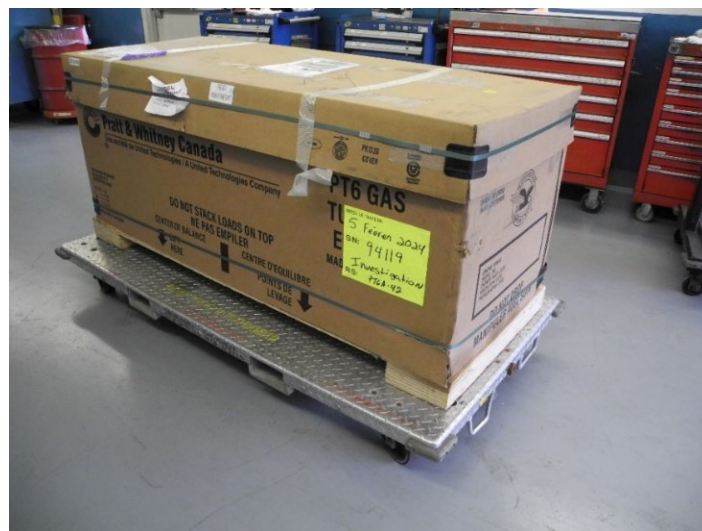
The engine was in a standard cardboard engine container which was opened in the presence of the NTSB (**Photo 1**).

**Photo 1** - Engine in Shipping Container - As Received

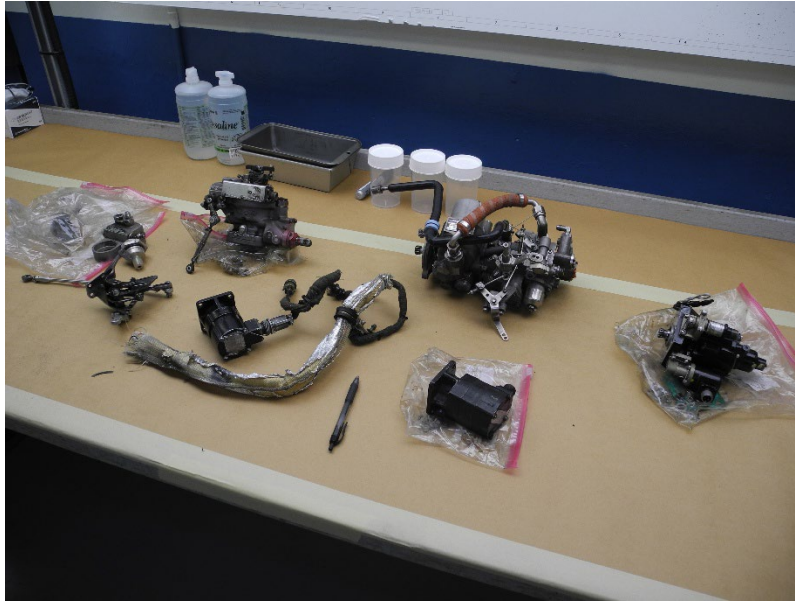
Of the accessories, only the oil and scavenge pump, oil/fuel heat exchanger and P3 filter housing were still attached to the engine. An additional box, reported to have been shipped separately later, contained the other accessories (**Photo 5**) that were reported to be on the engine at the time of the accident. Below is a list of those components:

**Photo 5** - Contents of Separate Box

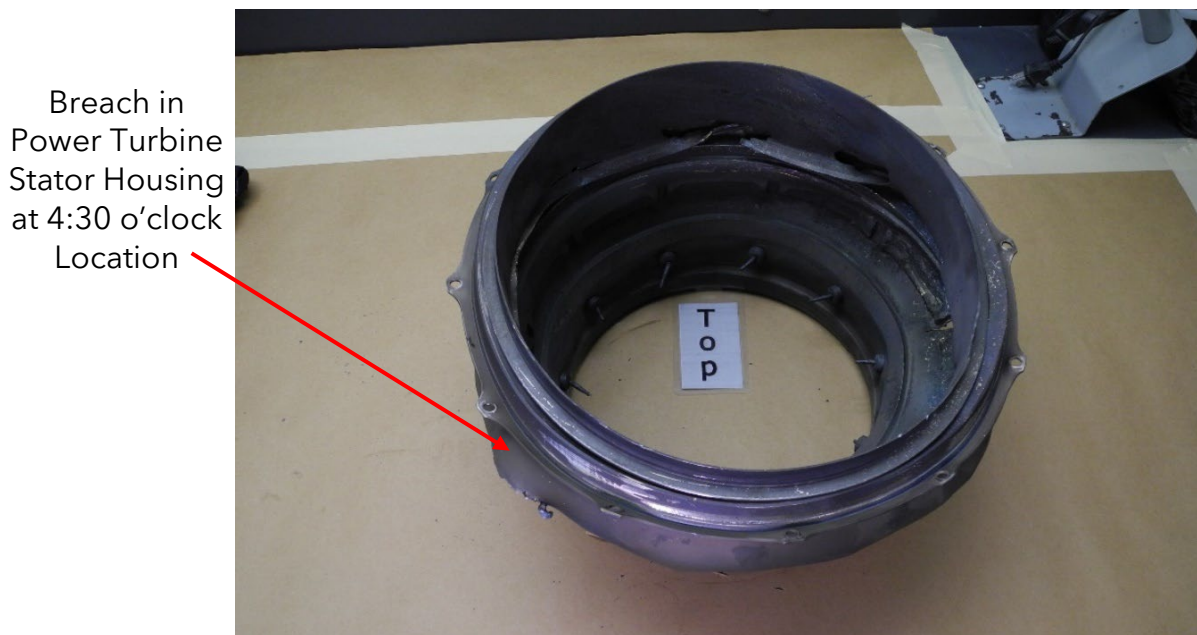
**Photo 12** - Power Turbine Stator Housing - ALF as Installed

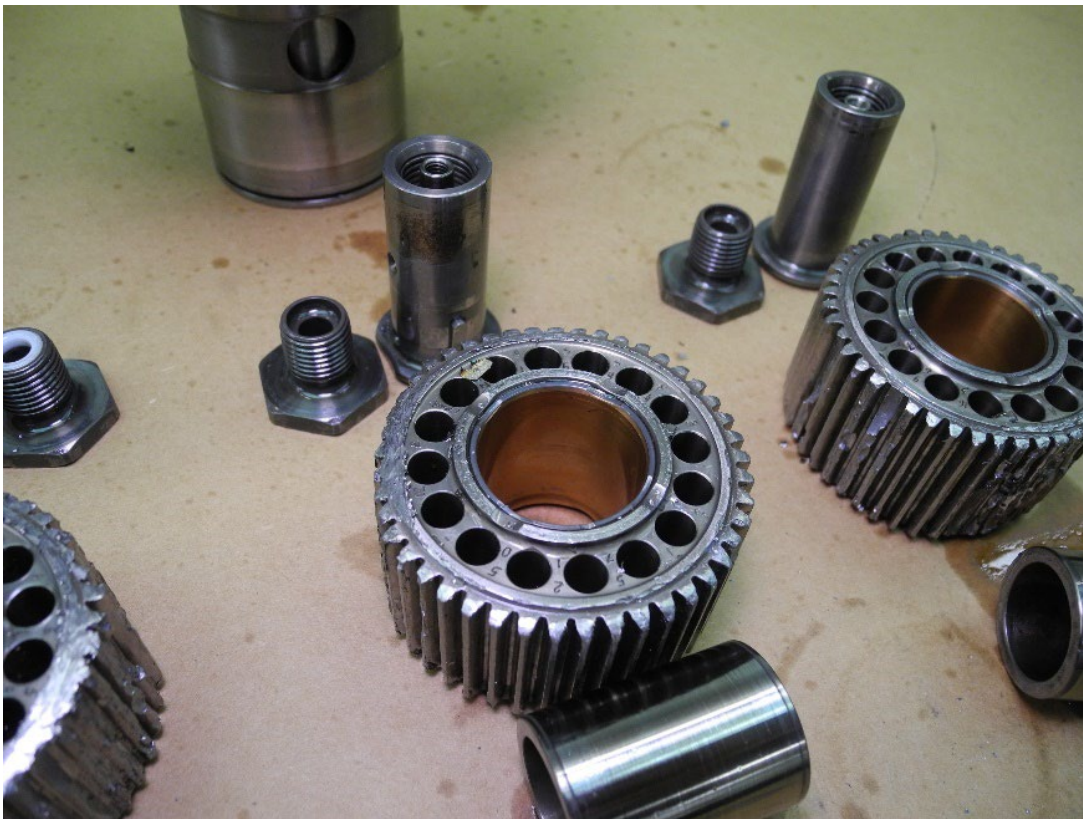
The three 1<sup>st</sup> stage planet gears were still free to rotate. An examination of the journals of all three gears revealed undamaged and oil wetted bushings and shafts (**Photo 20**). The 1<sup>st</sup> stage planetary gearset, consisting of the sun gear and three planet gears are manufactured as a matching set which may not be mixed. The sun gear was P/N 3028455, S/N 73E009. The planetary gears were P/N 3049216-01 and S/N's 76E118, 76E103, and 76E122. According to P&WC engineering, the set was sold as new in 2003.

**Photo 20** - Planetary Gears Bushings and Shafts - Undamaged

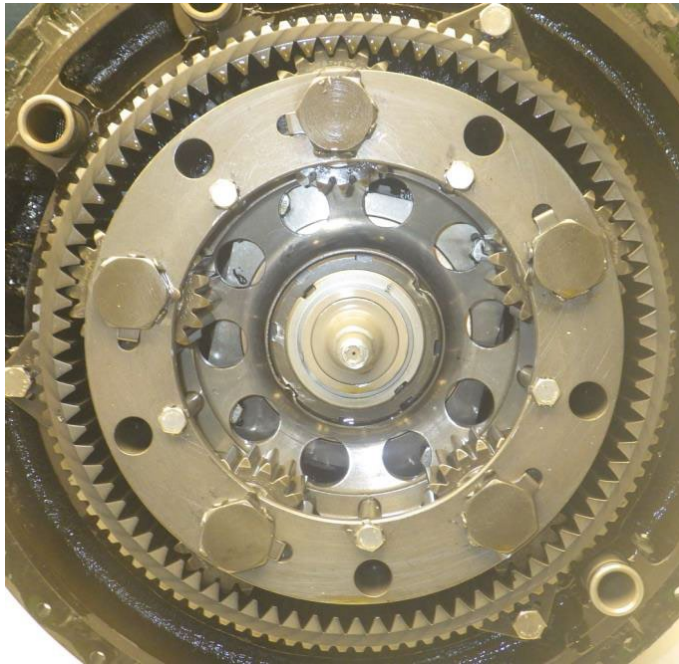
The 2<sup>nd</sup> stage sun gear, planet gears and ring gear (**Photo 21**) were intact, undamaged and oil wetted.

**Photo 21** - 2<sup>nd</sup> Stage Reduction Gear Assembly - Undamaged
