## Equipment Quality Analysis Report

**EQA NUMBER:** AS13704

**MODEL NUMBER:** 767-300F

**SUBJECT:** *Left Engine Fire During Initial Climb*

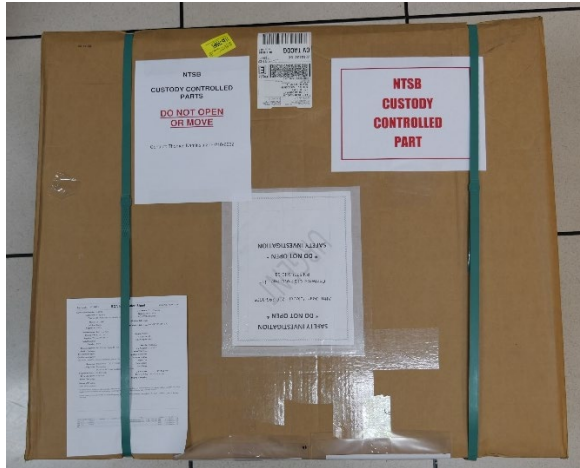
The hose assembly was received at the EQA facility on December 12, 2023. Images were taken of the container upon arrival. The exterior of the container was noted to be in good condition; see Figure 1 and Figure 2.

**Figure 1:** Container as received, top view

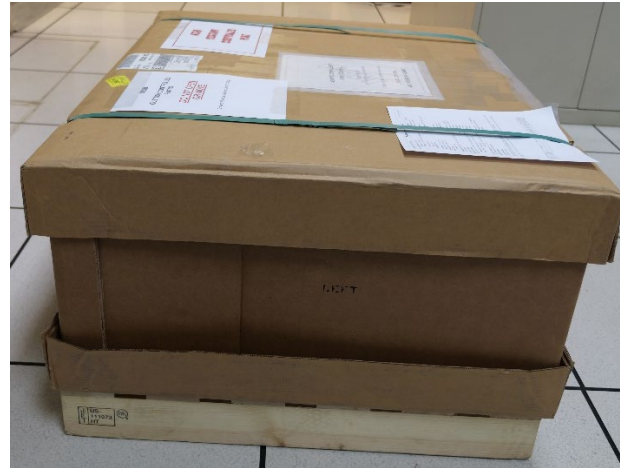
**Figure 2:** Container as received, side view

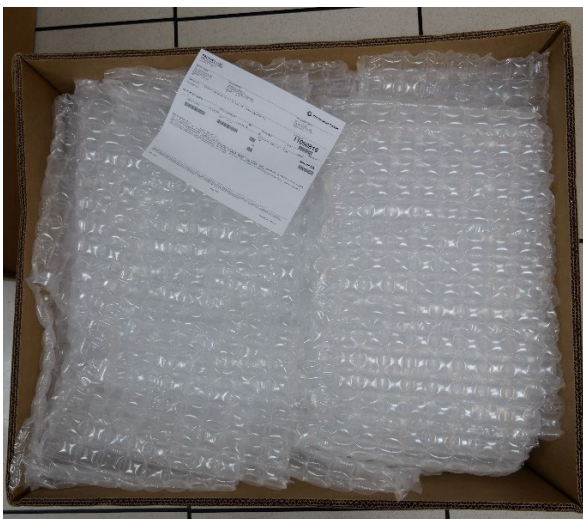
On December 15, 2023, prior to the examination date, Boeing ASI requested that EQA open the container to ensure that the gasket on flanged end of the hose was received. EQA opened the container and verified the presence of the gasket. It was secured to the hose by a bolt still engaged within a threaded insert, and a zip tie; see Figure 3 through Figure 5.

**Figure 3:** Container opened

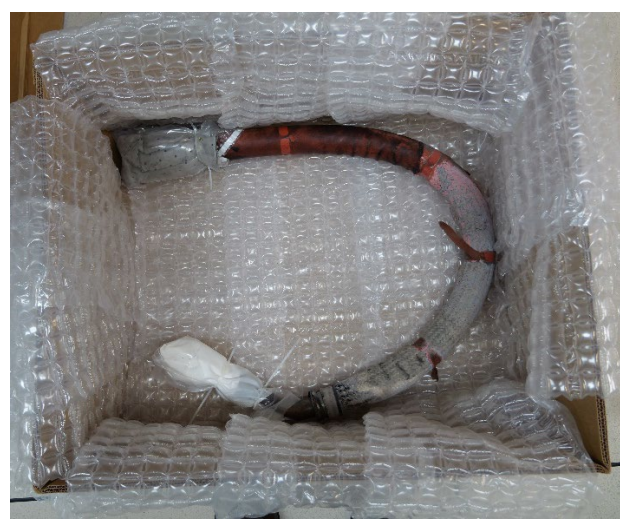
**Figure 4:** Hose assembly as received

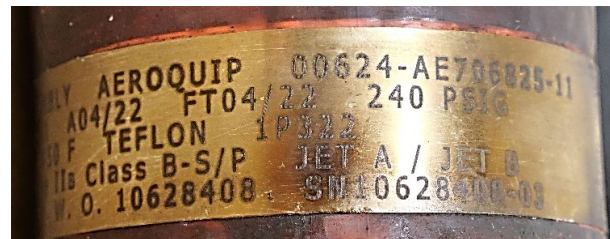
**Figure 8:** ID band, slightly rotated from Figure 7

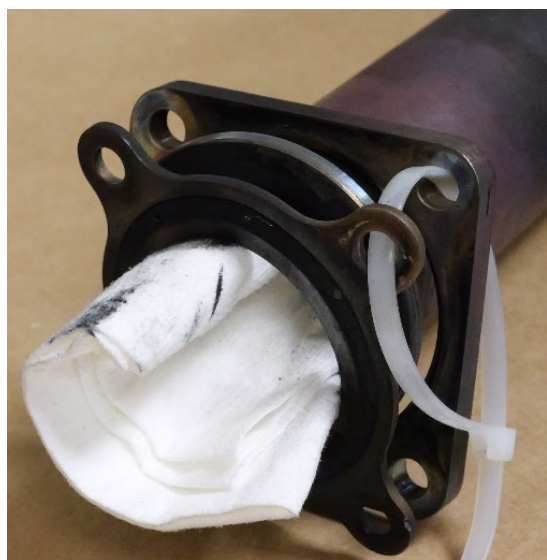
The protective covering was removed from the flanged end of the hose, exposing the four-bolt flange and gasket; see Figure 10. The protective covering was removed from the quick disconnect end; see Figure 11.

**Figure 10:** Flanged end of hose with gasket

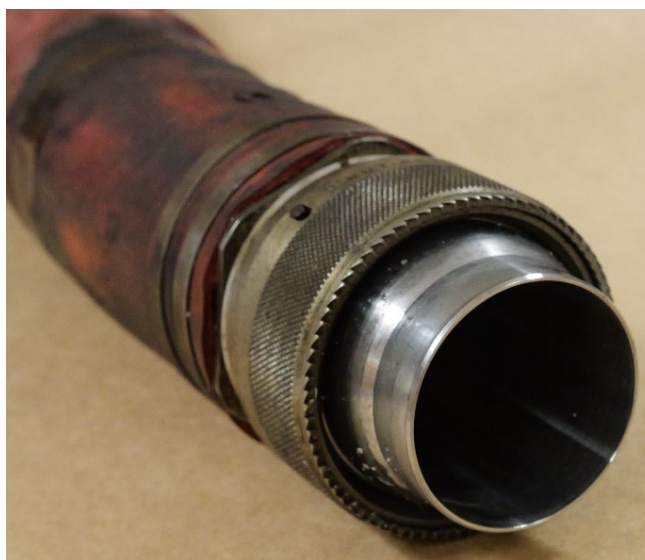
**Figure 11:** Quick disconnect end of the hose

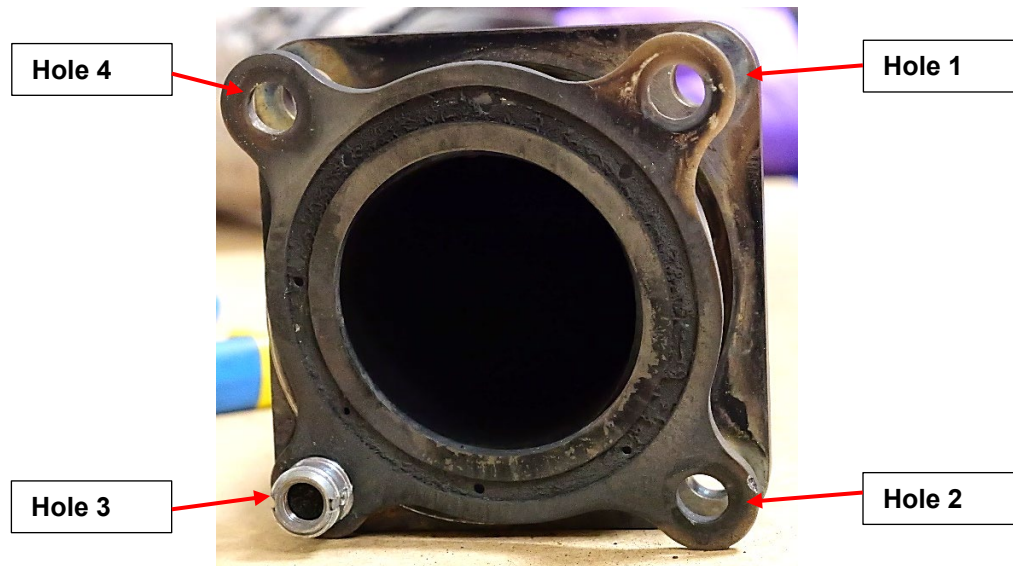
The rag inside the tube and the zip-tie securing the gasket were removed. The holes were then marked as holes 1 through 4 for identification purposes only; see Figure 12.

**Figure 12:** Flanged end of hose assembly

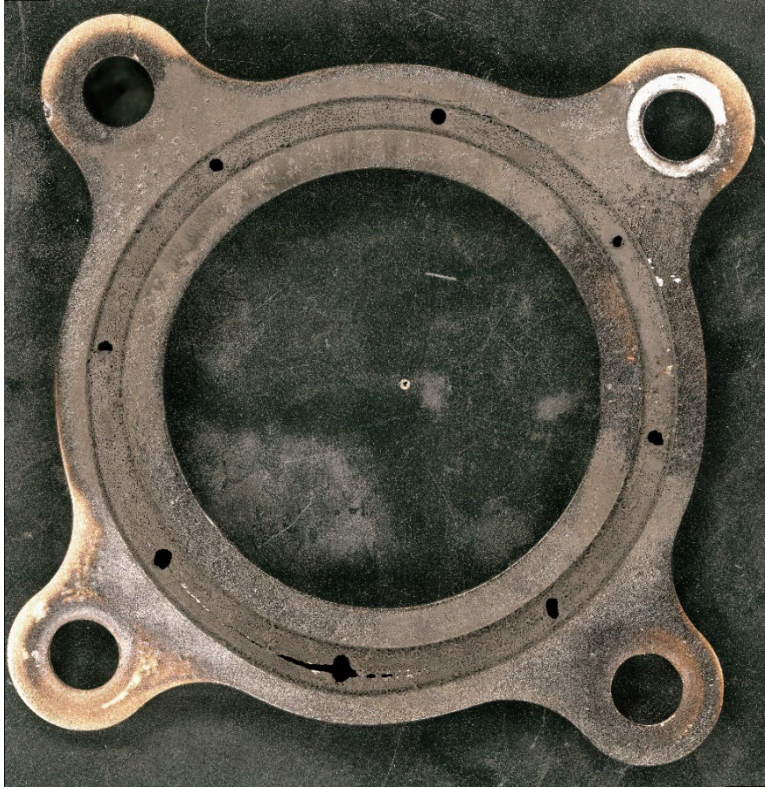
After a thermal event on a 767 a seal gasket (Sargent P/N CA-5465-0X) was submitted for fracture analysis (Figure 1). A region of cracking and absent material was found in approximately 20 percent of the circumference of the groove (Figure 2). The cracked region was excised for detailed examination with a scanning electron microscope (SEM). Figures 3 through 5 show SEM images of the fracture surface. The fractured region showed morphology indicating complete melting at the fracture surface.

Figure 1. EQA photograph of the as received seal gasket (Sargent P/N CA-5465-0X)
