# **Metallurgical Investigation Report**

## **DRB: AvEng-561264.A**

**EVALUATION OF A CF6-80C2 ESN 707-605 HMU IDLER  
ADAPTER FROM ESN 707-605 OPERATED BY FEDEX  
INVOLVED IN AN IN-FLIGHT SHUT-DOWN AND  
UNDERCOWL FIRE EVENT**

Part Number: 9395M78G10  
Part Serial Number: FIA217EE  
Part TSN / CSN: 1,421 hrs / 728 cycles

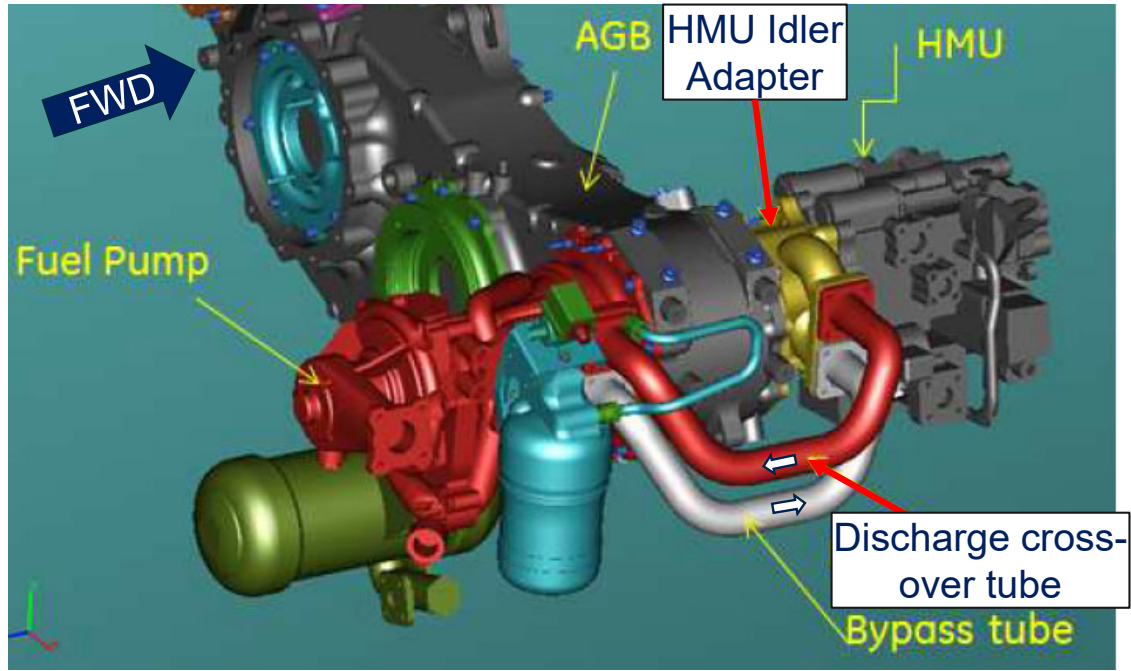
**Figure 1: Left:** A 3D model shows the assembly of the fuel pump (red) and HMU idler adapter (gold). The fuel pump sits aft of the Accessory Gearbox (AGB) and the HMU idler adapter sits forward of the AGB. A discharge cross-over tube (red) is attached by 4-bolt flanges to the fuel pump and HMU idler adapter. **Right:** an image captured during the on-site investigation shows the HMU idler adapter discharge cross-over tube flange. The top-left bolt and both locking wires are shown present. No bolts were found missing during disassembly.

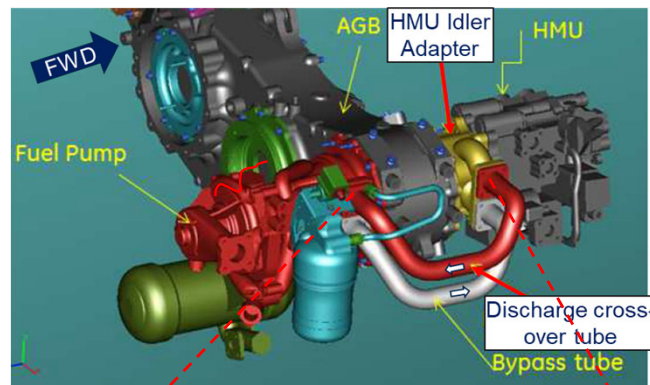
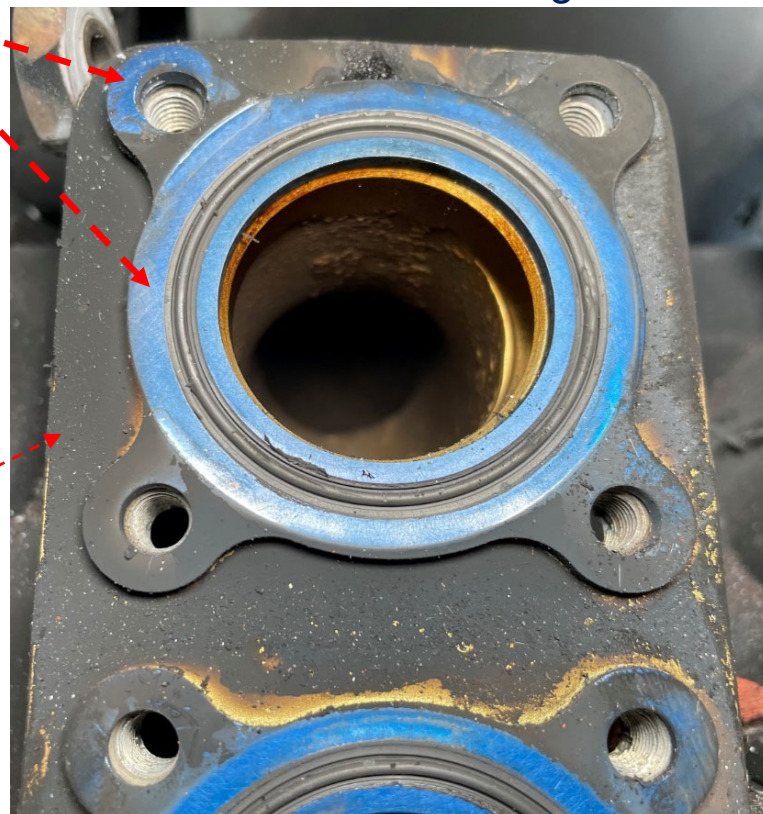
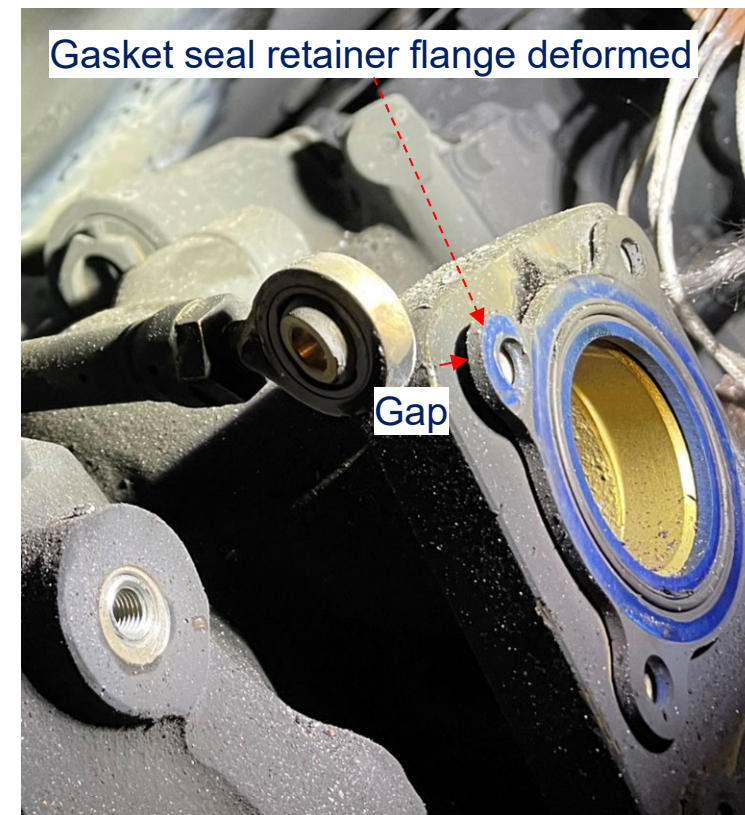
HMU Idler adapter discharge cross-over tube flange

No soot

Gasket seal retainer flange deformed

**Figure 2:** Images taken after the discharge and bypass tubes were removed, revealing the gasket seals (P/N 1453M60P04) that are assembled between the cross-over tube flange and HMU idler adapter flange surfaces . Most of the area is covered in black soot from the engine fire. Some areas of the gasket seal retainers are not covered in soot and are visually blue, consistent with these areas contacting the cross-over tube flanges during the fire. The top left tab of the aluminum gasket seal retainer is deformed outboard relative to the idler adapter flange surface.

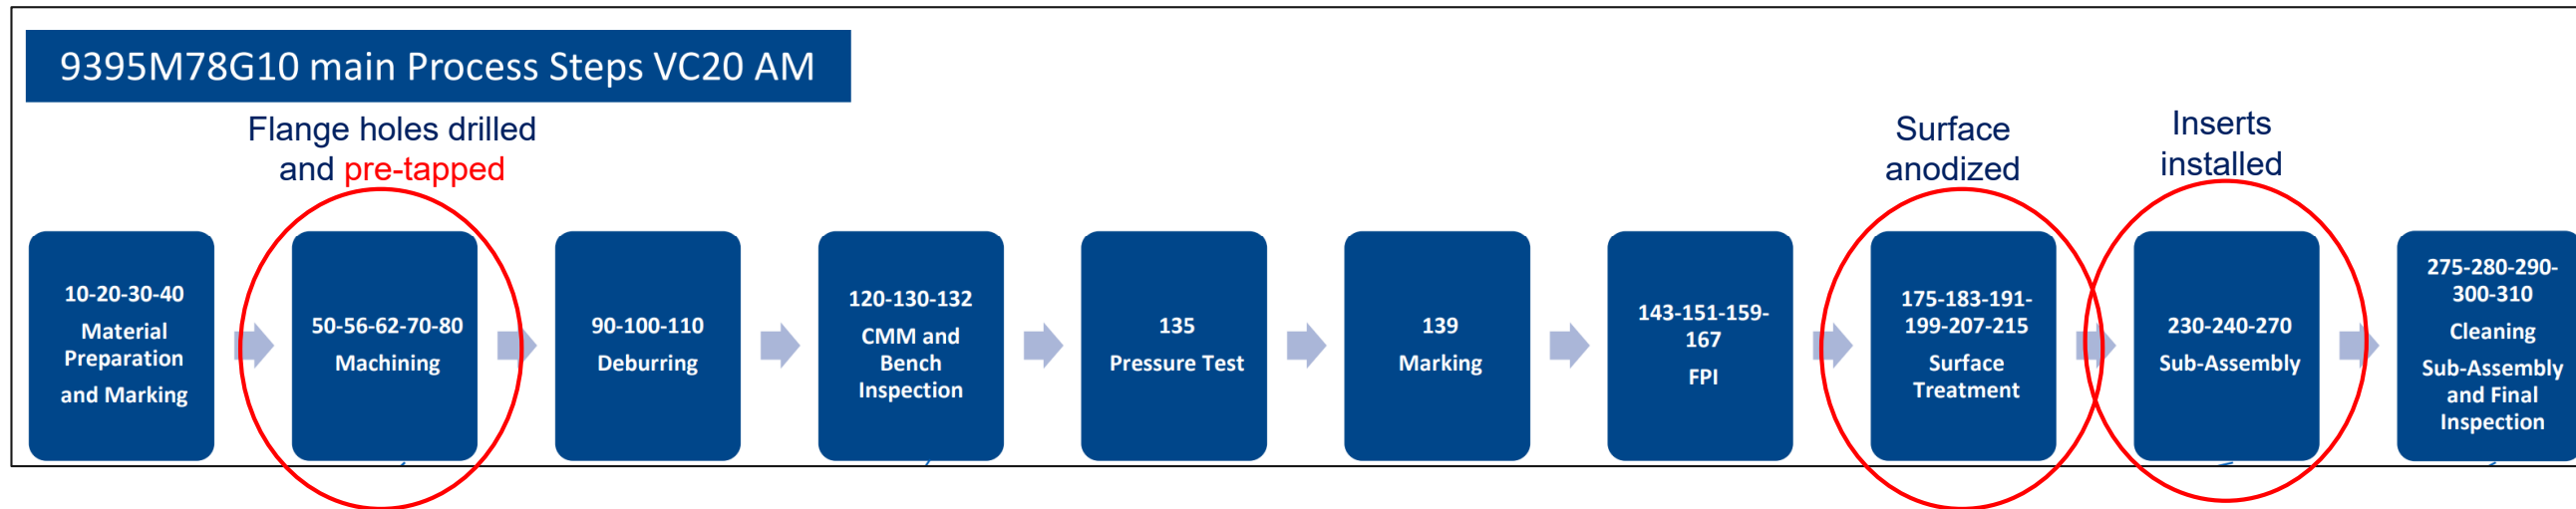
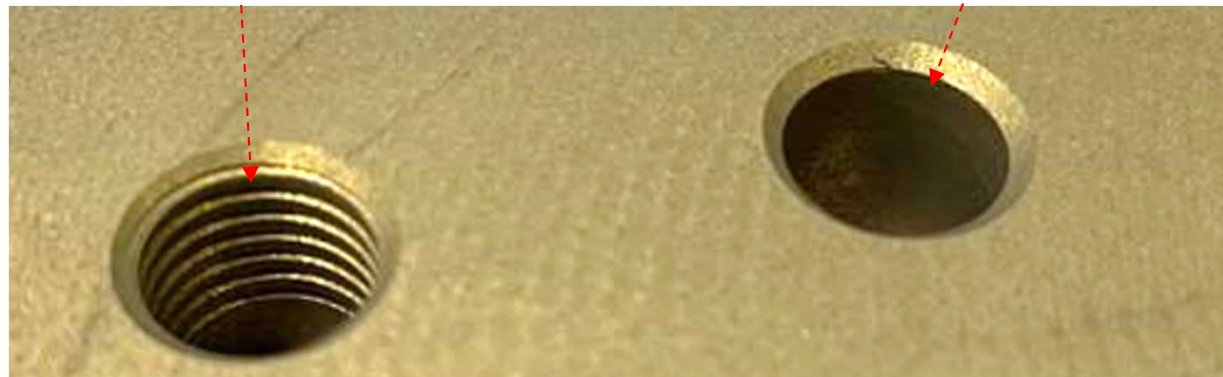
**Figure 5:** HMU Idler adapter main process steps taken from the Avio Gemba walk report. The event HMU idler adapter (S/N FIA217EE) is part of a population that received a non-conforming thread pre-tap during the machining step to assist in insert alignment. Approximately 60-70% of the hole depths were tapped. A surface anodize step occurs after the holes are drilled and tapped. The image below shows an example of a conforming, drilled thru-hole required by the part drawing, and an example of the non-conforming pre-tapped hole that was used for all insert locations on the event HMU idler adapter flange.

Example of a **non-conforming pre-tapped hole** with internal threads

Example of a **conforming drilled thru-hole** without internal threads

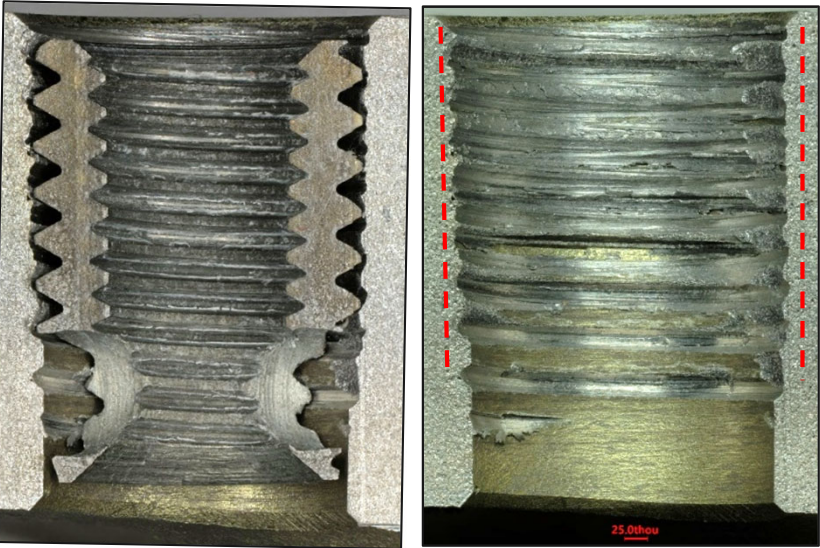
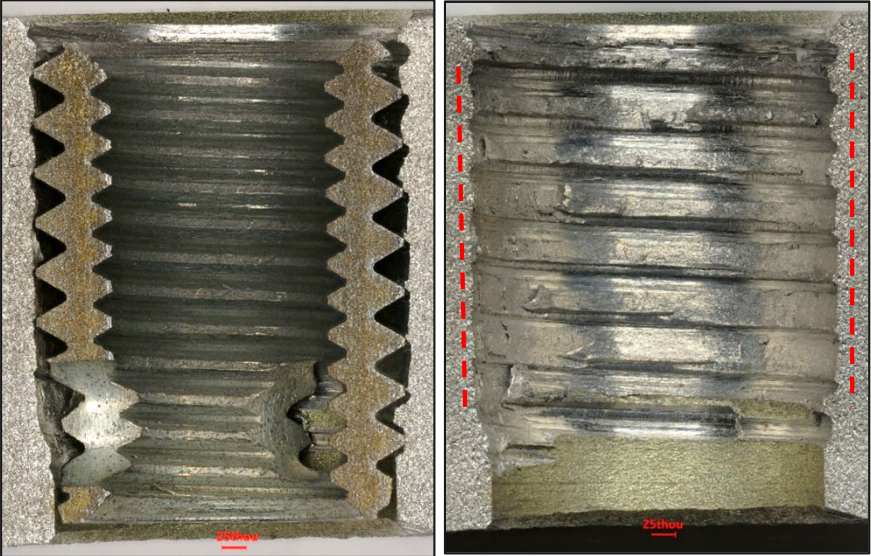
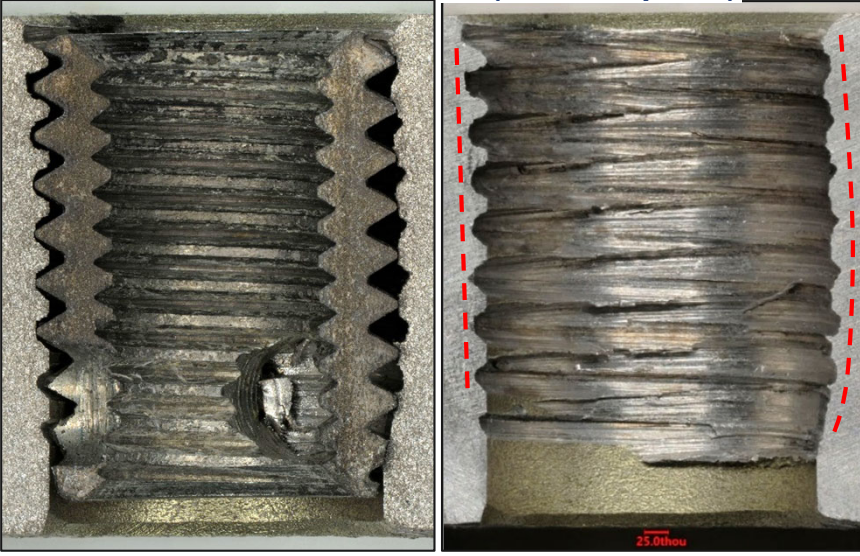
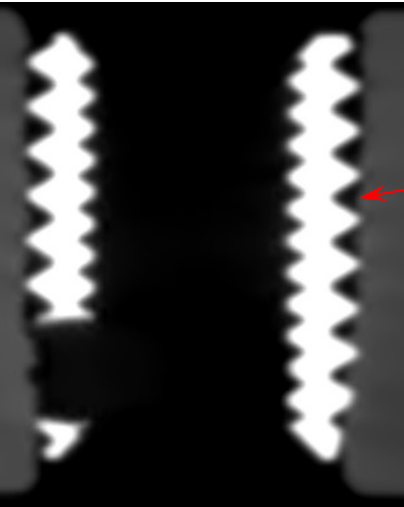
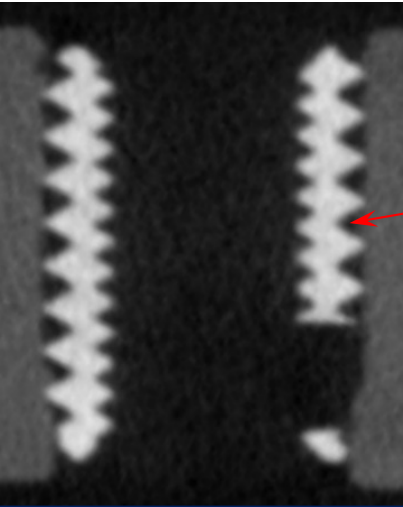
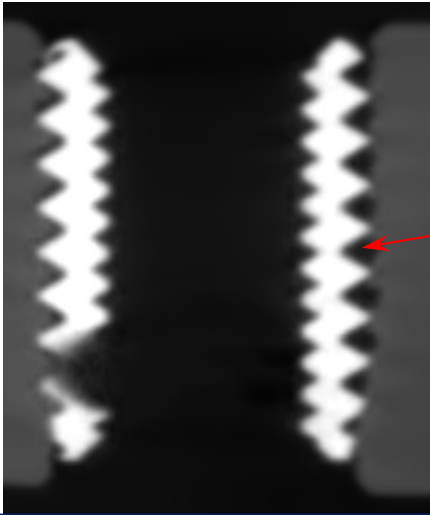
RTV S/N FIA231MR Hole 5 (Insert in place)

RTV S/N F1A1YN6T Hole 7 (Insert in place)

RTV S/N FIA217C9 Hole 3 (Insert in place)

Lack of threads

**Figure 6:** Side-by-side comparison of the insert holes of three Return To Vendor (RTV) parts (SNs FIA231MR, FIA1YN6T, and FIA217C9) that showed a lack of thread engagement in the CT scans. These inserts did not have a pull-out test performed so the inserts are in the undisturbed manufactured positions. All three insert locations have similar findings of no remaining thread debris, crossed cut lines, and missing anodized layer. Detailed analysis for each S/N can be found in the appendices.

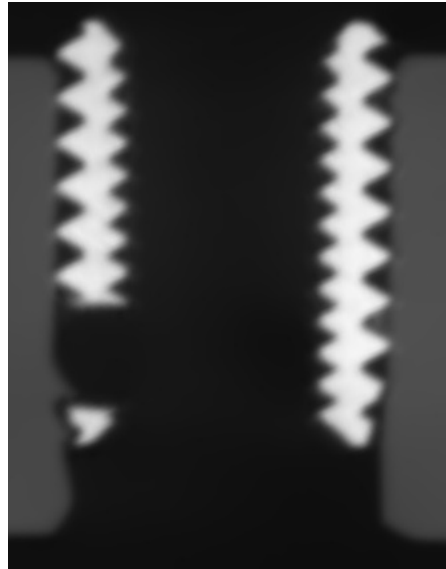
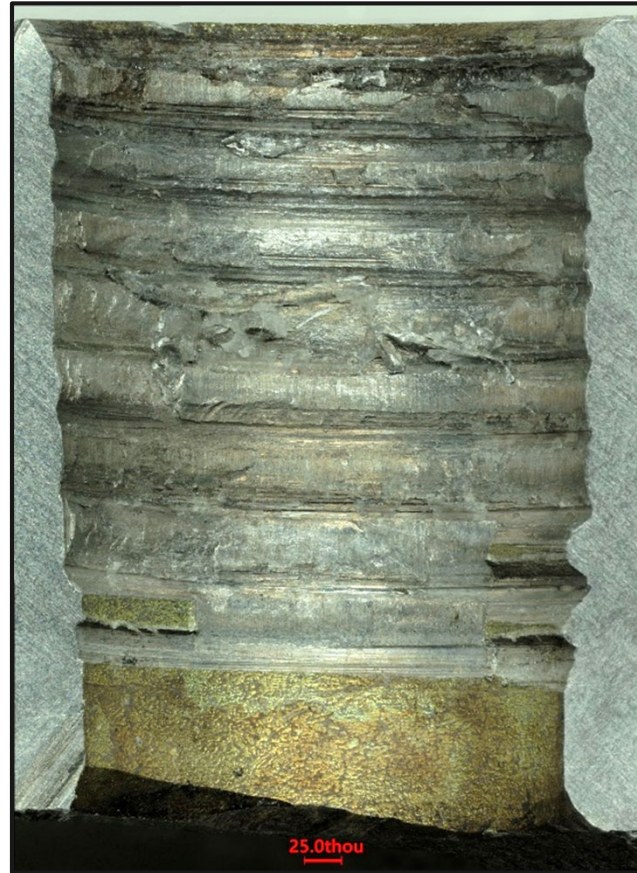
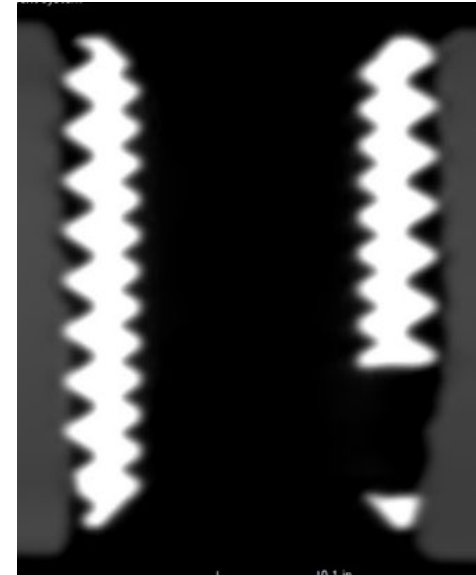
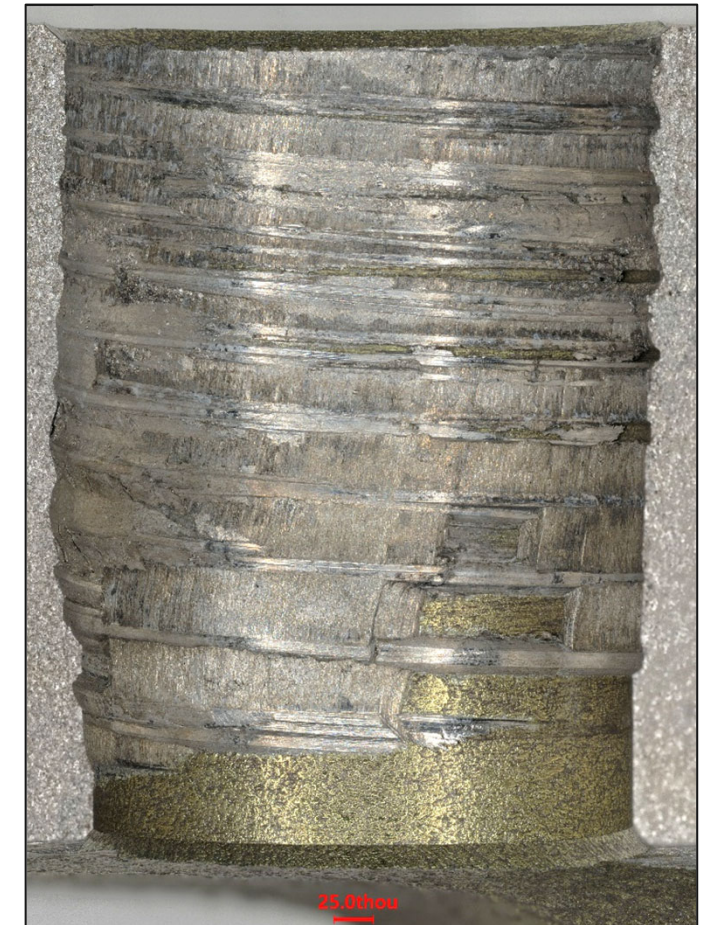
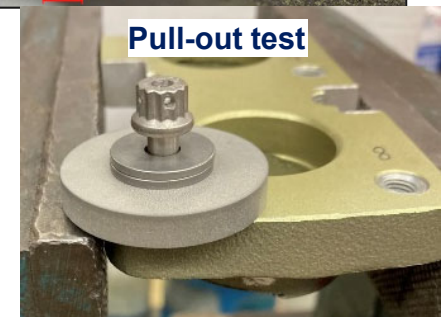
**Event Engine FIA217EE**  
Hole 2 (Insert pulled out)

**RTV FIA231MR**  
Hole 7 (Post Pull Out Test)

**Figure 7:** Comparison images of the RTV SN FIA231MR insert 7 hole to the event engine SN FIA217EE insert 2 hole. Both holes show similar lack of thread engagement in the CT scans. FIA217EE insert 2 was found protruding during disassembly and did not go through a pull-out test. FIA231MR insert 7 was pulled out during the lab pull-out test and shows similar surface condition to FIA217EE insert 2 (missing thread material, vertical scoring lines from the insert being pulled out, small areas with CCW smear).

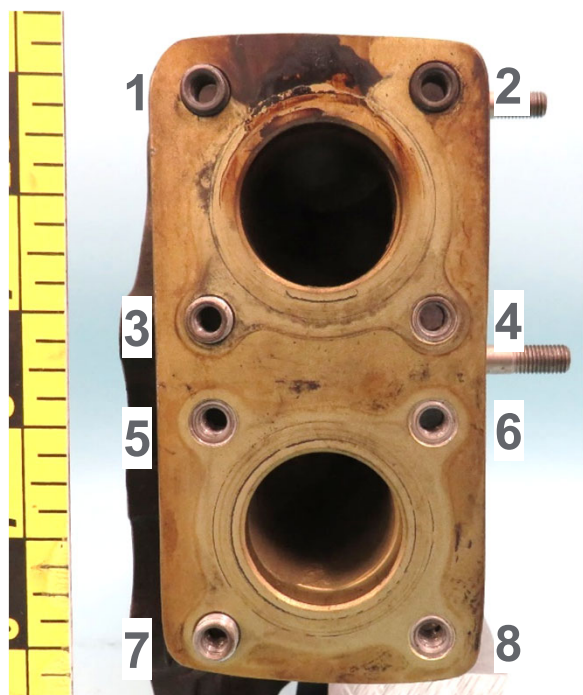
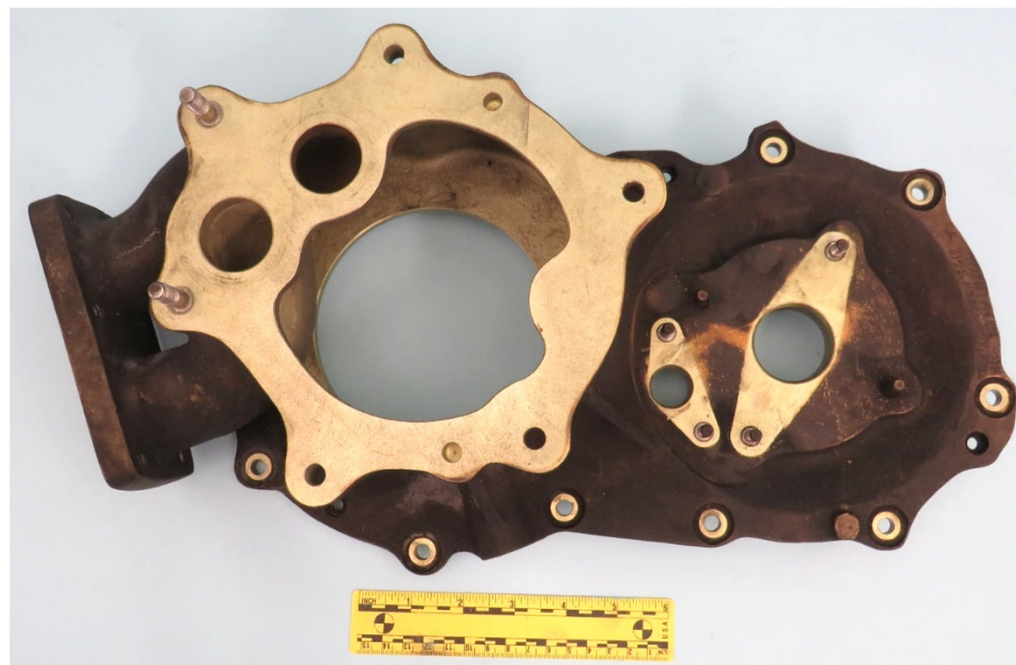
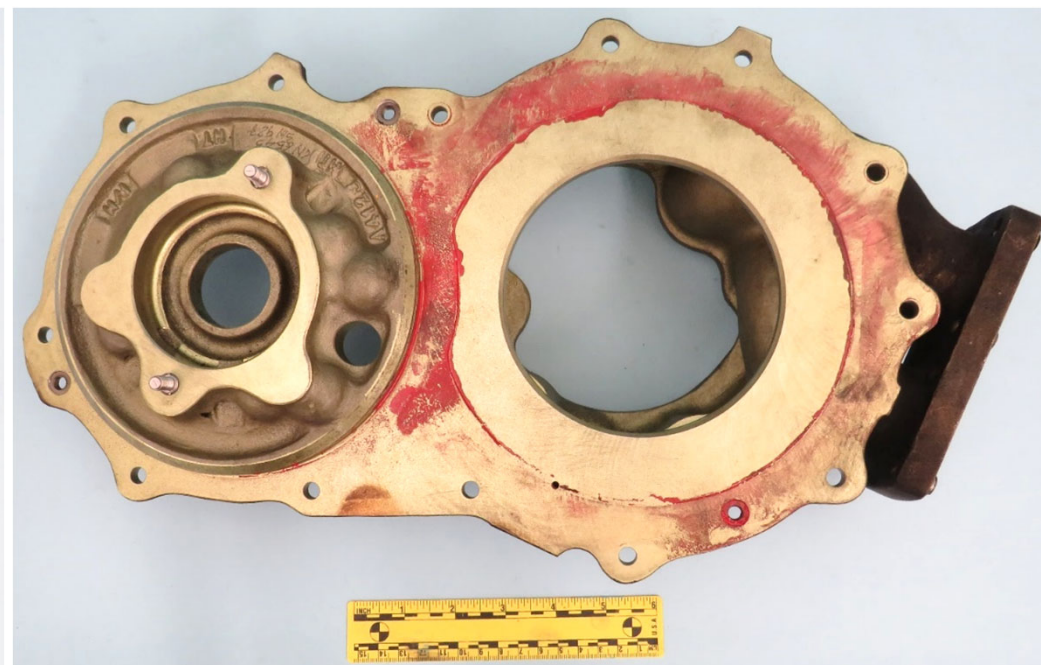
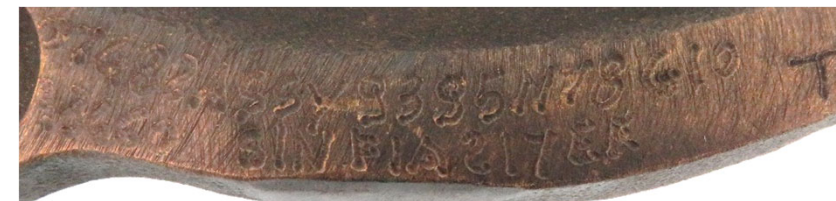
- Optical view of the HMU in the as-received condition is shown in Figure 8, along with the gasket seal in Figure 9. The images show that 2 of the inserts were proud of the flange surface (locations 1 and 2) and the gasket had a corresponding 70-degree region of blow-out seal, with corresponding coking on the flange (Figures 8 and 9).

**Figure 8:** Images of the HMU idler adapter as-received by the failure analysis lab. The part number (9395M78G10) and serial number (FIA217EE) markings are shown.

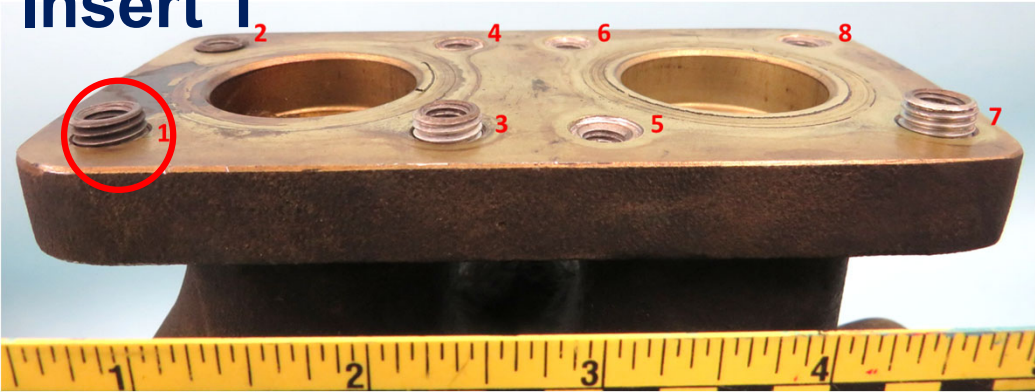
Insert 1

**Figure 11:** CT scan cross-section of thread insert position 1. The pre-tapped internal threads are missing. No thread engagement is observed into the flange material.

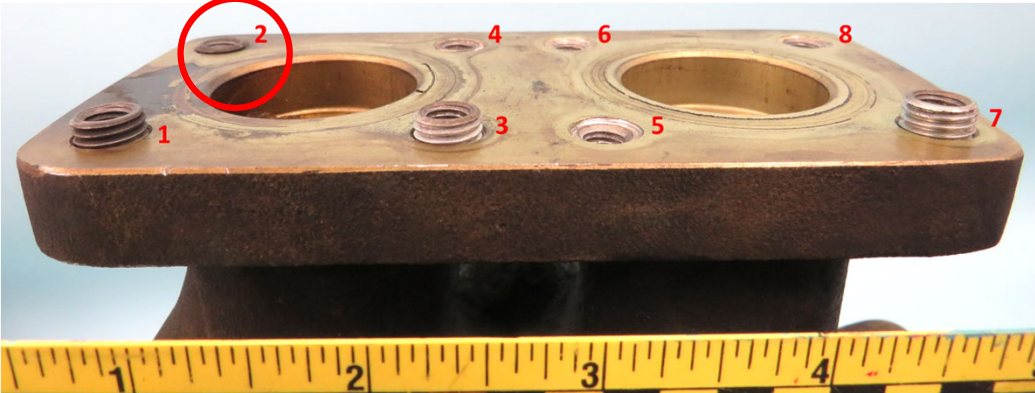
# Insert 2

**Figure 12:** CT scan cross-section of thread insert position 2. The pre-tapped internal threads are missing. No thread engagement is observed into the flange material.

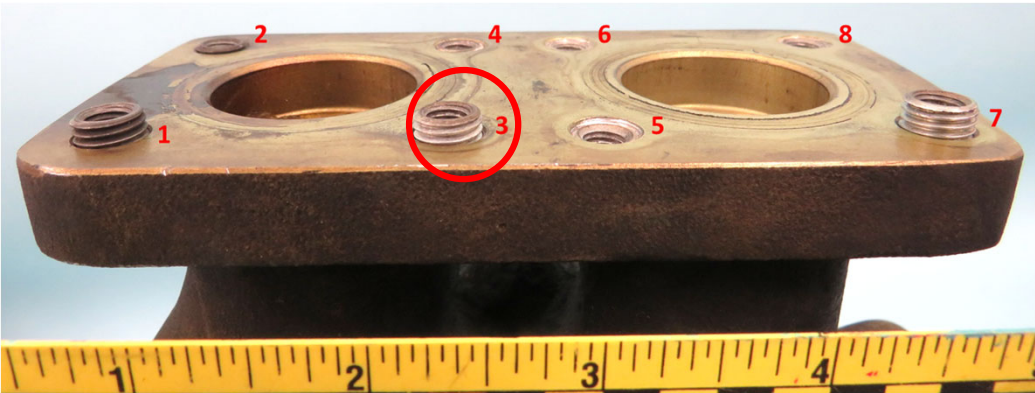
# Insert 3

**Figure 13:** CT scan cross-section of thread insert position 3. The pre-tapped internal threads are missing. No thread engagement is observed into the flange material.

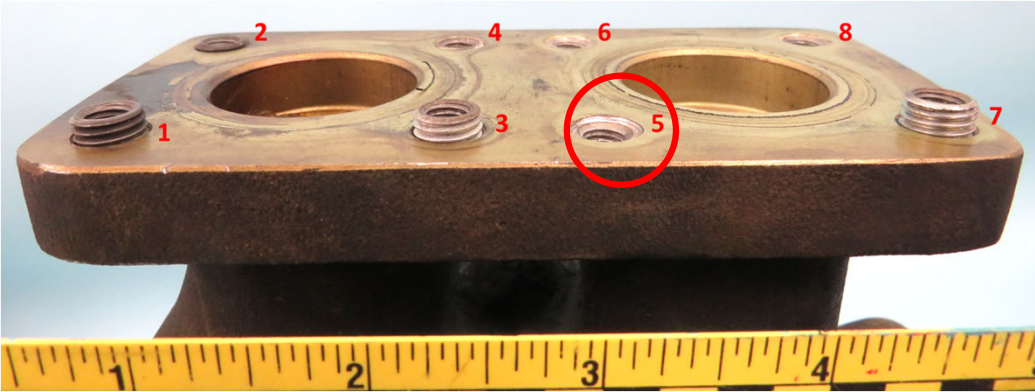
# Insert 5

**Figure 15:** CT scan cross-section of thread insert position 5. Thread engagement is observed into the flange material.

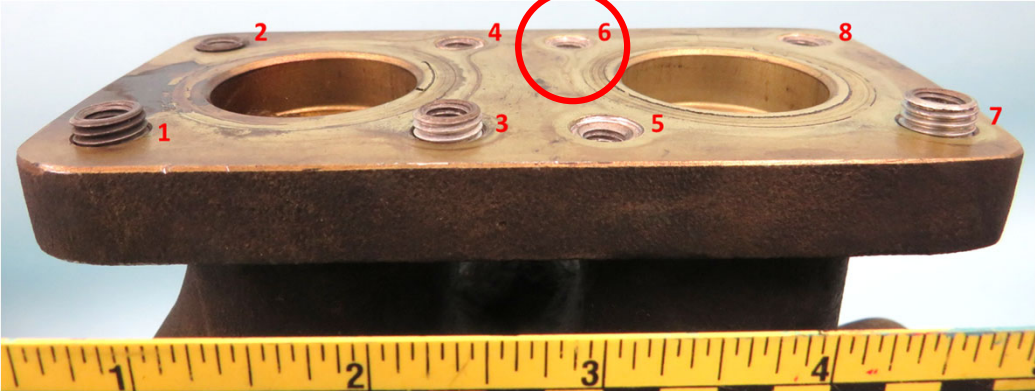
# Insert 6

**Figure 16:** CT scan cross-section of thread insert position 6. Thread engagement is observed into the flange material.

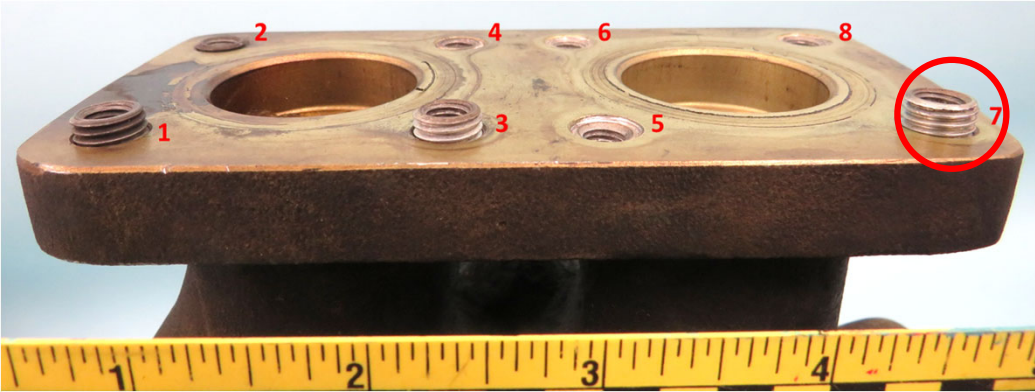
# Insert 7

**Figure 17:** CT scan cross-section of thread insert position 7. Thread engagement is observed into the flange material.

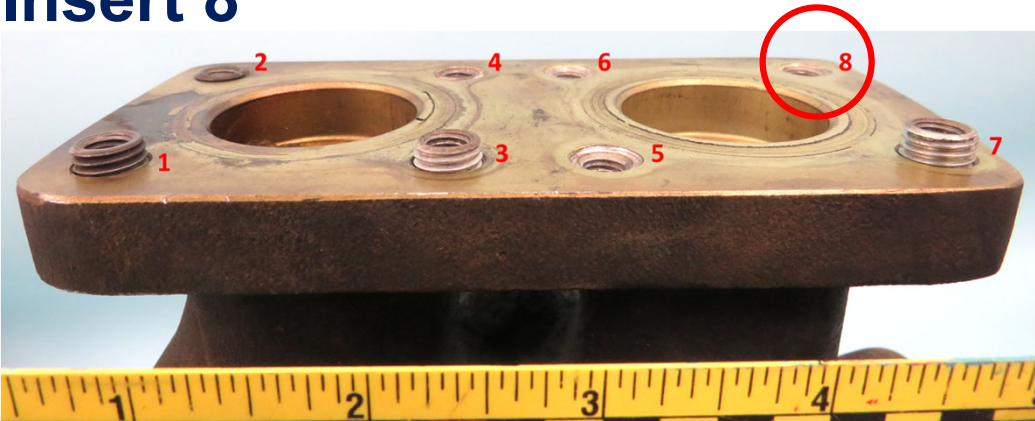
# Insert 8

**Figure 18:** CT scan cross-section of thread insert position 8. Thread engagement is observed into the flange material.

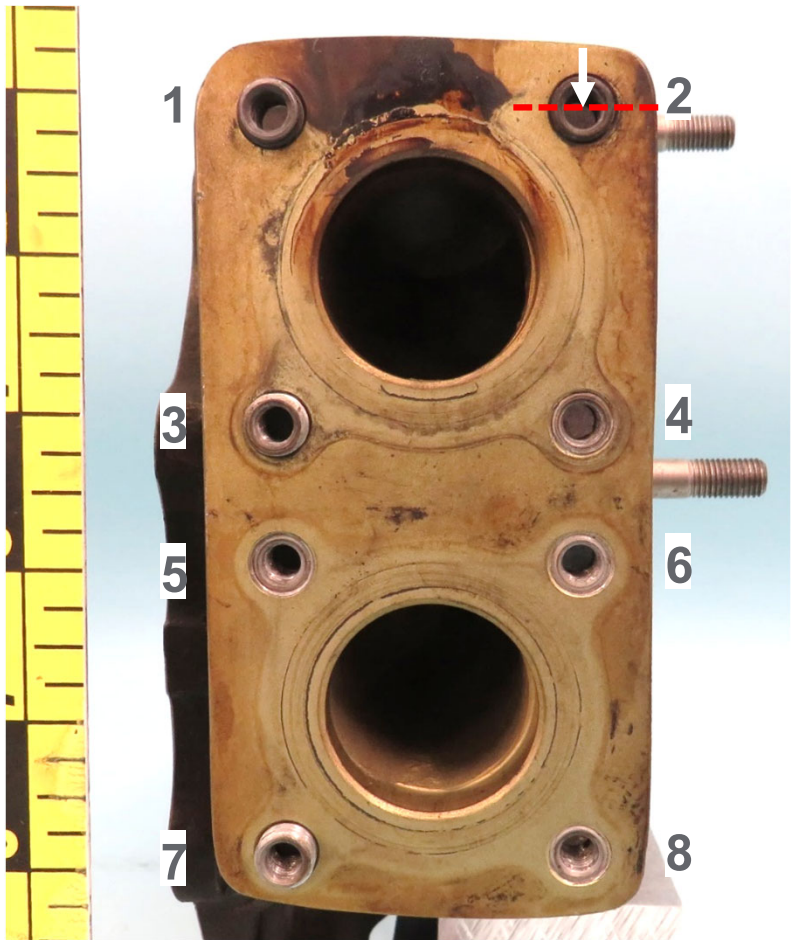
# Insert 2

- Sectioning of insert location 2 revealed the pre-tapped threads were missing 360-degrees around the hole to a depth of approximately 0.34-inches (Figure 20). High magnification views of the microstructure at the hole surface revealed no compressed grains that would indicate severe smearing, consistent with the material being cut out by the self-tapping inserts (Figures 23). Vertical scoring lines are observed in the areas with missing internal threads consistent with the insert contacting the surface while pulling out. Smeared material in the CCW direction is observed in multiple areas (Figures 21-22). Two areas with the intact threads are observed at the bottom of the hole with the same spacing as the insert installation holes 120-degrees around (Figure 24). The missing threads between them were found trapped in the insert threads, consistent with the aluminum parent metal thread shearing when the steel insert was pulled out.

CCW circumferential smear

**Figure 20:** Optical views of the lower half of the insert 2 hole with the inset removed. Most of the threads are stripped and the thread material is missing. Two areas with the intact threads are observed with the same spacing as the insert installation holes (120°). The threads are completely missing through approximately 0.34-inches of the hole depth.

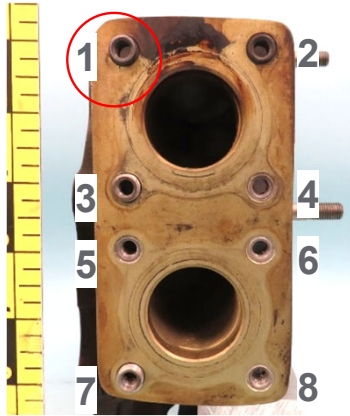
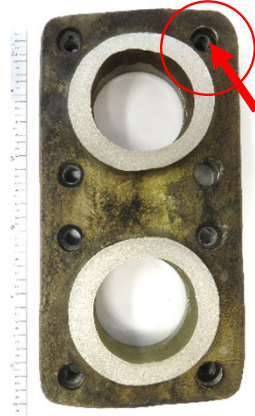
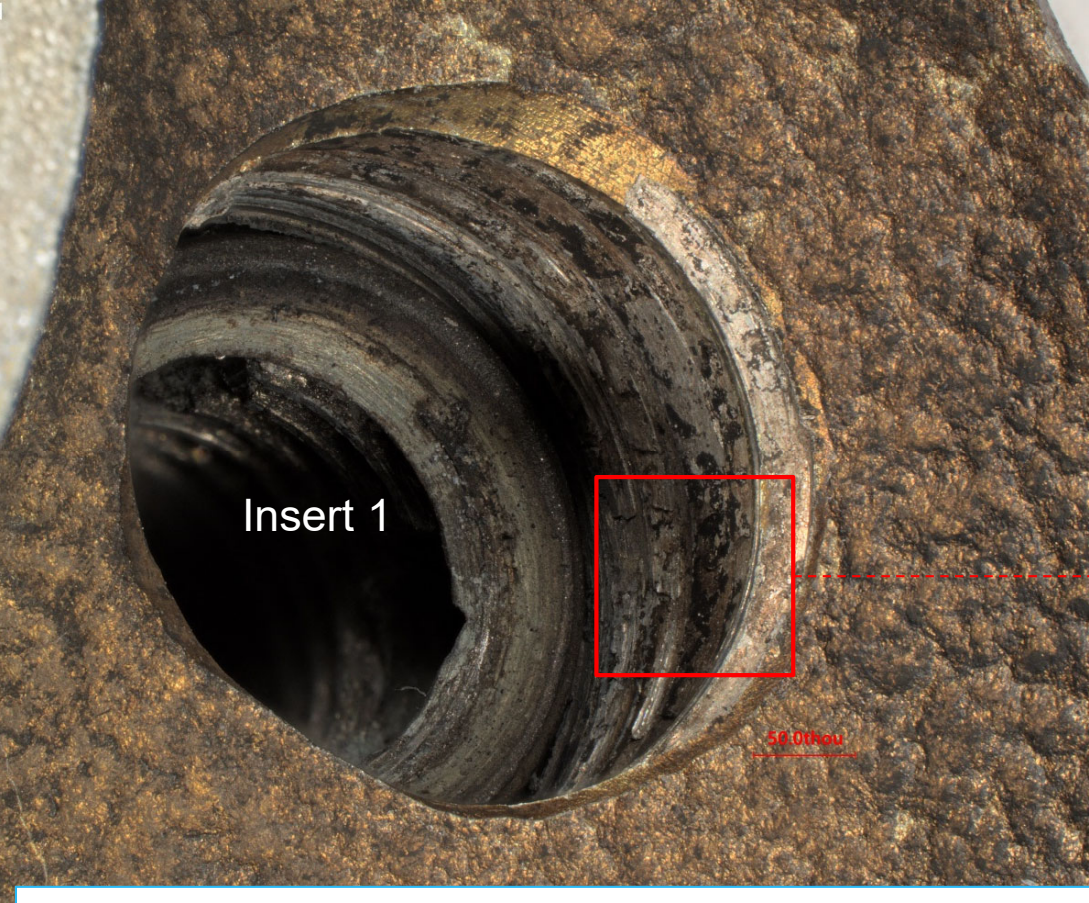
# Insert 1

Image looking into the back side of the hole

**Figure 25:** High magnification views of the Insert 1 hole circumferential damage reveal overlapping smear consistent with counter-clockwise rotation. Black soot-like material is observed on the smeared material, consistent with the smeared material existing during the fire.

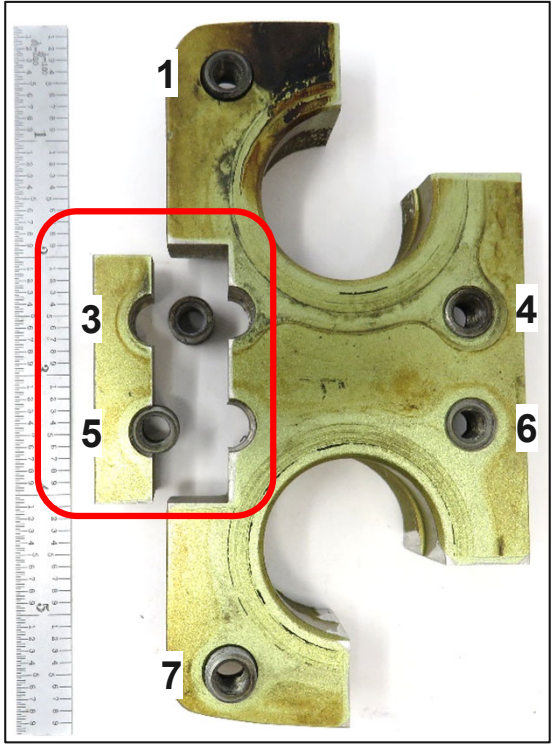
- Evaluation of a hole that showed thread engagement in the CT scan (insert 5) revealed the gold-colored anodized pre-tapped threads were still present (Figure 26). However, insert location 3 has similar vertical scoring lines and remaining lower two threads similar to findings observed in insert 2 (Figure 27). The insert 3 damaged location also showed insert cut lines that were angled and out of phase with the original pre-tapped threads, consistent with cross-threading during installation of the inserts (Figure 28).

**Figure 26:** Optical views of insert hole numbers 3 and 5 after wire EDM sectioning. Insert 3 was loose and fell out due to normal handling prior to cutting. The wire EDM cutting was stopped on both sides of Insert 5 so it could be removed and inspected. The top image shows the sectioned holes with the inserts in place, and the bottom image shows the holes with the inserts removed. The gold-like color observed on the Insert 5 hole threads is from the anodized surface treatment which occurs after hole drilling and pre-tap. The fresh, silver metal observed in Insert 5 hole is from the insert tapping threads. The insert 3 hole shows all of the threads are missing, except for three areas that align with the three insert hole locations.

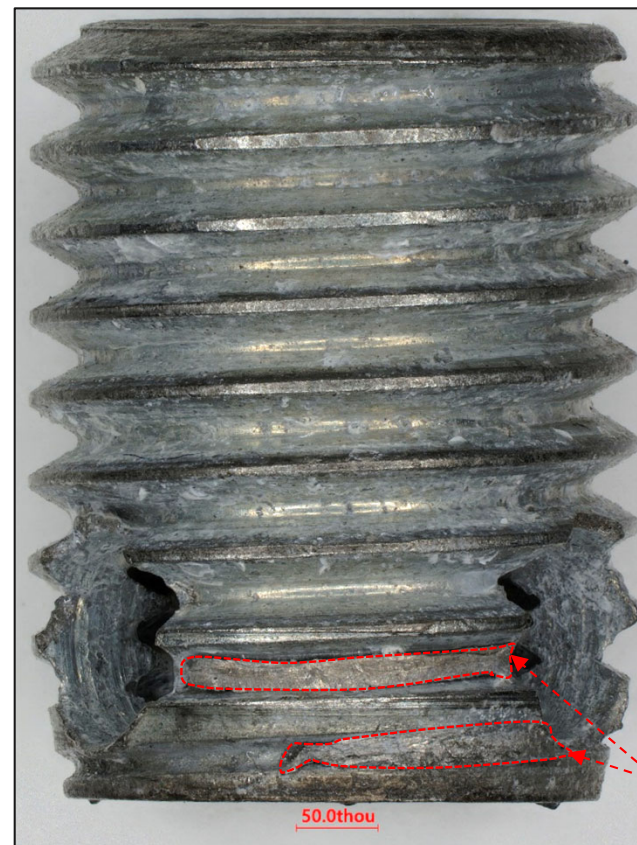
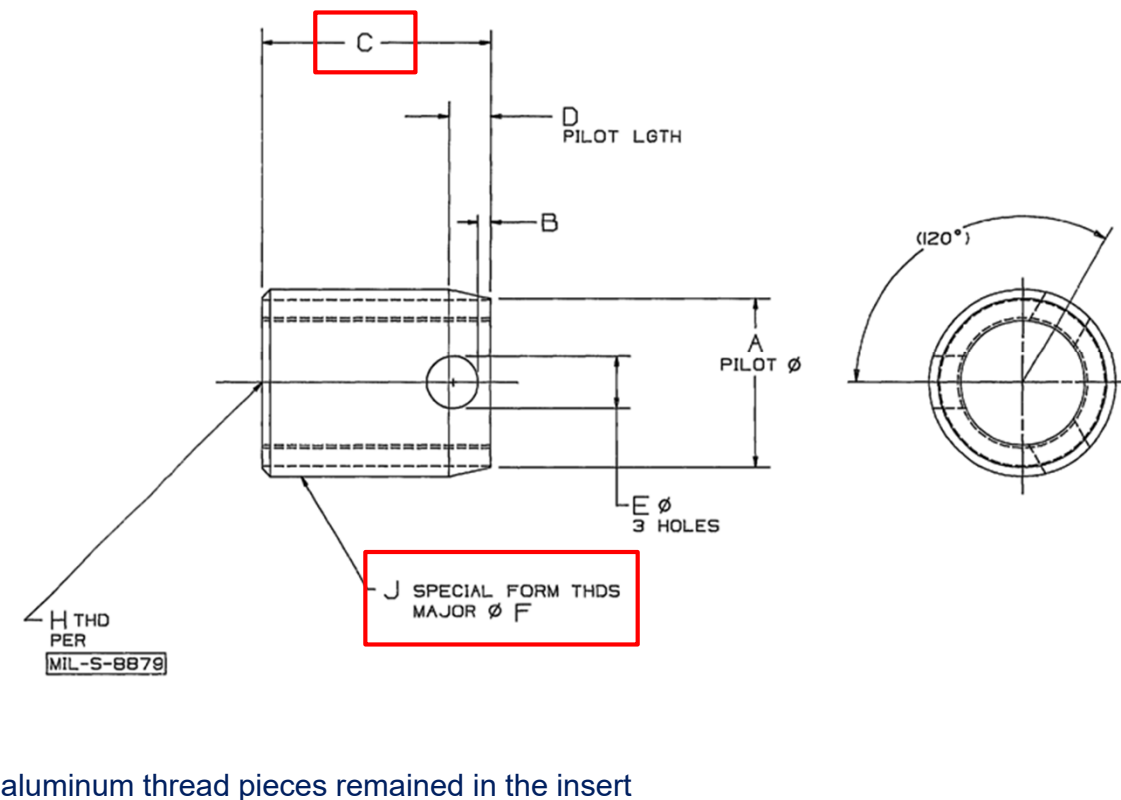
**Insert 3 (Failed pull-out test)**

- Dimensional analysis of inserts 3 and 5 showed the lengths and diameters were conforming to the drawing (1518M34P02) (Figure 29).
- Cross-section images reveal a similar microstructure at the top of the flange near holes 2 and the bottom of the flange near hole 8. Hardness was measured to be 86 HRE near the bottom of the flange and decreases to 76 HRE at the top of the flange, consistent with softening due to overaging due to heat exposure from the fire (Figure 31).

**Figure 29:** Images of insert 3 and 5 after removal from the flange. The major diameter of inserts 1, 3, 5, and 8 were measured and are conforming to the drawing requirement. The drilled hole diameters for holes 2 and 8 were measured at the bottom of the holes in the untapped section and both are conforming.

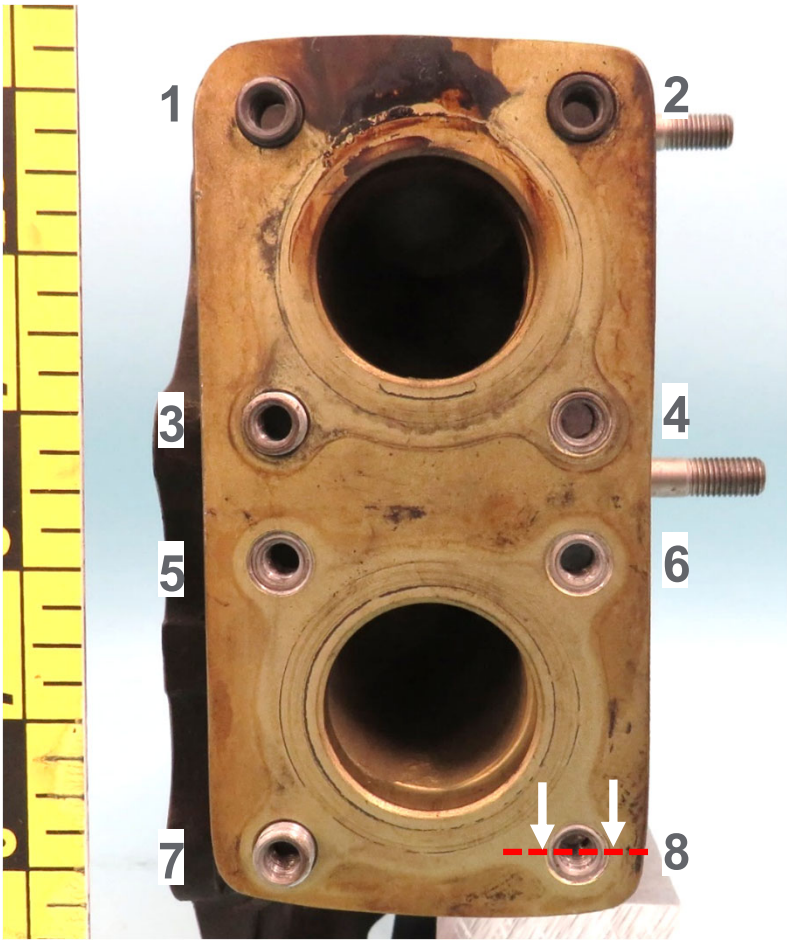
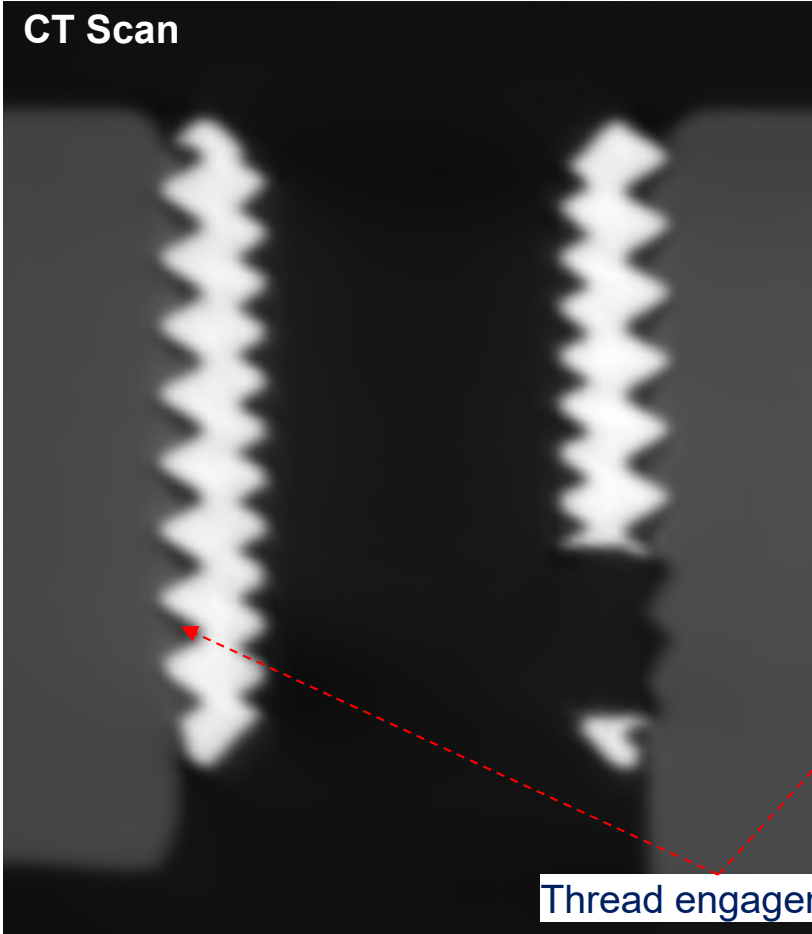
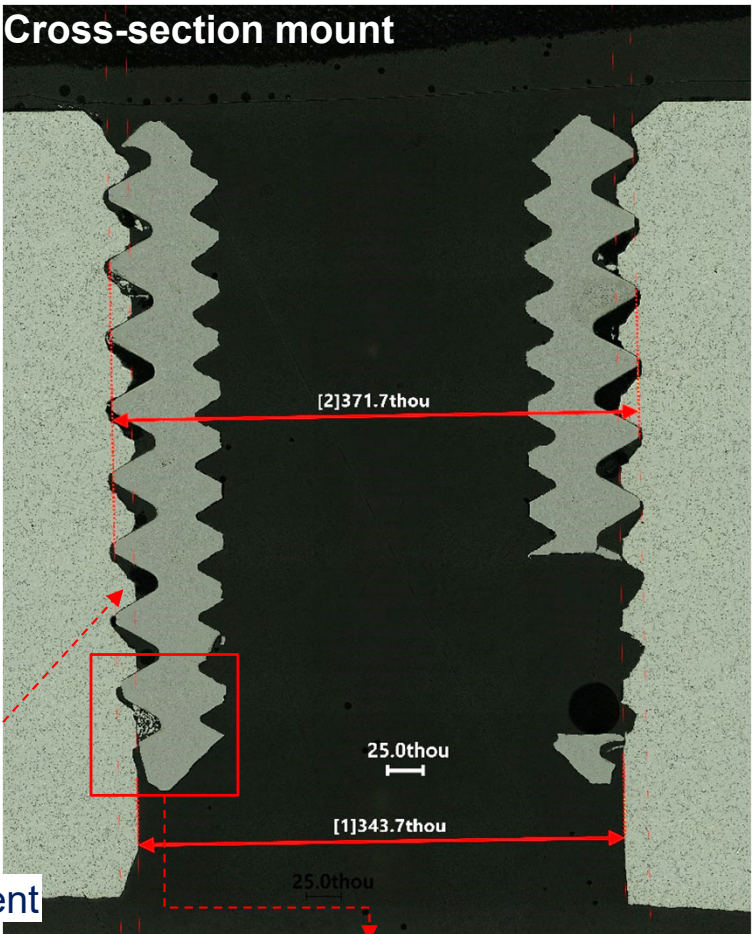
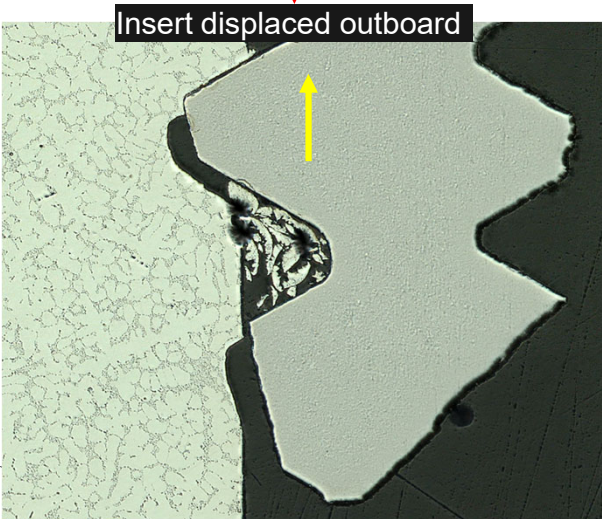
# Insert 8

**Figure 30:** Insert 8 cross-section mount views confirms the thread engagement observed in the CT scan. This insert passed the pull-out test. The cut threads in the aluminum flange are larger than the steel insert thread, however, evidence of a sheared lower thread and displacement of an insert thread into the adjacent aluminum thread (lower right image) is consistent with the insert moving outboard from the original cut position. It is unknown whether the outboard movement occurred at installation or during the post-flight pull-out test.
