# **Metallurgical Investigation Report**

## **DRB: AvEng-561264.A**

**EVALUATION OF A CF6-80C2 ESN 707-605 HMU IDLER  
ADAPTER FROM ESN 707-605 OPERATED BY FEDEX  
INVOLVED IN AN IN-FLIGHT SHUT-DOWN AND  
UNDERCOWL FIRE EVENT**

Part Number: 9395M78G10  
Part Serial Number: FIA217EE  
Part TSN / CSN: 1,421 hrs / 728 cycles

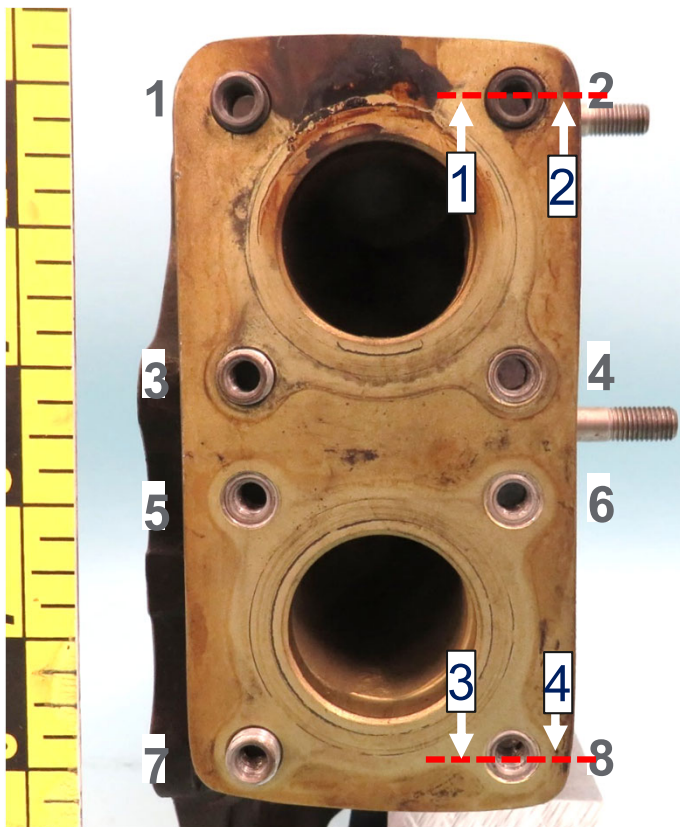
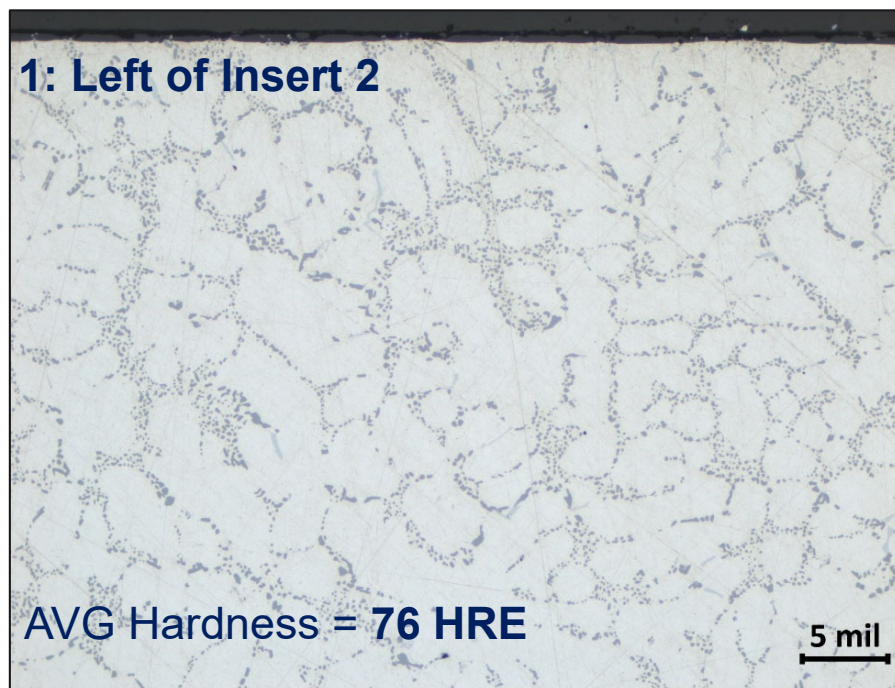
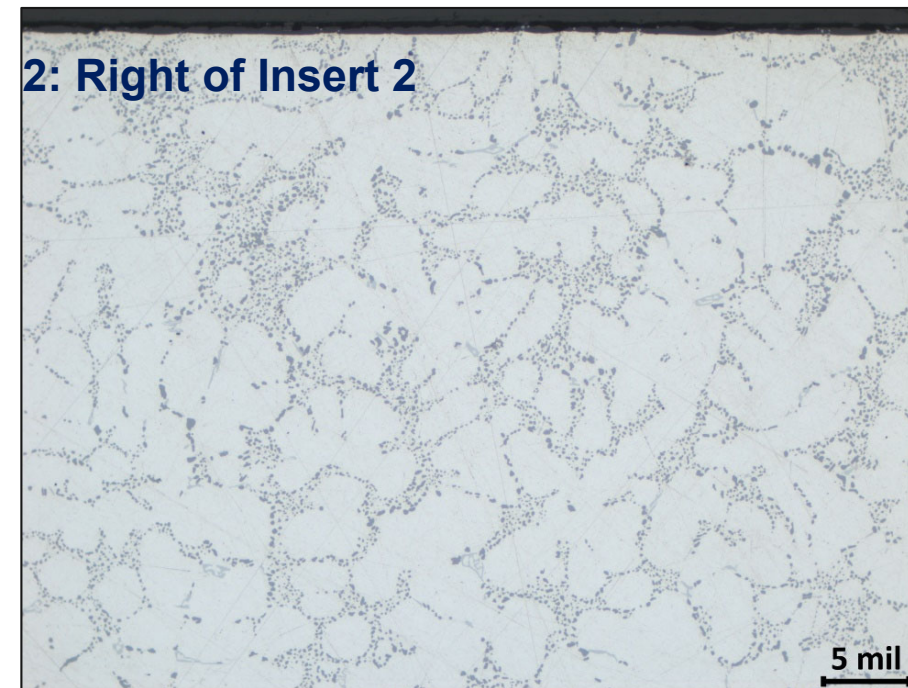
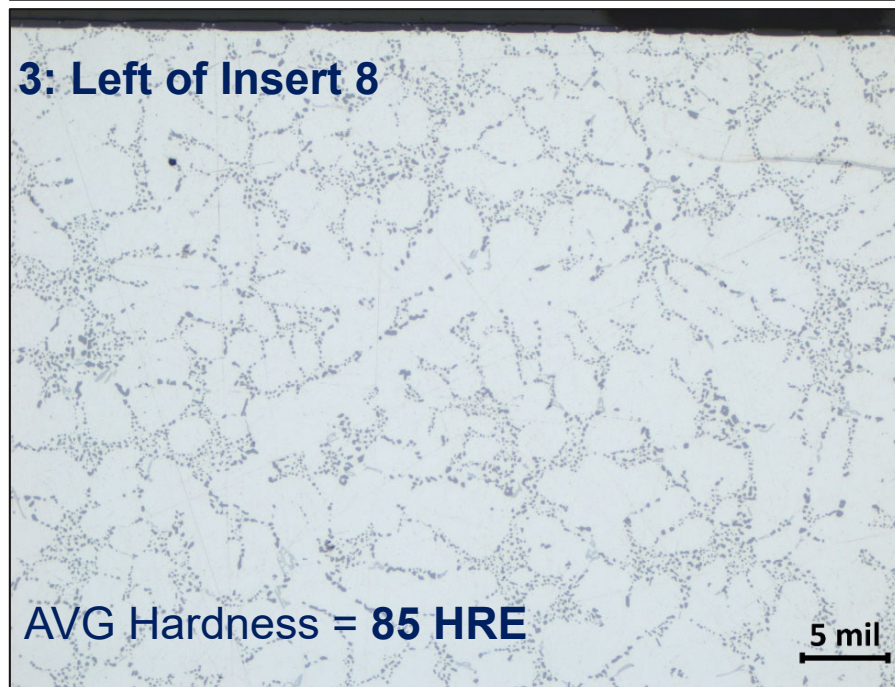
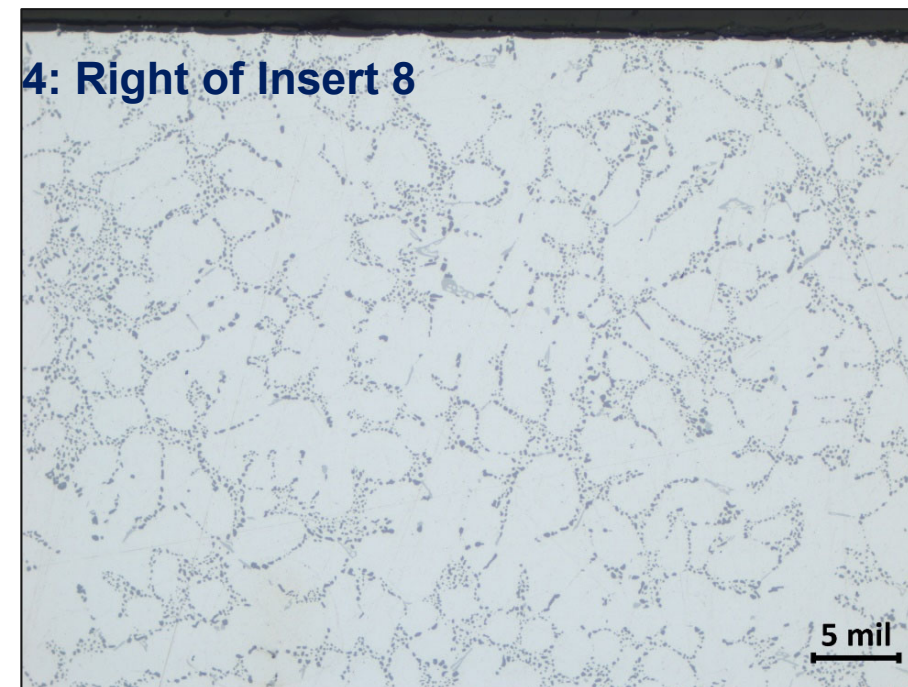
- Dimensional analysis of inserts 3 and 5 showed the lengths and diameters were conforming to the drawing (1518M34P02) (Figure 29).
- Cross-section images reveal a similar microstructure at the top of the flange near holes 2 and the bottom of the flange near hole 8. Hardness was measured to be 86 HRE near the bottom of the flange and decreases to 76 HRE at the top of the flange, consistent with softening due to overaging due to heat exposure from the fire (Figure 31).

**Figure 31:** Cross-section images reveal a similar microstructure near holes 2 and 8. Hardness is 76 HRE near the top of the flange and increases towards the bottom, consistent with aging due to heat exposure from the fire.

Hole 2 AVG Hardness: 76 HRE

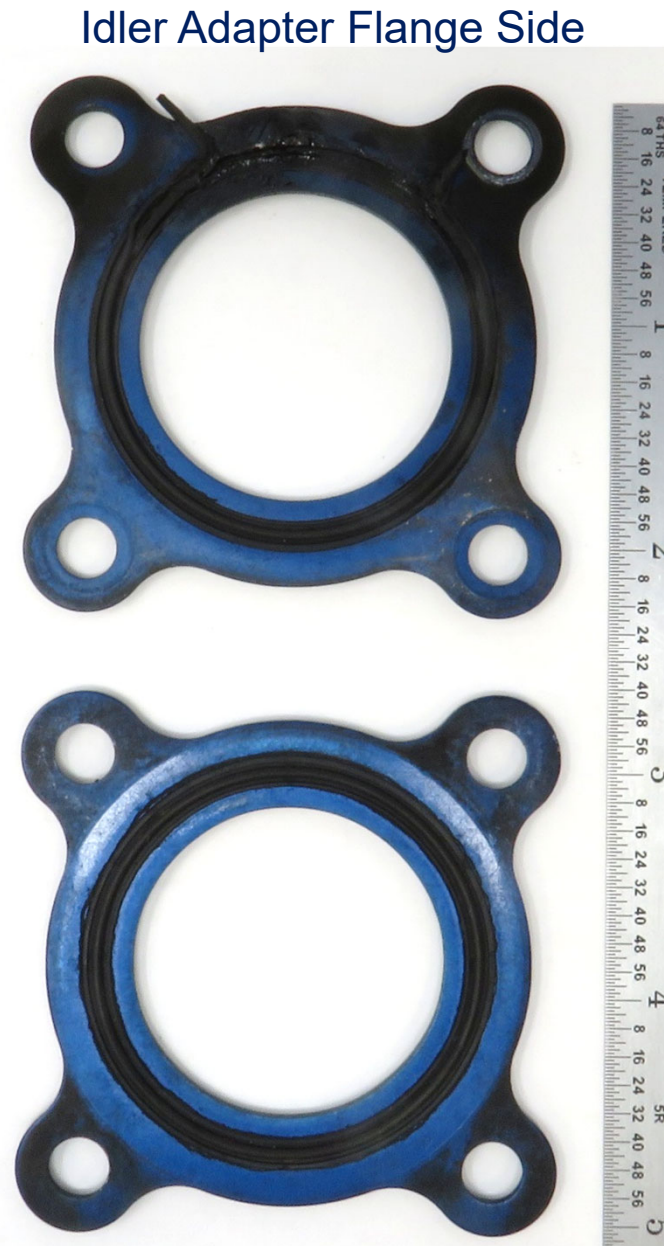
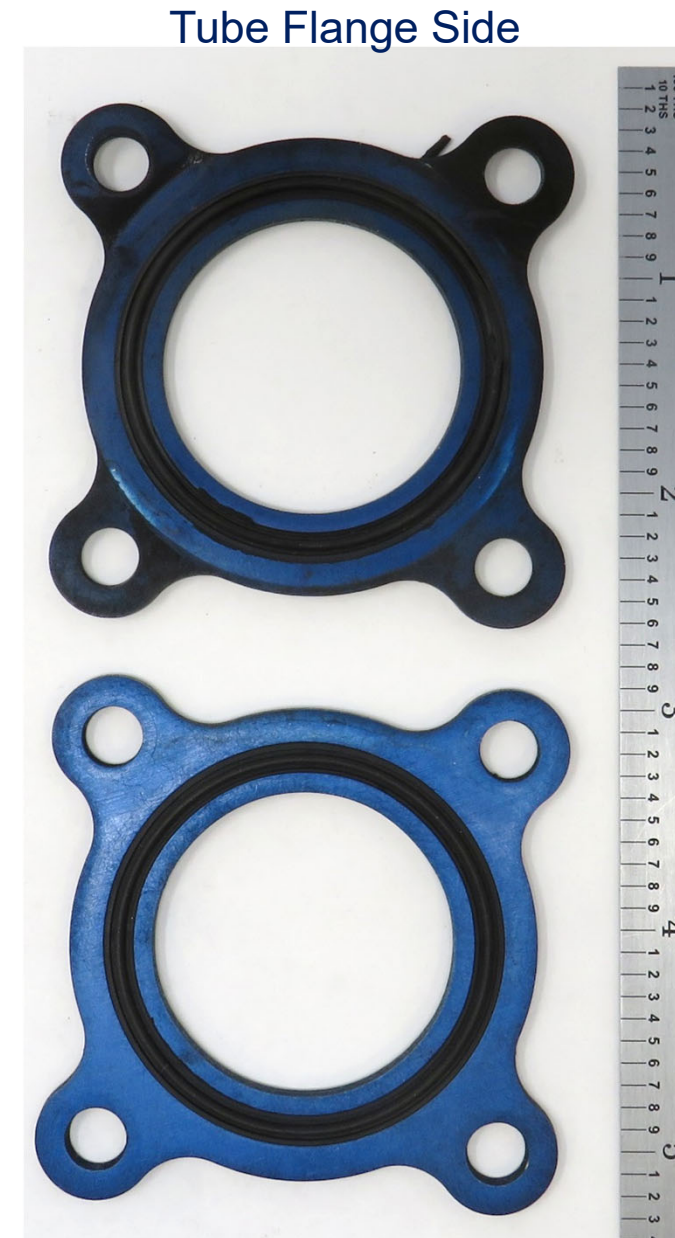
- Evaluation of the gasket seal found 70-degrees of the rubber seal at the 12:00 position was ruptured and approximately 150-degrees of the rubber seal was damaged (Figures 32-33). Impressions were found in the gasket seal retainer matched the shape and size of the protruding thread inserts (Figure 34). Blue light scans show the location 1 gasket seal retainer tab was deformed outboard approximately 0.062 – 0.069 inches and the location 2 tab was deformed approximately 0.012-inches (Figures 36-37). Two areas of the gasket seal retainer do not have black surface deposits, consistent with contacting the tube flange at these areas during the fire. The retainer surface that mates with the tube ferrule is relatively flat and has a circular impression, consistent with being clamped between the idler adapter flange and tube ferrule surfaces when the insert 1 gasket tab location deformed (Figure 35). The tube ferrule/flange average measured distance (gap) was 0.044-inches. Subtracting the measured 0.044-inch gap from the max 0.069-inches of gasket seal retainer deformation gives 0.025-inches of gap that would reduce the compression of the rubber seal. This is an approximate value; the actual leak gap was not measured prior to disassembly (Figure 38).

**Figure 32:** Optical views of the gasket seals as-received by the FA lab.

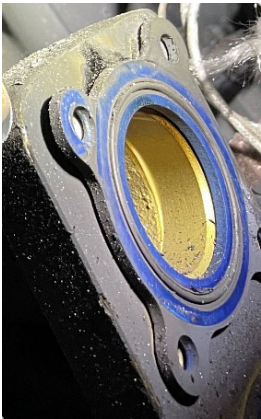
**Figure 33:** Images of the top gasket seal as-received by the FA lab. The retainer at the thread insert location1 is deformed outboard relative to the idler adapter flange surface. The thread insert was found protruding from the flange at this surface.

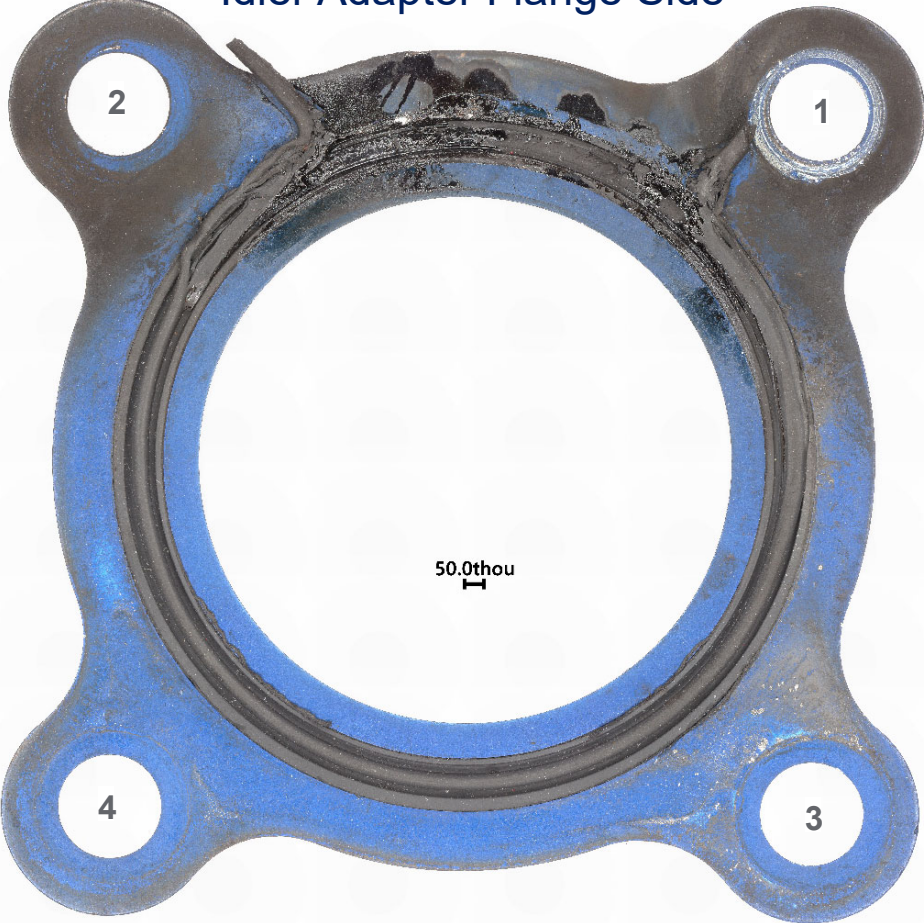
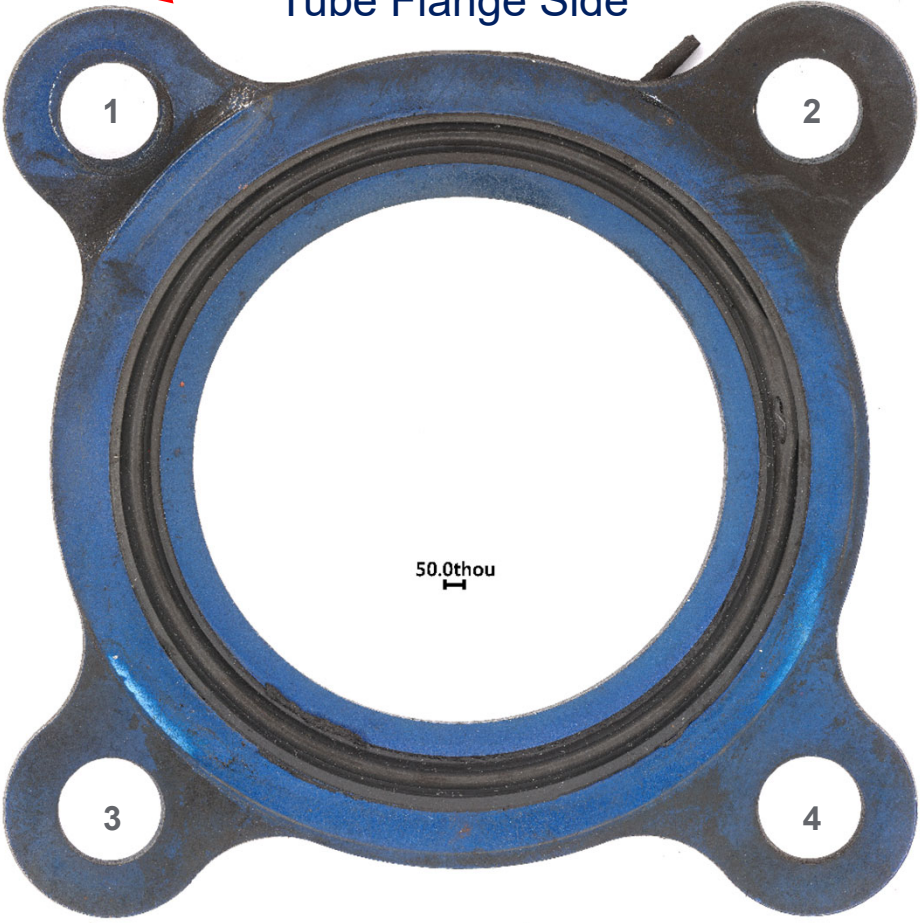
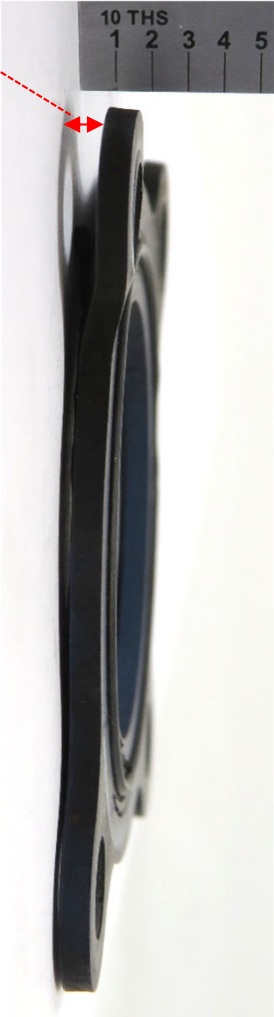
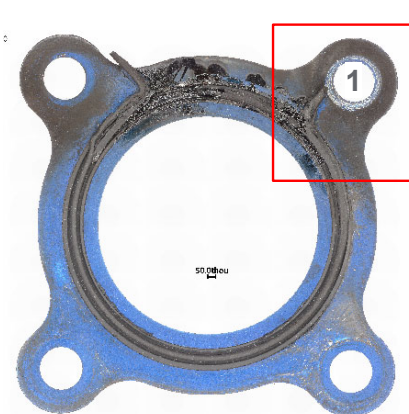
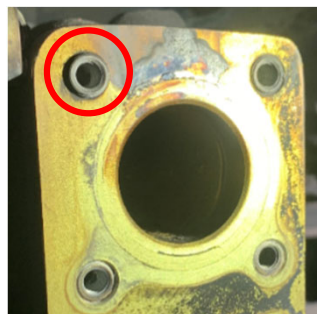
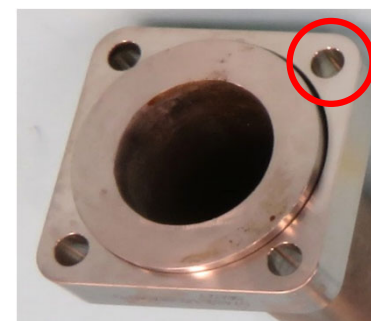
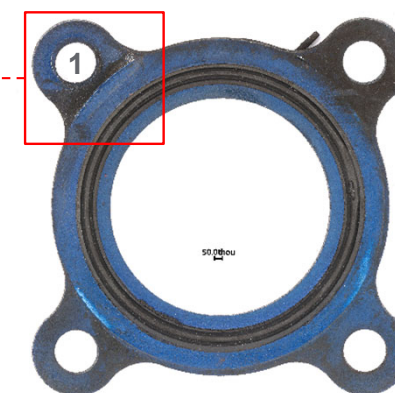
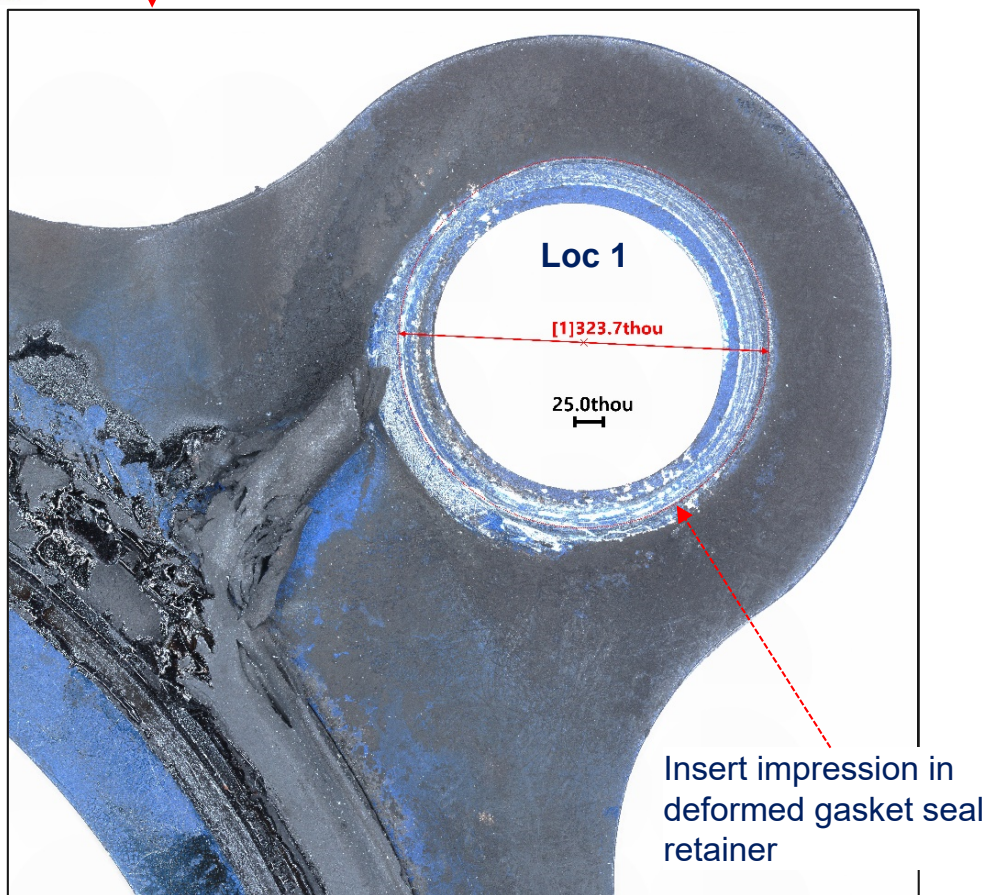
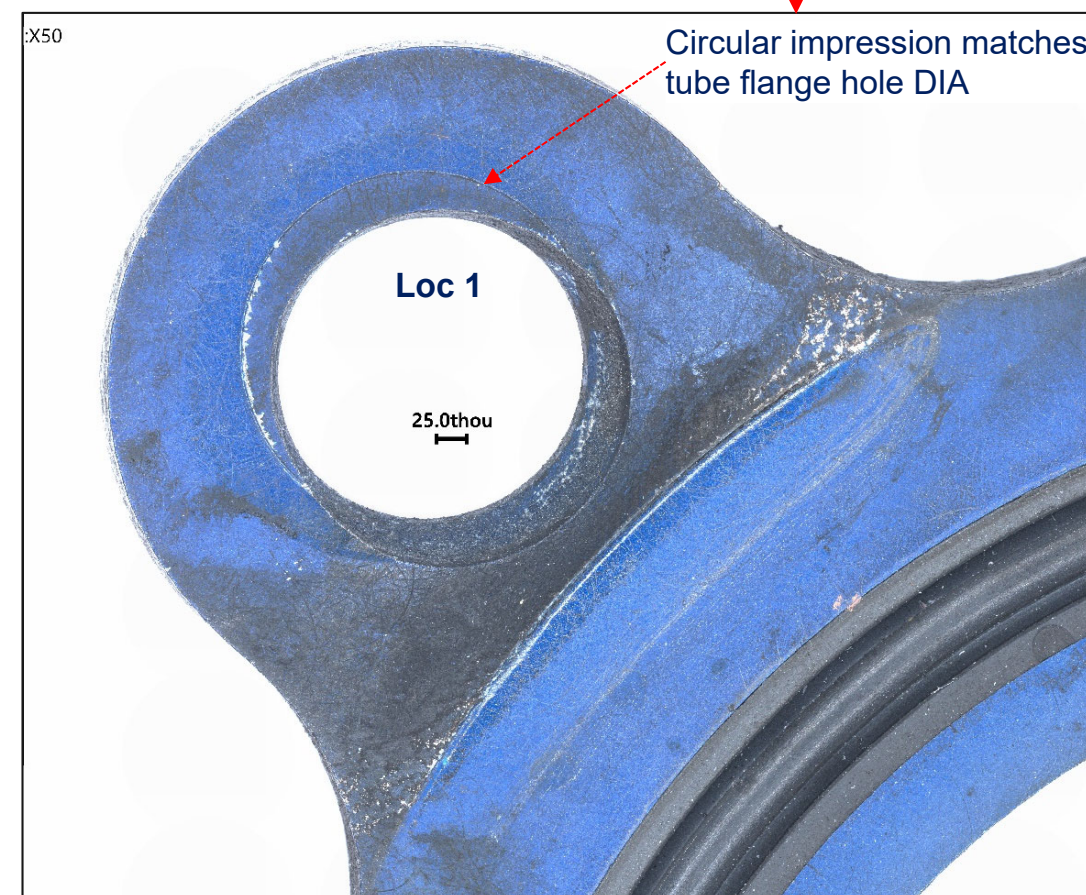
Deformed retainer flange

**Figure 34:** Images of the top gasket seal reveals an impression matching the shape and size of the thread insert at location 1, where the insert was found protruding from the flange (left). A circular impression observed on the tube flange side of the gasket is consistent with the tab contacting the tube flange after deforming outboard (right).

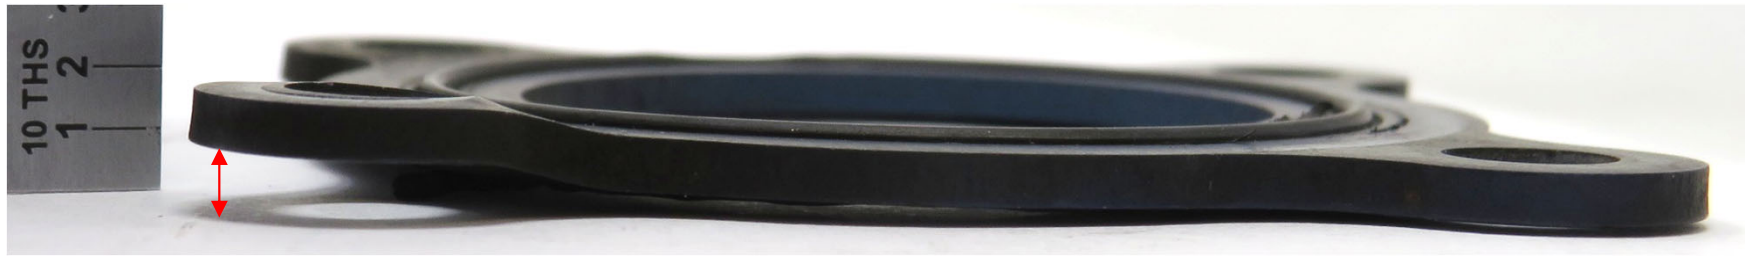
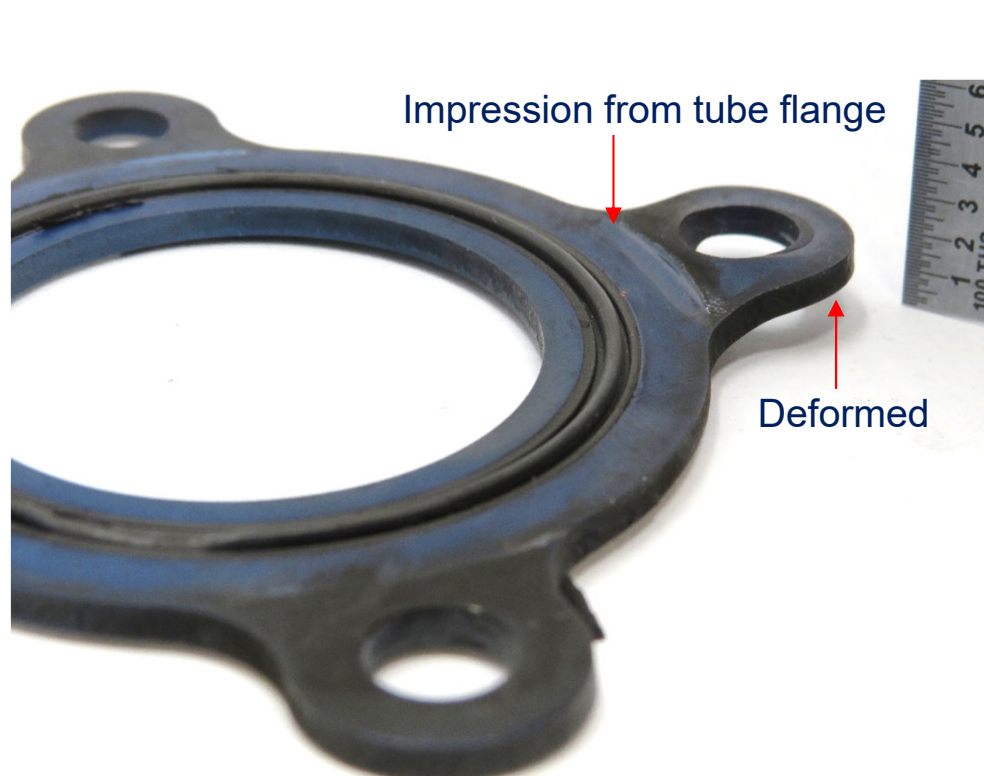
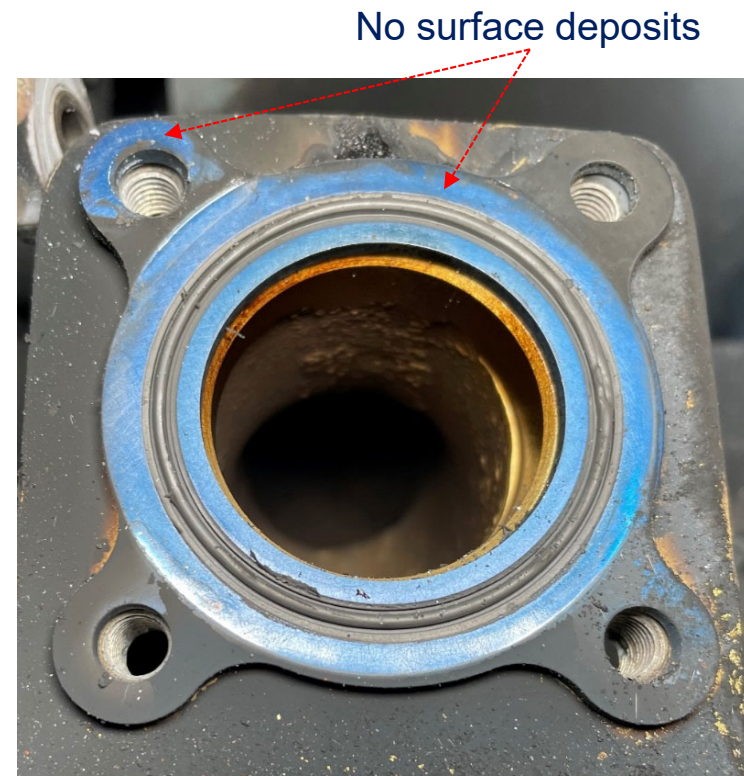
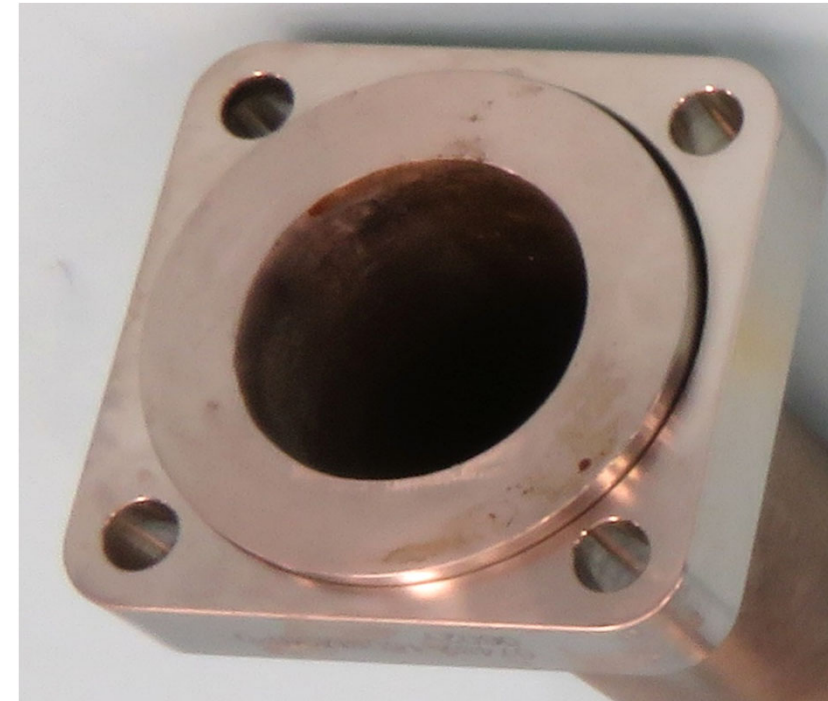
**Figure 35:** Two areas of the gasket seal retainer do not have black surface deposits, consistent with contacting the tube flange at these areas during the fire. The retainer surface that mates with the tube ferrule is relatively flat and has a circular impression, consistent with being clamped between the idler adapter flange and tube ferrule surfaces when the insert 1 gasket tab location deformed.

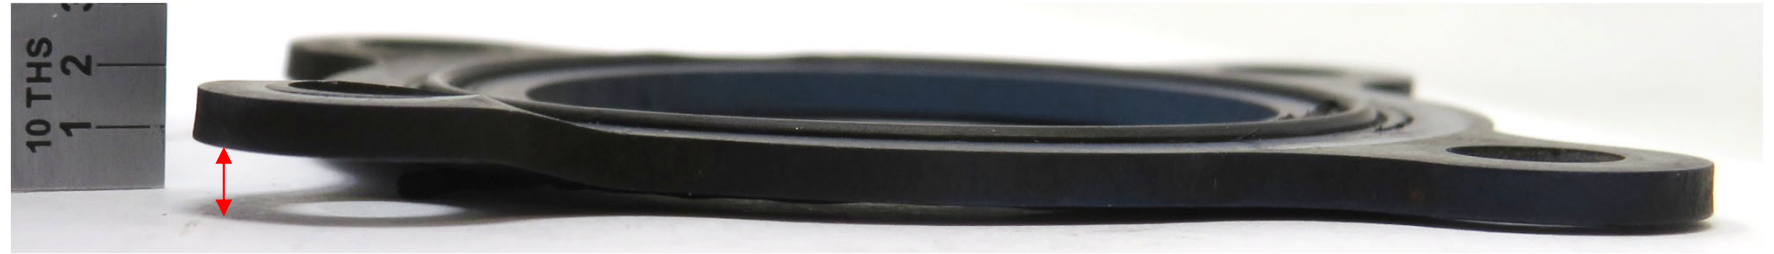
**Figure 36:** Blue light scan measurements of the top gasket seal reveals a 0.062 – 0.069 inches of deformation in the location 1 retainer flange.

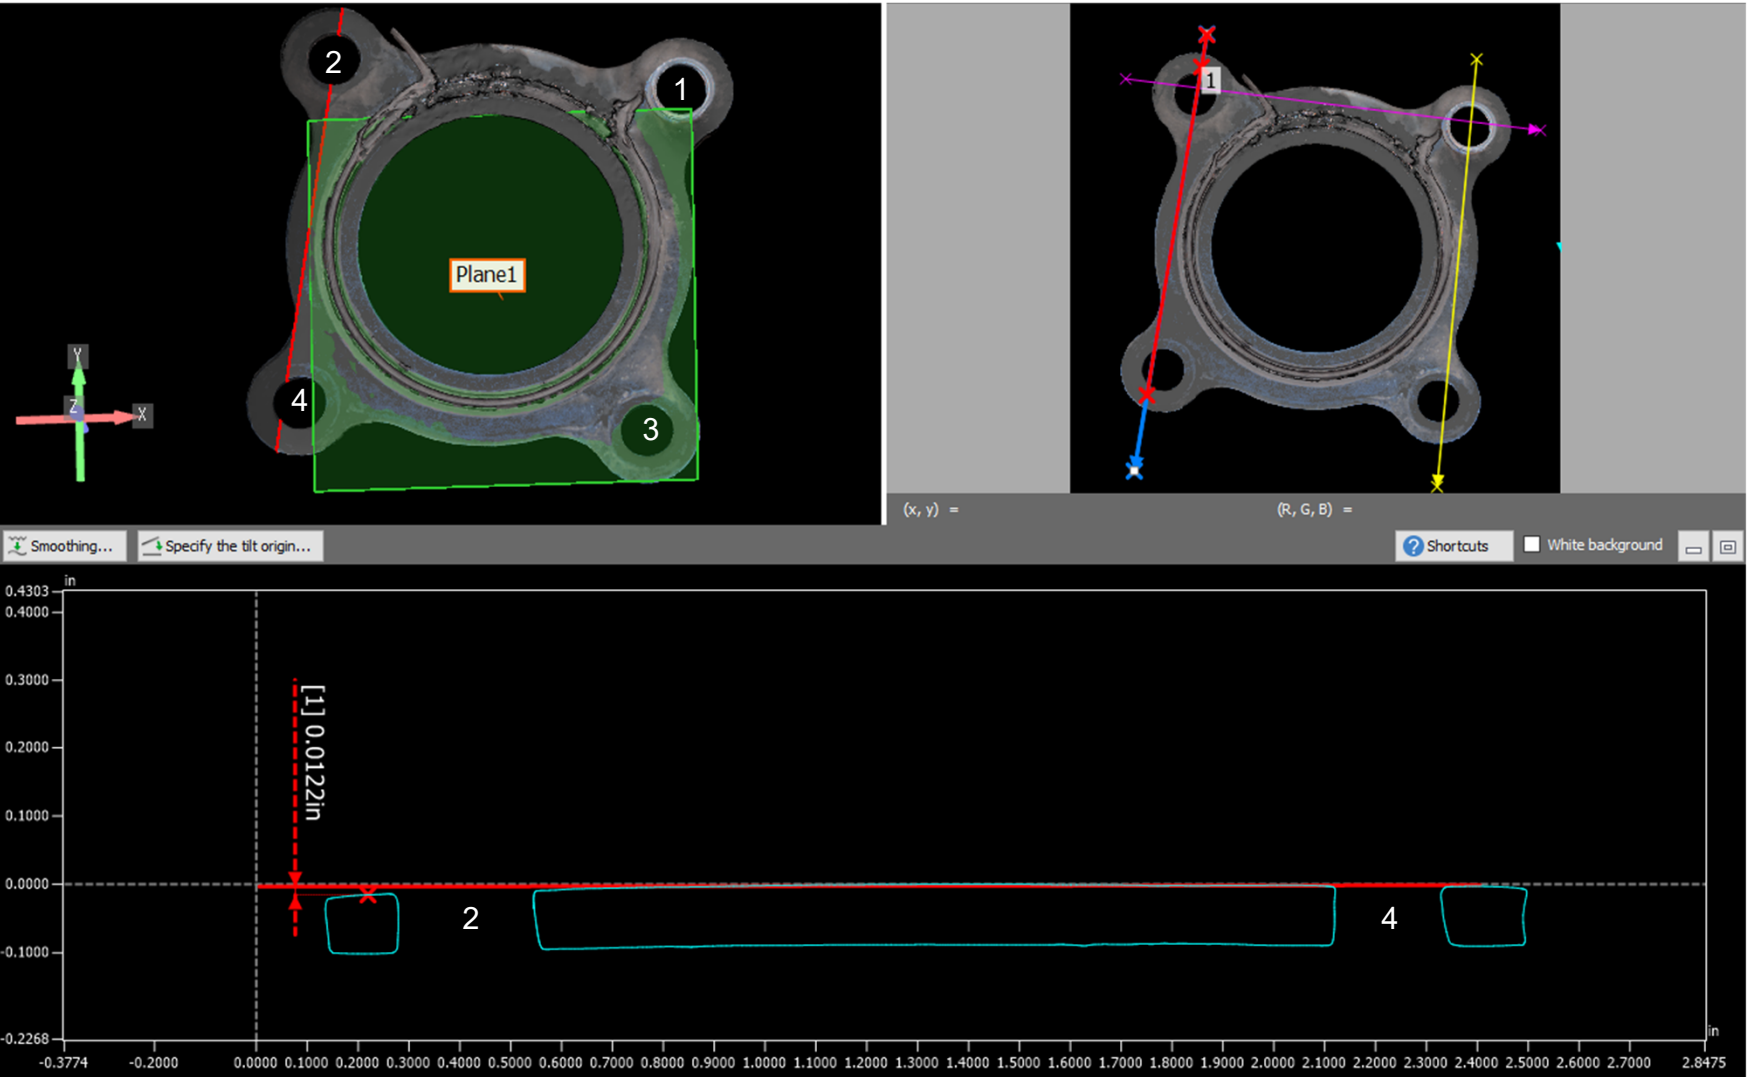
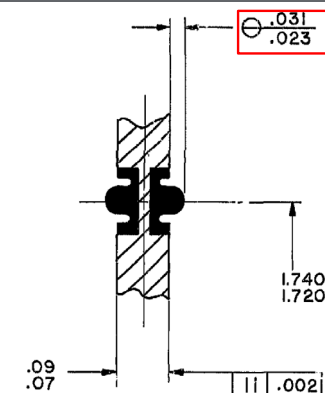
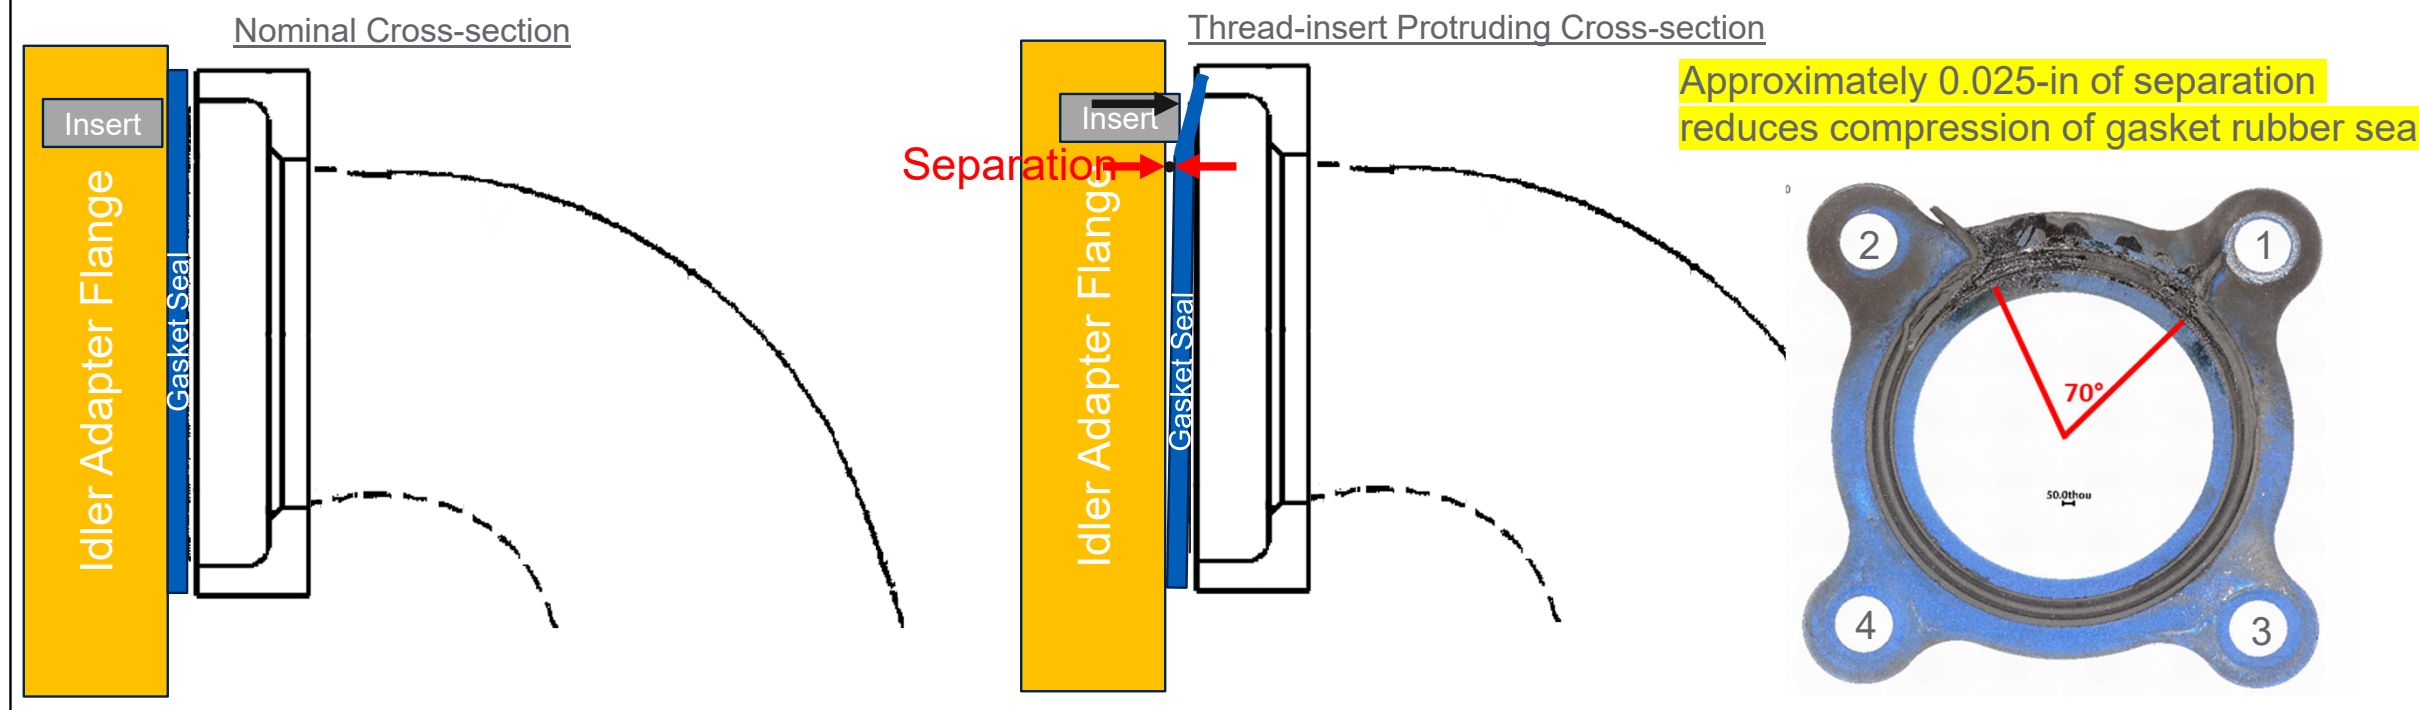
Seal retainer deformation = 0.069 in

Tube ferrule/flare AVG measured distance (gap) = 0.044 in

Approximate Idler Adapter Flange/Gasket Seal Retainer Separation = 0.069 in - 0.044 in = 0.025 in

Approximately 0.025-in of separation reduces compression of gasket rubber seal

**Figure 38:** Approximate flange separation calculation based on the average measured 0.044in tube ferrule-to-flange distance and the measured gasket seal retainer deformation.

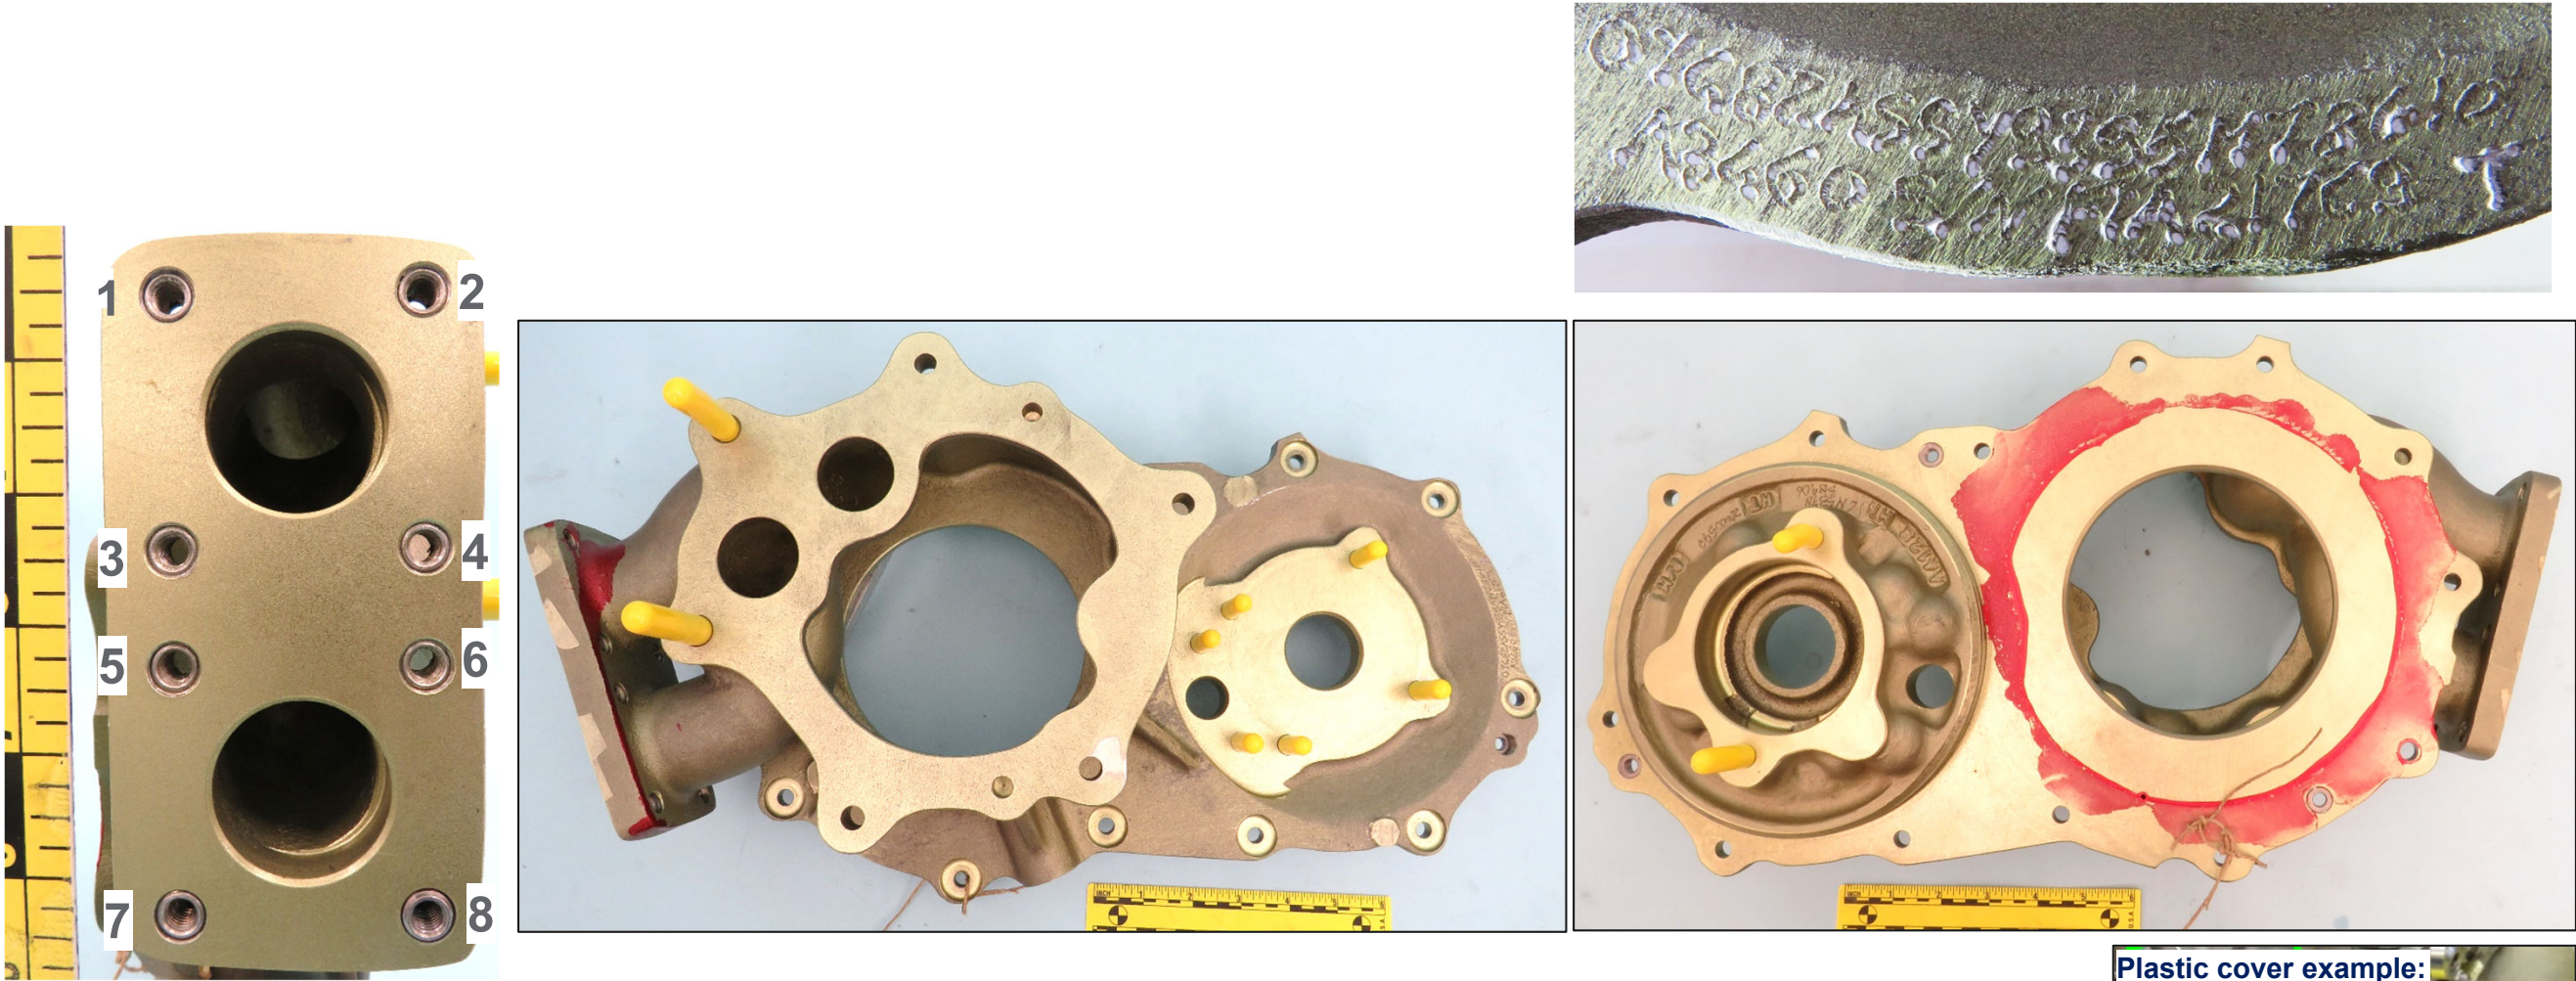
**Figure 40:** Images of a HMU idler adapter (P/N 9395M78G10, S/N FIA217C9) which was manufactured at Avio the same day as the ESN 707-605 event idler adapter (S/N F1A217EE). S/N FIA217C9 was returned to the manufacturer (Avio) from the Durham engine assembly facility. A protective plastic cover is attached to the flange at new make using two aluminum bolts which can be placed in insert locations 1, 2, 7, or 8 and removed during engine assembly (example image shown on the right). Reportedly, the thread insert labeled number 8 backed out while removing the plastic cover bolts during engine assembly at the Durham facility.

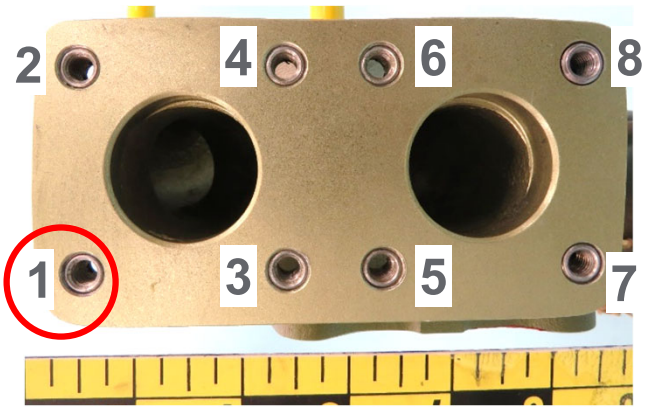
Insert 1

Figure 42: CT scan cross-section of thread insert position 1. Thread engagement is observed into the flange material.

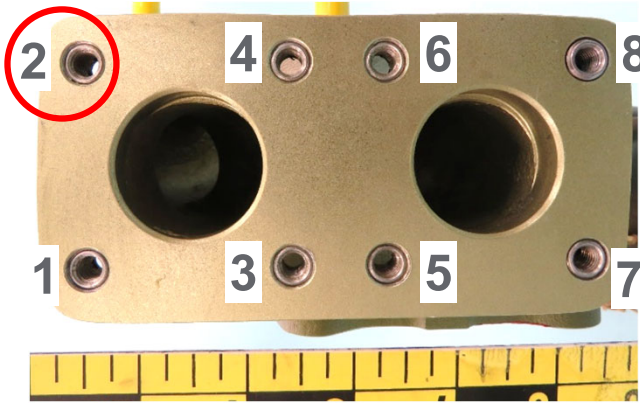
Insert 2

**Figure 43:** CT scan cross-section of thread insert position 2. Thread engagement is observed into the flange material.

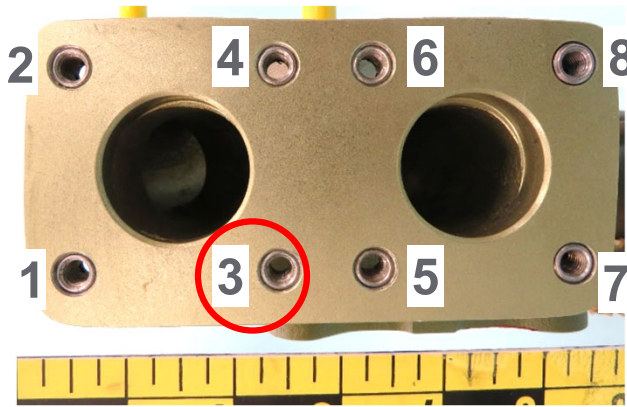
Insert 3

**Figure 44:** CT scan cross-section of thread insert position 3. No engagement is observed into the flange material on one side of the hole.

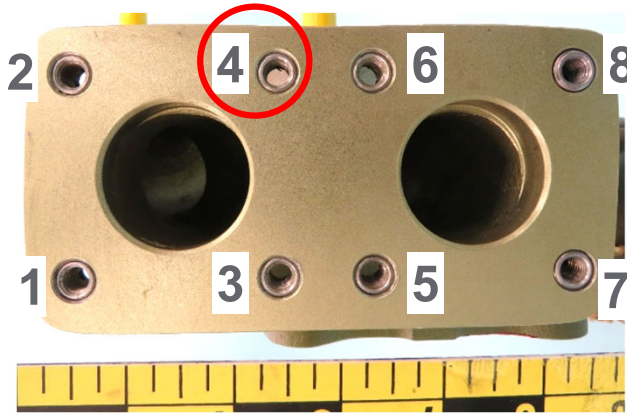
Insert 4

Figure 45: CT scan cross-section of thread insert position 4. Thread engagement is observed into the flange material.

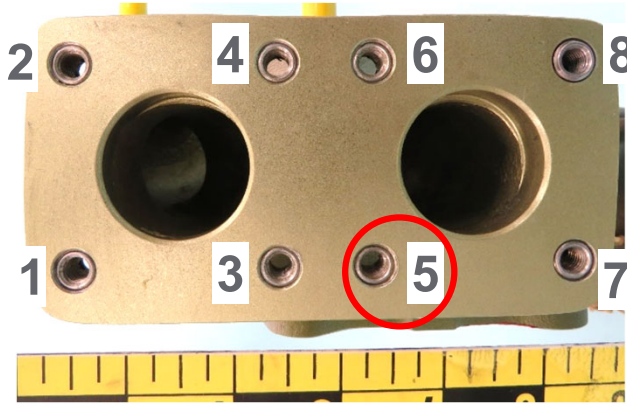
Insert 5

**Figure 46:** CT scan cross-section of thread insert position 5. Thread engagement is observed into the flange material.

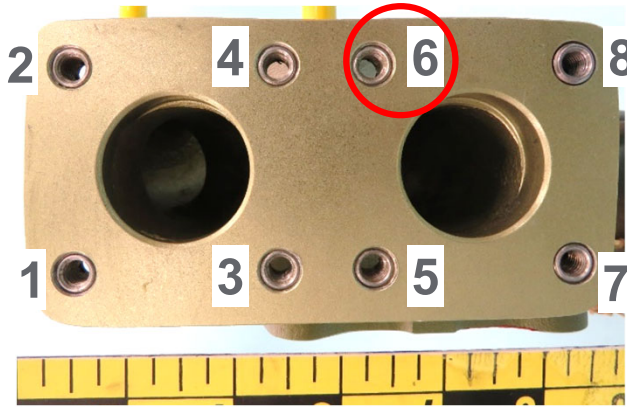
Insert 6

**Figure 47:** CT scan cross-section of thread insert position 6. Thread engagement is observed into the flange material.

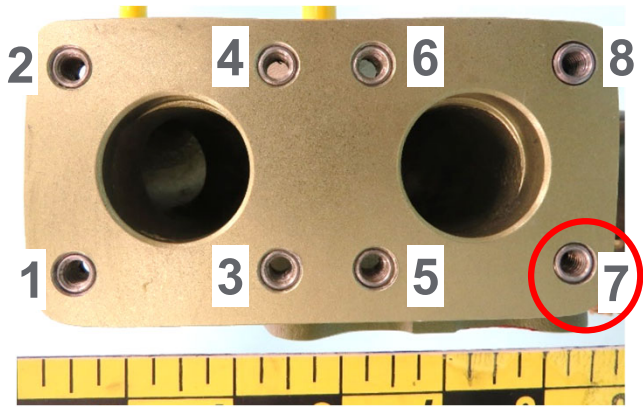
Insert 7

Figure 48: CT scan cross-section of thread insert position 7. Thread engagement is observed into the flange material.

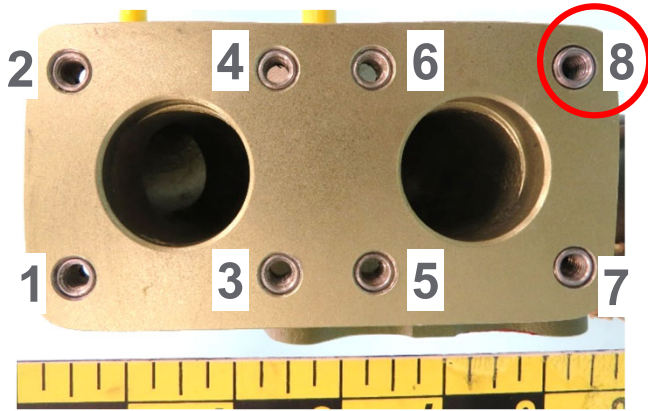
Insert 8

**Figure 49:** CT scan cross-section of thread insert position 8. Thread engagement is observed into the flange material.
