# **Metallurgical Investigation Report**

## **DRB: AvEng-561264.A**

**EVALUATION OF A CF6-80C2 ESN 707-605 HMU IDLER  
ADAPTER FROM ESN 707-605 OPERATED BY FEDEX  
INVOLVED IN AN IN-FLIGHT SHUT-DOWN AND  
UNDERCOWL FIRE EVENT**

Part Number: 9395M78G10  
Part Serial Number: FIA217EE  
Part TSN / CSN: 1,421 hrs / 728 cycles

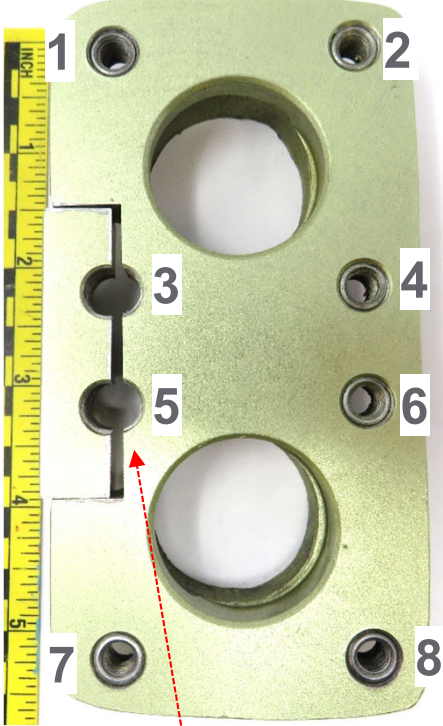
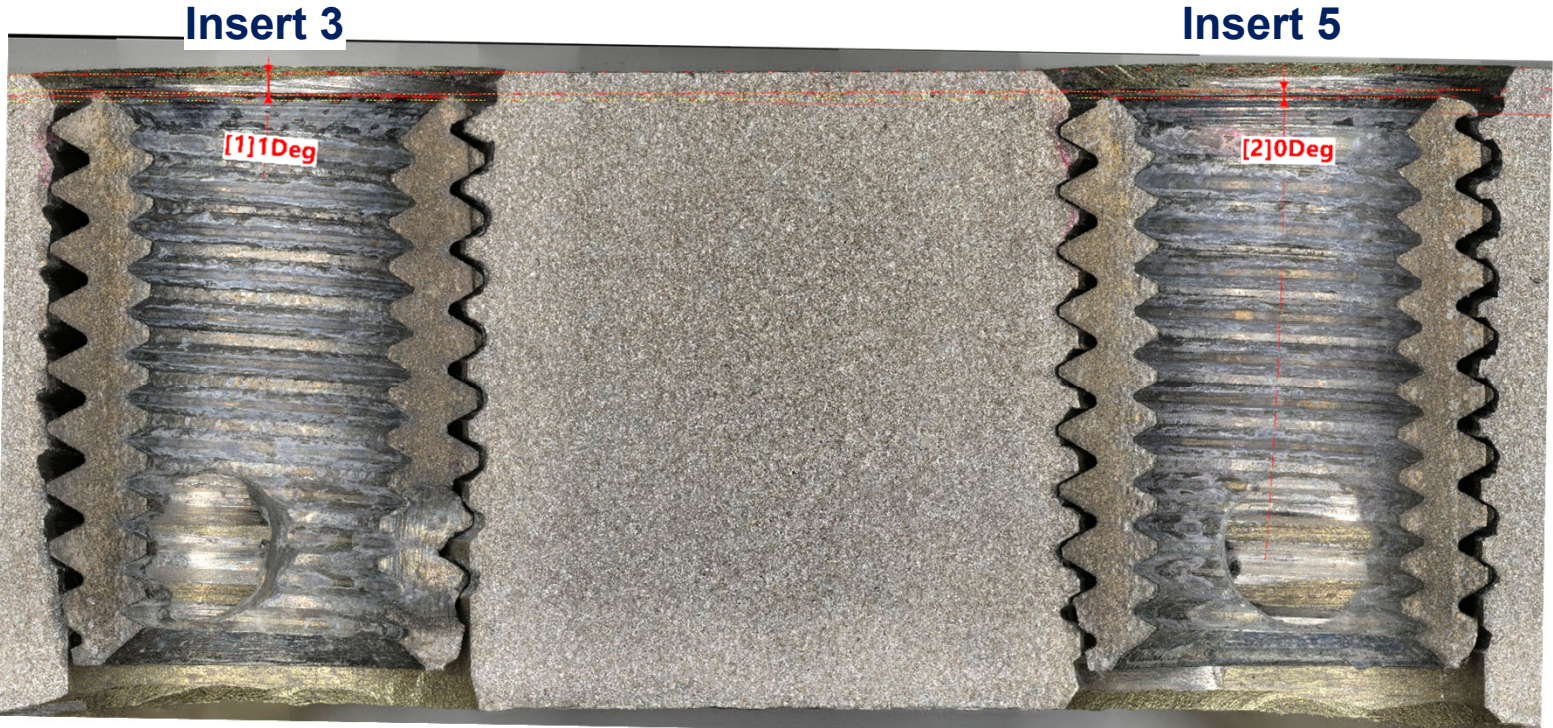
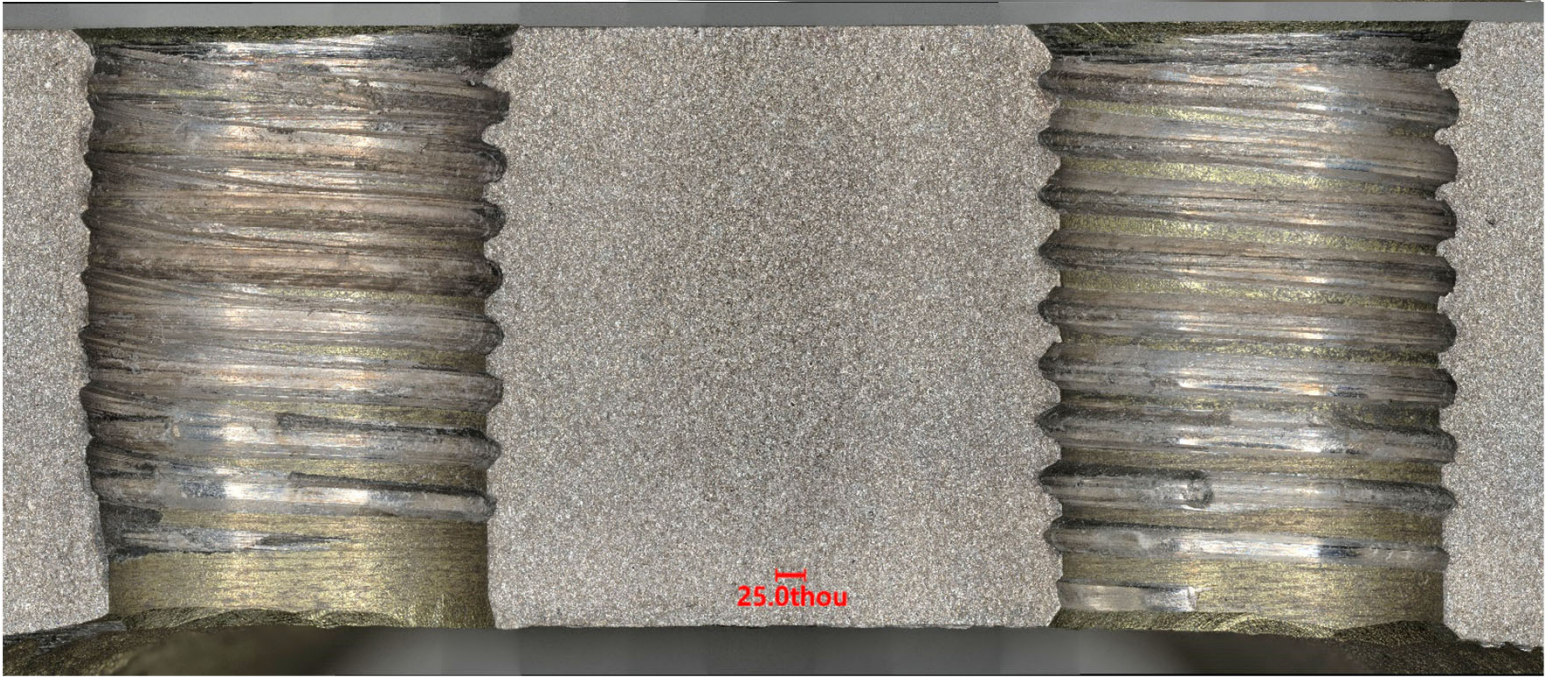
SN FIA217C9

**Figure 50:** Optical views of insert locations 3 and 5 with the inserts in place (top) and removed (bottom). Insert 3 is rotated approximately 1-degrees from the flange surface, consistent with being installed at an angle. Insert 5 is perpendicular to the flange surface.

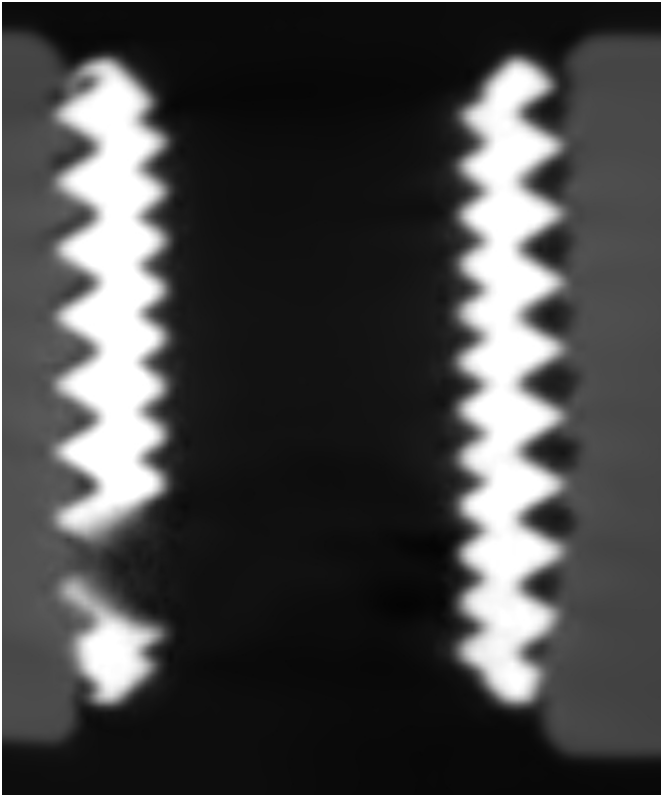
**Figure 51:** Optical views of insert location 3 reveals angled cut threads consistent with cross-threading. One side of the hole has a concave profile and is missing threads, while the opposite side of the hole is straight with some threads intact, consistent with the insert being installed at an angle and cutting through the pre-tapped threads.

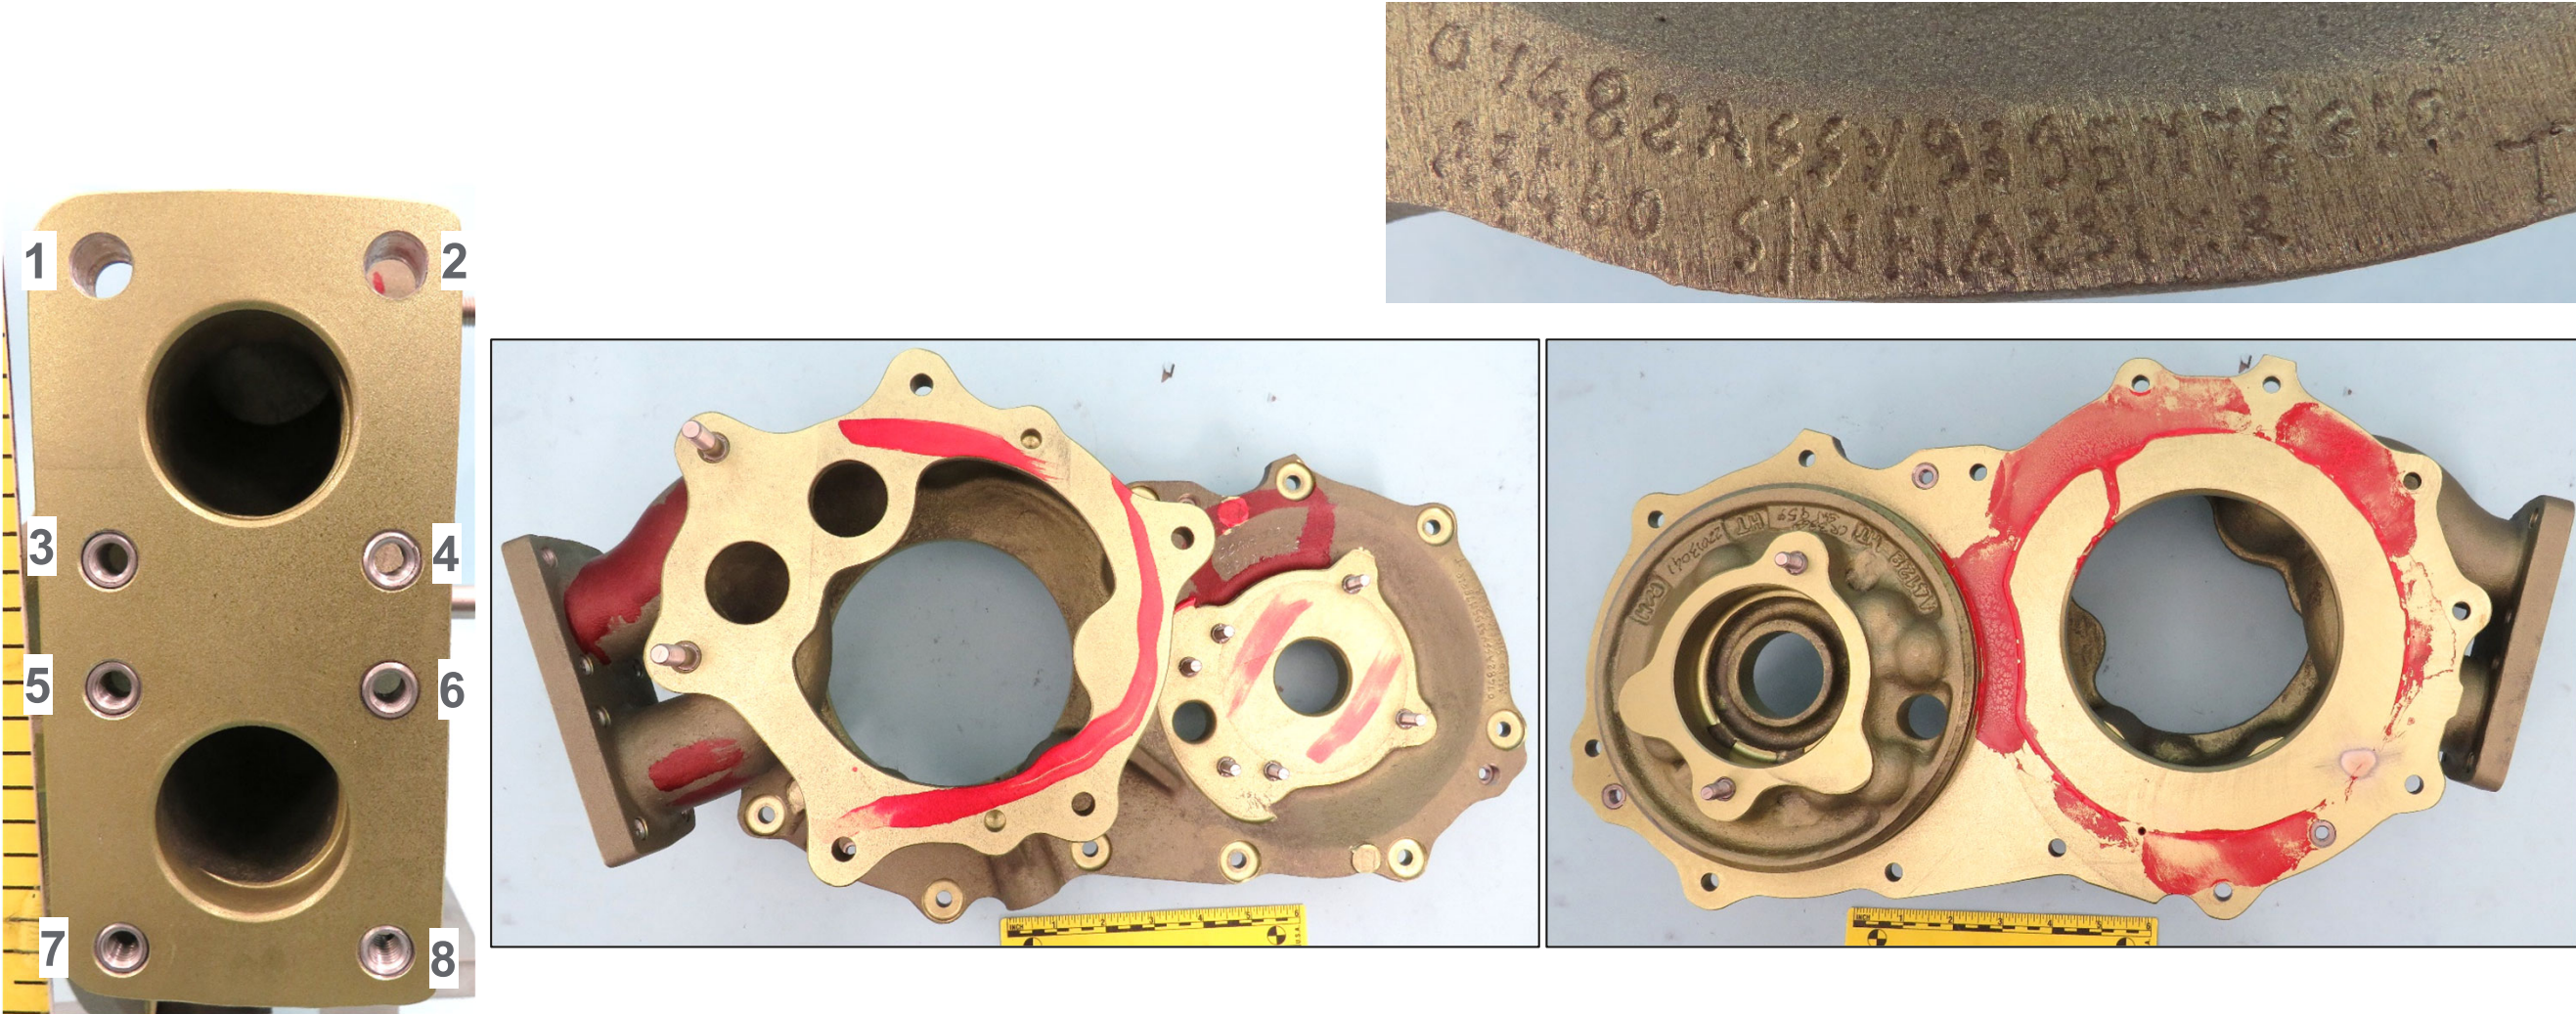
**Figure 53:** Images of a HMU idler adapter (P/N 9395M78G10, S/N FIA231MR) which was manufactured at Avio. The part was returned to the manufacturer (Avio) from the Durham engine assembly facility.

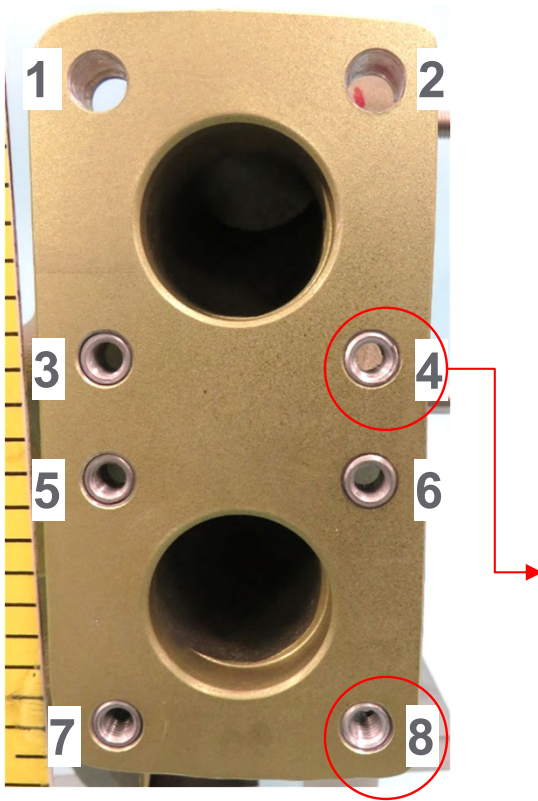
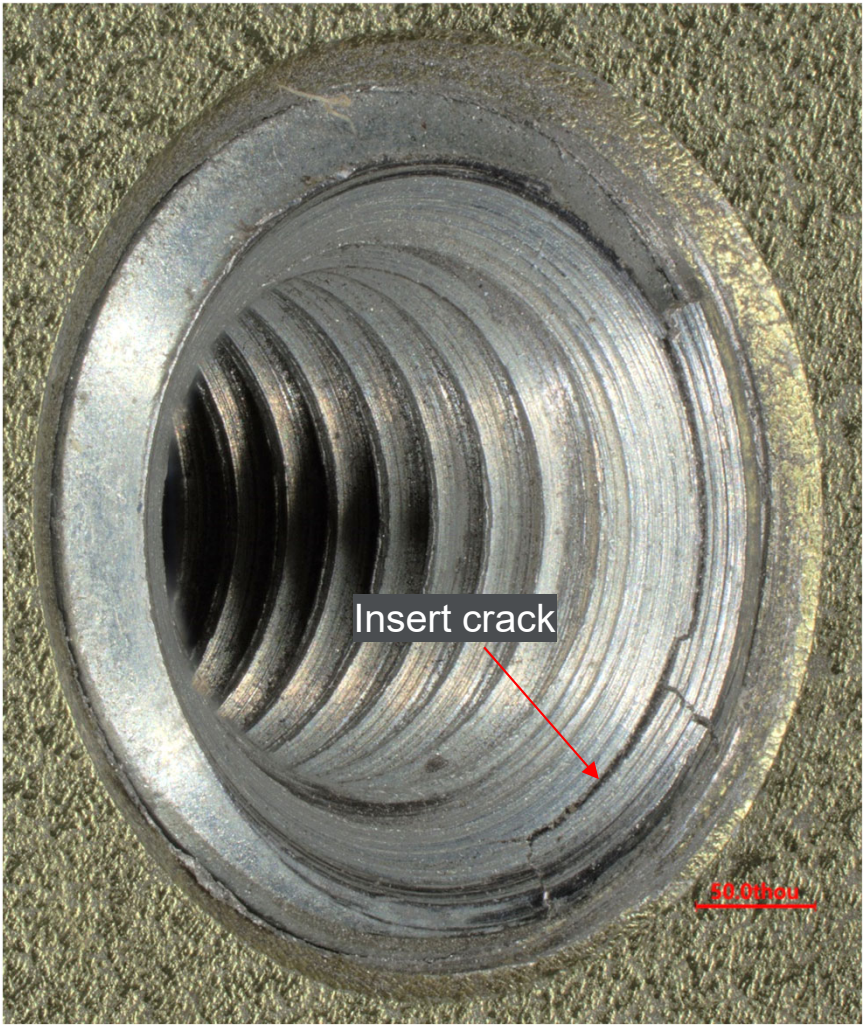
**Figure 54:** Insert locations 1 and 2 were removed prior to arriving to the FA lab. Insert number 6 was found protruding from the flange surface.

**Figure 55:** Insert locations 4 and 8 have cracked top threads as shown above.

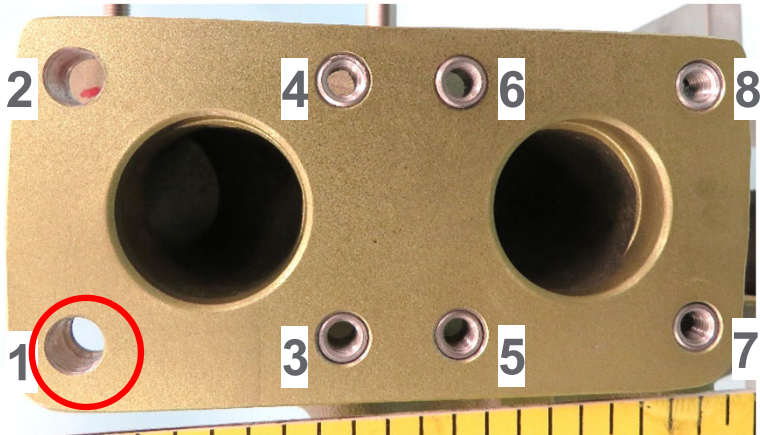
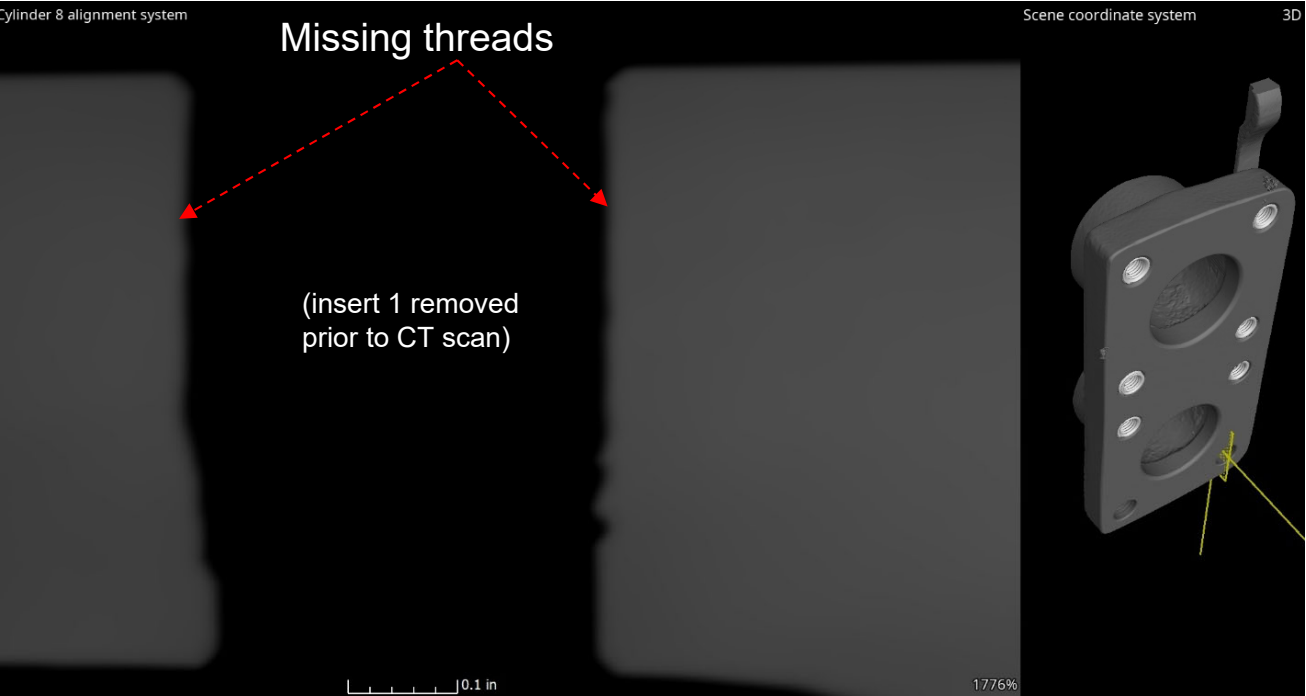
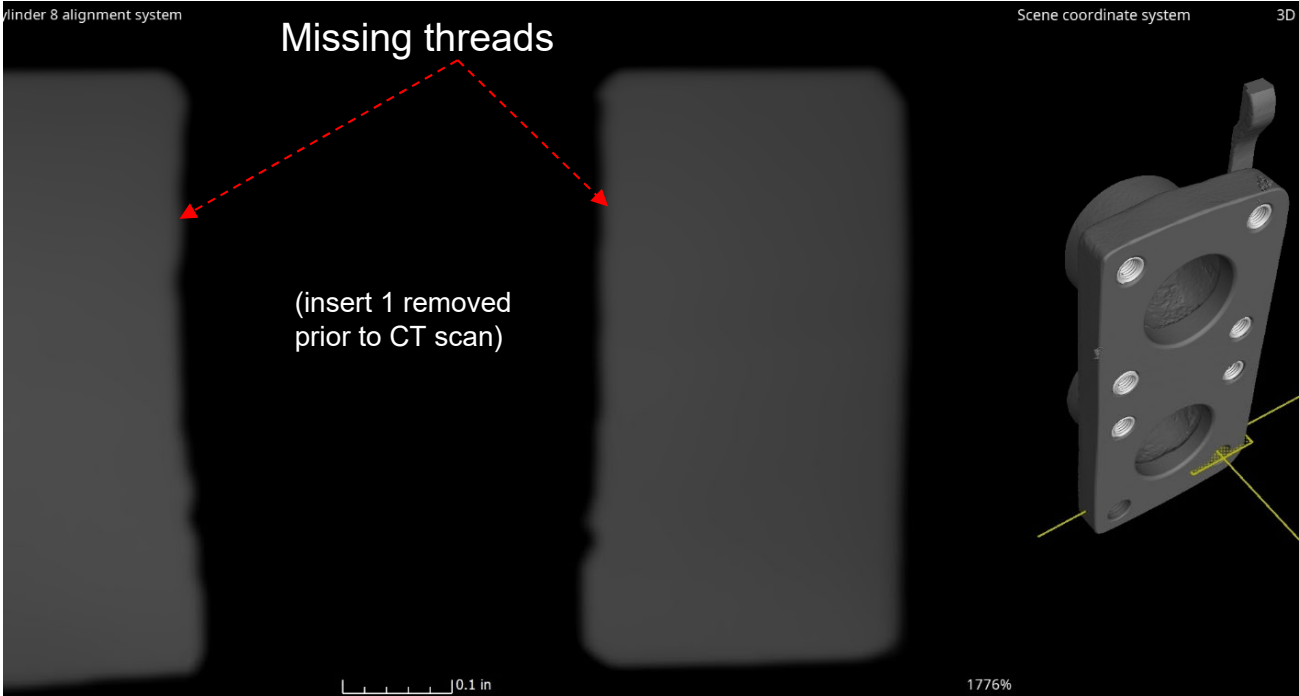
Insert 1

**Figure 56:** CT scan cross-section of thread insert position 1. The pre-tapped internal threads are missing. No thread engagement is observed into the flange material.

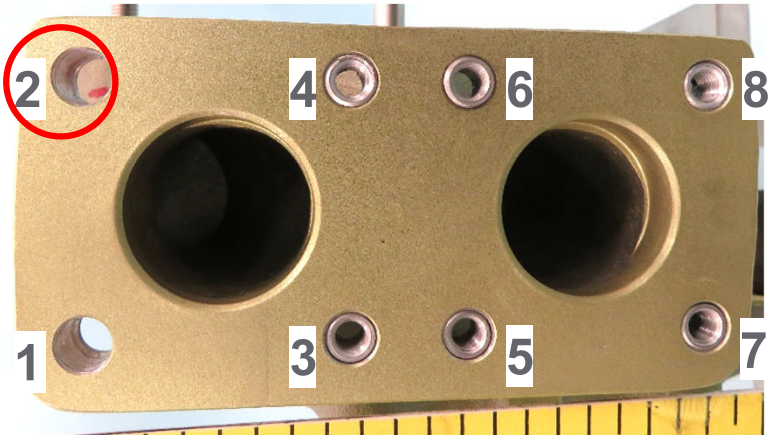
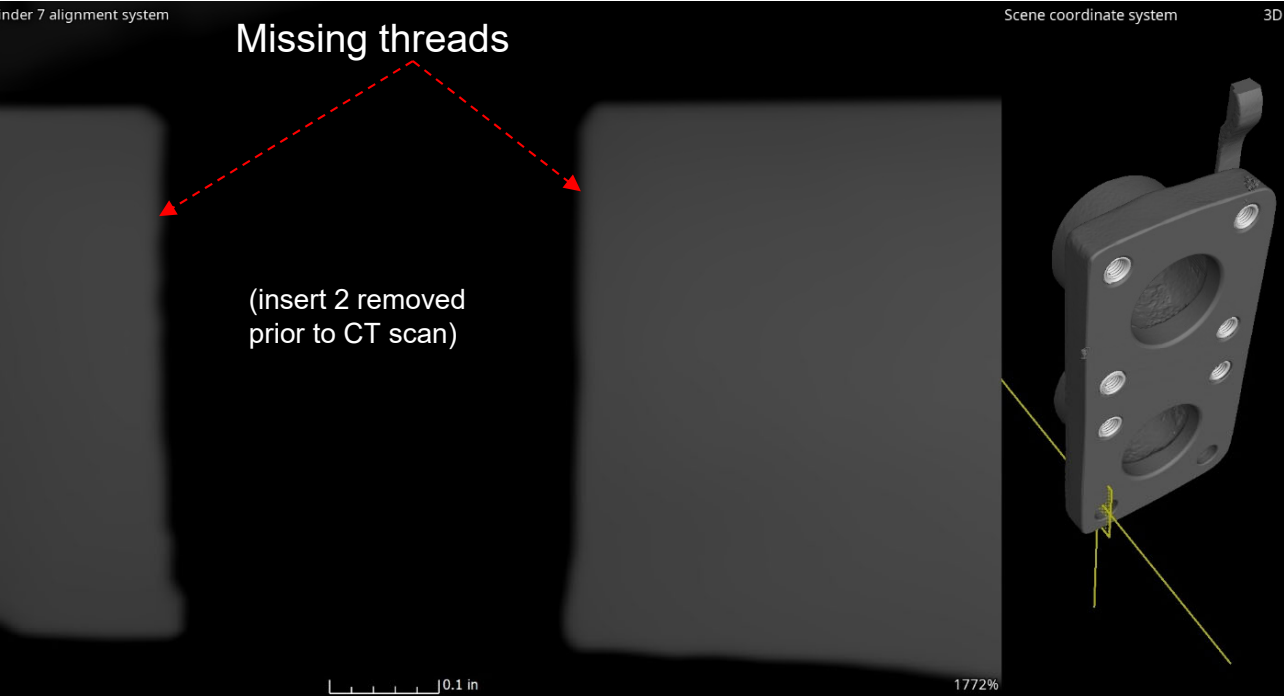
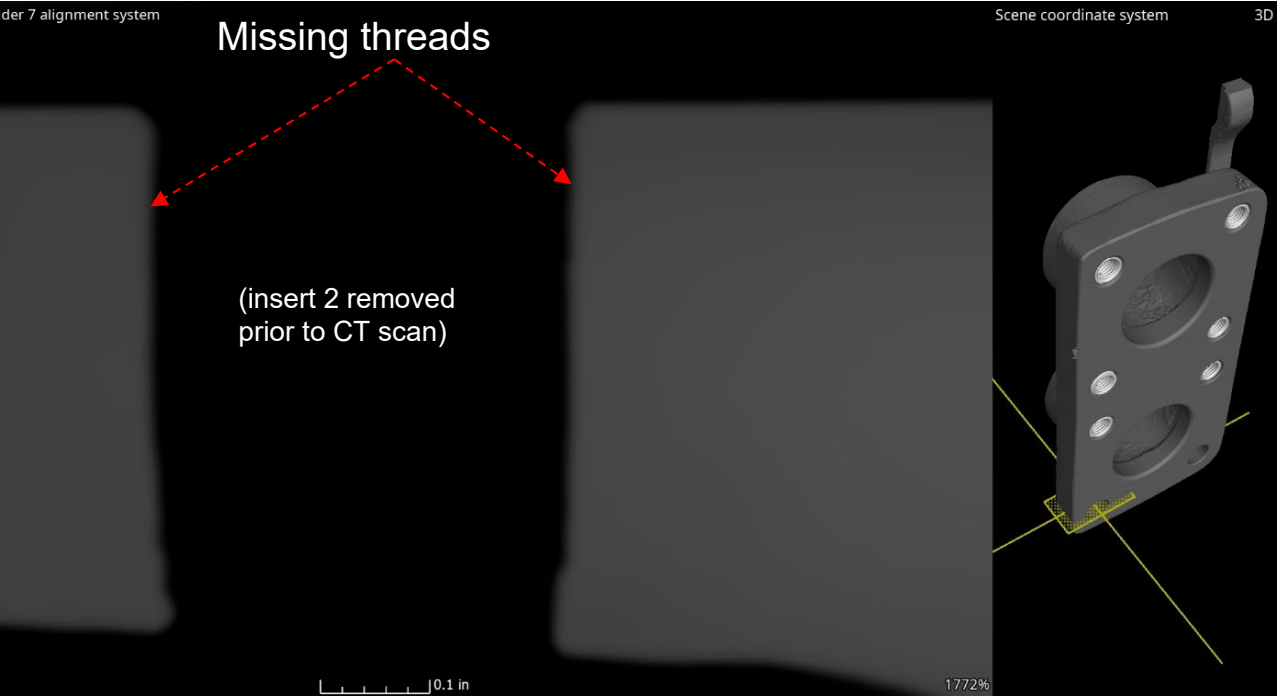
Insert 2

**Figure 57:** CT scan cross-section of thread insert position 2. The pre-tapped internal threads are missing. No thread engagement is observed into the flange material.

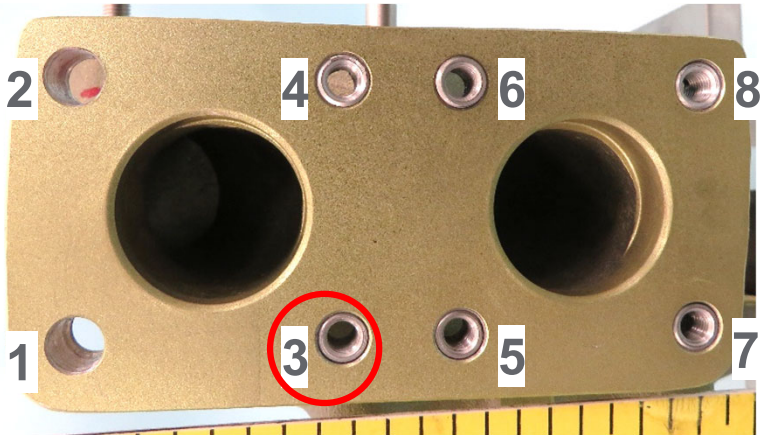
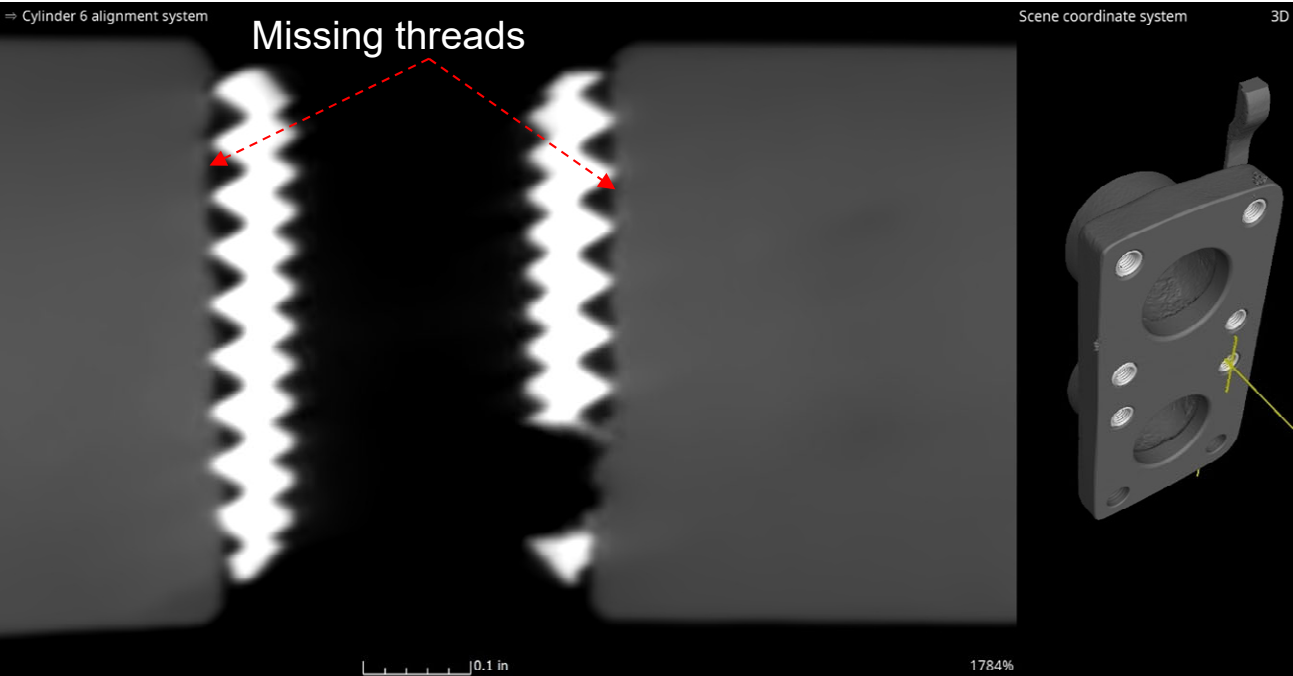
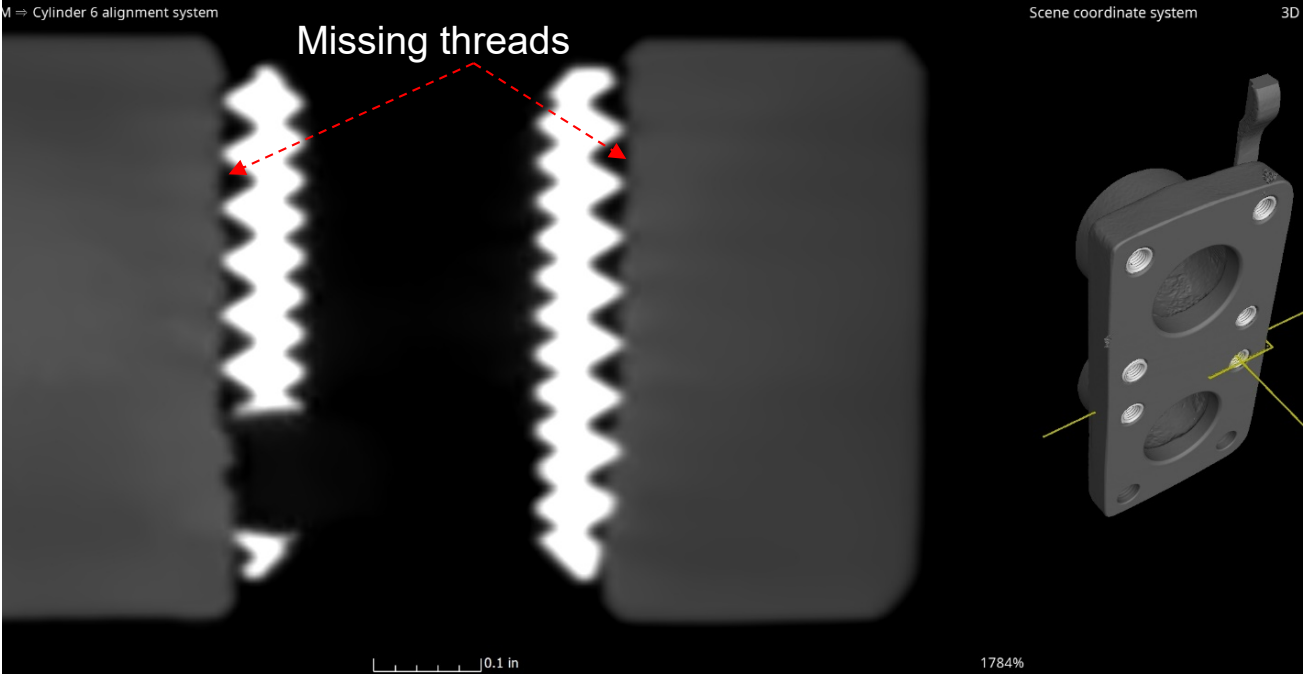
Insert 3

**Figure 58:** CT scan cross-section of thread insert position 3. The pre-tapped internal threads are missing. No thread engagement is observed into the flange material.

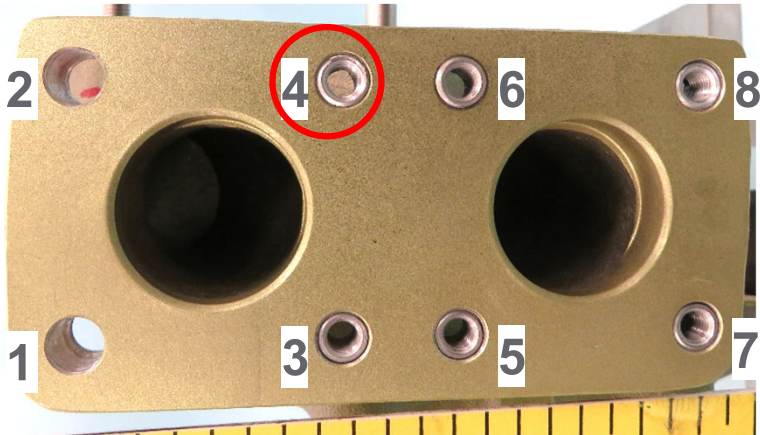
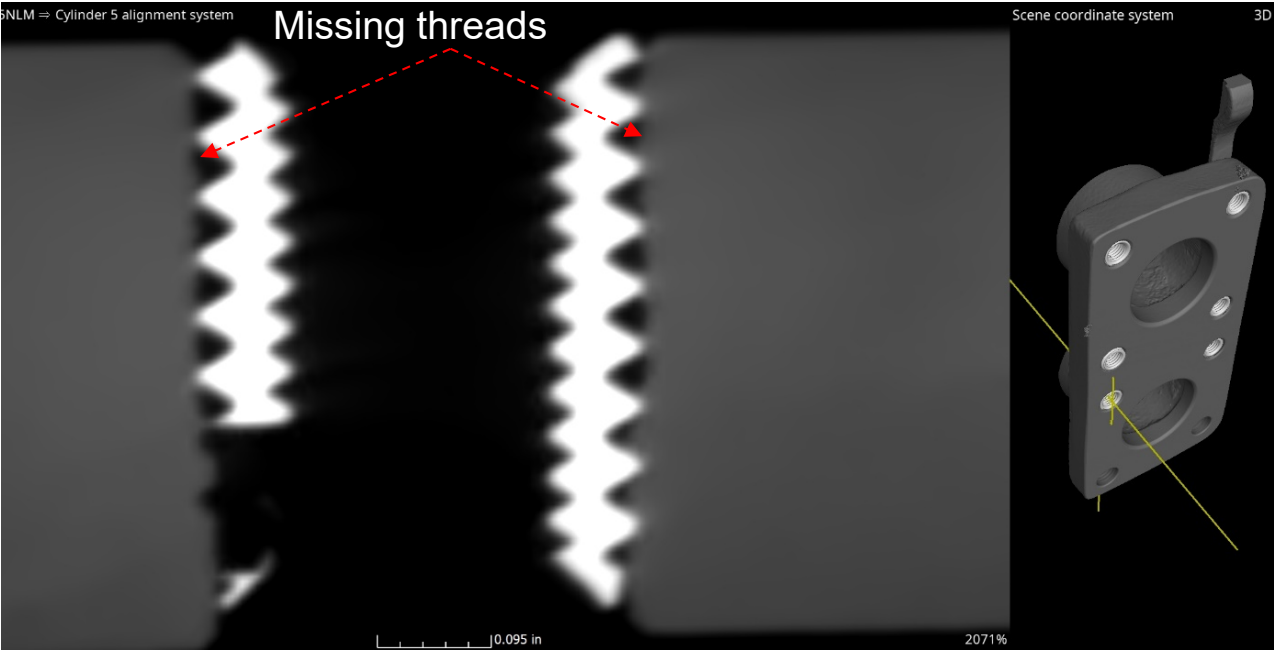
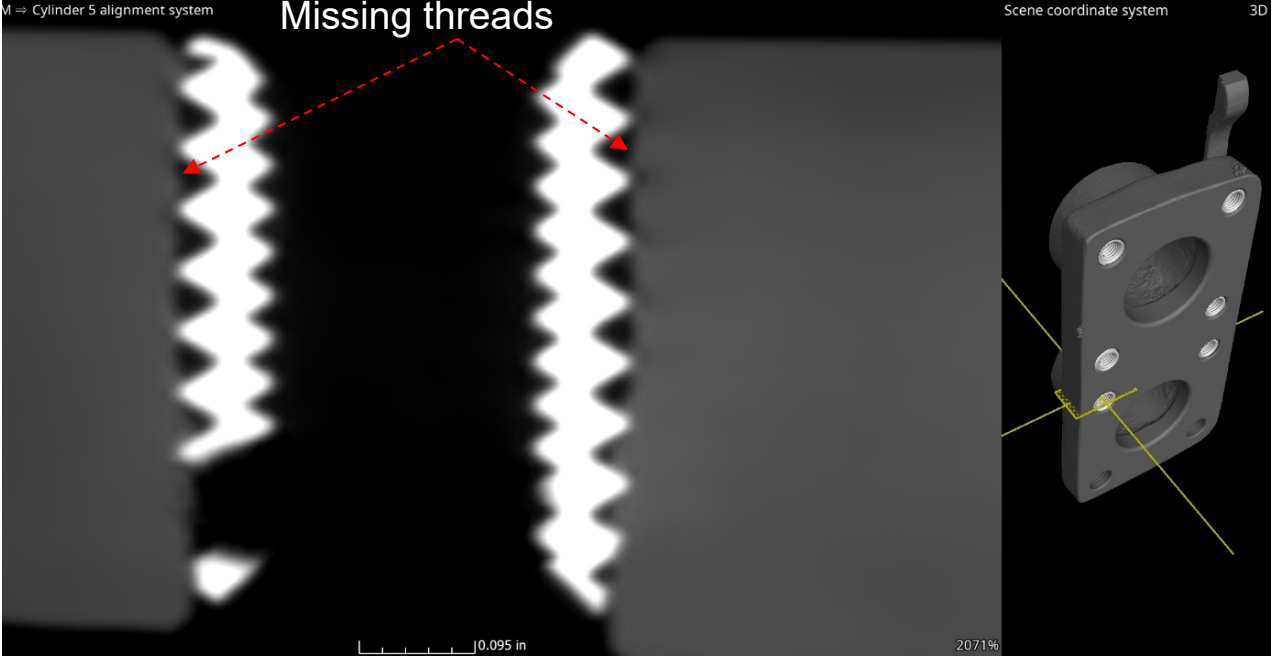
Insert 4

**Figure 59:** CT scan cross-section of thread insert position 4. The pre-tapped internal threads are missing. No thread engagement is observed into the flange material.

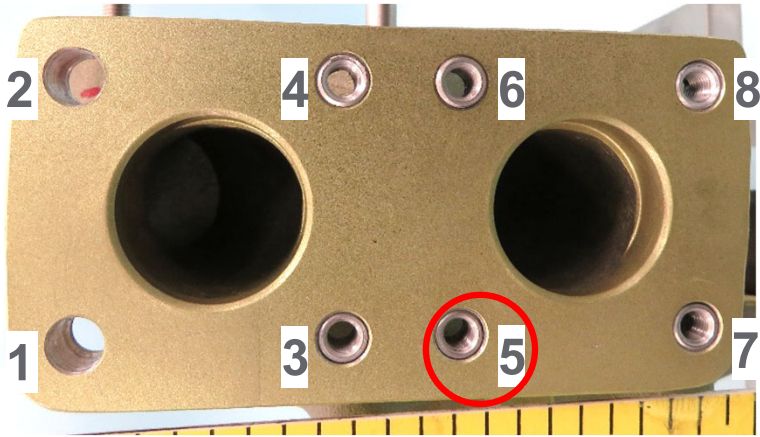
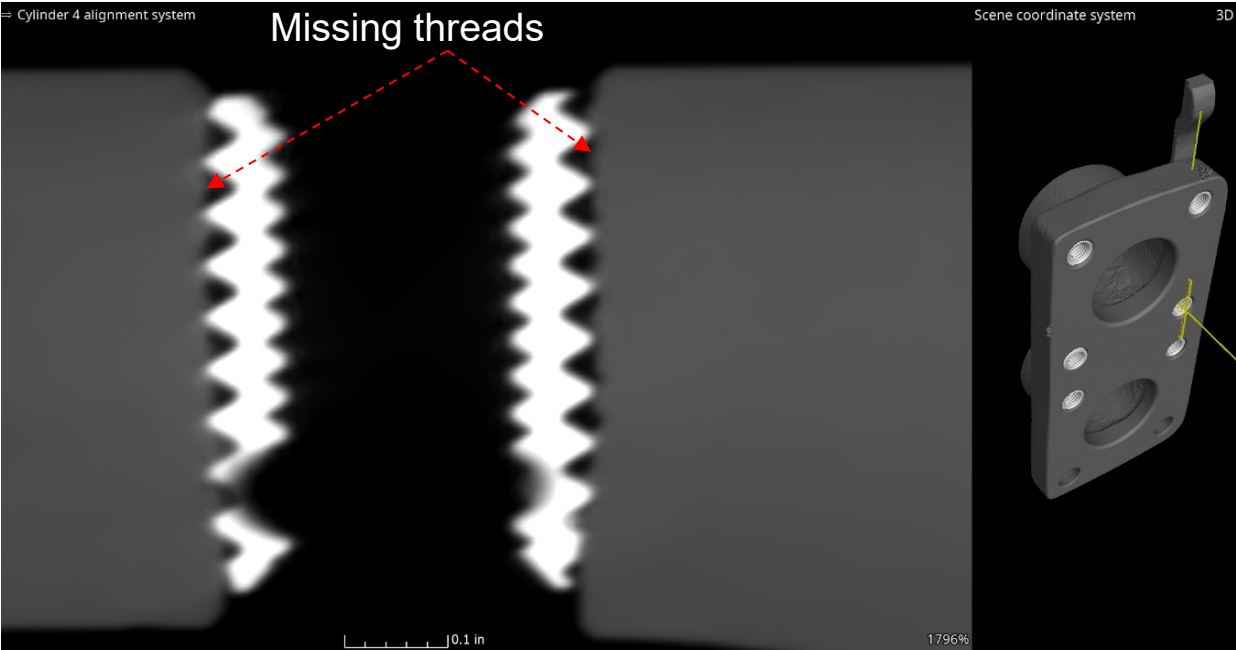
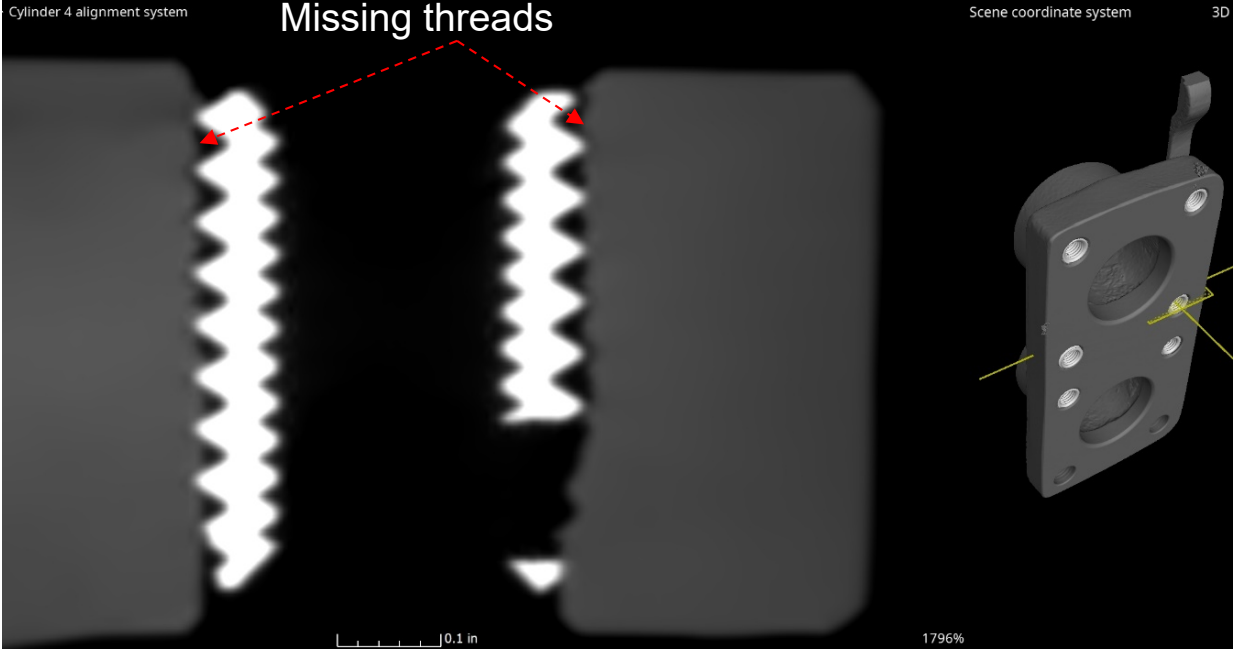
Insert 5

**Figure 60:** CT scan cross-section of thread insert position 5. The pre-tapped internal threads are missing. No thread engagement is observed into the flange material.

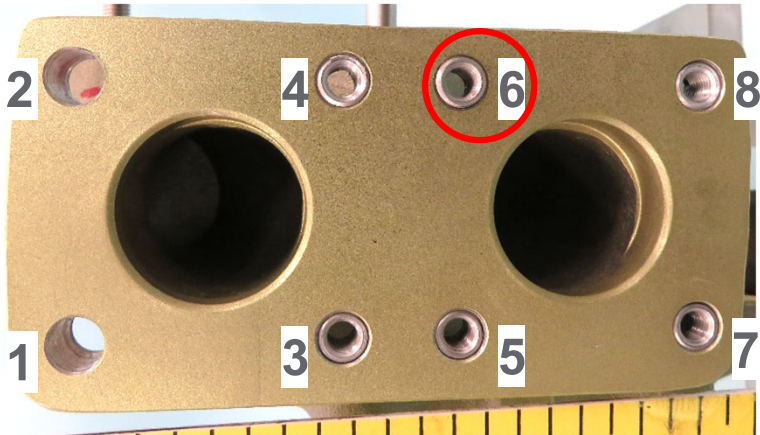
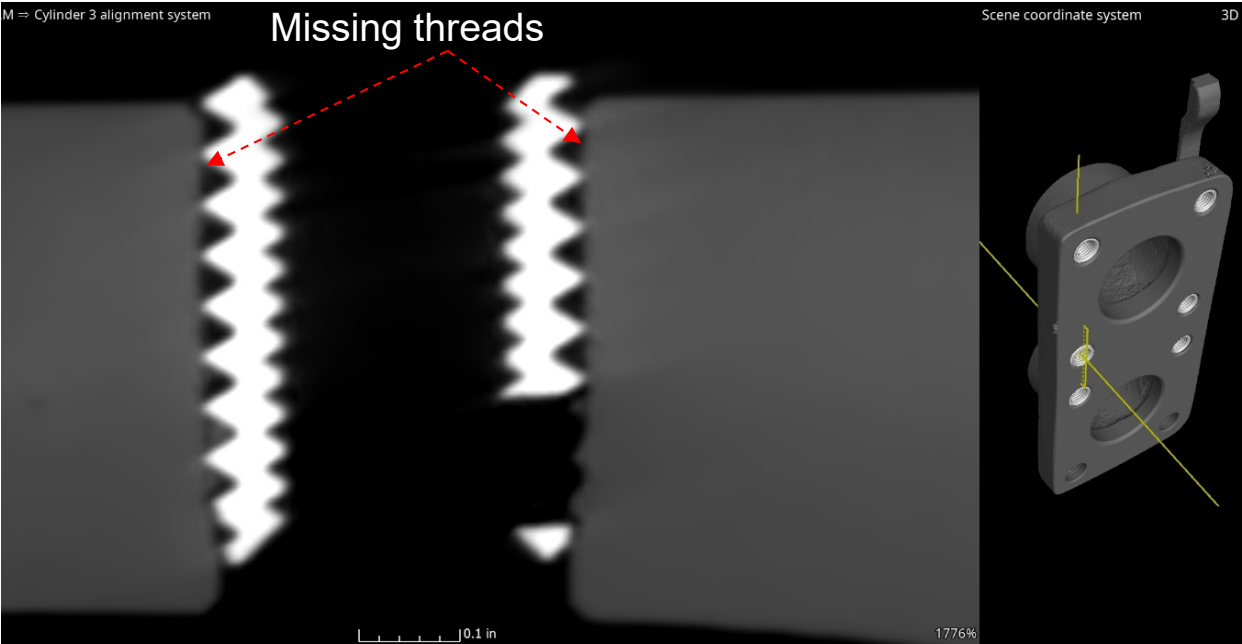
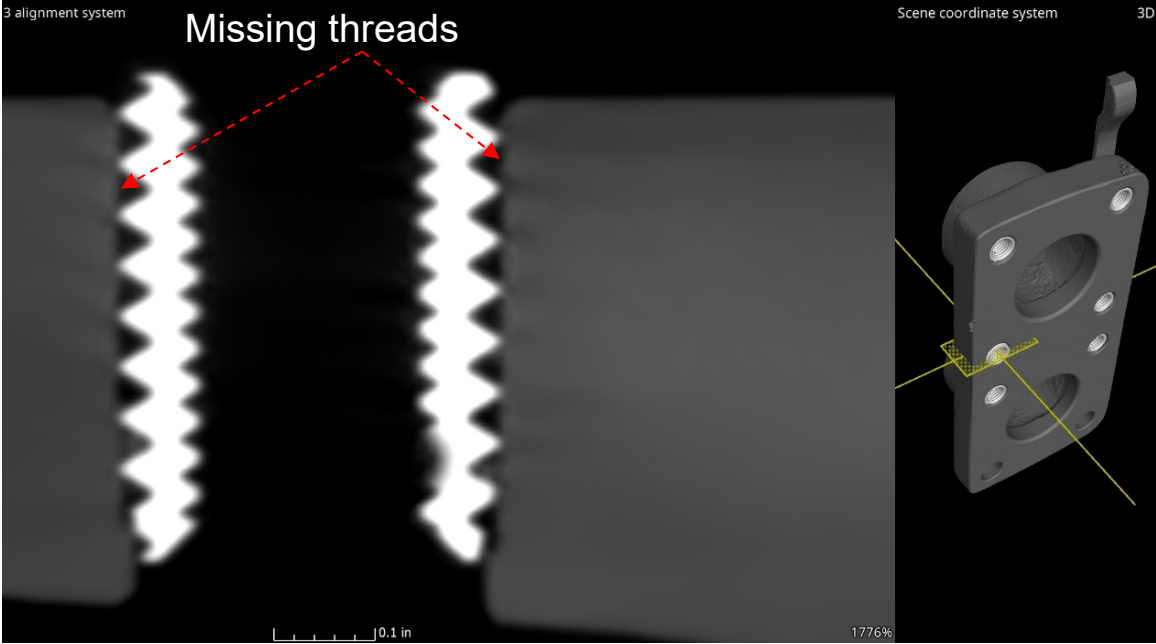
Insert 6

**Figure 61:** CT scan cross-section of thread insert position 6. The pre-tapped internal threads are missing. No thread engagement is observed into the flange material.

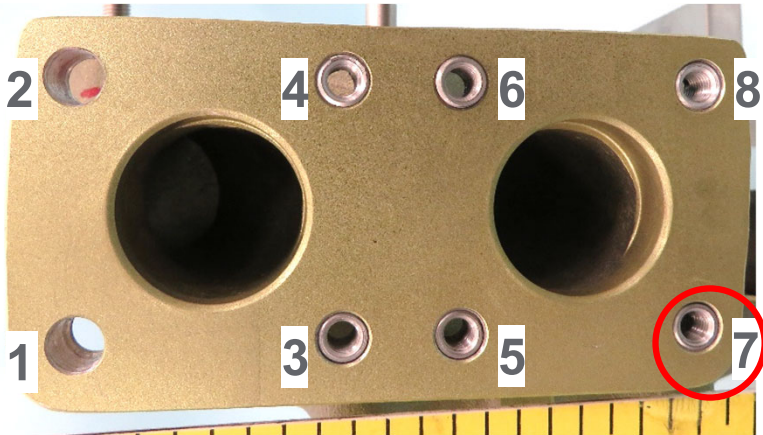
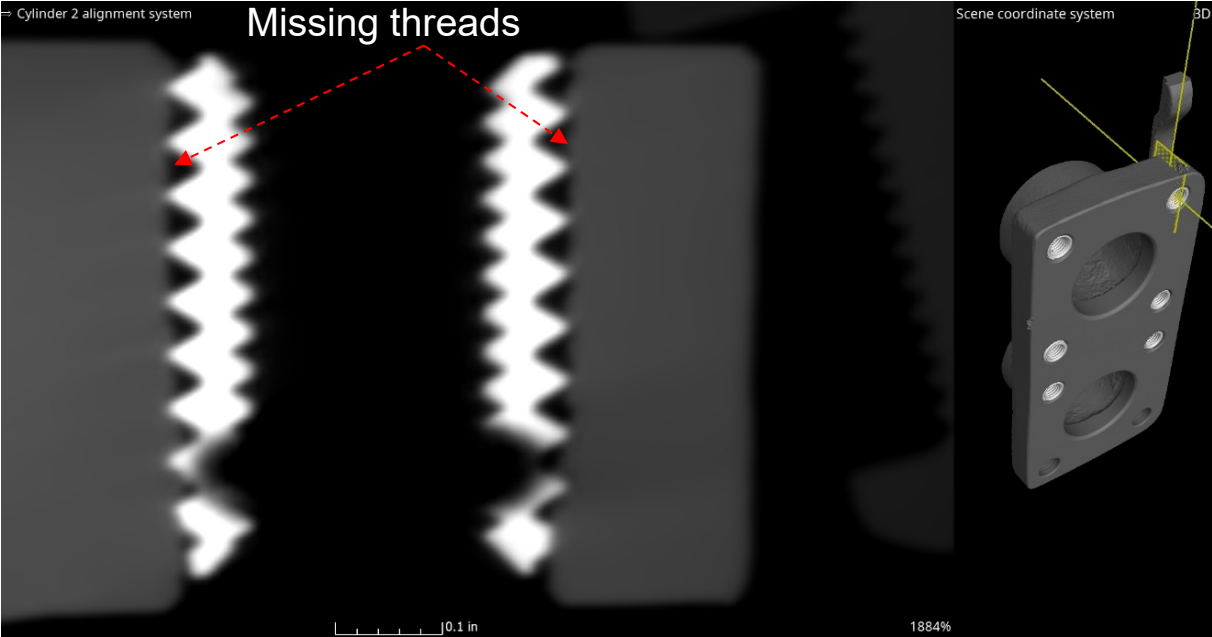
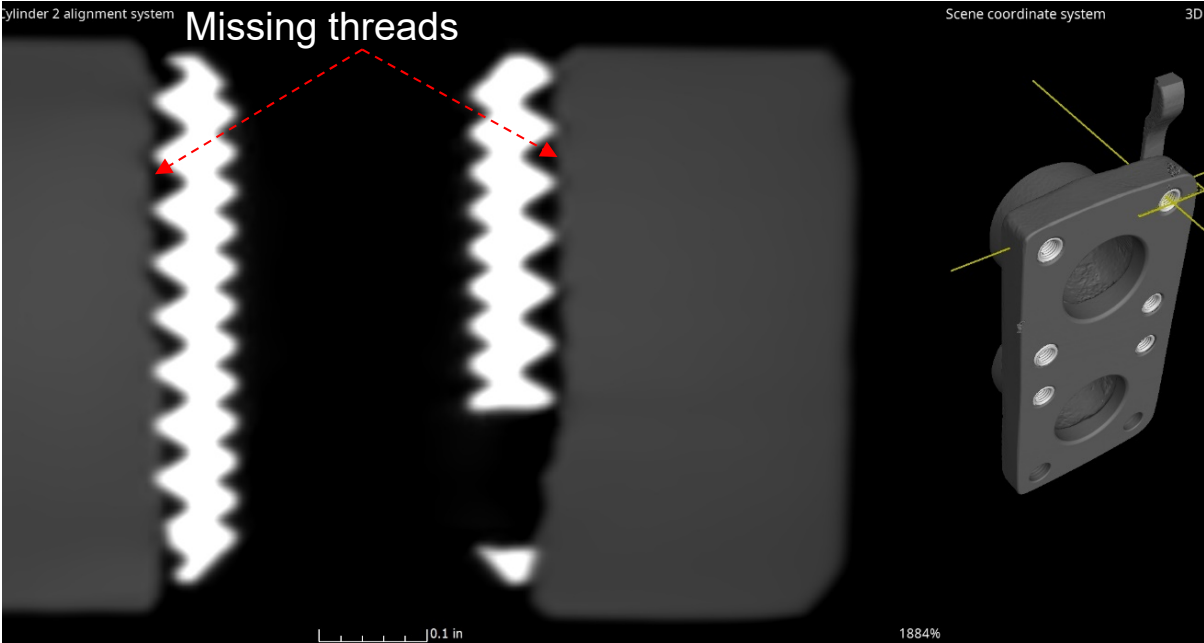
Insert 7

**Figure 62:** CT scan cross-section of thread insert position 7. The pre-tapped internal threads are missing. No thread engagement is observed into the flange material.
