# **Metallurgical Investigation Report**

## **DRB: AvEng-561264.A**

**EVALUATION OF A CF6-80C2 ESN 707-605 HMU IDLER  
ADAPTER FROM ESN 707-605 OPERATED BY FEDEX  
INVOLVED IN AN IN-FLIGHT SHUT-DOWN AND  
UNDERCOWL FIRE EVENT**

Part Number: 9395M78G10  
Part Serial Number: FIA217EE  
Part TSN / CSN: 1,421 hrs / 728 cycles

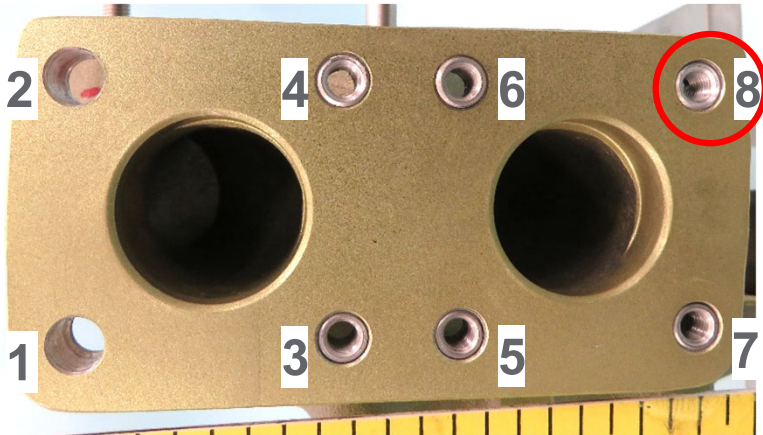
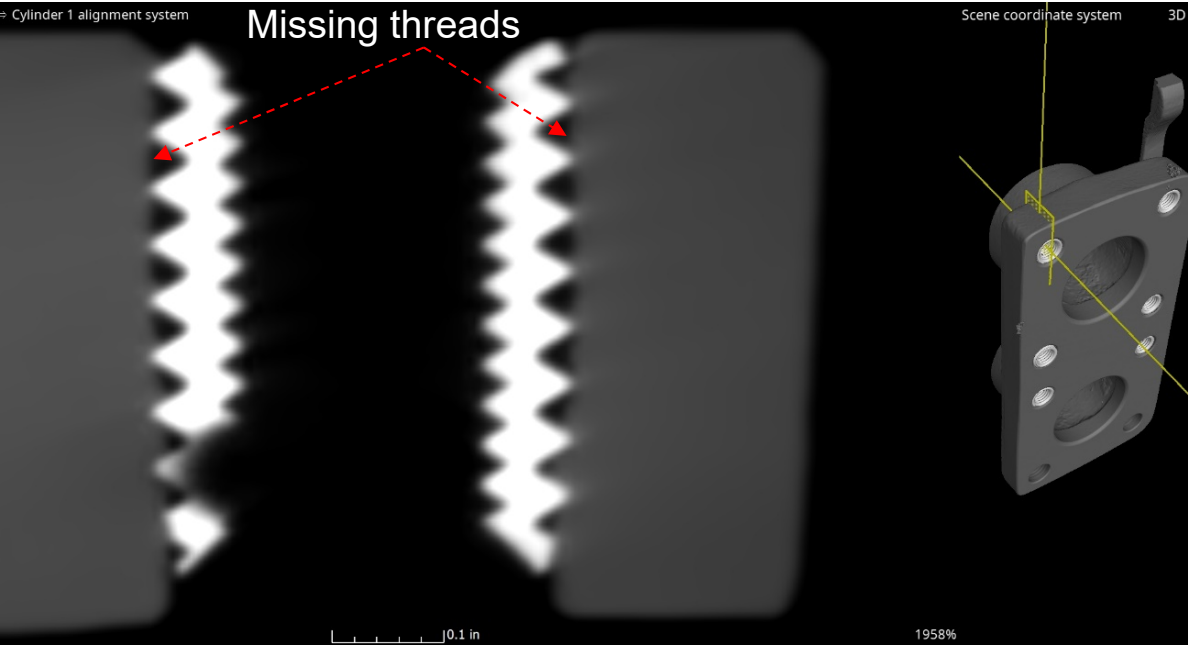
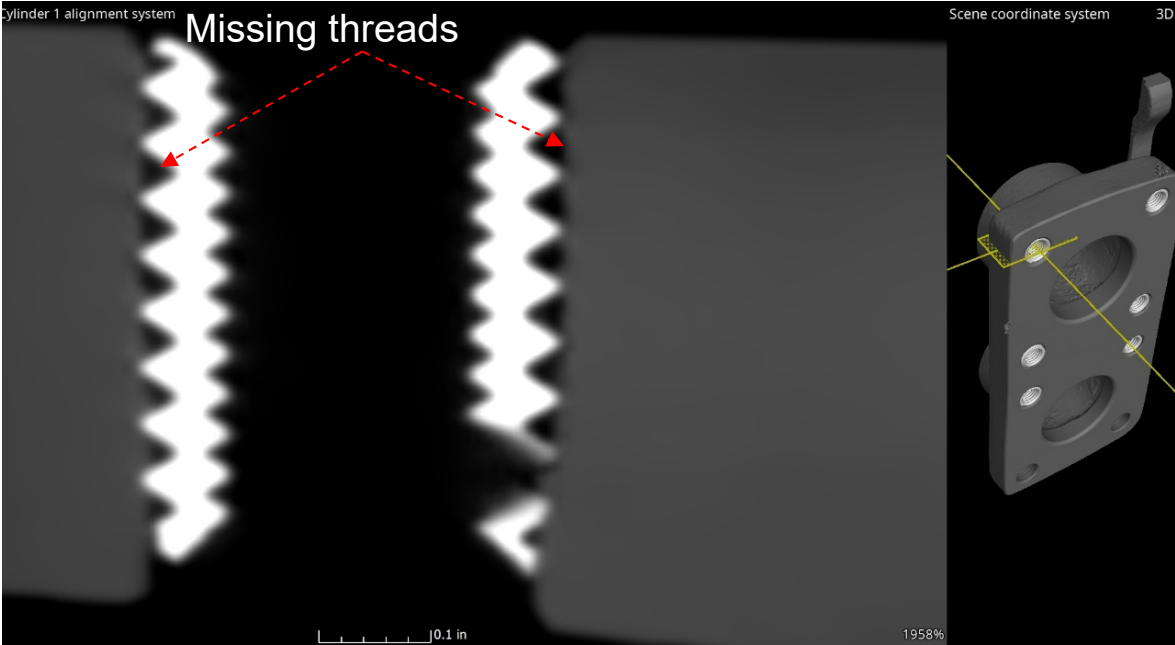
Insert 8

**Figure 63:** CT scan cross-section of thread insert position 8. The pre-tapped internal threads are missing. No thread engagement is observed into the flange material.

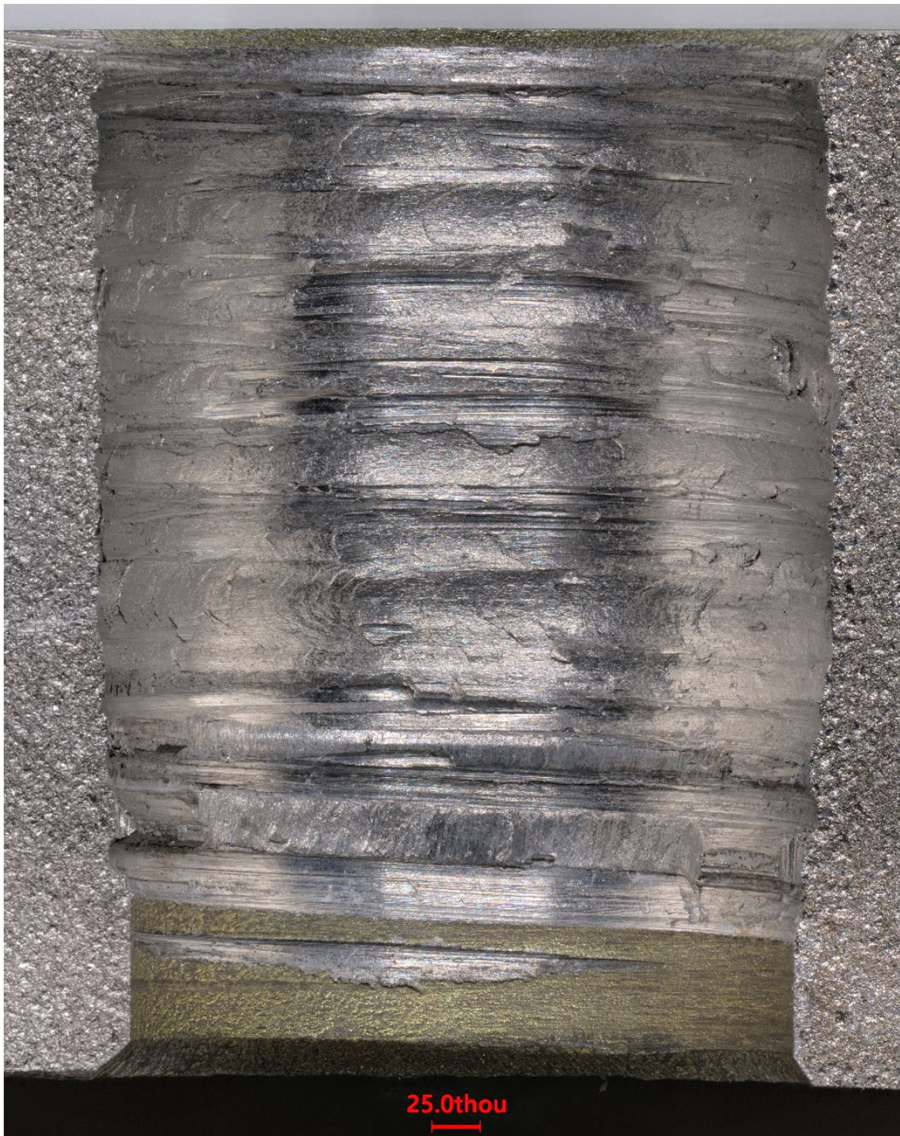
Insert 1 Side 1

**Figure 64:** Optical views of insert hole 1 reveals damaged threads.

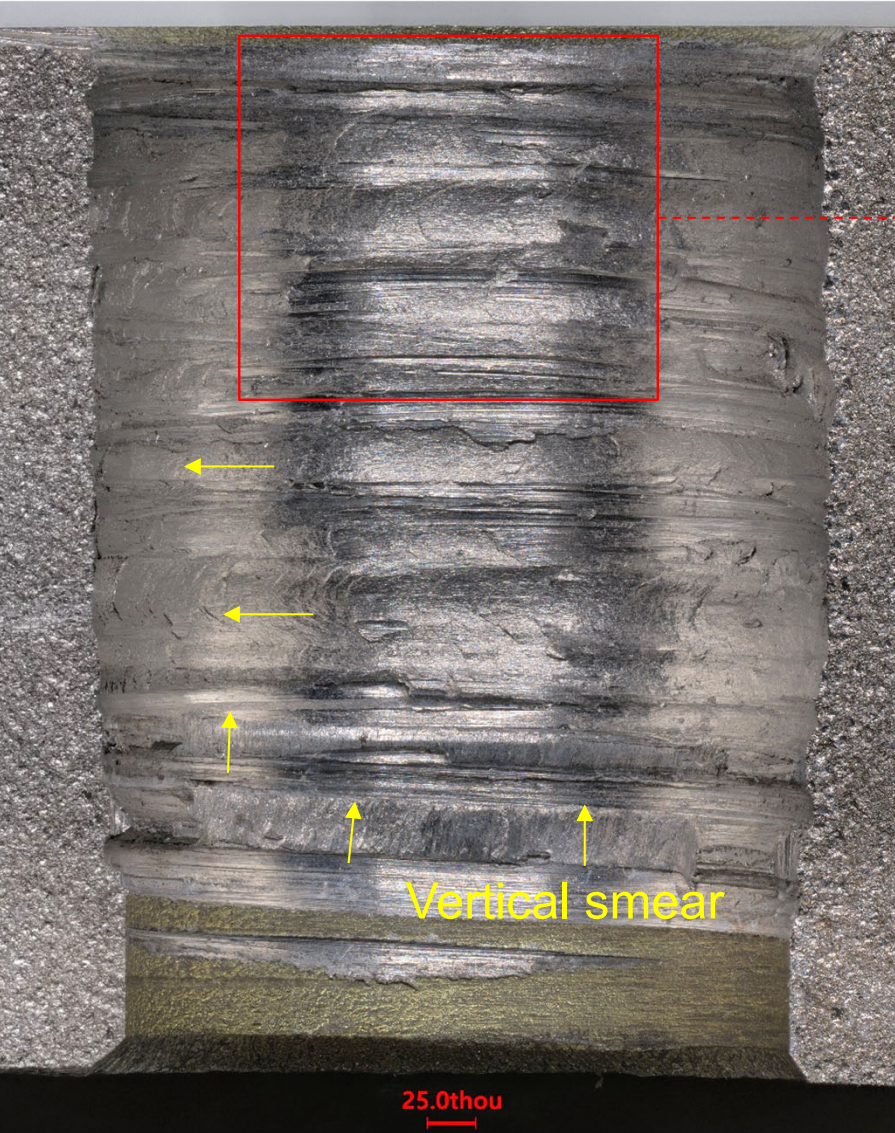
Insert 1 Side 1

**Figure 65:** Optical view of insert hole 1 reveals vertical smear lines consistent with the insert pulling out and overlapping smeared material consistent with CCW rotation.

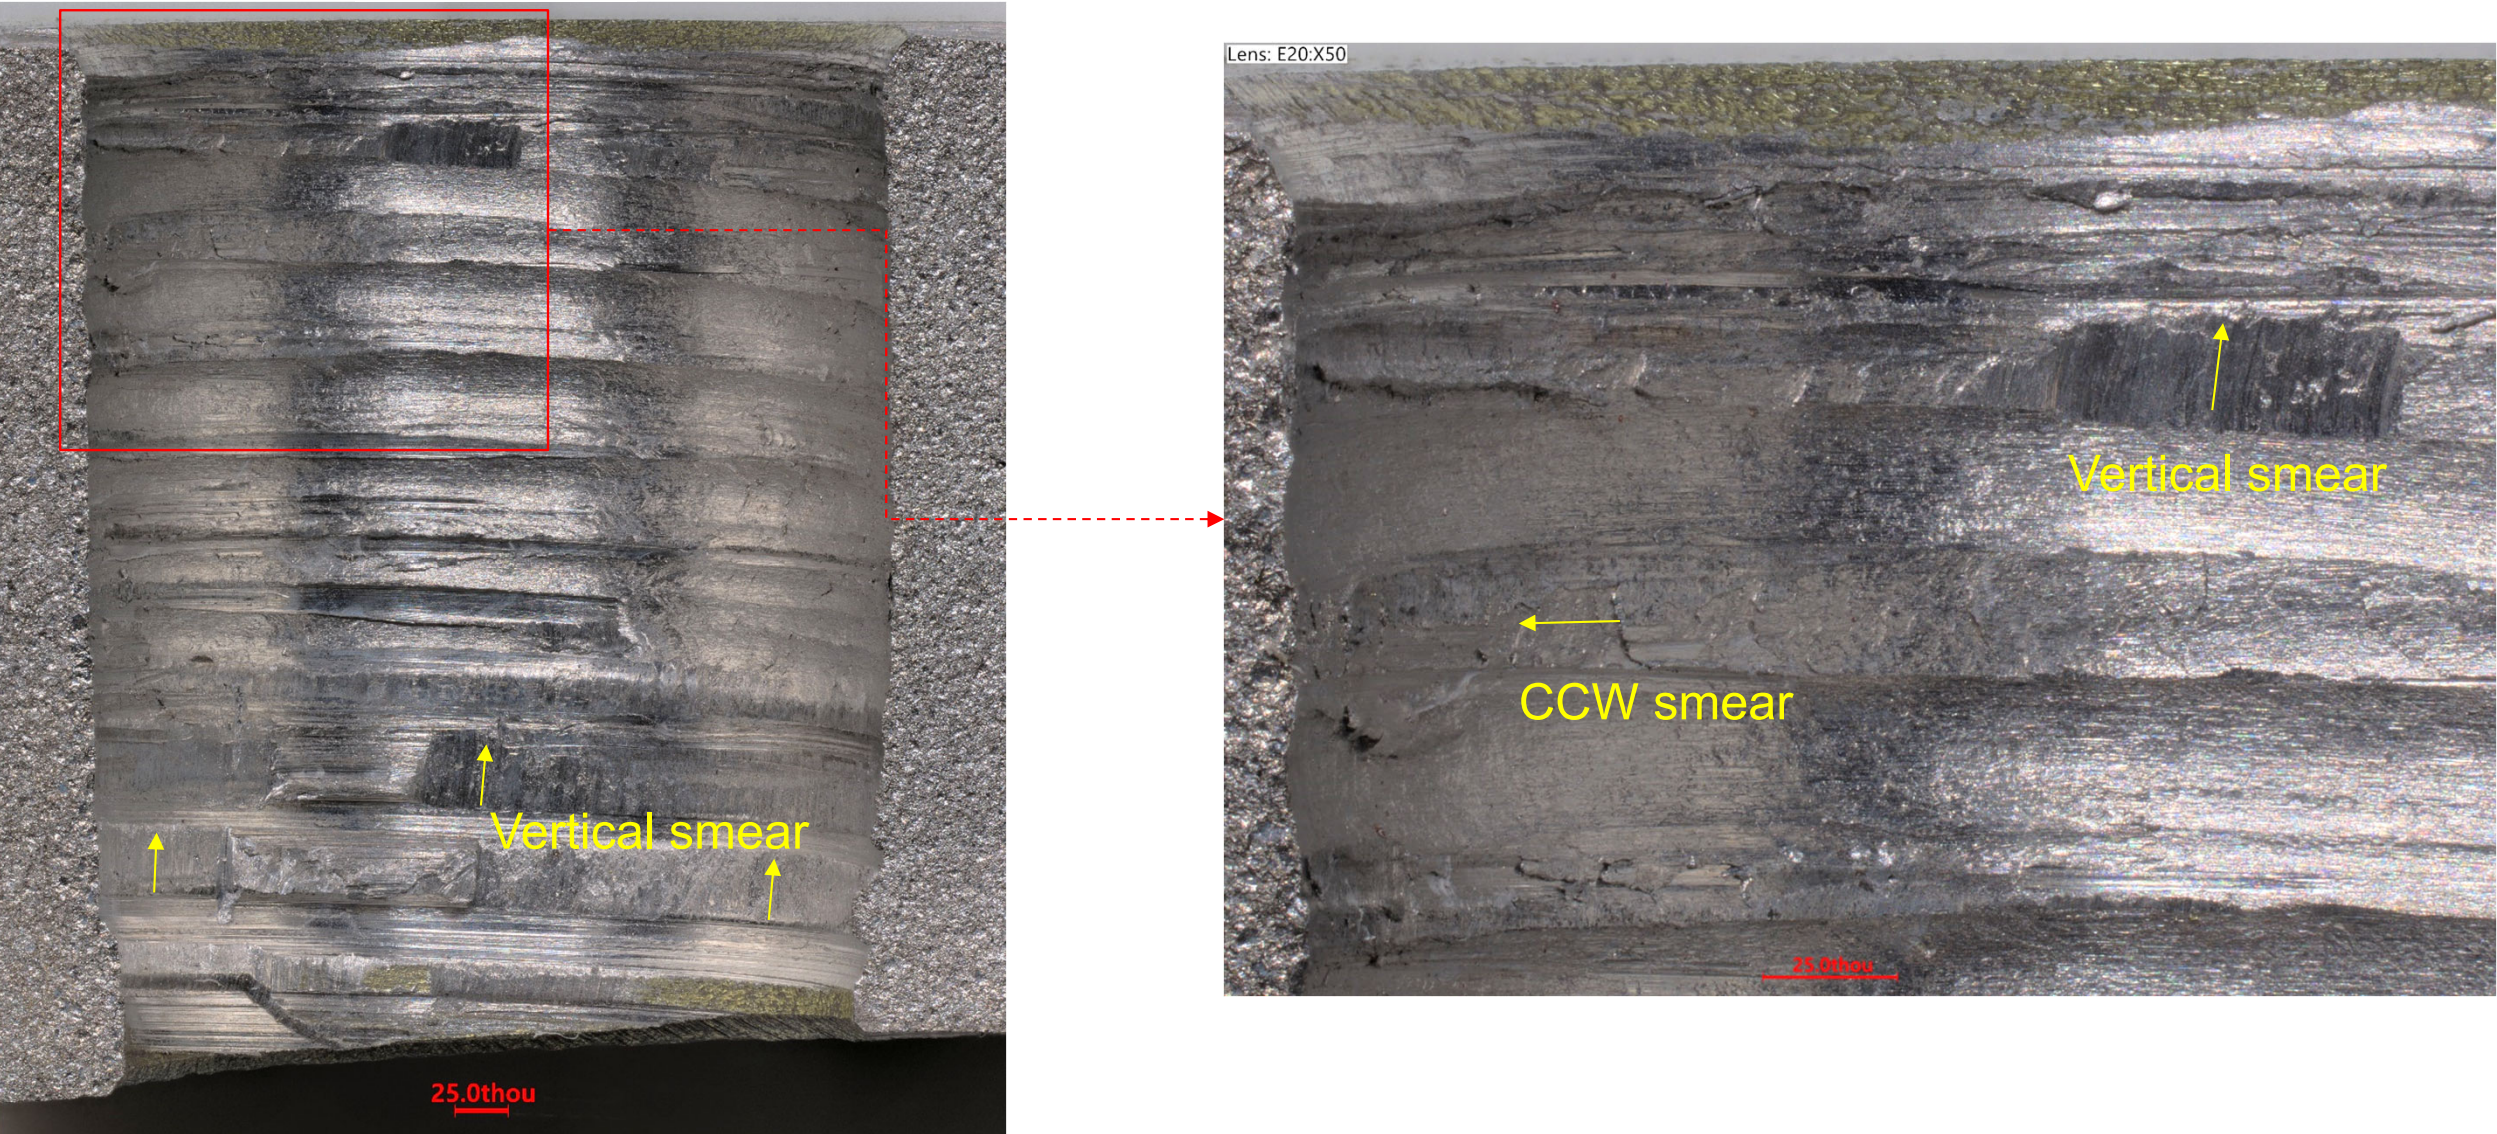
Hole 2 Side 1

**Figure 67:** Optical view of insert hole 2 reveals vertical smear lines consistent with the insert pulling out and overlapping smeared material consistent with CCW rotation.

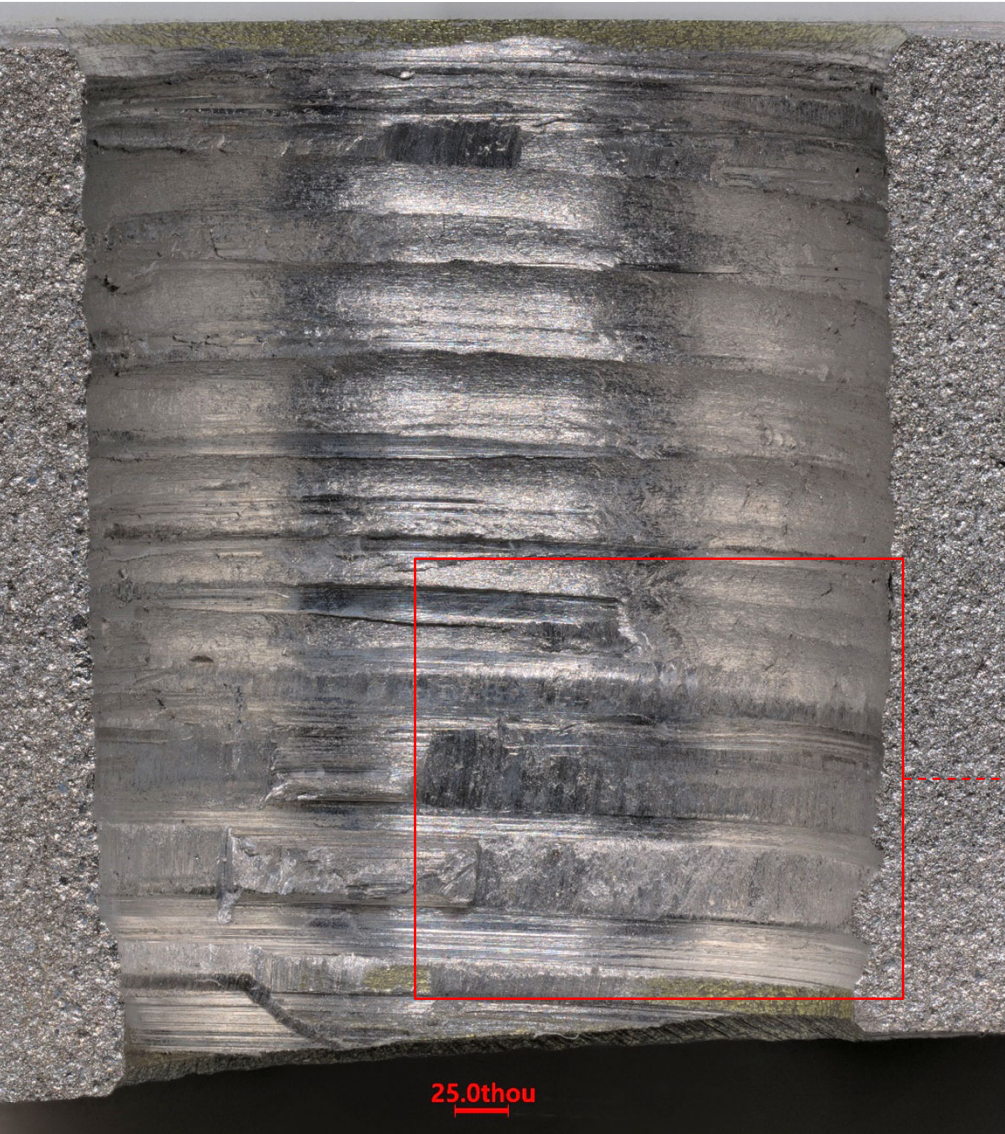
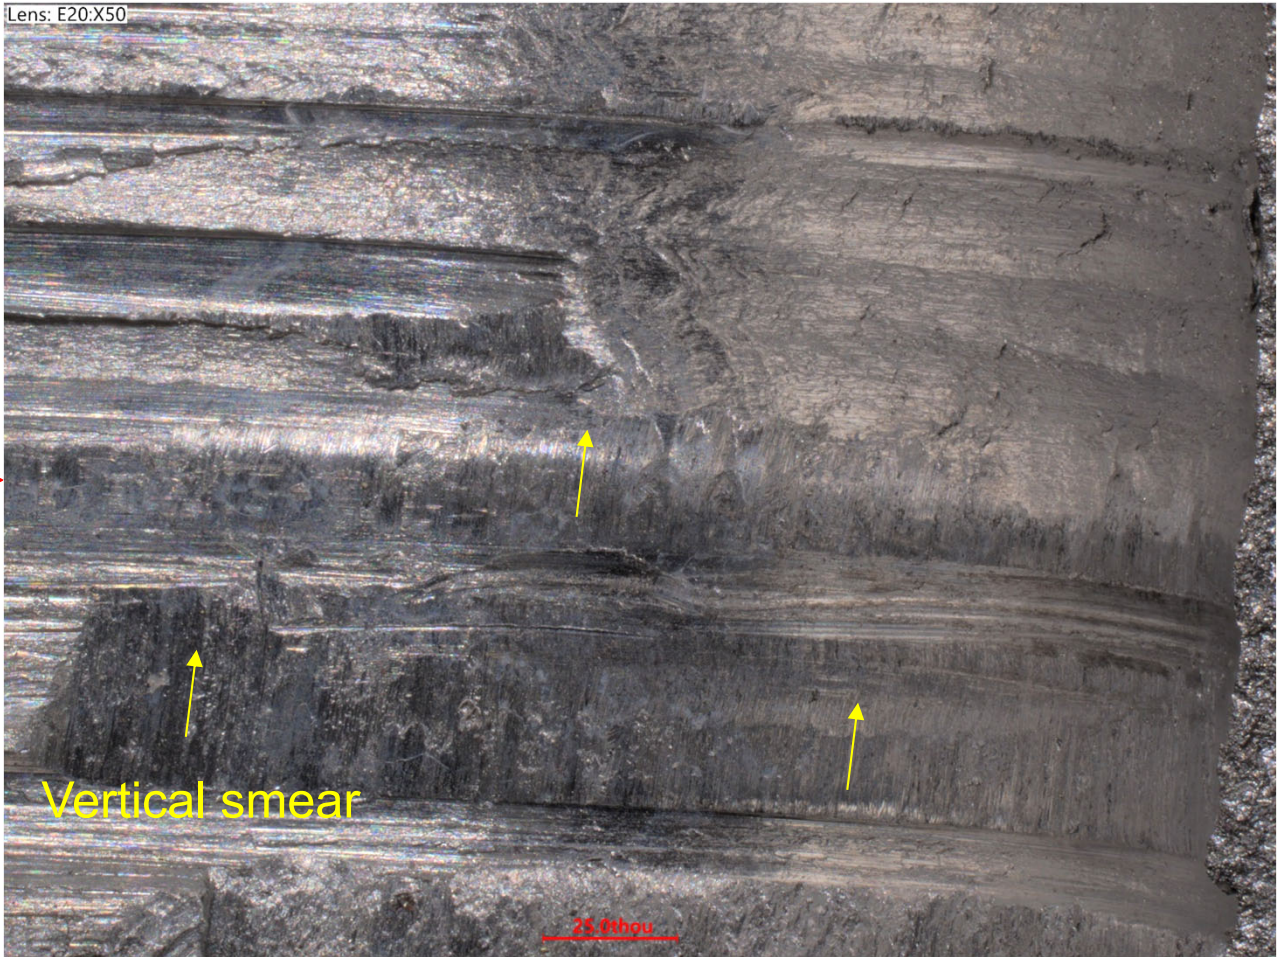
Hole 2 Side 1

**Figure 68:** Optical view of insert hole 2 reveals vertical smear lines consistent with the insert pulling out and smeared material consistent with CCW rotation.

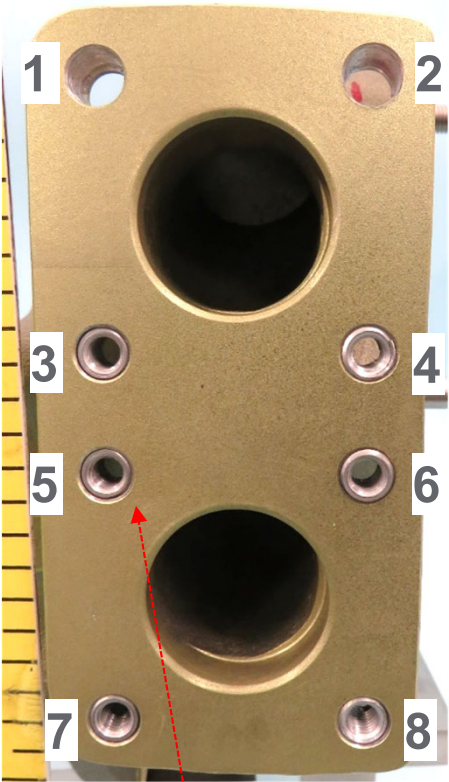
SN FIA231MR Holes 3 and 5

**Figure 69:** Optical views of insert locations 3 and 5 with the inserts in place and removed. Both insert holes have damaged and missing threads.

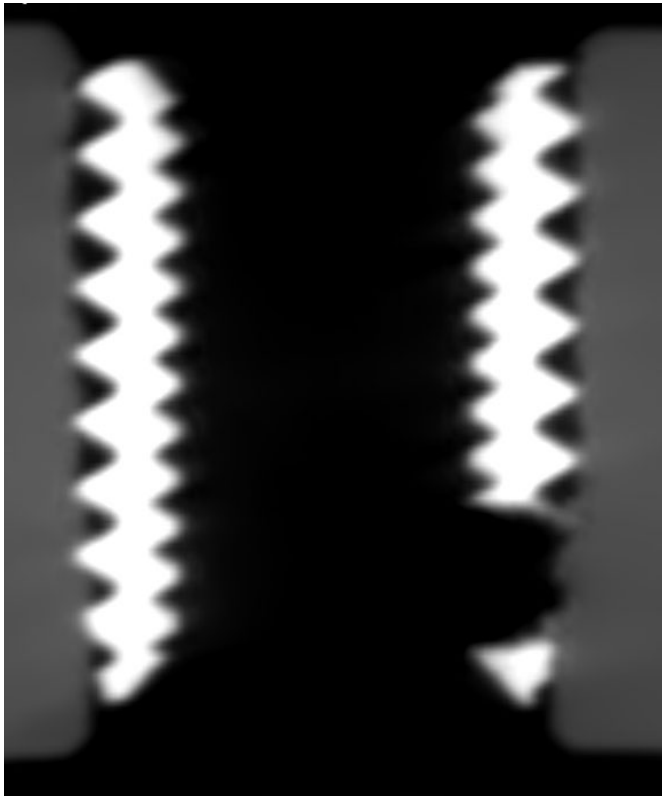
**Figure 70:** Optical views of insert hole location 3 reveals damaged threads.

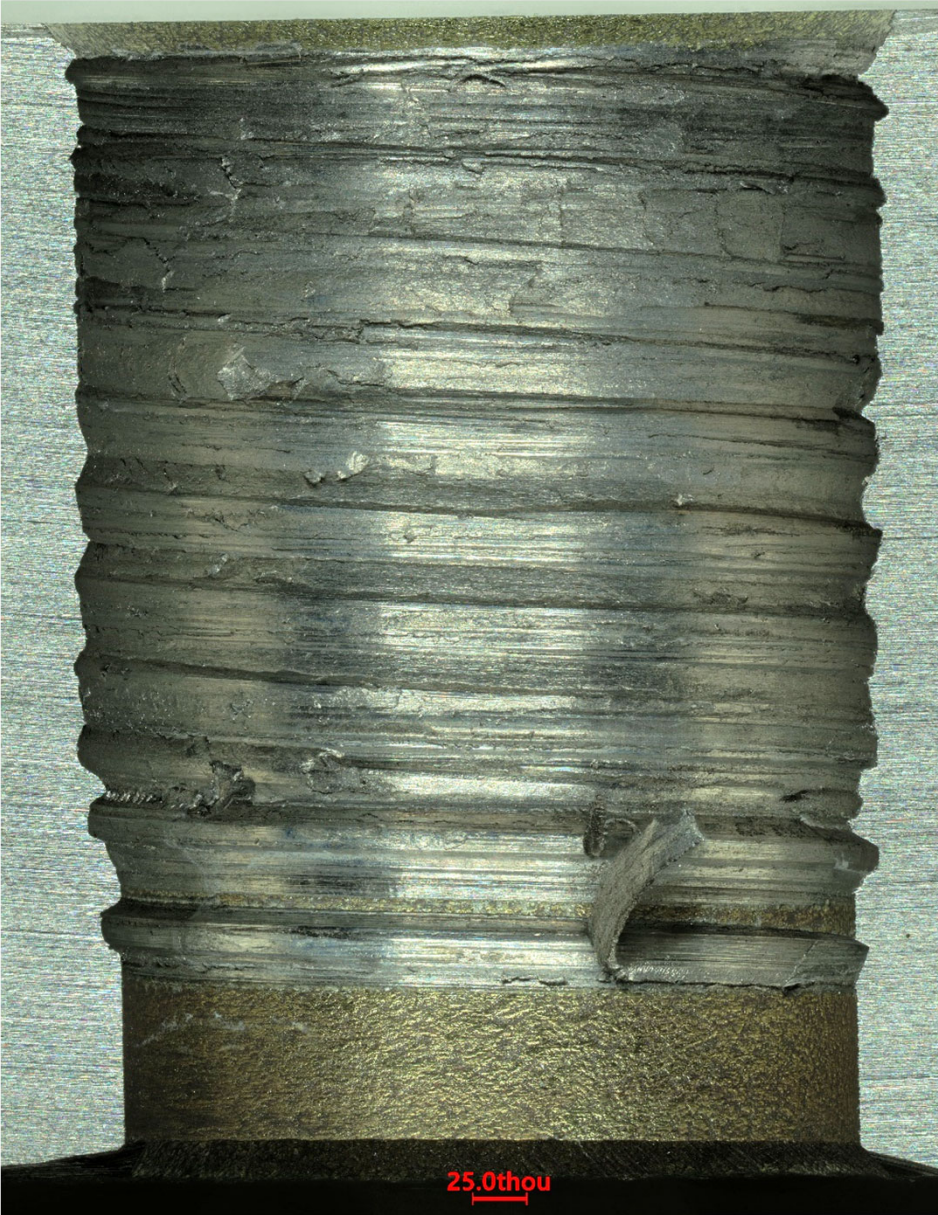
Insert 3 Side 1

**Figure 71:** High magnification views show the damaged threads reveals overlapping smeared material consistent with CCW rotation.

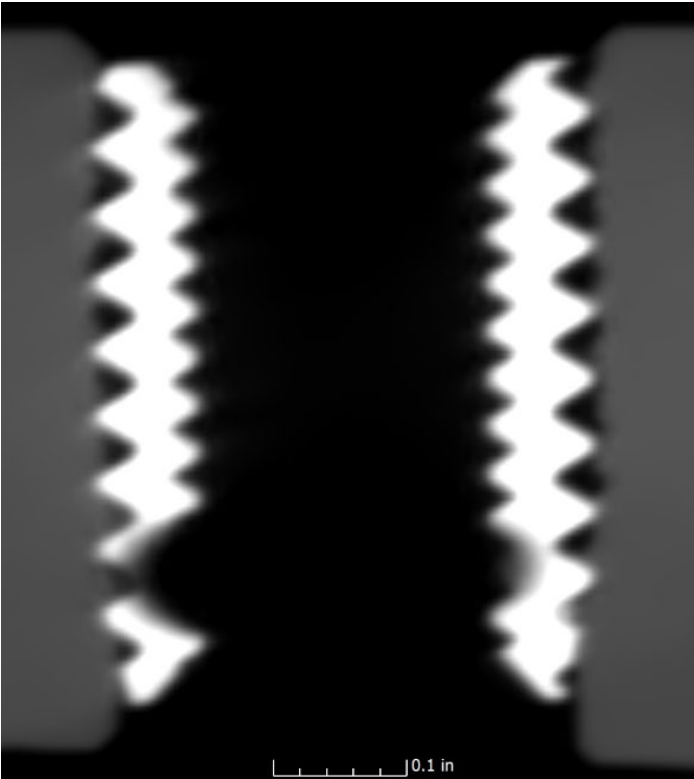
**Figure 72:** Optical views of insert locations 3 reveals damaged threads.

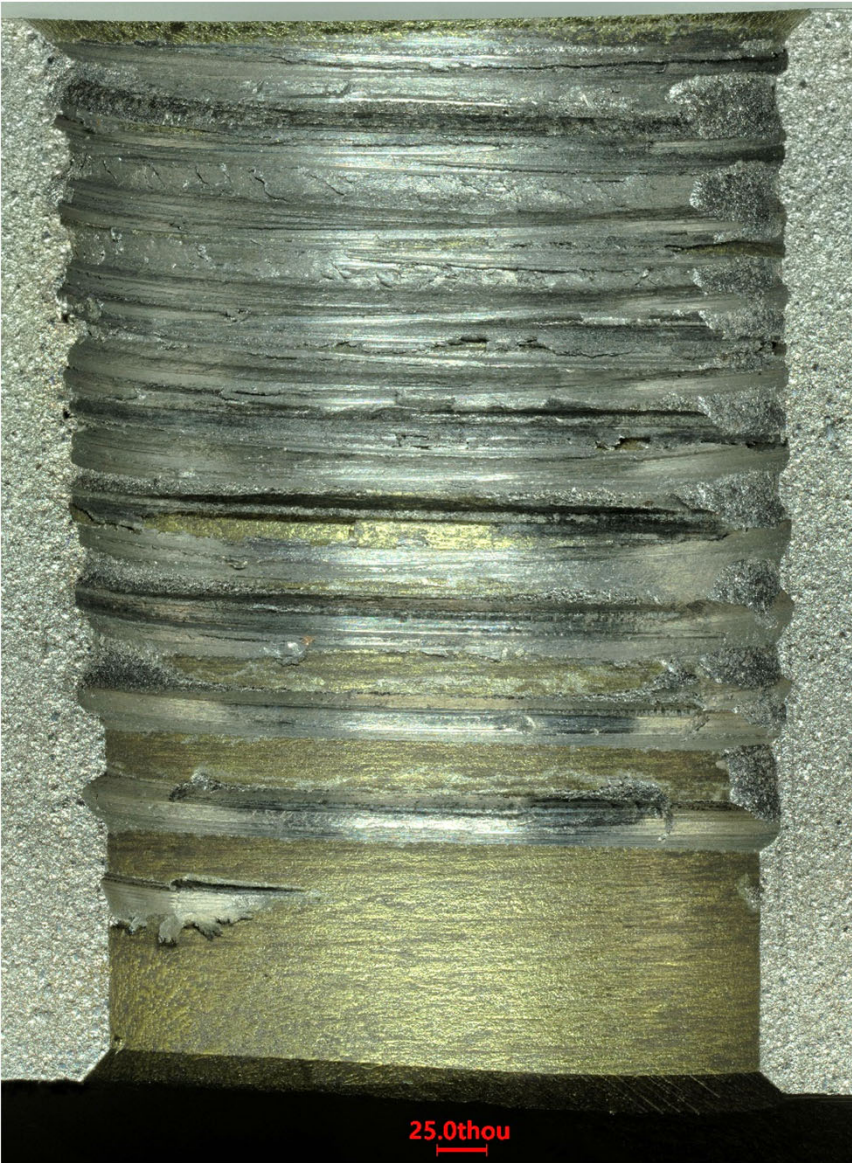
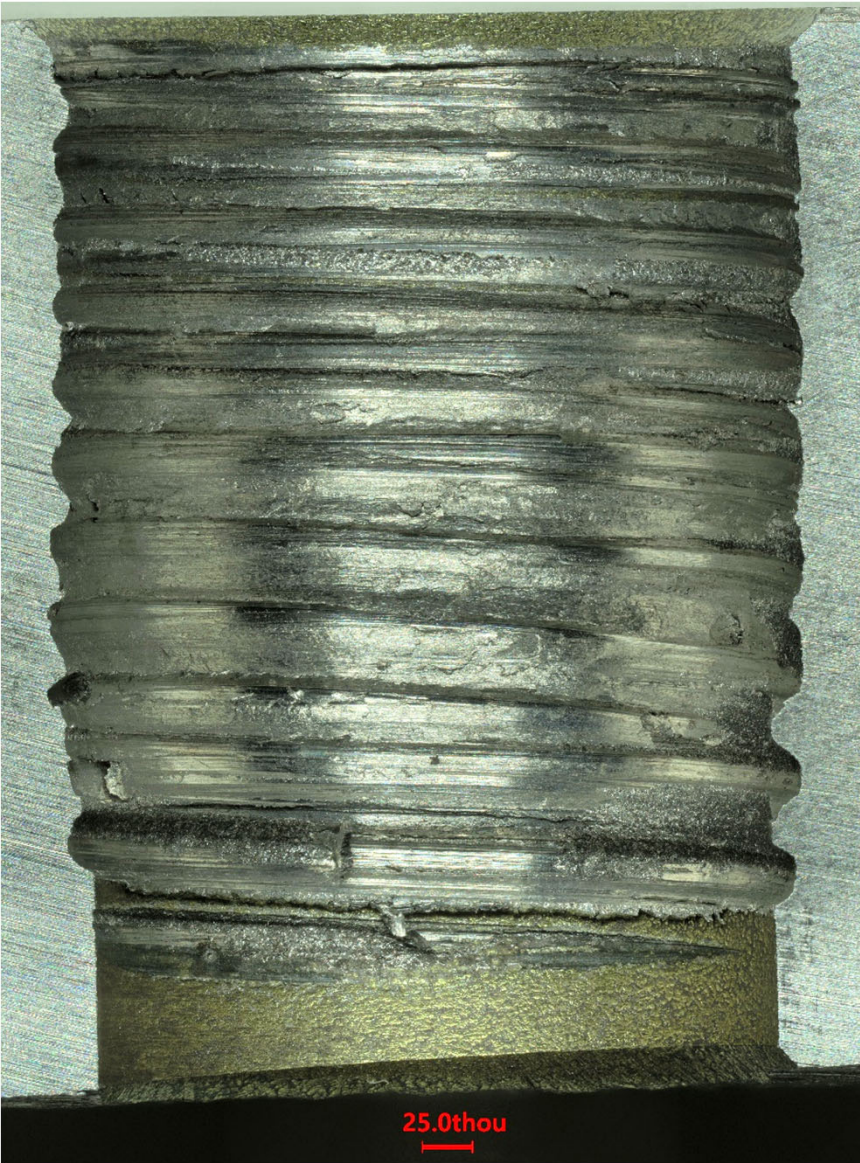
**Insert 5 Side 1**

**Figure 73:** High magnification views show the damaged threads reveals overlapping smeared material consistent with CCW rotation.

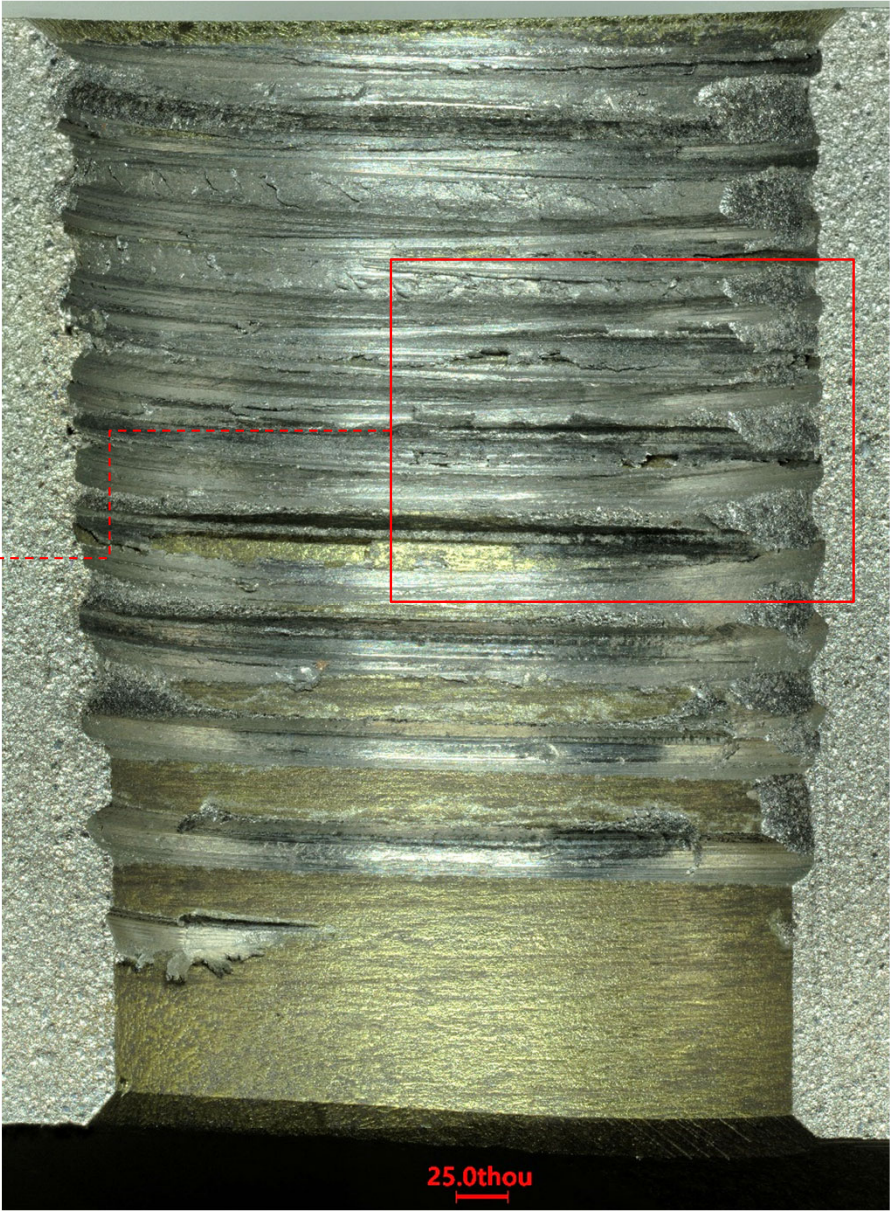
Insert 5 Side 1

**Figure 74:** High magnification views show the damaged threads reveals angled cut lines through the flange female threads, consistent with the thread insert cross-threading and cutting through the flange threads.

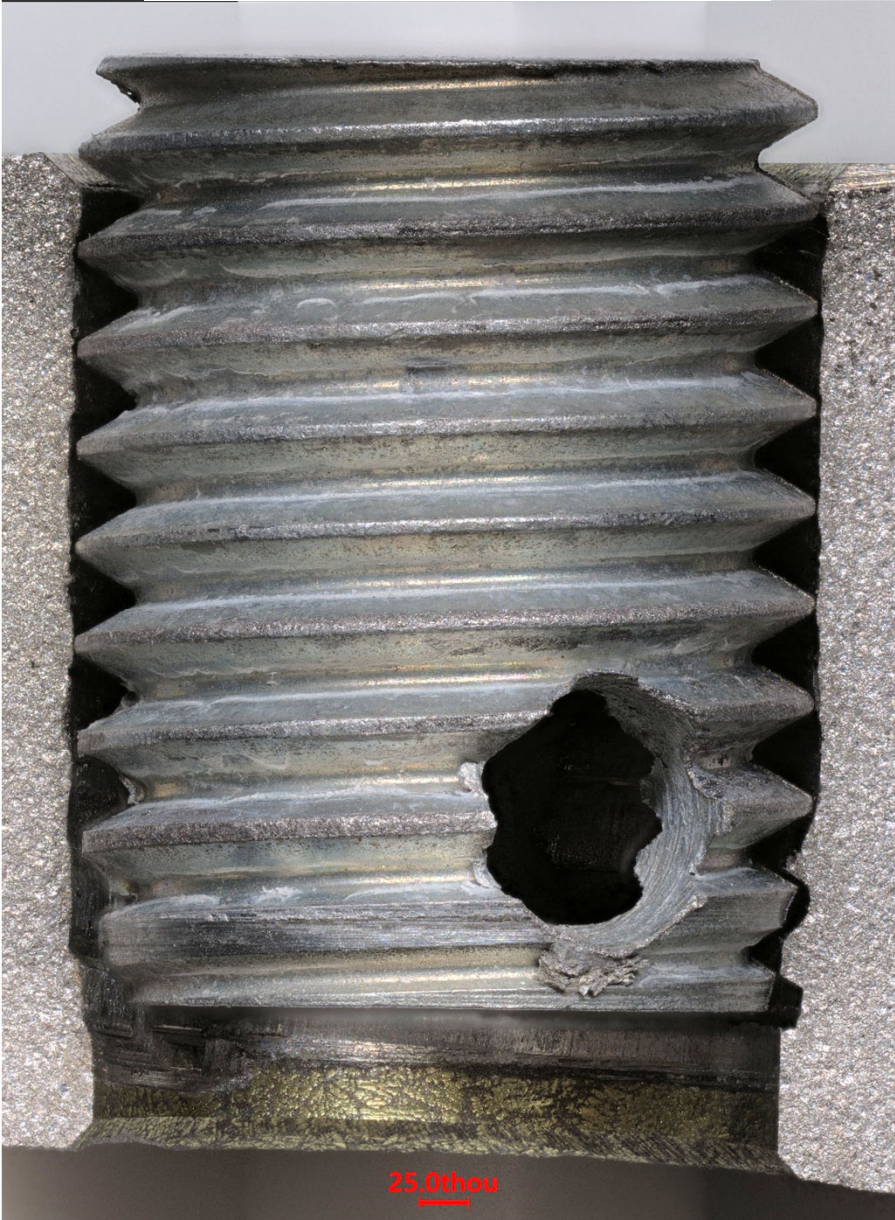
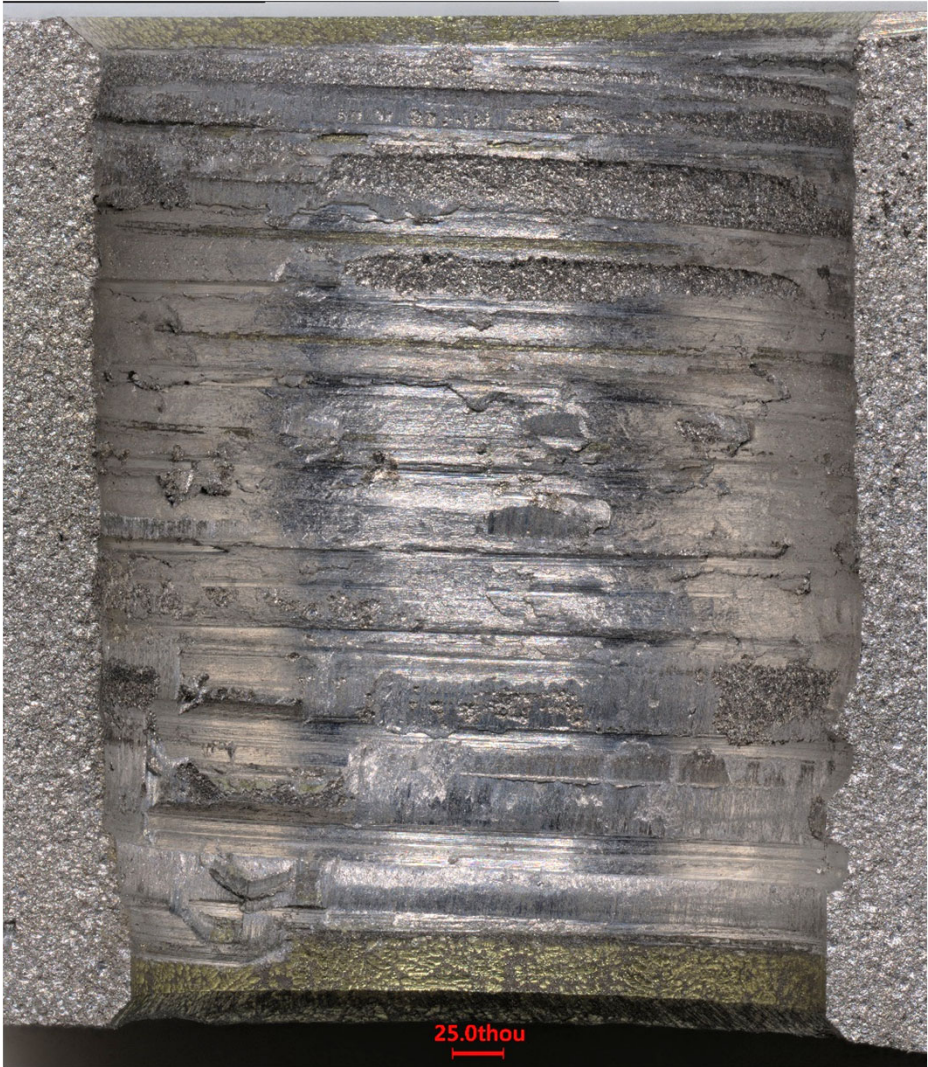
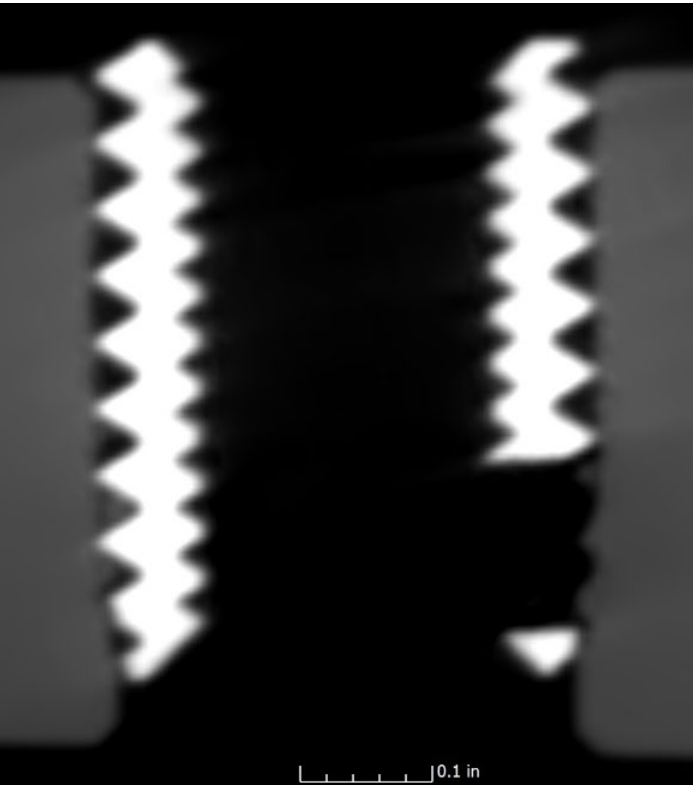
Insert 6 Side 1 Insert In Place

**Figure 75:** Optical views of insert location 6 reveals damaged threads.

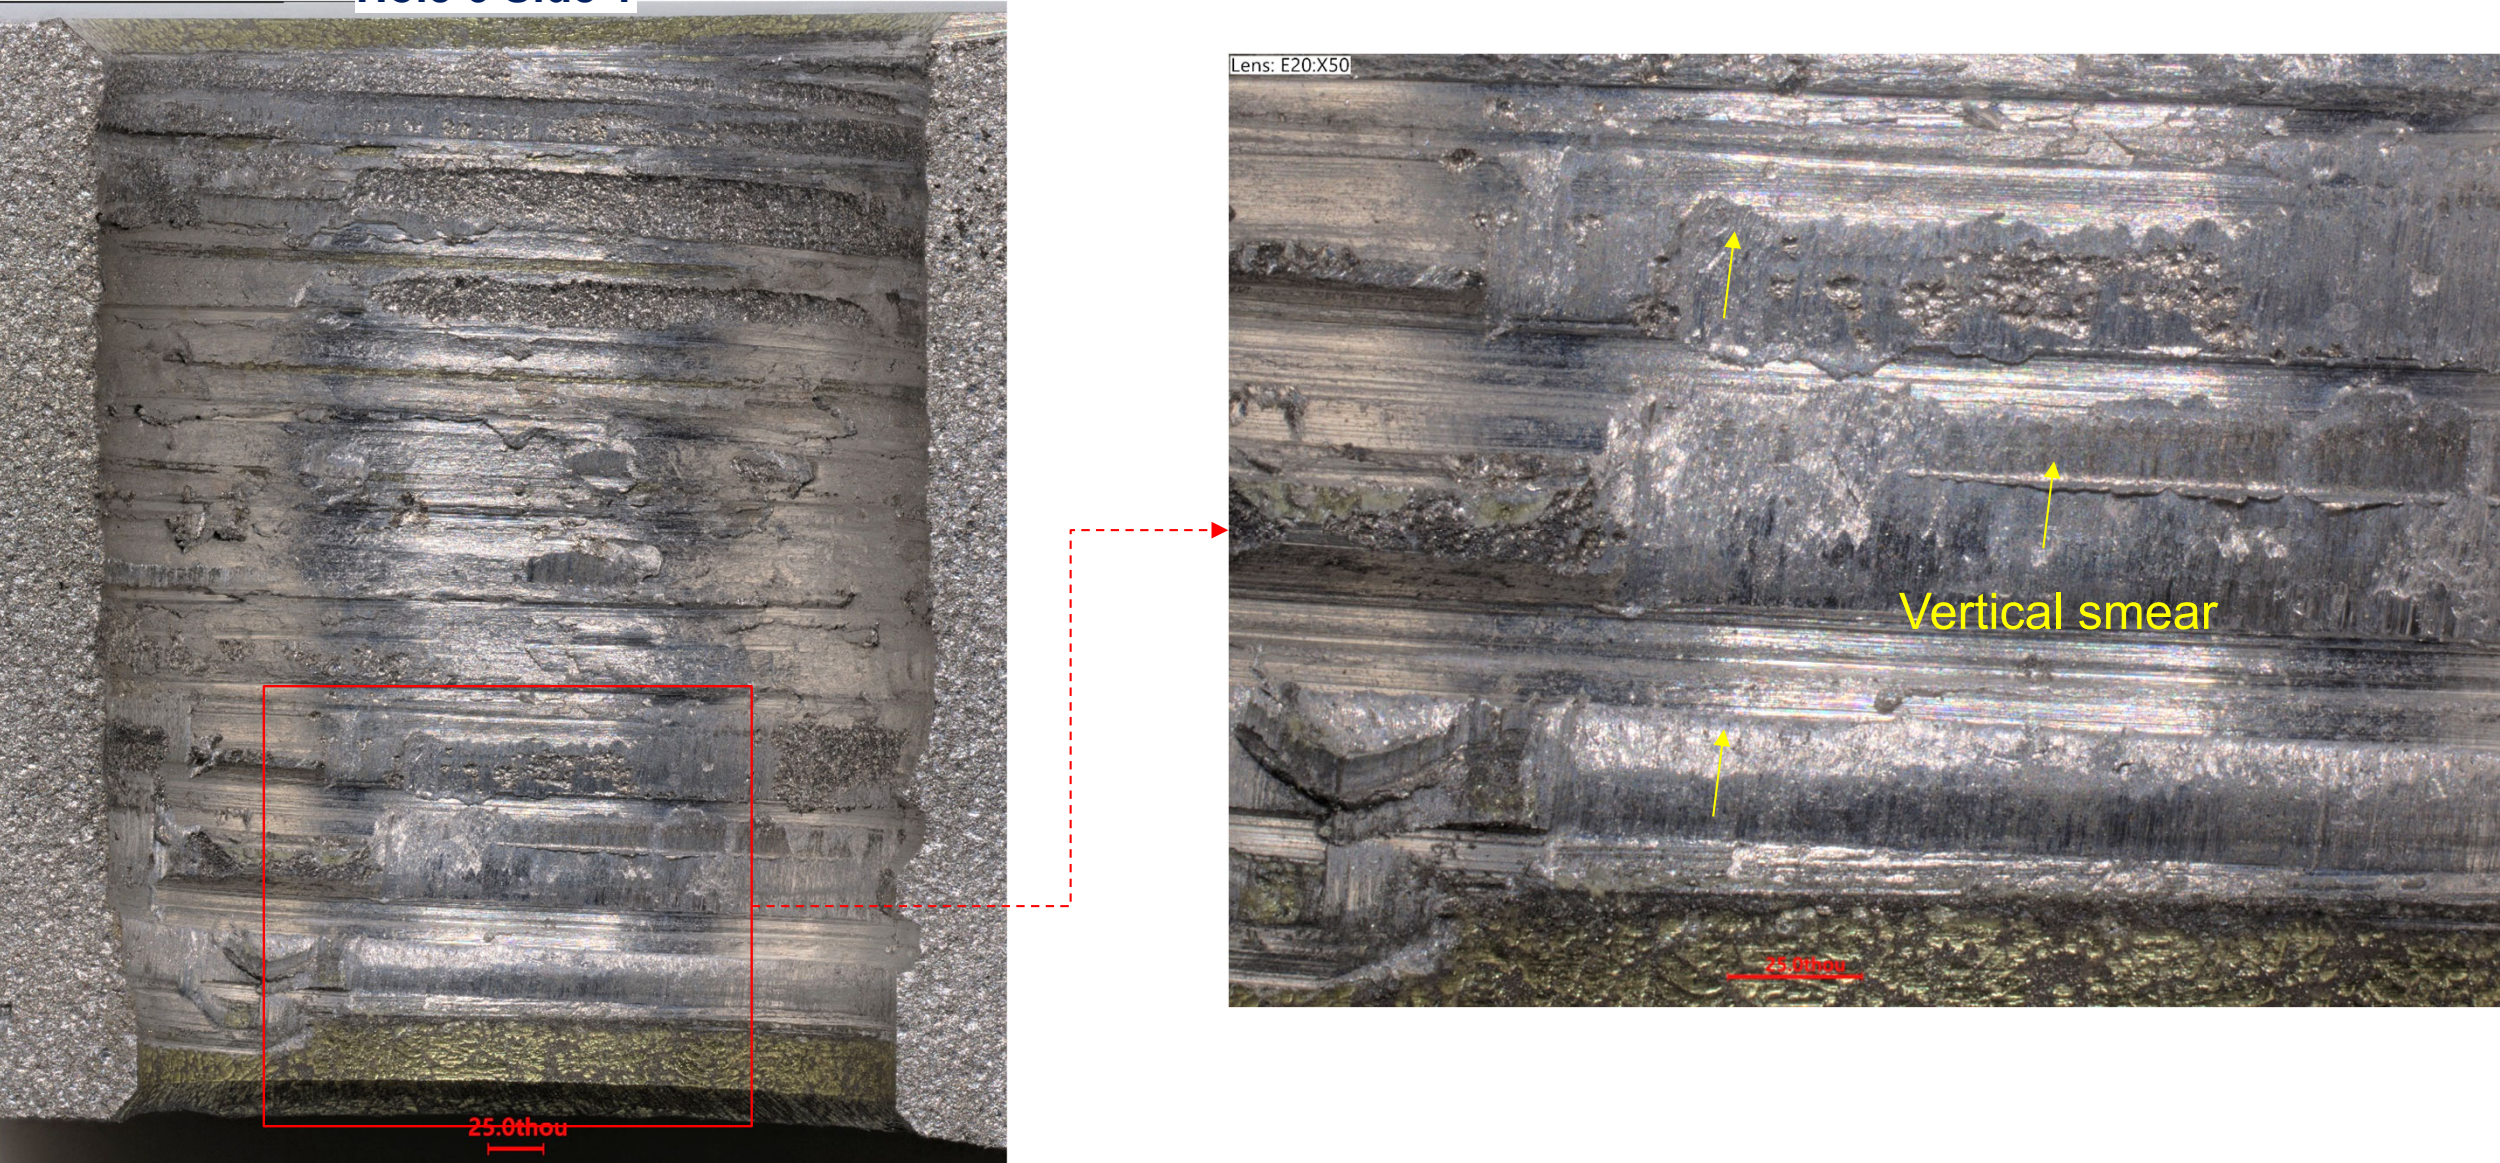
Hole 6 Side 1

**Figure 76:** Optical view of insert hole 6 reveals vertical smear lines consistent with the insert pulling out and overlapping smeared material consistent with CCW rotation.
