# **Metallurgical Investigation Report**

## **DRB: AvEng-561264.A**

**EVALUATION OF A CF6-80C2 ESN 707-605 HMU IDLER  
ADAPTER FROM ESN 707-605 OPERATED BY FEDEX  
INVOLVED IN AN IN-FLIGHT SHUT-DOWN AND  
UNDERCOWL FIRE EVENT**

Part Number: 9395M78G10  
Part Serial Number: FIA217EE  
Part TSN / CSN: 1,421 hrs / 728 cycles

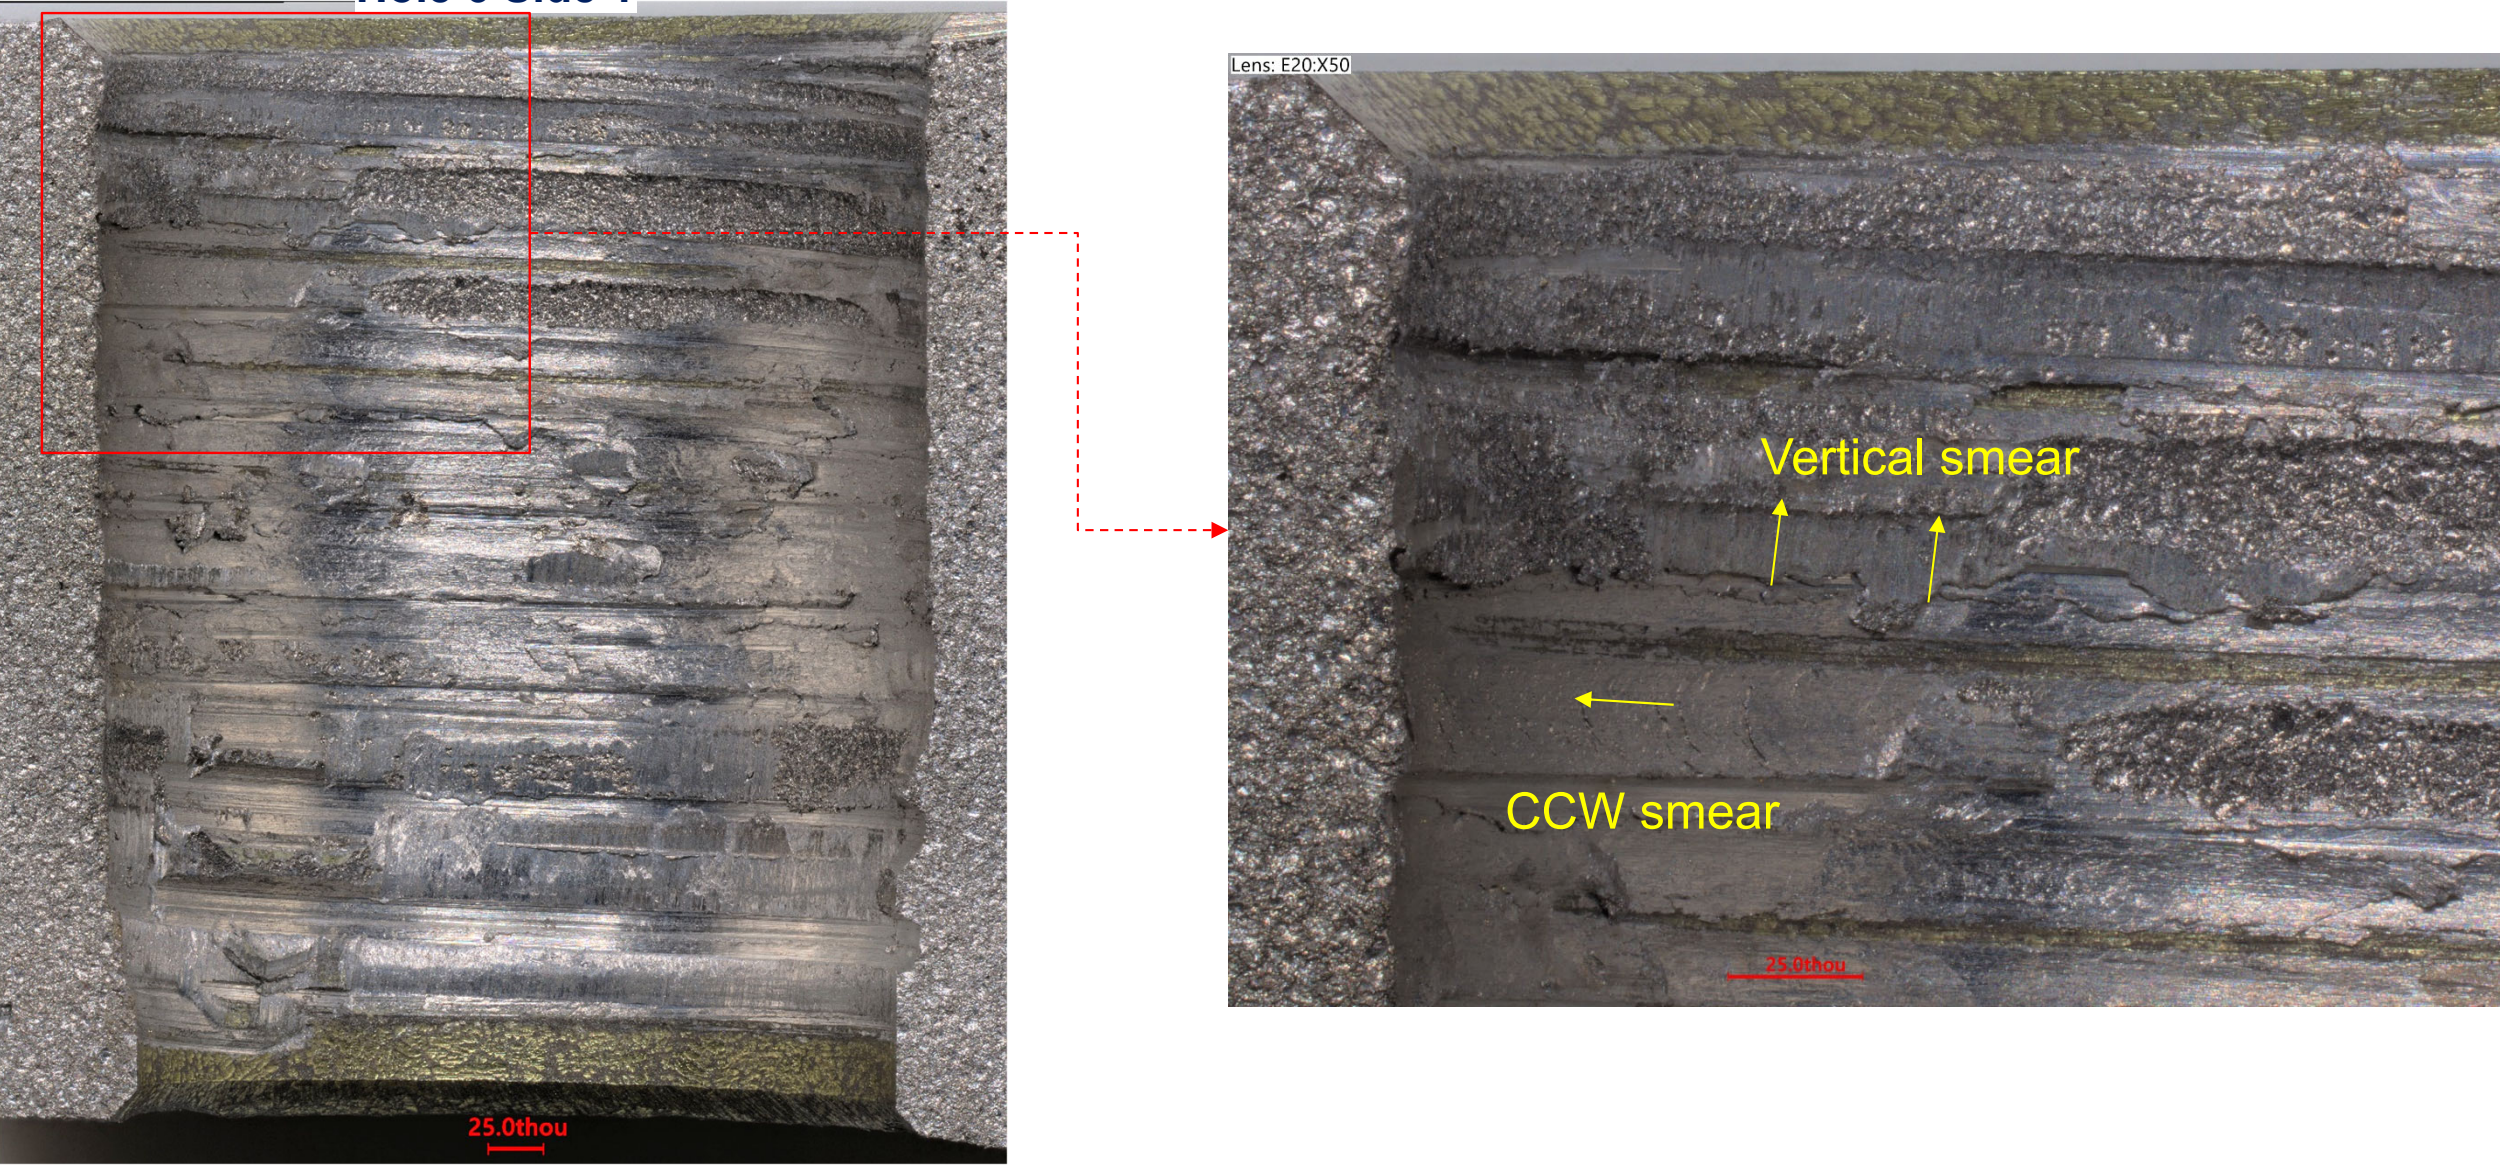
Hole 6 Side 1

**Figure 77:** Optical view of insert hole 6 reveals vertical smear lines consistent with the insert pulling out and overlapping smeared material consistent with CCW rotation.

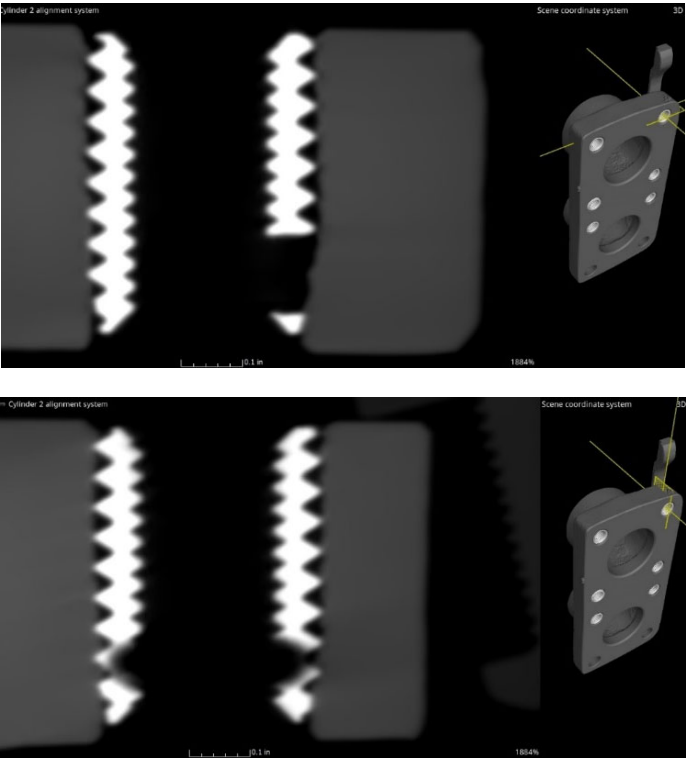
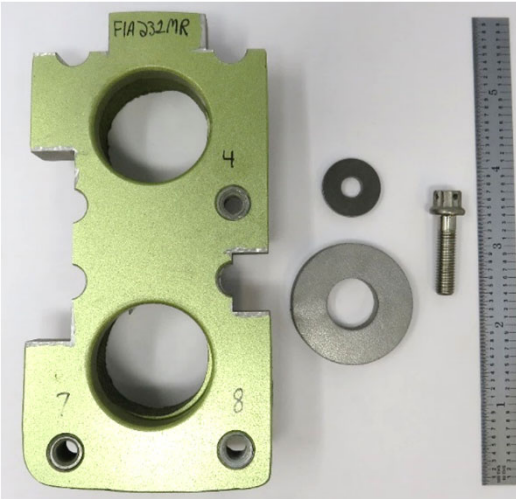
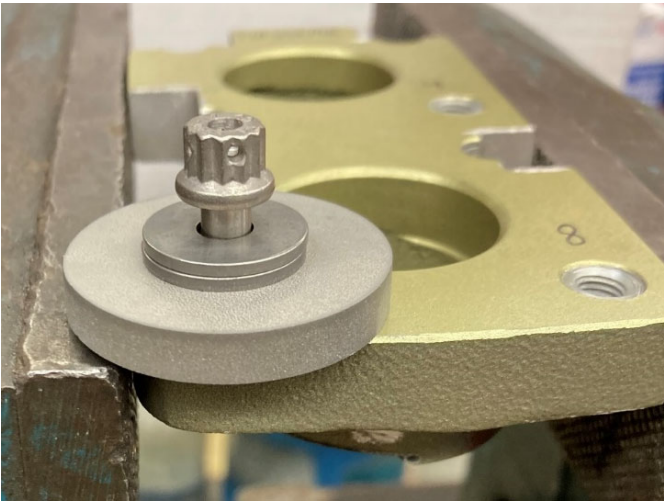
**Figure 78:** The SB 72-1577 pull out test was performed on insert location 7. The SB 72-1577 pull out test requires inserting a 1/4-28 bolt (PN MS9566) into the threaded insert and torquing to 190 – 210 in-lb. Prior to the test, insert 7 was measured to be 0.009-inches below the flange surface. During the test, the torque was slowly increased and experienced a torque drop at 150 in-lbs. The test fixture was removed, and the insert was found protruding 0.014-inches above the flange surface.

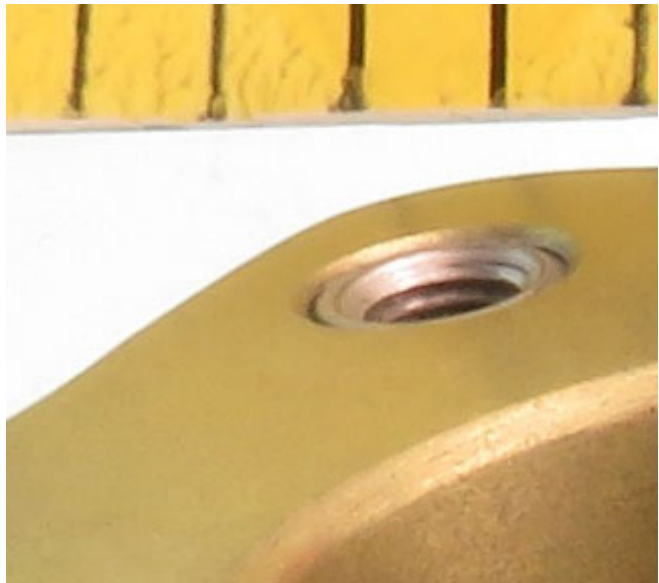
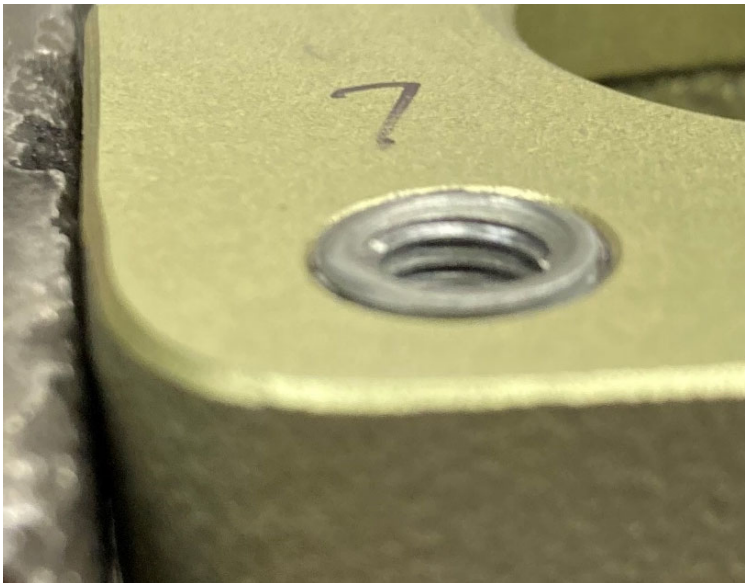
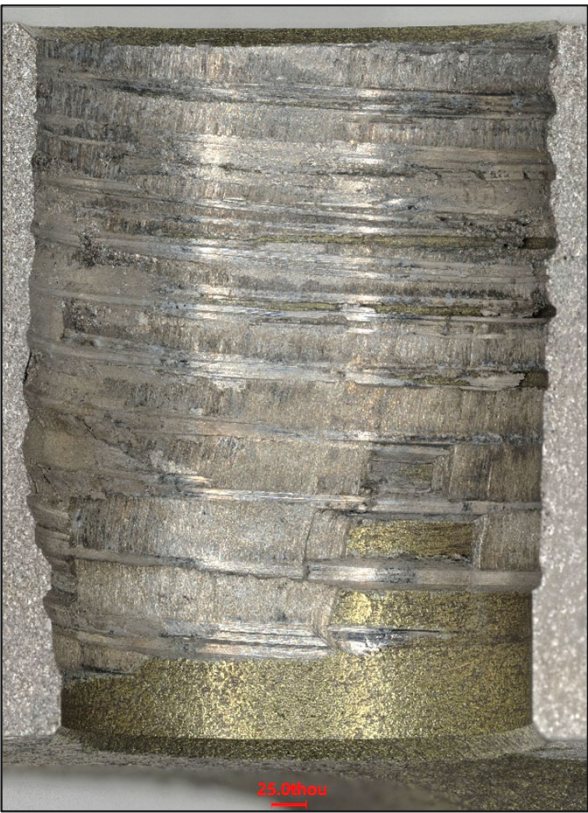
FIA231MR  
Hole 7 (Post Pull Out Test)

**Figure 79:** Images of insert 7 before and after the pull-out test show it started 0.009-inches below the flange surface and was pulled out to 0.014-inches above the flange surface during the test (0.023-inches of total vertical movement). The insert location was sectioned in half. Optical views (right) show the insert has similar vertical scoring lines as the event engine insert locations 2 and 3.

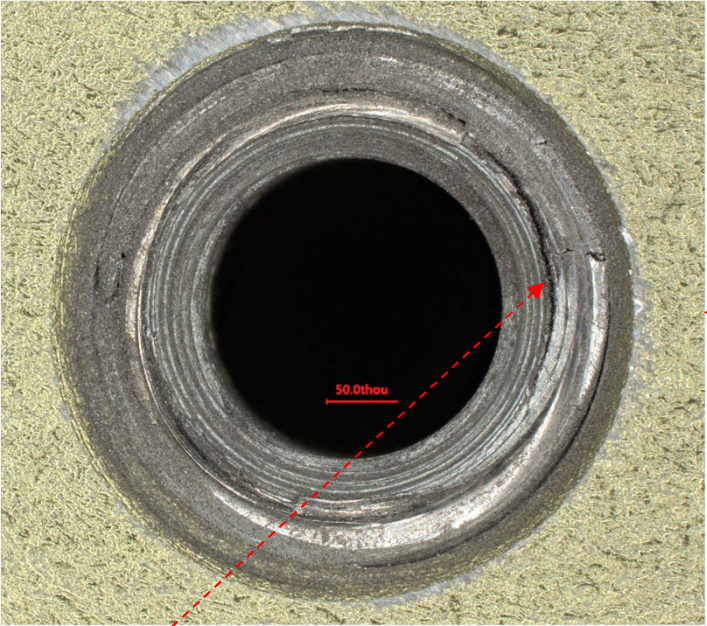
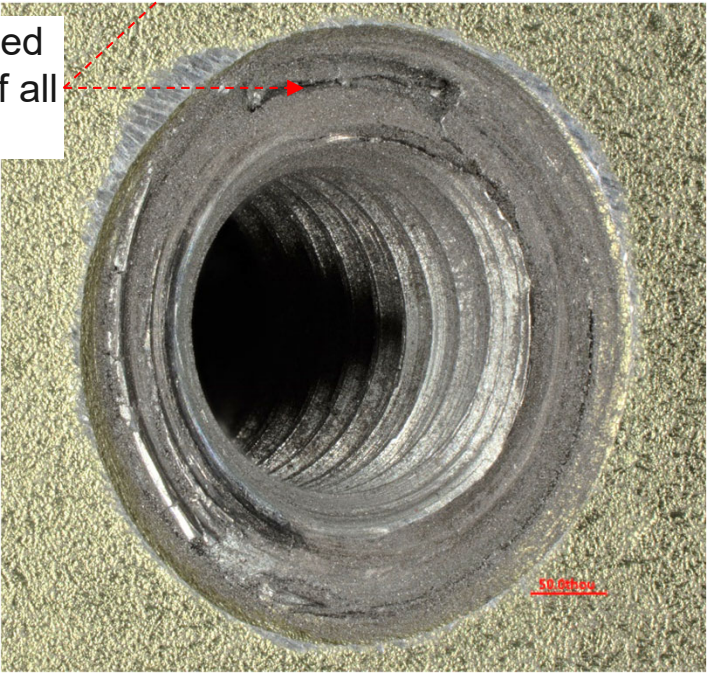
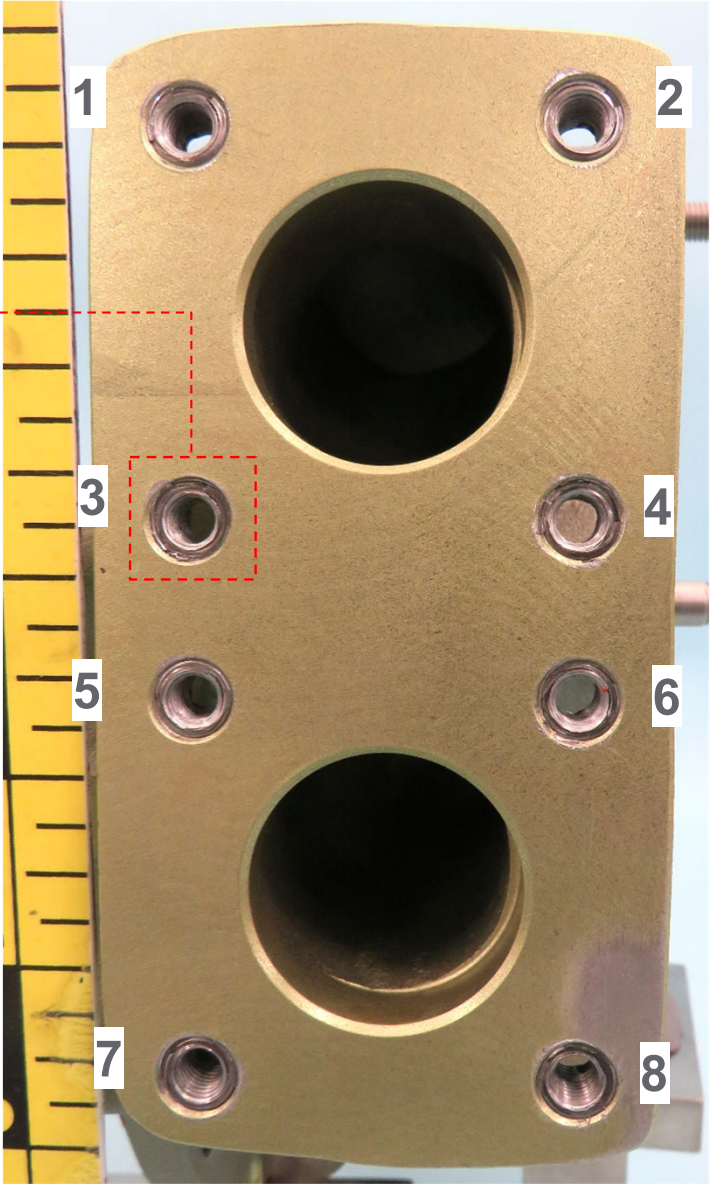
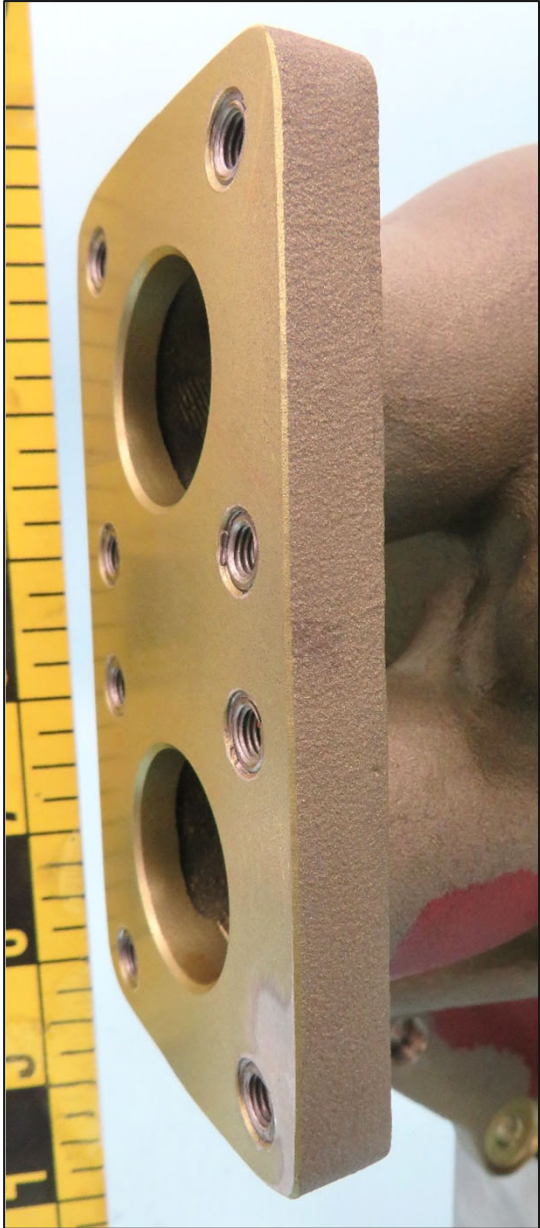
Cracks are observed in the top thread of all eight steel inserts

**Figure 81:** Images show none of the eight inserts were protruding from the flange surface. The top thread of all eight steel inserts are cracked.

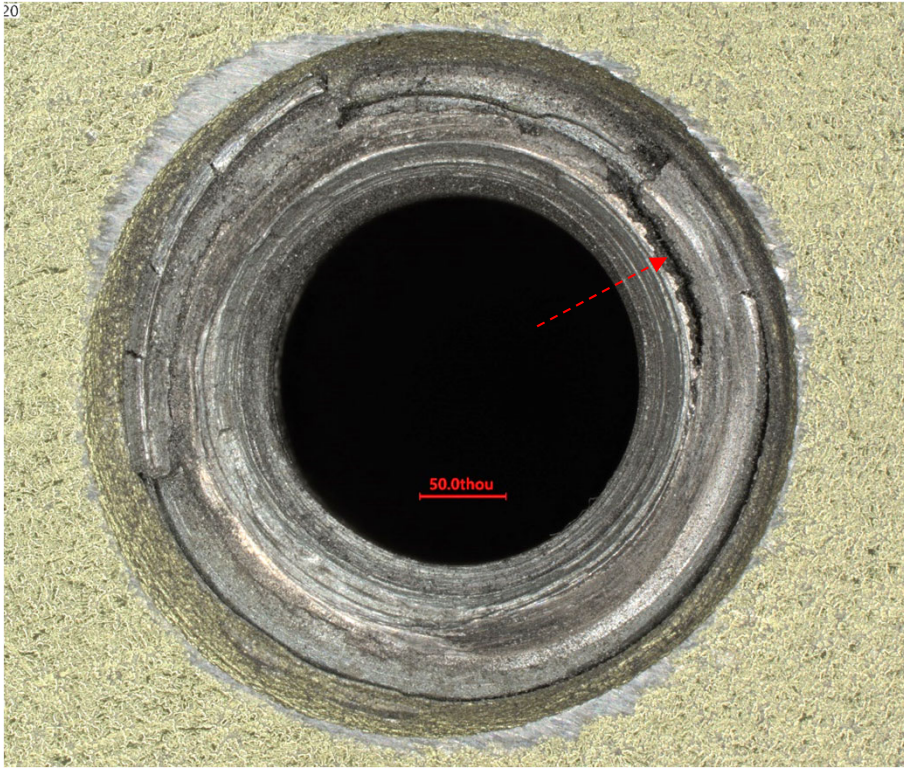
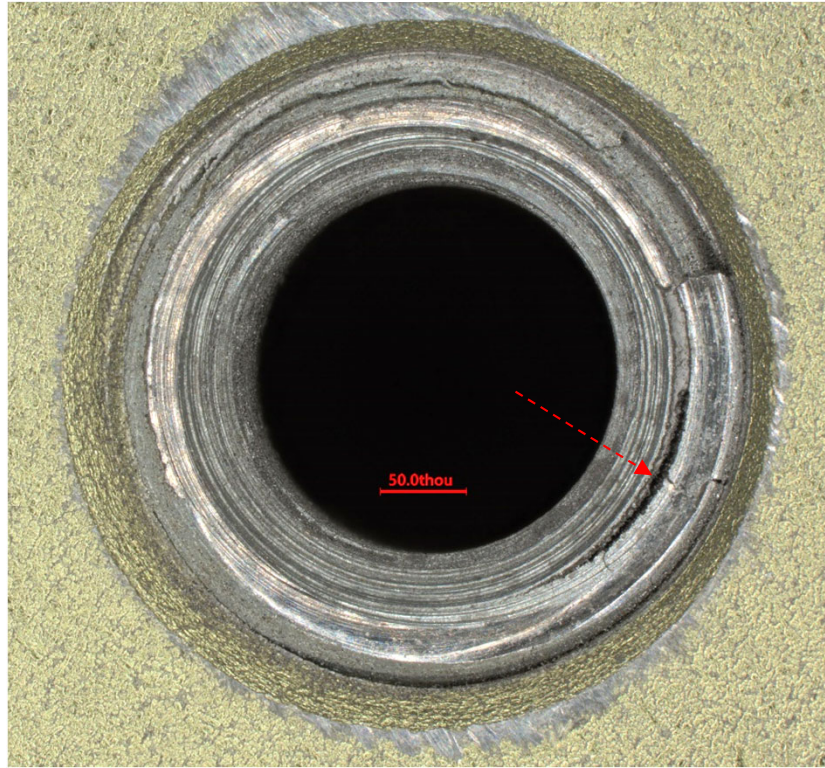
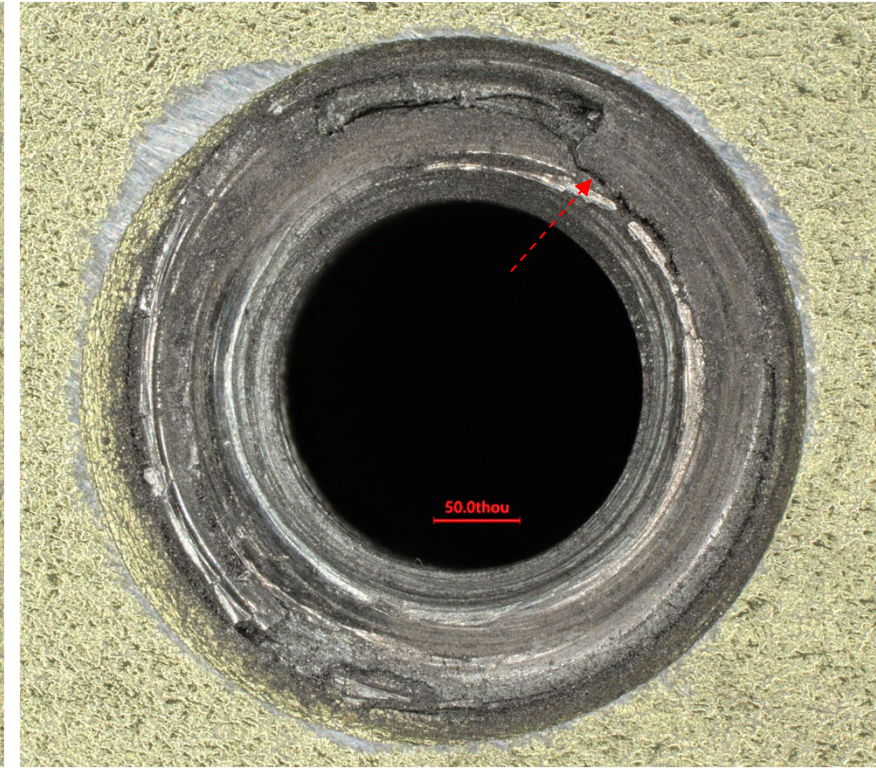
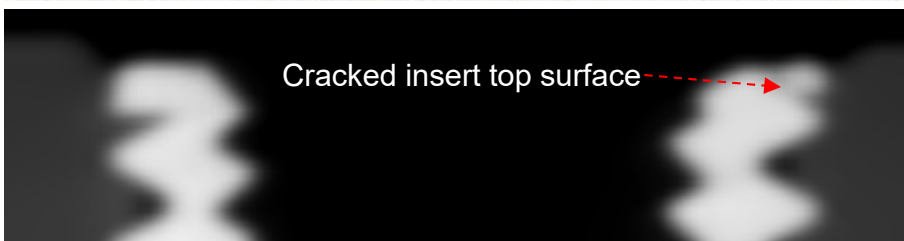
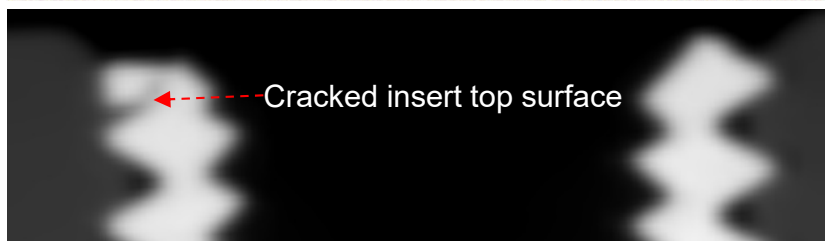
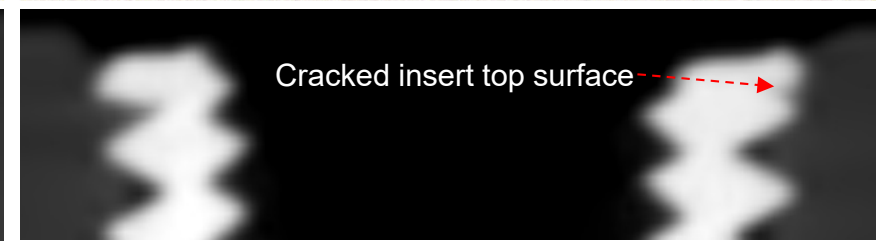
**Figure 82:** All eight steel inserts are cracked at the top surface. Images of inserts 1, 2, and 3 above show the crack locations. The CT scans reveal the cracks do not extent beyond the top insert thread.

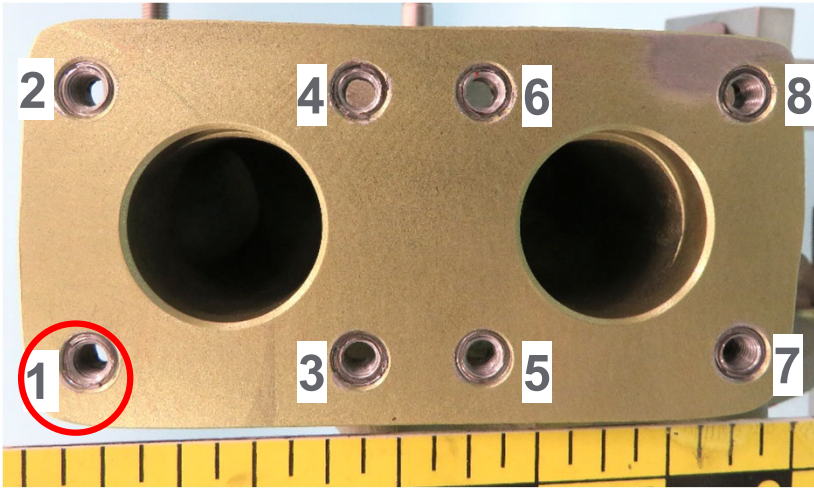
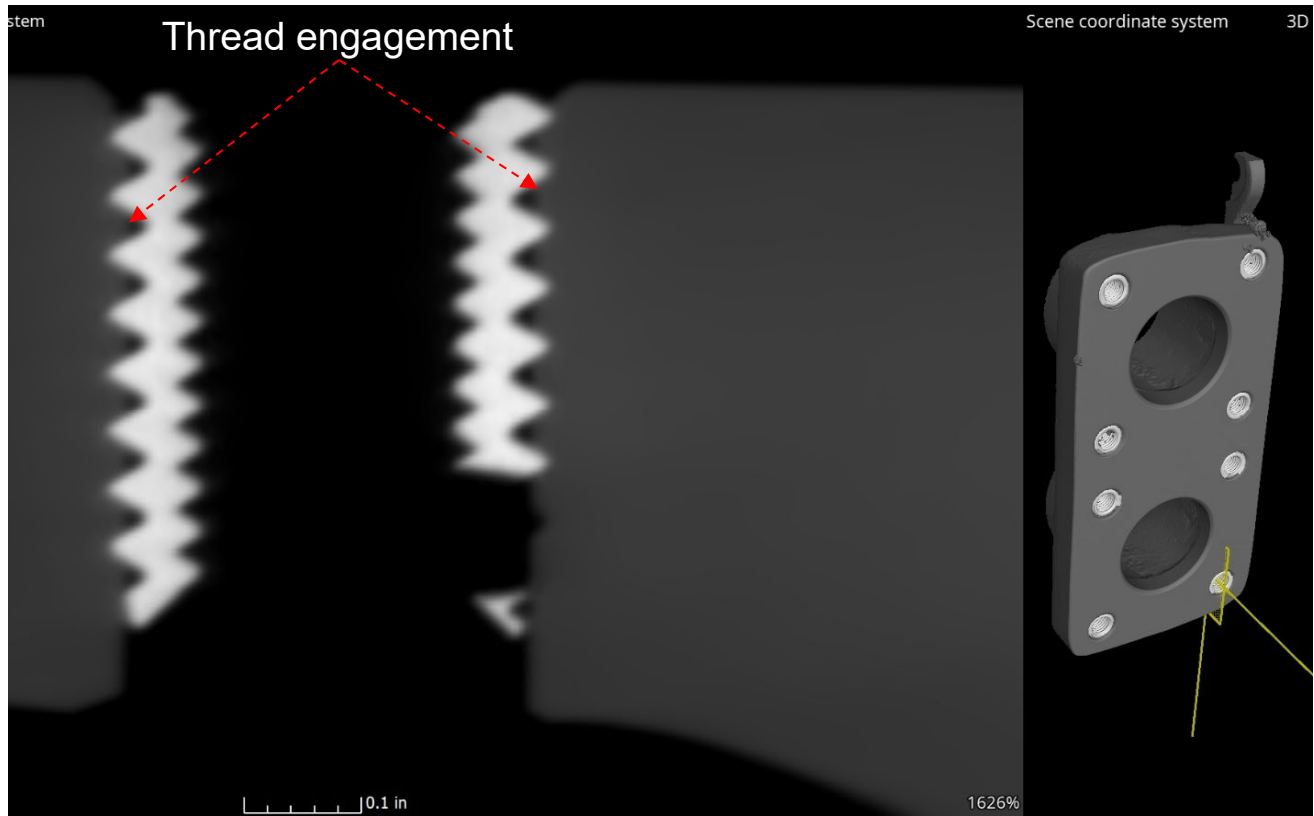
Insert 1

**Figure 83:** CT scan cross-section of thread insert position 1. Thread engagement is observed into the flange material.

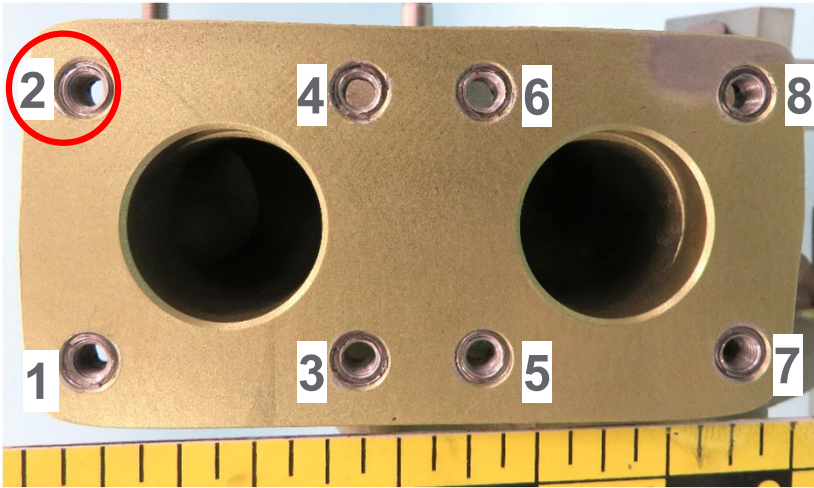
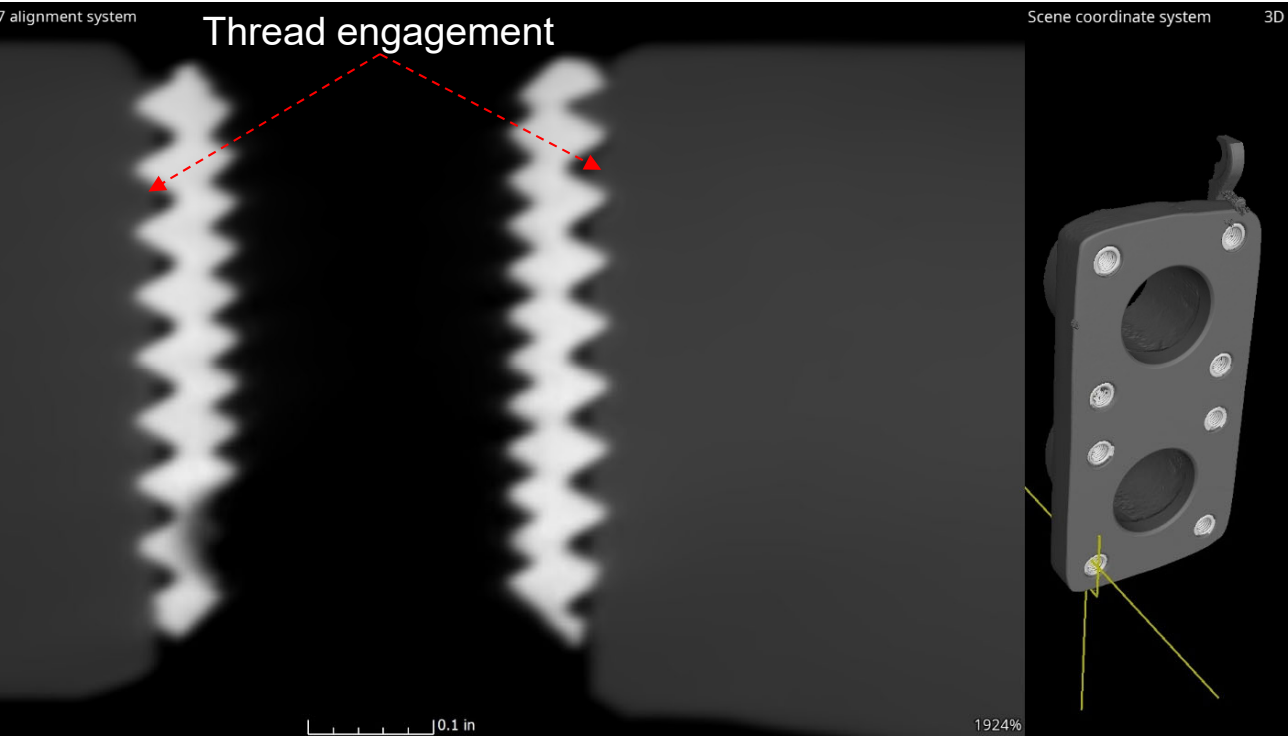
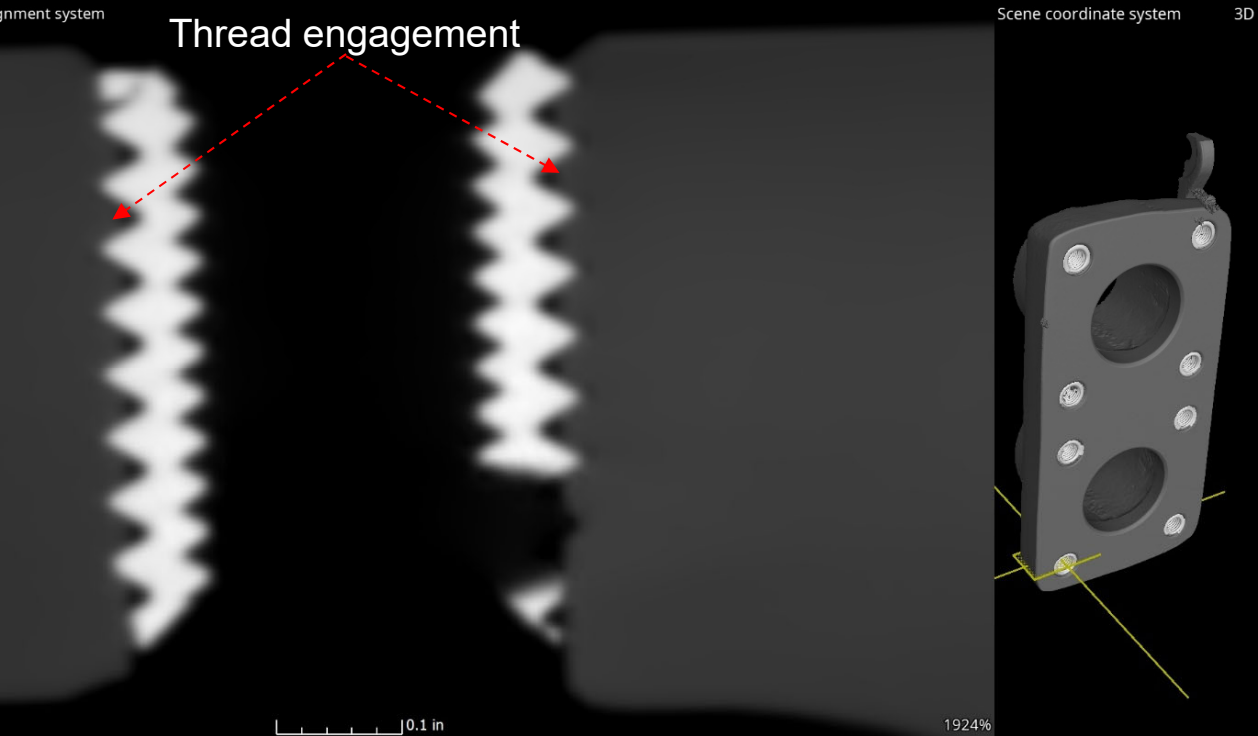
Insert 2

Figure 84: CT scan cross-section of thread insert position 2. Thread engagement is observed into the flange material.

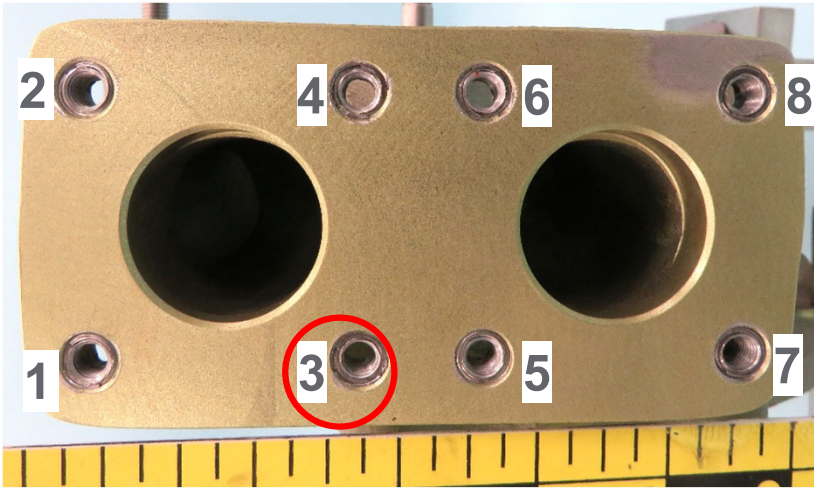
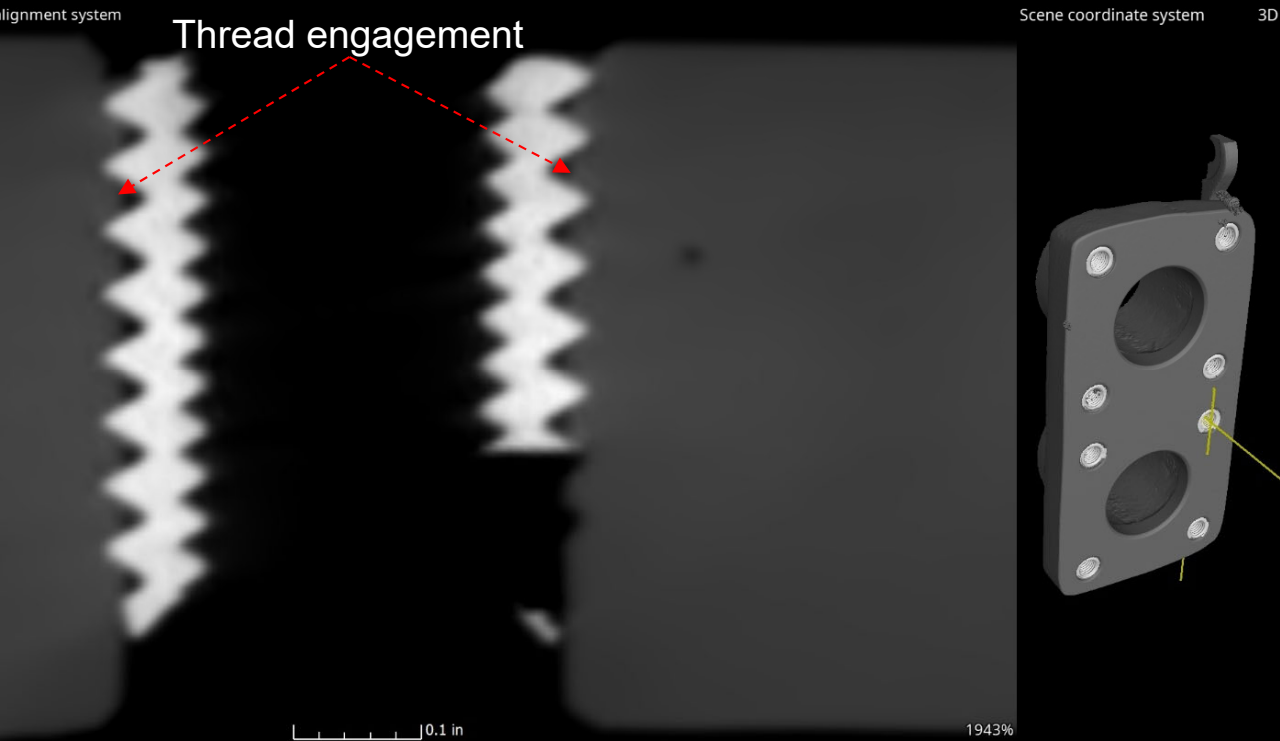
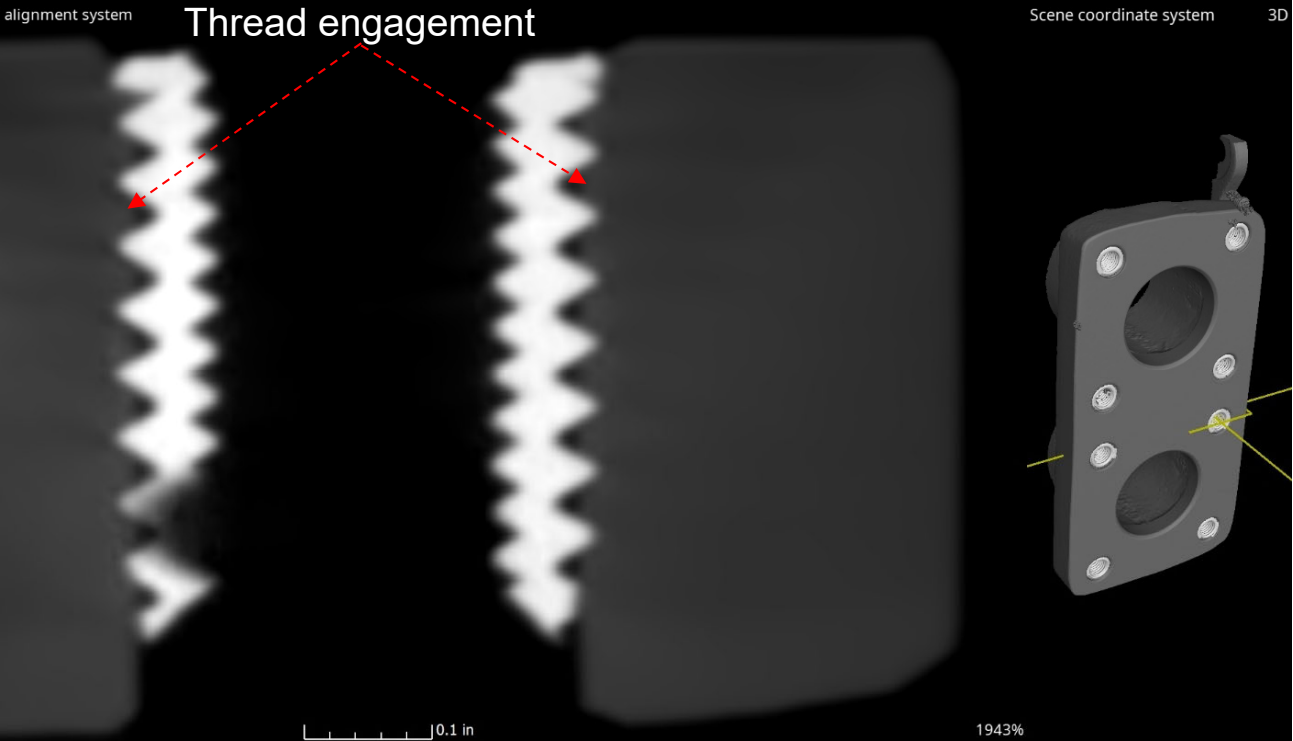
Insert 3

Figure 85: CT scan cross-section of thread insert position 3. Thread engagement is observed into the flange material.

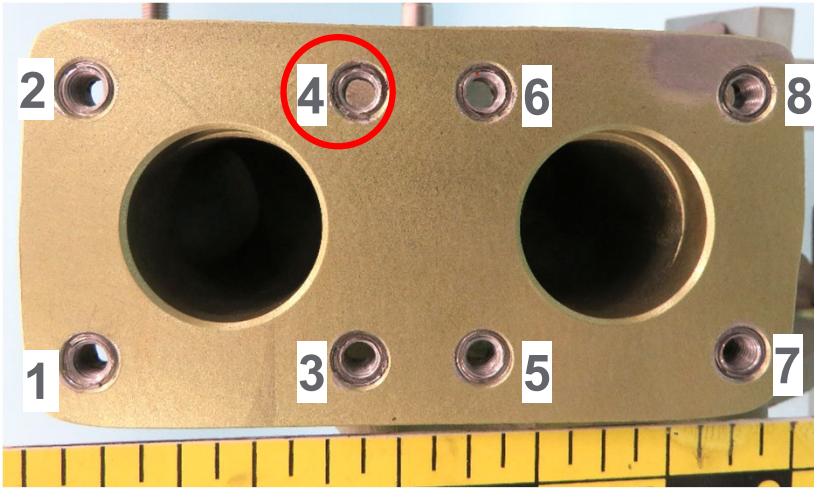
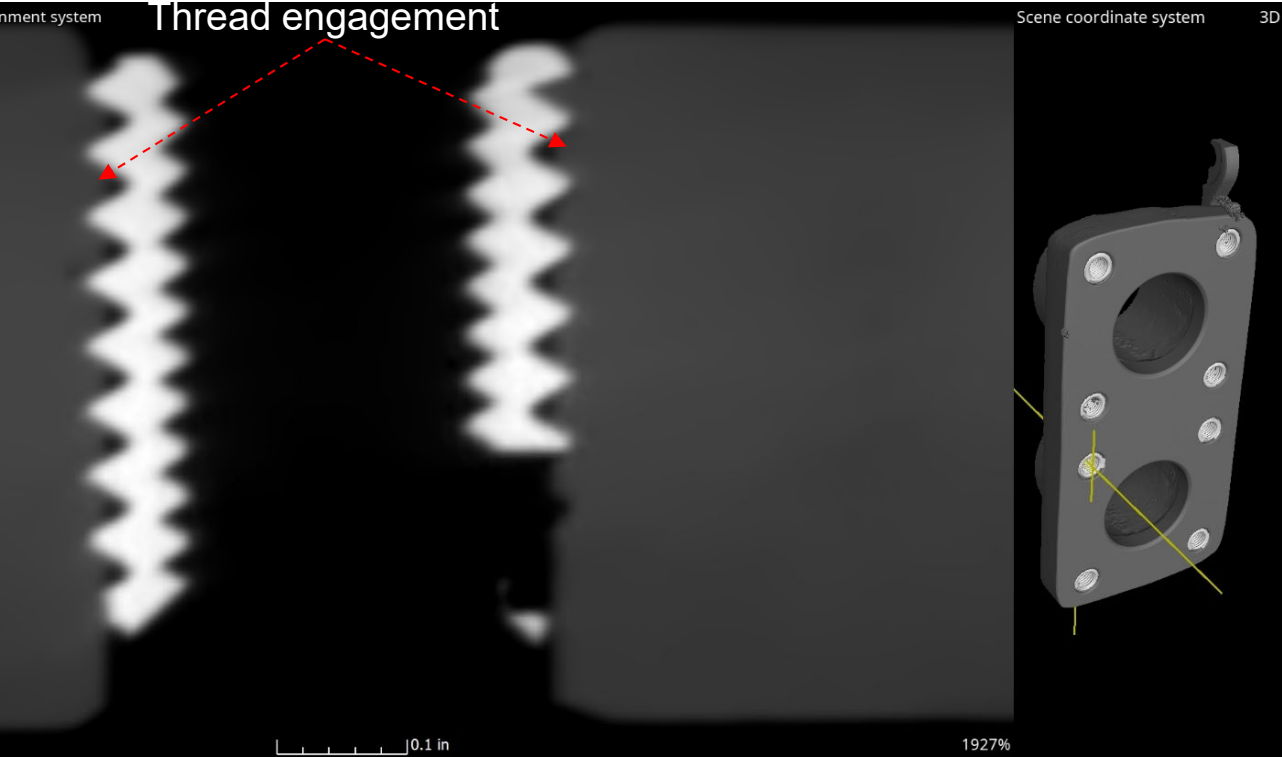
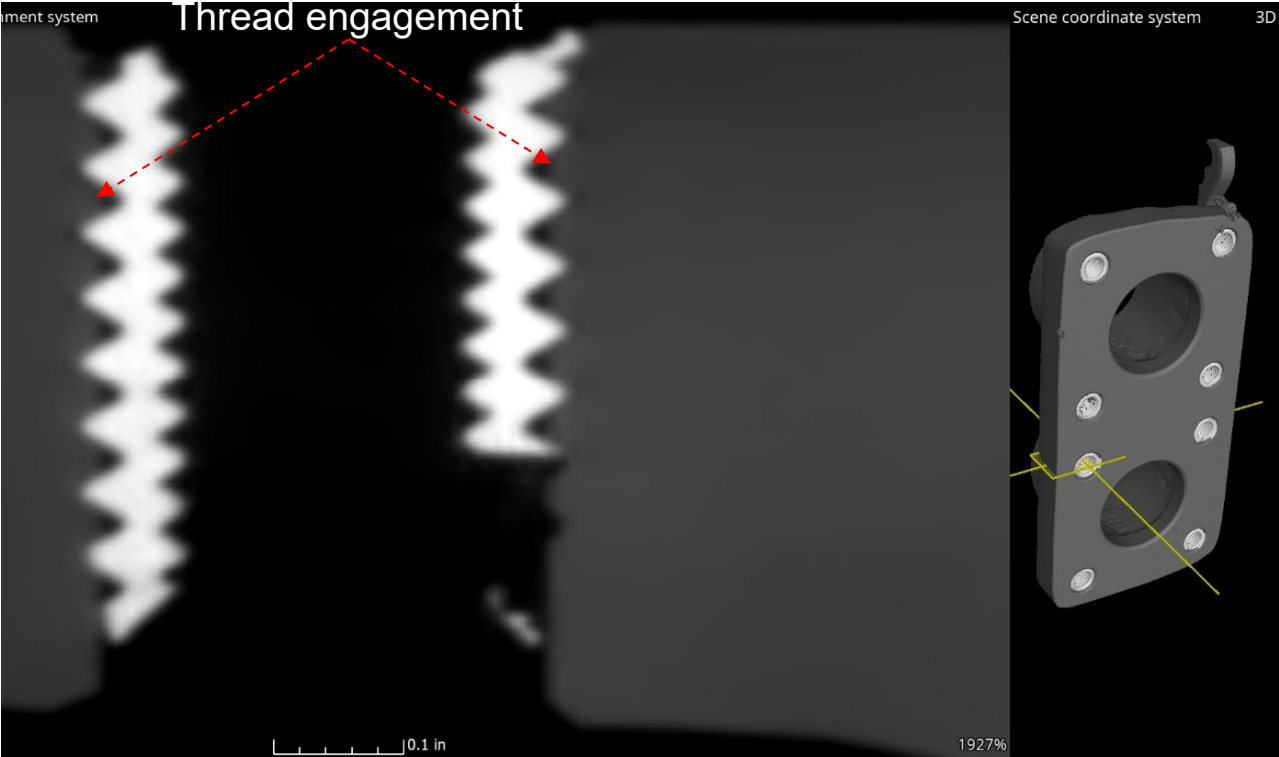
Insert 4

**Figure 86:** CT scan cross-section of thread insert position 4. Thread engagement is observed into the flange material.

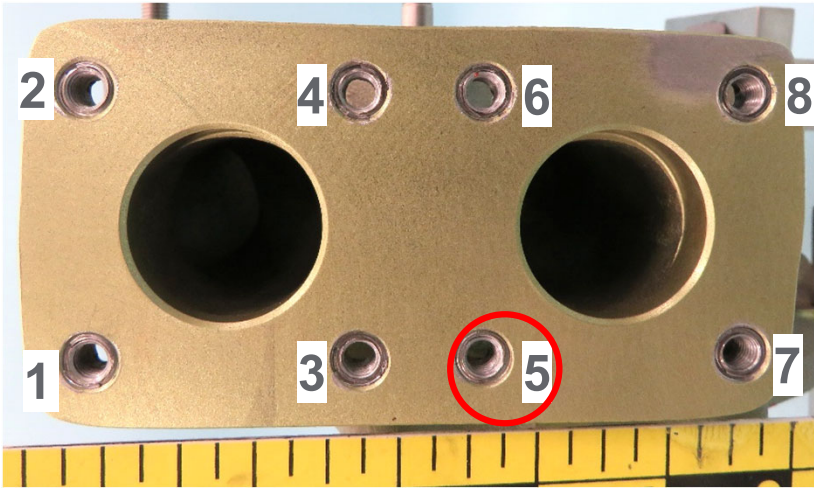
Insert 5

Figure 87: CT scan cross-section of thread insert position 5. Thread engagement is observed into the flange material.

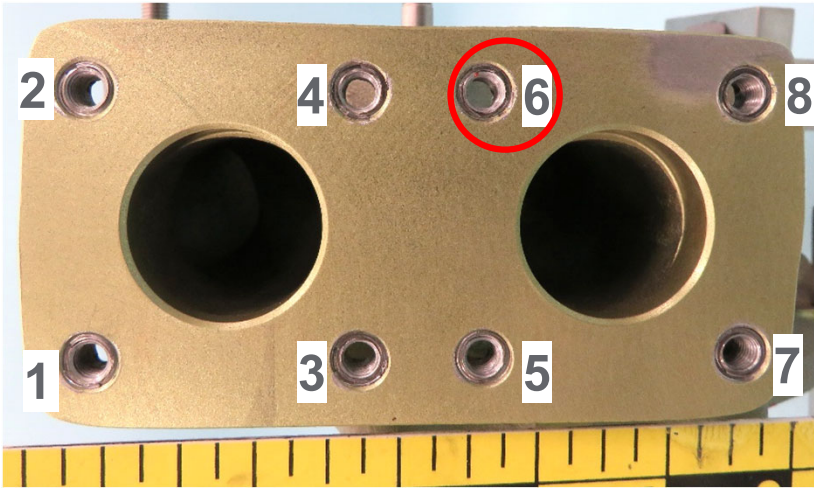
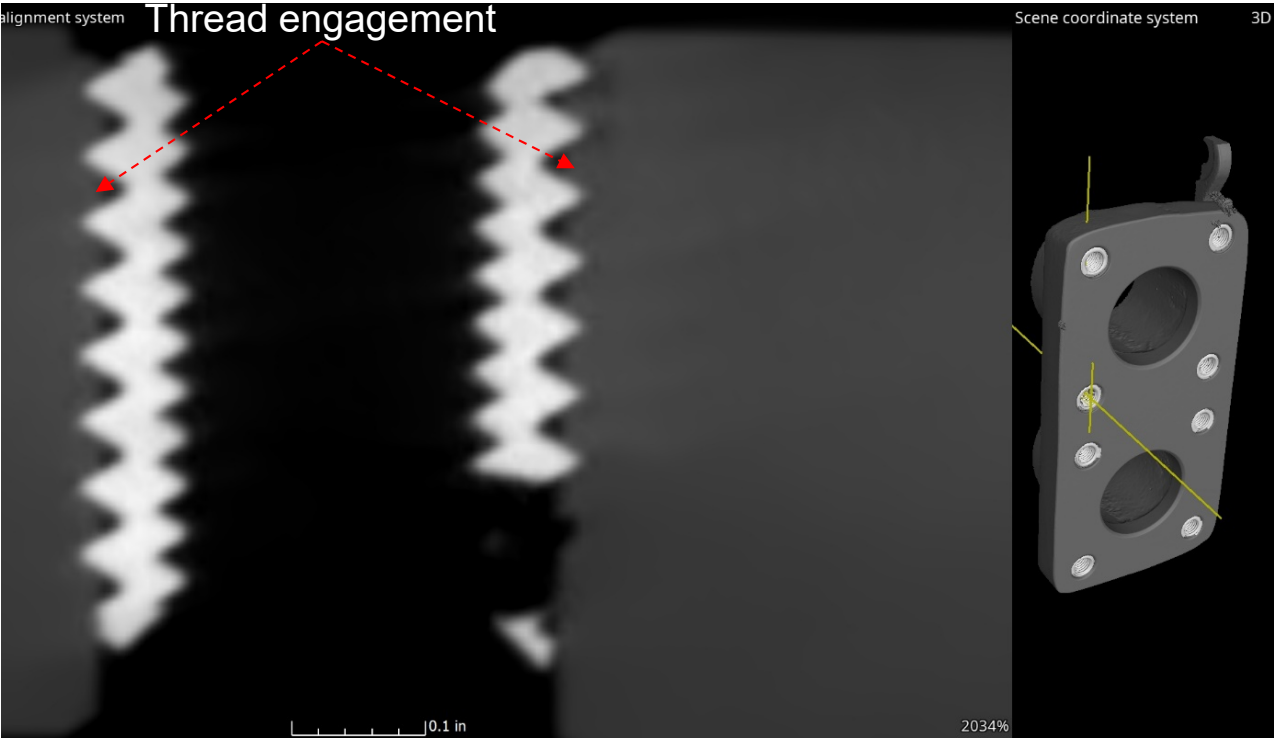
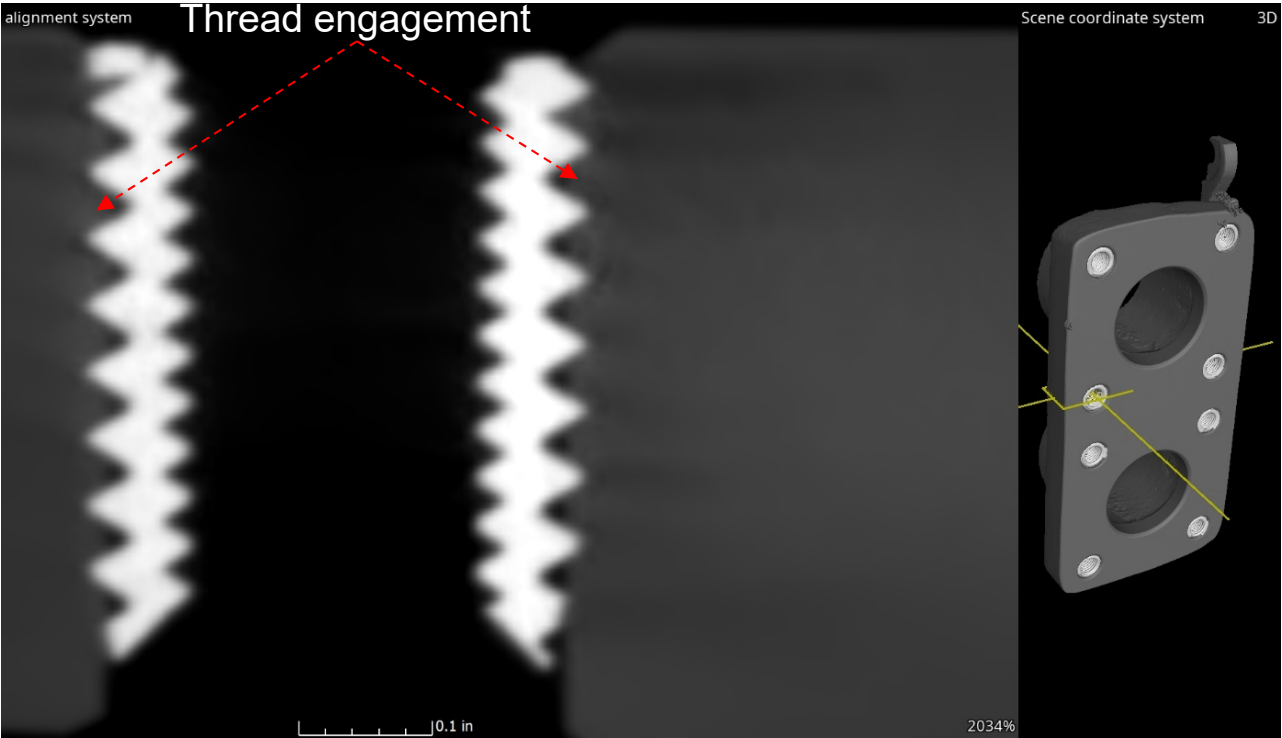
Insert 6

Figure 88: CT scan cross-section of thread insert position 6. Thread engagement is observed into the flange material.
