# **Metallurgical Investigation Report**

## **DRB: AvEng-561264.A**

**EVALUATION OF A CF6-80C2 ESN 707-605 HMU IDLER  
ADAPTER FROM ESN 707-605 OPERATED BY FEDEX  
INVOLVED IN AN IN-FLIGHT SHUT-DOWN AND  
UNDERCOWL FIRE EVENT**

Part Number: 9395M78G10  
Part Serial Number: FIA217EE  
Part TSN / CSN: 1,421 hrs / 728 cycles

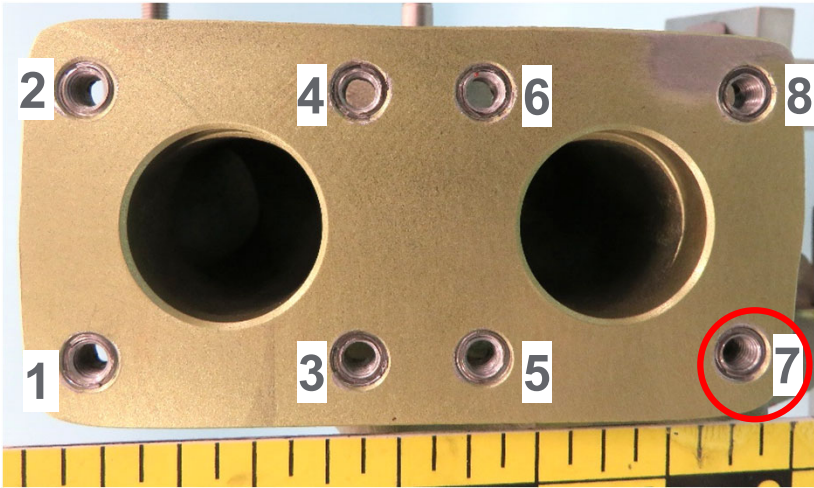
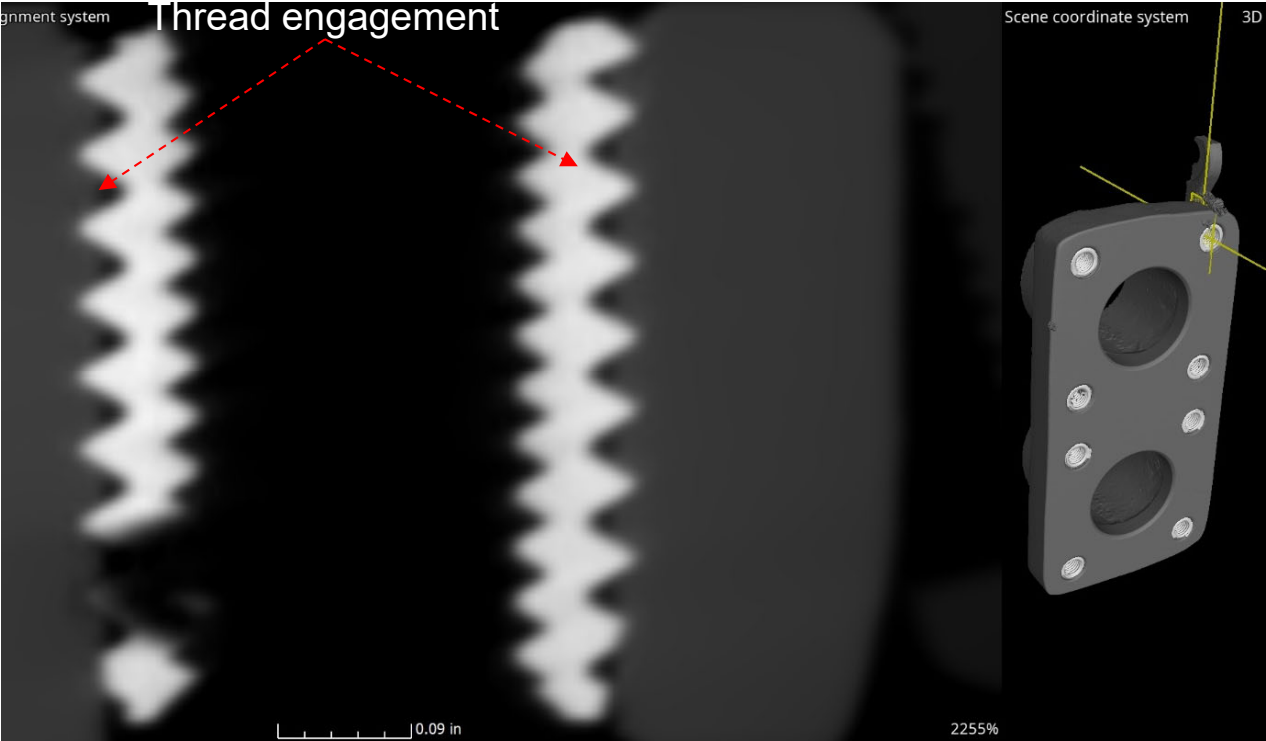
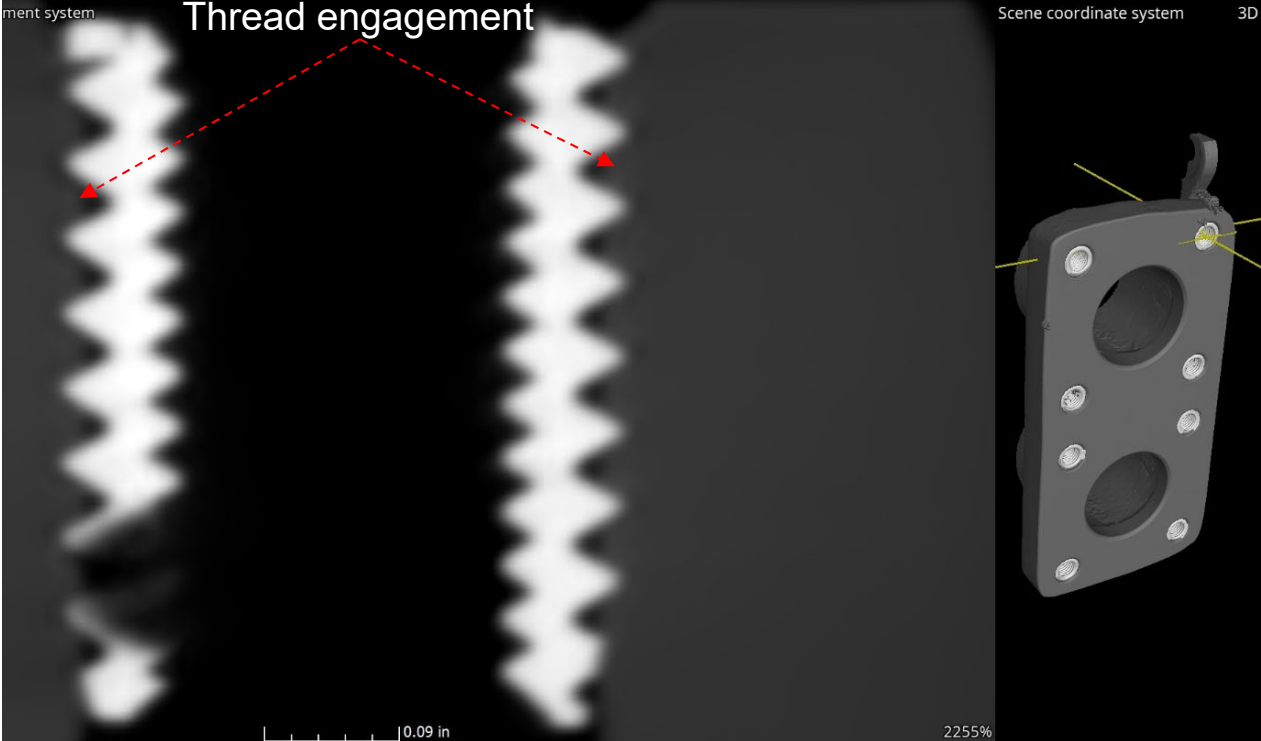
Insert 7

Figure 89: CT scan cross-section of thread insert position 7. Thread engagement is observed into the flange material.

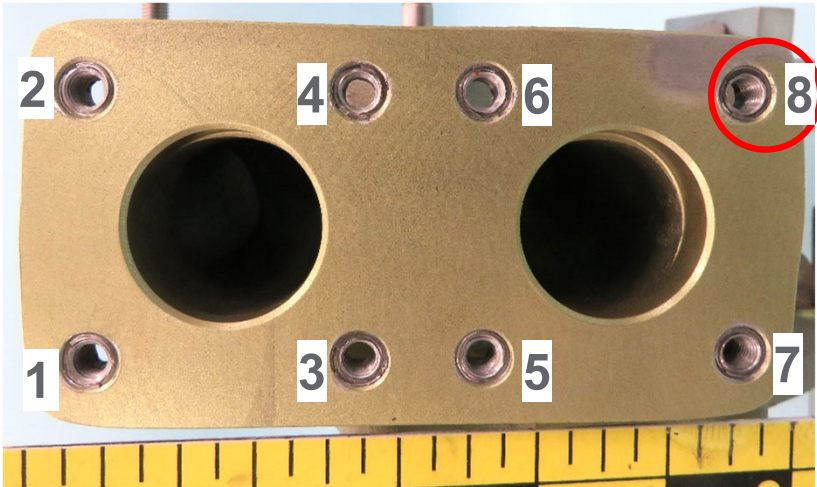
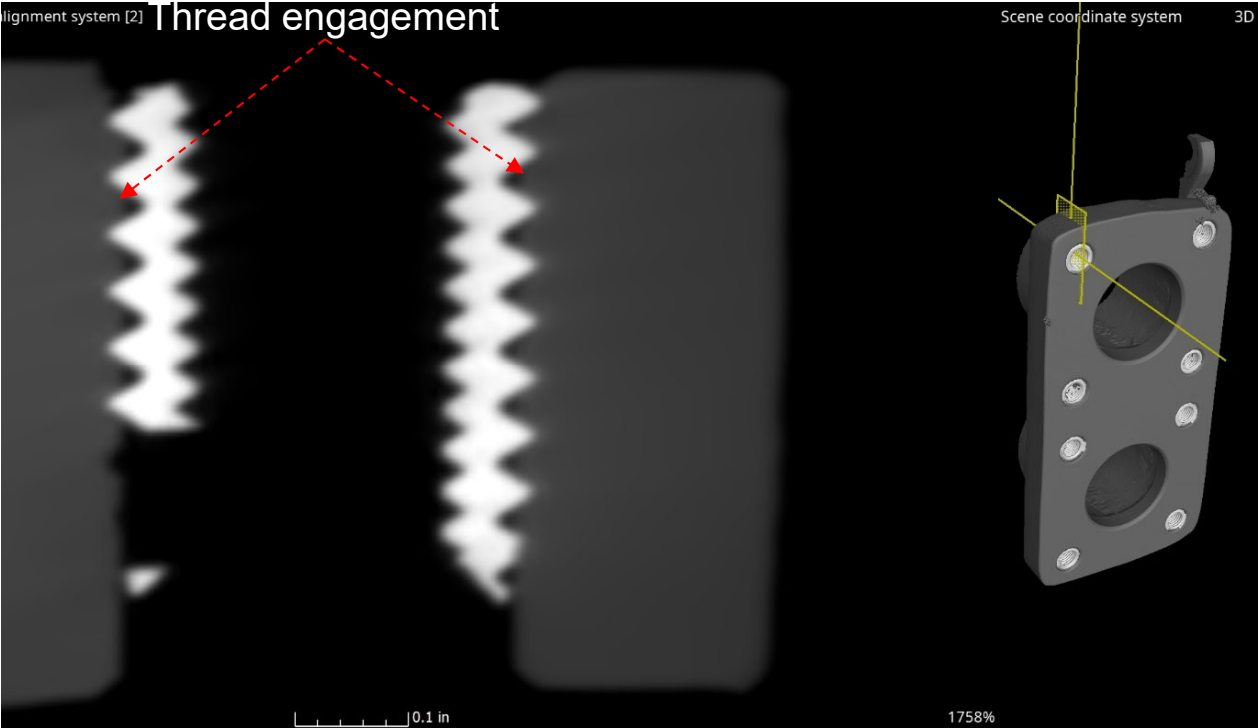
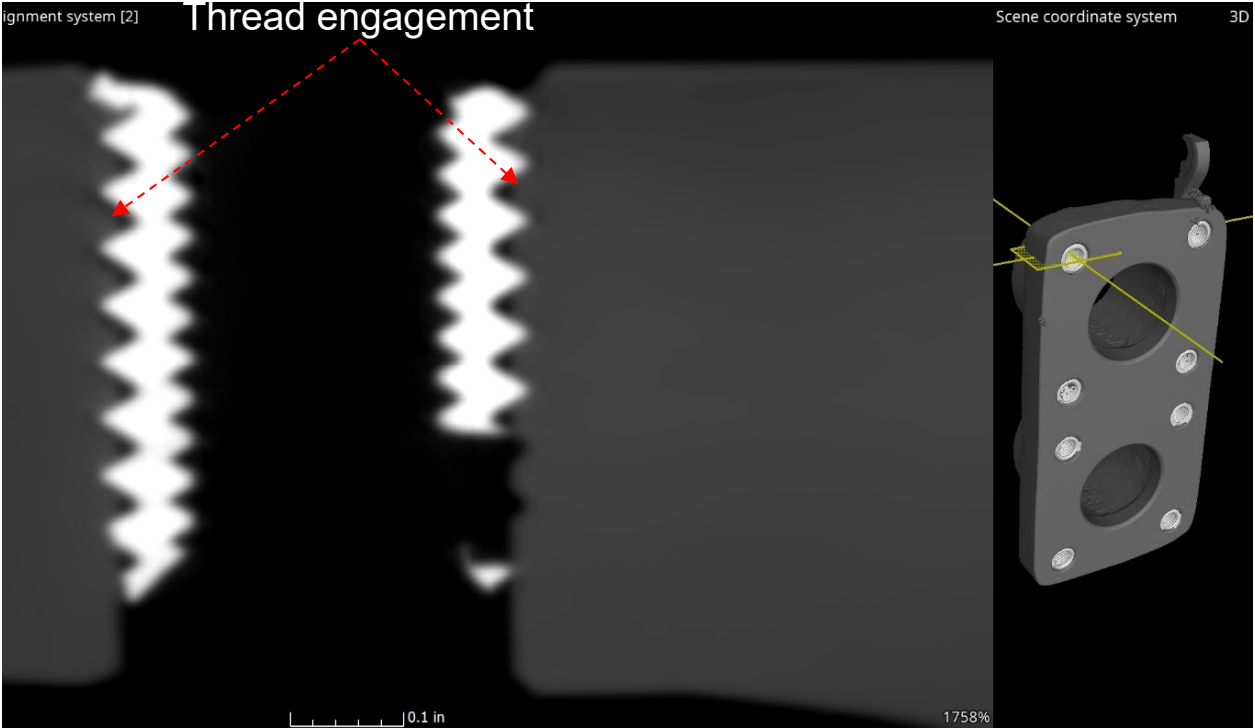
Insert 8

**Figure 90:** CT scan cross-section of thread insert position 8. Thread engagement is observed into the flange material.

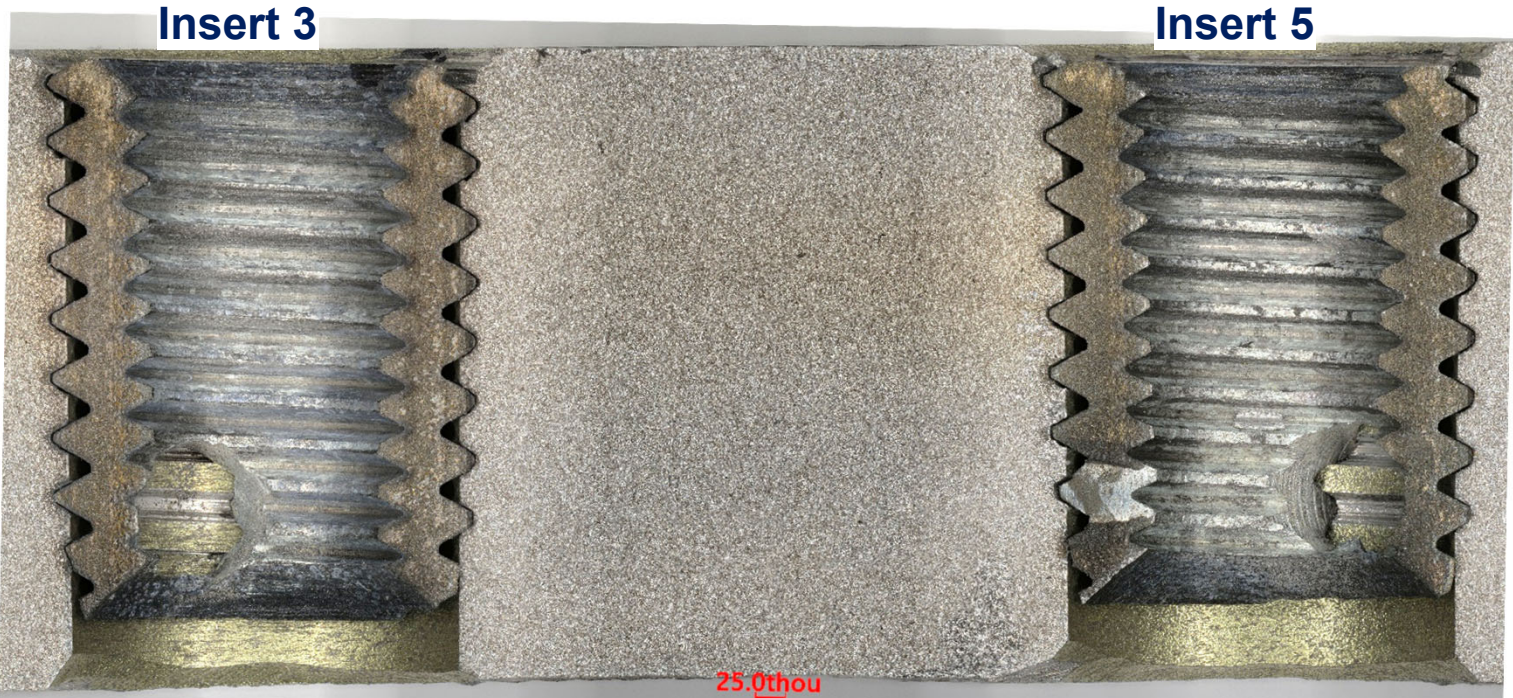
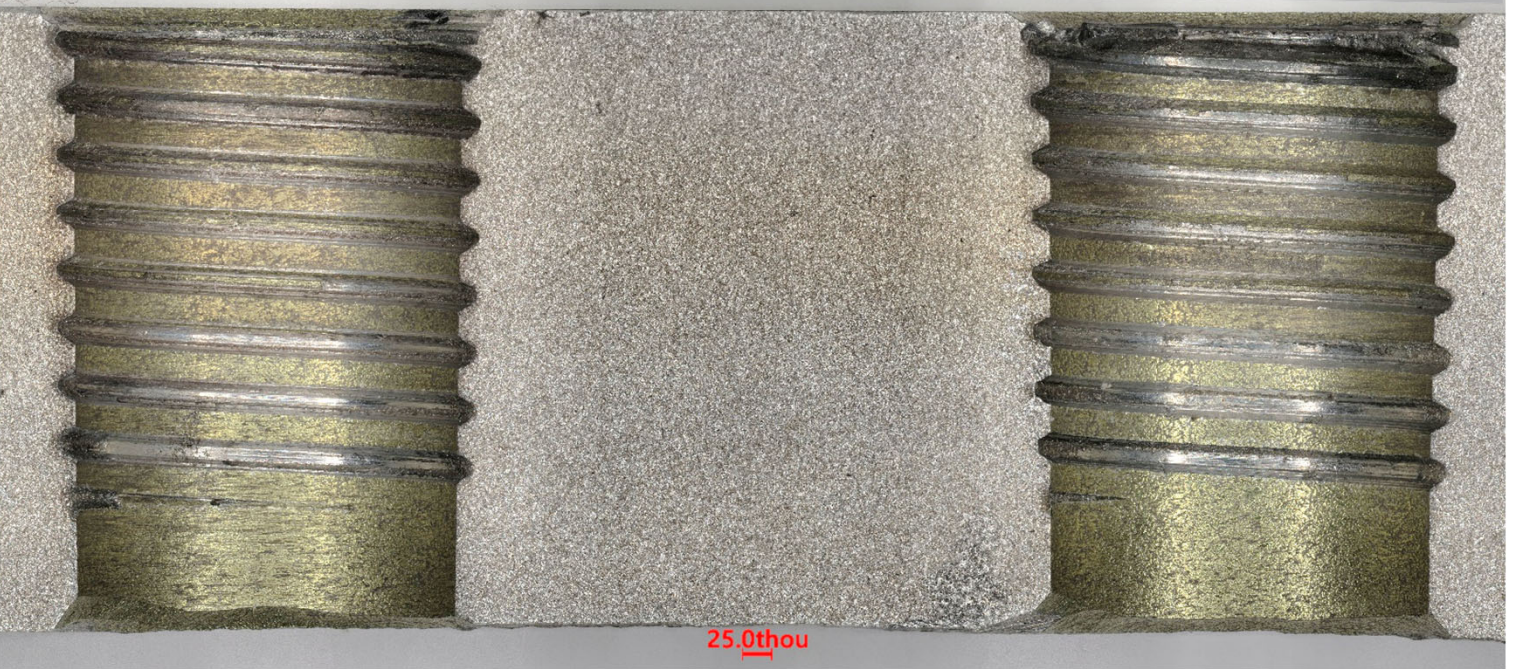
Inserts 3 and 5 cut in half  
with wire EDM

**Figure 91:** Optical views of insert locations 3 and 5 with the inserts in place and removed.

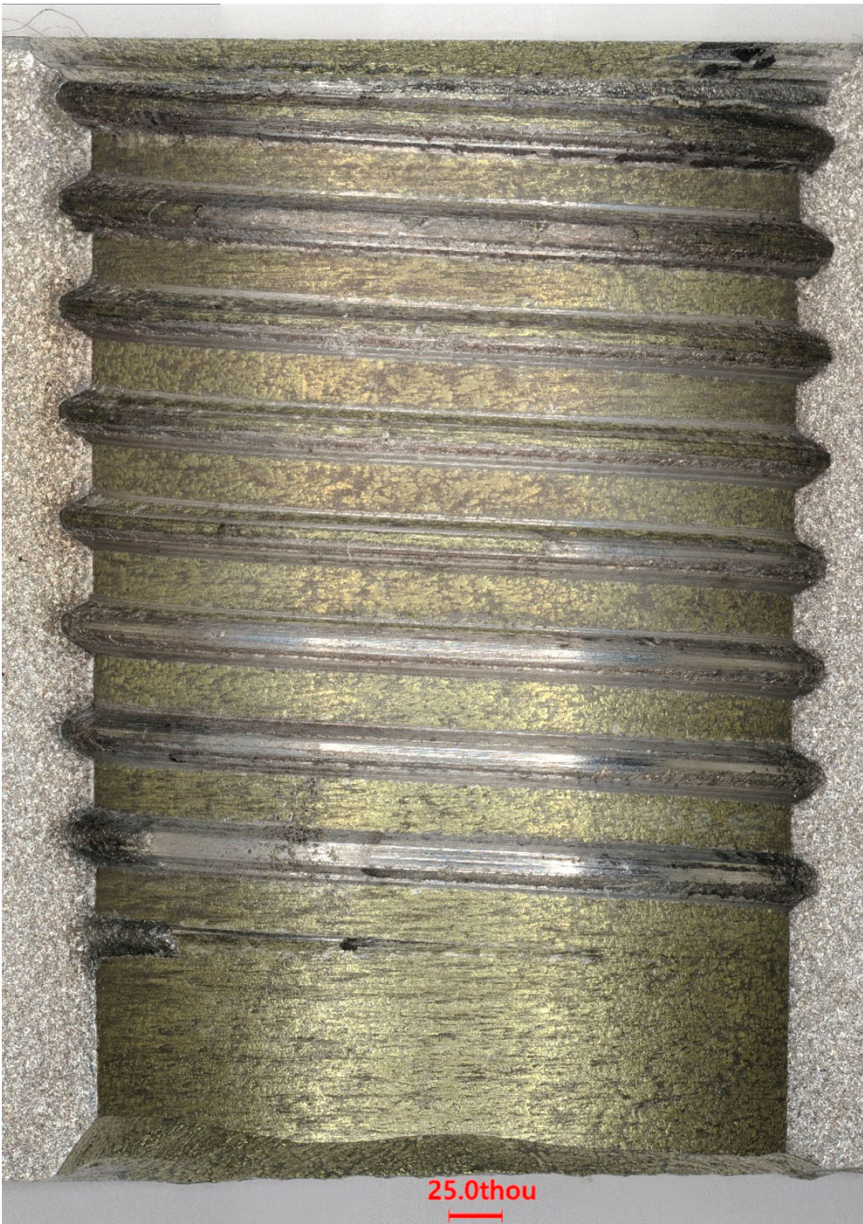
Fragment of the fractured steel insert top thread

**Figure 92:** Optical views of insert locations 3 and 5 reveal intact threads with the gold-colored anodized surface.

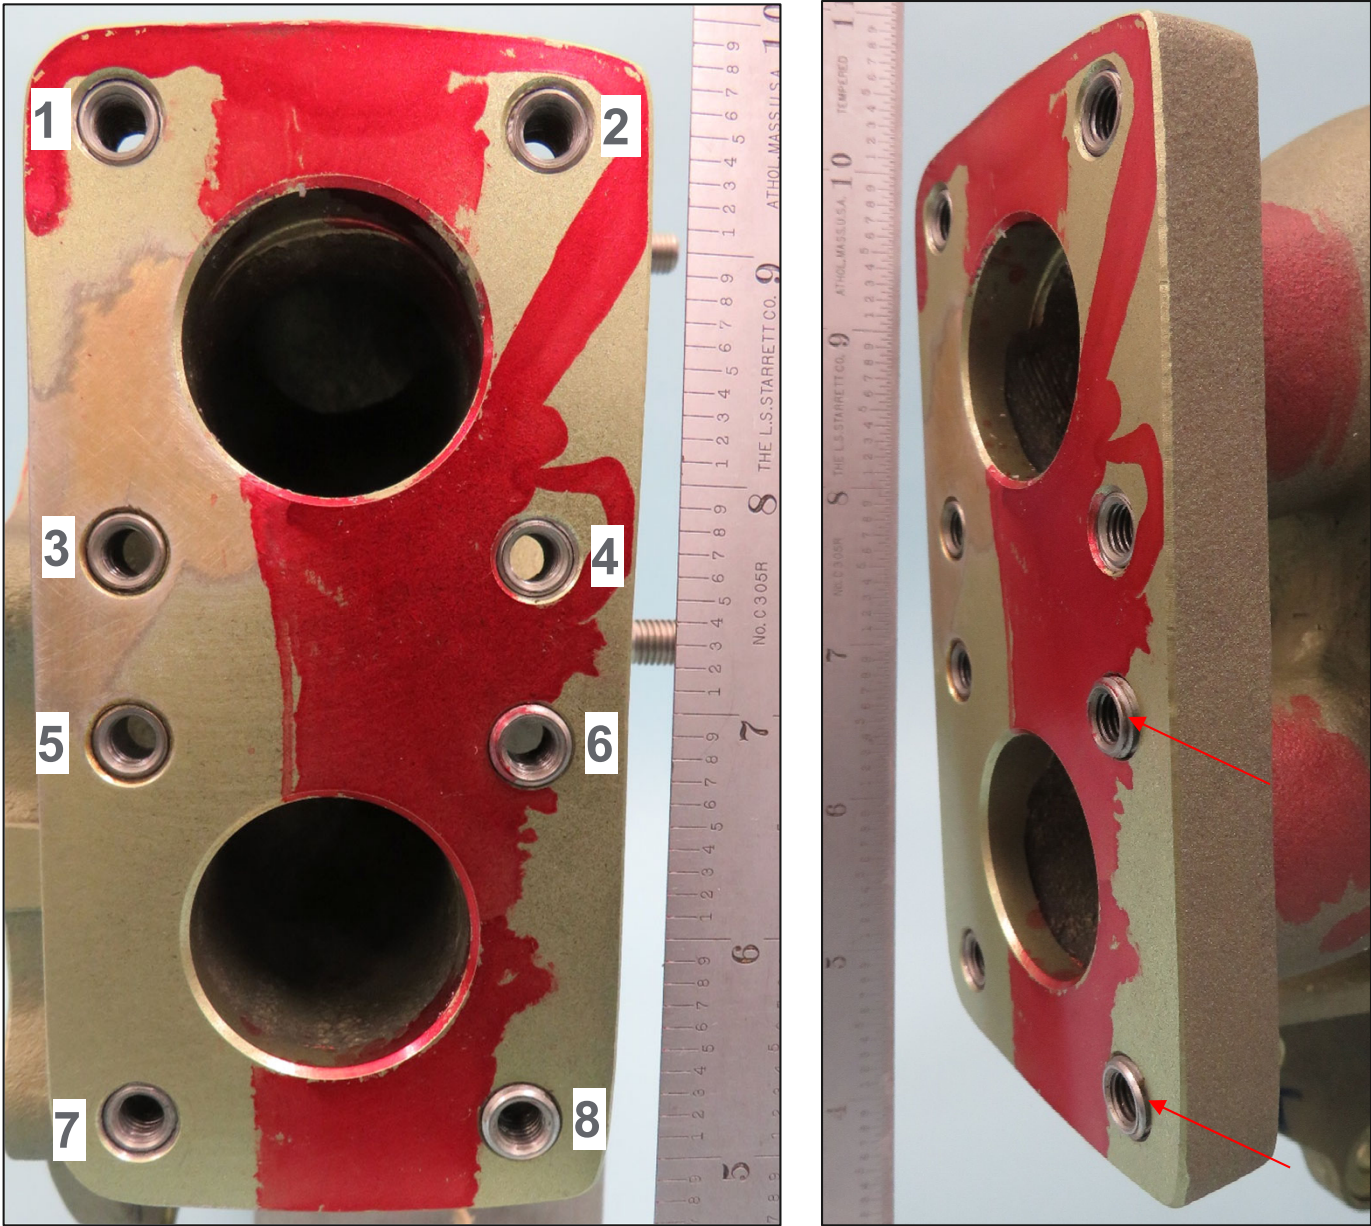
**Figure 93:** Optical views of SN F1A1YN6T flange as received by the lab. The red paint is to indicate a scrapped part. Insert location numbers 6 and 8 backed out prior to arrival at the FA lab.

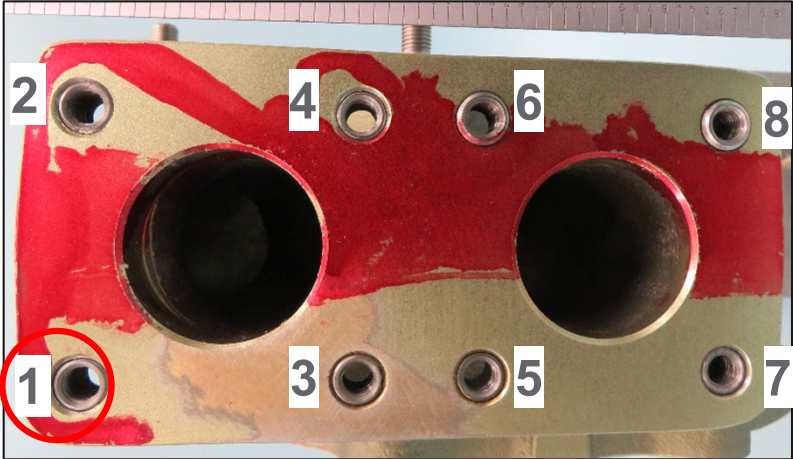
Inserts 1

**Figure 94:** CT scan cross-section of thread insert position 1. Thread engagement is observed into the flange material.

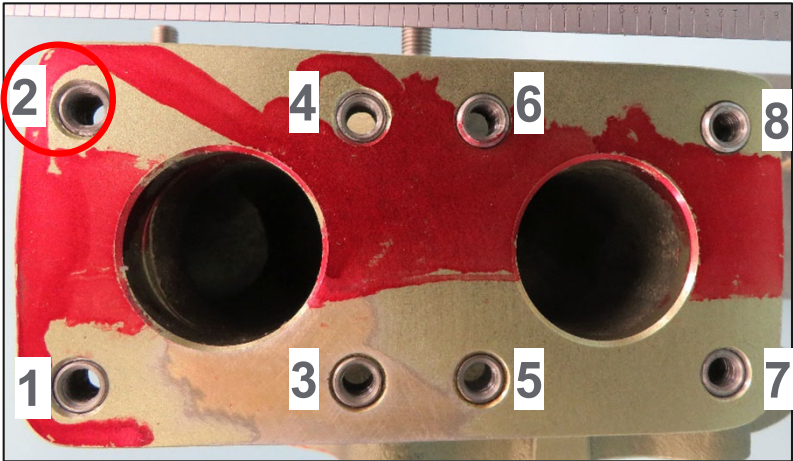
Inserts 2

**Figure 95:** CT scan cross-section of thread insert position 2. Thread engagement is observed into the flange material.

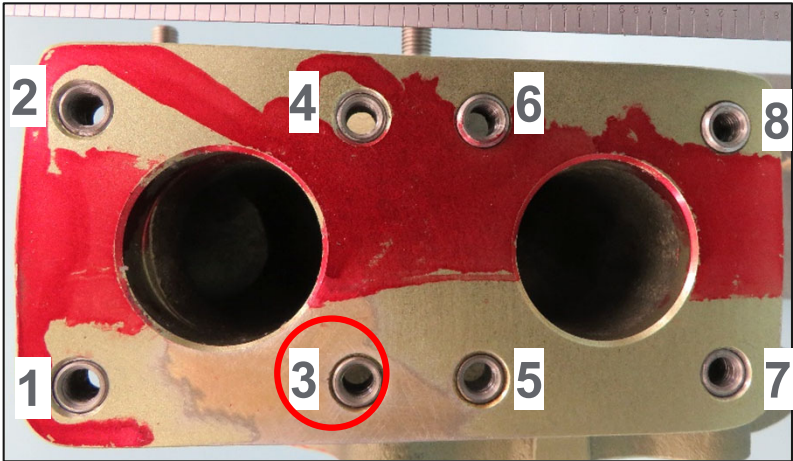
Inserts 3

**Figure 96:** CT scan cross-section of thread insert position 3. Thread engagement is observed into the flange material.

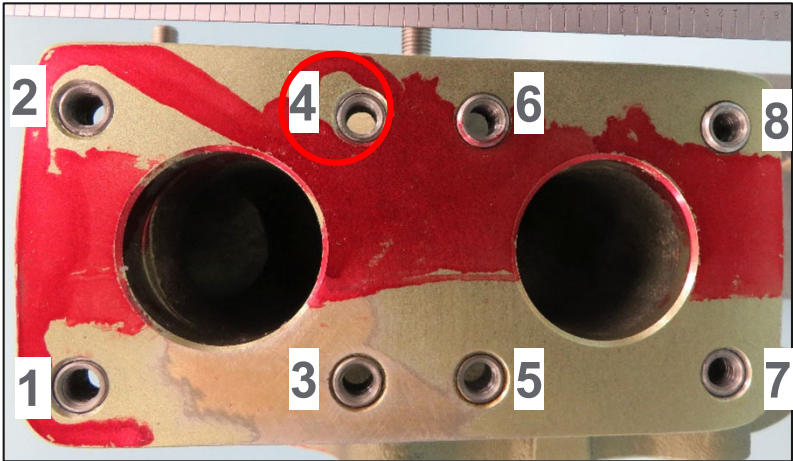
Inserts 4

**Figure 97:** CT scan cross-section of thread insert position 4. Thread engagement is observed into the flange material.

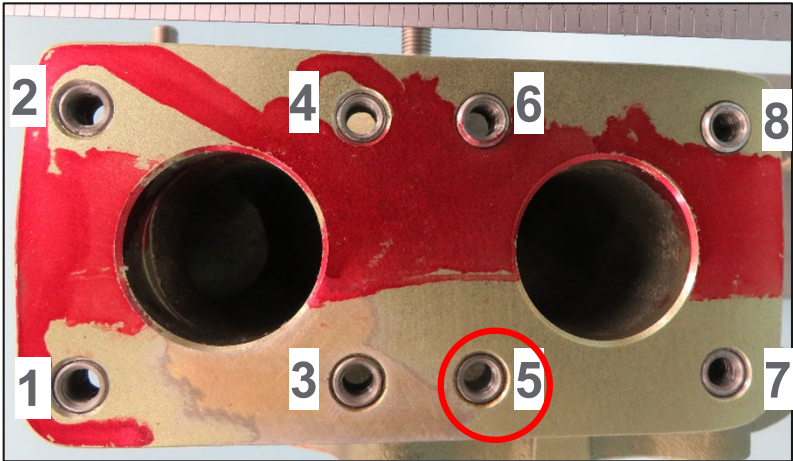
Inserts 5

**Figure 98:** CT scan cross-section of thread insert position 5. Thread engagement is observed into the flange material.

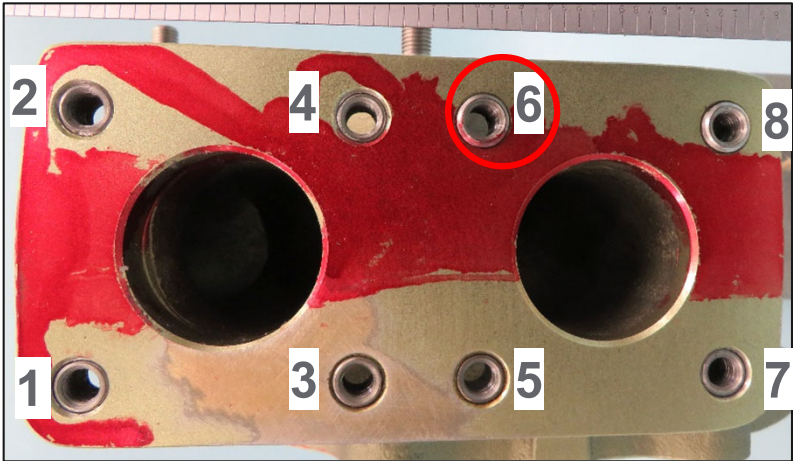
Inserts 6

**Figure 99:** CT scan cross-section of thread insert position 6. No thread engagement is observed into the flange material.

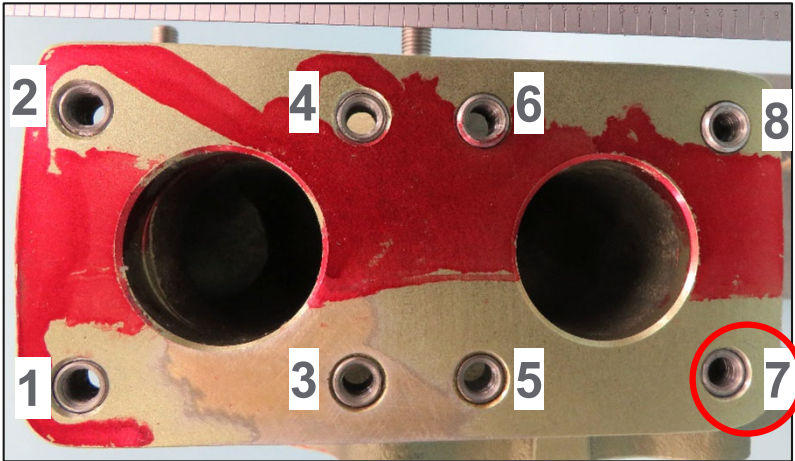
Inserts 7

**Figure 100:** CT scan cross-section of thread insert position 7. No thread engagement is observed into the flange material.

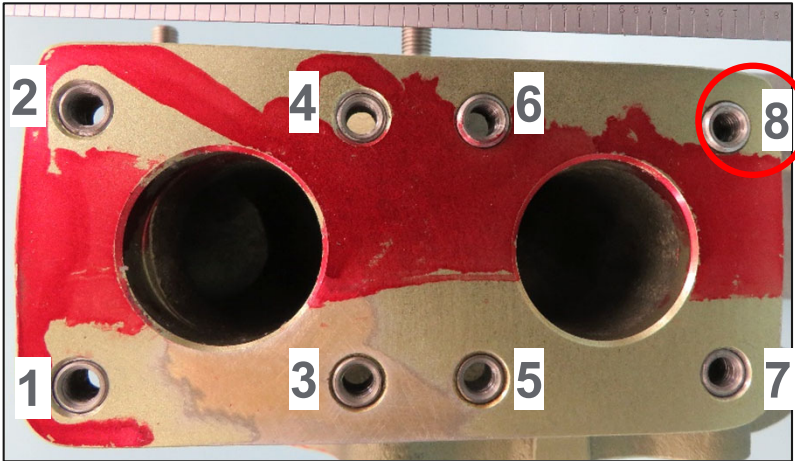
Inserts 8

**Figure 101:** CT scan cross-section of thread insert position 8. No thread engagement is observed into the flange material.

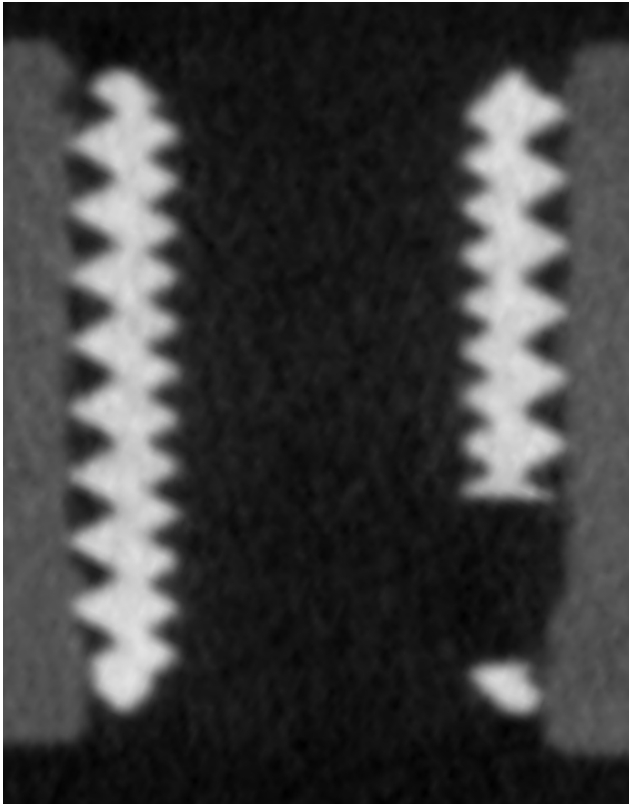
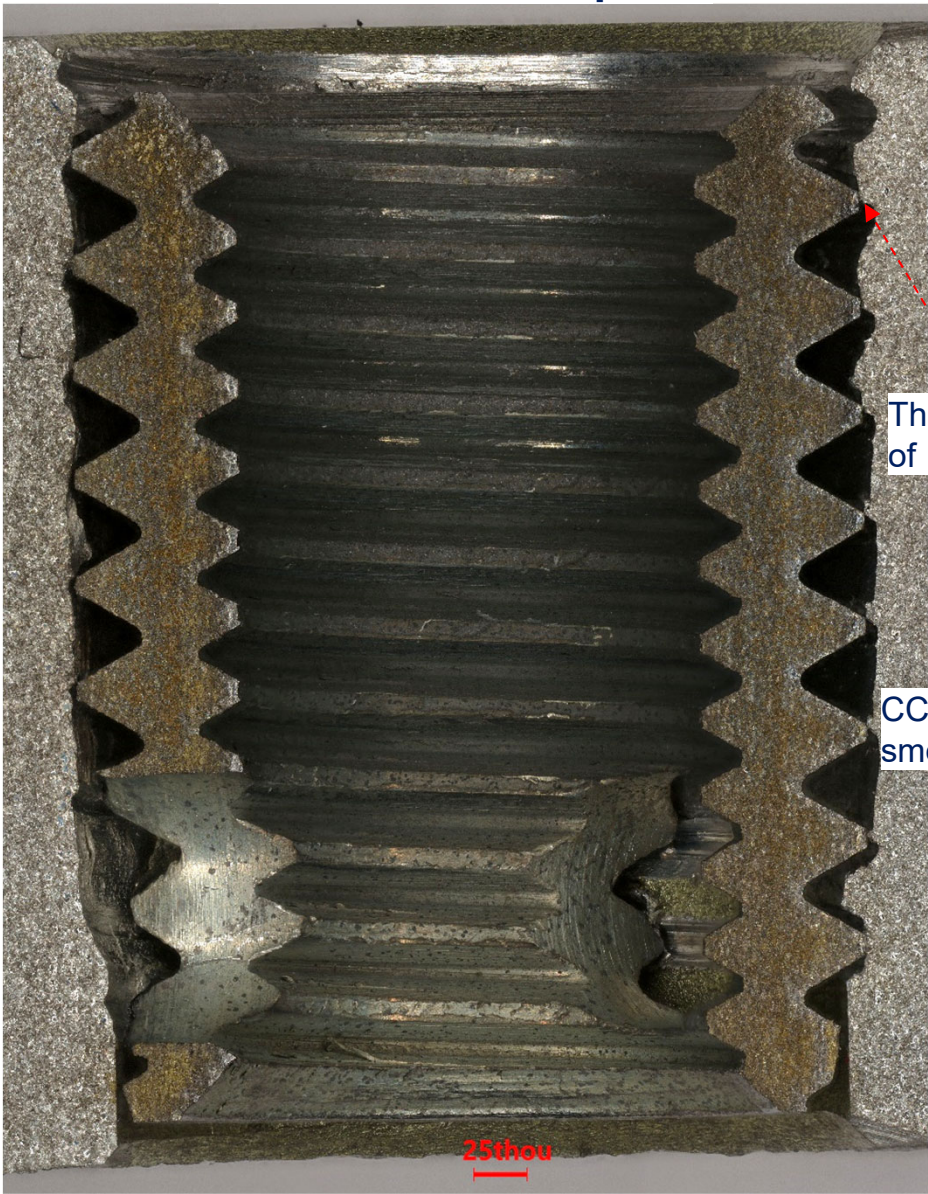
Insert 7: Insert in place

Threads out of phase

CCW smear

**Figure 102:** Optical views of insert location 7 with the inserts in place and removed. The threads have been removed 360-degrees around the hole and the insert is observed out of phase with the original pre-tapped threads, consistent with cross-threading. CCW smear is also observe in the damaged area.

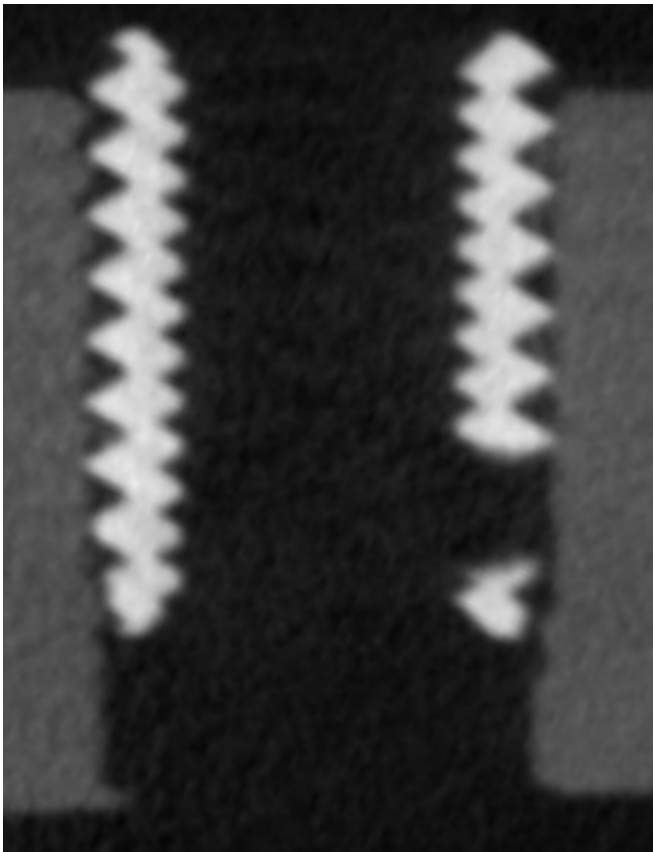
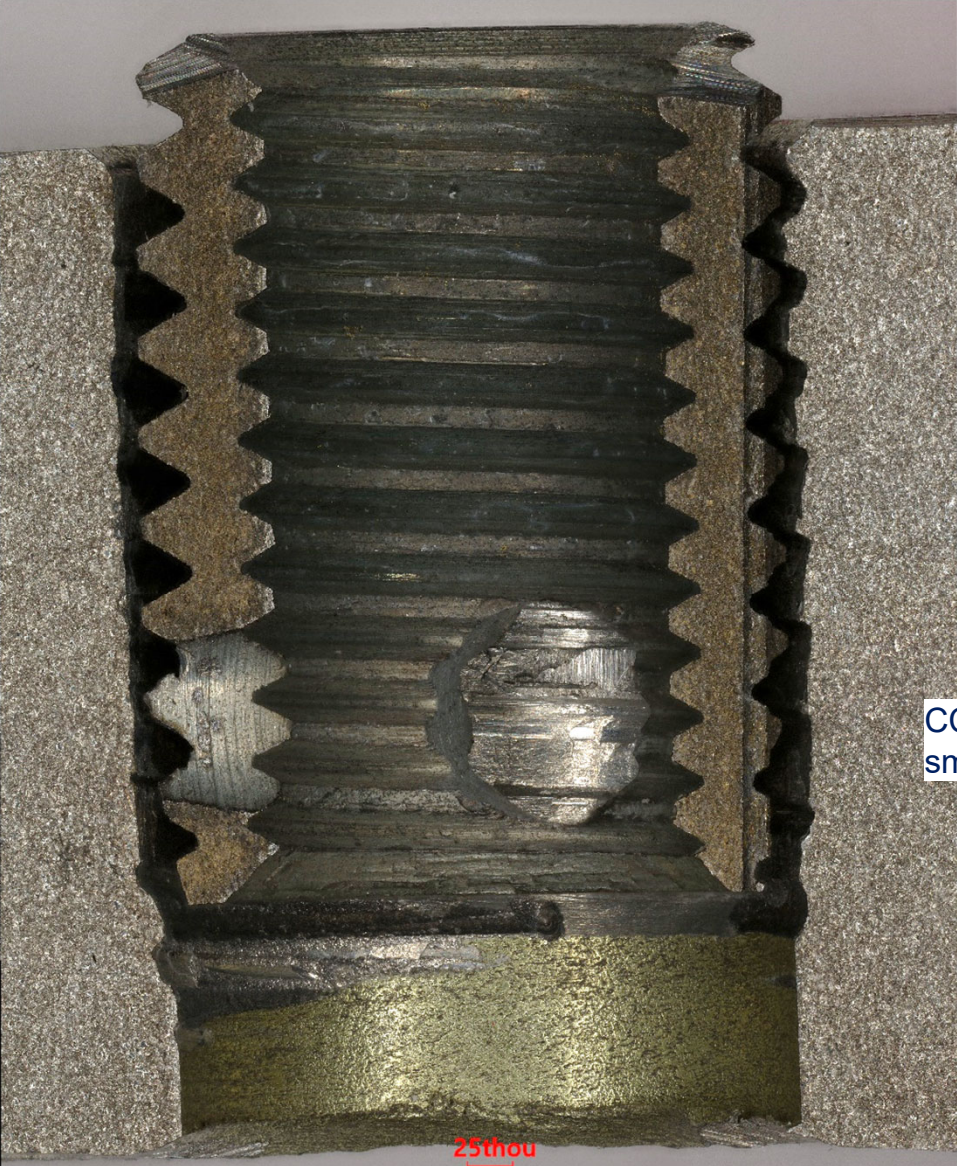
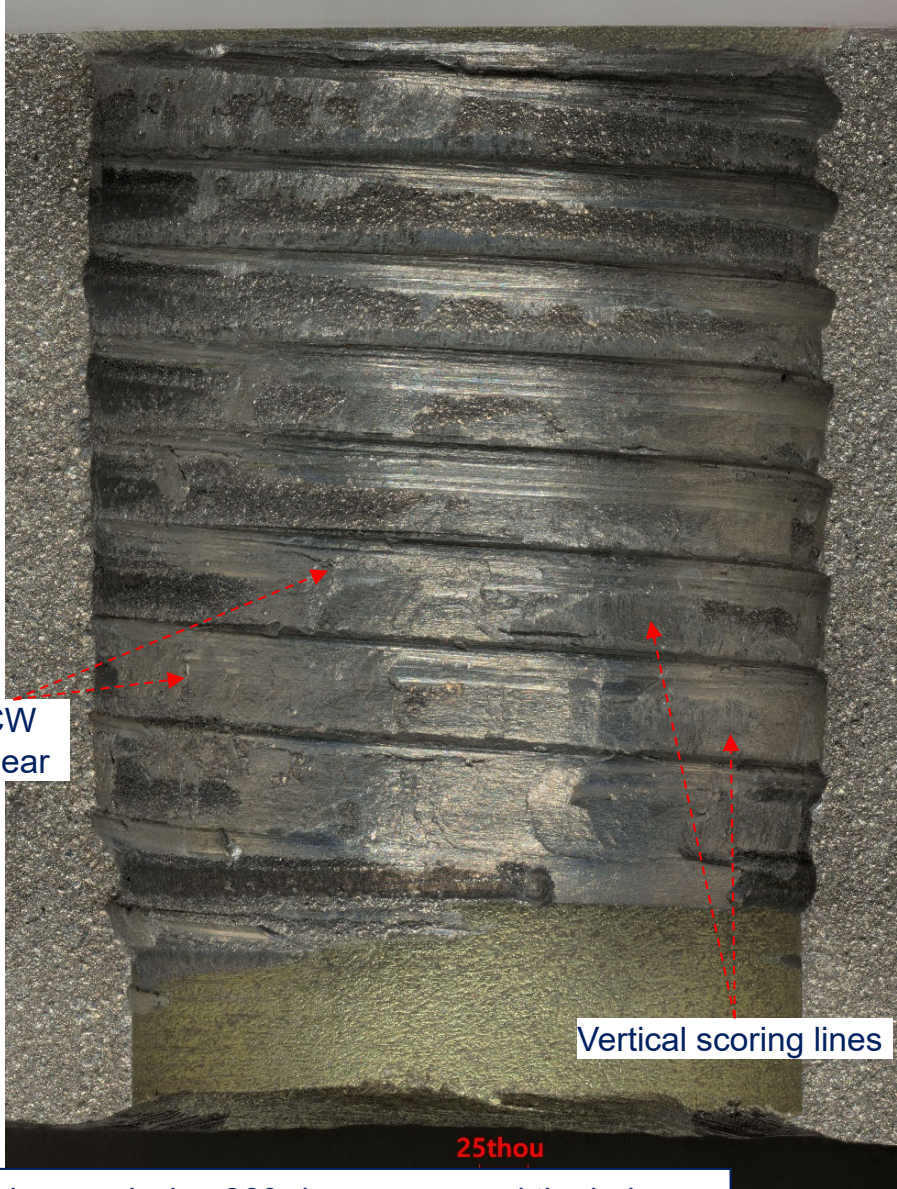
Insert 8: Insert in place (pulled out)

**Figure 103:** Optical views of insert location 8 with the inserts in place and removed. The threads are missing 360-degrees around the hole. The damaged area has vertical scoring lines consistent with the insert being pulled out. CCW smear is also observed in the damaged area.

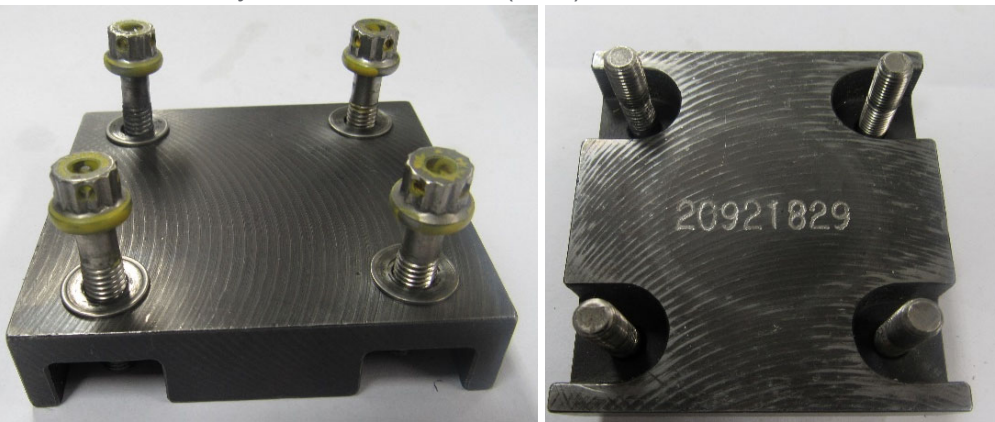
- If thread inserts are found loose or protruding the pull-out test is not performed (test not performed on inserts 1, 2, and 7)

**Figure 104:** Idler adapter thread insert inspections performed at GE Celma
