## Materials Project Report

Report No. 20230667

Subject: CF6 Input Housing P/N 5006834M Failure Investigation

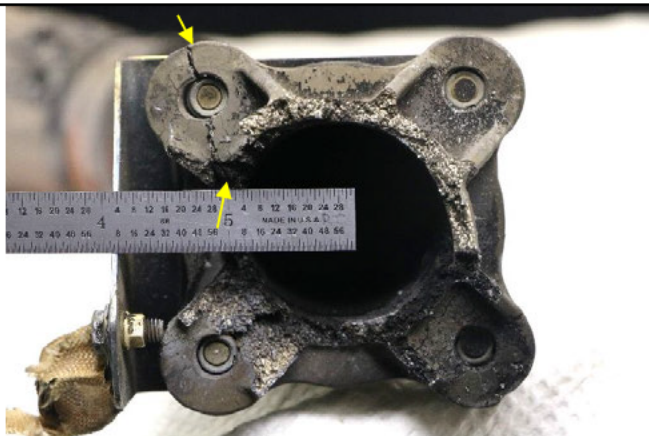
**Figure 8**

Optical image displaying the mating failure surfaces positioned next to each other. The mounting flange generally exhibits more discoloration and contamination on the failure surfaces than the opposing surface on the input housing takeoff arm.

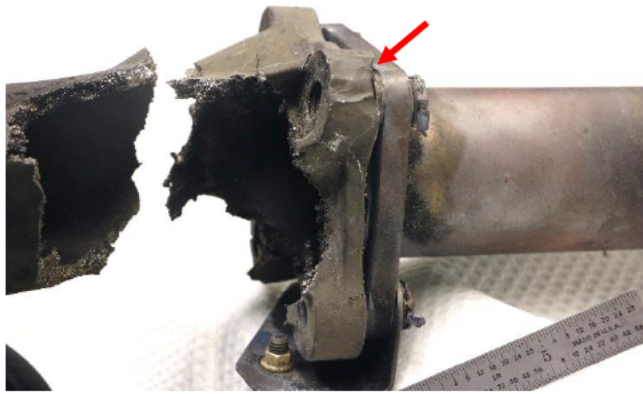
**Figure 9**

Optical image showing the mounting flange section of the input housing that remained attached to the fuel inlet tube after failure. The upper left bolt location exhibits two cracks on either side of the bolt that formed in the flange.

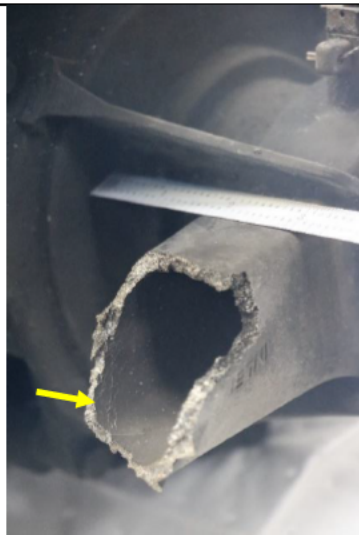
**Figure 11**

Optical image showing the surface of the input housing in the as-received condition. The inlet tube had separated from the housing flange during the failure event. A secondary crack was observed on the ID surface of the inlet tube propagating transverse to the primary failure surface. Multiple smaller secondary cracks were also observed in approximately the same location.

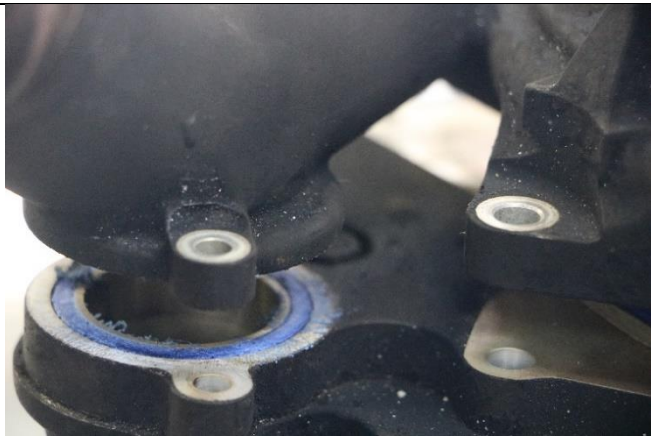
**Figure 22**

Optical image showing accumulation of metallic material. Thermally induced damage was observed for the seals in each bore interface at the split line. Evidence of material extrusion onto the mating surfaces and out of the assembly was present.

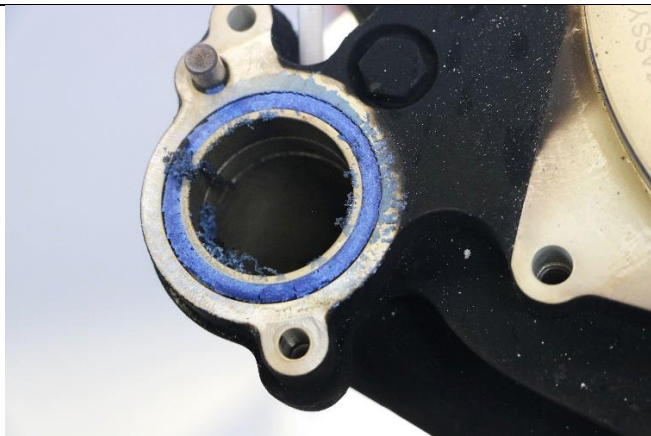
**Figure 23**

Optical image showing evidence of seal extrusion between the mating surfaces due to elevated temperature exposure.

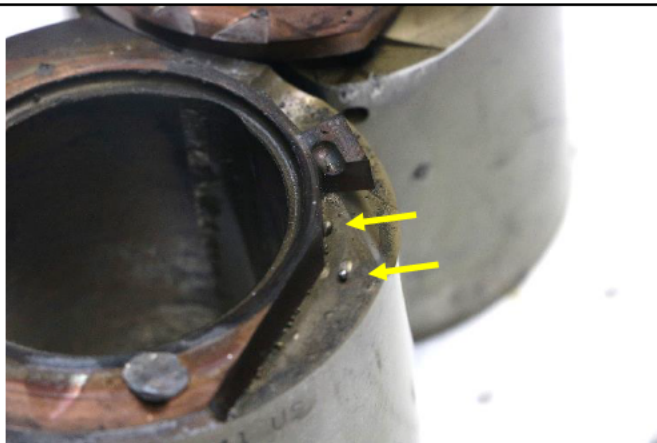
**Figure 26**

Optical image showing the journal bearings after removal from the fuel pump assembly. Impressions from the gear teeth were observed in the leaded bronze surface that were reported to have been generated during the disassembly process. Metallic material was also discovered on the surface of one journal bearing.

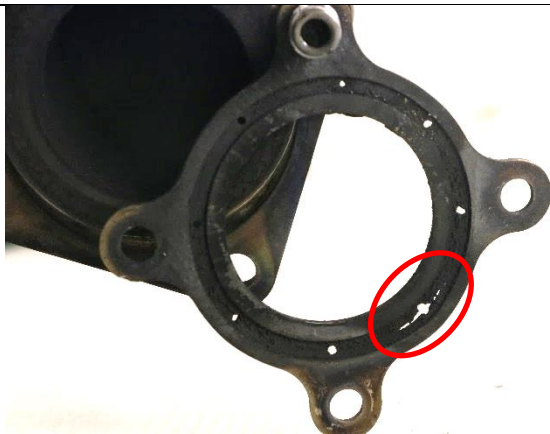
**Figure 29**

Optical image showing the mating surface for the fuel pump assembly. The darkened circular feature on this surface was created by transfer of the non-metallic seal material that was assembled between this surface and the fuel inlet tube.

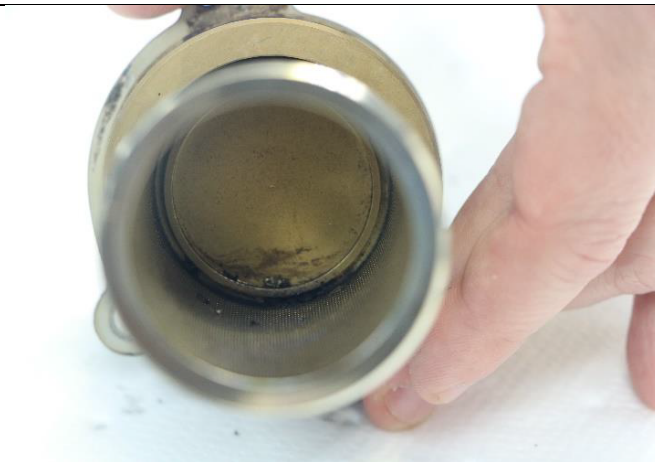
**Figure 32**

Optical image showing the filter after removal from the fuel pump. No cleaning or collection of debris occurred prior to visual examination and capture of this image. Evidence of discoloration was noted on the exterior surface of the filter.

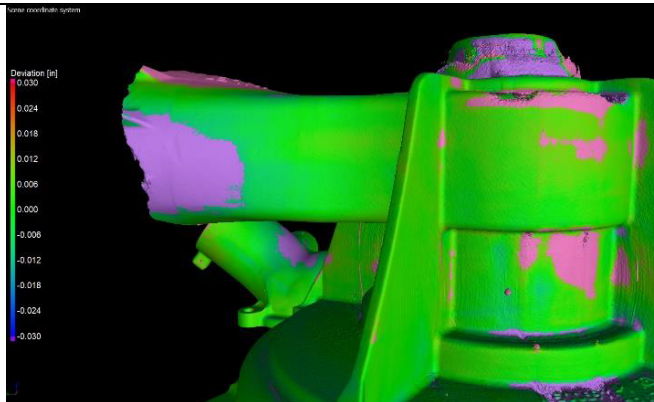
**Figure 34**

3D CT image showing the output of a comparison between the event housing and a nominal housing from inventory. The coloration represents distortion of the event housing from the nominal housing geometry. The inlet tube area and fracture surface exhibited the greatest deviation from the nominal geometry.

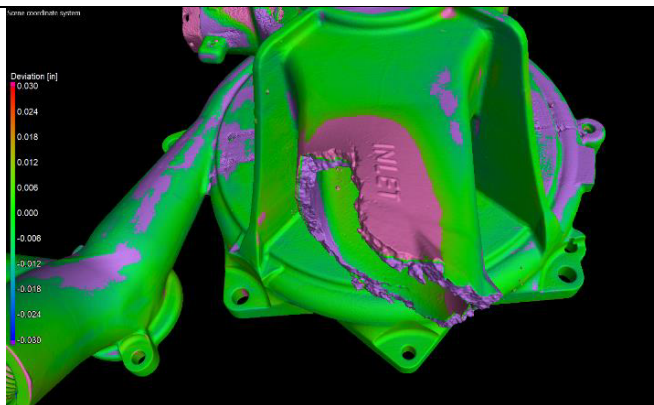
**Figure 35**

3D CT image showing the output of a comparison between the event housing and a nominal housing from inventory. The body of the event housing appeared well aligned with the geometry of the nominal housing. The inlet tube near the event location exhibited deviation as shown by the purple and pink coloration.

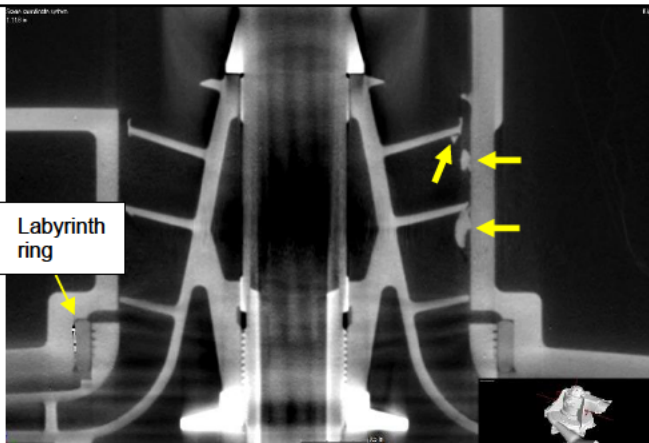
**Figure 37**

Examination of the 3D CT volumetric data for the event unit revealed evidence of damage to the inducer blades (**Figure 37 & Figure 38**). Material was observed to be adhered to the discharge side of the input housing interior surface. Only limited adhered material was observed on the input side of the housing interior surface. Representative images showing the input housing inlet takeoff in multiple cross sections are shown in **Figure 39 & Figure 40**. A series of images showing evidence of deformation along the length of the inlet takeoff are shown in **Figure 41 through Figure 44** with the greatest deformation present at or near the failure surface.

2D CT image showing a 2D cross section from the volumetric data set. The image shows a cross section of the inlet pump housing with the impeller assembly retained in the housing. The unit is in the as-received condition after disassembly of the fuel pump assembly.

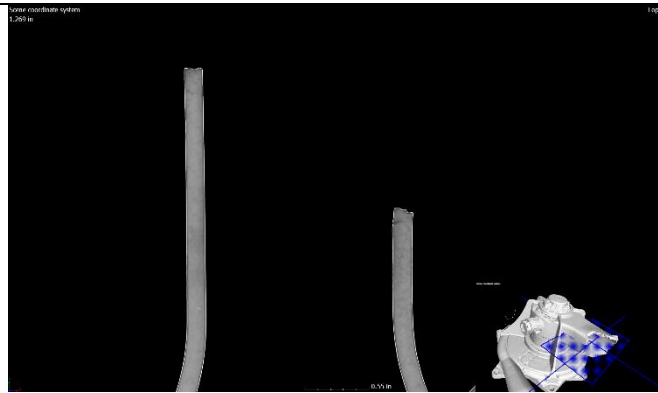
**Figure 39**

CT image showing a 2D cross section from the volumetric data set. Porosity and missing material were observed at the end of the inlet tube from the housing. The bright area of the image is the higher density leaded bronze bearing that absorbed some of the x-ray energy during the 3D CT scan.

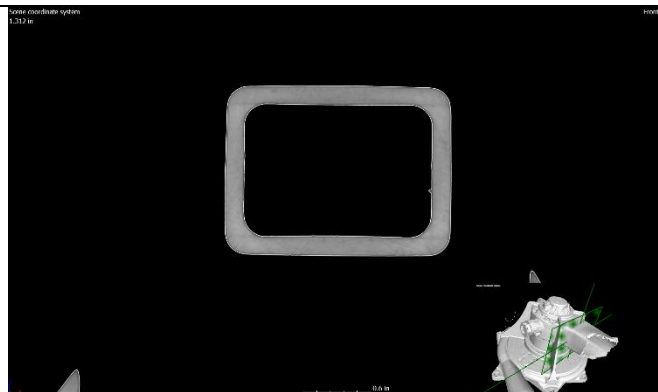
**Figure 40**

CT image showing a 2D cross section from the volumetric data set. The viewing plane was oriented 90 degrees to that shown in **Figure 39**. Porosity and missing material were observed at the end of the inlet tube from the housing.

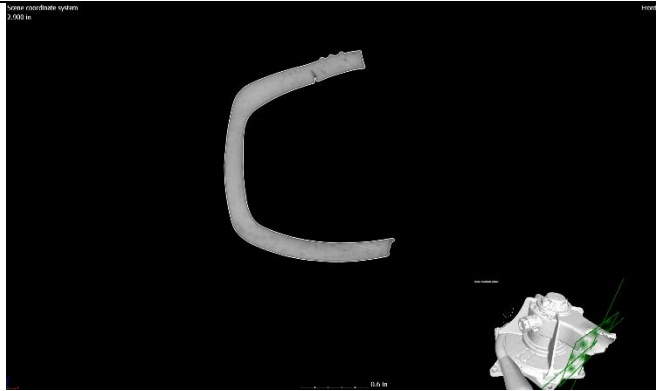
**Figure 42**

CT image showing a 2D cross section from the volumetric data set. The viewing plane was oriented transverse to the geometry of the inlet tube located near the body of the inlet housing. The image shows evidence of deformation of the tube at this location, with a linear indication and separation in the wall in the upper right of the tube.

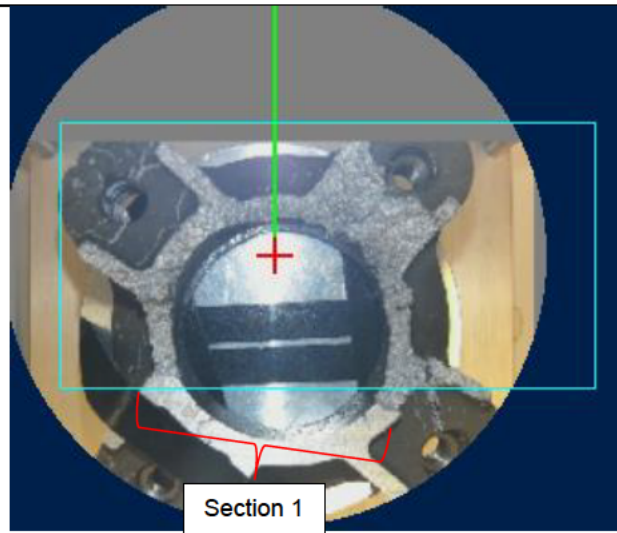
**Figure 48**

A representative optical image the upper section of the surface is shown in **Figure 45** for reference purposes. Fractography of the surfaces associated with the mounting flange revealed evidence of melting and re-solidification. The surface was typically smooth in appearance where the aluminum base metal had melted from exposure to a heat source above the melting temperature of the base metal. No evidence of a mechanical failure mode was observed during the analysis. Representative SEM images from this segment of the exposed surface are shown in **Figure 46 – Figure 48**.

Representative SEM image showing the fracture surface from the middle of the wall thickness of Section 1. The surface exhibited evidence of melting and re-solidification as evidenced by the wrinkled appearance of the surface. No indications of a mechanical failure mode were observed at this location.

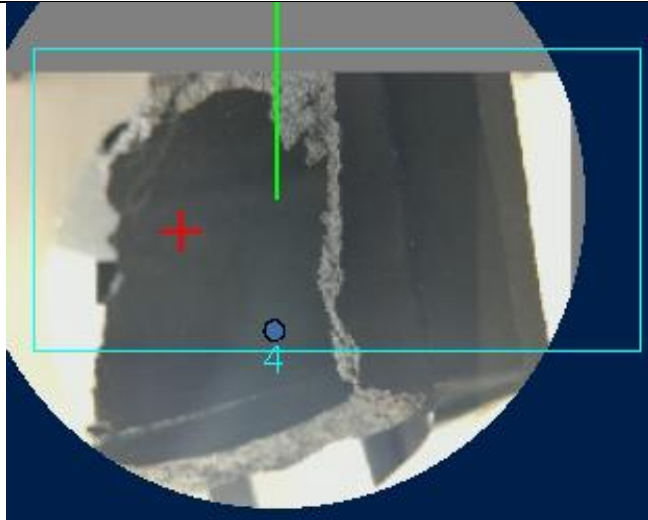
**Figure 51**

An optical image showing the lower section of the surface captured within the SEM chamber for positioning is shown in **Figure 49**. The remainder of the surface exhibited similar melting and re-solidification features observed in the upper part. Representative SEM images showing evidence of melting and re-solidification are shown in **Figure 50 and Figure 51**.

Representative SEM image from section 2 of the mounting interface showing evidence of a melted and re-solidified surface. The entirety of the fracture surface was examined at various magnification levels revealing similar features across this section.

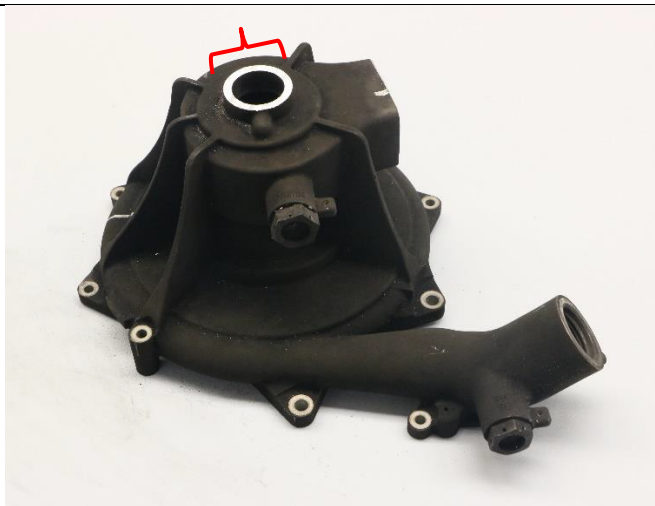
**Figure 65**

Prior to disassembly, the impeller assembly was confirmed to be retained within the input housing. The cause for retention could not be identified using non-destructive inspection methods. An optical image showing the impeller retained within the input housing is shown in **Figure 65**. A sectioning plan was established to isolate the center shaft of the impeller assembly by selective machining and removal of the top of the input housing (**Figure 66**). Once the input housing was machined, the impeller assembly was pushed out with limited force required.

Optical image showing the impeller assembly that had been retained within the input housing after the failure event. It could not be removed without the aid of tools or other methods.

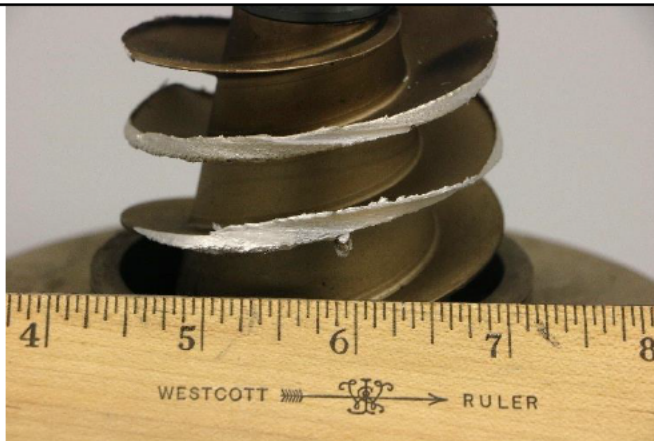
**Figure 68**

Optical image of the impeller assembly after removal from the fuel pump inlet housing. Deformation of the inducer blade was observed after removal. The deformation aligns with the location of adhered material on the interior surface of the housing observed during CT inspection of the assembly.

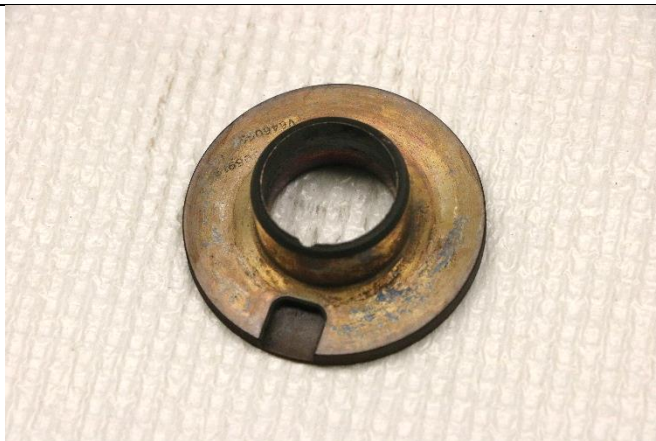
**Figure 71**

The wear surface from the top of the impeller assembly exhibited no indications of wear damage such as scoring from hard or abrasive particles. A representative image showing the wear surface is shown in **Figure 71**. This surface was determined to be in good condition and did not contribute to retention of the impeller assembly within the input housing. Similar observations were made of the journal bearing that was easily removed during extraction of the impeller assembly from the input housing. The journal bearing was free to move axially in the housing and was easily removed from the housing during disassembly. The journal bearing did not exhibit any indications of wear damage consistent with hard or abrasive particle contamination on the primary wear surface (**Figure 72 & Figure 73**).

Representative optical image showing the wear surface from the top of the impeller assembly. This area exhibited no indications of wear marks or damage that would be consistent with entrapment of abrasive or foreign material.

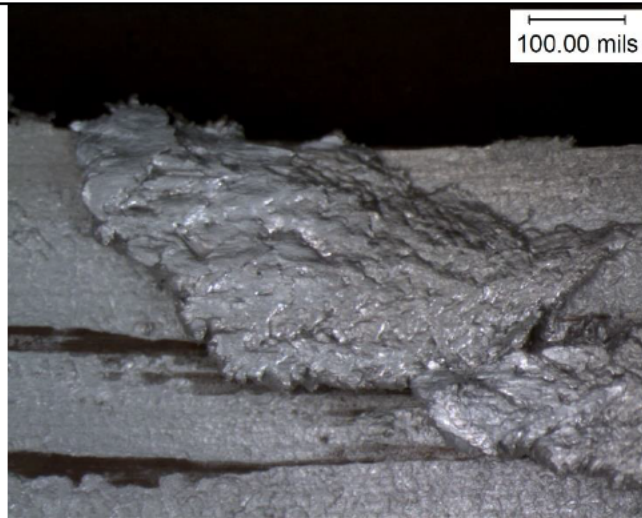
**Figure 75**

Optical image showing the interior surface of the input housing after removal of the impeller assembly. Material was found adhered to the surface that exhibited a lateral adhesion pattern consistent with the motion of the inducer during operation of the fuel pump. The side shown is from the discharge side of the housing.

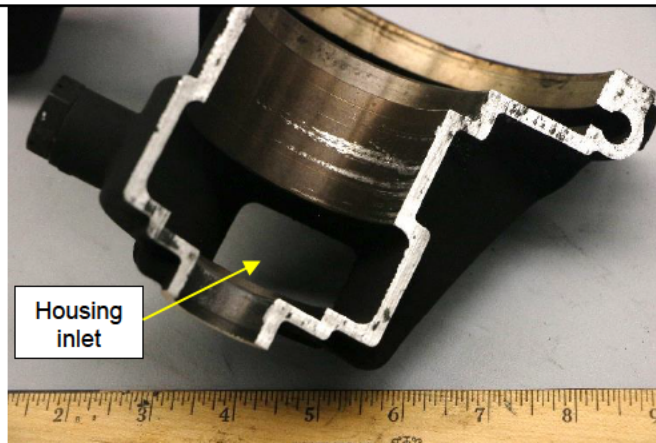
**Figure 76**

Optical image at increased magnification showing the adhered metallic material from **Figure 75**. A representative piece of adhered material was removed for X-ray fluorescent spectroscopy.

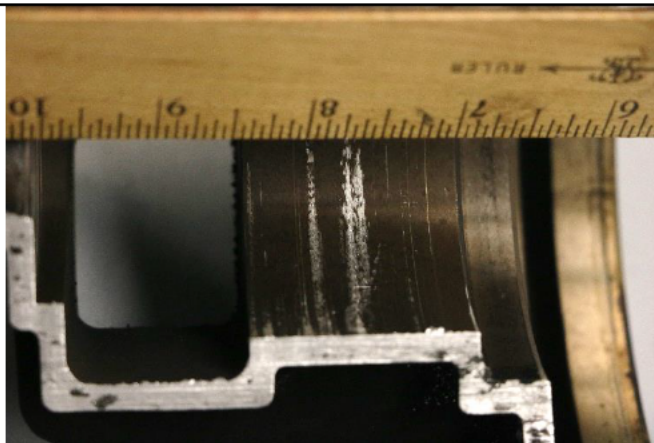
**Figure 77**

The inlet side of the input housing also exhibited evidence of metallic material adhesion on the interior surface. However, the adhesion indications were discrete with minimal accumulation of material away from the surface (**Figure 77** & **Figure 78**).

Optical image showing the interior surface of the input housing after removal of the impeller assembly. Evidence of adhered material was observed on the interior surface of the housing. The side shown is from the inlet side of the housing.

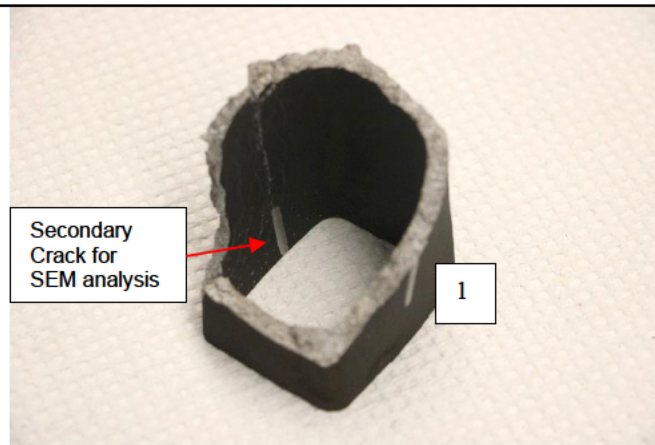
**Figure 78**

Optical image showing the interior surface of the input housing after removal of the impeller assembly. The pattern of adhered material is consistent with motion of the inducer during operation of the fuel pump.

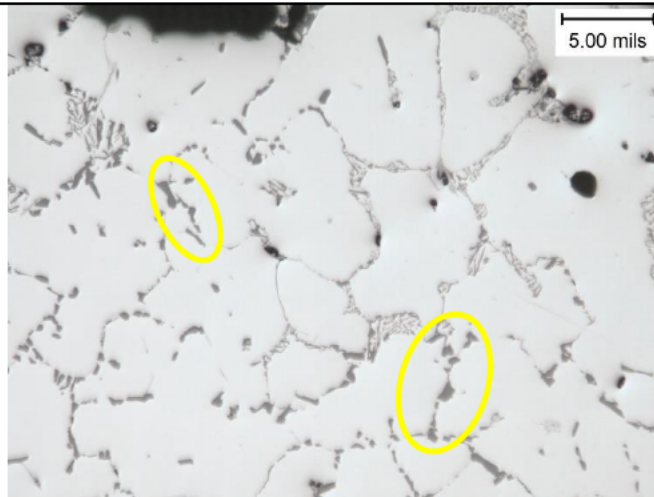
**Figure 81**

Two metallographic cross sections were excised from the inlet tube that incorporated the failed end surface (**Figure 79** & **Figure 80**). Metallographic examination of the polished cross section from location 1 showed the failure surface primarily followed pre-existing grain boundaries within the material microstructure (**Figure 81**). The material microstructure at this location exhibited evidence of intermetallic growth as well as propagation along grain boundaries. The square / rectangular morphology with sharp features and a continuous layer along the grain boundary in discrete locations are evidence of sustained exposure to elevated temperatures (**Figure 82** – **Figure 84**).

Metallographic image showing the cast aluminum base metal from Location 1 identified in **Figure 79**. Part of the fracture is captured within this image that primarily follows pre-existing grain boundaries within the material microstructure.

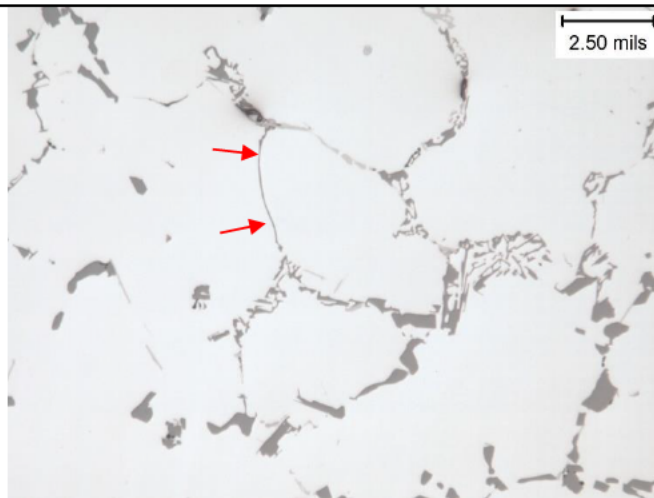
**Figure 82**

Metallographic image at increased magnification showing the cast aluminum base metal from Location 1 identified in **Figure 79**. Examination of the material microstructure revealed evidence of intermetallic growth in both overall size as well as along grain boundaries. The intermetallic features encircled in the image exhibit larger and more square / rectangular morphology.

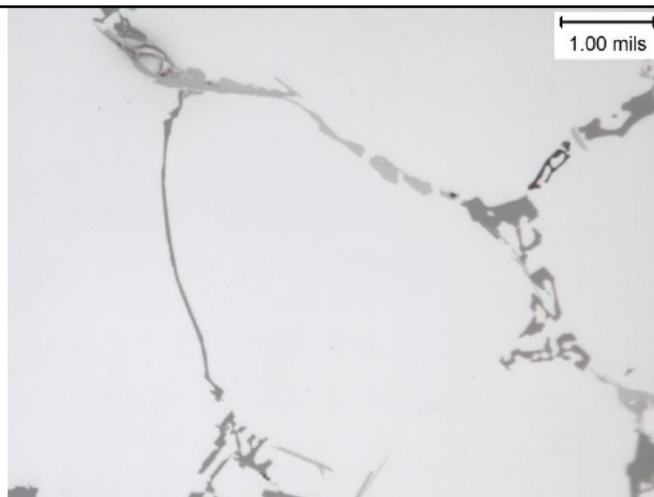
**Figure 83**

Metallographic image from location 1 showing the microstructure of the aluminum housing located immediately adjacent to the thermal event. The silicon rich intermetallics expanded in size, exhibiting a blocky appearance. The intermetallic constituent also forms a continuous layer along the grain boundary in discrete locations.

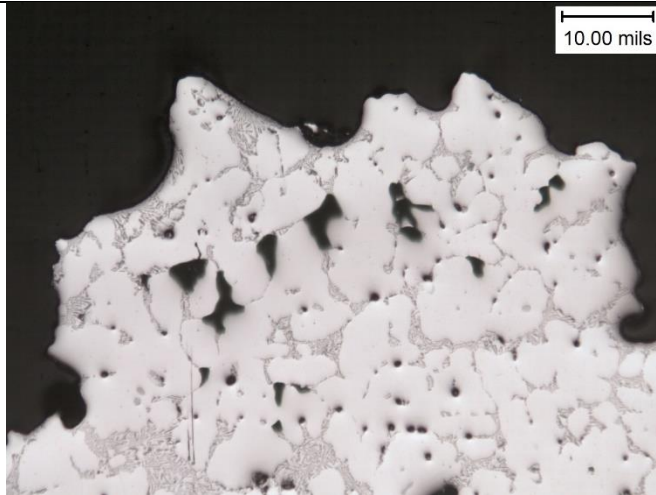
**Figure 84**

Metallographic image from location 1 at increased magnification showing a continuous intermetallic layer along a grain boundary as well as the block like / rectangular morphology observed throughout the microstructure at this location.

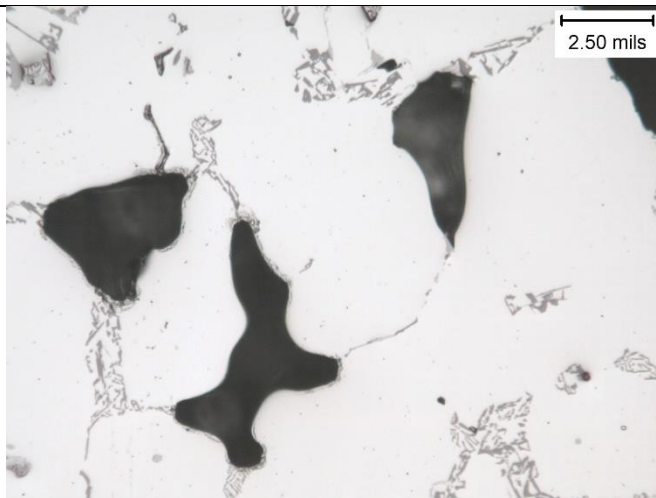
**Figure 85**

Metallographic examination of the polished cross section from location 2 showed similar features that were observed at location 1. More porosity was observed near the failure surface with silicon rich intermetallics having propagated along grain boundaries between adjacent porosity indications (**Figure 85** & **Figure 86**). While porosity was observed, review of the radiographic film showed the cast material from this general location of the input housing had met the acceptance criteria established by the engineering drawing. Examination at increased magnification revealed that the intermetallics exhibited the same square / rectangular morphology with sharp features (**Figure 87**).

Representative metallographic image showing the microstructure from location 2 of the inlet tube shown in **Figure 80**. The top of the microstructure represents the edge of the failure location directly exposed to the thermal event. Porosity of varying size was observed throughout this location.

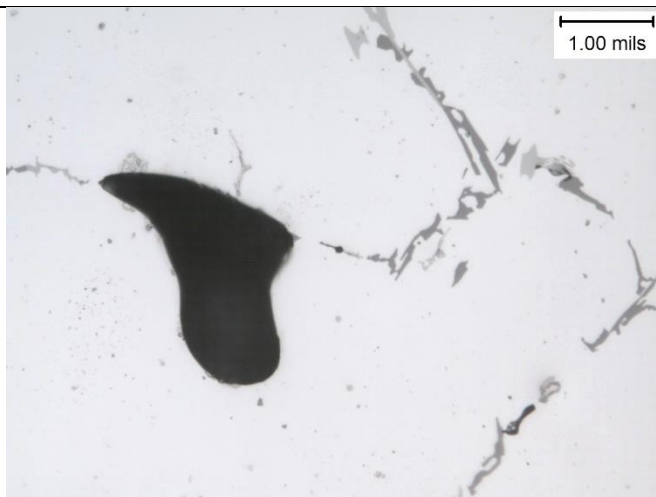
**Figure 86**

Representative metallographic image at increased magnification showing the microstructure from location 2. The silicon rich intermetallics propagated along grain boundaries, and in this image connected adjacent porosity indications.

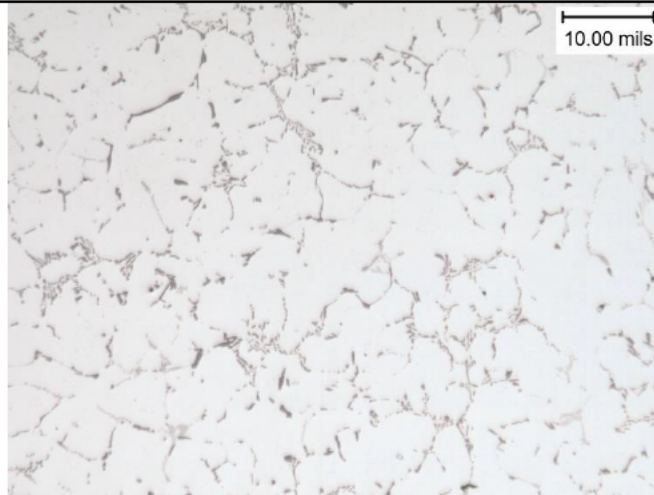
**Figure 87**

Representative metallographic image at increased magnification showing the microstructure from location 2. The silicon rich intermetallic morphology is angular and sharp in appearance, often connected through a grain boundary network.

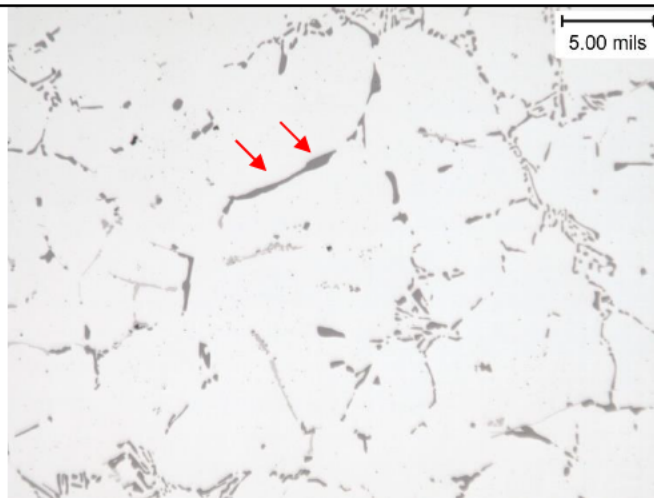
**Figure 88**

A metallographic section was taken from a location of the input housing representing the furthest distance away from the failure event location (**Figure 88**). The metallurgical microstructure was generally uniform in appearance but did exhibit discrete grain boundary features with a morphology that was not consistent with the surrounding material as well as the heat treatment defined by the engineering drawing. Formation of longer grain boundary intermetallic features were influenced by the elevated temperature inducing a limited overaging effect on the cast aluminum material at this location. (**Figure 89**). The silicon rich intermetallics generally exhibited an appearance consistent with the defined heat treatment. Limited effects from heat input were observed within the material microstructure. The long, thin feature shown in **Figure 90** is an example of localized propagation of the intermetallic phase propagated along the grain boundary because of the heat input from the failure event.

Metallographic image showing a cross section of the cast aluminum material from a location opposite thermal event location. The metallurgical microstructure was uniform in appearance but did exhibit grain boundary features not consistent with the defined heat treatment. Longer grain boundary features were observed scattered throughout the microstructure.

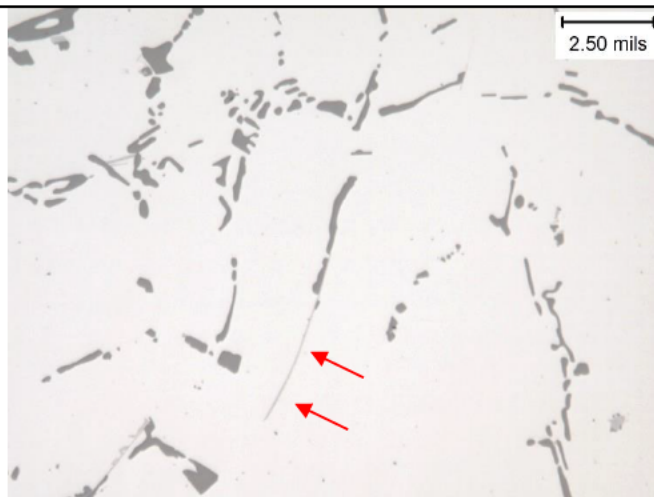
**Figure 89**

Metallographic image of the cast aluminum structure at increased magnification located opposite from the thermal event location. Limited effects from the failure event were observed in the microstructure at this location. Formation of the longer grain boundary intermetallic features were influenced by the elevated temperature inducing a localized overaging effect on the cast aluminum material at this location.

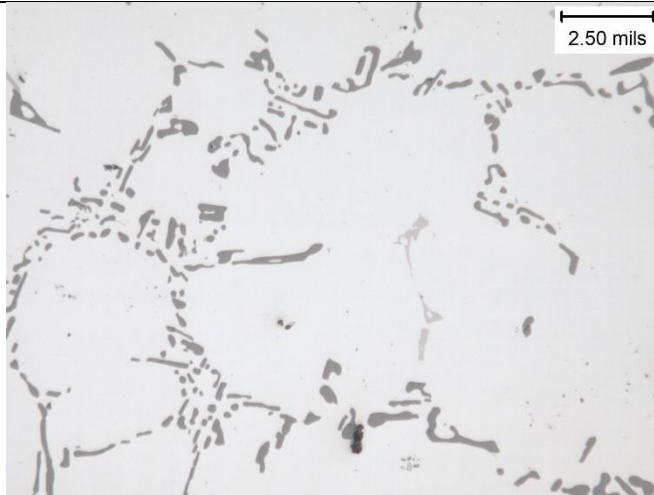
**Figure 90**

Metallographic image of the cast aluminum structure at increased magnification. The silicon rich intermetallics generally exhibited an appearance consistent with the heat treatment defined by the engineering drawing. The long, thin feature is an example of the intermetallic phase propagating along the grain boundary as a result of the heat input from the failure event.

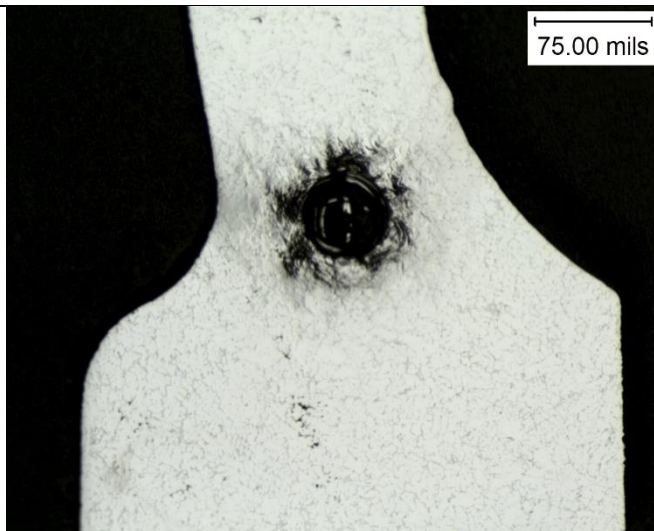
**Figure 91**

Additional examination from a representative section of the material at increased magnification revealed the silicon rich intermetallics exhibited an appearance consistent with the heat treatment defined by the engineering drawing. The intermetallic particles are rounded and well distributed with very few larger particles which is consistent with the prescribed heat treatment (**Figure 91**).

Metallographic image of the cast aluminum structure at increased magnification showing a section of the cast material exhibiting evidence of a good response to heat treatment. The individual intermetallic particles are rounded and well distributed with very few larger particles along grain boundaries.
