National Transportation Safety Board  
Office of Aviation Safety  
Washington, DC 20594

ENG24LA014

## **POWERPLANTS**

Group Chair's Factual Report

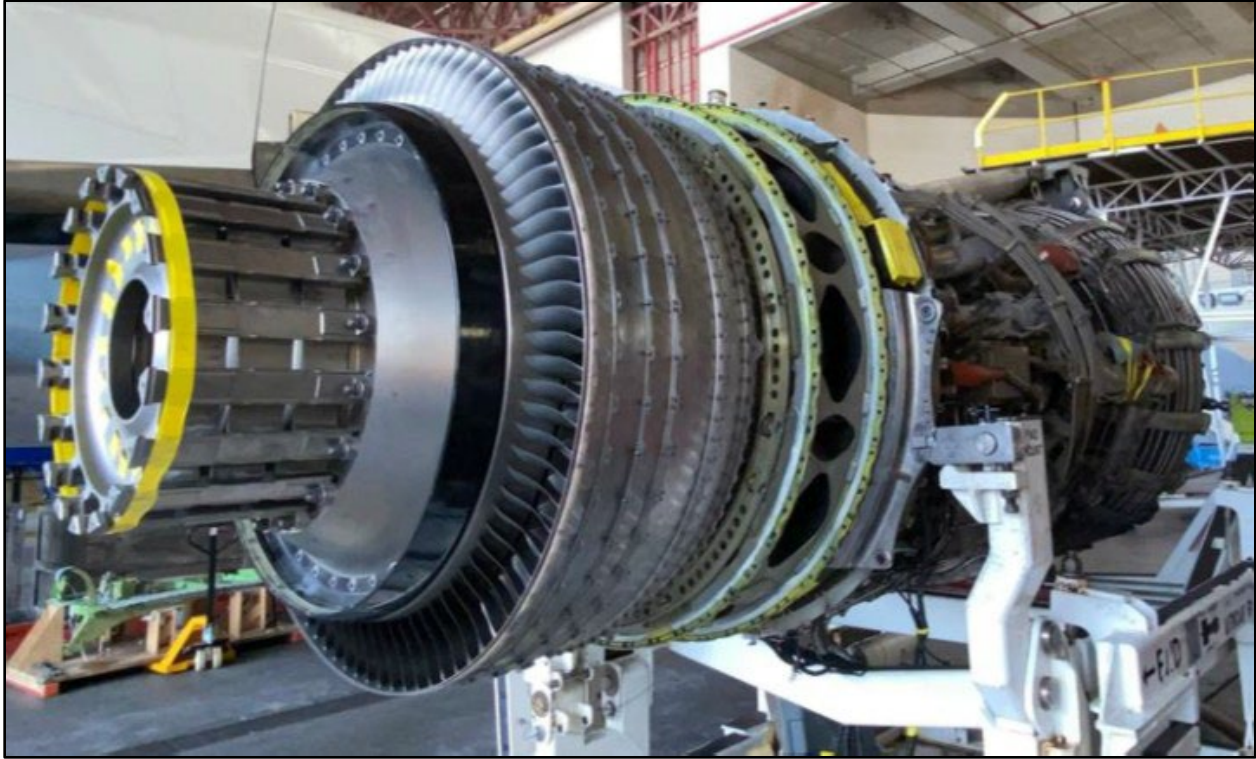
**Figure 19.** Engine Fan Module Removed

With the engine removed from the airplane, the damage was found to be localized to the engine propulsor module, left side TR fan duct and left side thrust reverser hardware. With approval from the NTSB, the fan module, the exhaust nozzle and aft center body were removed from the engine and locally retained by UAL (Figure 19).

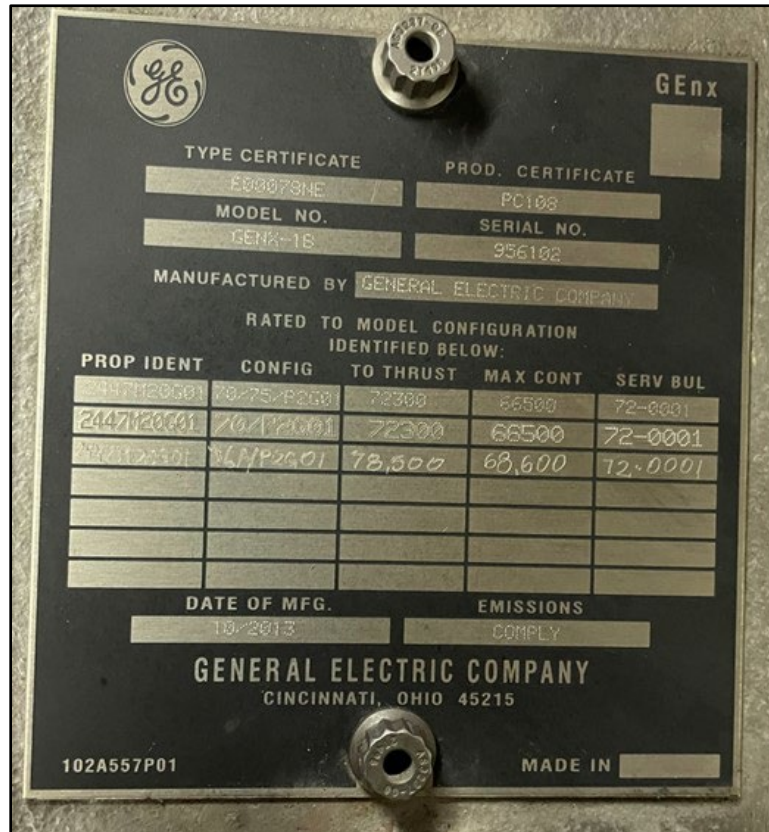
**Figure 27.** Engine Propulsor Data Plate

The engine propulsor data plate, located on the fan hub frame, for ESN 956102 was verified (Figure 27).

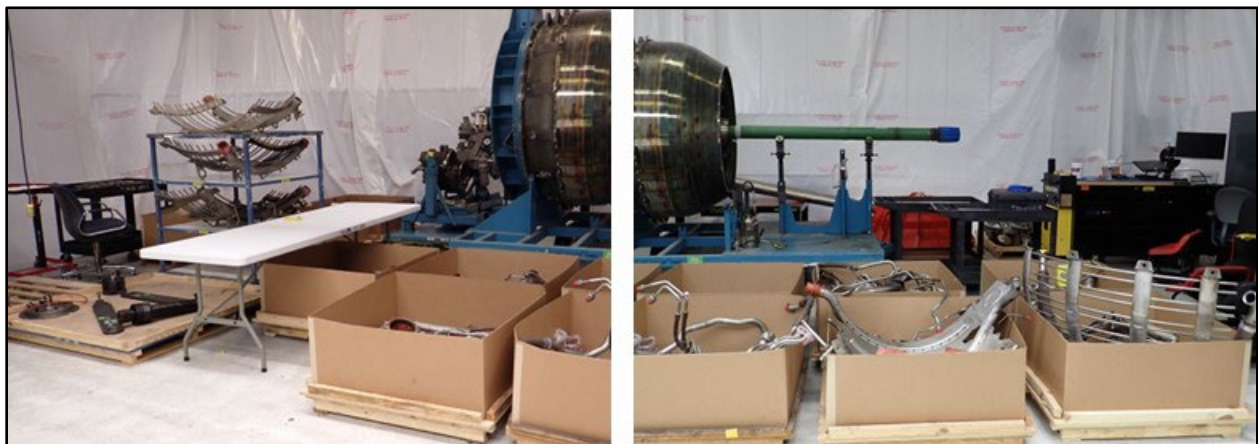
**Figure 28.** Engine Hardware Removed

Upon the investigation team's arrival, all the hardware removed prior to our arrival was placed in boxes and staged in the secure disassembly area (Figure 28).

Nine boxes with various engine components were shipped to GE's facility, which included engine mounting hardware, fan module attachment hardware, two fan blades, the FADEC, the EMU, the bifurcation panel, and loose hardware found at the event site. The components within the boxes were inventoried by GE personnel and stored in a secure trailer until their release.

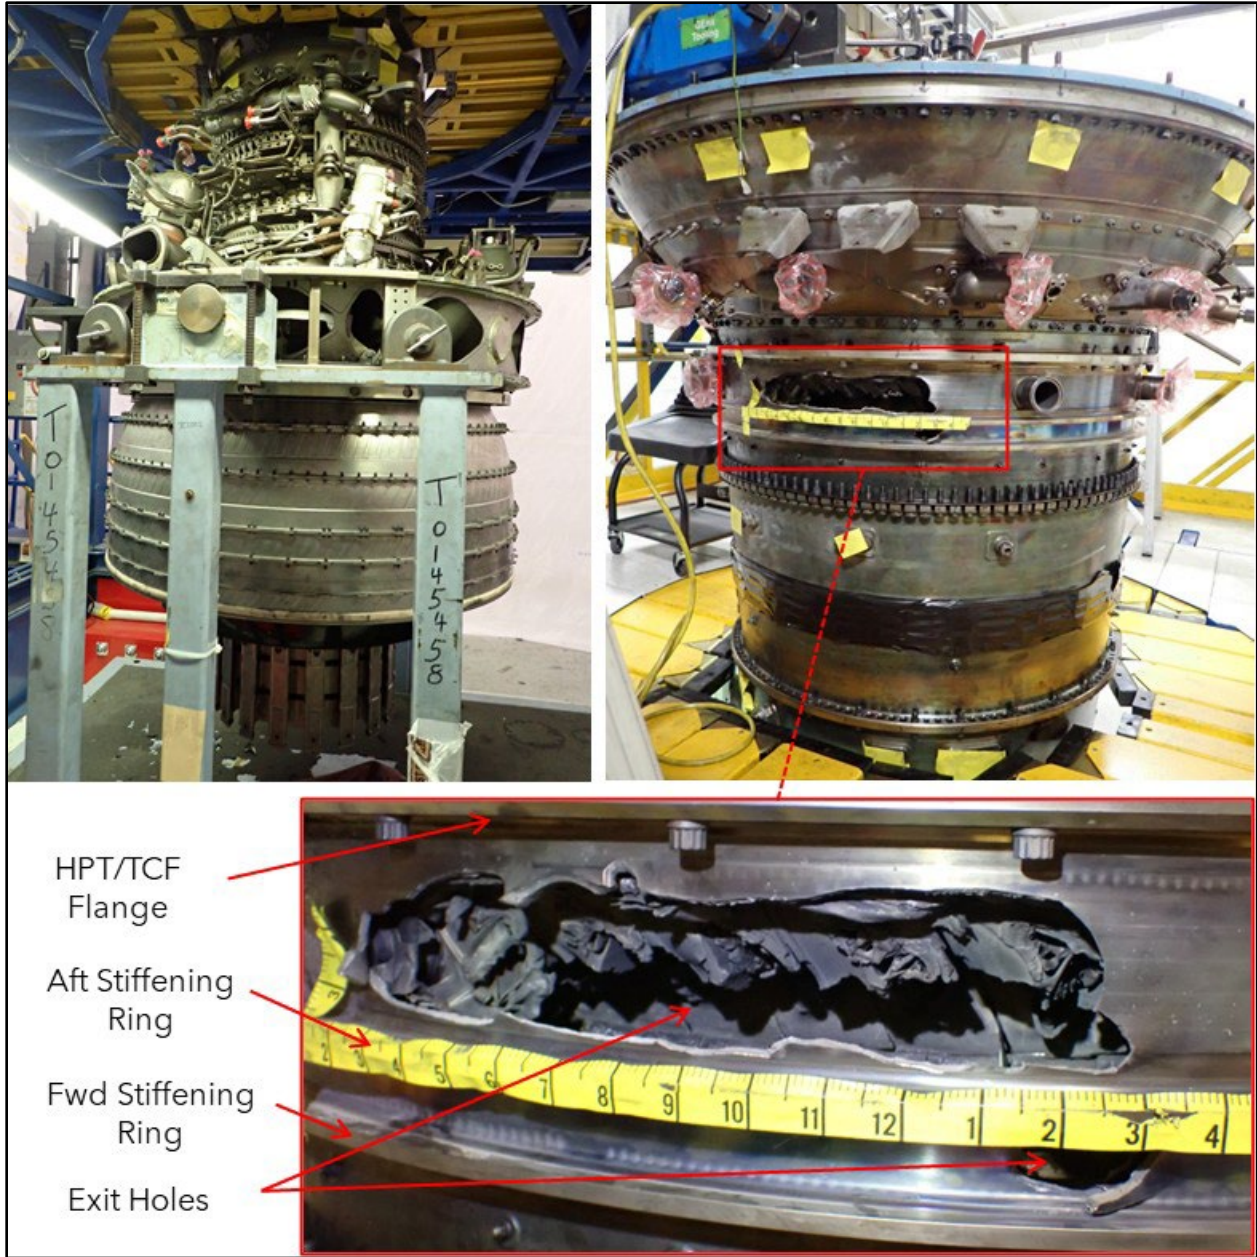
**Figure 30.** Engine Propulsor Upon Arrival

The engine propulsor was installed in a vertical stand to facilitate disassembly and removal of the HPT hardware (Figure 30).

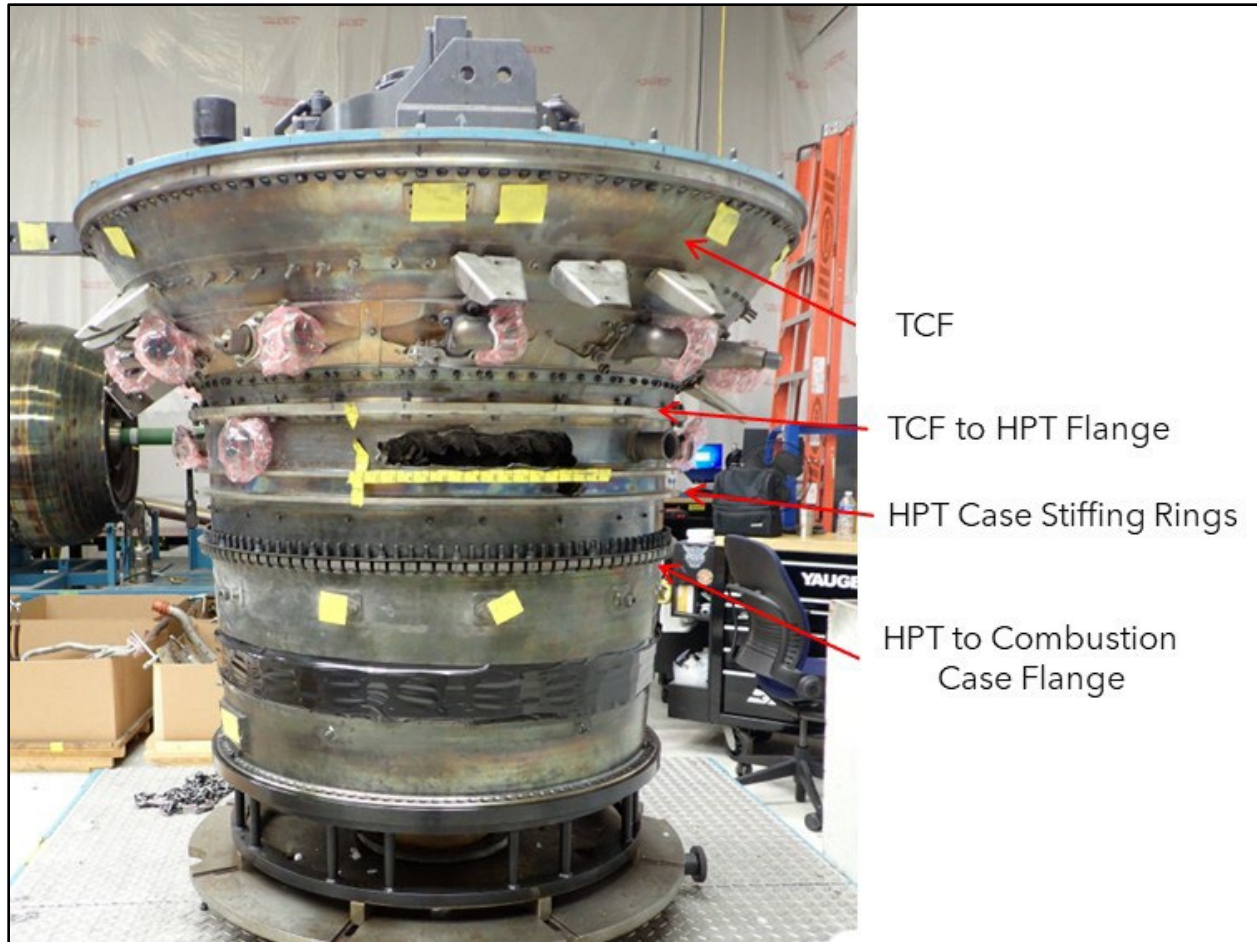
**Figure 33.** FLANGE LOCATIONS

In preparation for removal of the TCF from the HPT turbine case, the breakaway torques of the attachment bolts were measured and found to be within the normal experience during disassembly according to GE maintenance personnel. The nominal torque range according to the engine manual is 362-432 inch pounds. Every fifth attachment bolt was left in place and secured for removal of the TCF once the investigation team arrived (Figure 33).

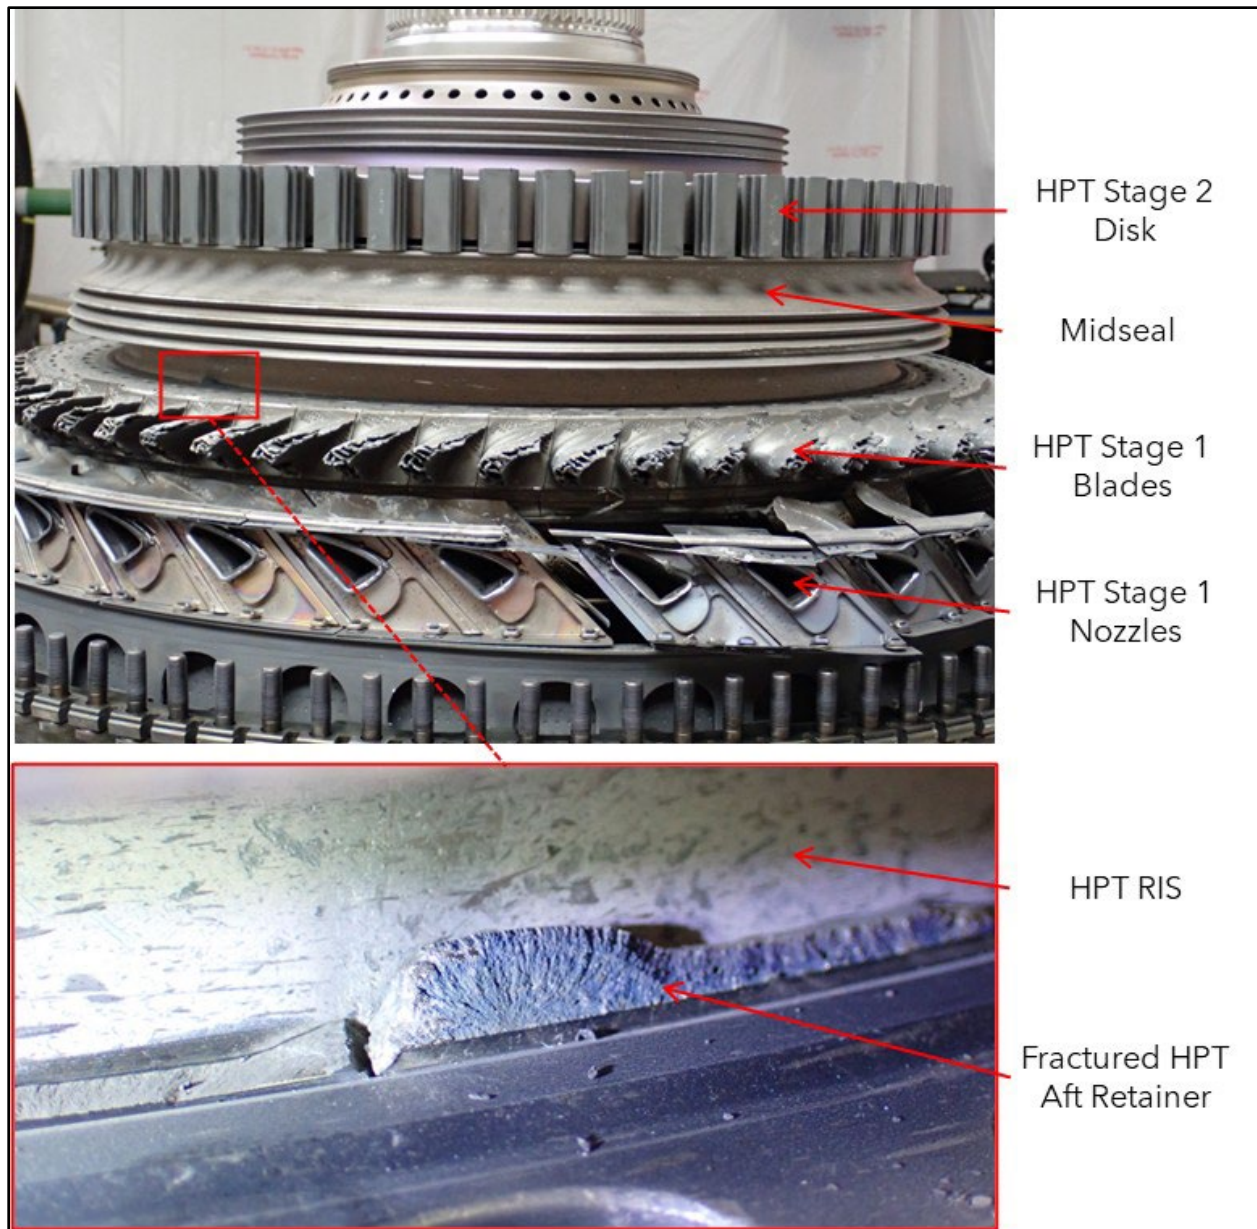
**Figure 39.** HPT Rotor Assembly - HPT Case Removed

With the HPT case removed, the HPT rotor assembly was exposed (Figure 39).

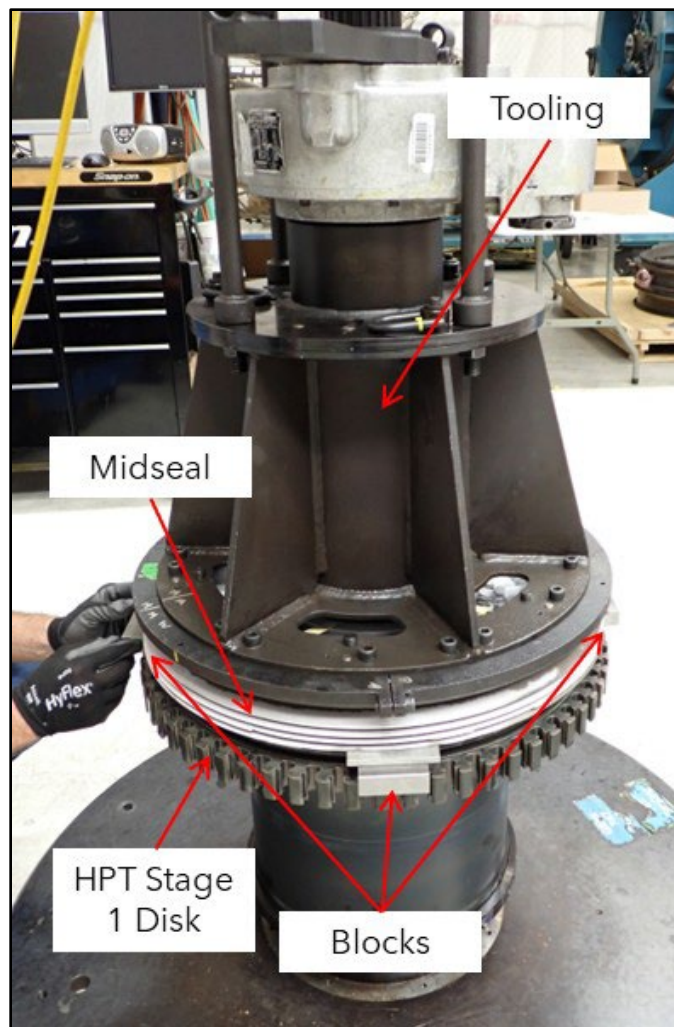
**Figure 46.** BLOCKED HPT STAGE 1 DISK AND HPT RIS

The HPT RIS remained with the HPT stage 1 disk when the HPT stage 2 disk was removed. The HPT RIS sustained damage to all four of the seal teeth, circumferential scoring and contact marks were present on the seal teeth and the surfaces located forward and aft of the seal teeth. Once the assembly load between the HPT stage 1 disk and the HPT RIS was relieved, the HPT stage 1 aft blade retainer became visible on the forward side of the HPT RIS. As the HPT RIS was lifted, the HPT stage 1 aft blade retainer was observed to be partially attached to the HPT stage 1 disk.

In order to protect the HPT stage 1 aft blade retainer primary fracture surface from damage during its removal, metal blocks were placed between the HPT stage 1 disk and the HPT RIS around the outer diameter and on either side of the primary fracture surface of interest to prevent the HPT RIS and attached tooling from relaxing back onto the HPT stage 1 aft retainer after it disengaged from the HPT stage 1 disk (Figure 46). The hydraulic load was then released to allow tooling to be removed the disassembly process to continue.

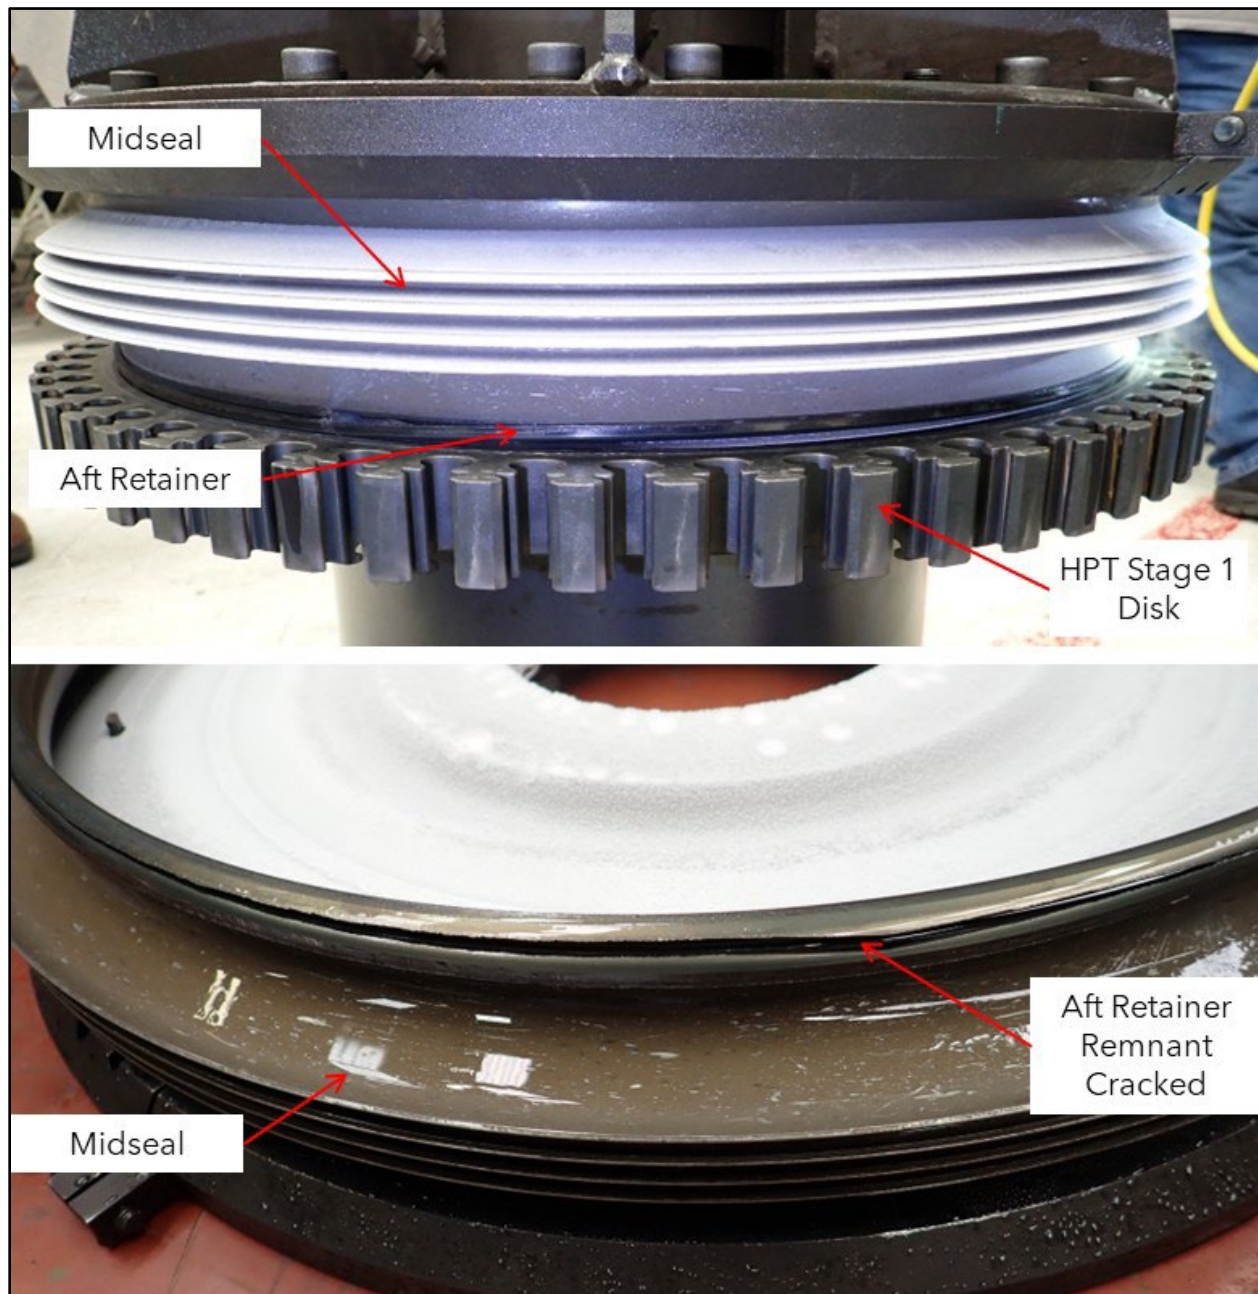
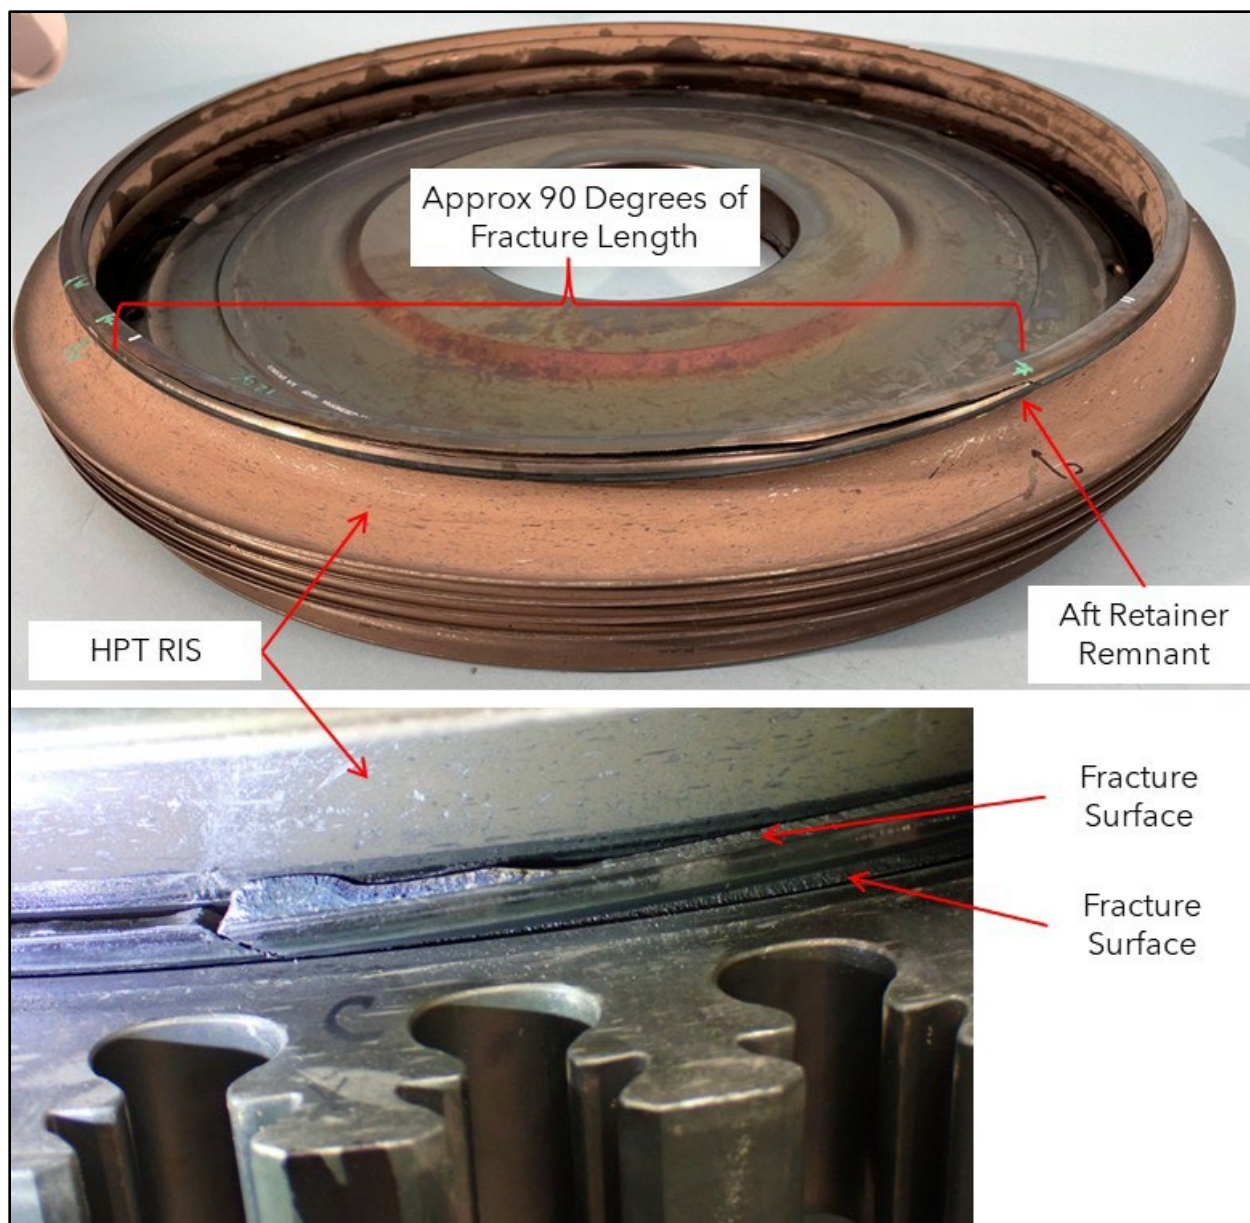
**Figure 47.** HPT RIS AND HPT Stage 1 AFT BLADE RETAINER

The HPT RIS and HPT stage 1 aft blade retainer assembly was transported to GE's material systems laboratory for initial photo documentation, and with approval from the NTSB, the metallurgist separated the HPT stage 1 aft blade retainer from the HPT RIS. Both parts were photo documented and an initial evaluation of the HPT stage 1 aft blade retainer fracture surface was performed (Figure 47 and Figure 48).

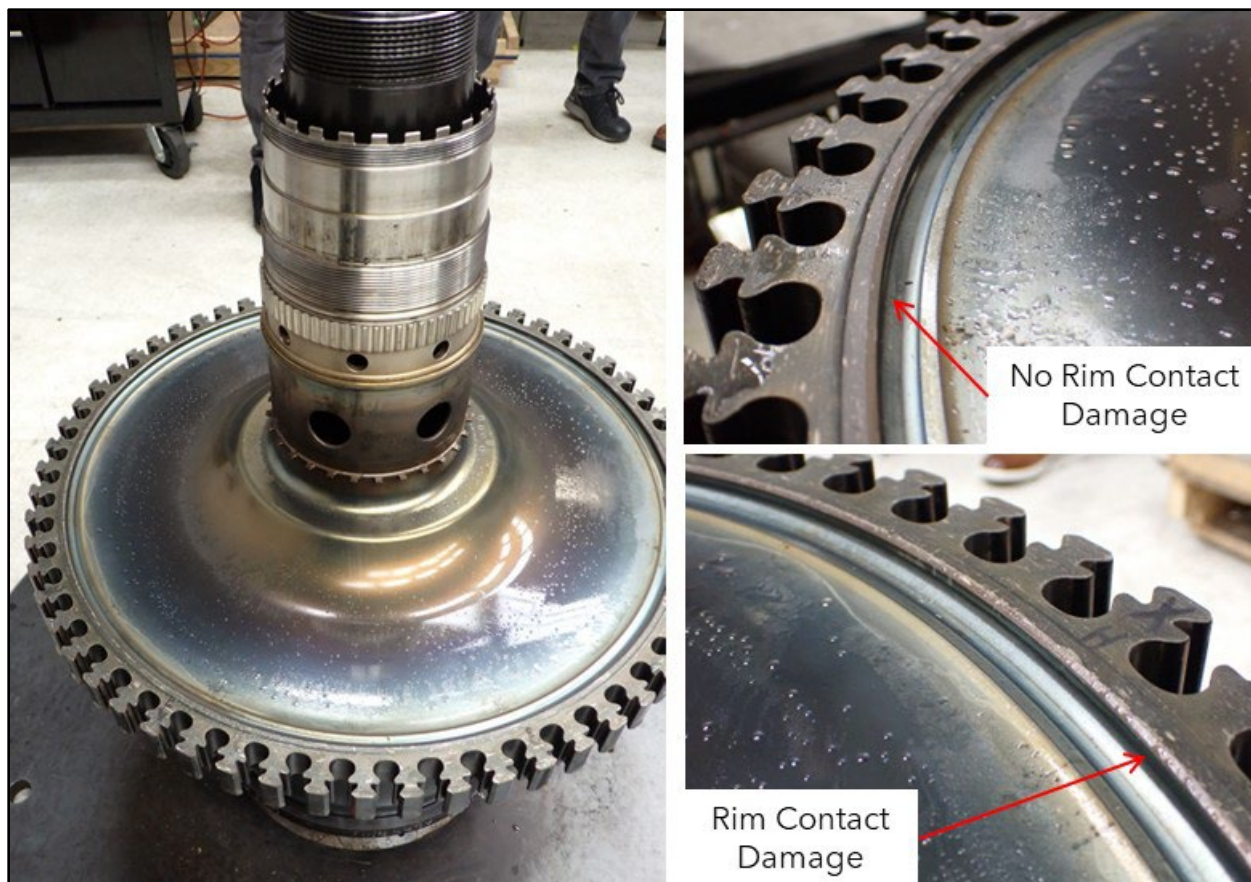
**Figure 49.** Stage 1 Disk

Once removed, the HPT stage 1 disk appeared intact and visually in good condition, the aft side of the disk posts exhibited impact/contact damage and rubbing contact was observed on approximately 90-degrees of the rim corner circumference, inboard of the dovetail slots (Figure 49).

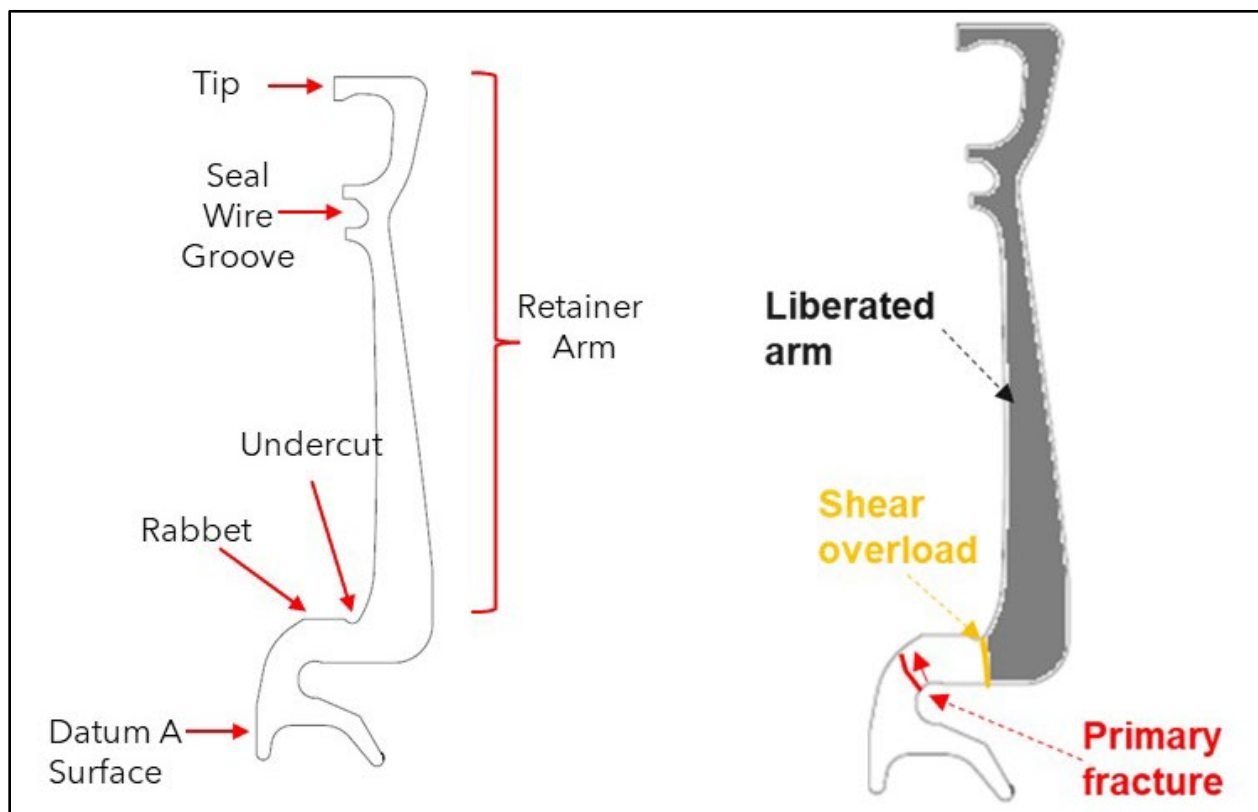
**Figure 50.** HPT Stage 1 Aft Blade Retainer - Cross Sectional View

The remaining inboard portion of the HPT stage 1 aft blade retainer was dislodged from the HPT stage 1 disk and visually examined, which presented a 360-degree circumferential fracture surface located adjacent to the rabbet undercut fillet consistent with overstress (Figure 50). Additionally, a through-wall circumferential crack was observed at the inboard collet radius with a circumferential length spanning a sector of approximately 80-degrees consistent with primary fatigue (Figure 51). The two fracture surfaces connected at one end and at that transition region a parallel approximate 1.25 inch region consistent with secondary cyclic damage was observed in the undercut radius

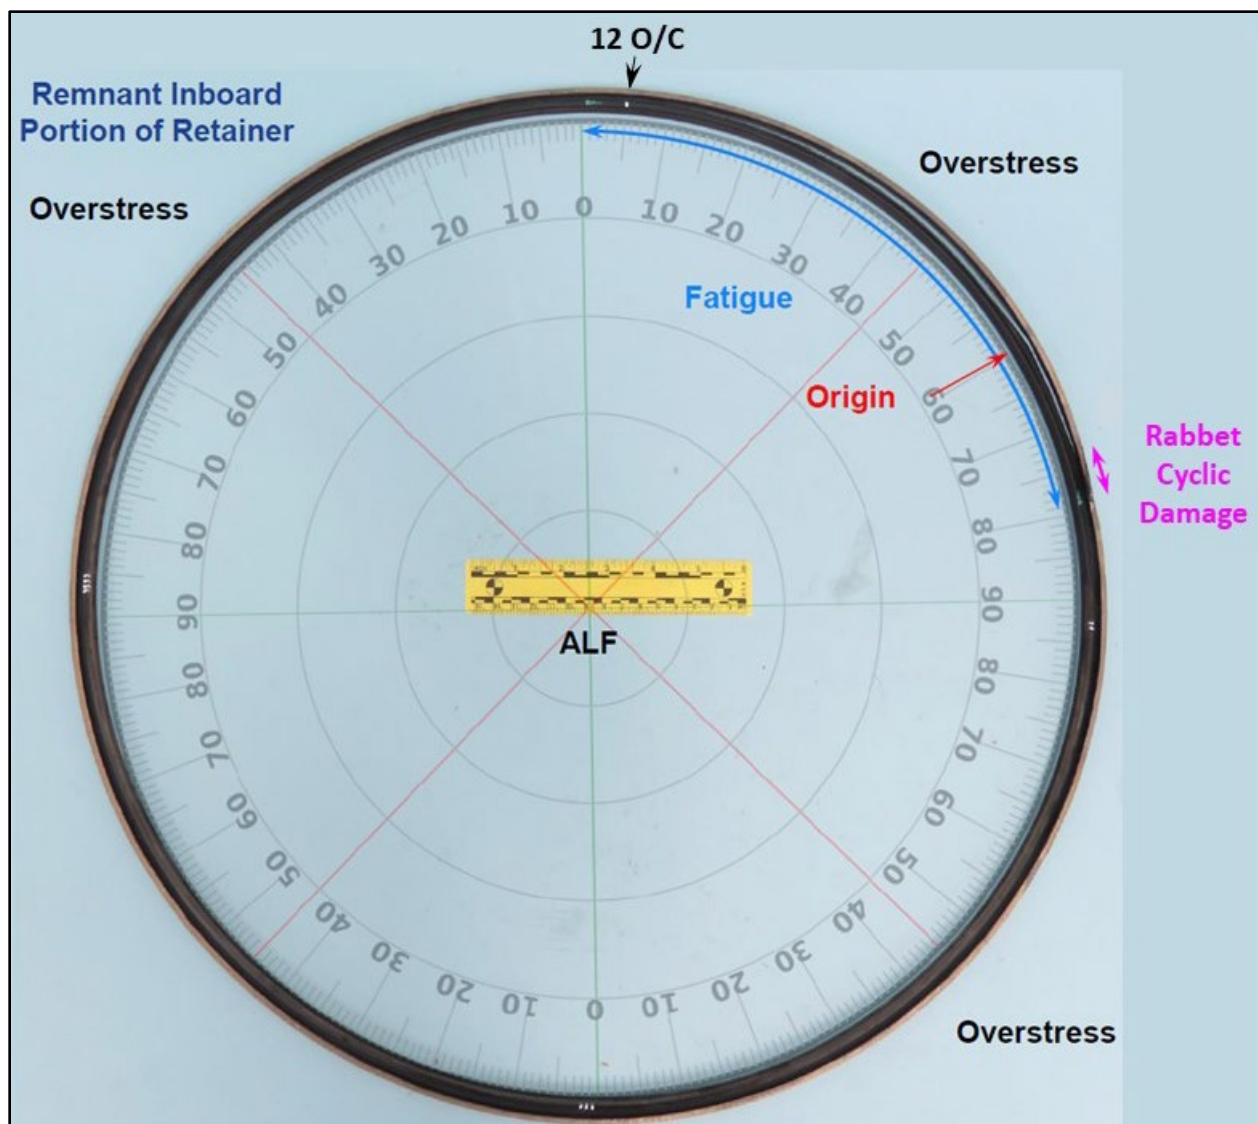
**Figure 51.** HPT Stage 1 Aft Blade Retainer

Various components were retained and transported to GE's material systems laboratory for further examination and dimensional verification, this included the remains of the HPT stage 1 aft blade retainer, the turbine case, the HPT RIS, HPT stage 1 turbine blades, and the HPT stage 1 turbine disk. All inspections (ex. visual, blue light, dimensional), testing, and analysis work performed on hardware other than the HPT stage 1 aft blade retainer found all dimensional and material characteristics to be conforming to GE's drawings and material specifications.

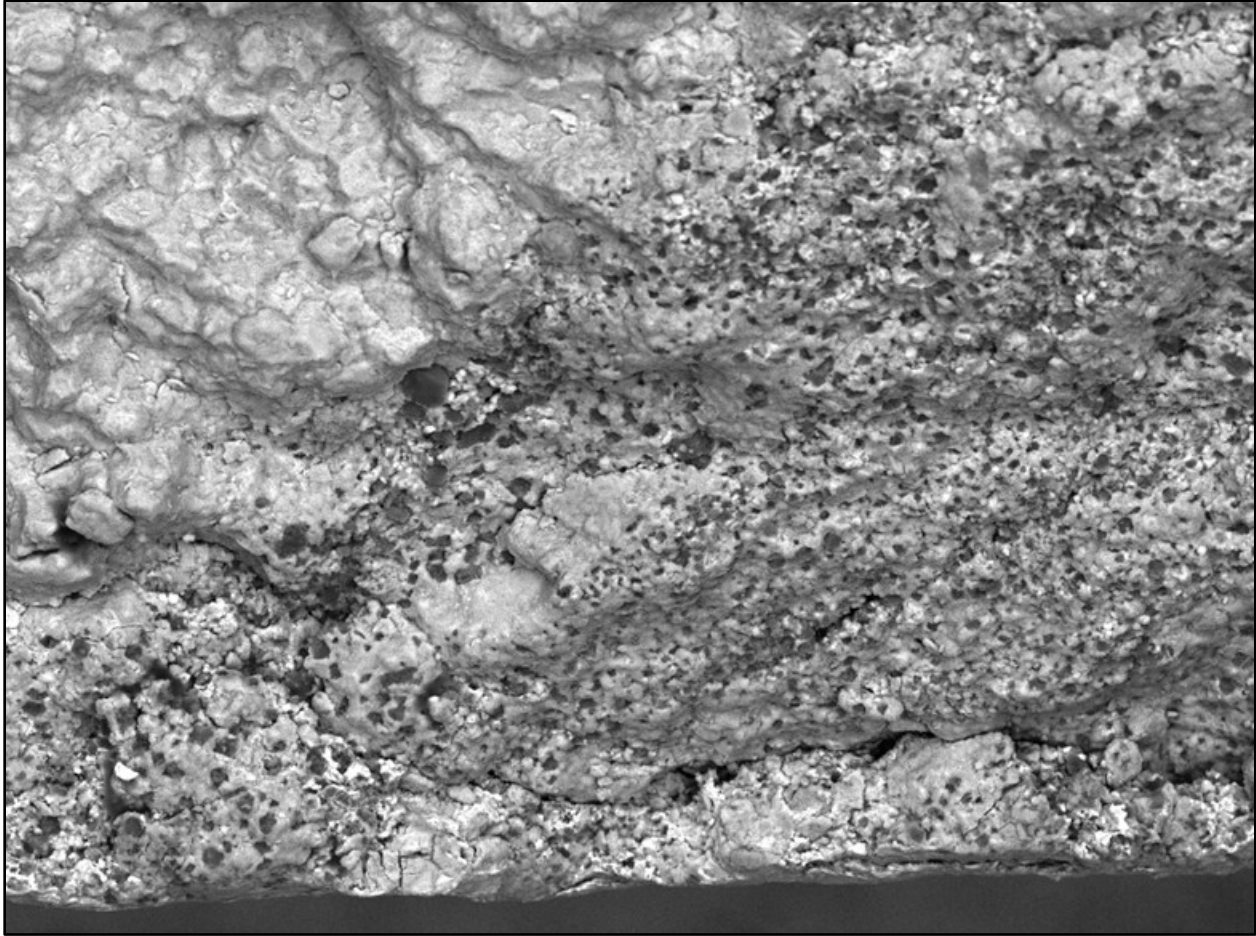
**Figure 54.** Close Up of OCNC Particle Cluster

Fractography revealed that the primary fatigue crack initiated in the upper collet radius at a single point of origin, with the origin plane approximately 0.048 inches aft of rabbet (Figure 52). The crack origin contained a surface connected anomaly that measured 0.005 inches by 0.015 inches by 0.0005 inches. Approximately 0.0017 inches of smeared material was observed at the origin which was added to the observed length of the inclusion to make it an estimated 0.015 inches long. The surface connected inclusion was analyzed with Energy-dispersive X-ray spectroscopy (EDS) and scanning electron microscopy (SEM) which determined the anomaly to be a cluster of particles enriched with Titanium, Aluminum, Zirconium, Magnesium, and Oxygen, which is consistent with OCNC<sup>8</sup> particles (Figure 53 and Figure 54). This OCNC particle

Committee) defined standardized term to define specific melt-related anomalies (the group is formed by OEMs, the FAA, and melters). Similar terms are non-metallic inclusion (NMI) or to some degree stringer depending on size/shape and are a known nickel anomaly.

The long-term corrective action being pursued by GE will re-establish the manufacturing process for the previously approved HPT stage 1 aft blade retainer configuration made of a Rene 88 alloy, a nickel-based superalloy powder metal. GE intends to make the Rene 88 retainer the primary configuration. The Rene 65 retainer will remain certified for use and listed in the illustrated parts catalog (IPC) but it will no longer be available as a spare part, further diminishing the population of the Rene 65 retainers through attrition.

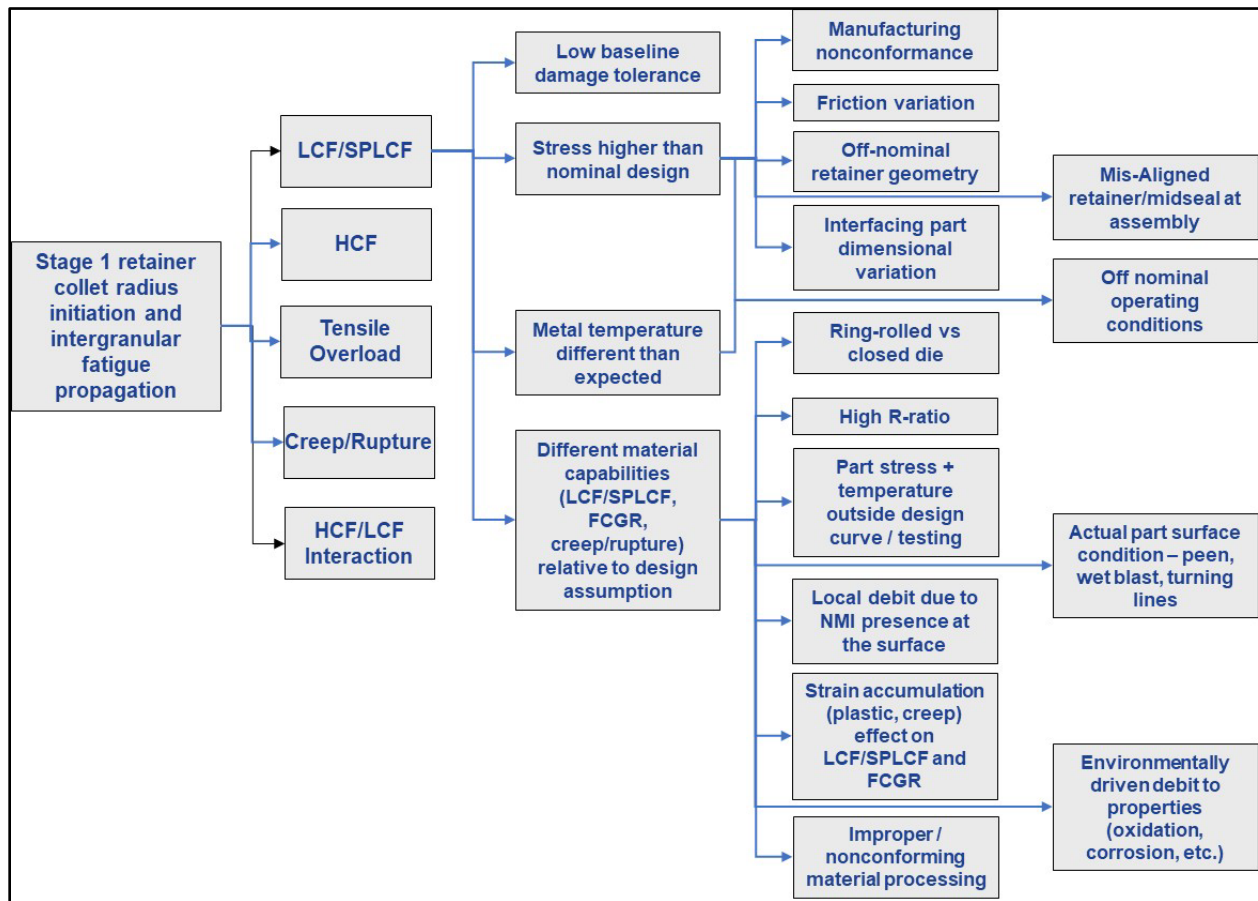
**Figure 56.** Initial Fault Tree Diagram

An initial fault tree was established to consider various aspects of the component design, specifically related to the collet feature, to determine and understand the root cause and whether there were any contributing factors with regard to crack initiation and failure of the HPT stage 1 aft blade retainer component (Figure 56).
