# National Transportation Safety Board

ENG24LA014

GE Aerospace - Metallurgical Investigation Report (DRB AvEng-558171.A)

**METALLURGICAL EVALUATION OF A GENX-1B  
HPT STAGE 1 AFT BLADE RETAINER INVOLVED IN  
AN UNCONTAINED EVENT FROM ESN 956-102  
OPERATED BY UNITED**

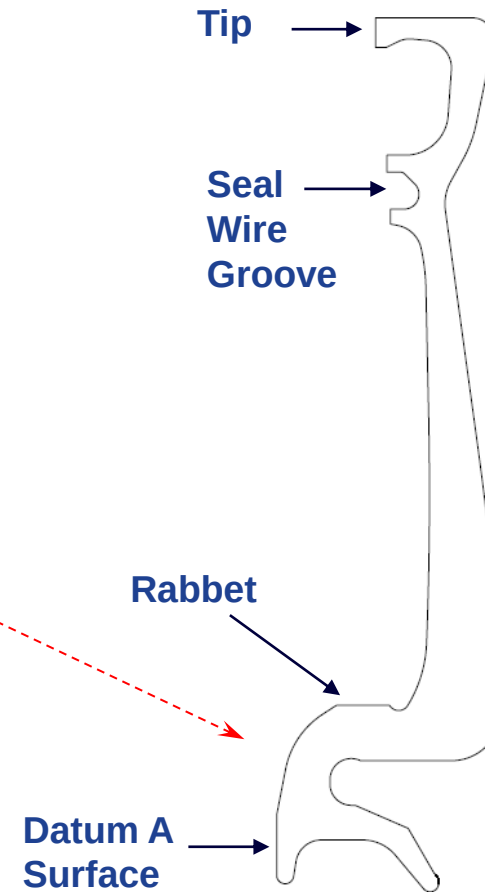
**Figure 1:** Schematic of the GEnx cross-section showing the location/configuration of the retainer and the fracture plane for 956-102 that grew from the outer area of the collet radius and grew outboard.

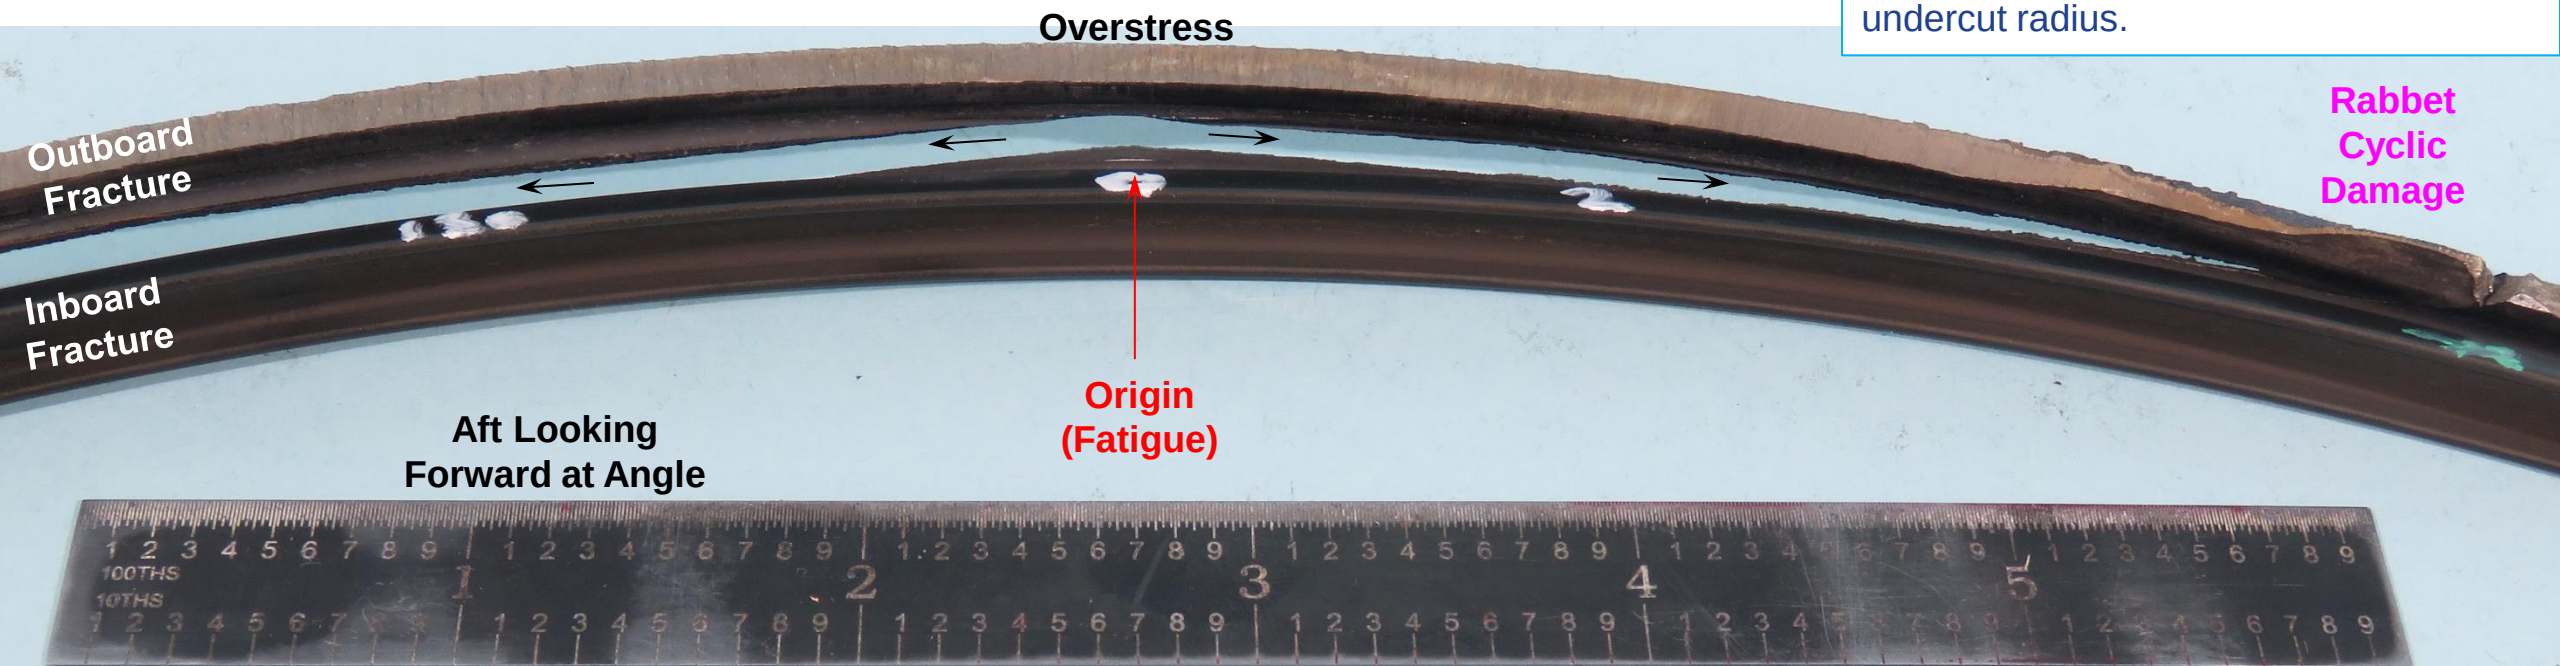
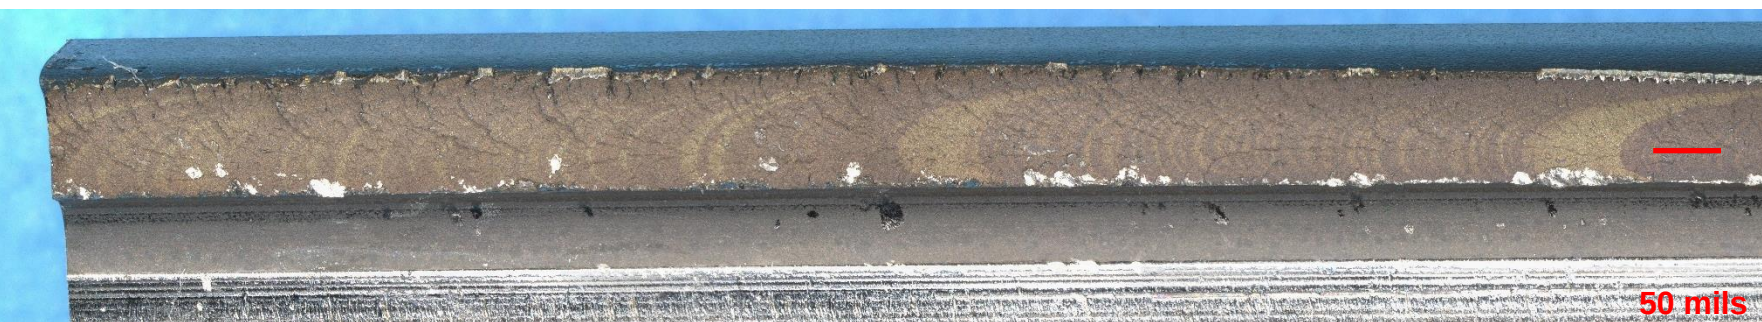
- Visual examination revealed that the entire outboard arm from the disk undercut rabbet radius was liberated. The inboard portion had an approximate **80-degree through-wall circumferential** crack between approximately 12-2:30 (relative to S/N) in the inboard **collet radius** consistent with fatigue (Figure 2). The crack then moved aft into the retainer disk rabbet radius and fractured 360 degrees around with features consistent with overstress (overlapping the fatigue region). At the fatigue/overstress transition region there was also a region with cyclic damage (Figures 2-3).

**Figure 3:** Optical view of the excised mating halves of the inboard portions of the retainers that remained in the engine. The images show that the fatigue region initiated at the top (outboard) side of the collet feature and then moved further inboard as it grew circumferentially. Near the end of the fatigue region, additional cyclic damage was observed in the rabbet undercut region growing inward (pink area). The crack then finally separated in overstress 360 degrees around in the plane of the undercut radius.

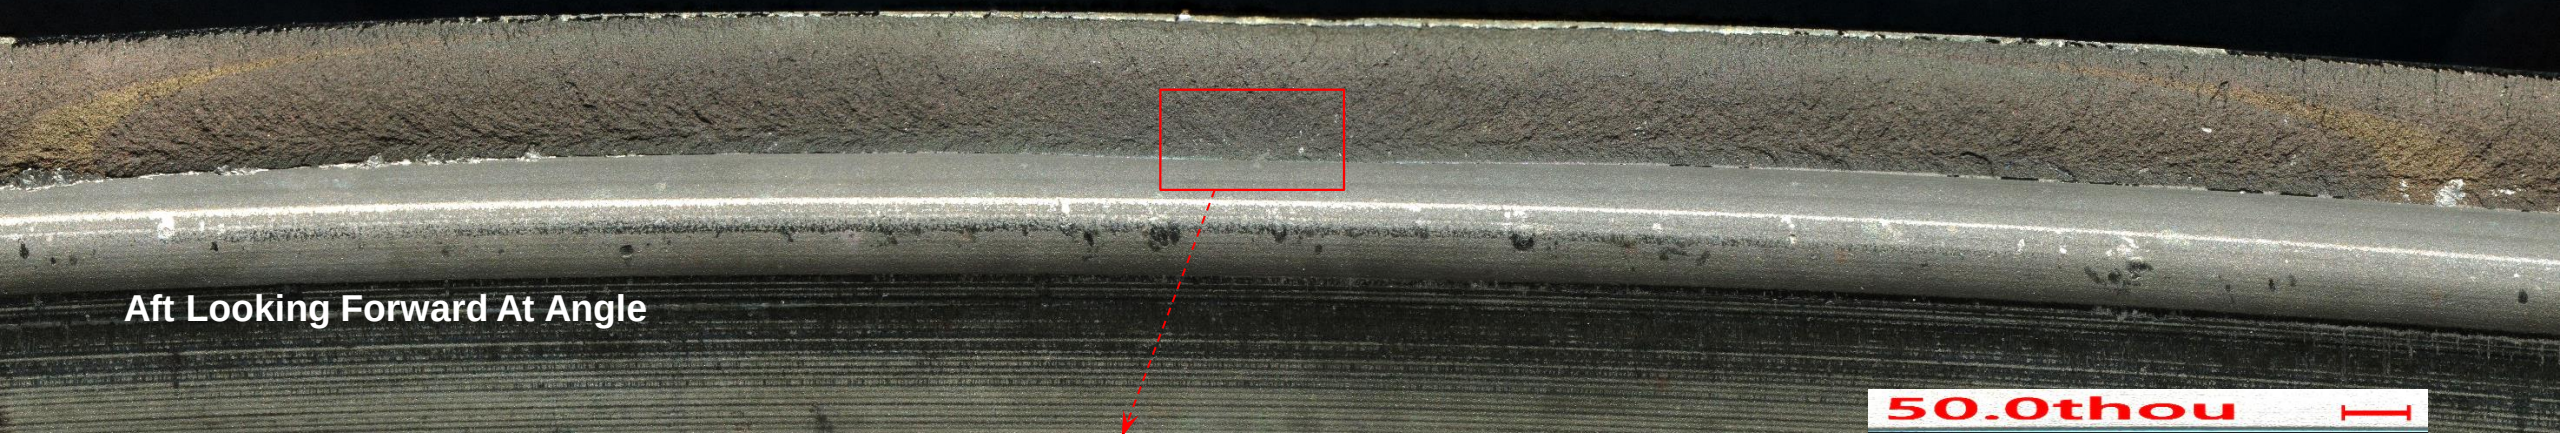
**Figure 6:** Close-up optical view of the fracture surface in the region of the origin showing that it initiated from a single origin at the surface (see SEM).

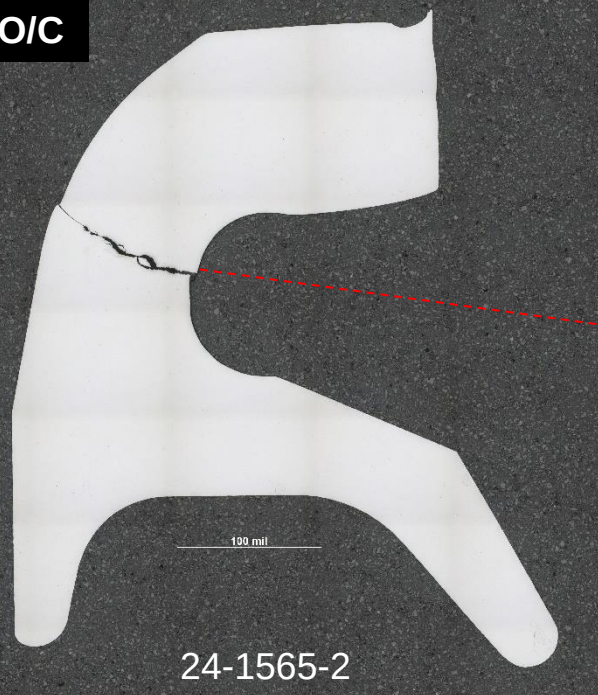
- Mounts made at the origin (near 1:45) and the crack end (near 12 o'clock), confirmed that the initial fracture plane was at the upper portion of the collet radius, then moved inboard as the crack grew larger into the peak predicted stress location (Figures 17 and 19).

**Figure 17:** The left image shows a micro through the end of the crack showing the that the fracture plane changed from the upper/outboard side of the collet radius near the origin to further inboard near the center of the collet near the crack end.

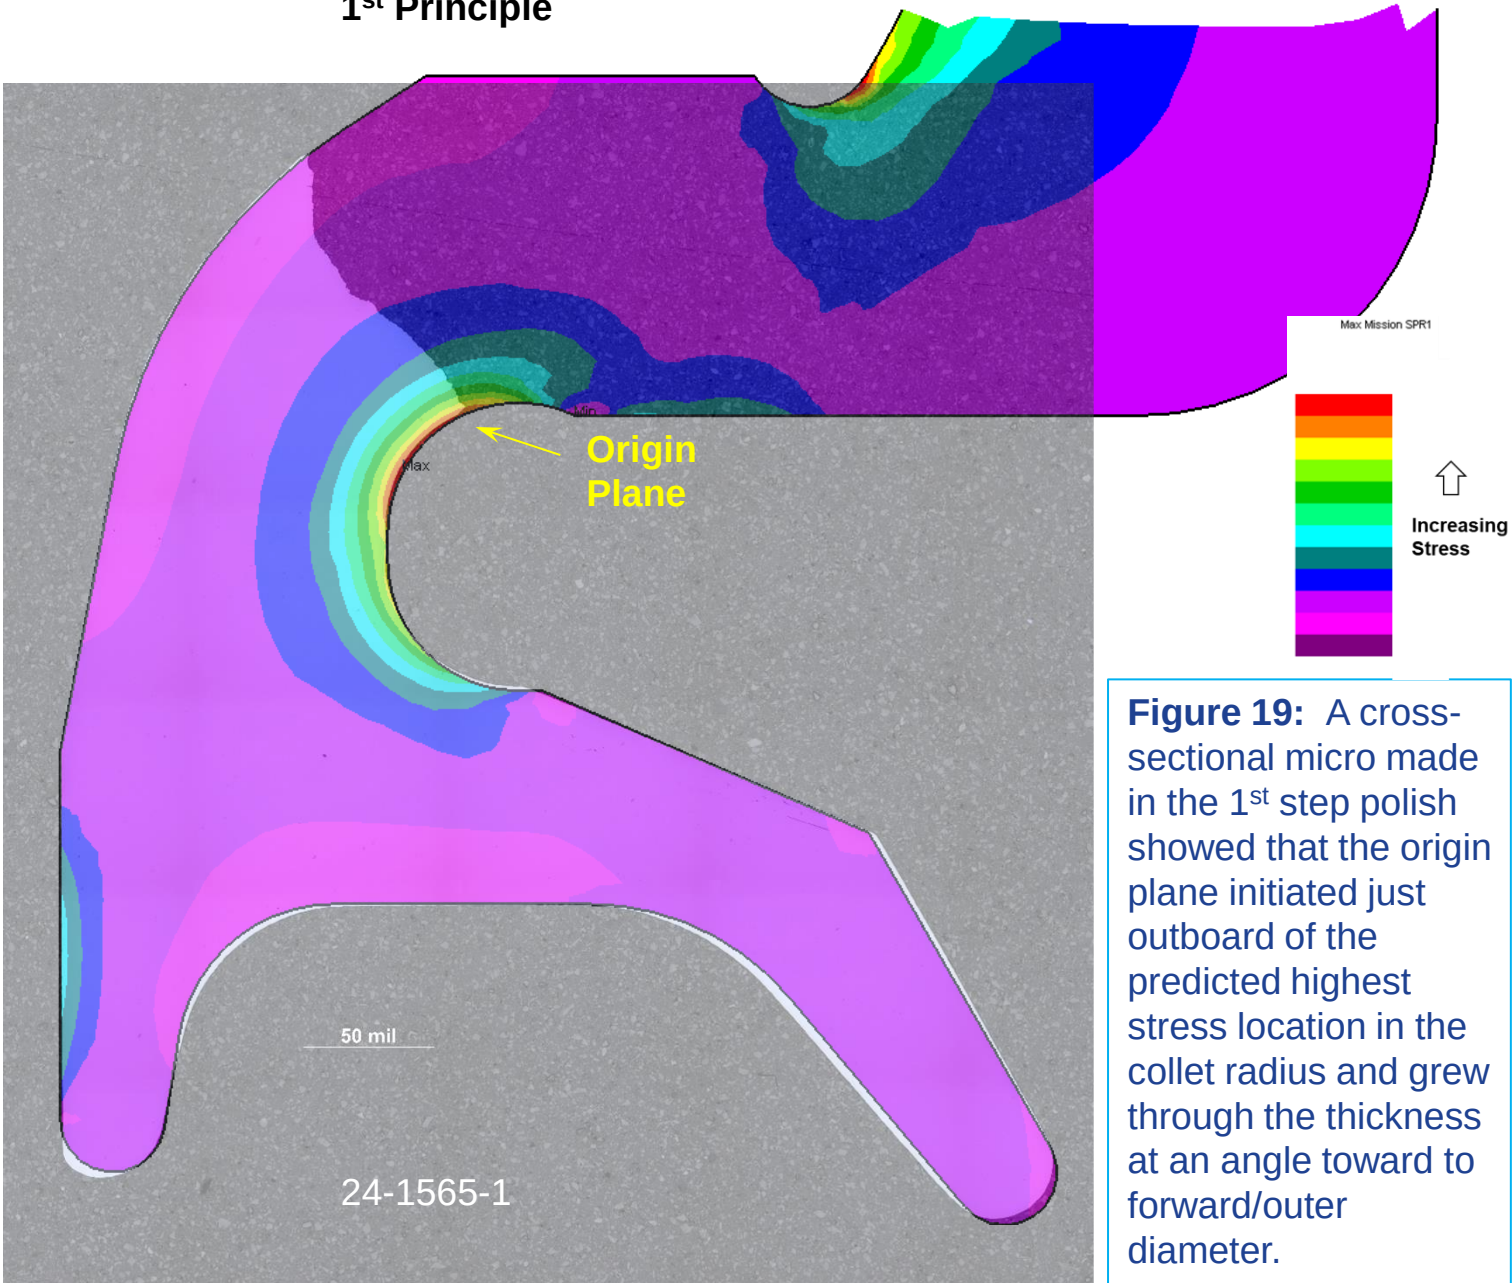
**Figure 19:** A cross-sectional micro made in the 1<sup>st</sup> step polish showed that the origin plane initiated just outboard of the predicted highest stress location in the collet radius and grew through the thickness at an angle toward to forward/outer diameter.

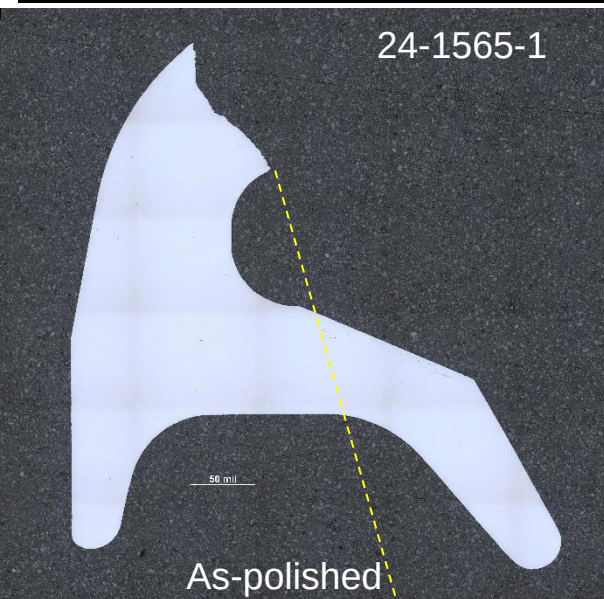
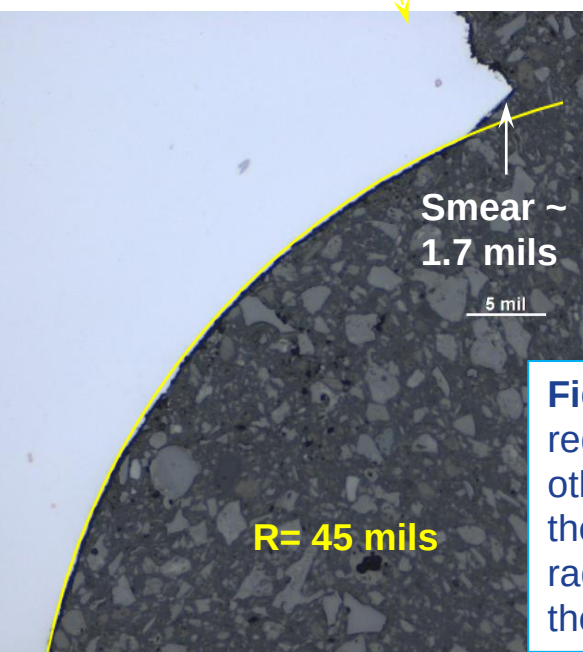
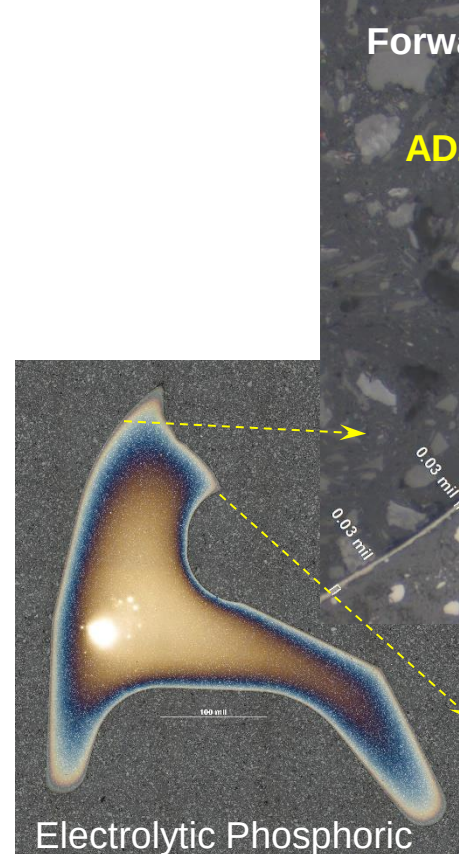
**Figure 20:** 1<sup>st</sup> step as-polished and etched micros showing that the origin region had approximately 1.7 mils of post-fracture smeared material, but no other material anomalies were observed and the alloy depletions zone (ADZ) in the undamaged forward radius was approximately 0.03 mils thick. The collet radius was approximately 45 mils, conforming to the drawing requirement, and the microstructure was consistent with properly processed R65 per C50TF133.

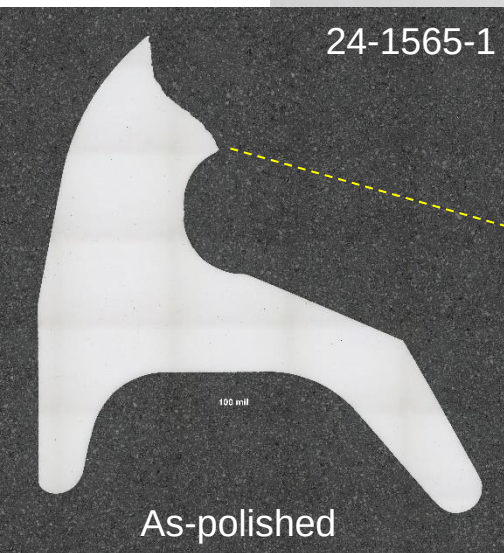
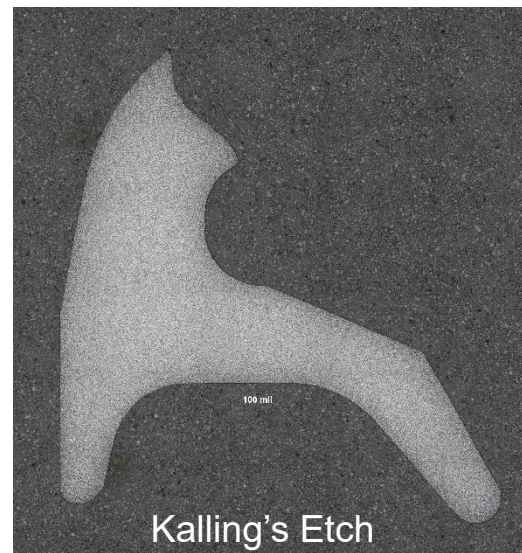
- The **microstructure** was consistent with properly processed R65 material, with an average grain size of approximately **ASTM 10.5**, conforming to the requirements of C50TF133 CL-A (Figures 22 and 23).

**Figure 22:** 2<sup>nd</sup> step as-polished and etched micros showing that the origin region had post-fracture smeared material, but no other material anomalies were observed, and the microstructure was consistent with properly processed R65 per C50TF133, with an average grain size of approximately ASTM 10.5. The fracture progressed in an intergranular manner, consistent with fatigue hold time crack growth.

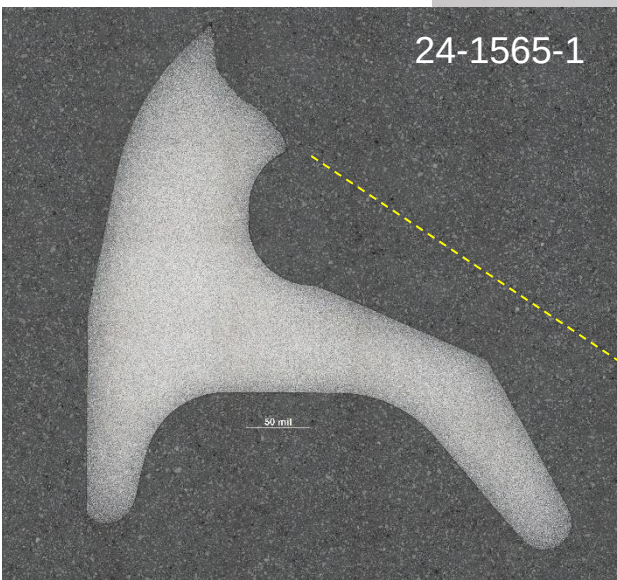
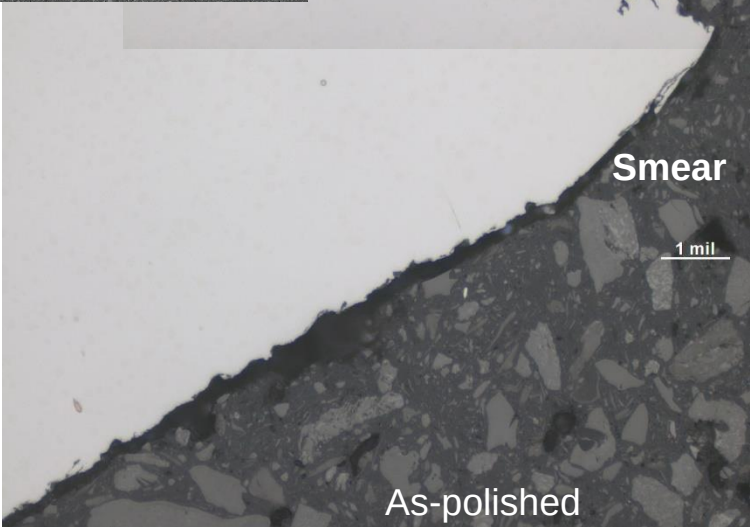
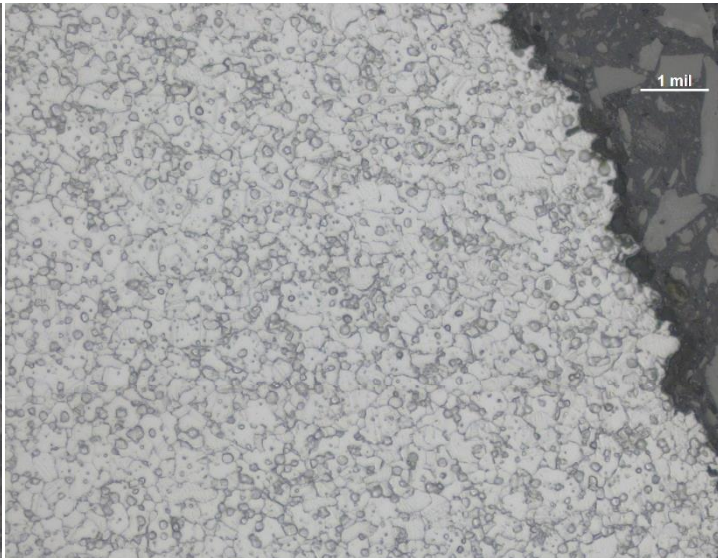
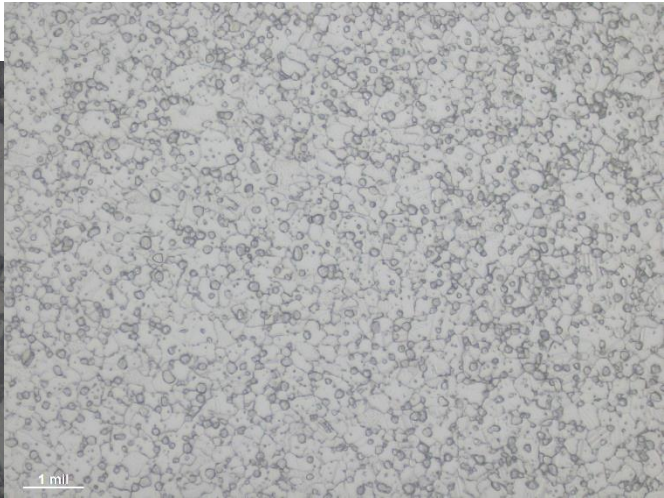
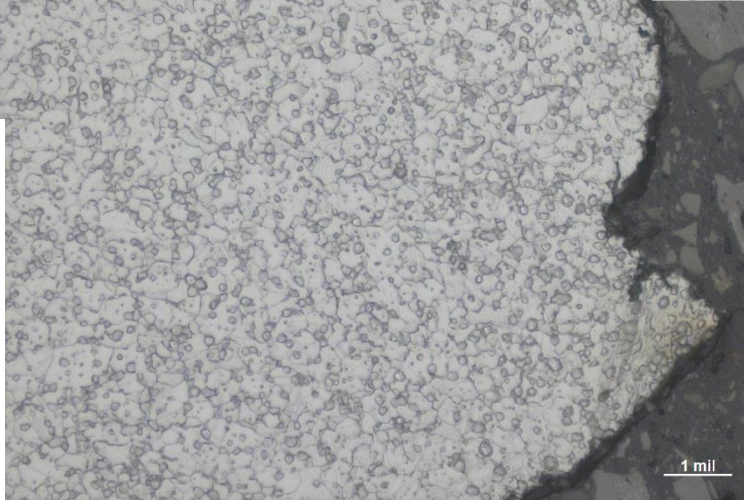
**Figure 23:** 3<sup>rd</sup> step as-polished and etched micros at the edge of the origin showing it had post-fracture smeared material, but no other material anomalies were observed, and the microstructure was consistent with properly processed R65 per C50TF133, with an average grain size of approximately ASTM 10.5.

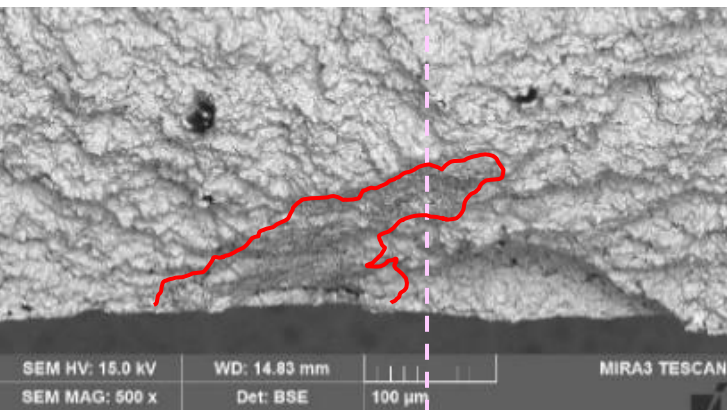
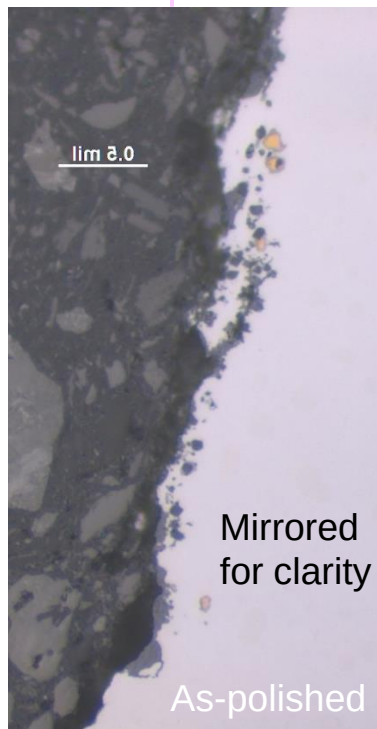
**Figure 25:** Views of the same micro in the as-polished condition in the SEM showing a conforming microstructure, but the origin area had mixed-oxides, consistent with an inherent OCNC (see next page).

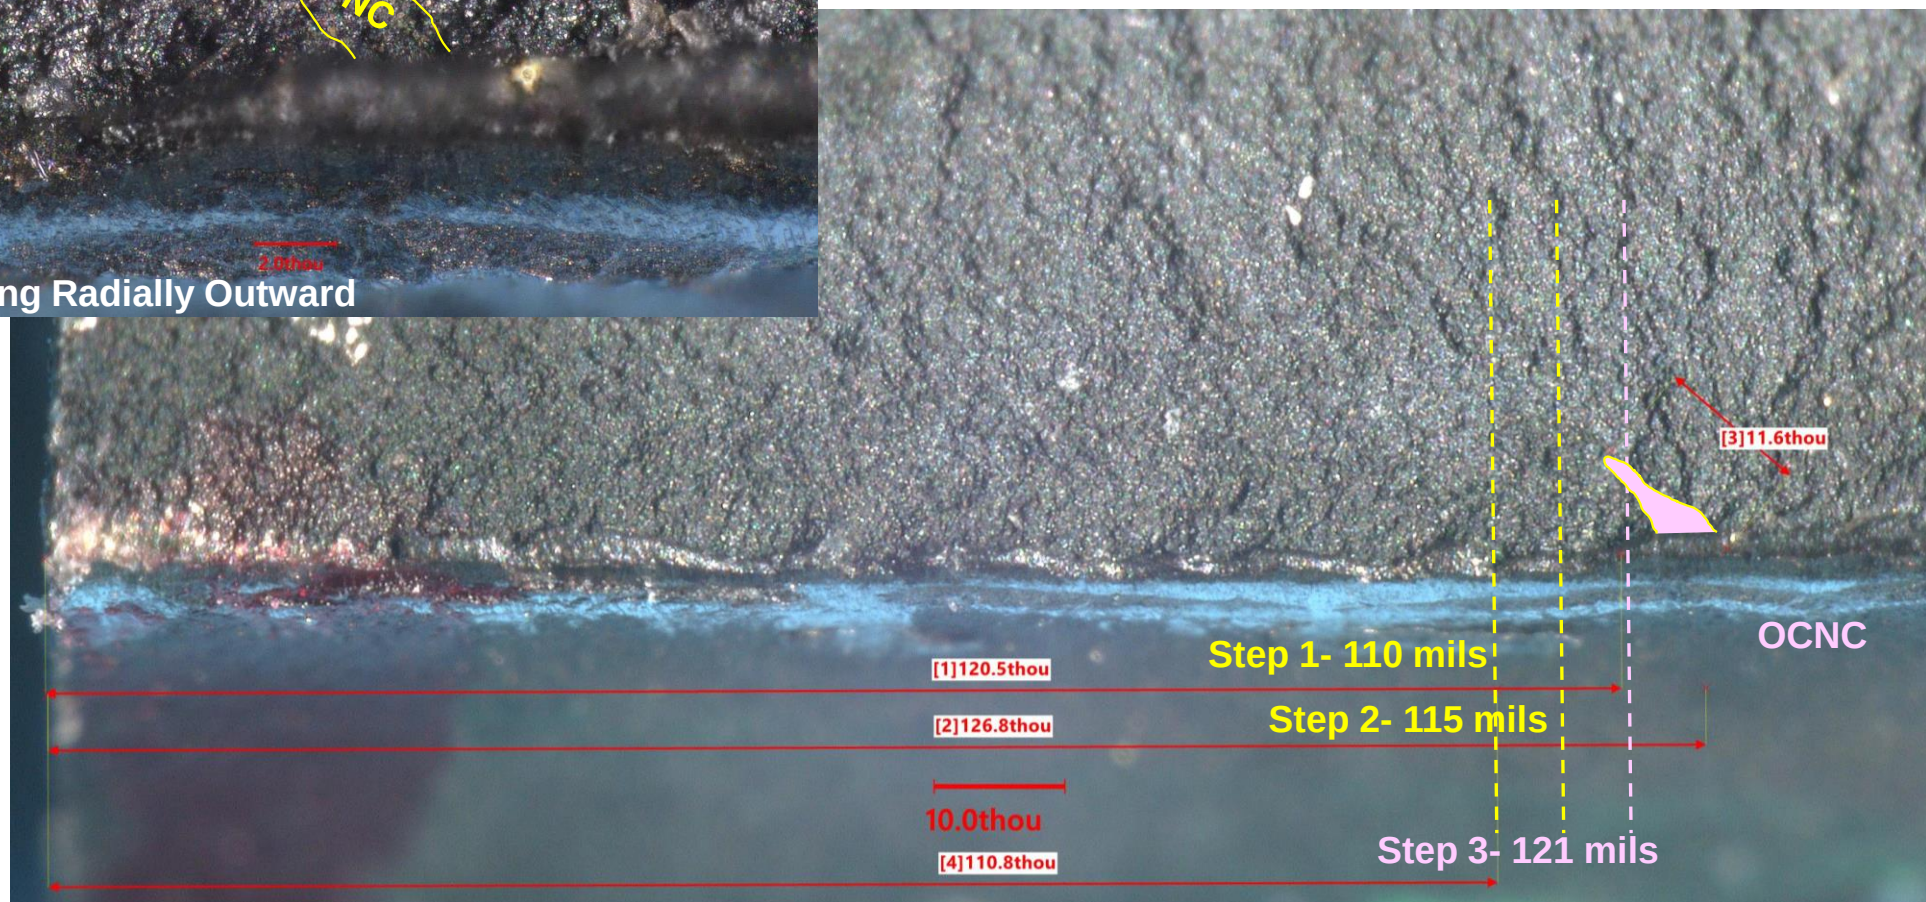
**Figure 33:** A cross-sectional micro made in the 1<sup>st</sup> step polish of the outboard sector showed that the origin plane initiated near the top/outboard side of the collet radius. The section was deformed at the aft end consistent with damage from the final overstress of the part.

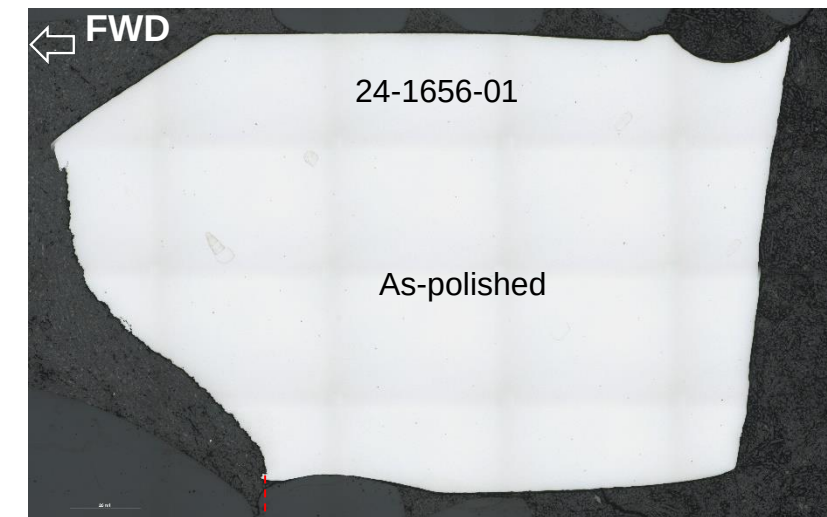
**Figure 34:** A cross-sectional micro made across the outboard mating origin half showed that that the surface itself was smeared, but the crack extended from a region of mixed oxides consistent with an inherent OCNC inclusion that was approximately 0.5 mils thick in the plane of polish.

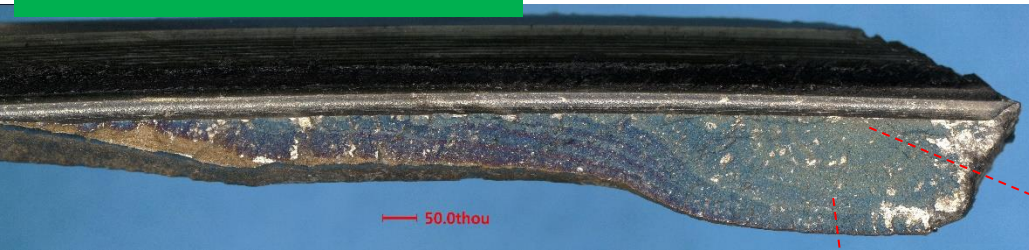
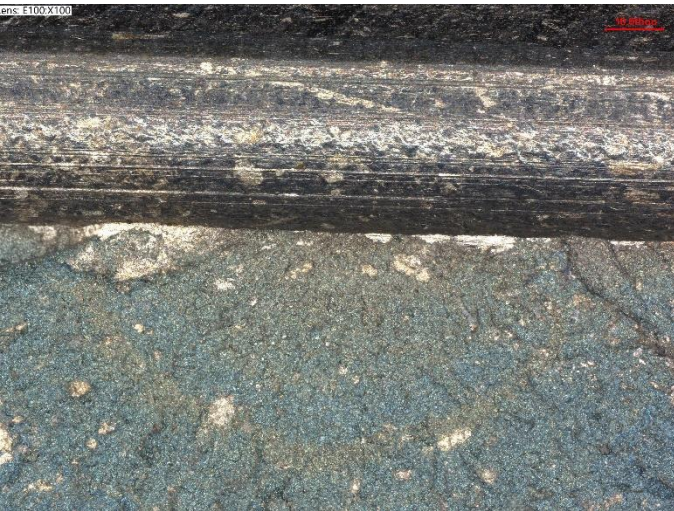
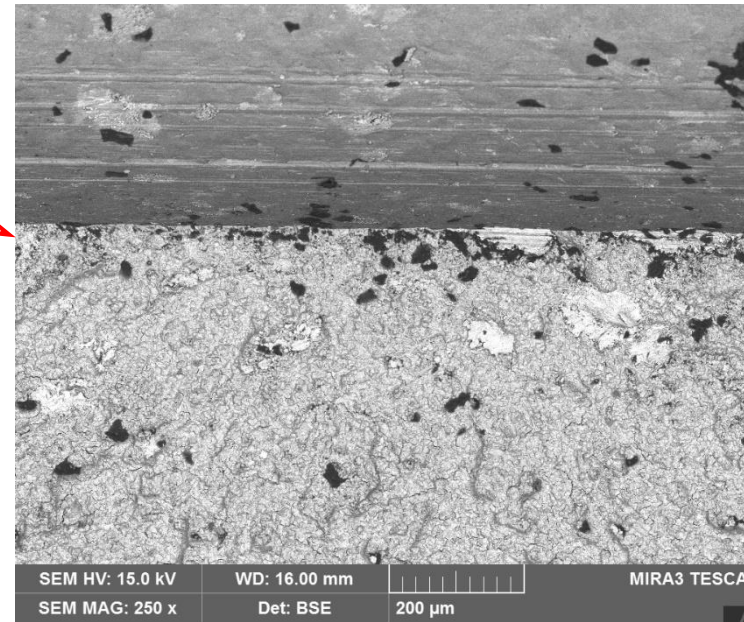
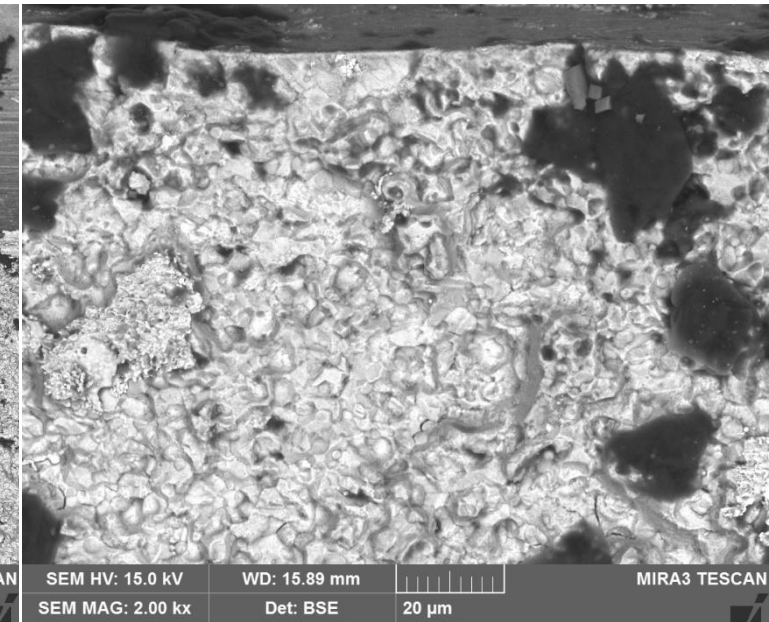
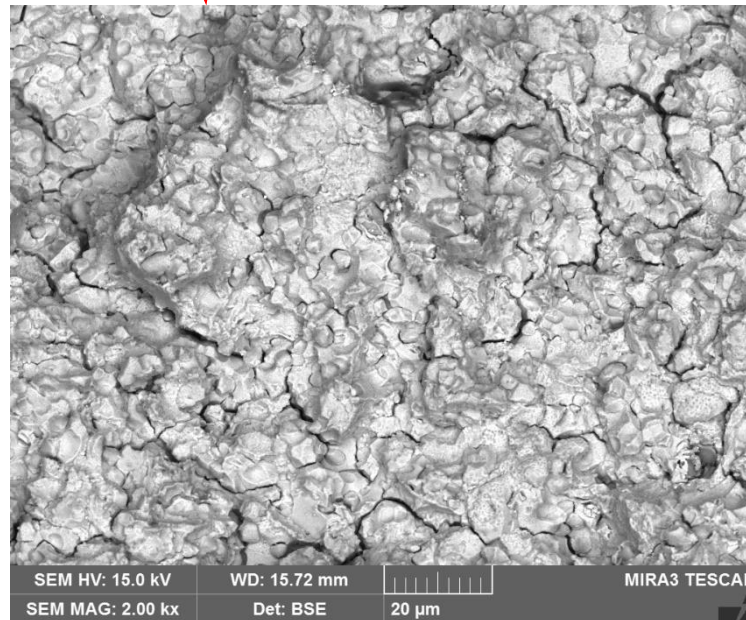
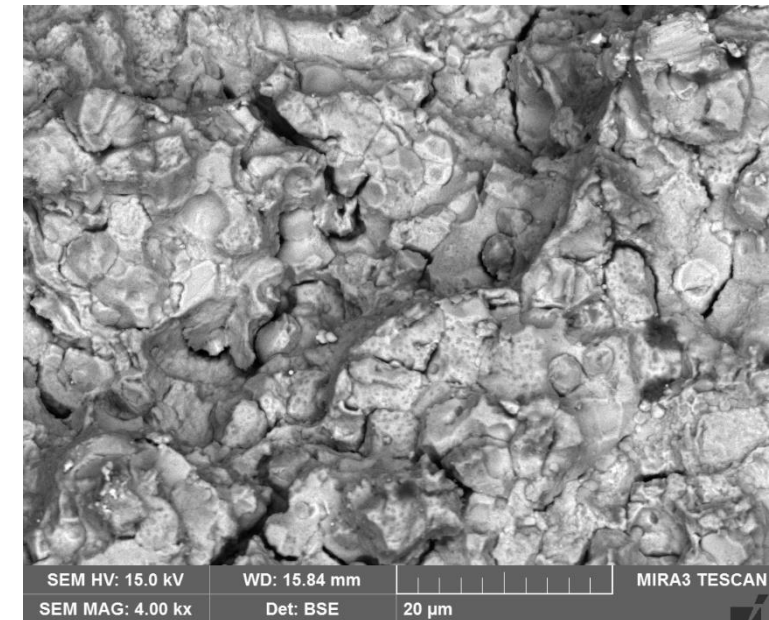
**Figure 37:** The OD rabbet undercut region with beach marks was examined in the SEM and shown to be fully intergranular in the larger thumb-nail-shaped region, consistent with secondary cyclic hold-time damage.

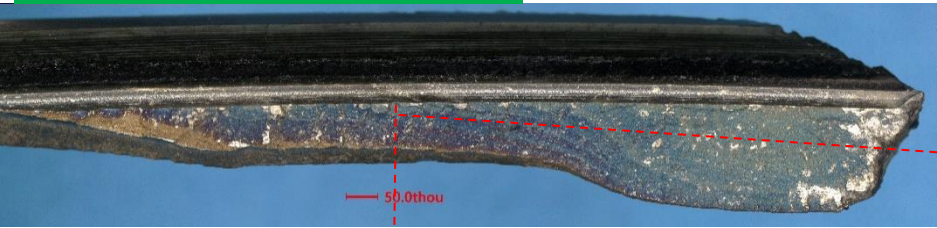
**Figure 38:** Moving toward one of the smaller thumbnails in the OD rabbet radius beach mark region revealed a combination of intergranular and ductile dimple regions, consistent with secondary cyclic tensile/hold time fatigue region.

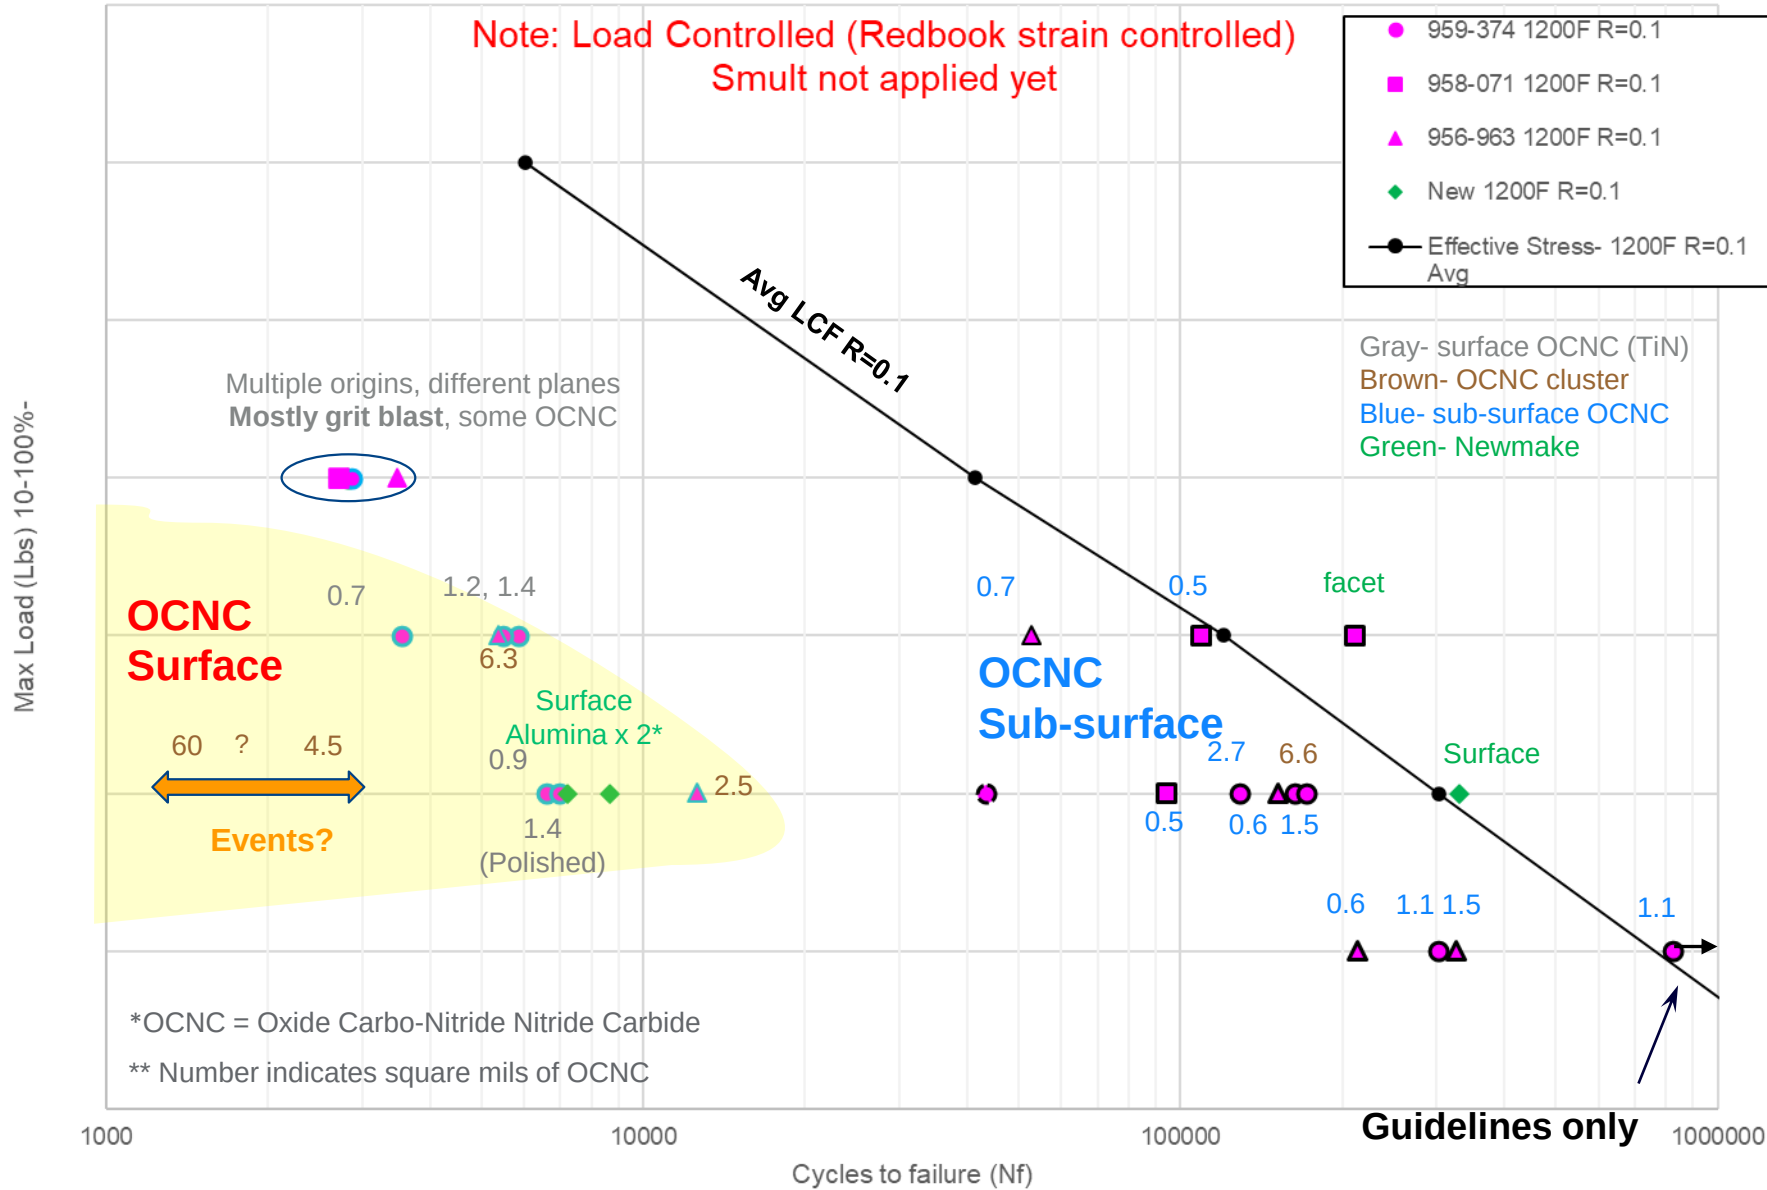
LCF Tests 1200F R=0.1

- At very high stress: All had multiple origins at the surface initiating from the surface, grit blast particles, or OCNCs. They did not look similar to the event parts.
- At high stress: The lives had a **bimodal** distribution and either initiated with low lives at **surface OCNCs**, or subsurface at higher lives near average expectations.
- At intermediate loads: **All 5** specimens initiated **sub-surface** with average expected lives.

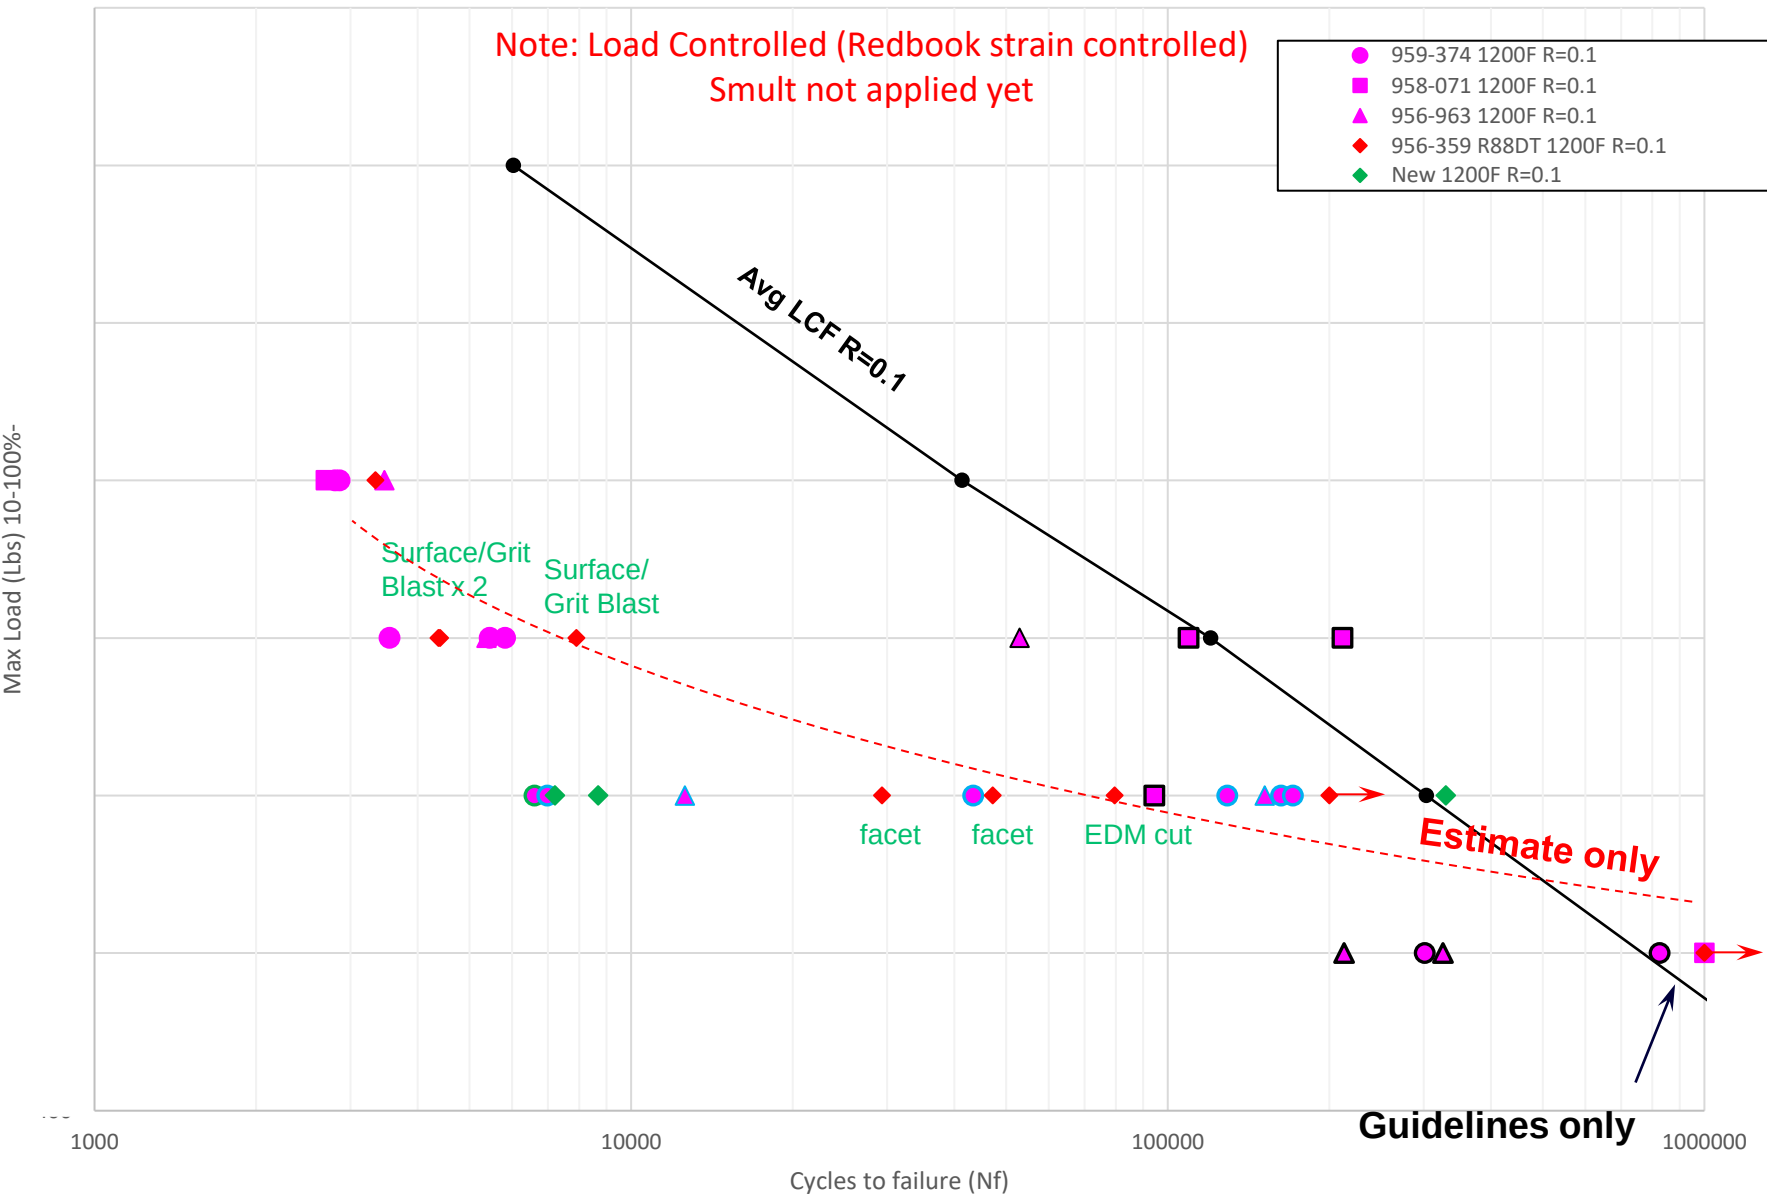
LCF Tests 1200F R=0.1

Comparing R88DT (red) to R65 showed that at very high loads the lives were similar, but as the stress decreased the lives were improved without the very low data points (differences in OCNC/inclusion type/distribution/sizes).

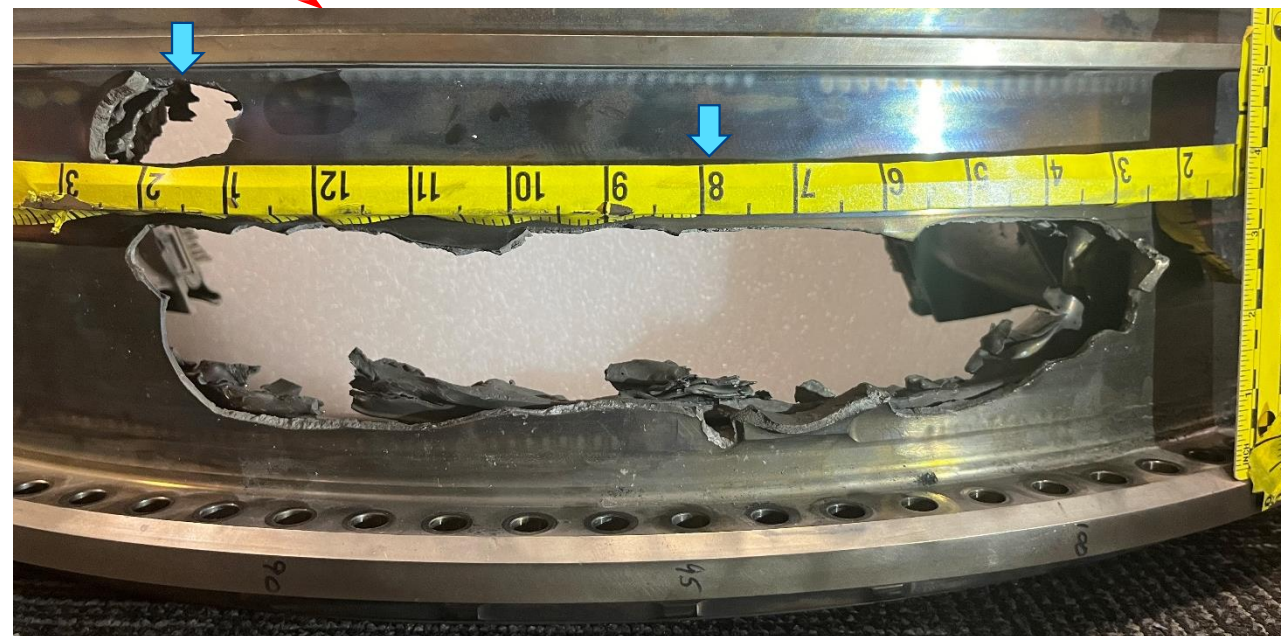
07482-2302M93P01 S/N TMT2NR66  
T0545

Liberated Material
