# National Transportation Safety Board

ENG24LA014

GE Aerospace - Metallurgical Investigation Report (DRB AvEng-558171.A)

**METALLURGICAL EVALUATION OF A GENX-1B  
HPT STAGE 1 AFT BLADE RETAINER INVOLVED IN  
AN UNCONTAINED EVENT FROM ESN 956-102  
OPERATED BY UNITED**

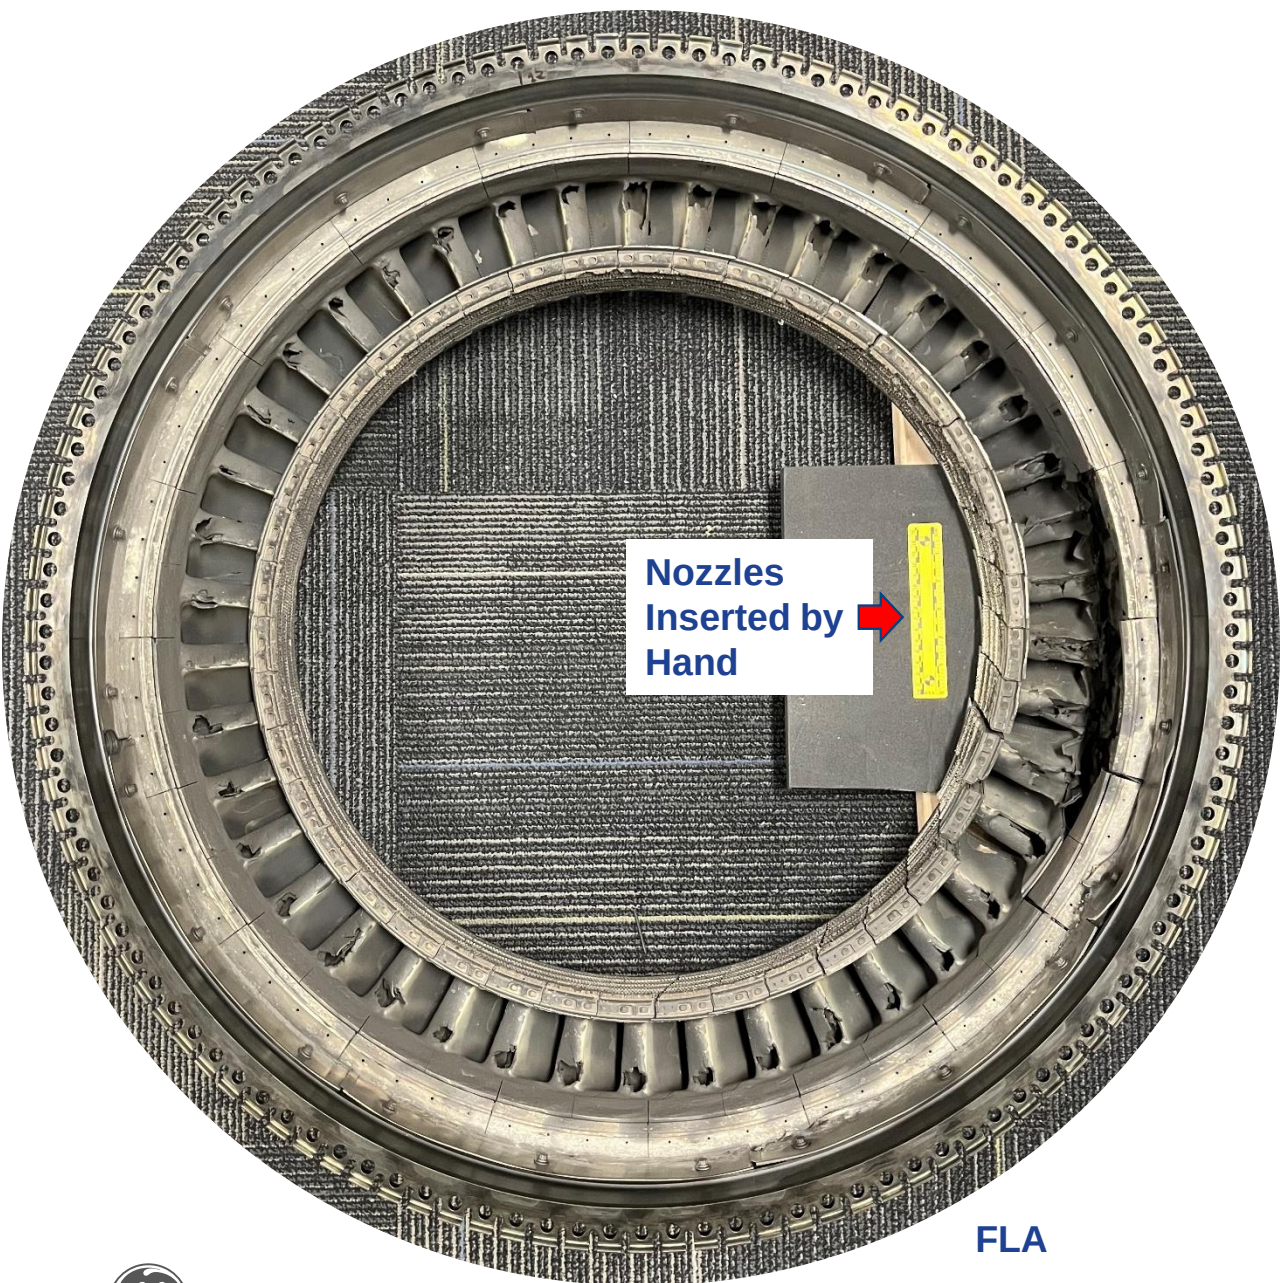
Nozzles  
Inserted by  
Hand

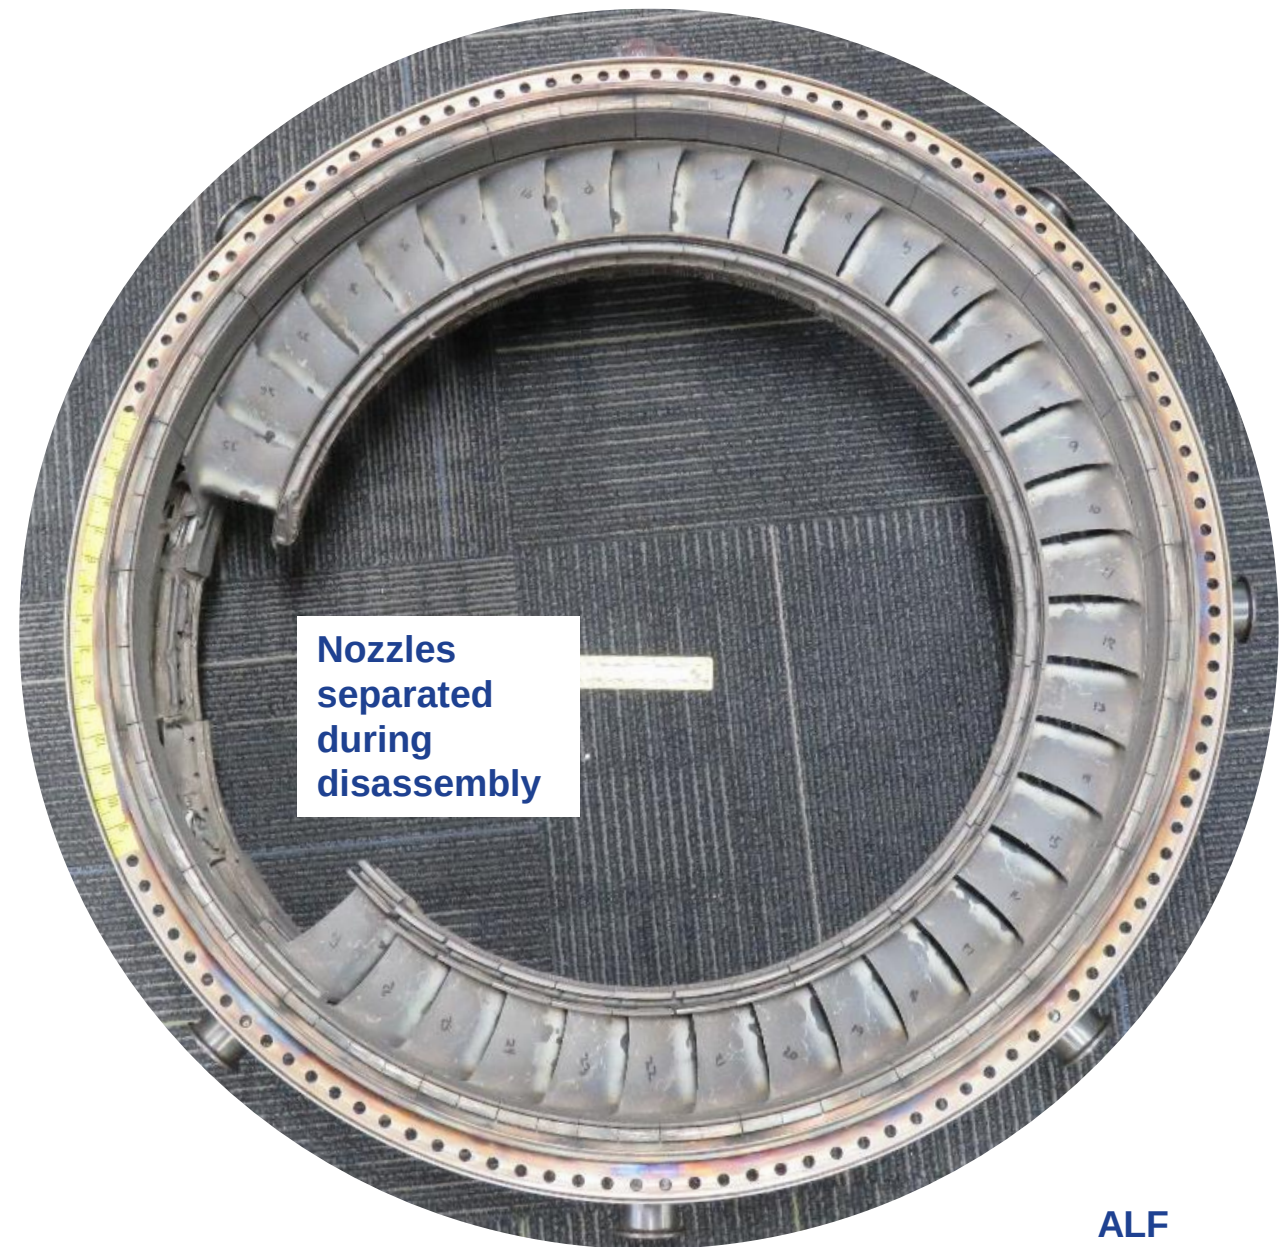
Nozzles  
separated  
during  
disassembly

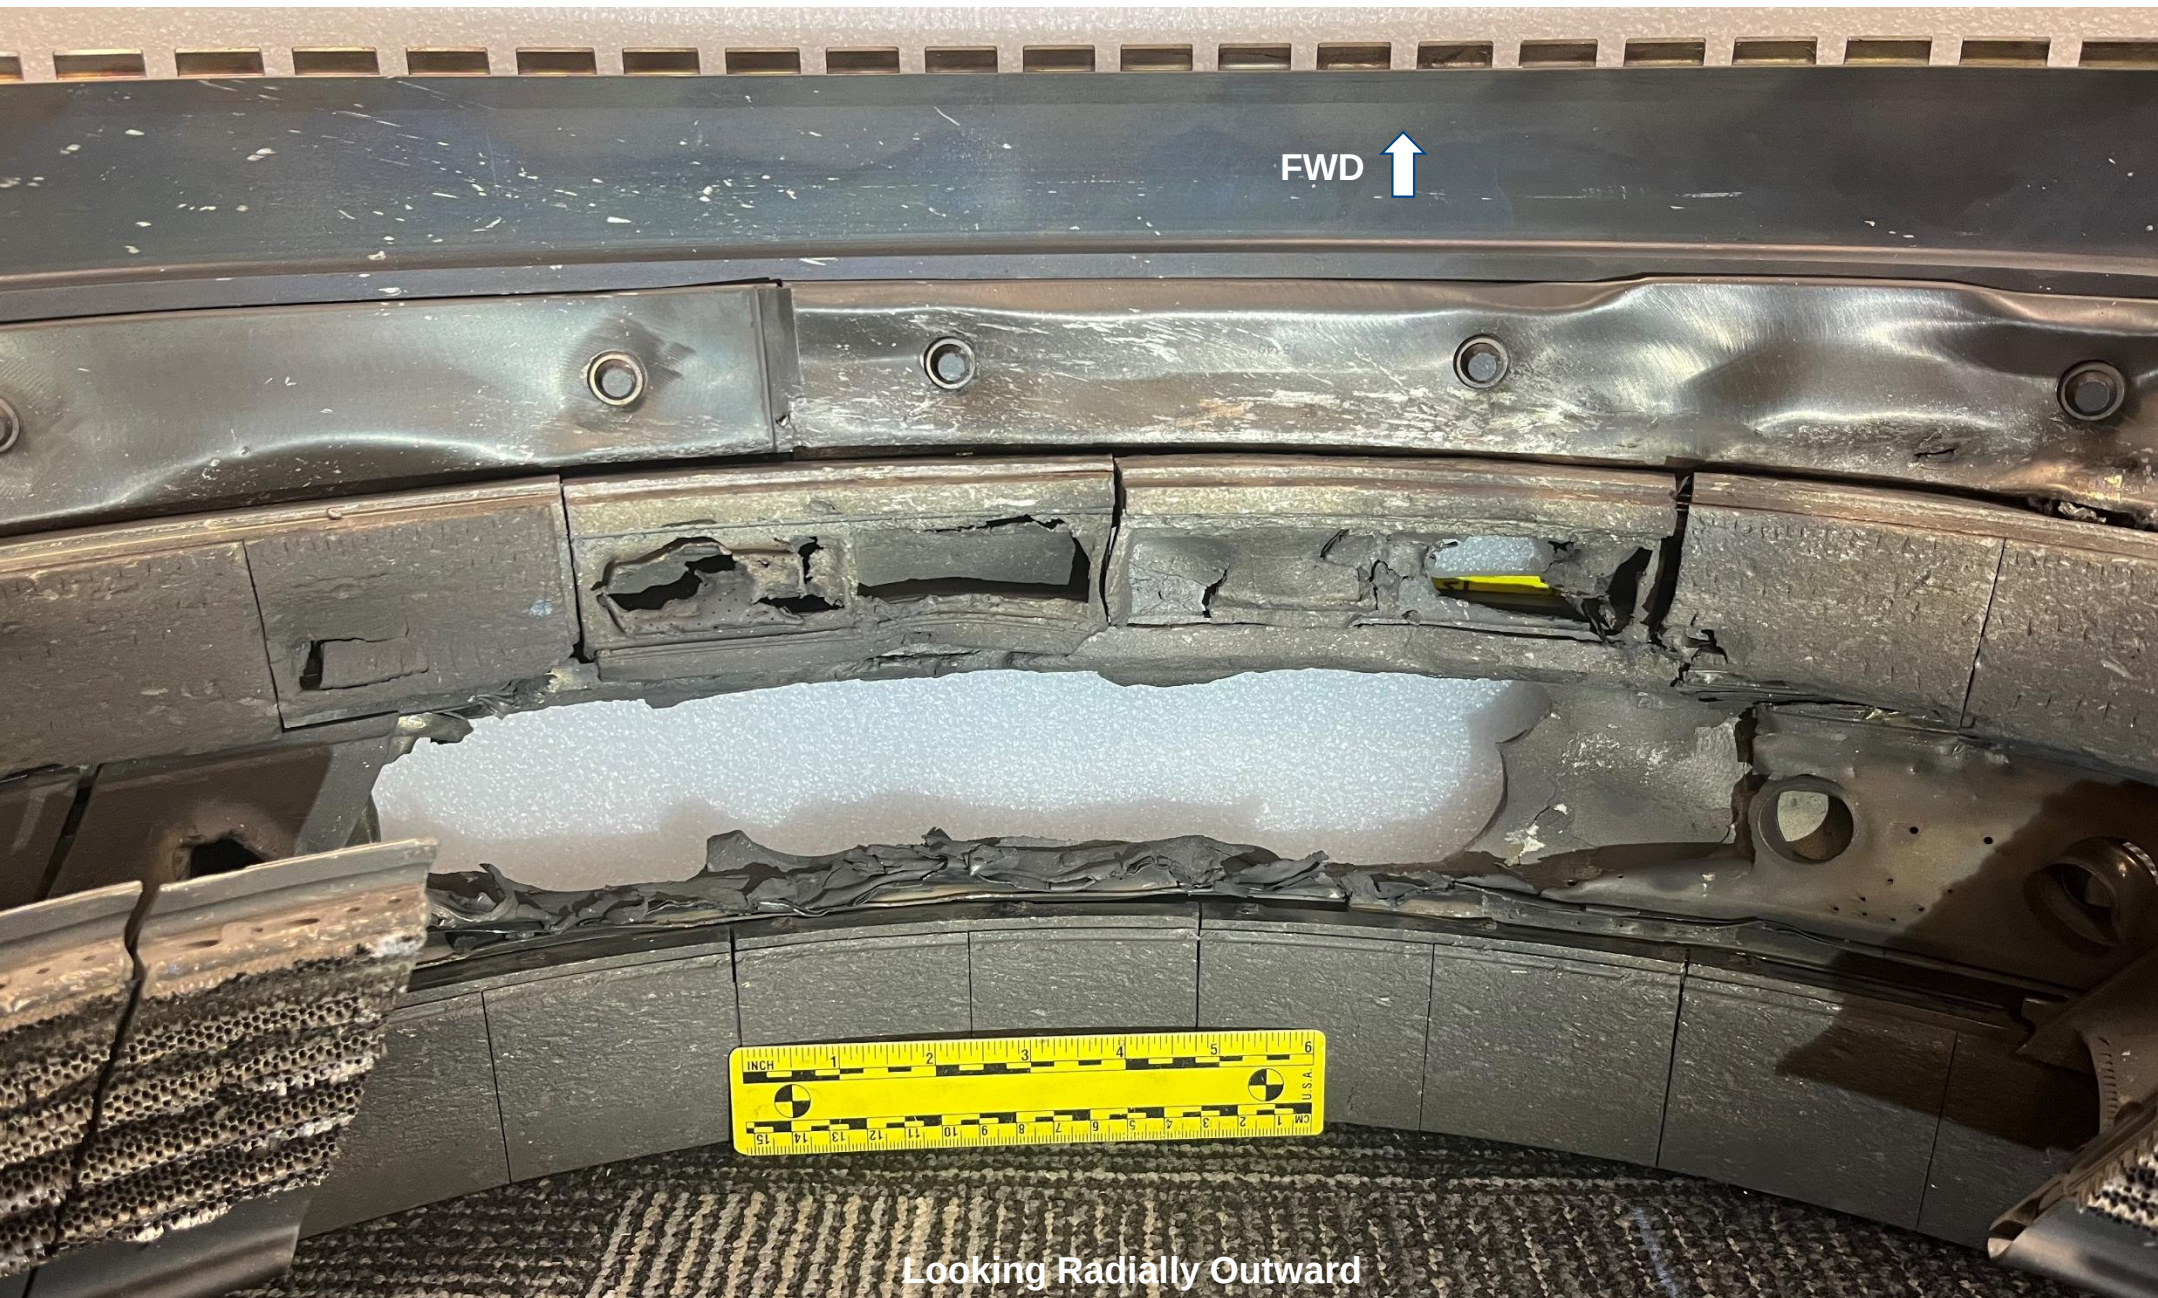
Circumferential offset of damage progressing from the retainer/S2 nozzle forward angel wing outward

Missing/damaged S2N forward angel wing

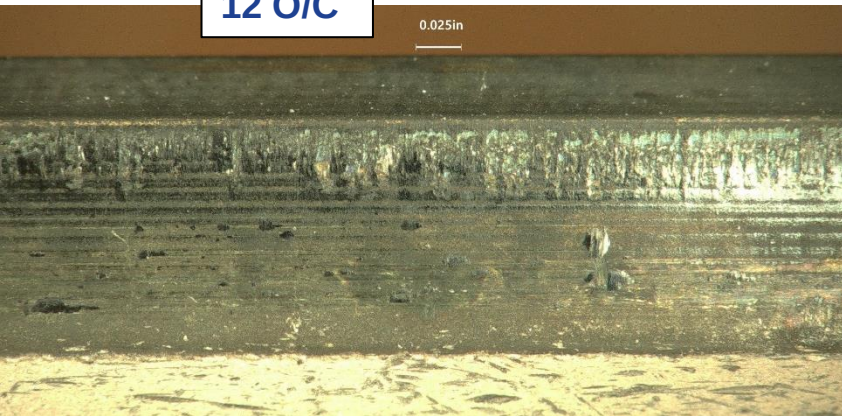
12 O/C

~Origin
