U.S. Department  
of Transportation  
**Federal Aviation  
Administration**

Damage report Accident Number ERA13LA060

**Aircraft** was a 1963 Beech 35-B33 Debonair serial # CD-628 aircraft registration # N8519M issued to; Westchester Flying Club  
Address: [REDACTED] Purchase NY, 10577-0254  
Date of registration issue: July 23, 1986 Expires November 30, 2014  
Airworthiness certificate category: Standard-Utility  
Airworthiness certificate issued: replacement 05-13-1963

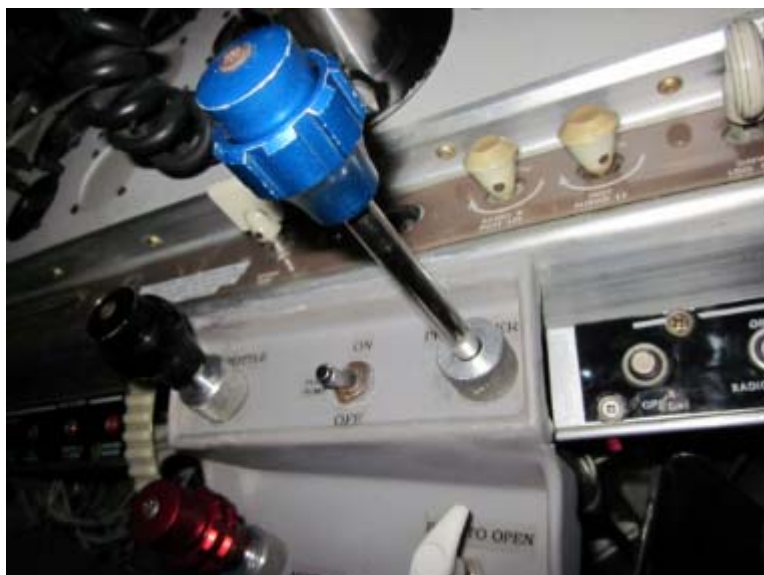
The Throttle has the black control. The current position that it is placed is what would be expected. An attempted restart would show an intermediate position. There was continuity to the Fuel Control Unit and operable.
