Rotech Flight Safety Ltd. 6235 Okanagan Landing Road

## **INVESTIGATION REPORT**

| <b>Date of accident:</b> | March 16 2013 | <b>NTSB file number:</b> | ERA13LA171 |

| <b>Aircraft Make:</b> | Aerolite | <b>Aircraft registration:</b> | N2549W |

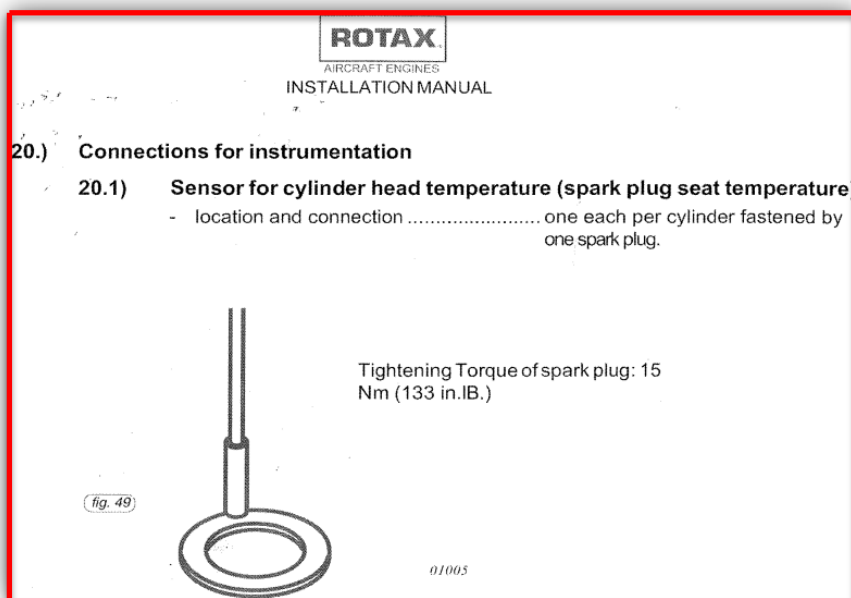
Having only one CHT terminal monitoring one cylinder head temperature would only provide limited information on the running condition of the engine.

In the Rotax installation manual section **20) Connections for Instruments, page 20-1** It states the location and connection for the CHT sensor terminal and states one each per cylinder fastened by one spark plug.

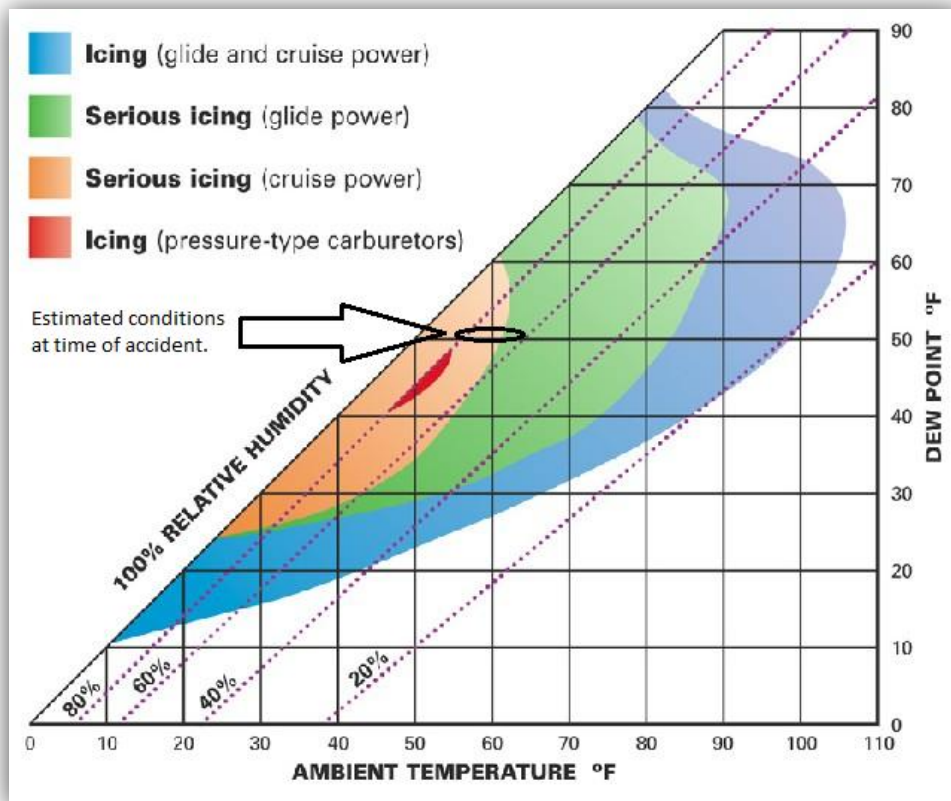
According to the ice conditions and carburetor ice chart provided by FAA Aviation Safety Inspector Thomas Kuhns, the pilot was flying in serious icing conditions.

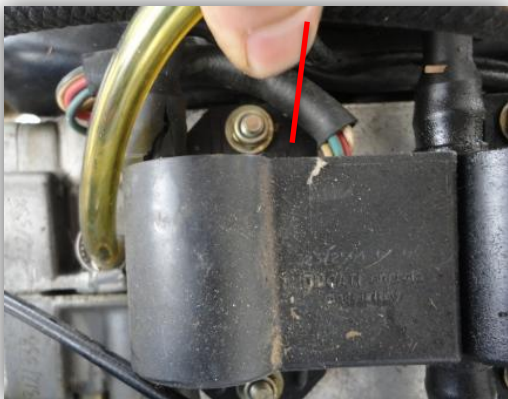
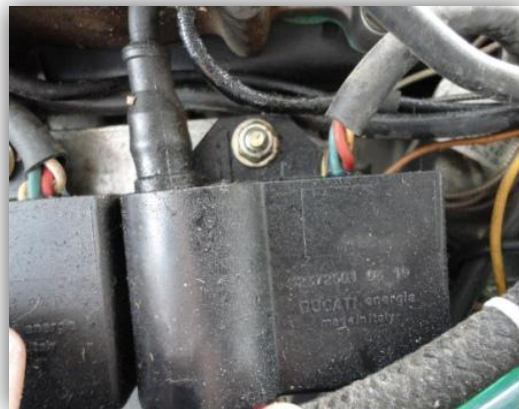
A cracked boot was found on the # 4 MAG spark plug ignition wire. This boot is to protect the contacts from the elements. Rotax maintenance manual section **10.2) Maintenance schedule** it states that checking of the ignition system is to be done every 25 hours. (See Appendix A for the Rotax Maintenance schedule)

Rotax maintenance manual section **11.9) Check of the ignition system** states to “ Verify all electrical connections for good contact and ensure there are free of corrosion. Inspect the wiring for wear, damage and corrosion.

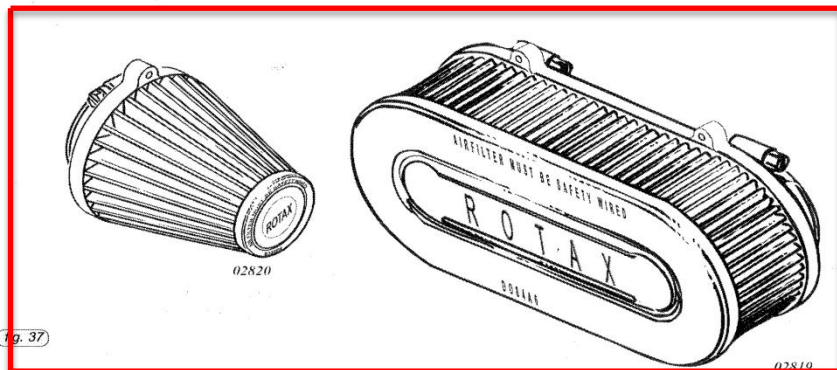
The air filter was examined for condition and conformity. The air filter was found to be dirty which would affect the overall performance of the engine.

The air filter was found to be a non conforming air filter with no lock wire fixation tabs. In the Rotax installation manual section **17.2) Air filter** it states that only air filters approved by Rotax are permitted for use. The air filters specified by Rotax are special K&N air filters.

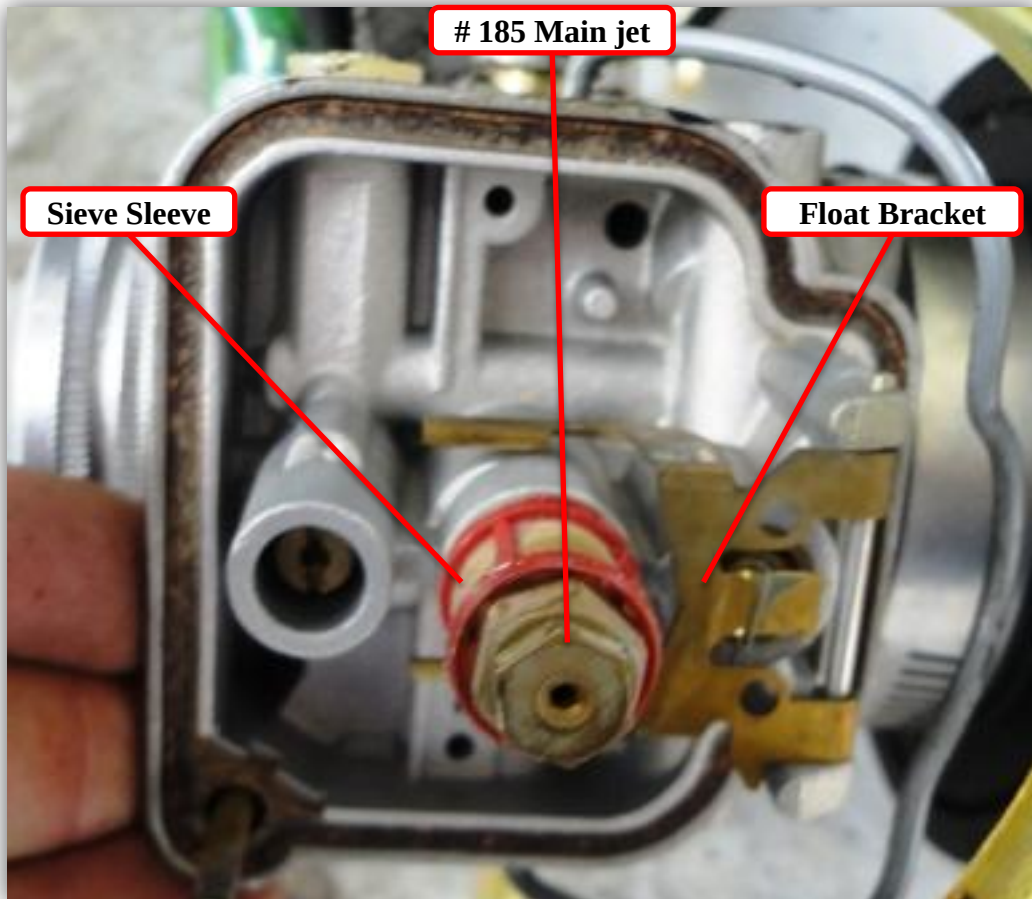
With the float bowl removed the bottom of the carburetor could be examined for condition and proper components.

The main jet was examined for proper size and any obstructions and blockages. The carburetor main jet was a number 185 (stock size) and was free of any obstructions and blockages.

The sieve sleeve was examined for condition proper installation. No anomalies were seen with the sieve sleeve. The float bracket was examined and found to be in good overall condition.

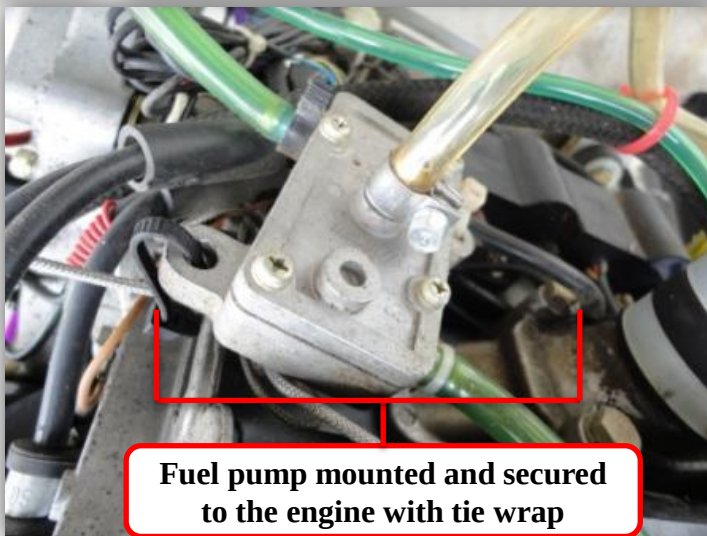
The Fuel pump was improperly mounted using tie wraps and fixated to the engine. In the Rotax installation manual section **15) Fuel system page 15-1** It states "The fuel pump should be installed in a cool place (not on the engine itself). With the small drain hole near the impulse connection towards the bottom". No other anomalies were found with the fuel pump.

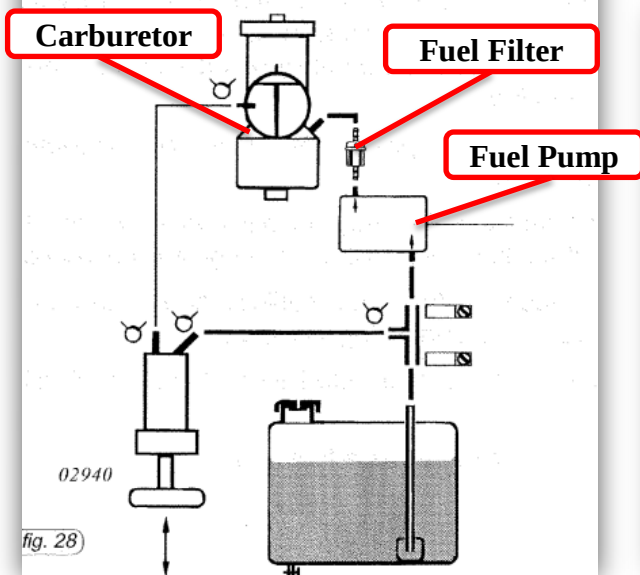
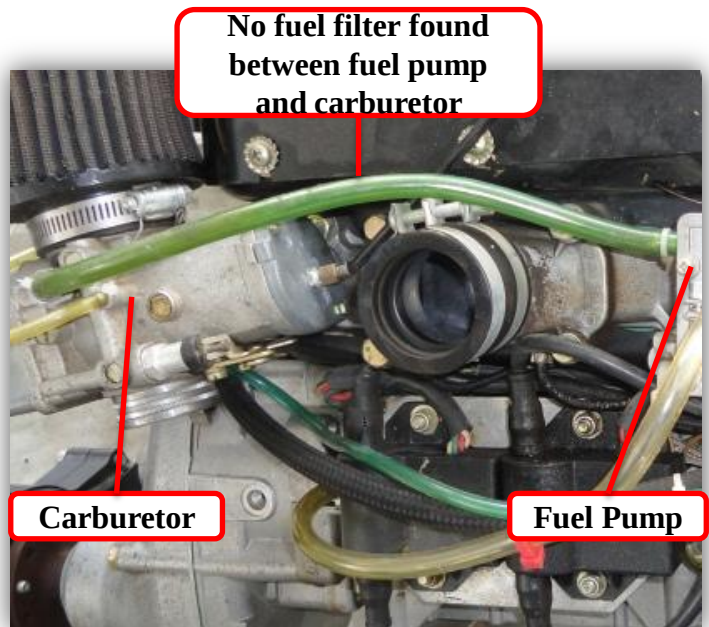
In the Rotax installation manual section **15) Fuel System**, page 15-2, it states that “A suitable fuel filter of 0.15mm mesh size must be fitted between fuel pump and the carburetor. No fuel filter was found installed between the fuel pump and Carburetor.

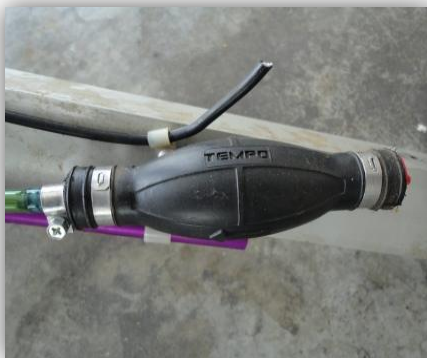
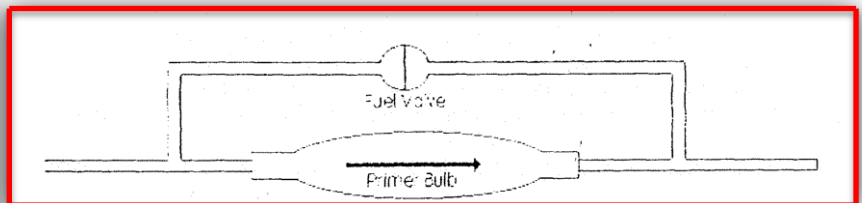
Rotax does not state the use of a primer bulb in the Rotax installation manual. Primer bulbs can fail and causing a fuel starvation. It is standard practice and recommended that a by pass system be installed around the primer bulb with the use of a fuel valve as seen in the diagram below.

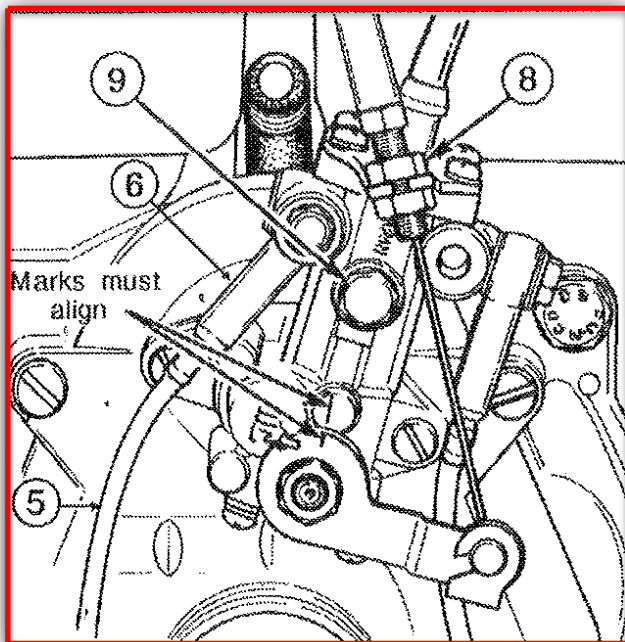
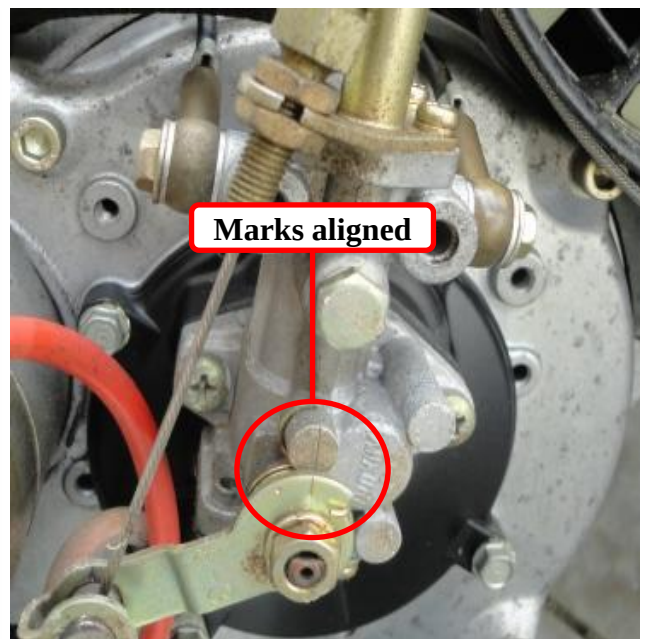
Inspection into the set up of this engines oil injection system appeared to be correct as the alignment marks on the injection pump and lever lined up with the throttle positioned at idle.

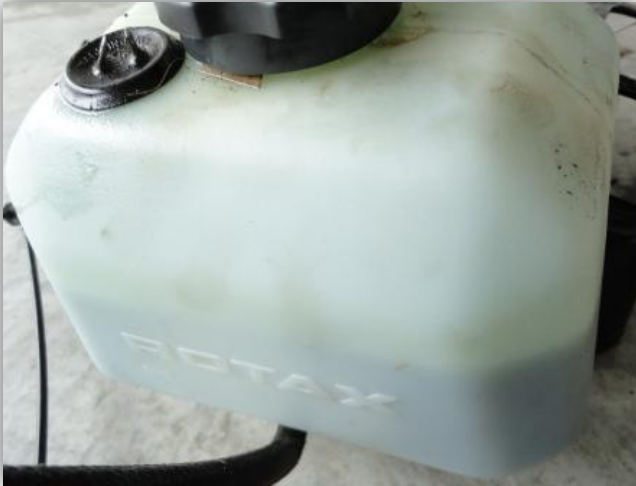
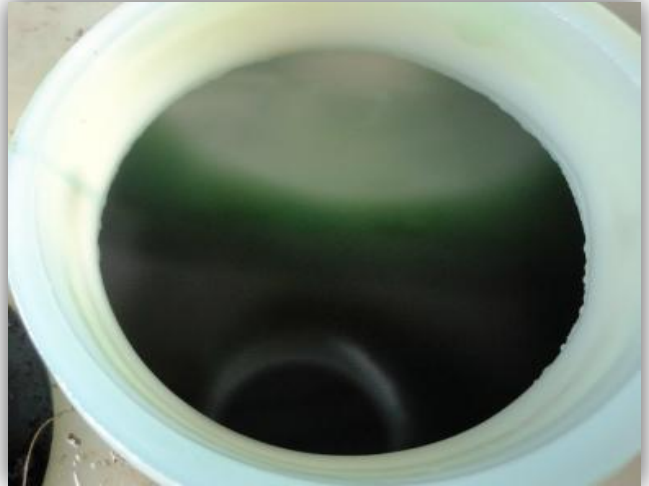
The oil injection tank was examined for contents and condition. The injection tank appeared be in good overall condition and half full of oil. It is undetermined the type of oil that was used in the injection tank.

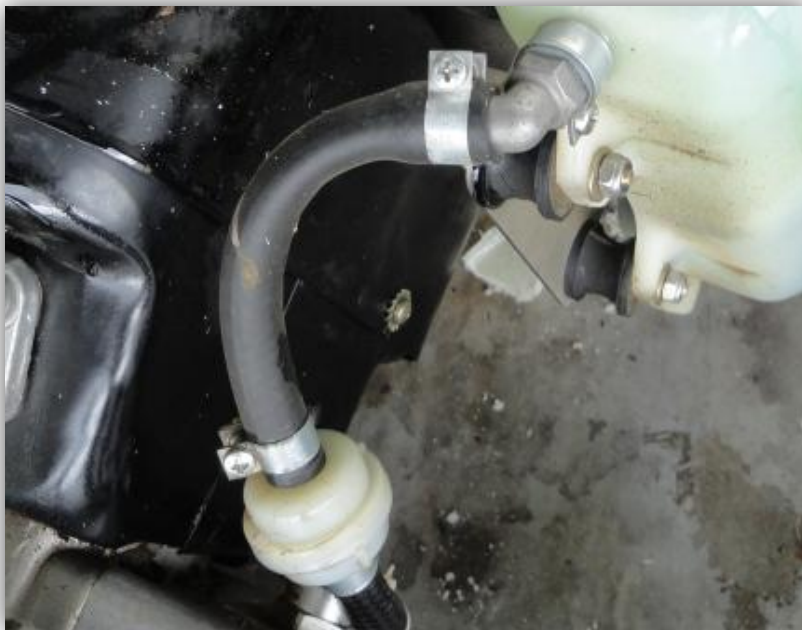
The injection feed line from oil tank to injection pump was examined for condition. The injection feed line appeared to be in good overall condition with no leaks. The oil filter was examined for blockage. No blockage could be seen in the oil filter.

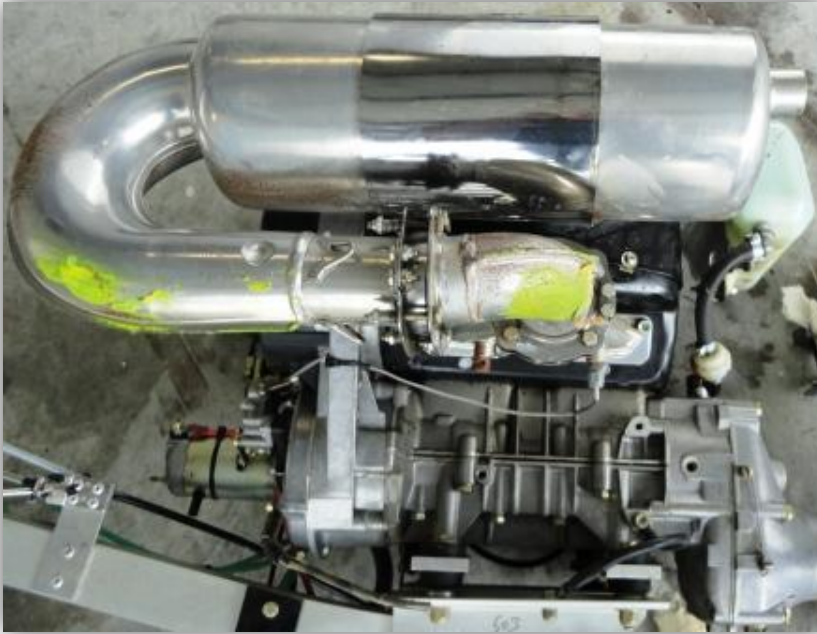
The exhaust system was examined for condition , modifications and the proper approved type. The exhaust appeared to be in good overall condition and of the proper type with no modifications found. No anomalies found with the exhaust system.

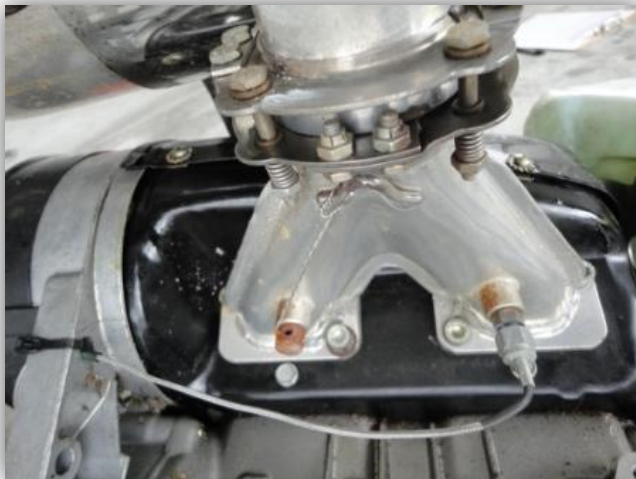
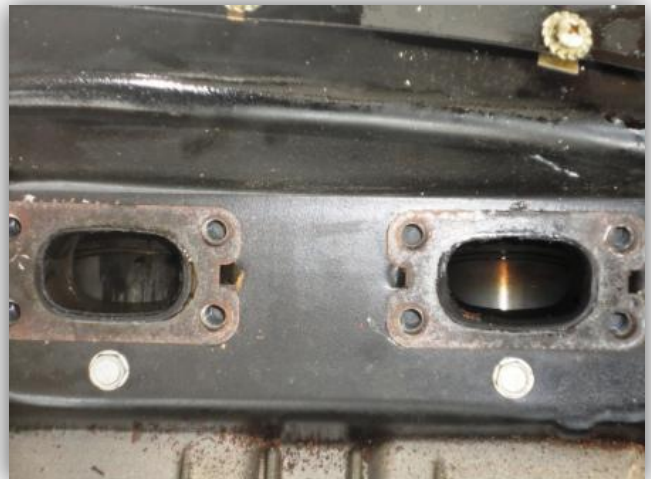
The exhaust Y pipe was removed to expose the exhaust side of the piston's for seizure and metal transfer marks.

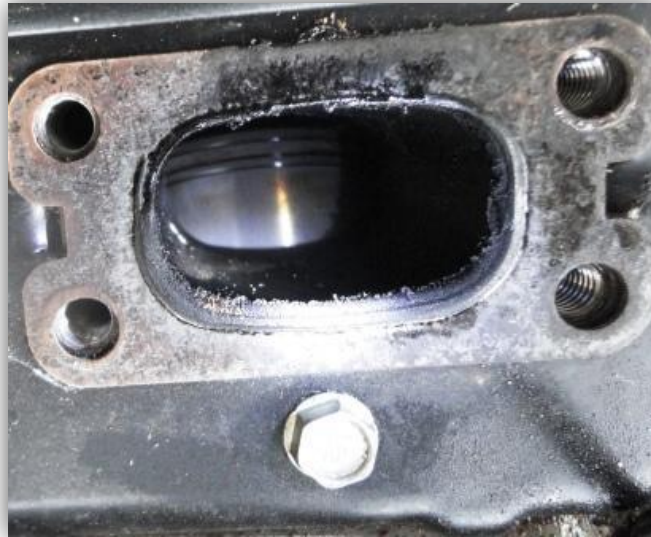
With the exhaust ports exposed the exhaust side of the Power take-off piston could be examined. No metal transfer, vertical scoring or seizure marks were seen on the exhaust side of the Power take-off piston.

The Power take-off piston rings were free in there respective ring land grooves and were in good overall condition. No anomalies were found on the exhaust side of the PTO piston.

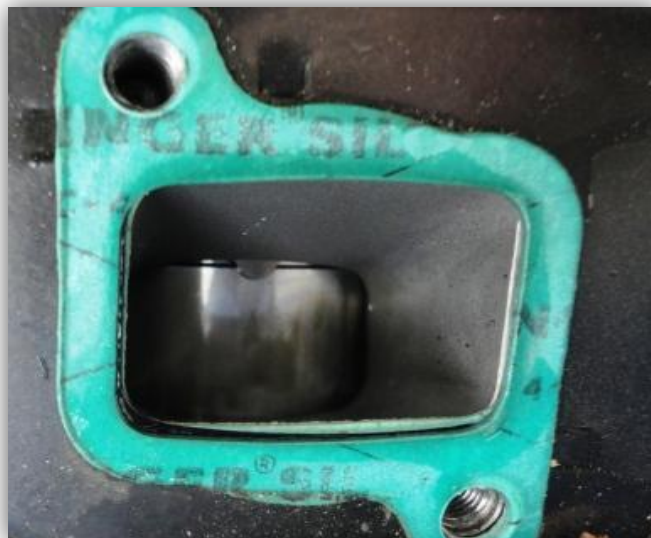
The intake manifold was removed to expose the intake side of the PTO piston. No metal transfer, vertical scoring or seizure marks were seen on the intake side of the Power take-off piston. No anomalies were found on the intake side of the PTO piston.

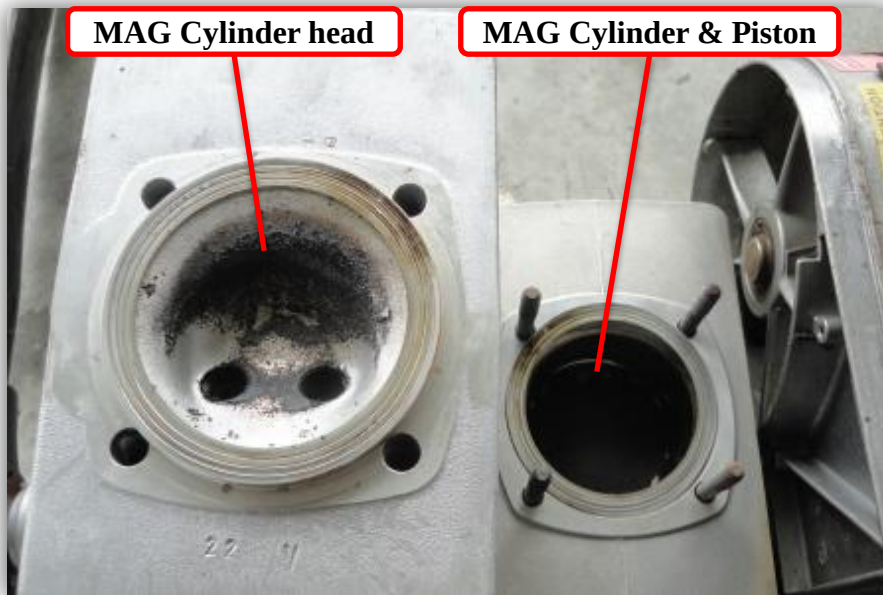
The Magneto cylinder head was removed for examination and to access the cylinder and piston.

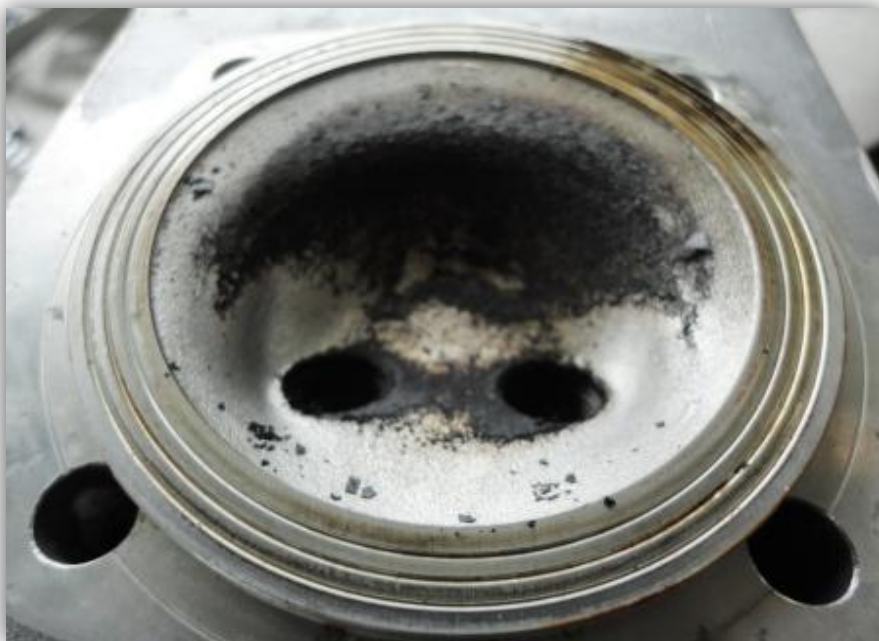
The cylinder head was examined for damage and excessive build up of carbon. No anomalies were seen with the magneto cylinder head.

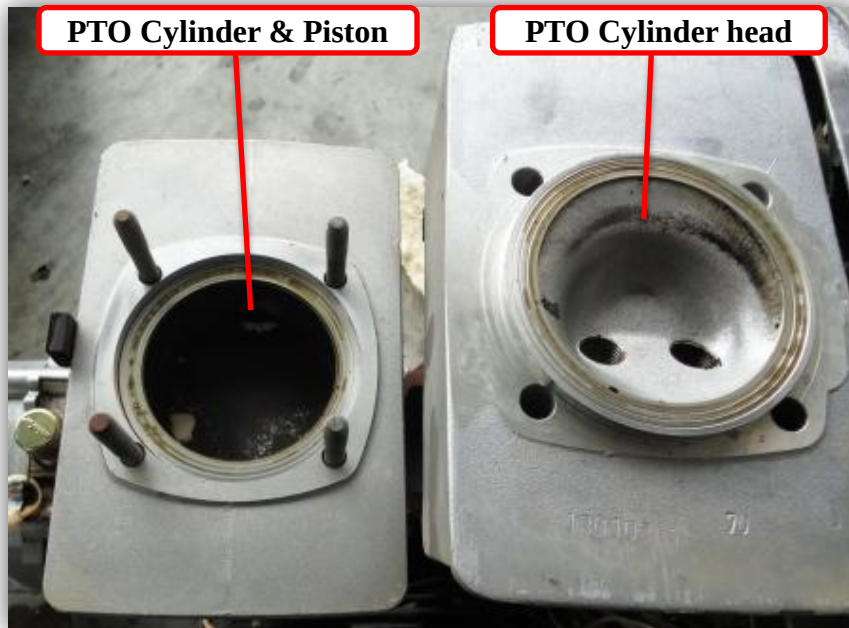
The Power take-off cylinder head was removed for examination and to access the cylinder and piston.

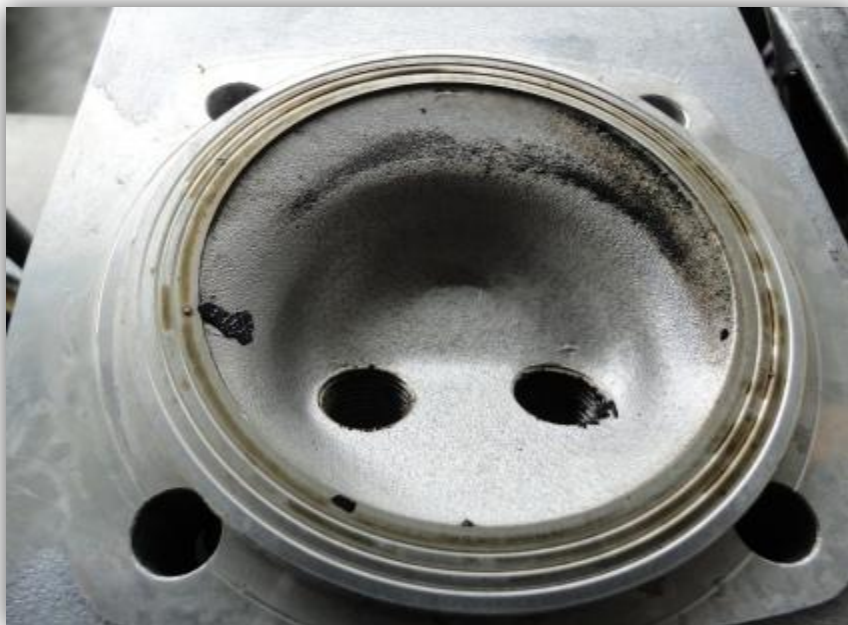
The cylinder head was examined for damage and excessive build up of carbon. No anomalies were seen with the magneto cylinder head.

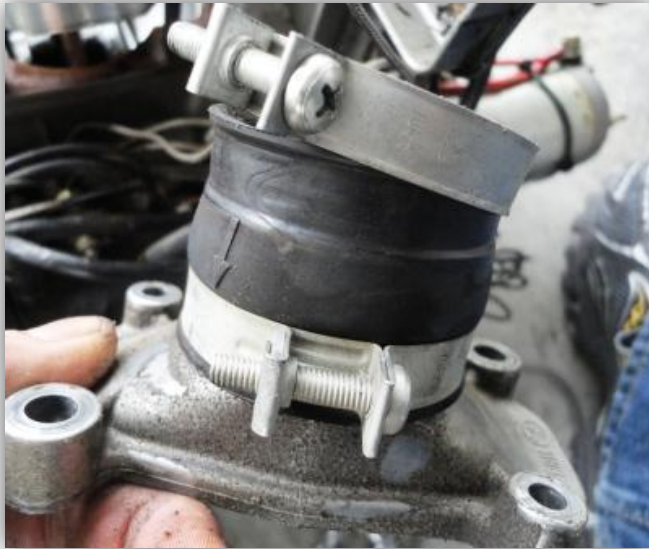
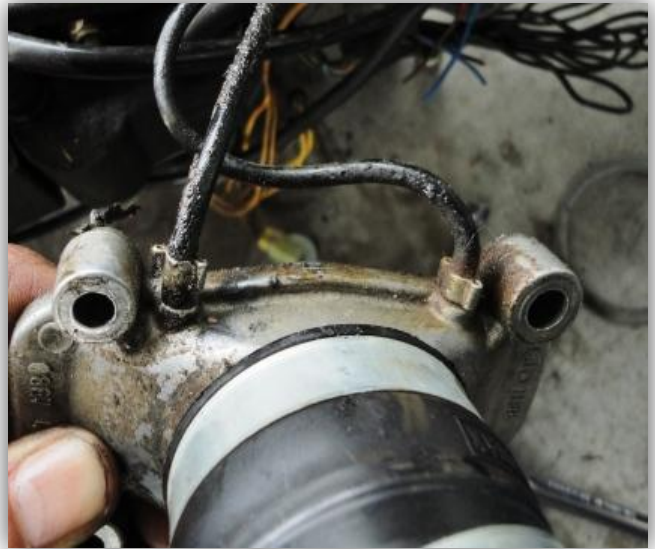
The carburetor socket was examined for cracking and deterioration. No cracking or deterioration was seen on the carburetor socket. The intake manifold was examined for condition. The oil injection lines connecting to the intake manifold appeared to be leaking. No other anomalies were found with the intake manifold.

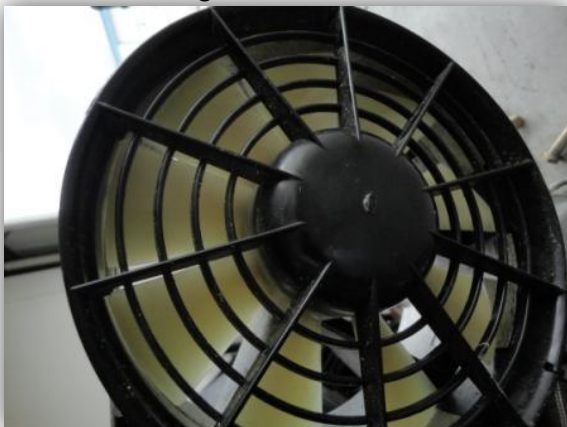
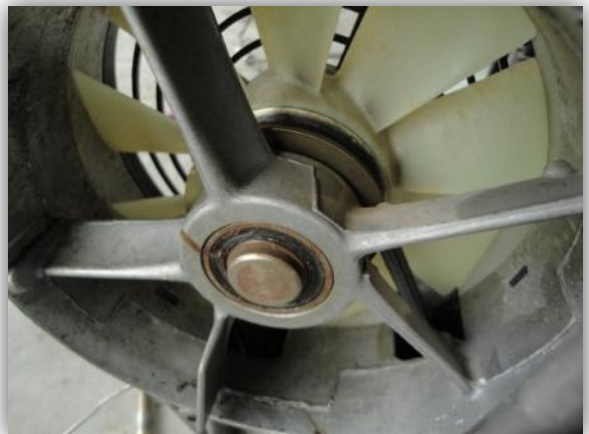
The cooling fan and belt were examined for condition. The cooling fan appeared to be in good overall condition and the Belt was tight with no evidence of fraying. No anomalies were found with the cooling fan & belt.
