Narrative of N2275G Accident on Sunday, July 27, 2014 at approximately 16:30 (EDT).

Location: GA18 – Big Creek Flying Ranch, Clayton, GA  
2800' x 50' grass strip

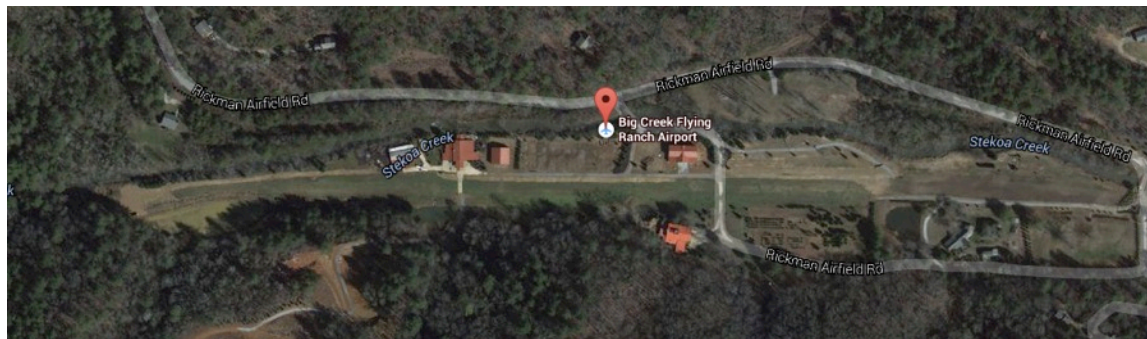
#### Aerial View

As can be readily noted from the aerial photos above, the runway is significantly narrower at the extreme west end, but I wanted to make sure I had the entire runway length available for takeoff due to the aforementioned conditions.

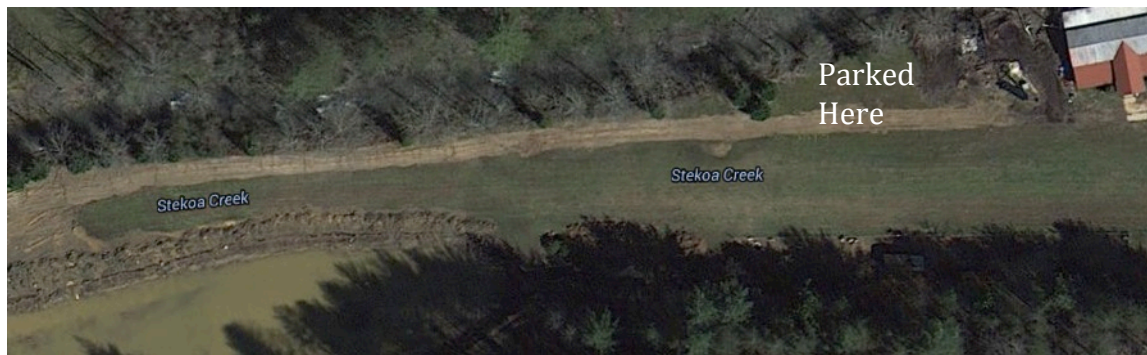
We had a safe and uneventful landing to the west at this location (RW27) at approximately 12:15 EDT and parked at the location indicated below. After attending a function nearby for several hours, we returned at approximately 16:25 with the intention of flying home to Stockbridge, GA - 7GA7 Berry Hill Airport; approximately 40 minutes of flight time.
