# NATIONAL TRANSPORTATION SAFETY BOARD

MATERIALS LABORATORY FACTUAL REPORT

Report No. 14-088

Place : St. Albans, Vermont  
Date : April 18, 2014  
Vehicle : Ultimate Aero 10-200, N827D  
NTSB No. : ERA14LA202  
Investigator : Todd Gunther, AS-ERA

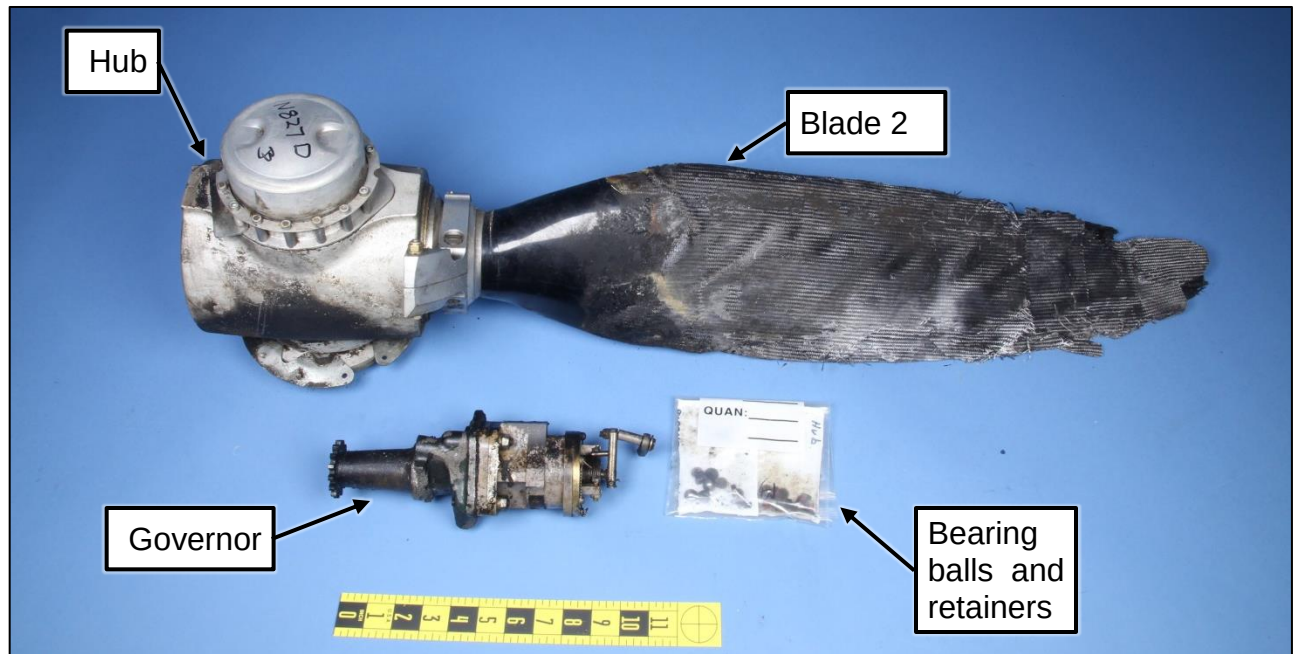
An overall view of the submitted components is shown in figure 1. The propeller was a Whirl Wind Aviation (WWA) model 200C propeller, serial number 200C-280 which was installed on a Lycoming IO-360 engine. Blade 1 was fractured in the root within the hub as shown in figure 2, and the portion outboard of the fracture was not recovered. Blade 2 was largely intact but showed damage consistent with exposure to a fire. A bag containing bearing balls and retainers that were recovered loose from inside the propeller hub and from the ground at the crash site and the governor were also received but were not examined in detail.

Figure 1. Overall view of the submitted components.

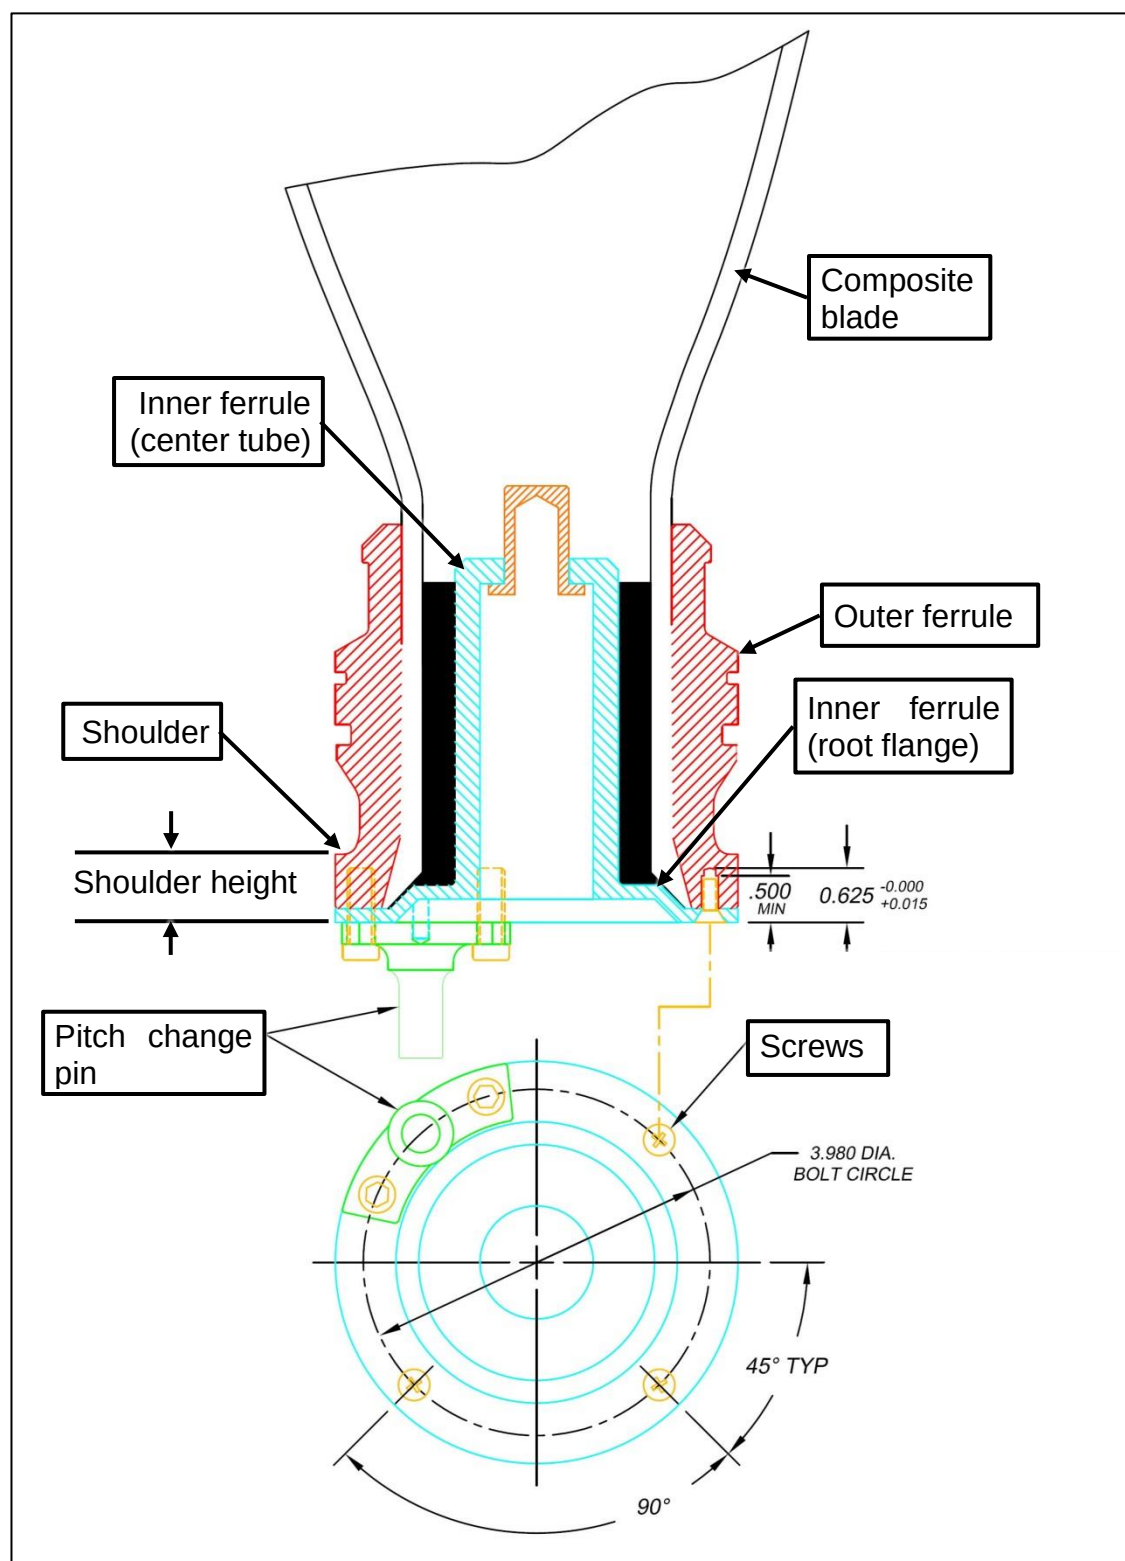
A drawing showing the overall construction of the root end of a Whirl Wind 200C or 400C series propeller blade is shown in figure 3. The drawing in figure 3 was adapted from WWA Mandatory Service Letter SL-200C/400C-002 dated February 4, 2003, which required the installation of pan-head screws into the root end face of the blade. According to a subsequent WWA mandatory service letter (SL-200C/400C-070214 dated July 8, 2014), the 200C series propellers affected by WWA SL-200C/400C-002 had serial numbers 200C-238 and lower. The propeller on the accident airplane was serial number 200C-280, and the propeller blades did not have the pan-head screws shown in figure 3.

As installed, the blades are retained in place during operation with a split ring insert that rests against the shoulder on the outer ferrule (the shoulder is labeled in figure 3) and against the bearing race half on the root side of the blade bearing (bearing that facilitates pitch changes). The bearing race half on the airfoil side of the bearing is retained by the propeller hub. At rest, the blade is prevented from moving inward by a

Figure 3. Section-view and end-view drawing of the hub end of the blade from the Whirl Wind 200C and 400C series propellers. (Adapted from Whirl Wind Aviation Mandatory Service Letter SL-200C/400C-002 dated February 4, 2003.)

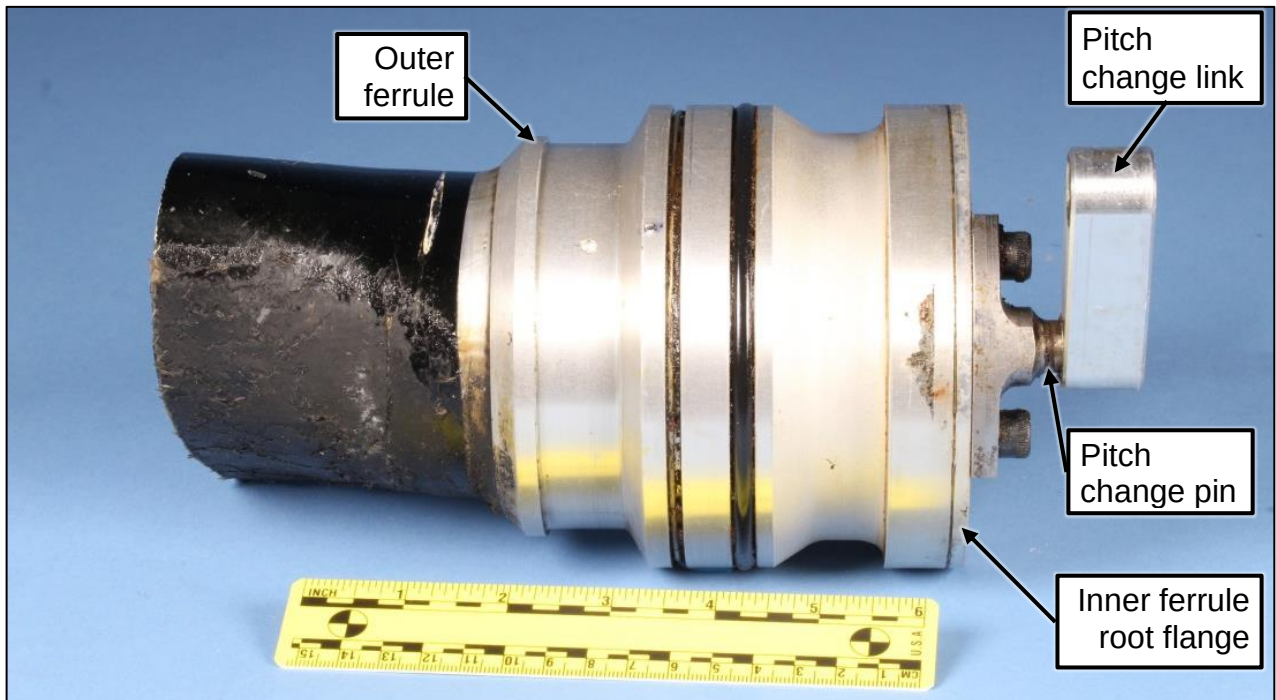
The airfoil on blade 2 was cut chordwise near the blade root to facilitate handling and examination of the blade root. The blade root was then disassembled from the hub, and grease was wiped away with disposable wipes. A view of the blade 2 root after disassembly and wiping away the grease is shown in figure 7.

Figure 7. Root end of blade 2 after cutting off most of the blade, removal of the blade root from the hub, and wiping away grease with disposable wipes.

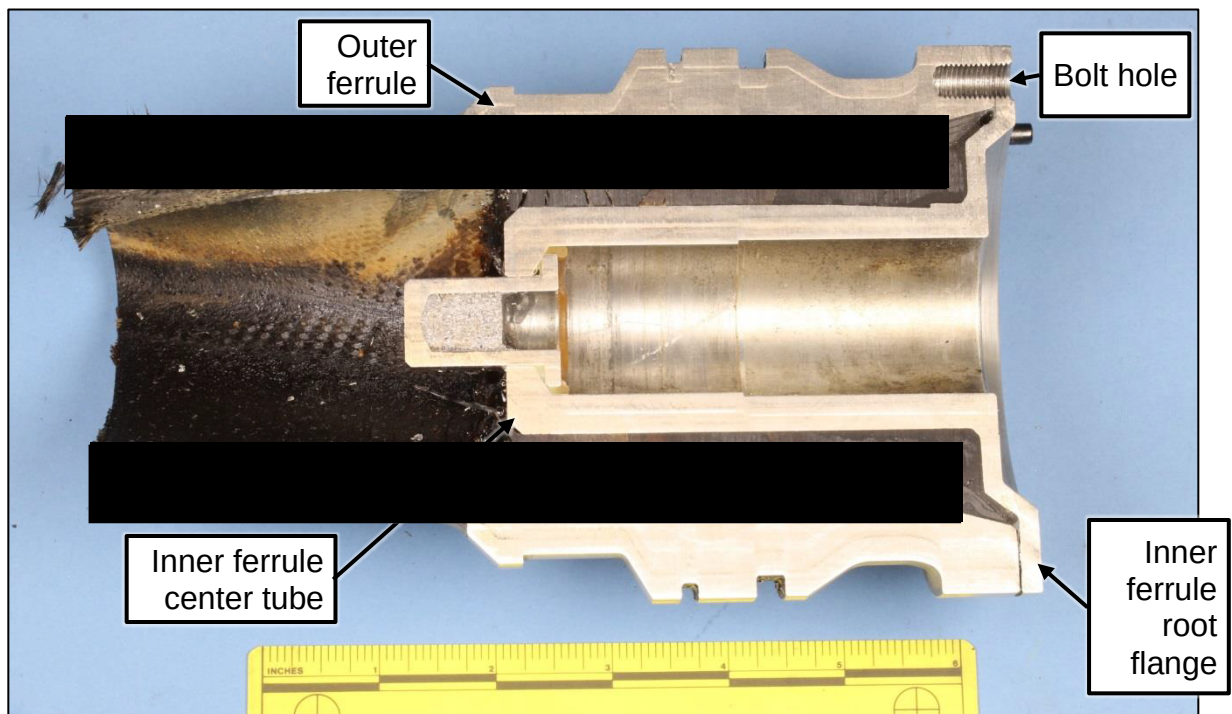
The root end of blade 2 was then cut axially using a bandsaw approximately through the center of the blade and the center of one of the pitch change pin attachment holes. The resulting cross-section is shown in figure 8, and a closer view of the pitch change pin attachment bolt hole is shown in figure 9. The depth the the threaded portion of the bolt hole was measured on the cross-section, and the threaded portion of the hole extended up to 0.65 inch from the root face of the inner ferrule root flange.

Figure 8. Cross-sectional view of the blade 2 root after an axial cut approximately through the center of the blade root and through the center of one of the holes for the pitch change pin attachment bolts. Portions of the image are redacted.

On January 30, 2015, Whirl Wind Aviation issued Mandatory Service Letter SL-200/400C-070214, which included a requirement to measure the depth of the bolt holes for attaching the pitch change pin on model 200C (serial numbers 200C-385 and lower) and model 400C (serial numbers 400C-226 and lower) propellers. The stated reason for the service letter was that pitch change pin attachment bolt holes could vary in depth, which in some cases could compromise the integrity of the blade outer ferrule and lead to fatigue failure of the ferrule and loss of blade retention. Upon inspection, blades found with bolt holes greater than 0.760 inch in depth as measured from the root face of the internal ferrule root flange are to be removed from service.
