June 20, 2014

# Sentimental Journey Fly-In

### Accident Report

Prepared by: Ben R. Coleman

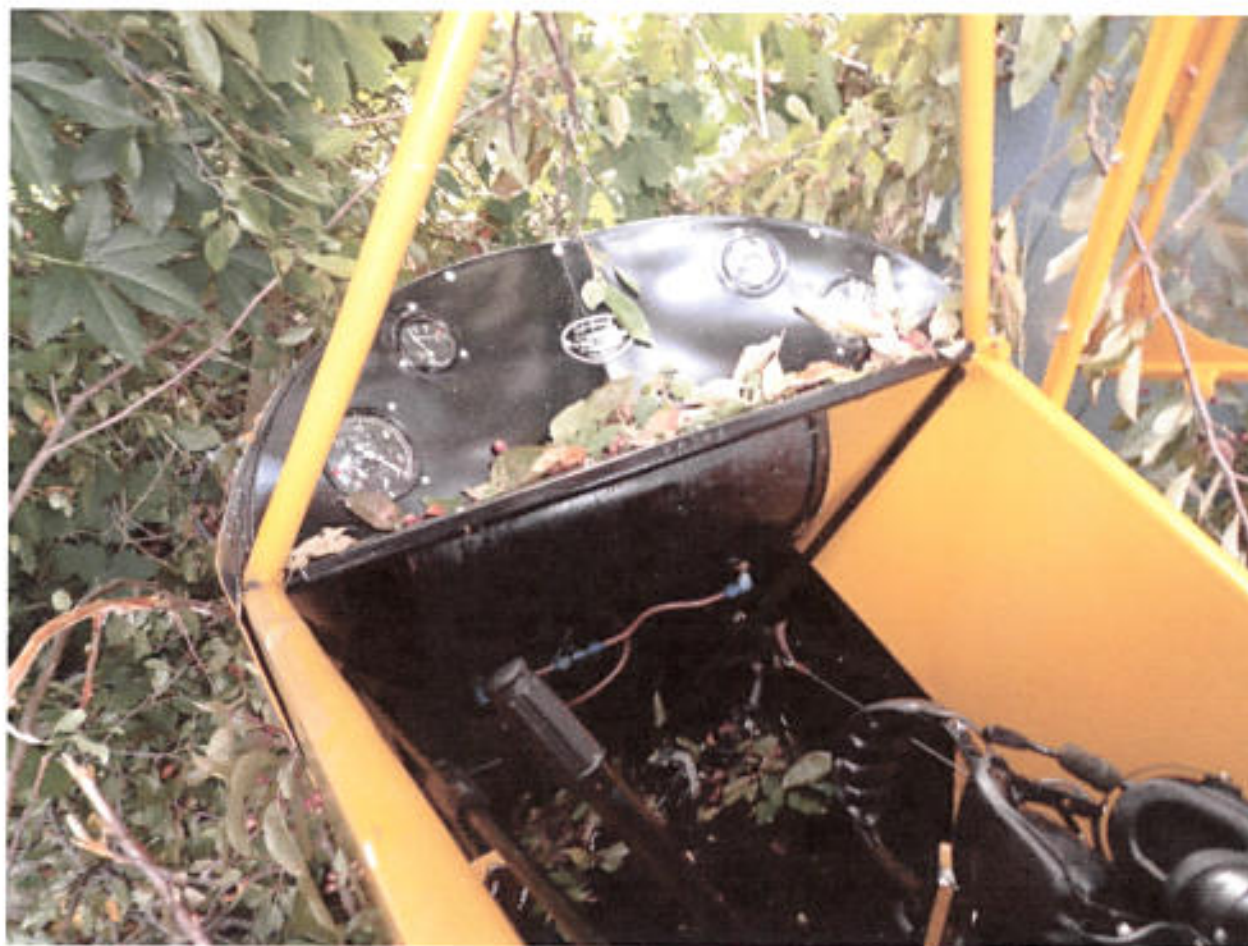
6. Forward Cockpit

The pilot had been seated in the rear seat as normal operations for a J-2 and it was equipped with shoulder harnesses. The harnesses were intact and the pilot harness latch mechanism was not damaged. Flight control continuity was confirmed in all axis's. The engine was not rotated to preserve that function for the official investigation.

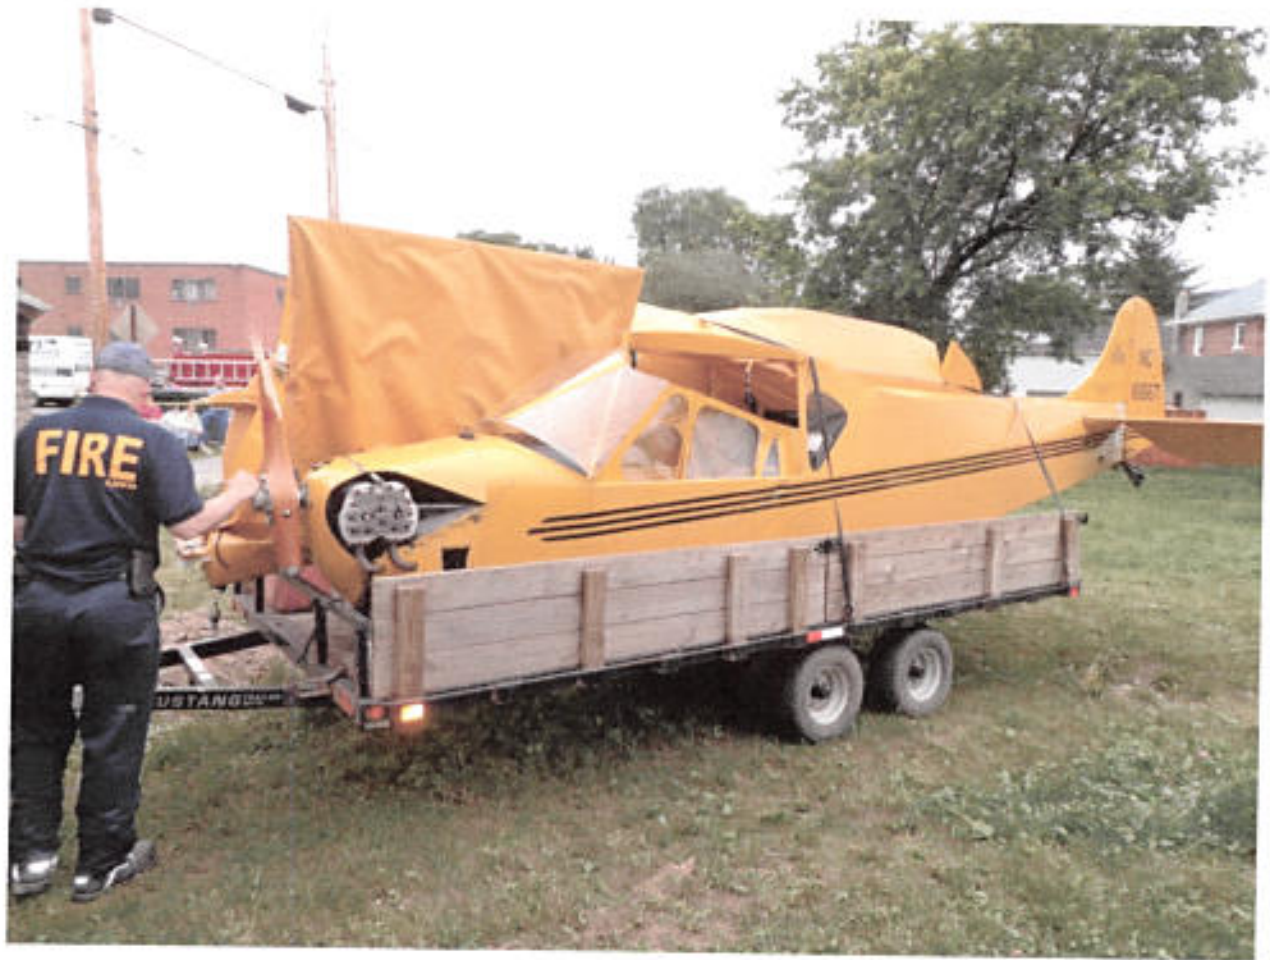
14. Loaded on trailer and preparing to transport
