## **INVESTIGATION REPORT**

| <b>Aircraft Make:</b> | FLIGHT DESIGN GMBH | <b>Aircraft registration:</b> | N508CT |
| <b>Aircraft Model:</b> | CT-SW 2006 | <b>Aircraft S/N</b> | Unknown |

| <b>RFS File number:</b> | 2015-028 | | |

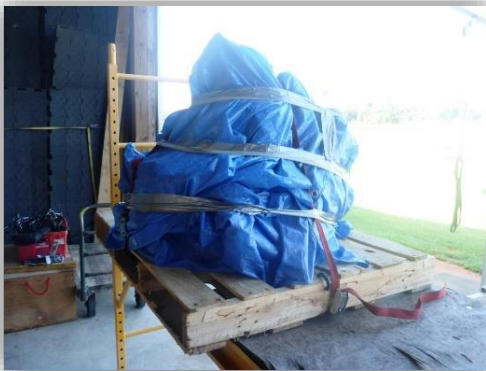
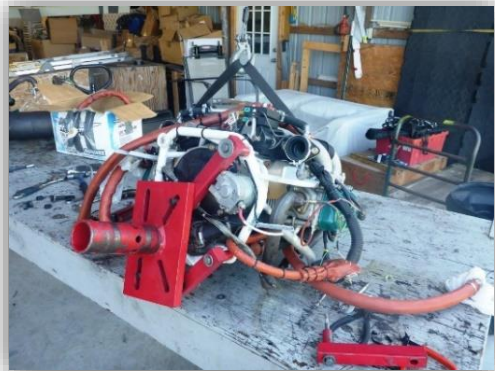
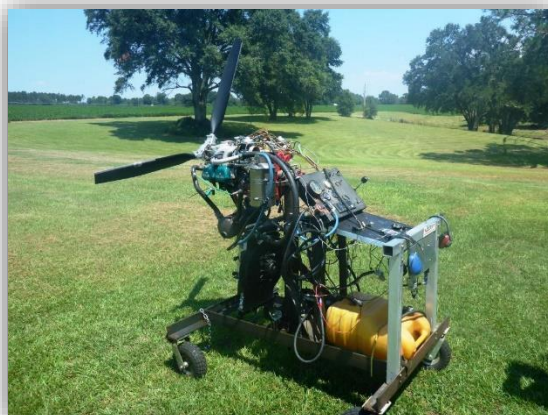
The engine was removed from the shipping crate and mounted on a engine test stand. A calibrated propeller was installed on the engine propeller shaft and the carburetors were re-installed. All oil lines, fuel lines, coolant lines and engine controls were connected to the engine from the test stand. All fluids were replaced with new and the oils system was purged of all air. All gauges were connected and the engine was ready for a test run.

Oil pressure was noticed on the gauge and the throttle was set to 2200 RPM. A mag check was done and the normal 100 RPM drop was noticed on both A and B magnetos when selected. The RPM was then increased to 3400 RPM for a few seconds and ran at that setting with no anomalies noted.

Several engine test runs were completed without any anomalies noted.

No mechanical anomalies were found during the engine test run that was conducted at South Mississippi Light Aircraft (SMLA) on August 13 2015 under the oversight of FAA Air Safety Investigator, Robert F. Mahaffey out of the Jackson, MS FSDO.
