## Accident / Incident Summary Report

**Report No.: 14-081**

**Croom Aviation  
Gulfstream-Schweizer G-164B Reg. N425LS  
Bonifay, Florida  
25 July 2014  
PT6A-27 Engine  
S/N 40160**

**Date of Issue:** 5 October 2015

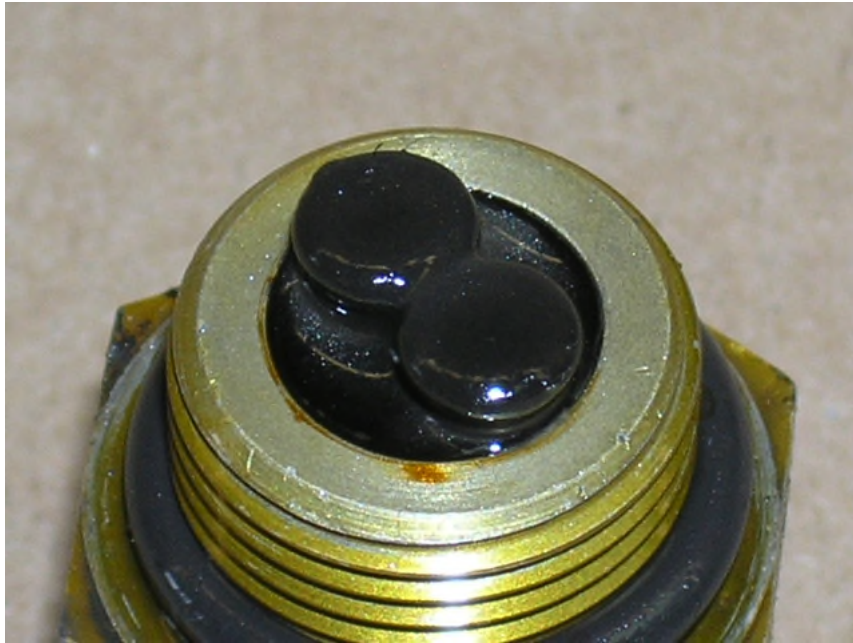
**Reduction Gearbox Chip Detector:** Clean. Please refer to photo No. 12.

Photo No. 12  
Reduction gearbox chip detector.

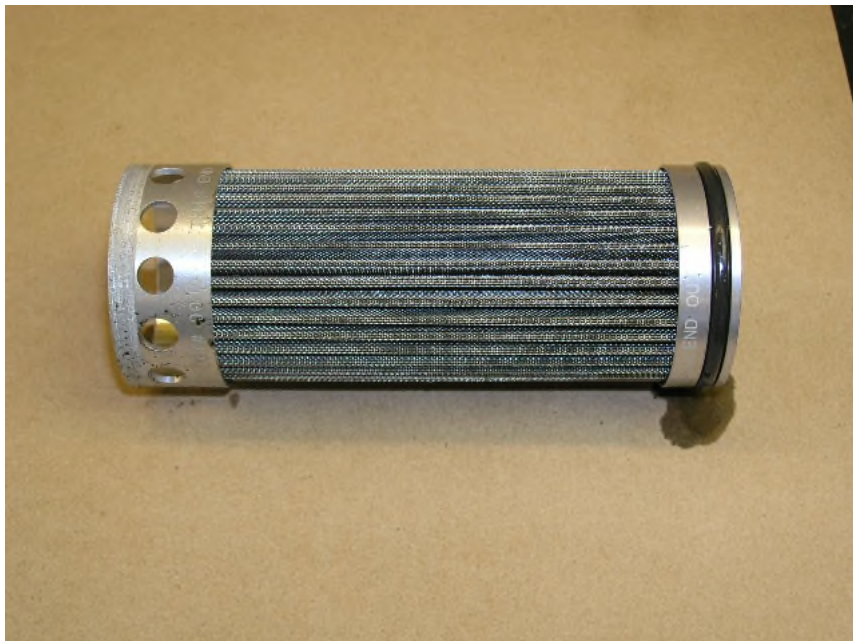
**Oil Filter:** Clean. Please refer to photo No. 13.

Photo No. 13  
Oil filter

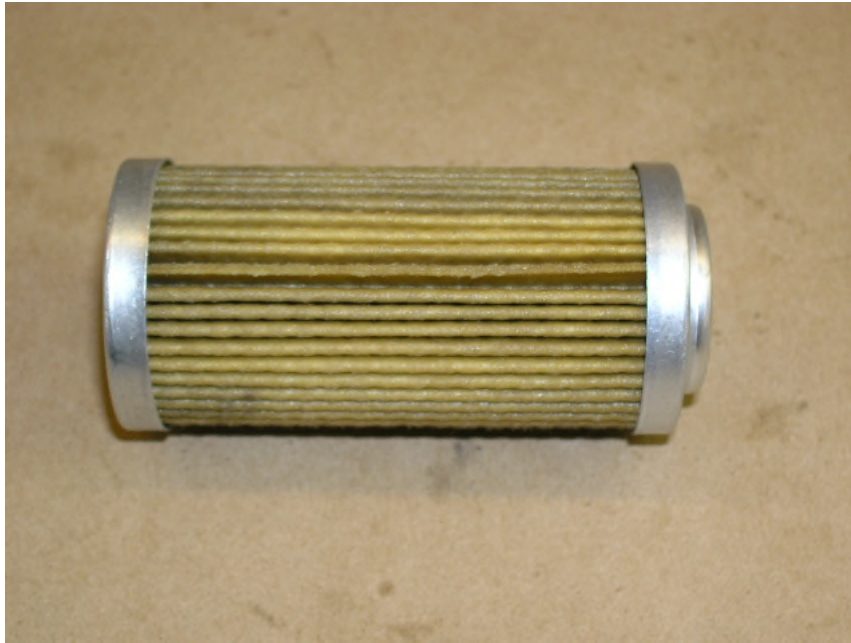
**Fuel Filter:** Clean. Please refer to photo No. 14.

Photo No. 14  
Fuel filter.

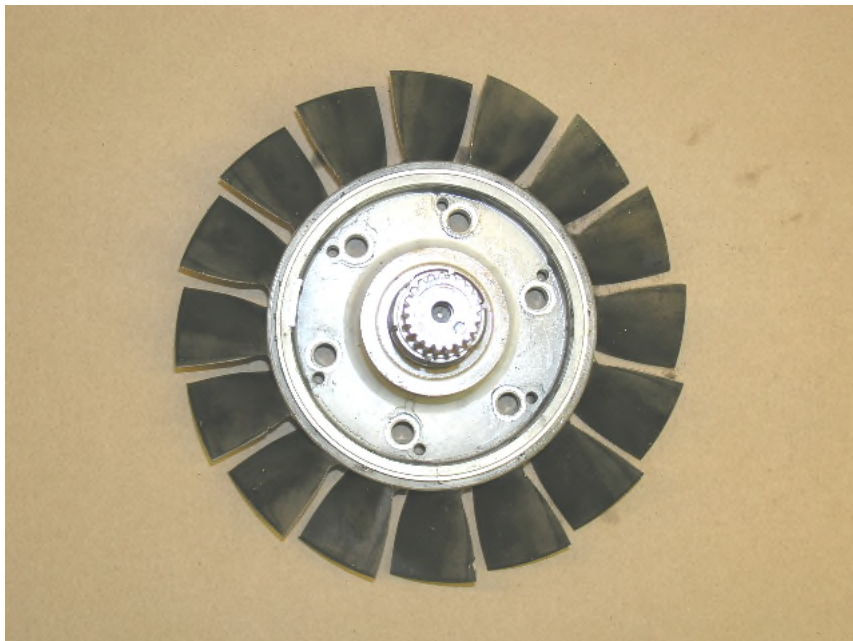
Photo No. 21  
Compressor 1<sup>st</sup> stage disc and blades, upstream side.

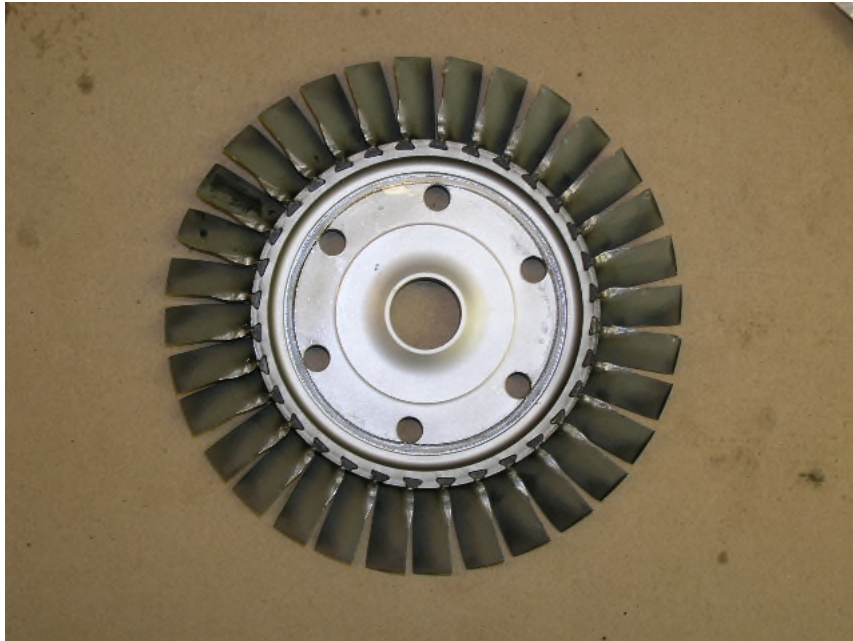
Photo No. 24  
Compressor 2<sup>nd</sup> stage disc and blades downstream side.

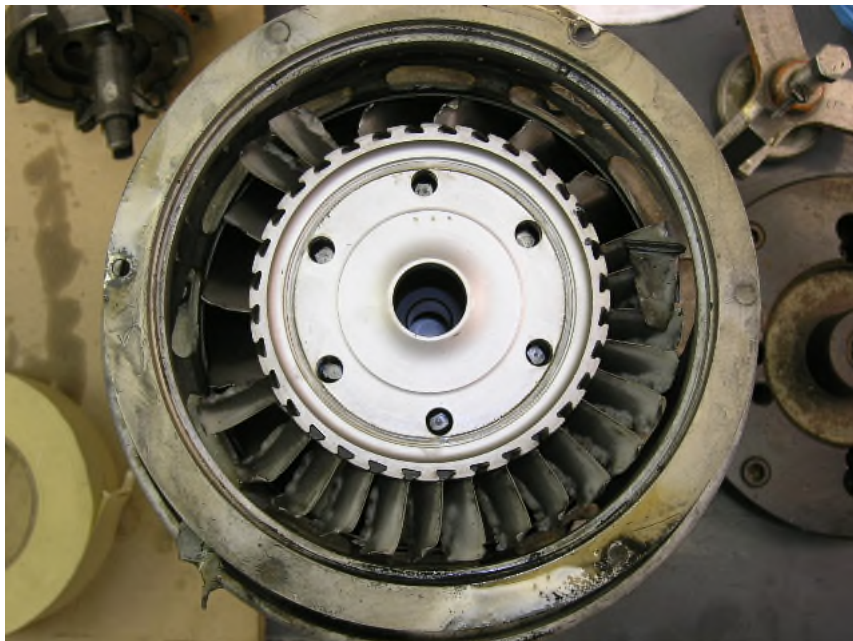
Photo No. 25  
Compressor 3<sup>rd</sup> stage disc and blades upstream side, in-situ.

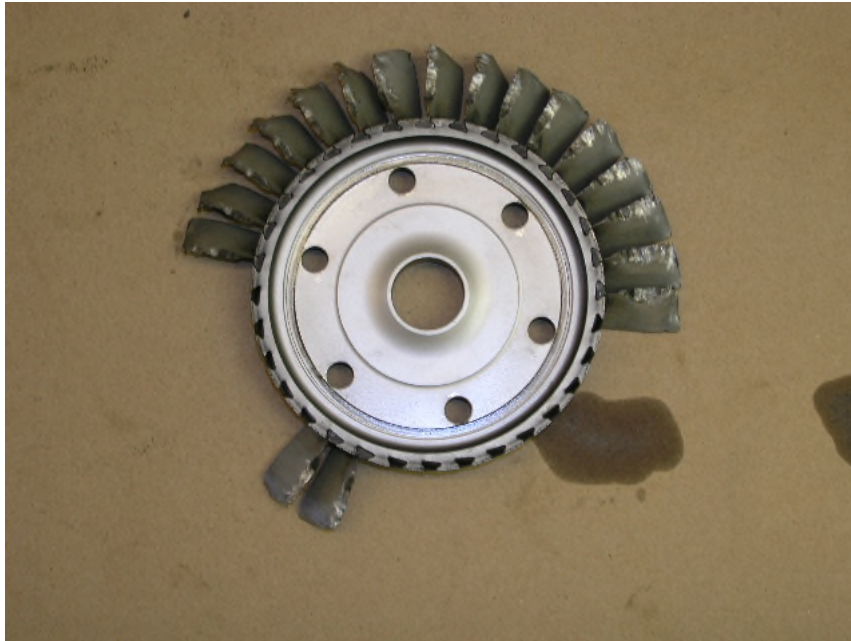
Photo No. 26  
Compressor 3<sup>rd</sup> stage disc and blades, downstream side.

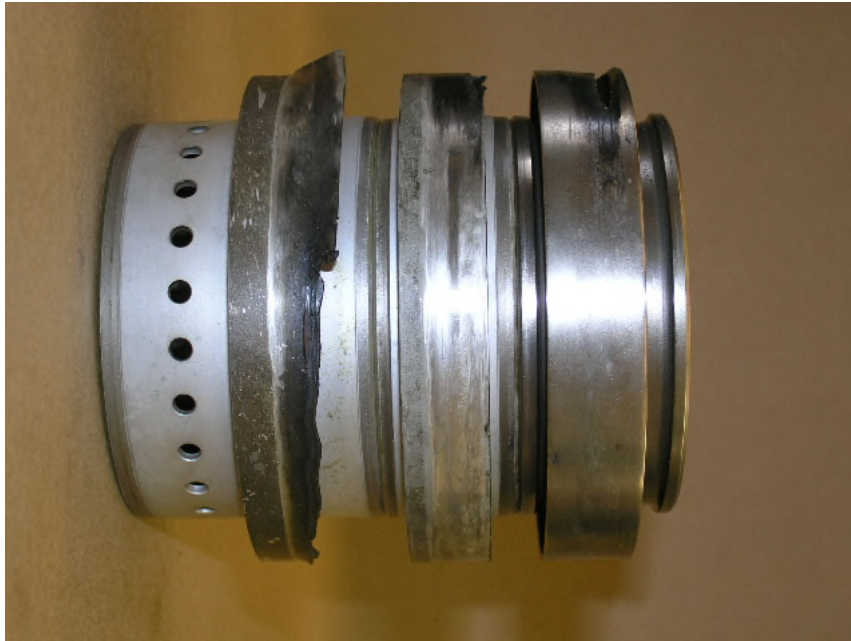
**Compressor 1<sup>st</sup>, 2<sup>nd</sup>, and 3<sup>rd</sup> Stage Spacers:** For identification the spacer assembly was divided into quadrants “W, X, Y, and Z” with quadrant “X” centred at the “X” rotor balancing mark, clockwise viewed from aft looking forward. The 3<sup>rd</sup> stage spacer was completely rubbed obliterated across approximately  $\frac{3}{4}$ 's of its circumference to due rubbing and machining under radial contact with the 3<sup>rd</sup> stage stator vanes. The 1<sup>st</sup> and 2<sup>nd</sup> stage spacers displayed circumferential rubbing and machining completely through the spacer around the quadrant “Y” due to radial contact with their adjacent stator vanes. Please refer to photos No. 35 and 39 through 45.

Photo No. 42  
1<sup>st</sup>, 2<sup>nd</sup>, and 3<sup>rd</sup> stage compressor spacers quadrant "Z".

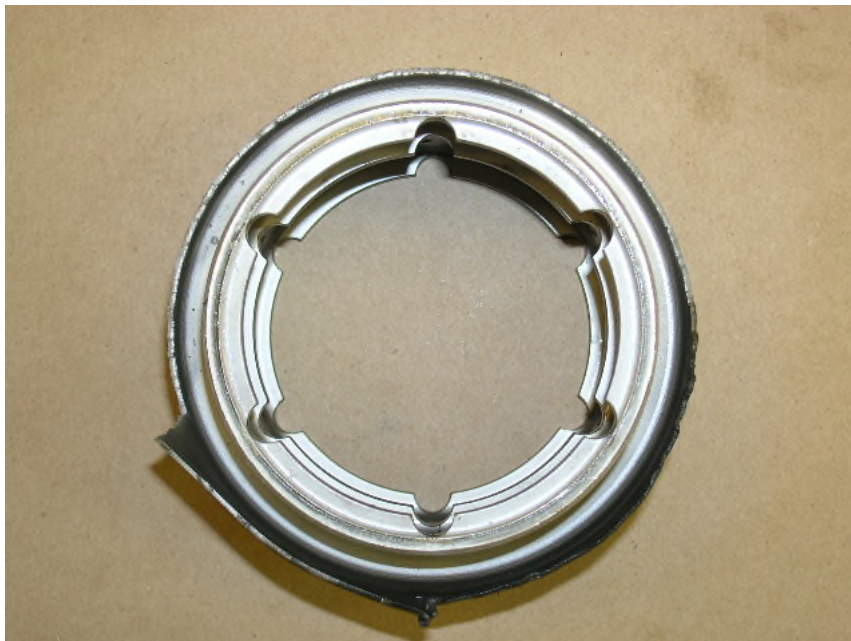
Photo No. 43  
Compressor 3<sup>rd</sup> stage spacer upstream side, position "X" at 12:00.

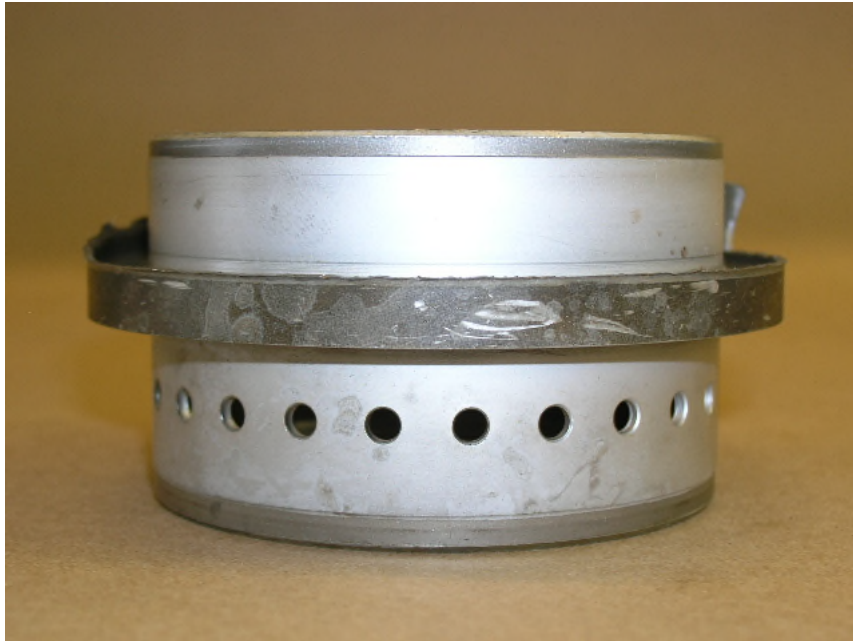
Photo No. 44  
Compressor 3<sup>rd</sup> stage spacer, centered at position “X”

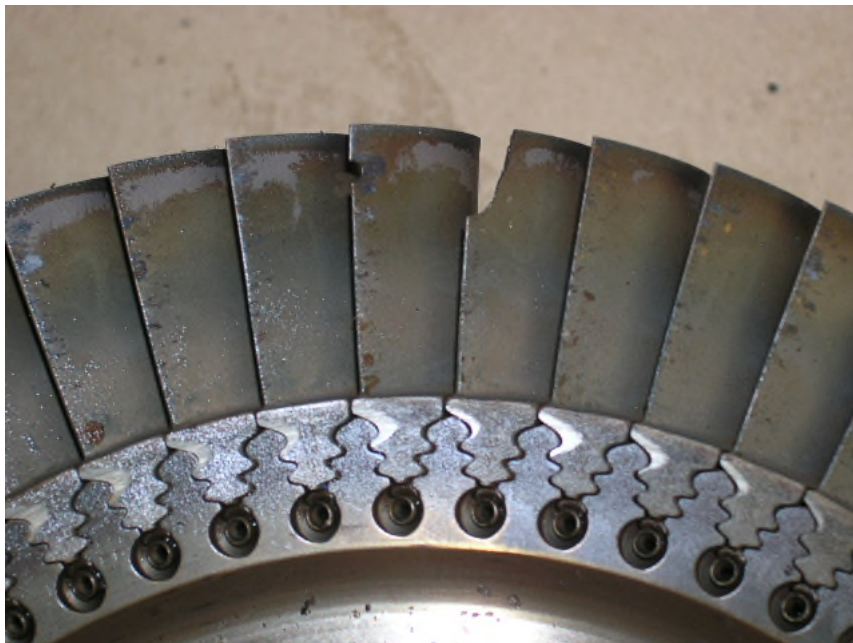
**Compressor Turbine:** The blade airfoils were lightly battered and gouged due to contact with upstream debris. The blade tips displayed circumferential rubbing due to contact with the shroud. Fine silver metal material was heat fused to the airfoil surfaces. The disc downstream side displayed circumferential rubbing due to contact with the power turbine guide vane ring. Please refer to photos No. 74 through 78.

Photo No. 77  
Compressor turbine downstream side, detail.
