# Continental Motors

## ENGINE FIELD INSPECTION REPORT **FINAL**

| ENGINE MODEL | IO-520-FcD |
| FILE NUMBER | 14-176 |

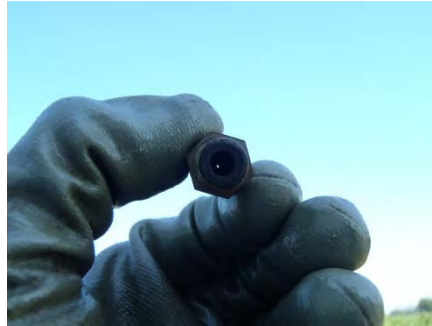
#1 Injector

The fuel pump remained attached to its respective installation point and displayed damage consistent with impact damage. The throttle body and fuel metering assembly remained partially attached to the engine through fuel lines and displayed damage consistent with impact damage. The fuel manifold valve remained attached to its respective installation point and displayed impact damage signatures to the vent line fitting. All six fuel injectors remained installed in their respective cylinders and there were no defects noted with the injectors.
