# **NATIONAL TRANSPORTATION SAFETY BOARD**

## **SYSTEMS GROUP CHAIRMAN'S FACTUAL REPORT**

A. **ACCIDENT:** ERA14LA424

**AIRCRAFT:** Socata TBM700, N900KN

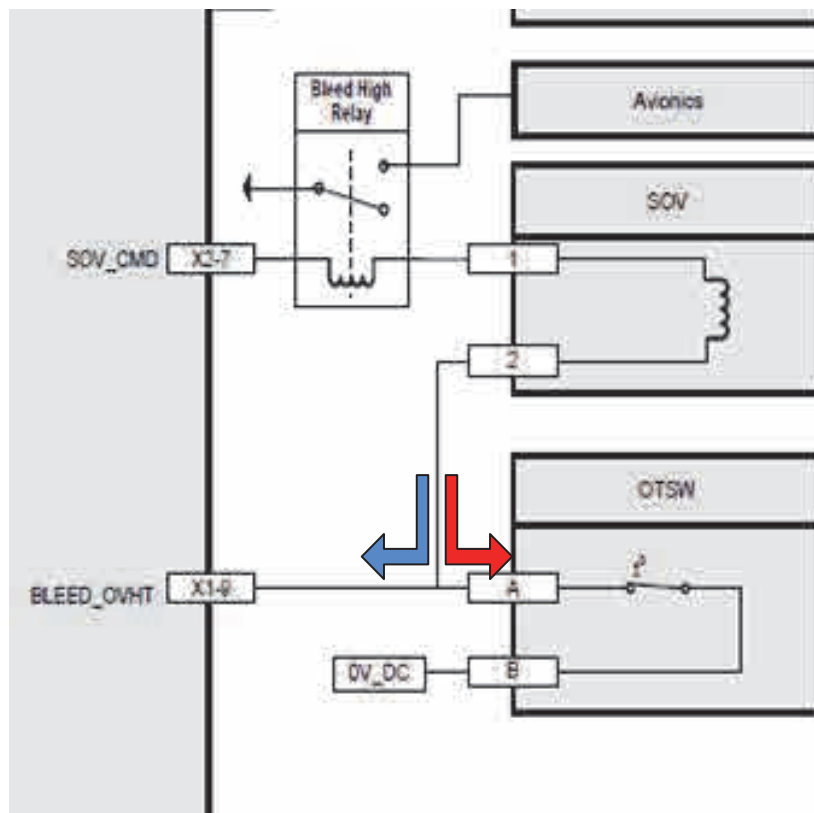
The path through the SOV and OTSW to ground is one leg of the parallel circuit (See Figure 8, red arrow to right). The GASC monitor circuit (light blue arrow to left) is a low current path for voltage measurement, isolated by a combination of diodes and resistors. This path through pin X1-9 leads to cockpit illumination of the BLEED OVHT caution message.

Figure 8. Liebherr-provided circuit diagram which shows the GASC along the left, P3 shutoff valve (SOV), and over temperature thermal switch (OTSW). The same circuit diagram also shows that when the OTSW contacts are open the SOV circuit is opened, shutting the source of P3 bleed air.

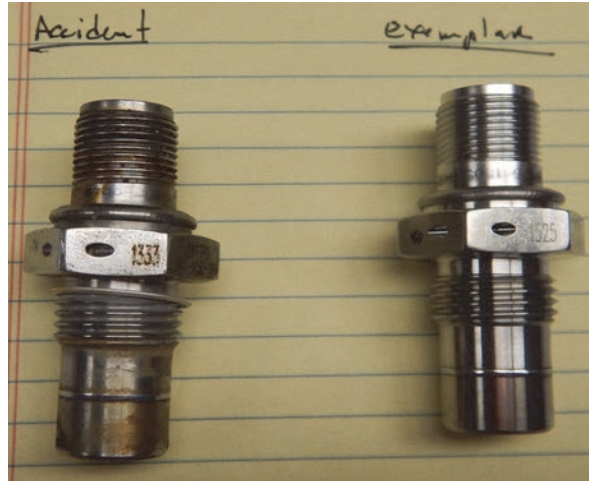
Figure 10. OTSW switch from N900KN and an exemplar. The electrical connector is at top and the capsule with the switch contacts is at the bottom.

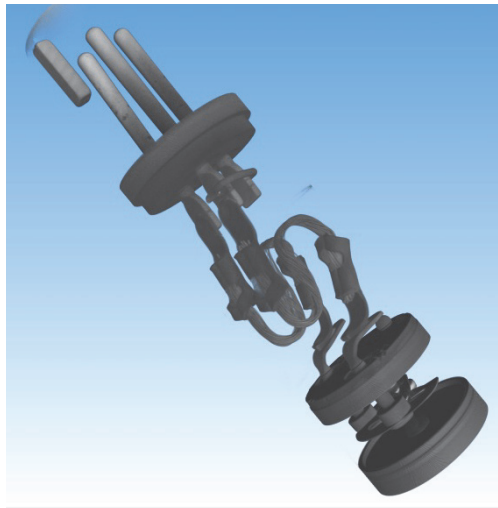
Figure 11. Computerized tomography (CT) image of the N900KN OTSW created by NTSB and used by the group to discuss various components within the body of the OTSW.

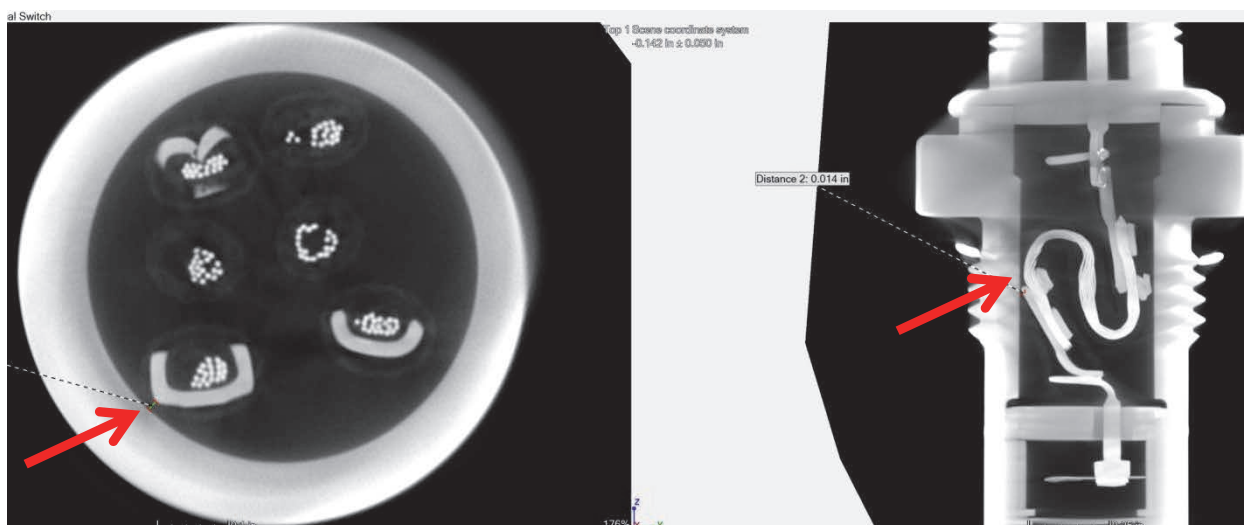
The switch was cut open at the failed weld on the connector side of the wrenching flat. A lathe was used by hand to create the cut, and then the three interior wire lugs were cut. Imaging from computerized tomography previously indicated that the connector on one wire had a 0.014" dimension to the metal tube of the switch body. (See Figure 15) After removal of the connector end, the wires were visible and they were resting against a layer of Kapton insulation which lined the tube interior. (See Figure 16)

Figure 15. CT images with arrows showing .014" measurement.

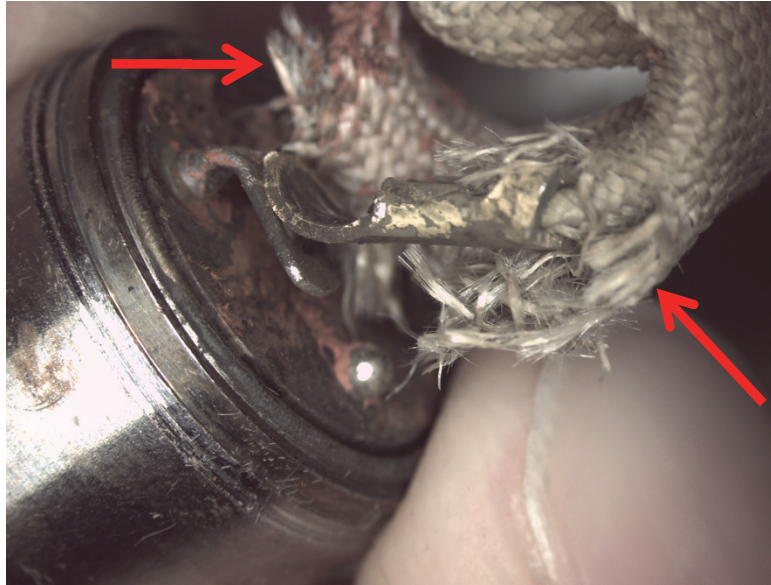
Figure 17. Layers of fiberglass insulation on wire after pulling apart the outer layer.

The outer layer of some fibers had minor areas where they had worn though, flattened, or become dark in locations where the switch rested against the Kapton. (See Figure 18) The interior layer of wire insulation remained intact, as had the Kapton where the wire had been in contact, and no short circuits of the wires or connectors to the switch housing were seen.

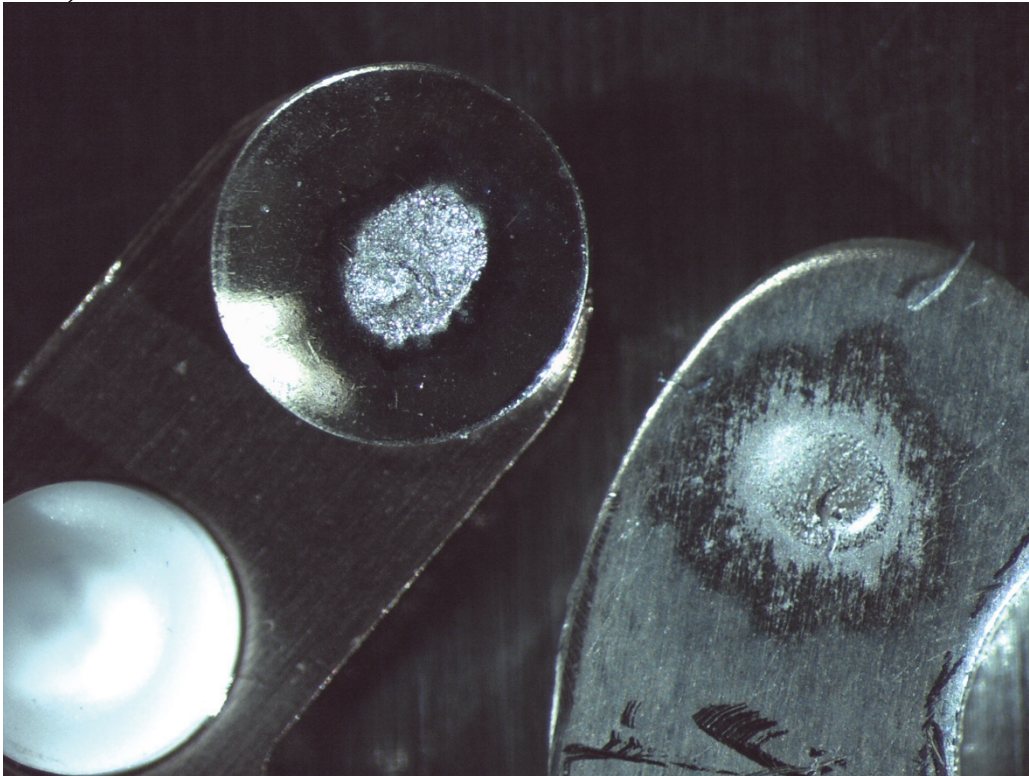
Honeywell provided contacts from two test OTSW which had accumulated 100,000 resistive load cycles at 28 VDC and 5 amperes.<sup>21</sup> The features of both contact assemblies in general were shiny and clean, as opposed to the dull brown features of the N900KN internal components. The group noted that while the N900KN switch was relatively new and had only about 141 flight hours, it had been recovered from months of time in ocean water. The contact set (called Set #1) from one switch had a roughened appearance in the wear area which covered more than half of the contact pad with very little depth. (See Figure 25)

Figure 25. Endurance test contact Set #1.

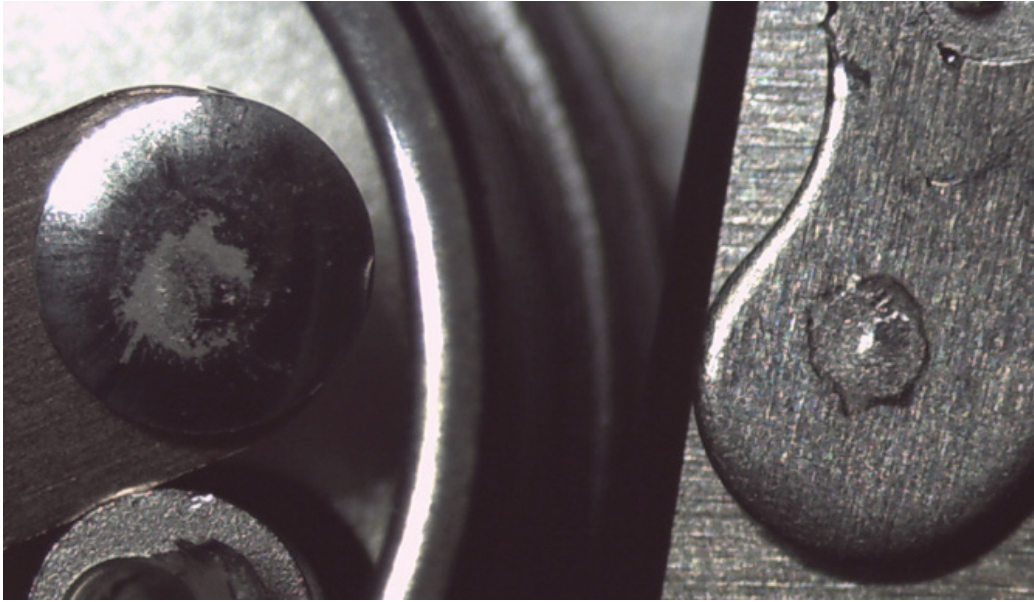
The wear area in the set of contacts from the second (called Set #2) was slightly smaller in diameter. (See Figure 26) The wear area was surrounded by a slightly darkened ring and the wear area had material transferred from one contact to the other with a depth similar to that seen in the N900KN contacts.

Figure 26. Endurance test contact Set #2.

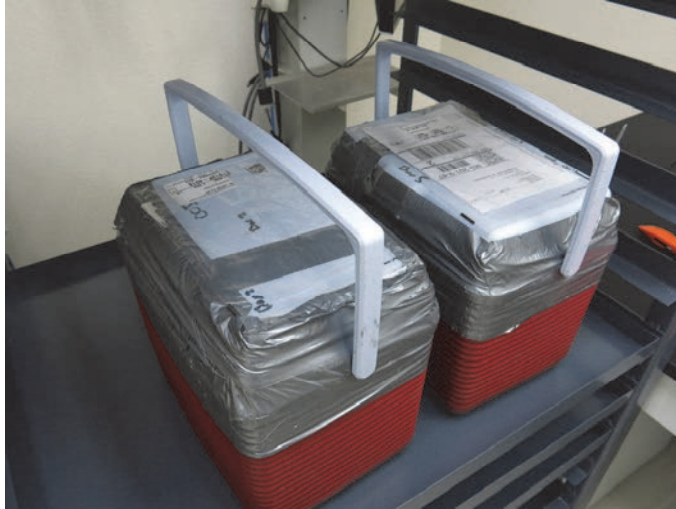
The OTSW was recovered from wreckage at the Eclipse warehouse and had dried, months after the recovery. When recovered from the ocean, the rest of the pressurization components had been placed in cooler boxes which were filled with water and sealed shut. (See Figure 27). Some parts had extensively corroded and had a slippery coating on the surfaces. Once removed from the water, most parts were sprayed with a water-dispersing anti-corrosion spray. Surfaces of the parts which the spray did not contact visibly corroded or oxidized within a day.

Figure 27. Examples of the sealed cooler boxes filled with water and pressurization parts.

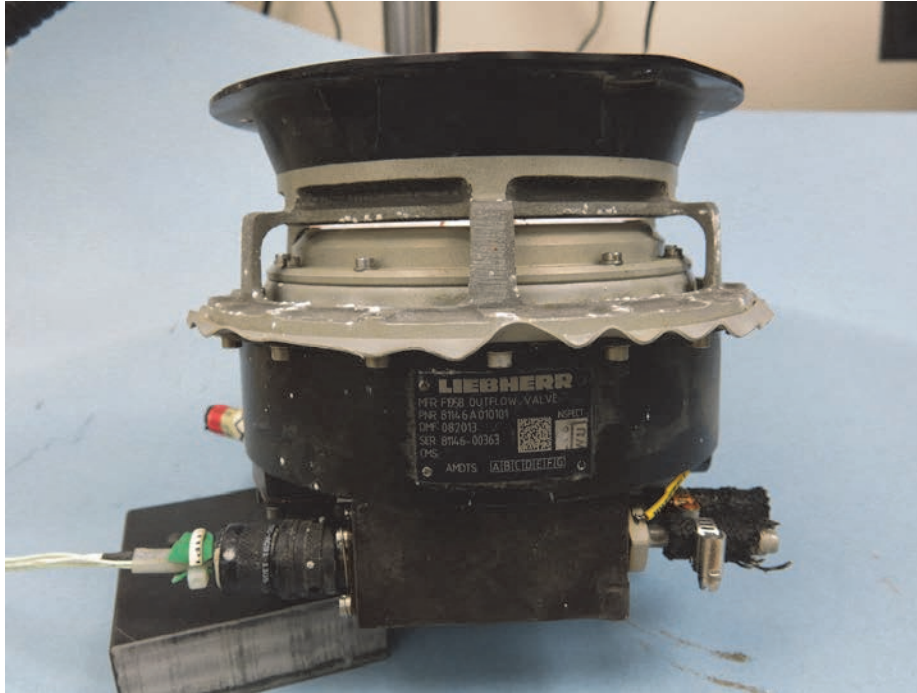
When removed from water in the packing box, the outflow valve assembly was found to have little deformation or other types of impact damage and was visually in good condition. The exterior was coated with a slippery substance and had minor white deposits on various surfaces. Exposed steel parts had rusted. Five yellow Liebherr anti-tamper sleeves existed on segments of safety wire at the fasteners. (See Figure 30)

Figure 30. The complete outflow valve assembly.

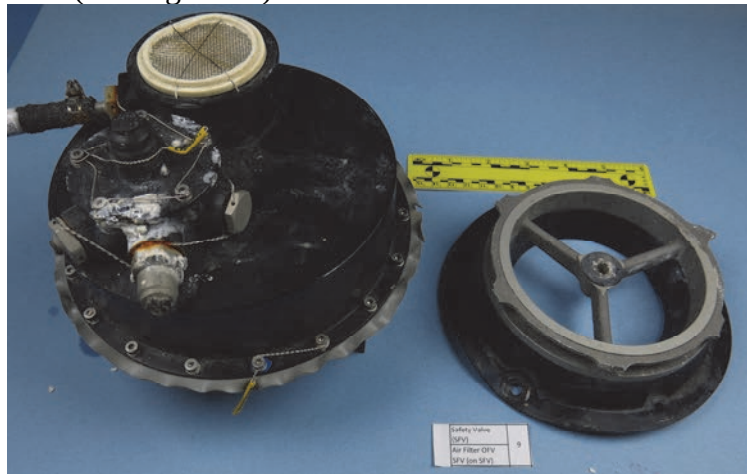
The valve was received as two major segments, with each in good condition visually. As with the outflow valve, the safety valve had minor white deposits, rusting of steel, and yellow Liebherr anti-tamper sleeves were found on segments of safety wired fasteners. The poppet and control portion comprised one segment, with the valve seat and frame as the second segment. (See Figure 33)

Figure 33. The complete two portions of the safety valve.

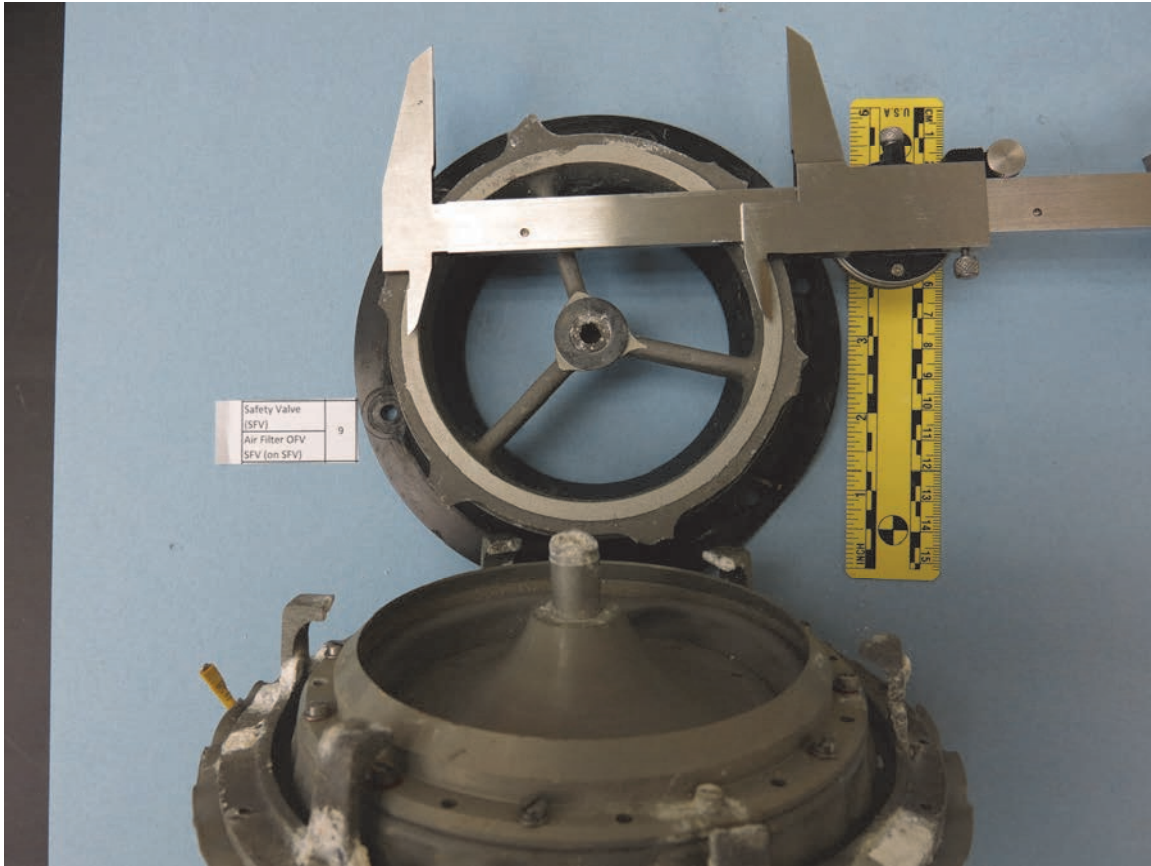
Figure 35. The calipers are set to the diameter of the main valve body knife-edge, and placed on the seating surface which the knife-edge would rest against in an intact valve.

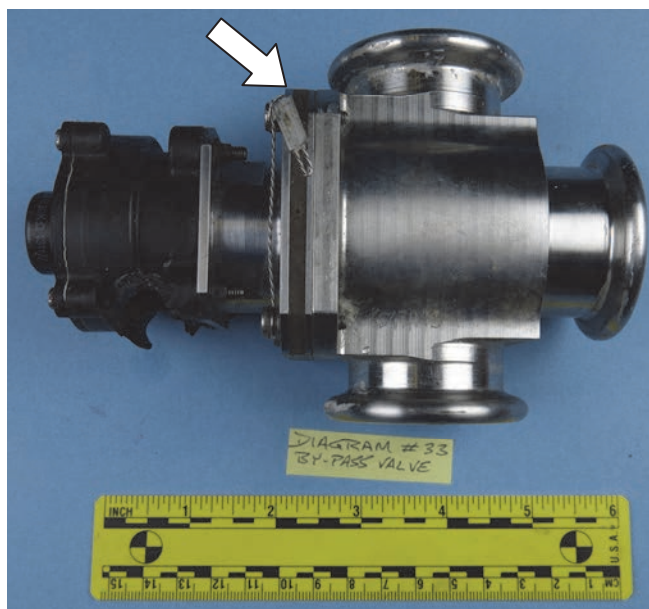
The stainless steel valve body and rotational inner sleeve were received intact and in a position which did not change with strong finger pressure. A portion of the plastic housing remained with a gear set. The motor portion of the plastic housing was not with the received valve. (See Figure 36)

Figure 36. Overall bypass valve as received. An arrow points to a projecting segment of safety wire as a common reference feature for comparison of valve orientation in the photographs.

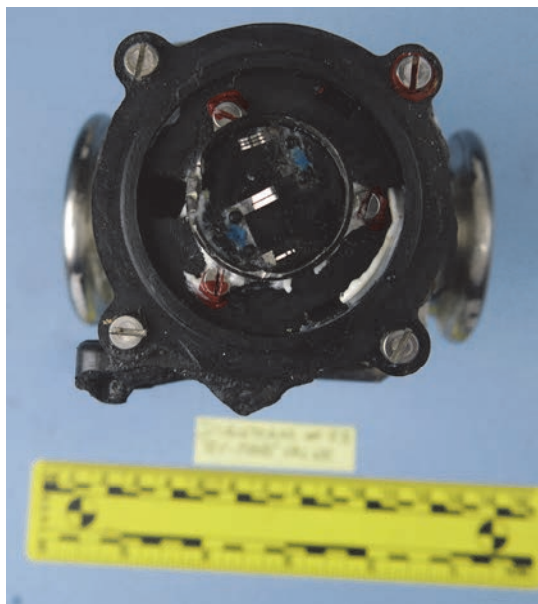
A set of exposed switch contacts were found at the end of the plastic housing furthest from the stainless steel valve body. (See Figure 37)

Figure 37. Exposed switch contacts.

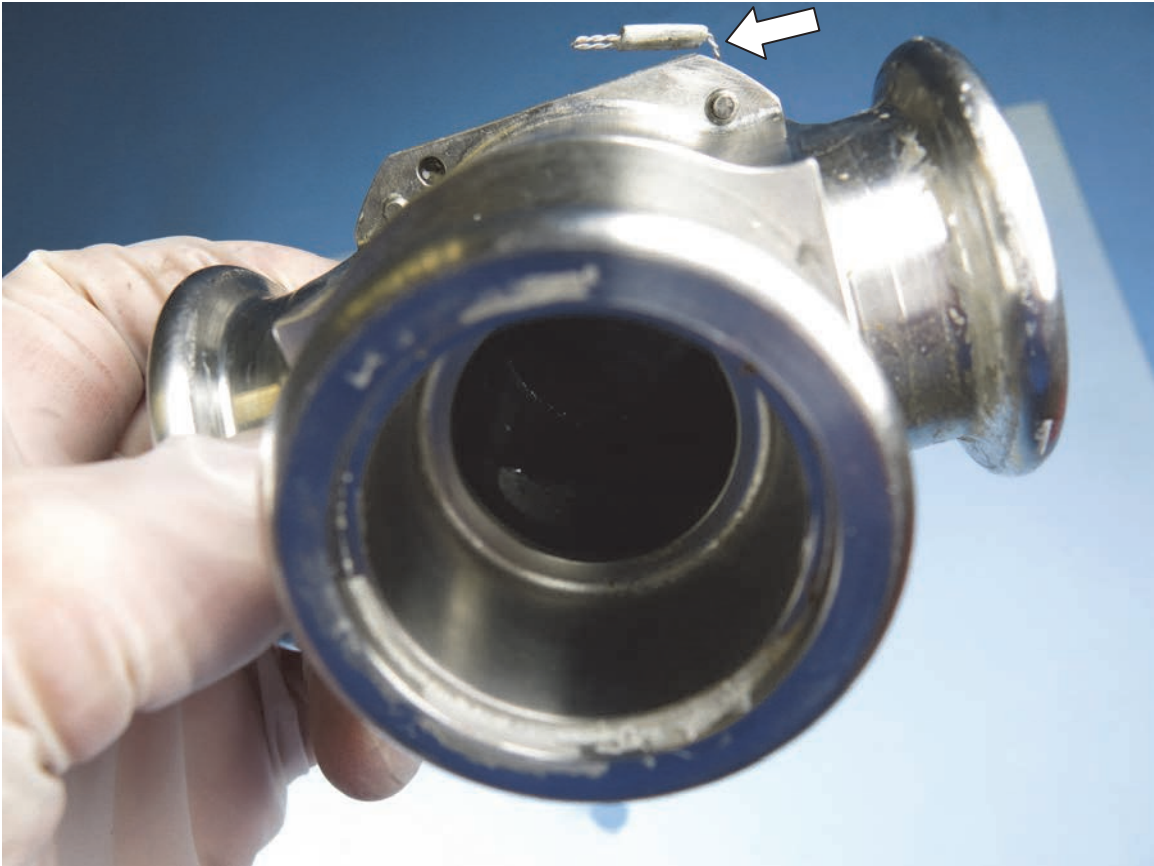
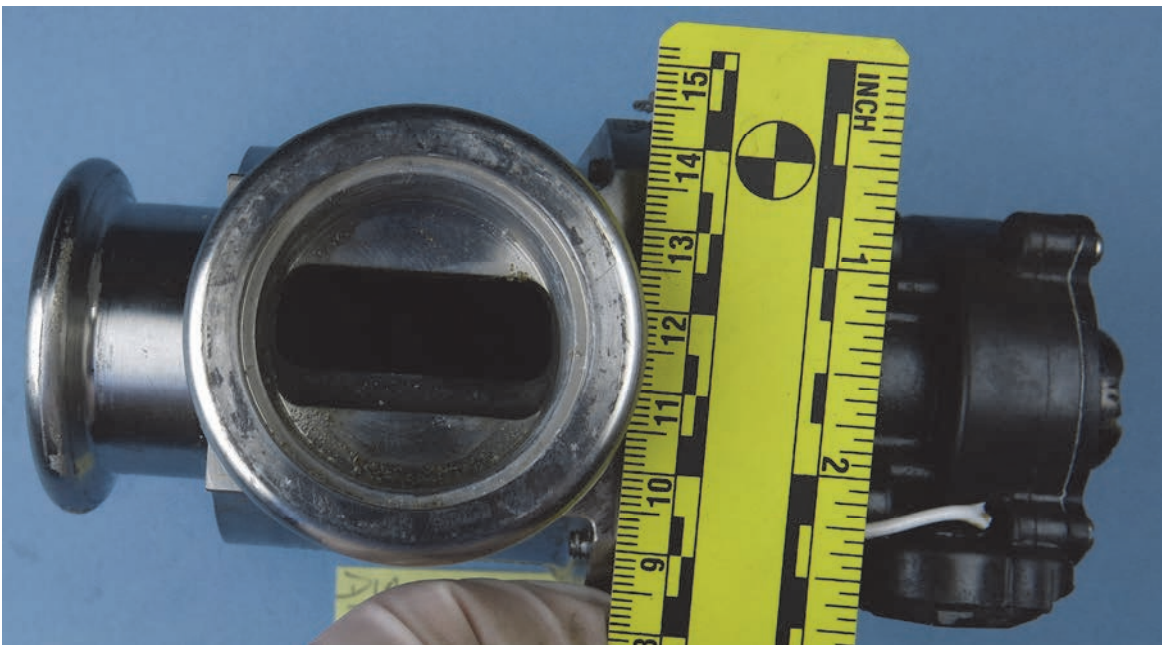
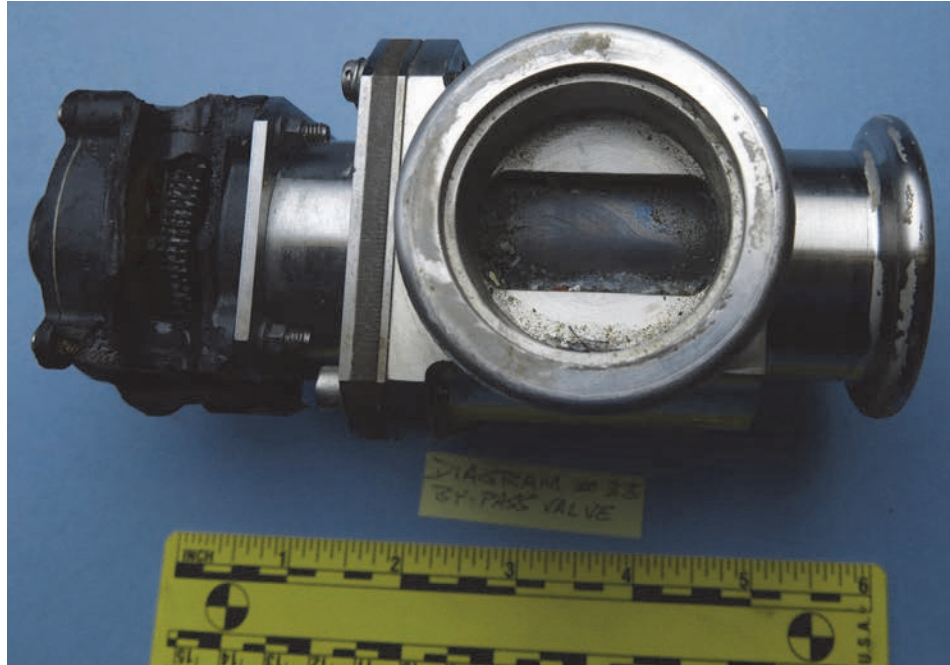
The sleeve valve was found at a rotational position which closes the port on the side of the exposed gear. On the port opposite the gear, the rotational position closed 5mm of the 17mm opening width. (See Figures 38 through 40)

Figure 38. Internal bypass valve orientation.

Figure 39. Partially closed bypass valve opening.

Figure 40. Closed bypass valve opening.

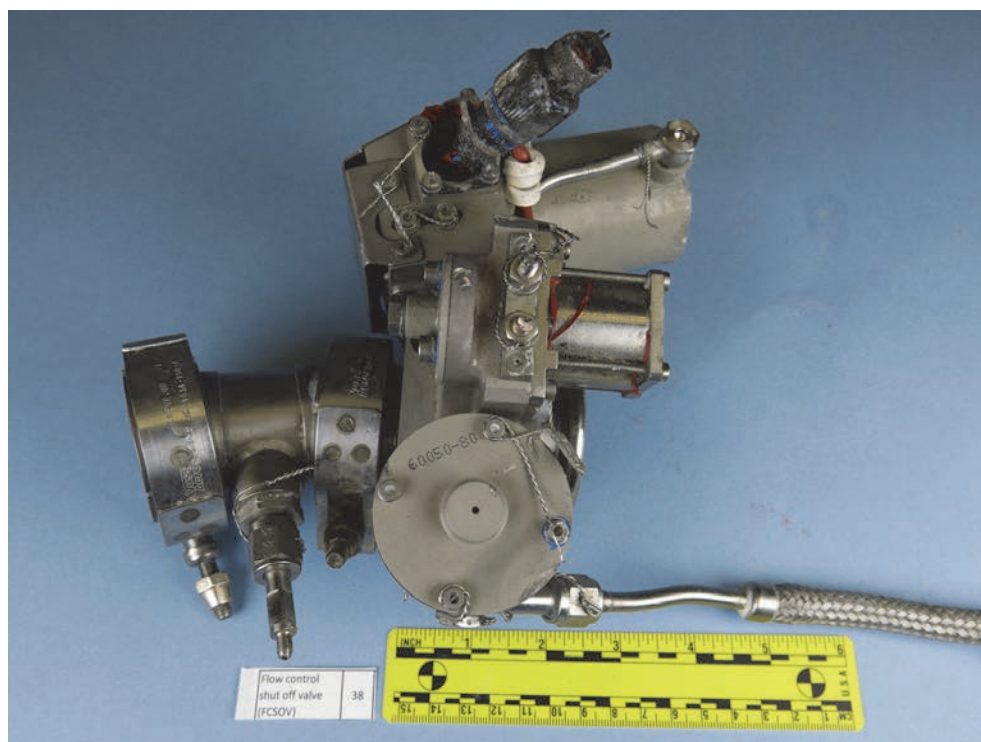
The complete valve assembly removed from water used for shipment had an overall slippery coating and extensive white deposits. Liebherr anti-tamper sleeves were on safety wire. (See Figure 41)

Figure 41. Overall FCSOV.

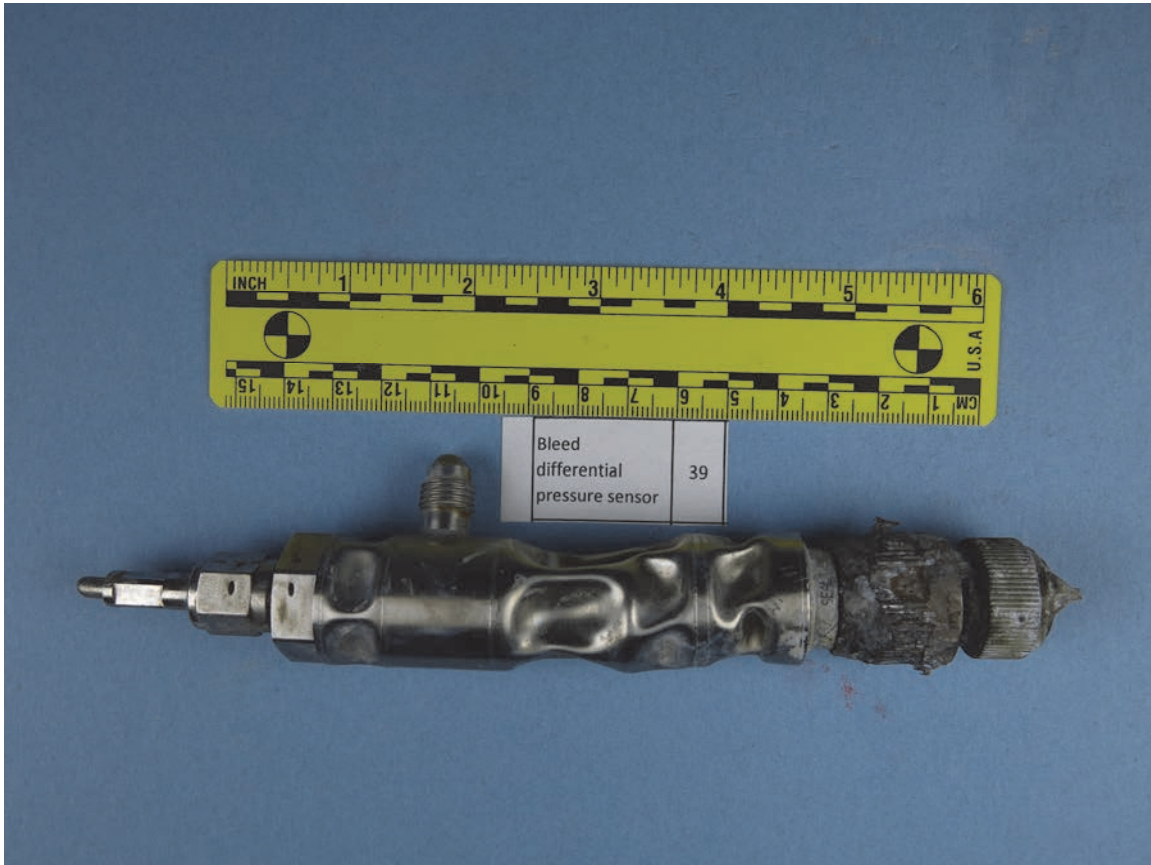
The stainless steel housing of the switch assembly was found crushed to the inner components. Beyond noting the marked information and visual condition, no further testing or examination was attempted due to the damage. (See Figure 43)

Figure 43. Bleed differential pressure sensor.

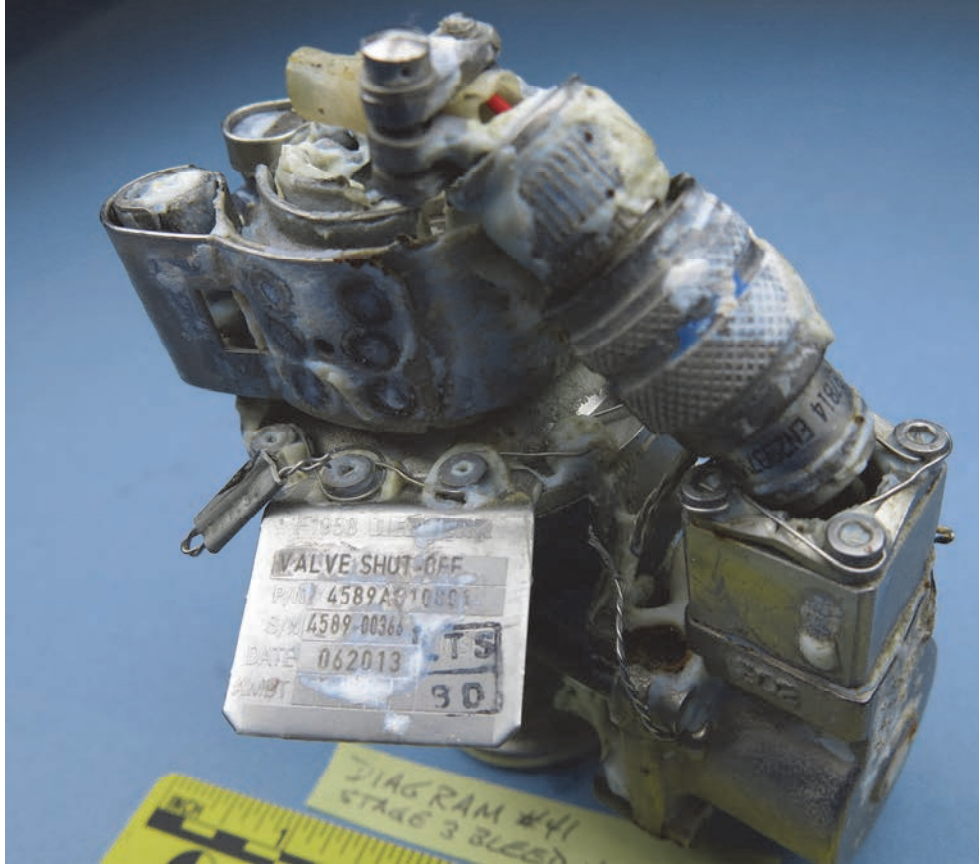
The Stage 3 bleed shut off valve was found with the separate data plate in a plastic bag, and with the electrical connector attached only by internal wiring. The valve was covered with a slippery coating and extensive white accretions. (See Figure 44)

Figure 44. Stage 3 bleed shutoff valve.

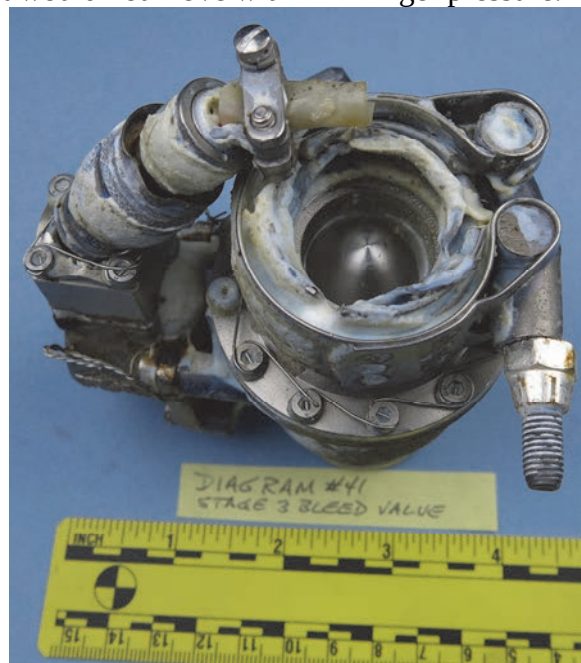
Examination of the SOV revealed that the interior poppet was in the closed position. (See Figure 21) The poppet would not move with firm finger pressure.

Figure 21. Closed poppet within the SOV.

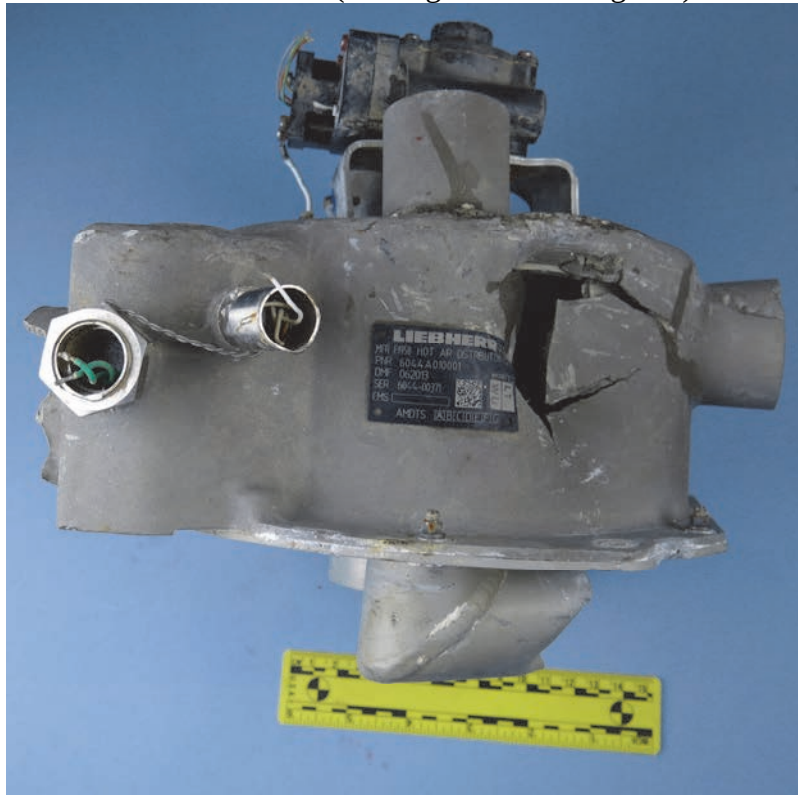
Figure 45. HAD data plate.

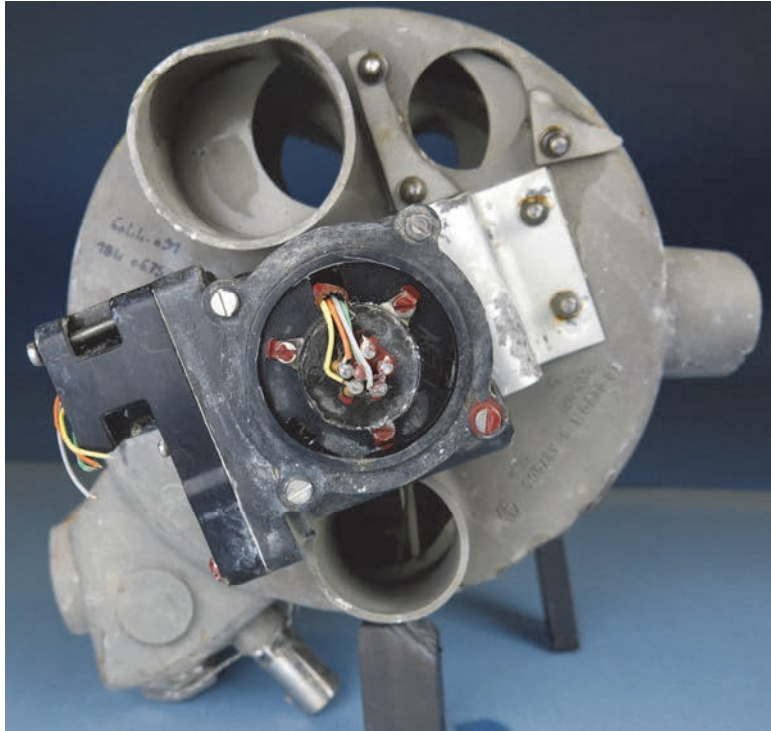
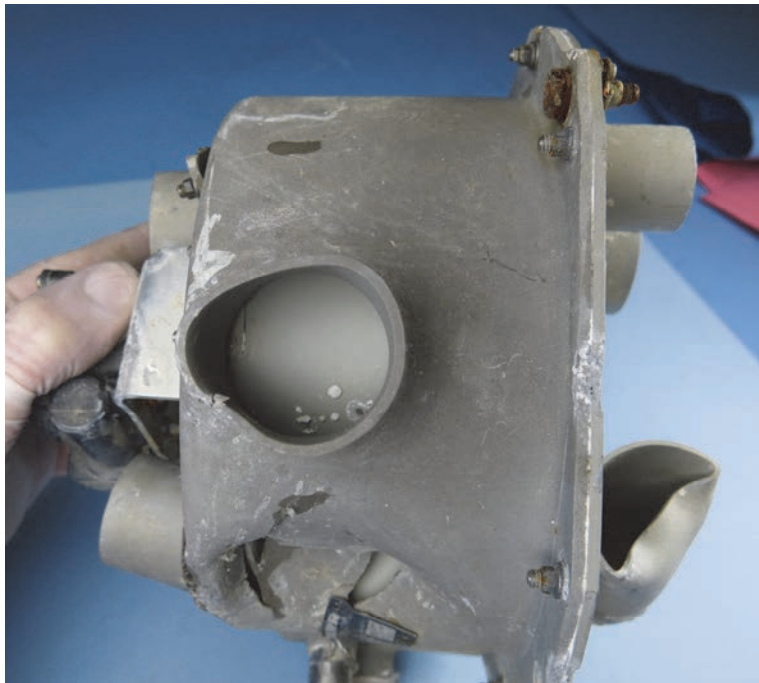
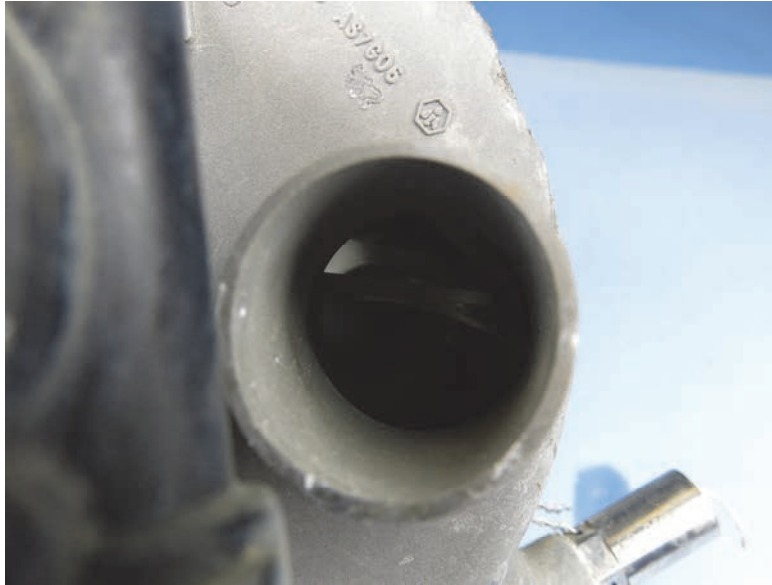
The hot air distributor was found in an intermediate position, consistent with delivering a controlled amount of heat to the cabin. (See Figures 45 through 48)

Figure 46. Position of hot air distributor valve.

Figure 47. Position of hot air distributor valve.

Figure 48. Position of hot air distributor valve.

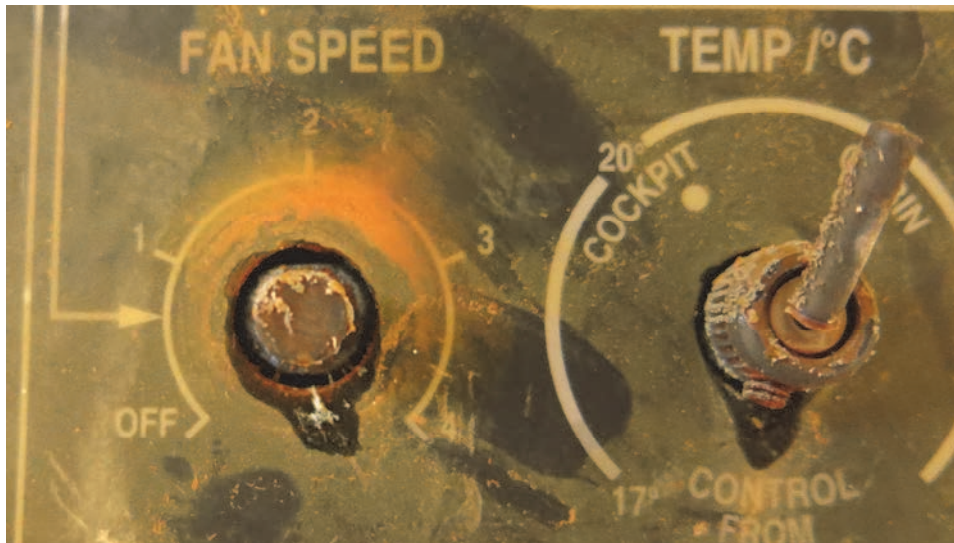
Figure 58. The photo shows the positions of the FAN SPEED and TEMP knobs.

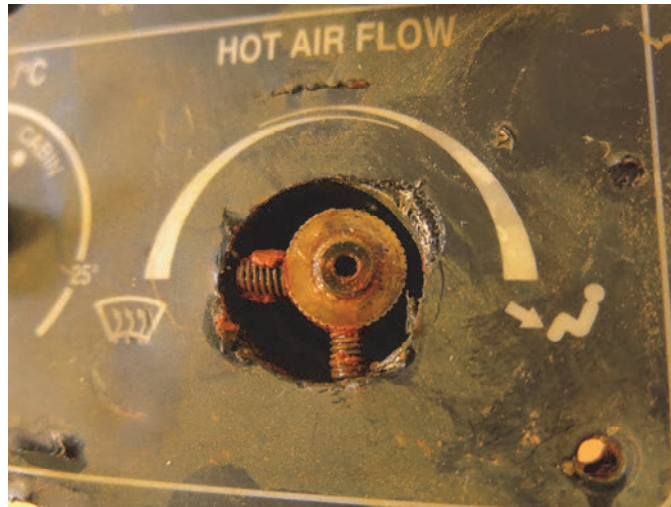
Figure 59. The HOT AIR FLOW knob was found with set screws at the 6 and 9 o'clock positions.

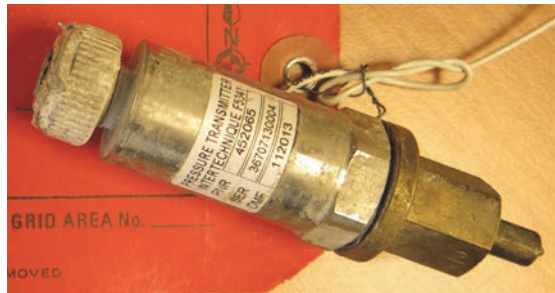
Figure 60. Intertechnique pressure transmitter. Note: The wire is loosely attached to keep the switch from being lost.

This component was found loose in the wreckage.

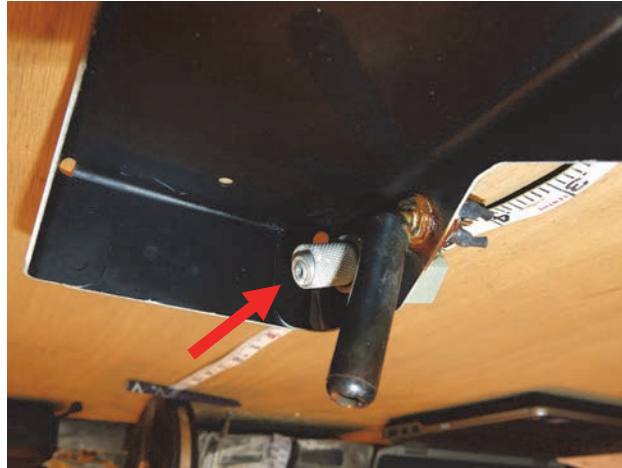
Two supplemental oxygen mask boxes from the cabin were found and in each were two connectors for oxygen and for a communication jack. (See Figure 61)

Figure 61. Right side supplemental oxygen mask box.

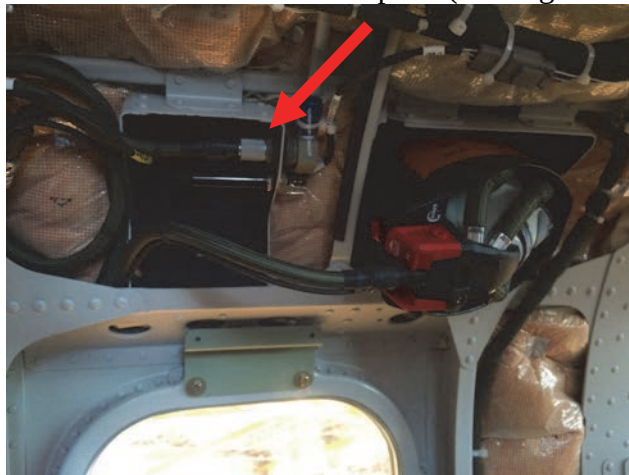
The similar boxes in an exemplar airplane were found to not have contained the oxygen masks. At the upper forward corner of each was a connection point for a cockpit oxygen mask and the orientation was such that the mass of the connectors would have been displaced forward in a forward deceleration at impact. (See Figure 62)

Figure 62. Left side cockpit mask connection box in an exemplar airplane. Forward in the airplane is to the right of the photo.

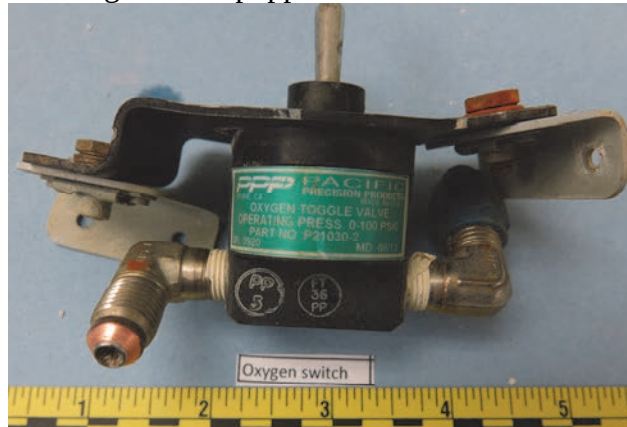
The oxygen switch was found in the closed position and did not pass air from one end to the other. As described in Section D3.2, this position prevents oxygen from reaching the oxygen masks. The valve was imaged with computerized tomography (CT), which identified foreign material against the poppet on the inlet side of the valve.

Figure 63. Supplemental oxygen switch. The scale at the bottom is marked in inches.

Following removal of the fittings from each side, the interior of the passages were found filled with organic material associated with the ocean. The group found the switch to be in the closed position. Microscopic examination of the base of the toggle did not reveal impressions or other potential indications that the switch had previously been in any other position at impact.

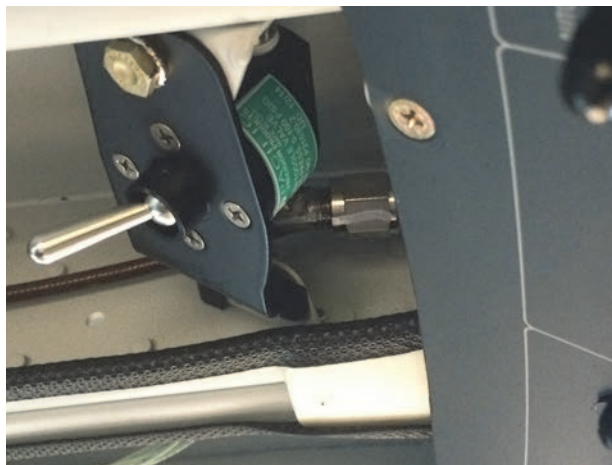
Figure 64. A switch installed in an exemplar airplane with the toggle in the OFF position. The view is from the copilot seat, so forward would be to the right of the photo.

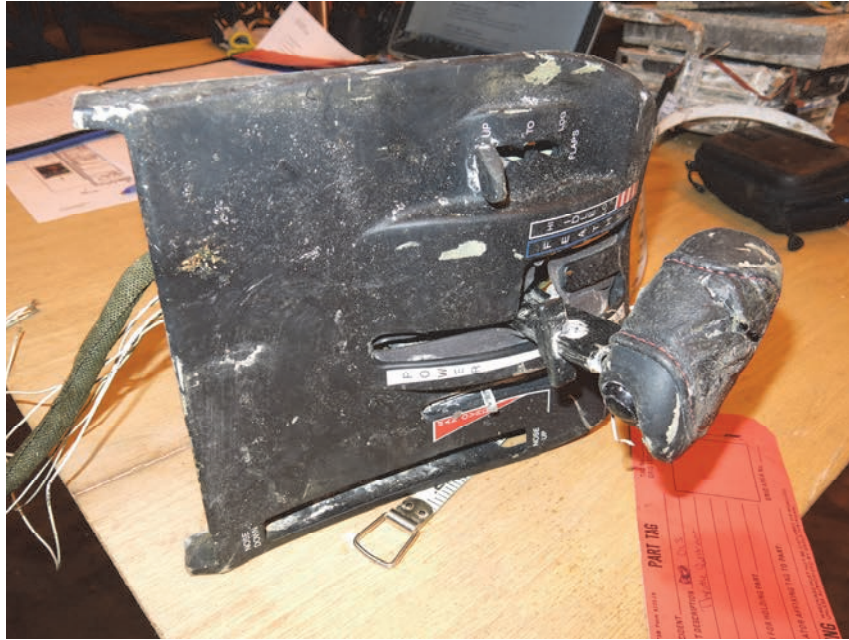
The throttle pedestal was found with extensive damage consistent with impact. (See Figures 65 through 67) The power lever was at the feather gate, the flap switch full up, and the manual throttle over ride was found in the mid-portion of the range of travel.

Figure 67. Overall view of throttle quadrant.
