# ATTACHMENT A

## Airplane Differences Report

**Analysis of Over Temperature Switch (OTSW) Contacts  
(Failure Analysis)**

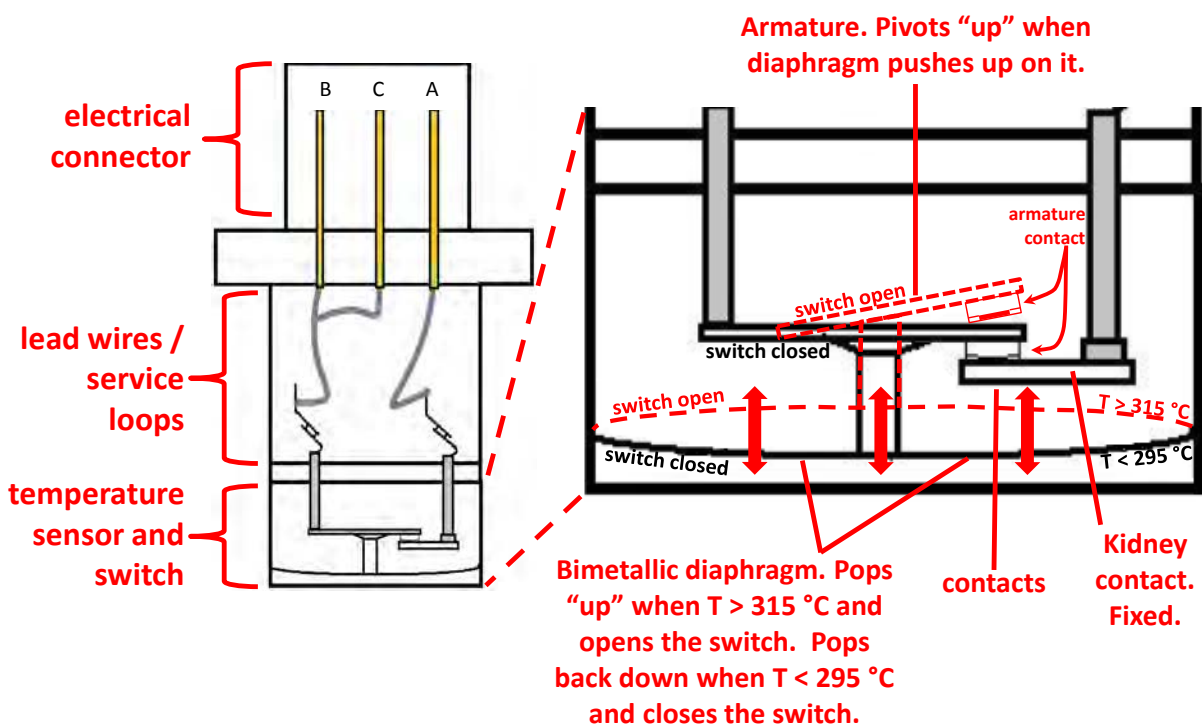
Figure 2. Diagram depicting operating principles for the OTSW.

A photo and radiograph of the OTSW from the accident airplane was provided by the NTSB ([Figure 1](#)). There are two sealed chambers inside the unit – one for the lead wires/service loops, and the other to house the temperature sensor and switch contacts. [Figure 2](#) is a diagram showing how the switch operates. There are two contacts: a contact affixed to a movable armature and a stationary “kidney” contact. A bimetallic diaphragm “pops up” when  $T > 315\text{ }^{\circ}\text{C}$  ( $\pm 5\text{ }^{\circ}\text{C}$ ) and pushes up on the armature, thereby pivoting the armature counterclockwise and opening the switch contacts. The diaphragm “pops back down” when  $T < 295\text{ }^{\circ}\text{C}$  and closes the switch contacts. [Figures 3](#) and [4](#) are close-up photos of the contacts in a non-incident OTSW, which further show the operating principles of the switch. These photos were also provided by the NTSB.

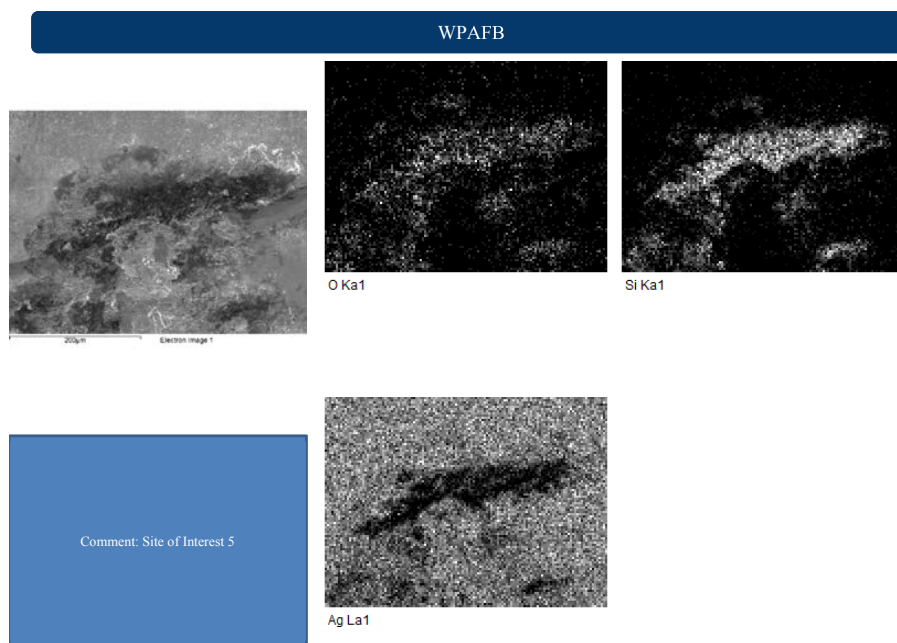
Figure A-3 – Higher Magnification Image and Elemental Map of Section of Dark Ring Area

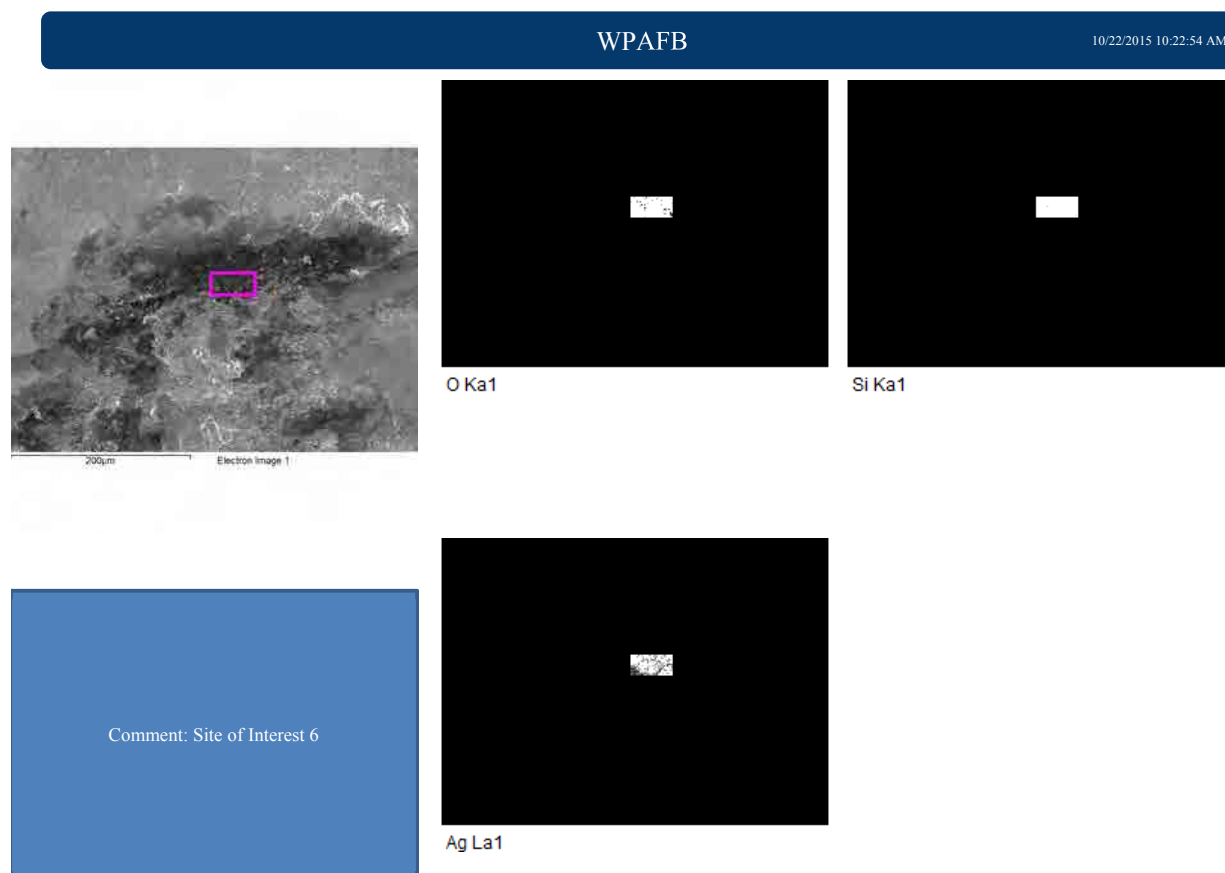
Figure A-4 – Image and Elemental Map of Examined Area of Dark Ring Residue

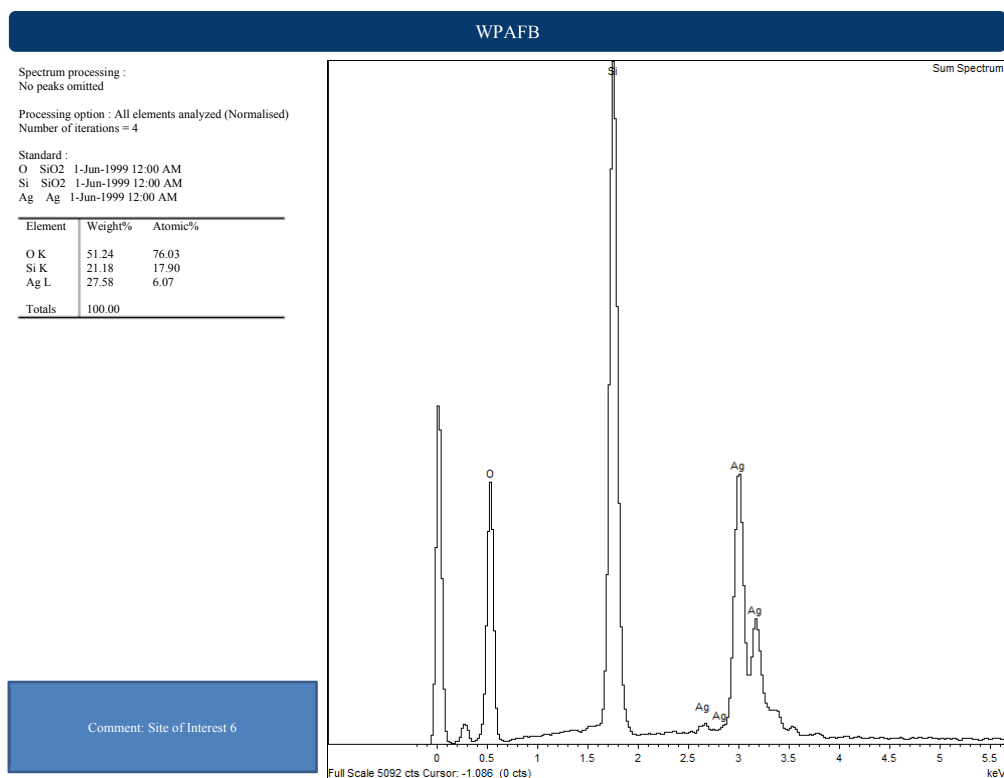
Figure A-5 – Spectra and Semi-Quantitative Analysis of Examined Area in Figure 4

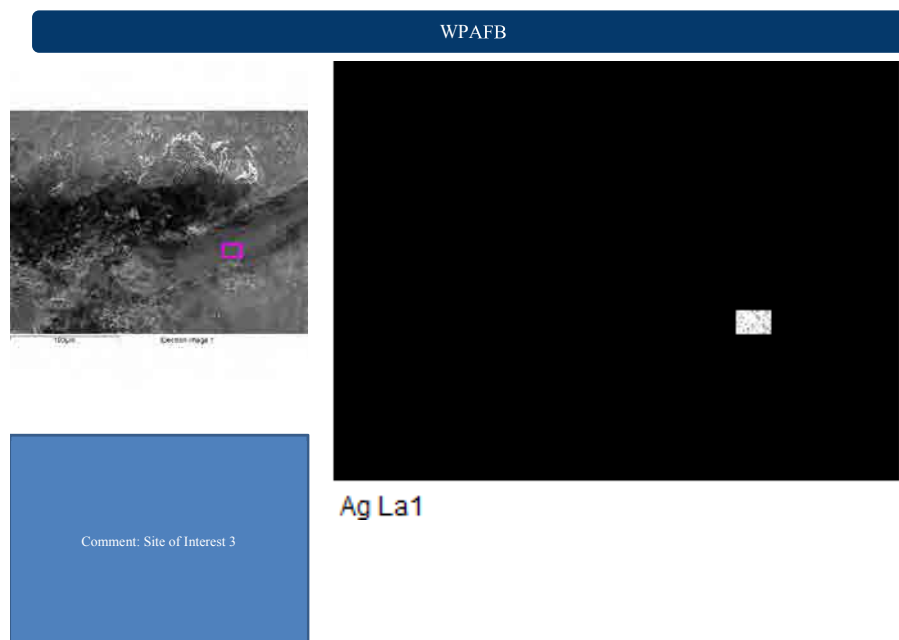
Figure A-6 – Image and Elemental Map of Examined Area of Silver Substrate

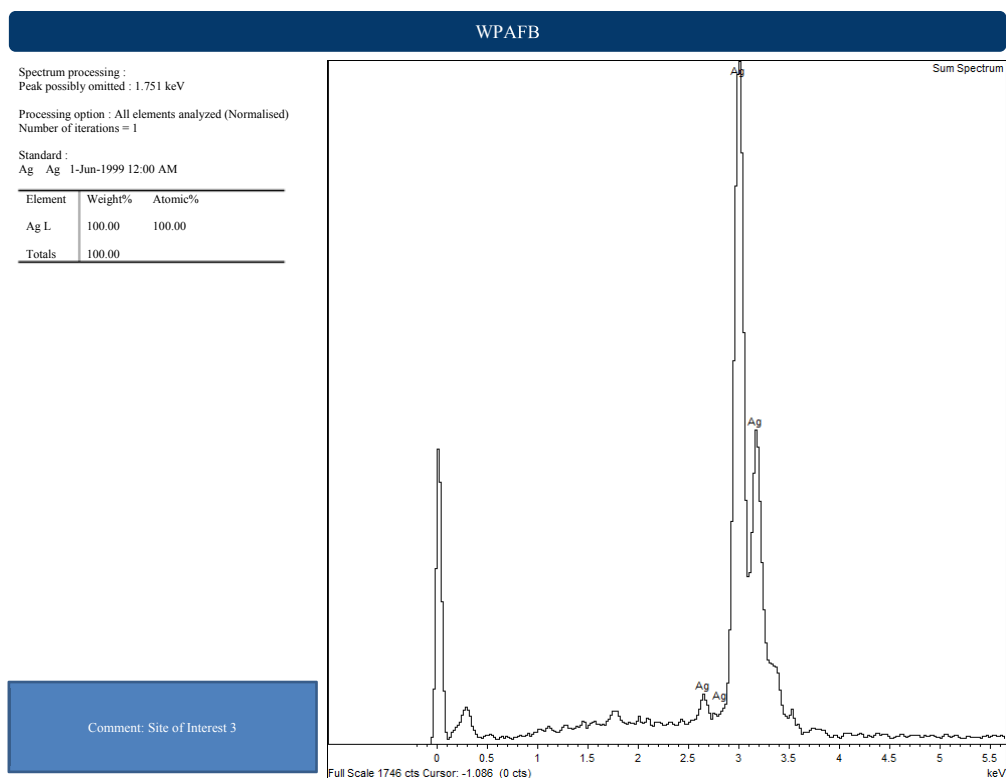
Figure A-7 - Spectra and Semi-Quantitative Analysis of Examined Area in Figure 6

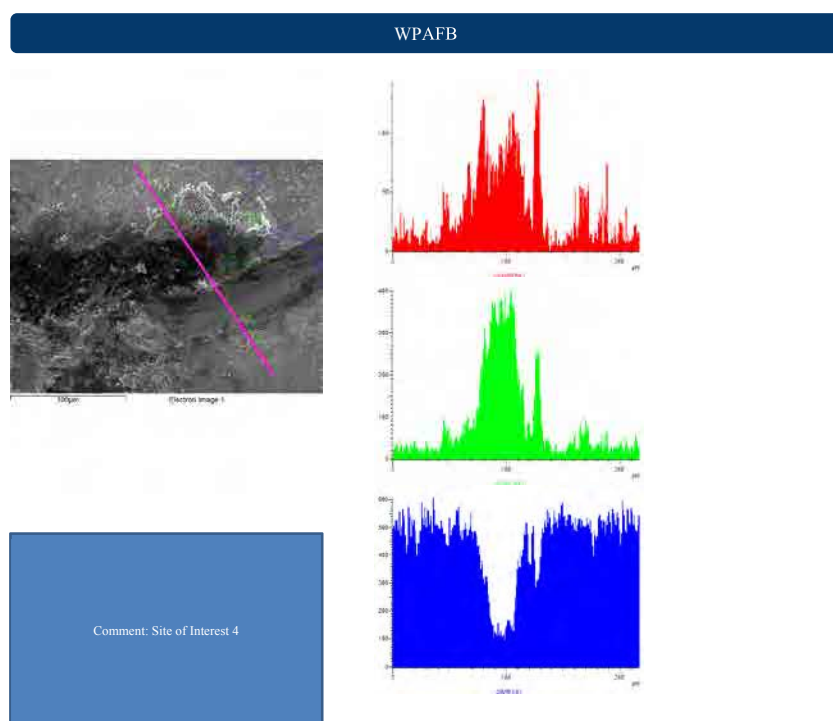
Figure A-8 – Line Scan Profile of Dark Ring Residue Area

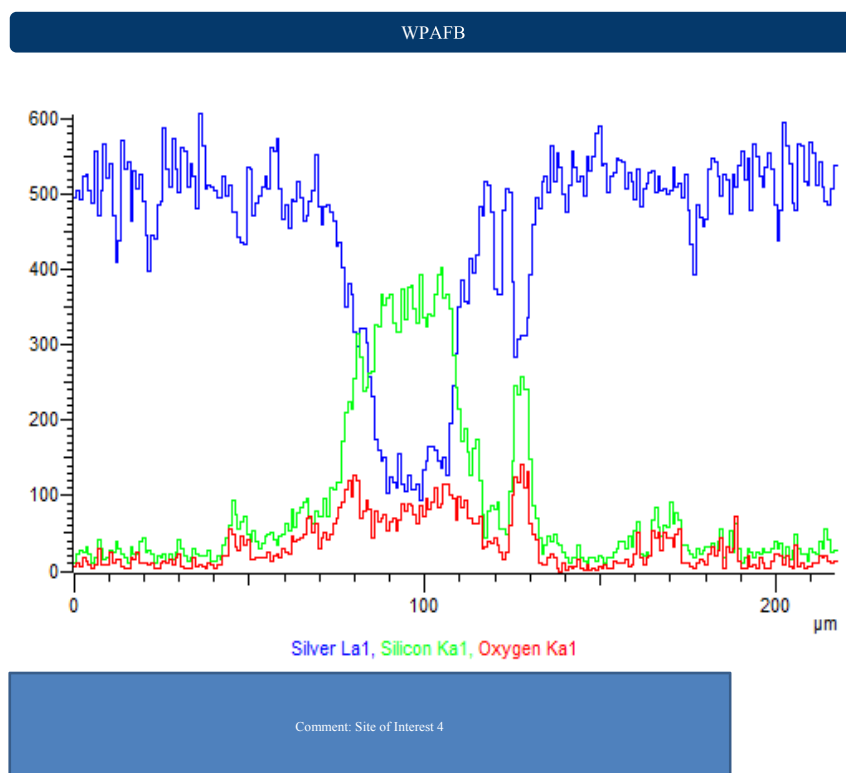
Figure A-9 – Plot of Signal Intensities Along Scanned Line in Figure 8

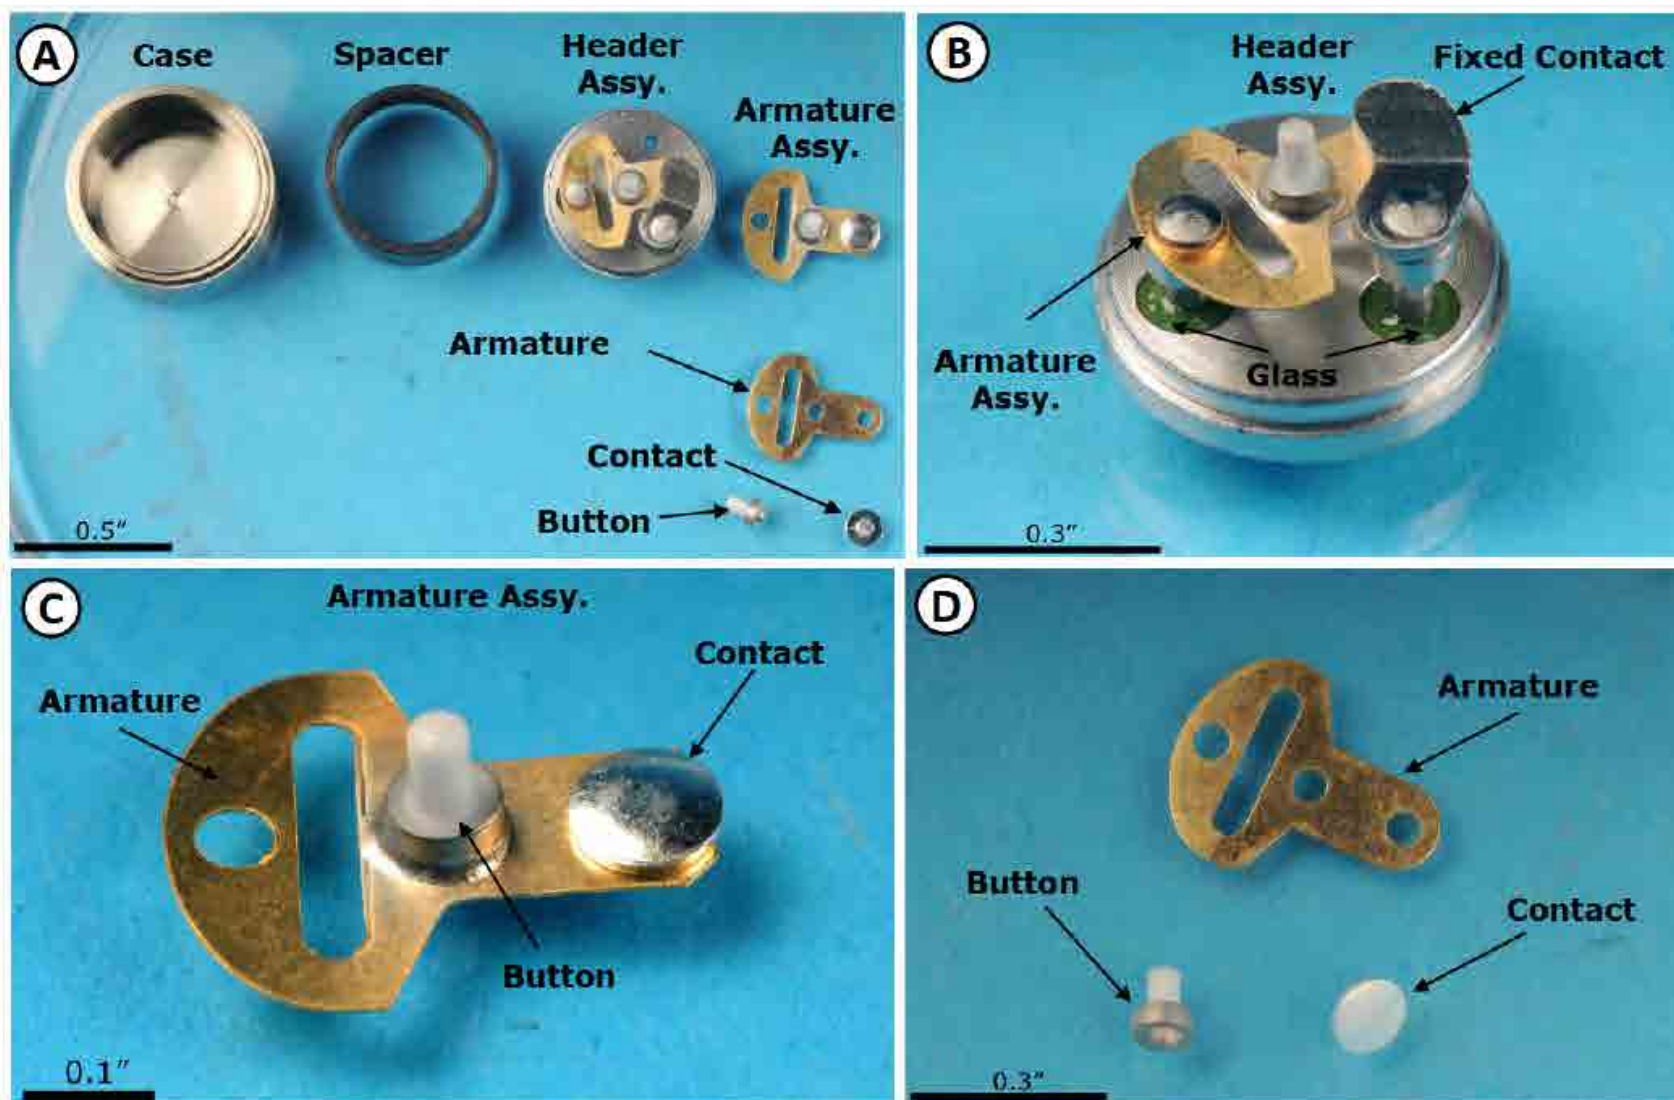
**Figure 1.**

The components had been grouped and packaged by P/N prior to receiving the hardware in the Phoenix Materials Laboratory. The switch sub-assemblies (header and armature assemblies), and individual components are identified in Figure 1.

(A) Overall and (B-D) close-up photos identifying the various components of the thermal switch. Refer to Table 1 for the quantity of parts submitted.
