# Inspector Statement

**Description:** N461MM Accident Investigation, Jacksonville, Florida, October 17, 2014  
NTSB # ERA-15-S-A-003

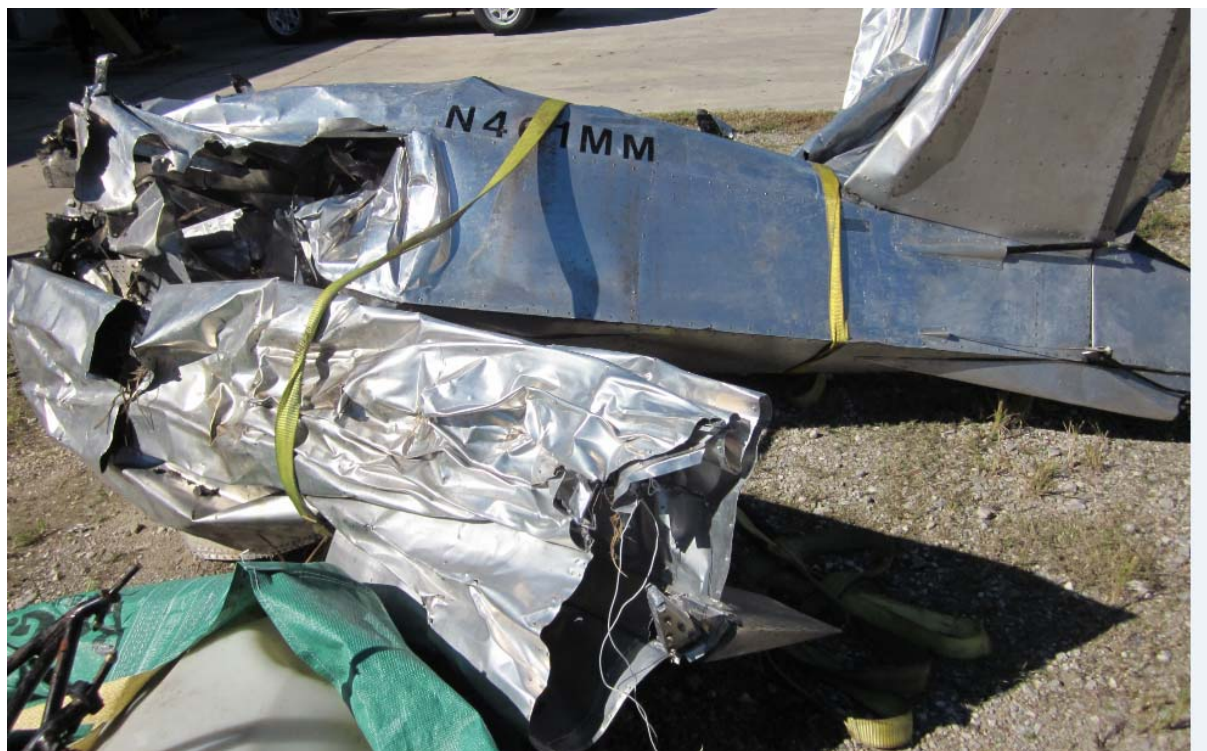
*On October 17, 2014 I arrived at the Florida Air recovery facilities in Jacksonville, Florida with the Operations Inspector to follow up with an investigation he was conducting. The aircraft was N461MM, an experimental model WAIEX (SONEX) serial Number W0156 with an engine model Aeroconvert-Aerovee. The aircraft remains were located at the yard and we met with Mr. Michael O'Shea, the recovery specialist. An inspection of the aircraft airframe was performed showing complete destruction of the airframe. The fuselage was damaged from the impact with the ground. The wings were bent back towards the tail section. The wings and fuselage became one and little remains of the tail were visible. It showed the structure was bent back from where the center main spar was located. Could not verify control surfaces travel and or connectivity to control wheel due to the damage of the fuselage. The cockpit had disintegrated and no seats or instrument panel was visible. There was no engine compartment as it was seen lying in the ground. Engine mount was bent on several places. There was no firewall that showed where the cockpit and the engine compartment were supposed to be. An engine teardown was coordinated to determine any possible cause of engine failure.*
