# NATIONAL TRANSPORTATION SAFETY BOARD

## MATERIALS LABORATORY FACTUAL REPORT

Report No. 15-017

Place : Sebring, Florida  
Date : January 16, 2015  
Vehicle : Aventura II, N511DS  
NTSB No. : ERA15FA102  
Investigator : Shawn Etcher, AS-ERA

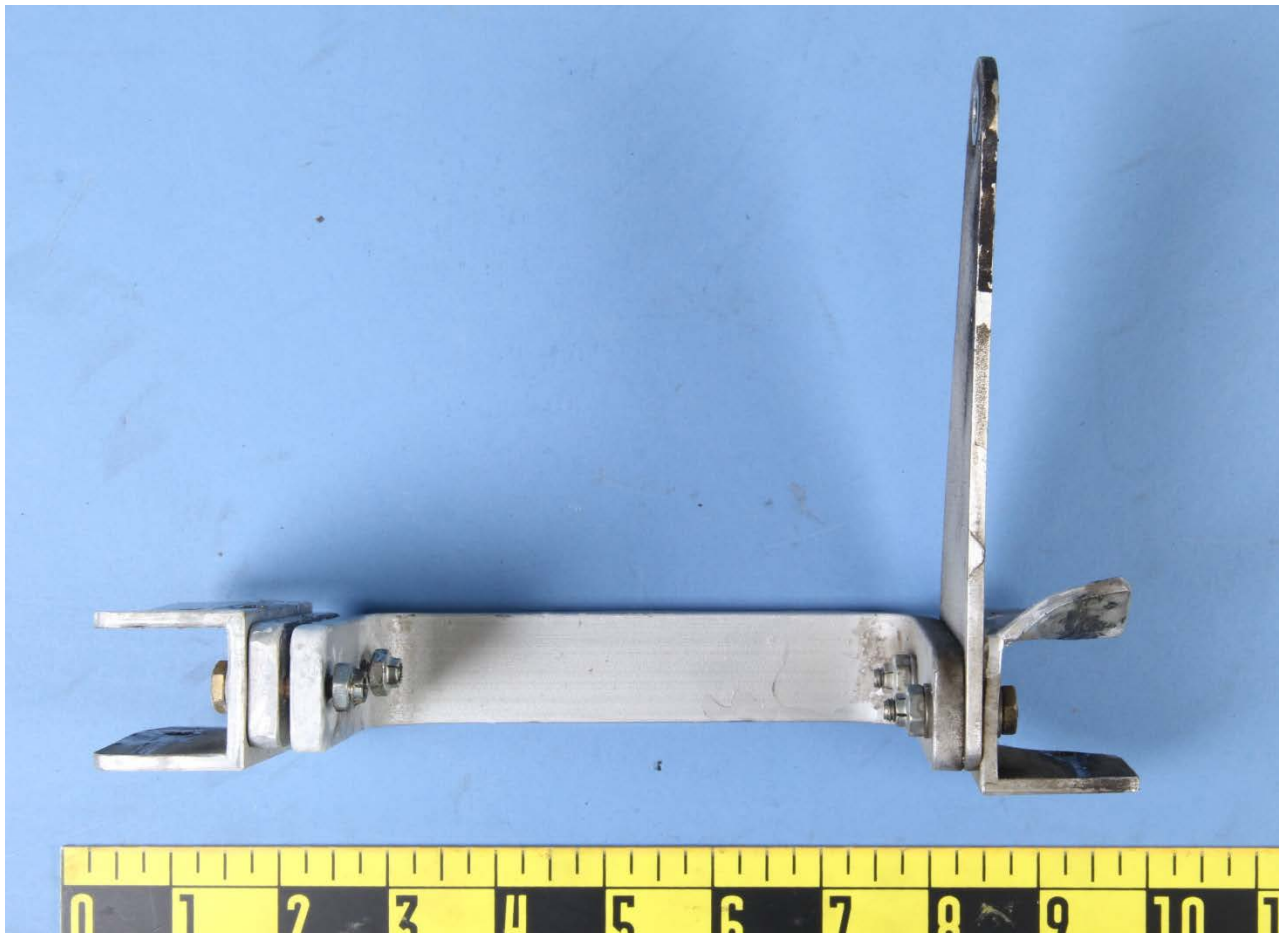
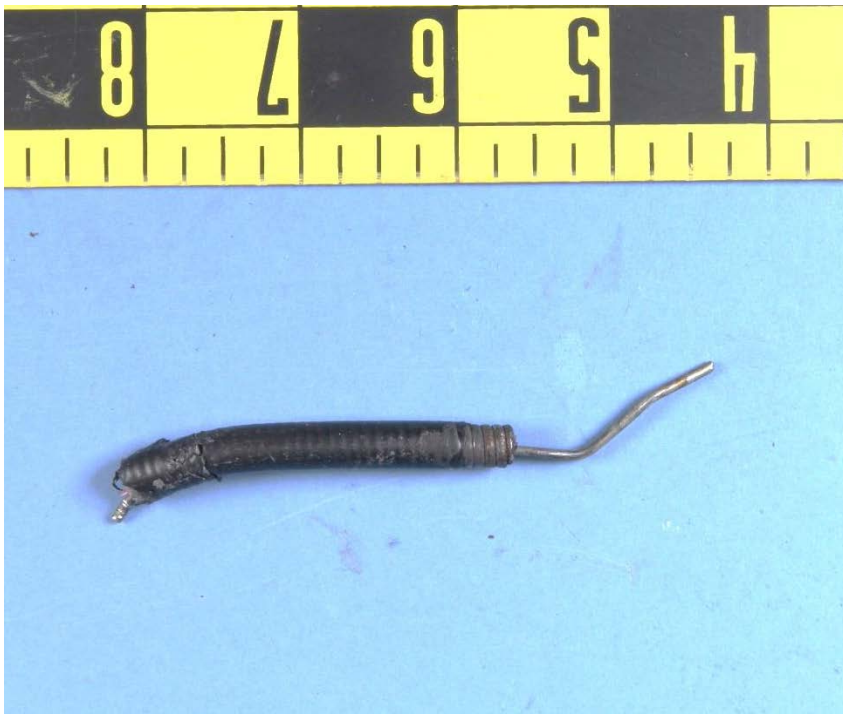
The received elevator horn assembly (top) and section of elevator trim cable (below) are displayed in the two views of figure 1.

Figure 1. Overall views of the as-received elevator horn, looking aft (top) and elevator trim cable section looking outboard (below).
