**Accident / Incident Report**

**Report No.: 15-012**

**Brinks Inc.  
Beech 1900C, Aircraft Reg. No. YV1674  
Miami, Florida, USA  
February 11, 2015  
PT6A-65B  
L/H S/N 32138  
R/H S/N G/G 32040 P/S 32065**

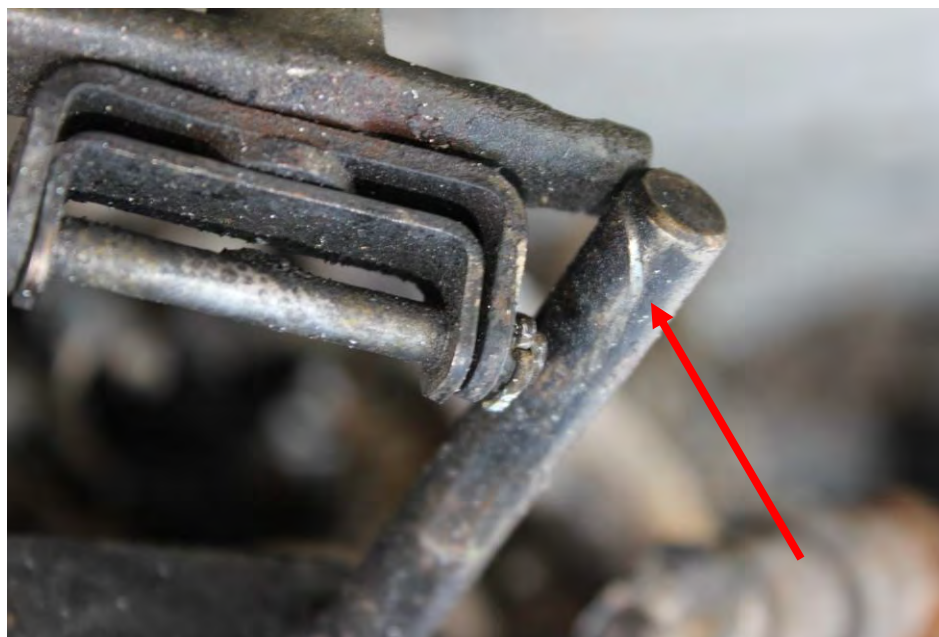
Photo No. 2

- 3.1 **External Condition:** The propeller shaft had been sectioned at the accident site to remove the propeller for examination (Ref. Photo No. 1). The propeller reversing lever was found above its respective guide pin that keeps the carbon block in the beta ring (Ref. Photos 1 to 3). There was a wear mark noted on the guide pin (Ref. Photo No. 2, red arrow). The four aircraft mounts were attached to their respective mount pads on the gas generator case but the rubber grommets were deteriorated from exposure to the post flight fire. The left hand exhaust stack was bent and the right hand exhaust stack and exhaust port flange were missing. The engine exhibited staining and some burnt regions from exposure to the post flight fire (Ref. Photos No. 4 to 7). The engine data plate showed the serial number was PC-E 32138 (Ref. Photo No. 8). The power section data plate showed the serial number was 32138 (Ref. Photo No. 9). Photo No. 10 shows an overview of the removed propeller.

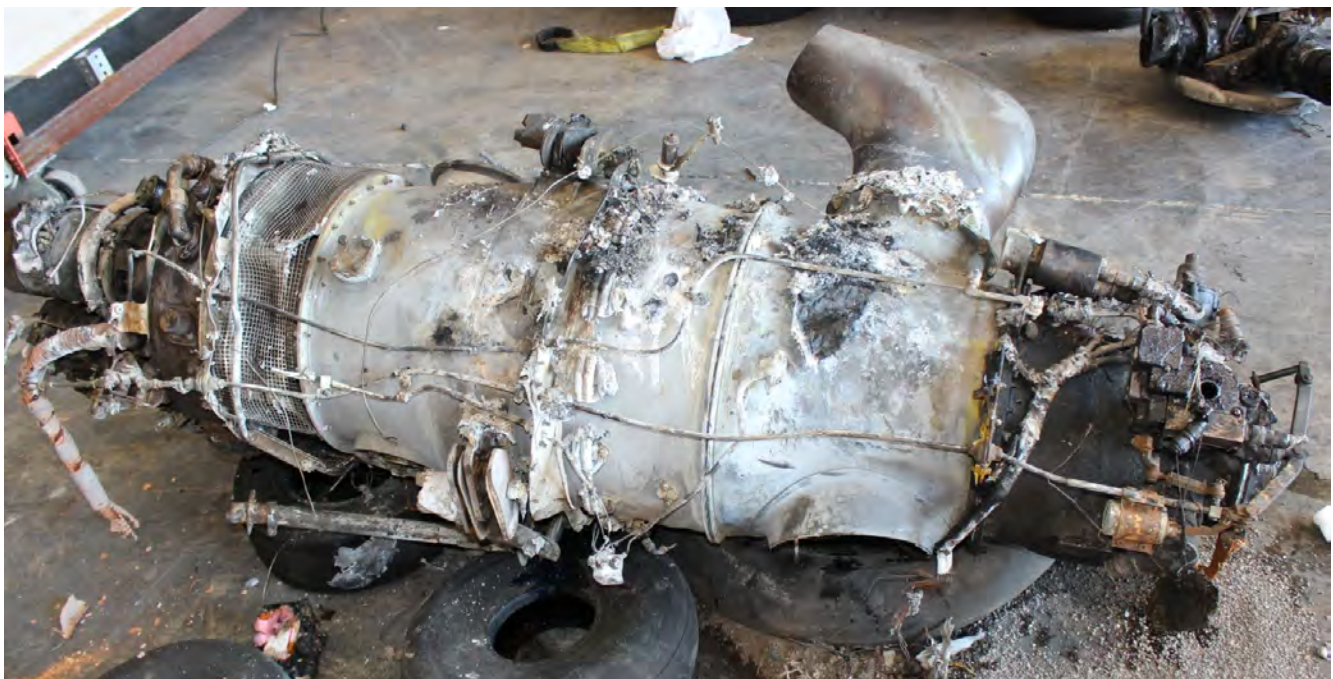
Photo No. 4, Right hand side of the engine

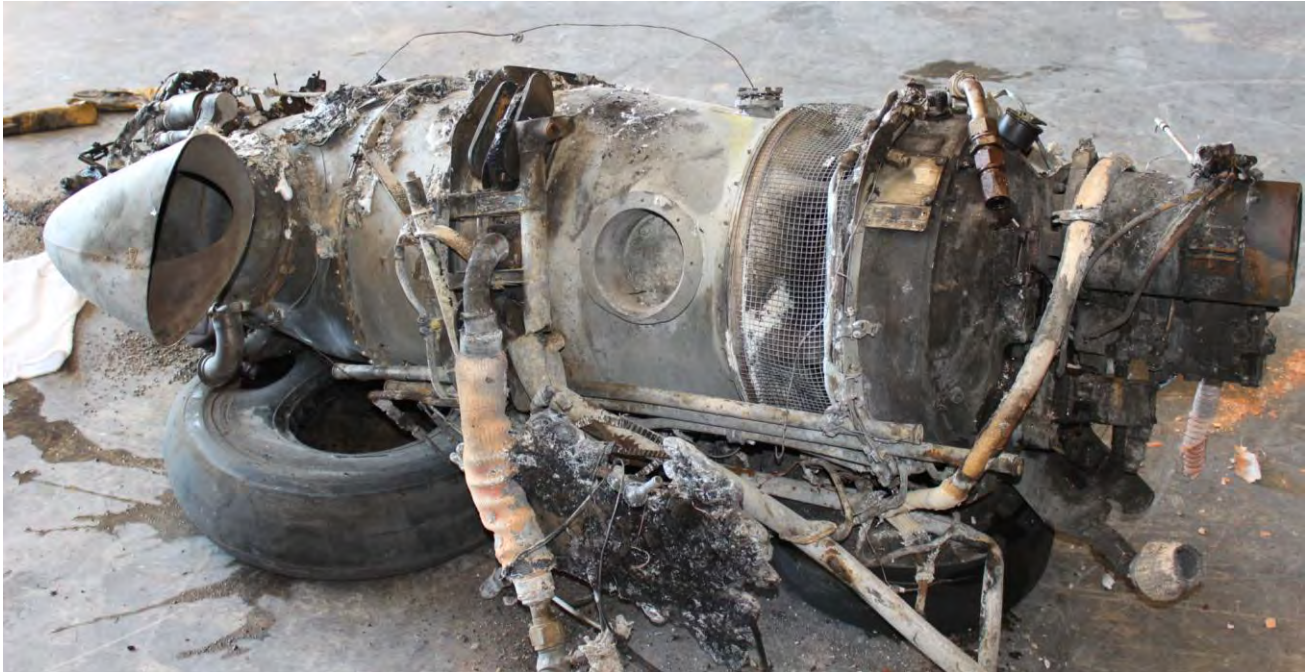
Photo No. 5, Left hand side of the engine

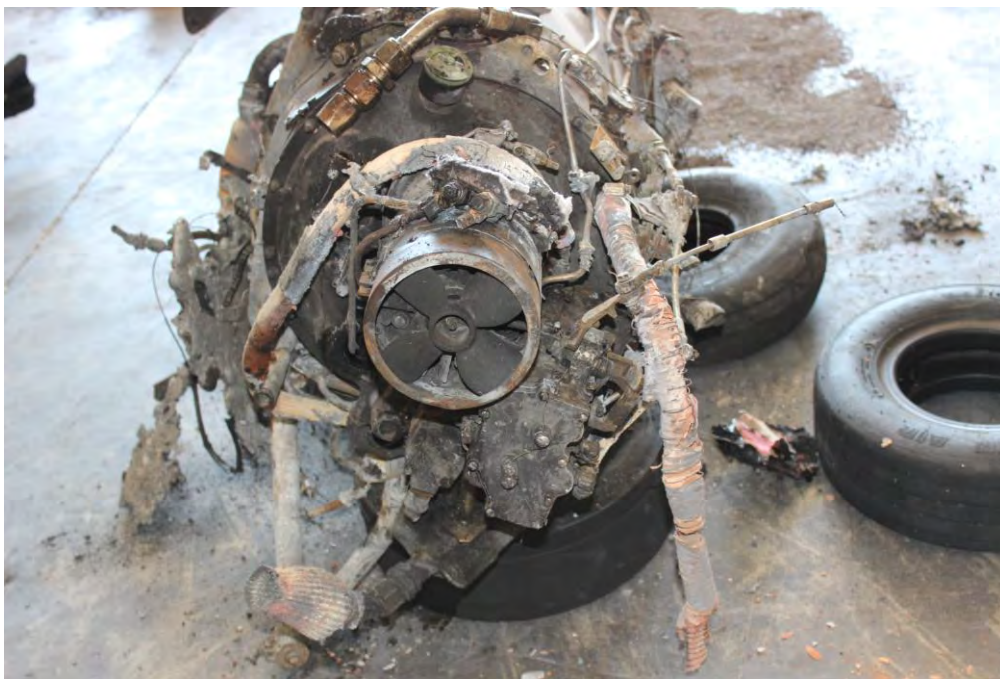
Photo No. 6, Rear of the engine

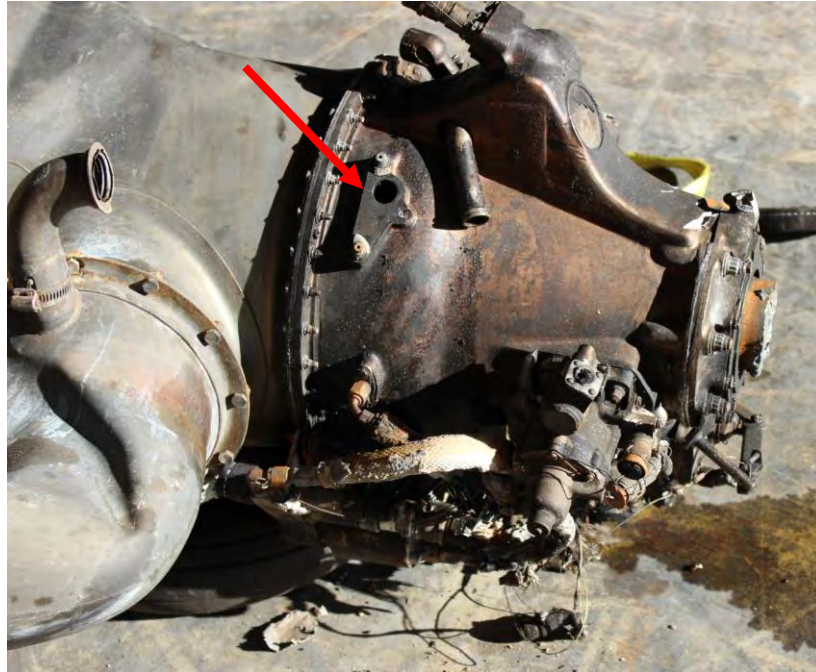
Photo No. 11

**Reduction Gearbox:** The gearbox housing was discoloured from exposure to the post flight fire and the scavenge oil tube boss was missing (Ref. Photo No. 11, red arrow). Several of the gearbox to the exhaust duct mating flange bolts were missing (Ref. Photo No. 12, red oval).

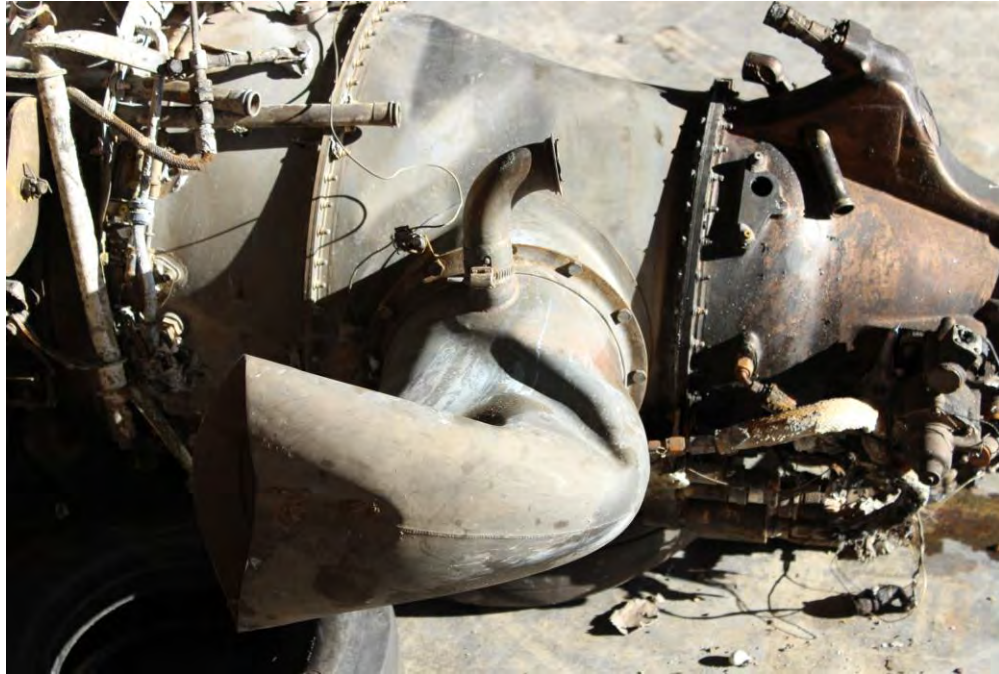
Photo No. 14

**Exhaust Duct:** The duct was bent and buckled mainly adjacent to the right exhaust port (Ref. Photo No. 13). The left exhaust stack was bent and buckled and the flange for the right hand exhaust stack was missing (Ref. Photos No. 14 & 15). Several of the exhaust duct to the gas generator mating flange bolts were missing (Ref. Photo No. 15, red oval).

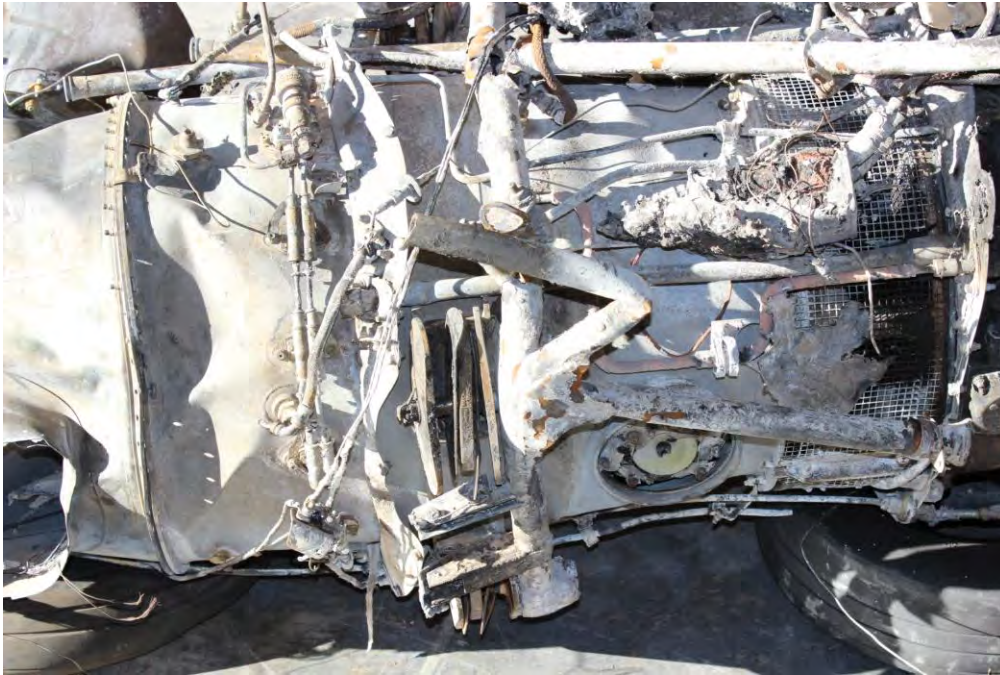
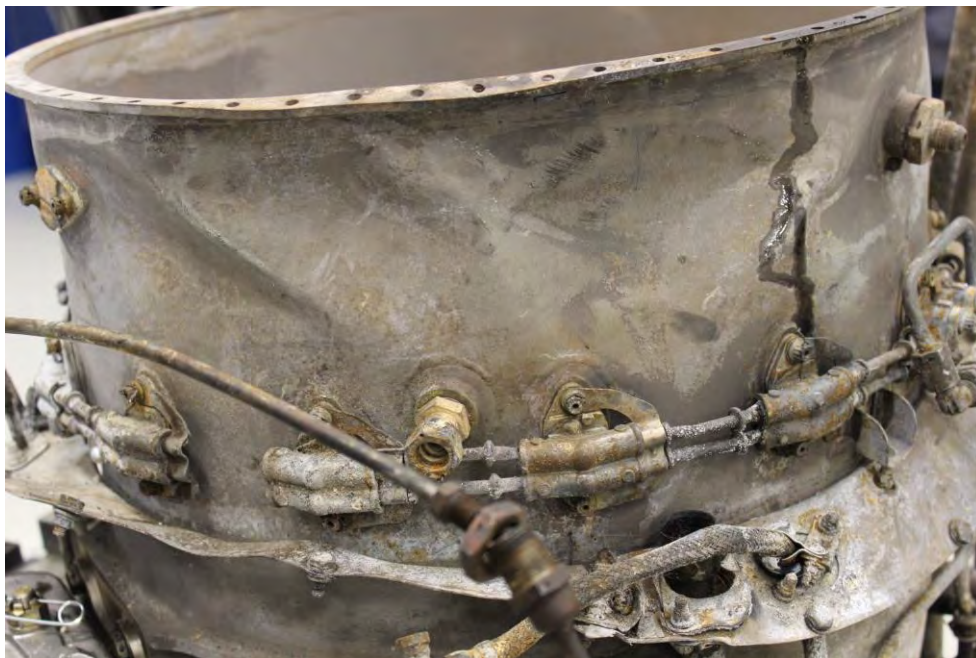
**Gas Generator Case:** The case exhibited compressional bending and external heat distress from exposure to the post flight fire (Ref. Photos No. 16 & 17).

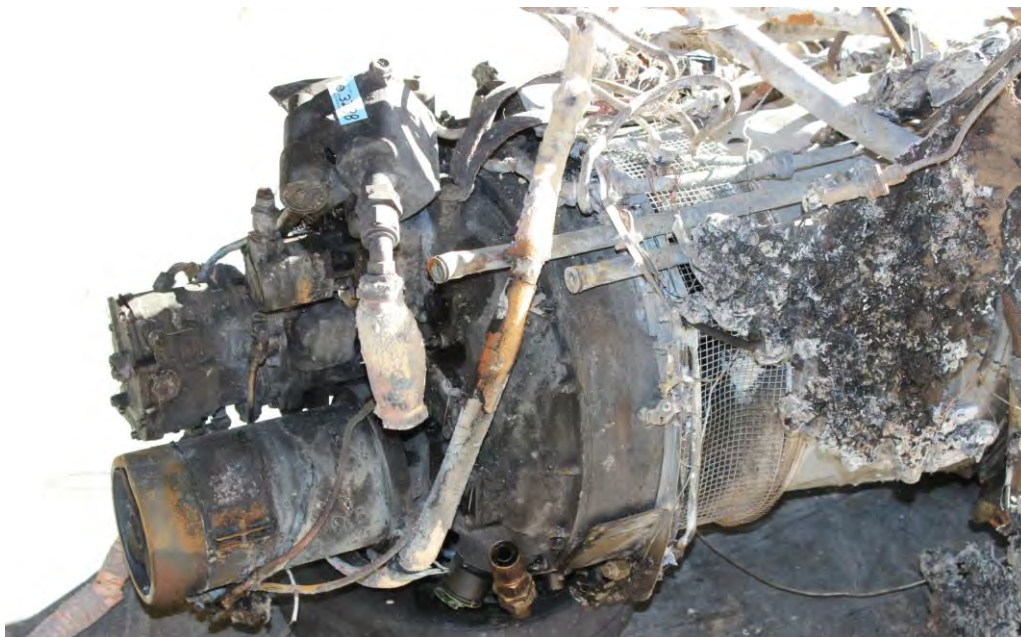
Photo No. 19

**Accessory Gearbox:** The exterior of the gearbox was blackened (Ref. Photos No. 18 & 19) and the inlet case exhibited some localized burning from exposure to the post flight fire (Ref. Photo No. 20).

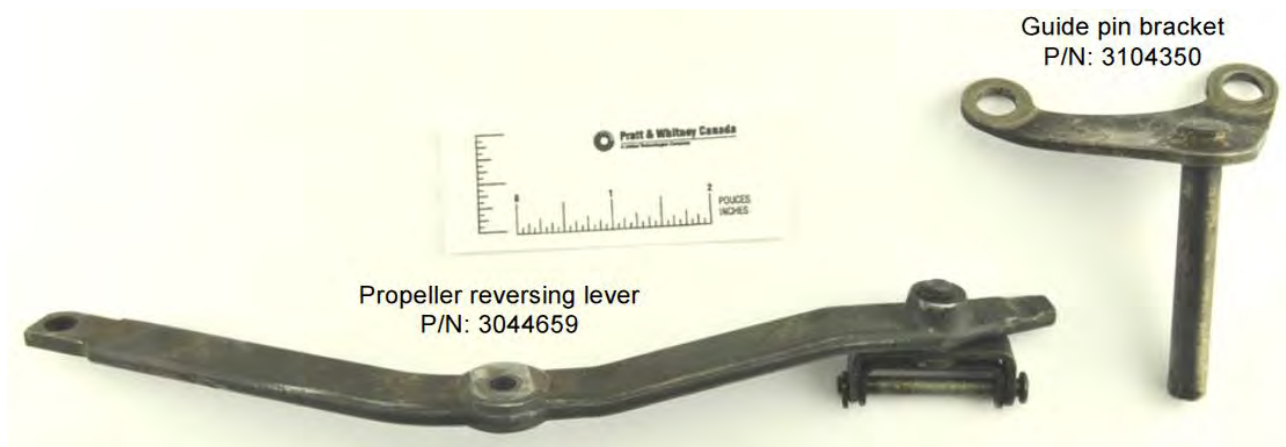
Photo No. 22 shows an overview of the propeller reversing lever and guide pin. The guide pin exhibited a shiny contact wear area indicating the propeller reversing lever had recently been properly seated against the underside of the pin (Ref. Photo No. 23, green rectangle). The width of the worn area corresponds to the width of the lever. An intermittent wear mark extending from the normal contact area to the forward tip of the pin indicating that the lever slid forcefully in a non-continuous manner from the underside of the pin across to its top side (Ref. Photo No. 23, red arrows). Scanning Electron Microscope (SEM)-Energy Dispersive X-Ray Spectrometry (EDS) analysis of debris recovered from the red dash outlined region in Photo No. 23 were Cadmium which suggest the debris originated from the Cadmium plated lever. A magnified view of the top side of the pin shows a continuous wear mark suggesting a continuous sliding movement (Ref. Photo No. 24, red arrows).

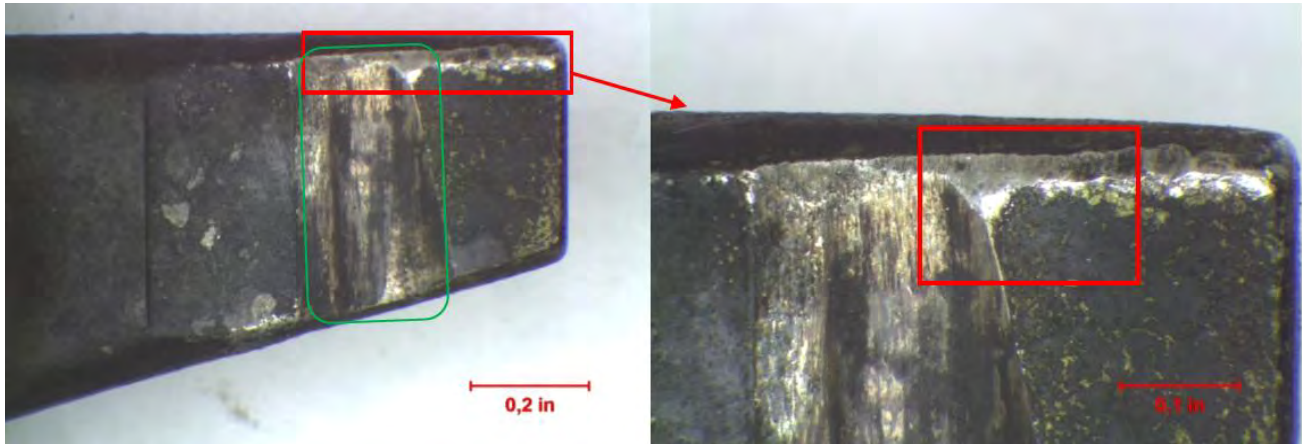
Photo No. 25

A magnified view of the top end of the propeller reversing lever shows evidence of contact damage on the aft edge of the lever (Ref. Photo No. 25). The shiny appearance of the damage indicates that the damage is recent and is consistent with the lever being forcefully moved from the underside of the pin across to its top side, most likely during the propeller removal process. In the normal position, this side of the lever is in contact with the underside of the guide pin. The groove depicted by the green rectangle, that exhibits a shiny appearance, indicates that it was seated correctly (Ref. Photo No. 25). A magnified view of the underside of the lever end shows slight contact damage along the edge (Ref. Photo No. 26, red rectangle). This portion of the lever was contacting the guide pin after the propeller was removed. The shiny appearance of the damage indicates that the damage is recent and was most likely created during the removal of the propeller. SEM/EDS analysis confirmed the presence of the Cadmium plated on the lever.

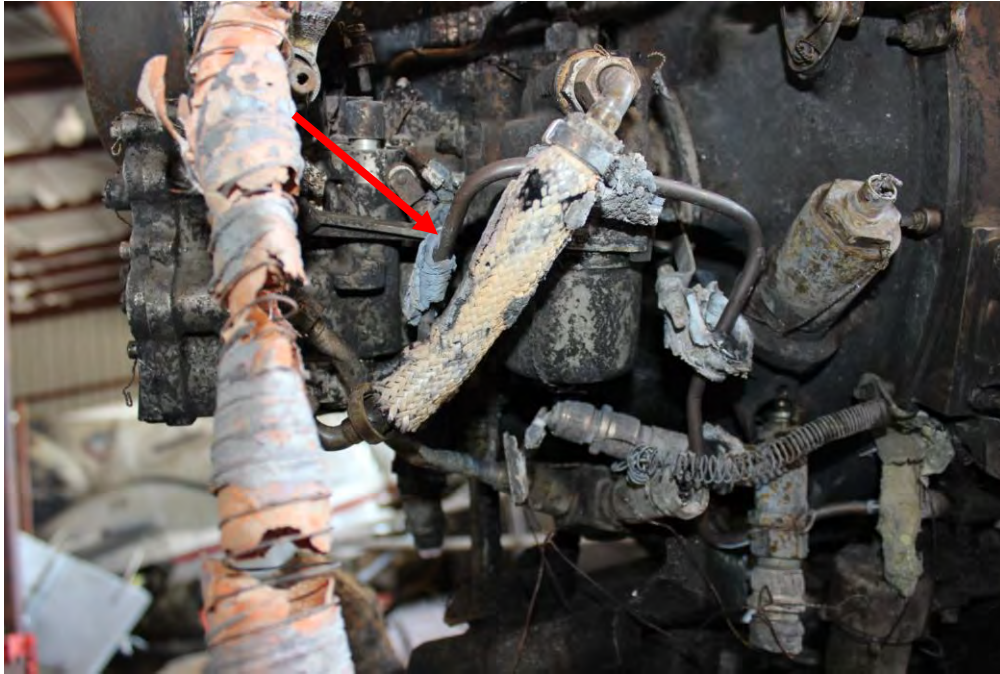
Photo No. 28

**Compressor Discharge Air (P3):** The tubes and filter housing were in place and secure. The thermal insulation was deteriorated from heat exposure from the post flight fire (Ref. Photo No. 28, red arrow). The P-3 air filter was discoloured, most likely due to heat exposure from the post flight fire (Ref. Photo No. 29).

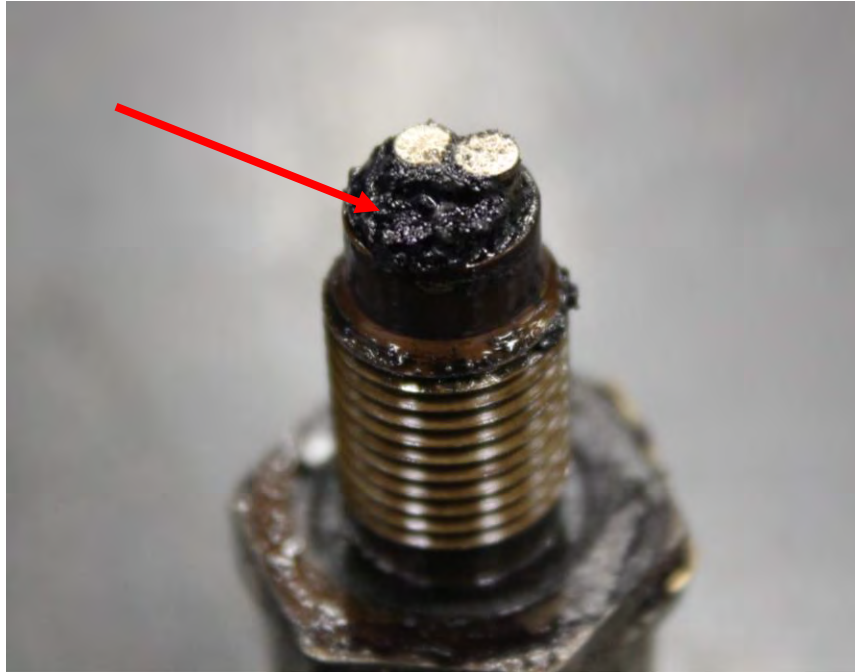
Photo No. 31

**Reduction Gearbox Chip Detector:** The detector was in place and secure. The potting material around the magnetic poles was swelled from heat exposure from the post flight fire (Ref. Photo No. 31, red arrow).

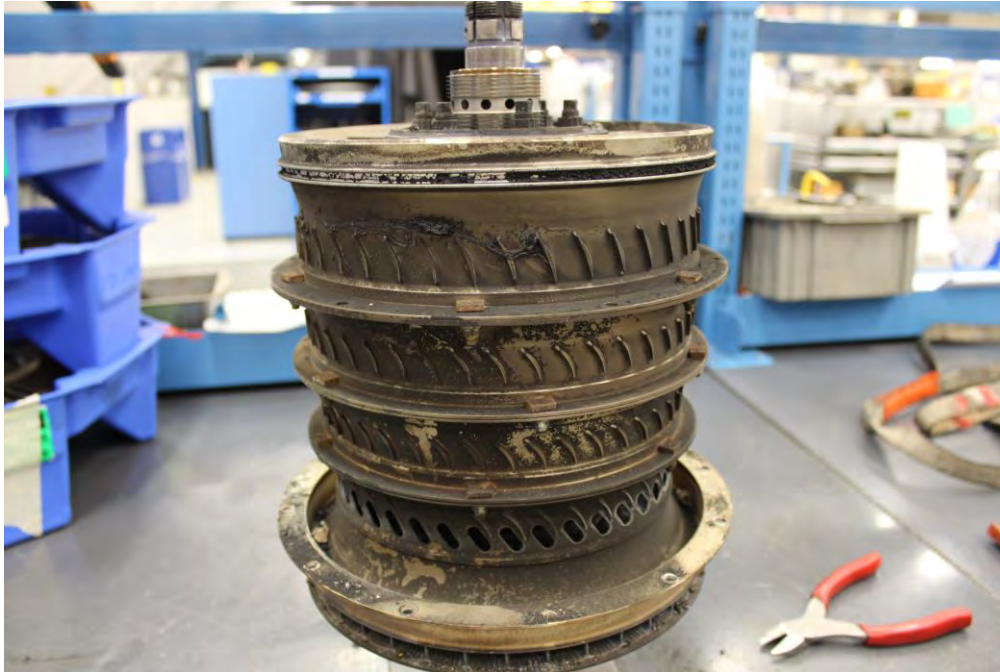
Photo No. 34

**Compressor 1<sup>st</sup>, 2<sup>nd</sup>, 3<sup>rd</sup>, and 4<sup>th</sup> Stage Discs and Blades:** The compressor was not capable of rotation. The compressor was removed from the gas generator case and placed on the disassembly fixture (Ref. Photo No. 34). The compressor stators were manipulated by hand and the stators rotated freely on the stationary rotor components. The 1<sup>st</sup> stage was coated with soot and debris (Ref. Photo No. 35 to 38). The blades had rubbed with the 1<sup>st</sup> stage shroud. Portions of the 2<sup>nd</sup> stage blade were viewed through the 1<sup>st</sup> stage stator airfoils and were coated with soot. The 2<sup>nd</sup>, 3<sup>rd</sup>, and 4<sup>th</sup> stage discs and blades were not accessed for the purposes of this investigation.

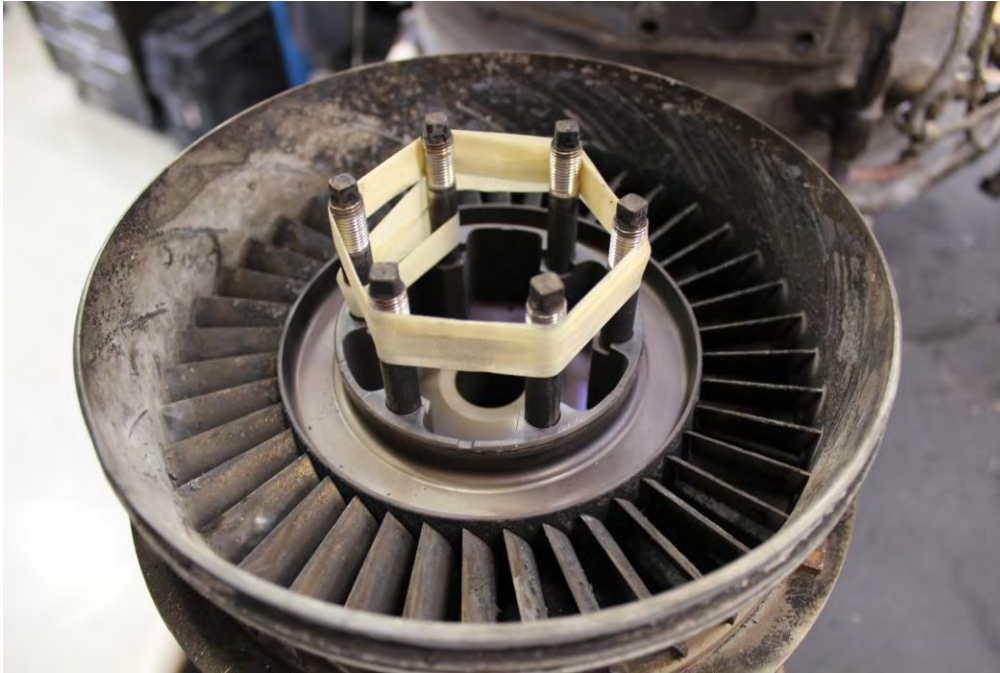
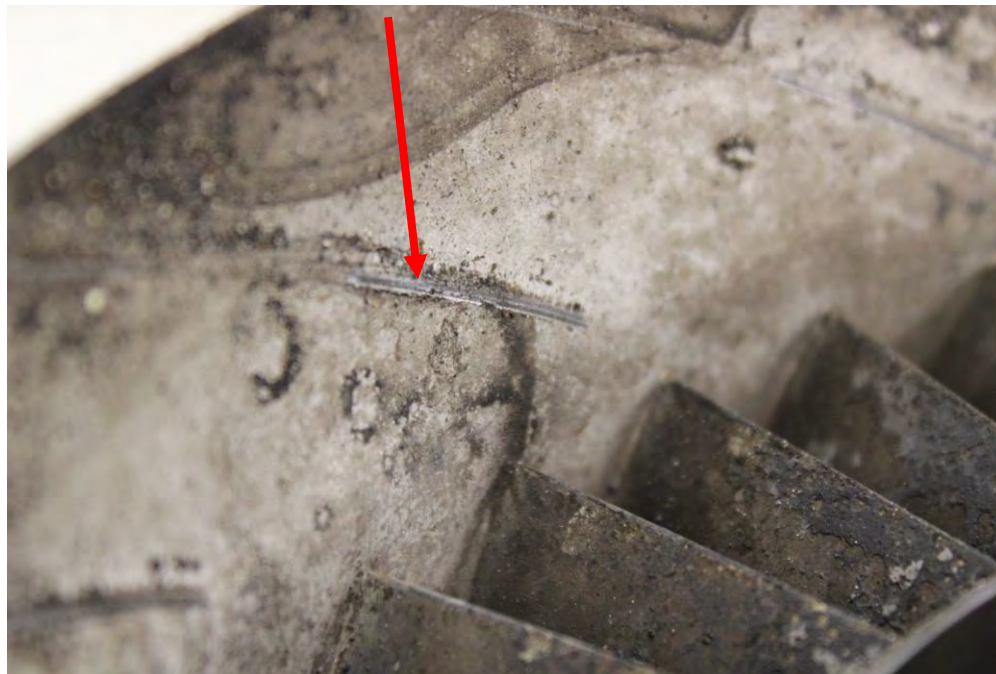
**Compressor 1<sup>st</sup>, 2<sup>nd</sup>, 3<sup>rd</sup>, and 4<sup>th</sup> Stage Stators and Shrouds:** The 1<sup>st</sup> stage shroud and stator exhibited soot and debris build-up (Ref. Photos No. 39 & 40). Static imprint marks from the 1<sup>st</sup> stage blades were evident in the shrouds protective coating (Ref. Photo No. 40, red arrow). The imprint marks may be attributed to thermal expansion of the stator/rotor during the post flight fire or may have occurred during recovery of the engine. The 2<sup>nd</sup>, 3<sup>rd</sup>, and 4<sup>th</sup> stage shrouds and stators were not accessed for the purposes of this investigation.

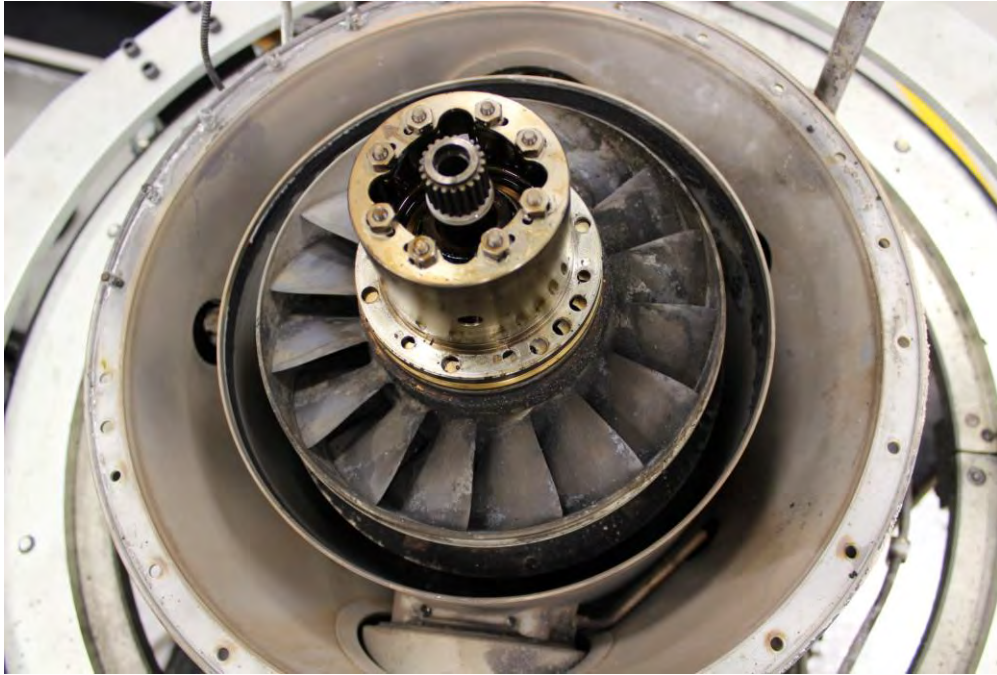
Photo No. 43

**No. 1 Bearing and Airseals:** The No. 1 bearing was oil wetted and rotated freely (Ref. Photo No. 43). The airseals did not exhibit any distress (Ref. Photo No. 44).

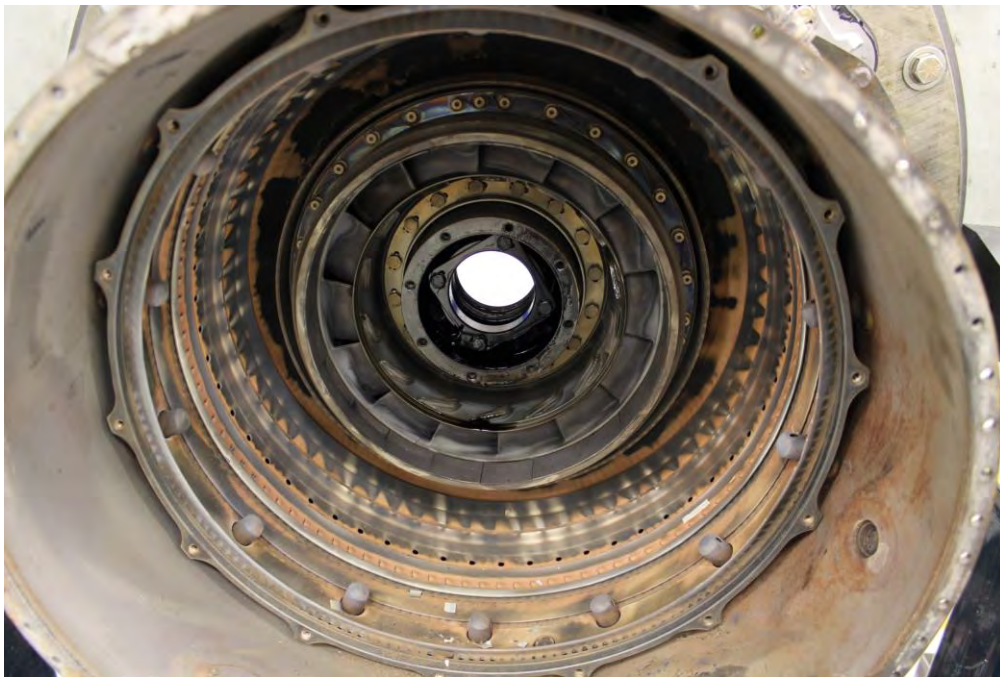
Photo No. 47

**Combustion Chamber Liner:** The liners exhibited some operational staining but did not exhibit any anomalies (Ref. Photo No. 46, inner liner & 47, outer liner). The outer liner was not removed for the purposes of this investigation.

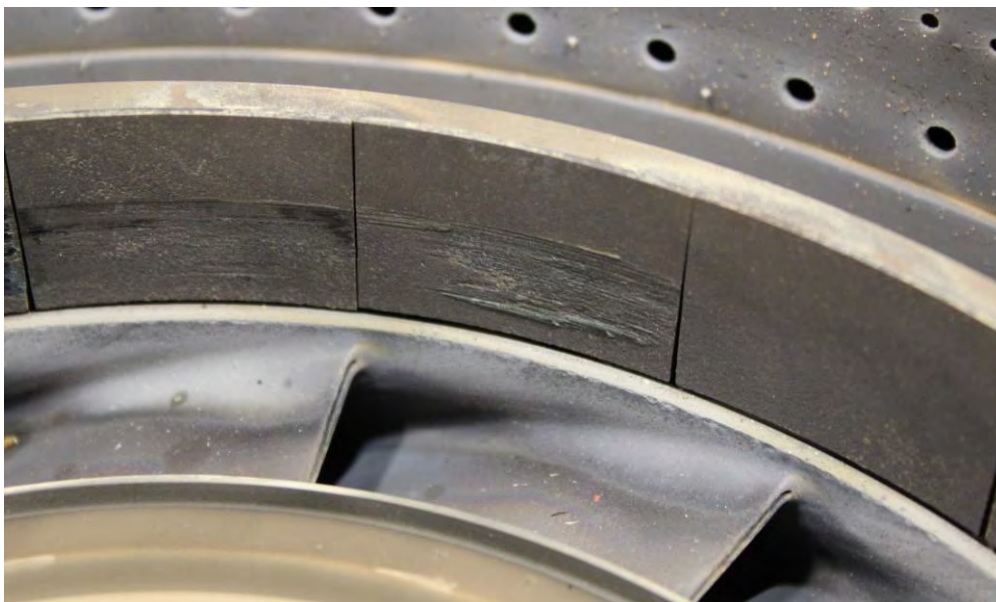
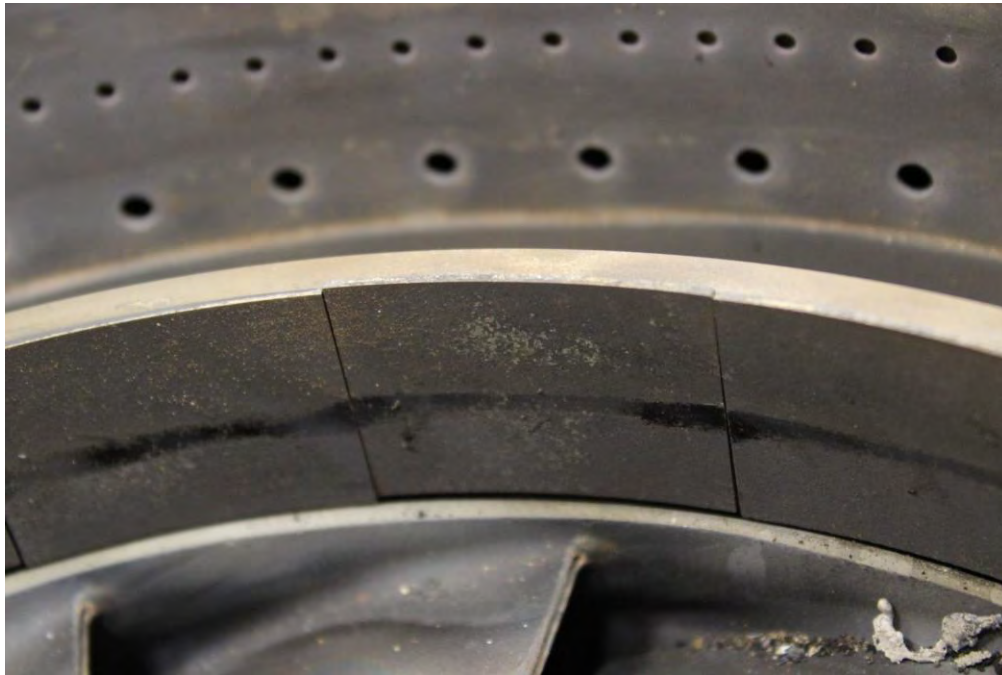
**Compressor Turbine Shroud:** The shroud was exhibited rubs from the 10 to 11 and from the 3 to 6 o'clock positions (Ref. Photos No. 50 & 51).

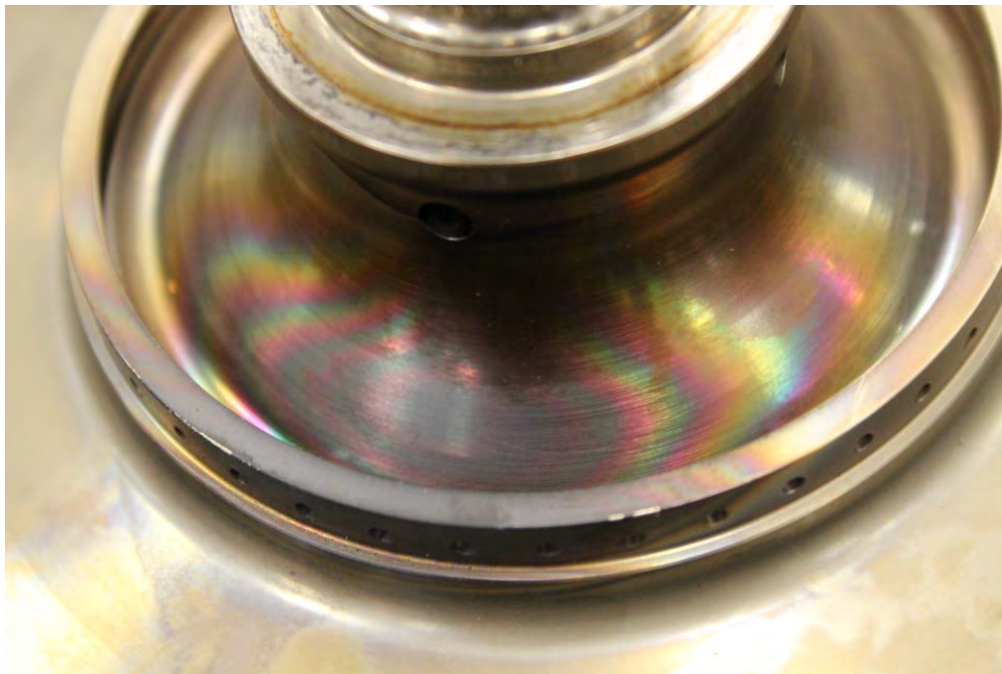
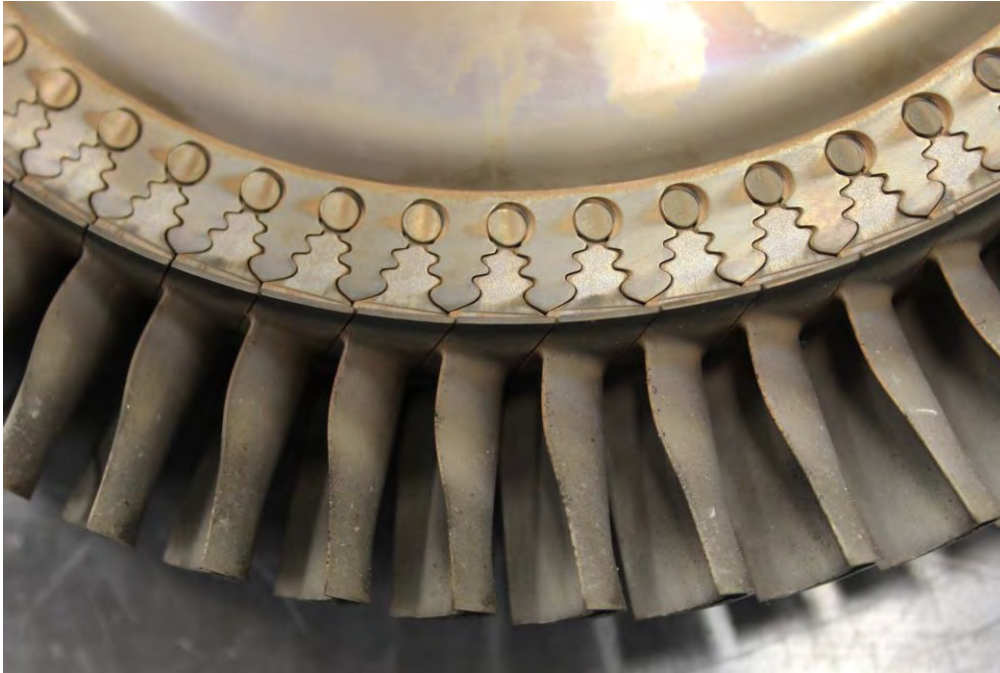
**Compressor Turbine:** The upstream side of the disc exhibited a stained region from a post impact oil leak from the turbine air seals (Ref. Photo No. 52 & 53). Some staining was evident on the upstream side of the blades (Ref. Photo No. 54). Several of the rivet flares and blade root firtrrees exhibited rub marks on the downstream side from contact the 1<sup>st</sup> stage power turbine vane and baffle (Ref. Photo's No. 55 to 57, red ovals). Staining was also evident on the downstream side of the blades (Ref. Photo No. 58). The blade tips were rubbed from contact with the compressor turbine shroud (Ref. Photo No. 59).

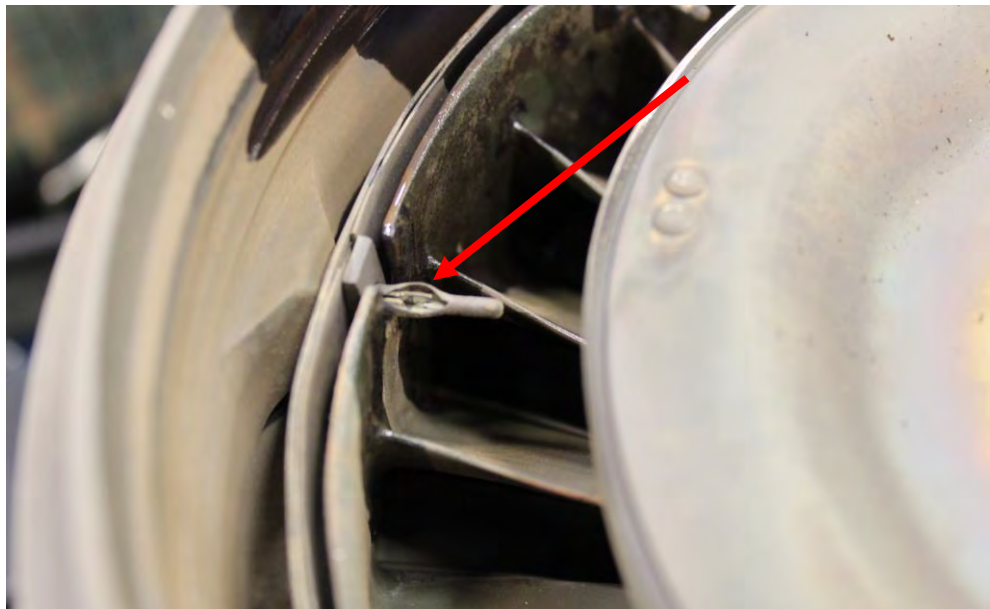
Photo No. 61

**ITT Probes, Busbar, and Harness:** All of the probes were in place and secure (Ref. Photo No. 60). One probe exhibited a burned region, most likely from operation (Ref. Photos No. 61, red arrow). The harness and busbar were in place and secure.

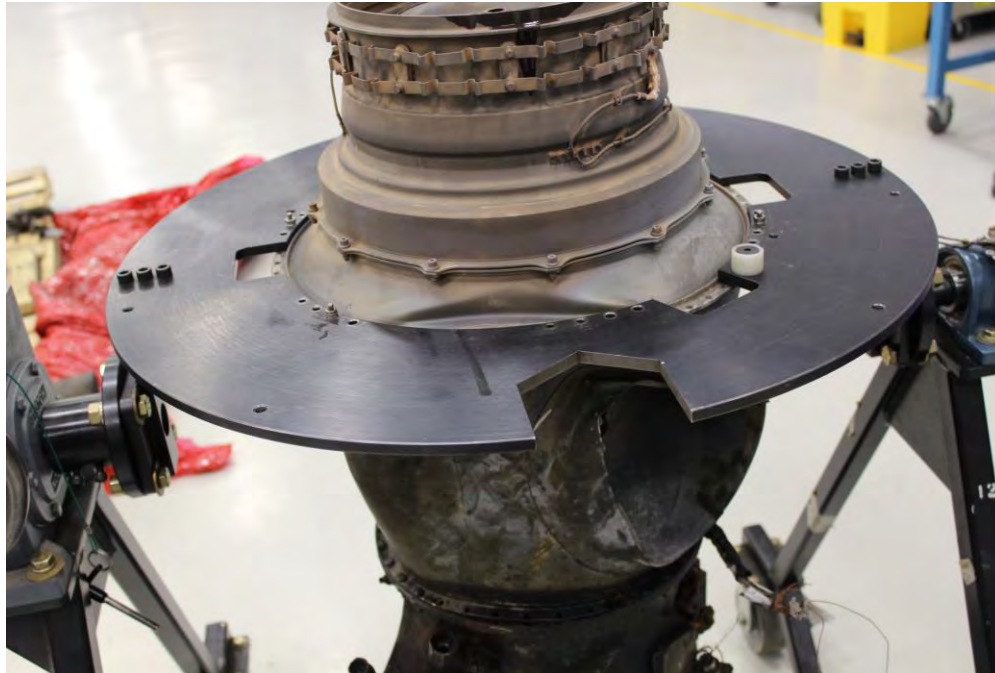
Photo No. 62

**Power Turbine Housing:** The housing was displaced rearward from its mating flange with the exhaust duct (Ref. Photos No. 62 & 63, red arrow).

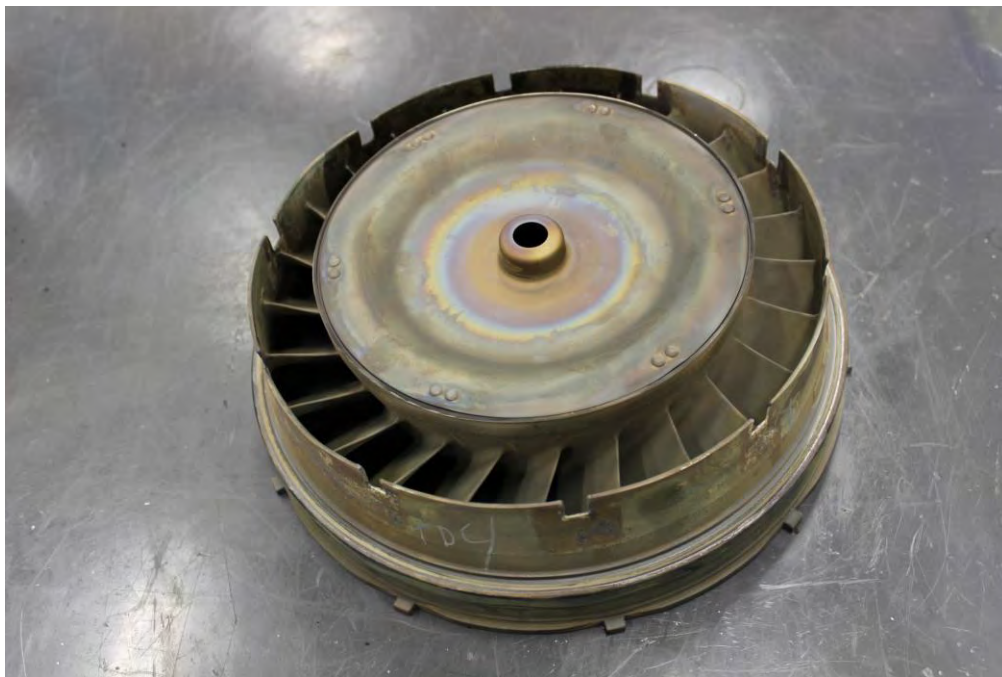
Photo No. 64, upstream side

**1<sup>st</sup> Stage Power Turbine Guide Vane Ring and Interstage Baffle:** The centre of the baffle on the upstream side exhibited a rub from contact with the bolt bore of the compressor turbine disc (Ref. Photos No. 64 & 65, red arrow). The inner rim of the vane and the retention rivets for the baffle were rubbed from contact with the compressor turbine blades and retention rivets (Ref. Photos No. 65 & 66, blue arrows). The outer rim exhibited a crack extending from one of the thermocouple slots to the face (Ref. Photo No. 67). The airfoils were covered with soot, soil, and oil coated (Ref. Photo No. 68).

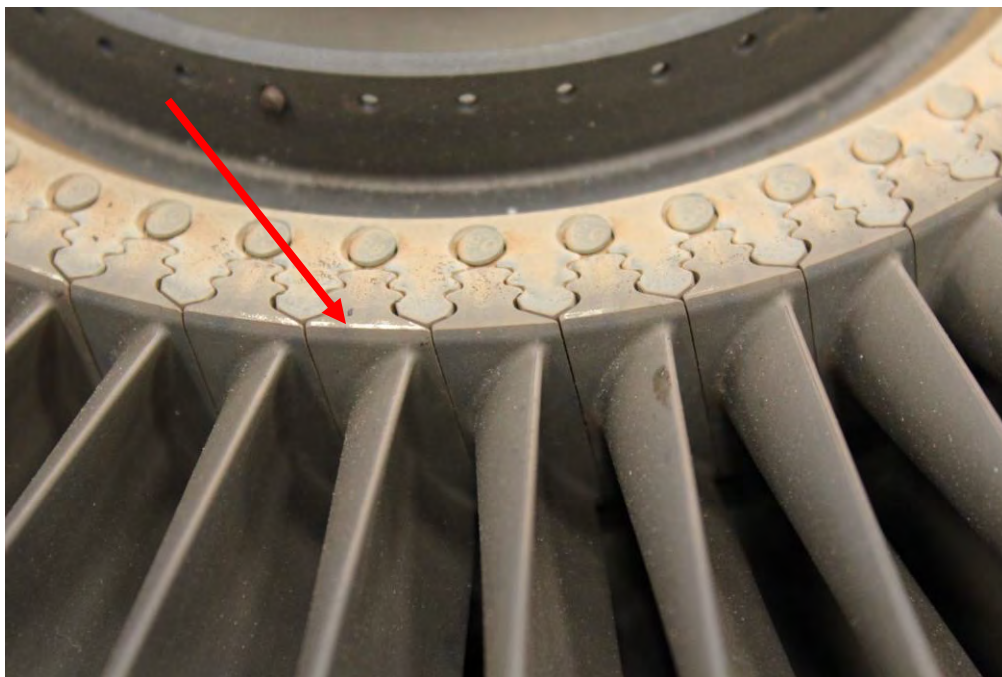
Photo No. 71, upstream side

**1<sup>st</sup> Stage Power Turbine:** The turbine was oil wetted in two regions, covered with soot and debris (Ref. Photos No. 70 & 72). A light rub was noted on upstream side of a few of the blade roots (Ref. Photo No. 71, red arrow). The blade tips exhibited rubs from contact with their respective shroud (Ref. Photo No. 73).

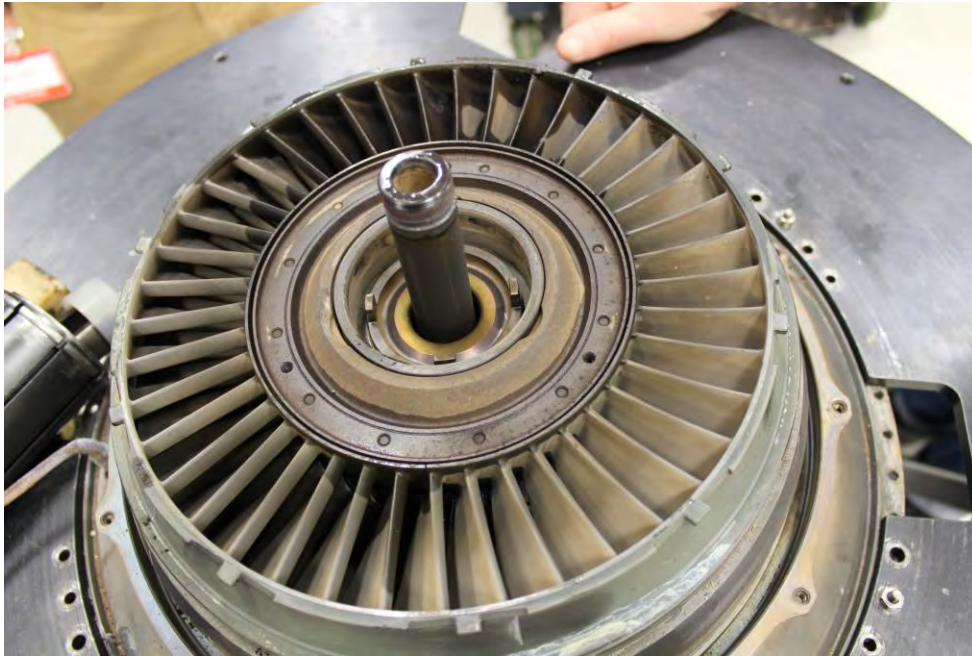
Photo No. 74, upstream side

**2<sup>nd</sup> Stage Power Turbine Guide Vane Ring:** The vane was partially oil wetted and covered with soot and debris (Ref. Photos No. 74 & 75).

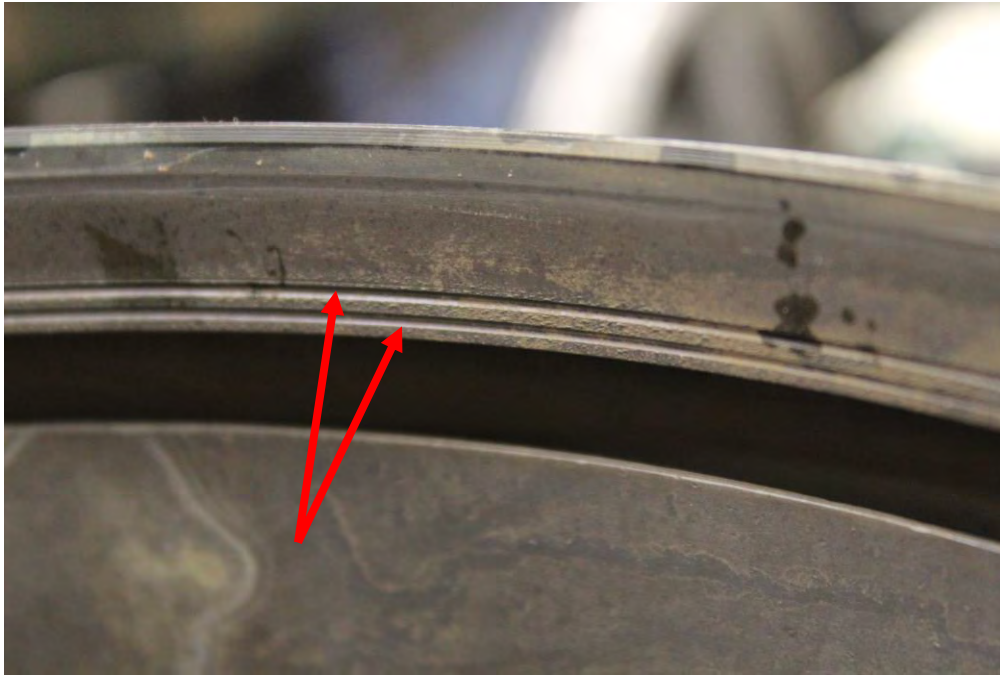
Photo No. 76

**2<sup>nd</sup> Stage Power Turbine Shroud:** The shroud exhibited rubs from contact with the 2<sup>nd</sup> stage turbine blade tips (Ref. Photo No. 76, red arrows).

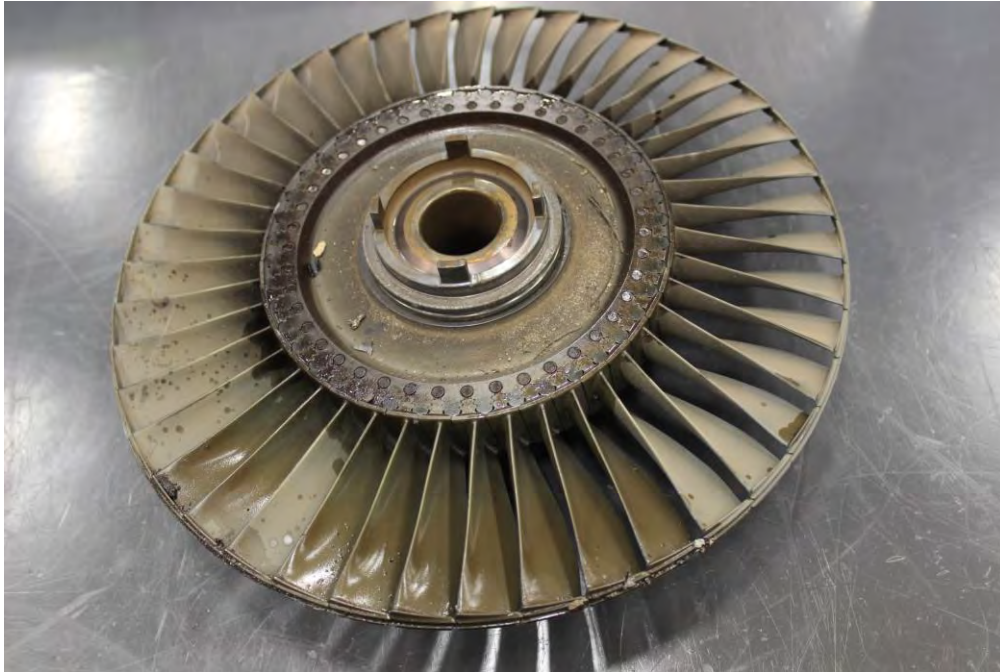
Photo No. 77, upstream side

**2<sup>nd</sup> Stage Power Turbine:** The vane was partially oil wetted and covered with soot and debris (Ref. Photos No. 77 & 78). The blade tips had rubbed against their respective shroud (Ref. Photo No. 79, red arrows).

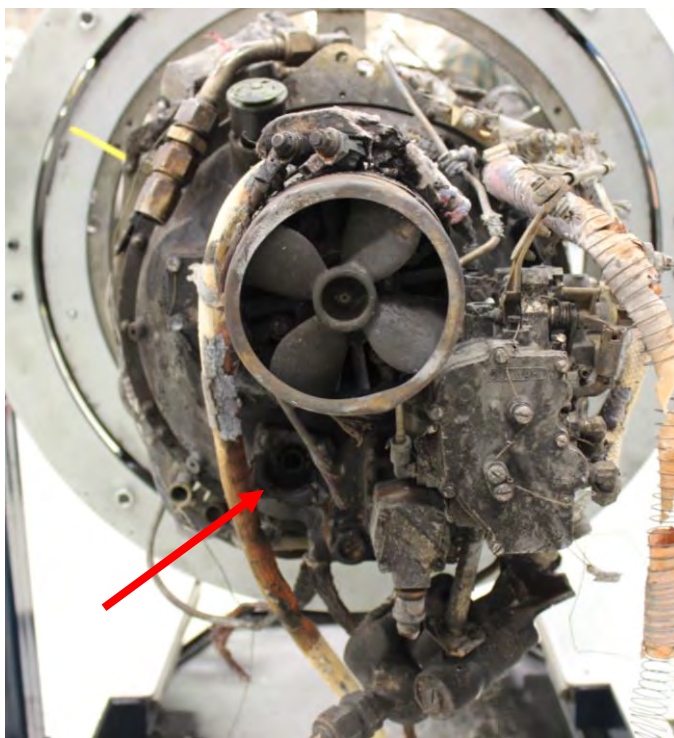
Photo No. 83

3.2.5 **Accessory Gearbox:** The gearbox was not disassembled for the purposes of this investigation. The gearbox manually rotated and rotated freely. The external scavenge oil pumps were missing from their mounting pad on the gearbox (Ref. Photo No. 83, red arrow). Portions of the accessory gearbox diaphragm and the inlet case exhibited staining above the residual oil level in the tank (Ref. Photo No. 84). The staining is a residue from the heated residual oil during the post flight fire.
