**Accident / Incident Report**

**Report No.: 15-012**

**Brinks Inc.  
Beech 1900C, Aircraft Reg. No. YV1674  
Miami, Florida, USA  
February 11, 2015  
PT6A-65B  
L/H S/N 32138  
R/H S/N G/G 32040 P/S 32065**

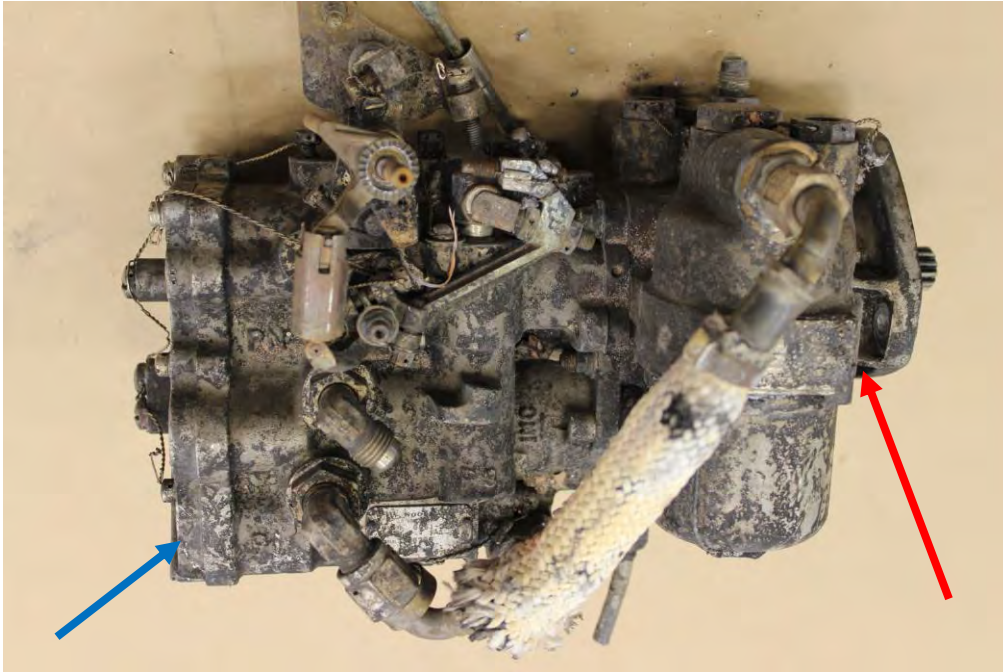
Photo No. 88

**Fuel Pump:** The pump was in place and secure (Ref. Photo No. 88, red arrow). The exterior of the pump was soot covered and exhibited some thermal damage from the post flight fire. The pump was forwarded to P&WC's Accessories Investigation for additional analysis. Due to the damage to the pump a functional test could not be performed. The outlet filter bowl required cutting to access the filter element. The filter was burned, blackened, and deteriorated due to heat exposure (Ref. Photo No. 89). The pump was disassembled. There was no evidence of cavitation of the gear pockets, on the gears or on the bearings. The packings and external fittings were heat-damaged. There were no defects or damage evident that would have prevented normal pump operation prior to the event.

**Fuel Control Unit:** The unit was in place and secure. The exterior of the unit was blackened with some heat distortion noted from the post flight fire (Ref. photo No. 88, blue arrow). A section of the airframe cable was attached to the fuel condition lever. The unit was forwarded to P&WC's Accessories Investigation for additional analysis. The power and condition levers could not be moved by hand. A functional test of the control was attempted, however it could not be performed due to fuel leaks. The unit was disassembled. The condition of many of the components showed damage due to heat exposure in the post flight fire. There were no defects or damage evident that would have prevented normal unit operation prior to the event.

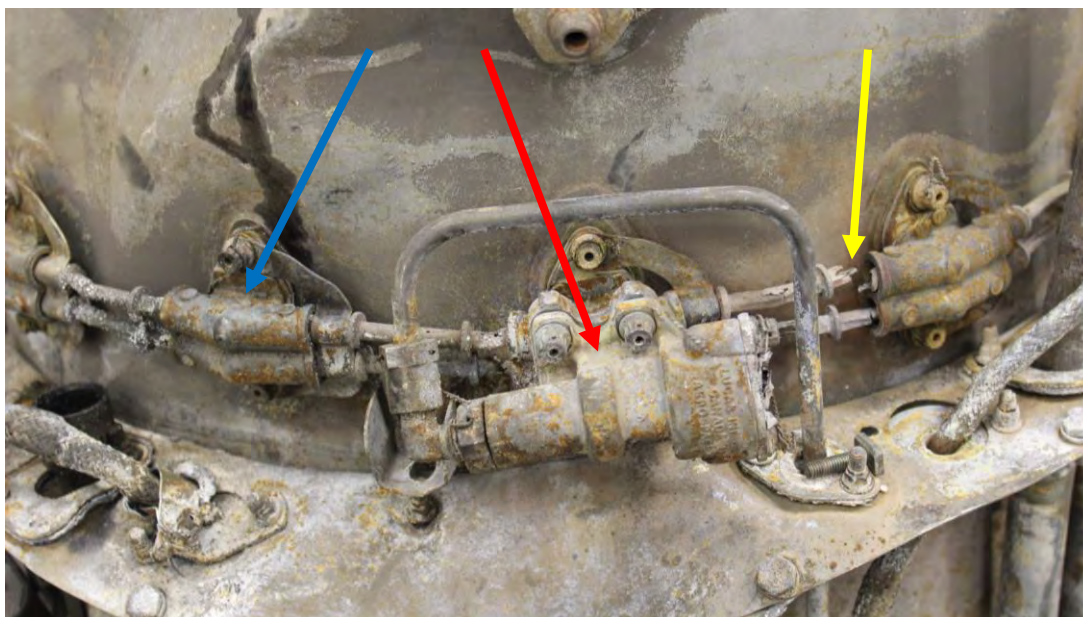
Photo No. 90

**Flow Divider:** The divider was in place and secure (Ref. Photo No. 90, red arrow). The exterior was discoloured with some melting evident from exposure to the post flight fire.

**Fuel Nozzles:** The nozzles were in place and secure (Ref. Photo No. 90, blue arrow). The nozzle exteriors were discoloured from exposure to the post flight fire. Several of the fuel nozzle transfer tubes were melted (Ref. Photo No. 90, yellow arrow).

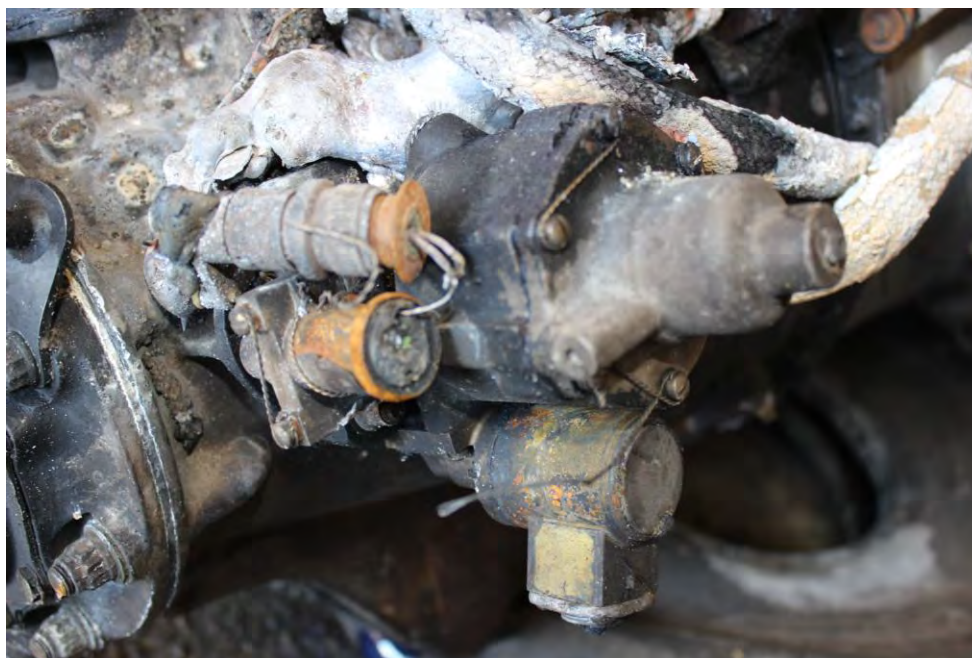
Photo No. 93

**Overspeed Governor:** The governor was in place and secure (Ref. Photo No. 93). The electrical connections were discoloured and melted from exposure to the post flight fire.

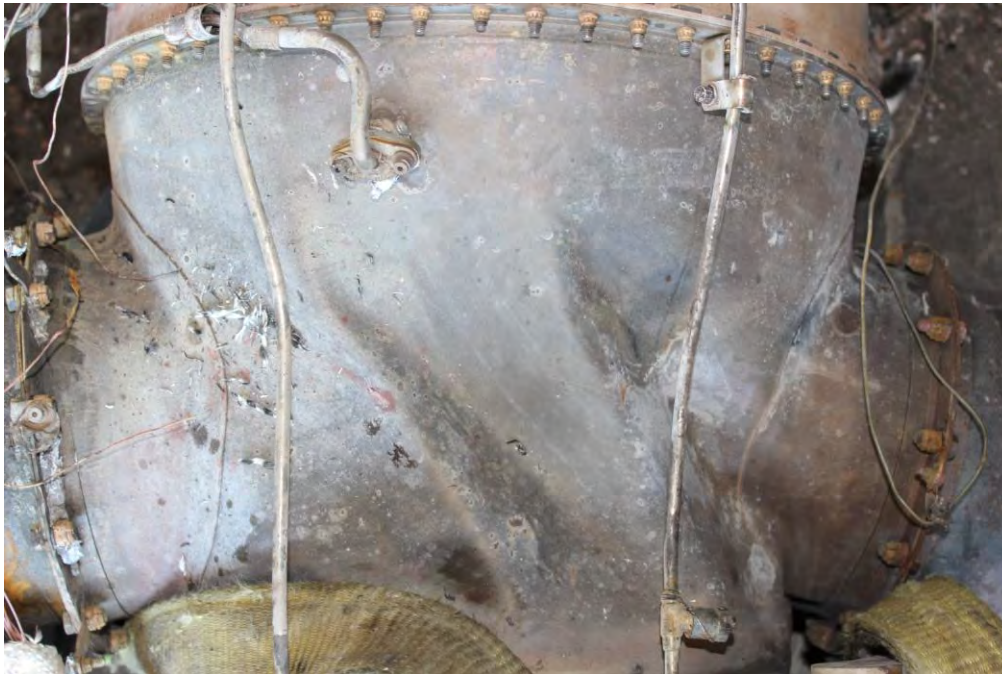
Photo No. 103

**Exhaust Duct:** The duct exhibited torsional bending, with a large portion of the exterior surface discoloured from exposure to the post flight fire (Ref. Photo No. 103).

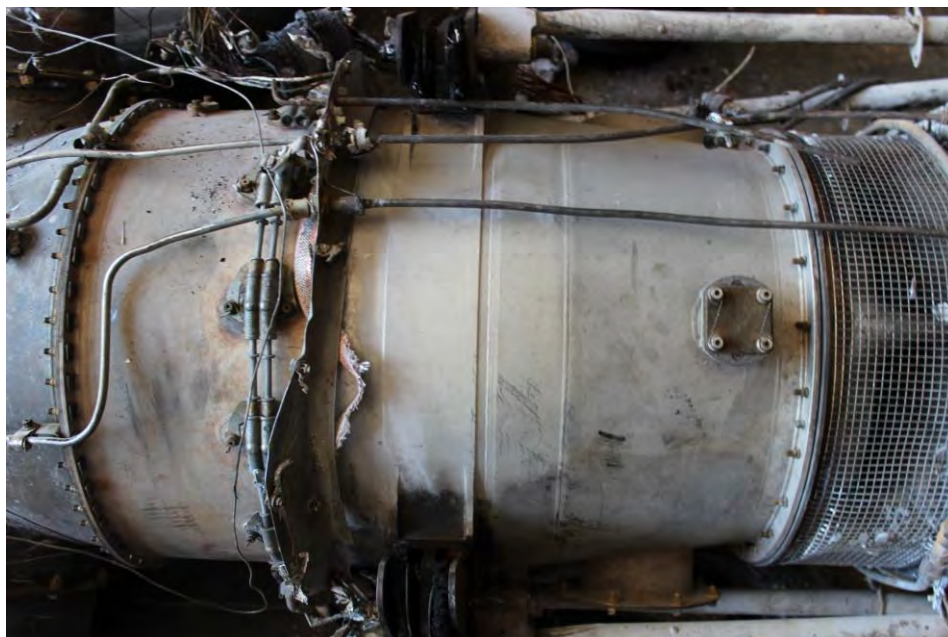
Photo No. 104

**Gas Generator Case:** The case was visually unremarkable except some discoloration from exposure to the post flight fire (Ref. Photo No. 104).

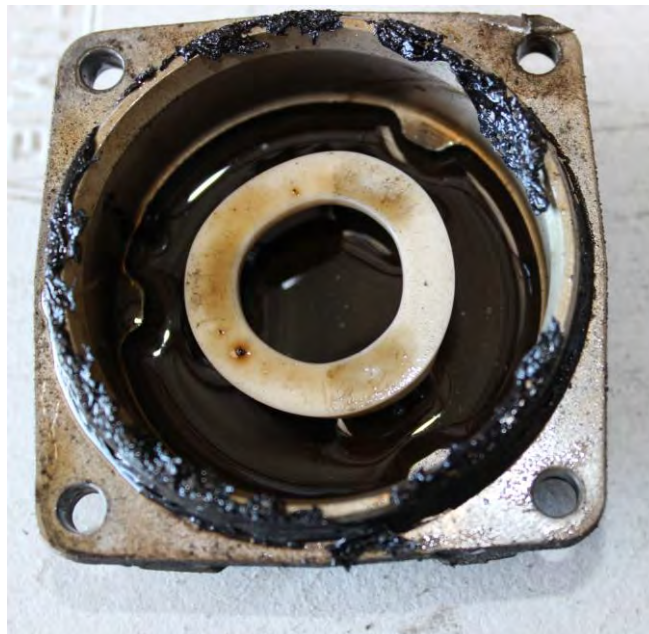
Photo No. 114

**Oil Filter:** The filter element exhibited no apparent contamination (Ref. Photo No. 113). The ends of the filter were loose due to heat exposure from the post flight fire affecting the adhesion compound. Partially solidified oil was adhered to the oil filter housing cover (Ref. Photo No. 114).

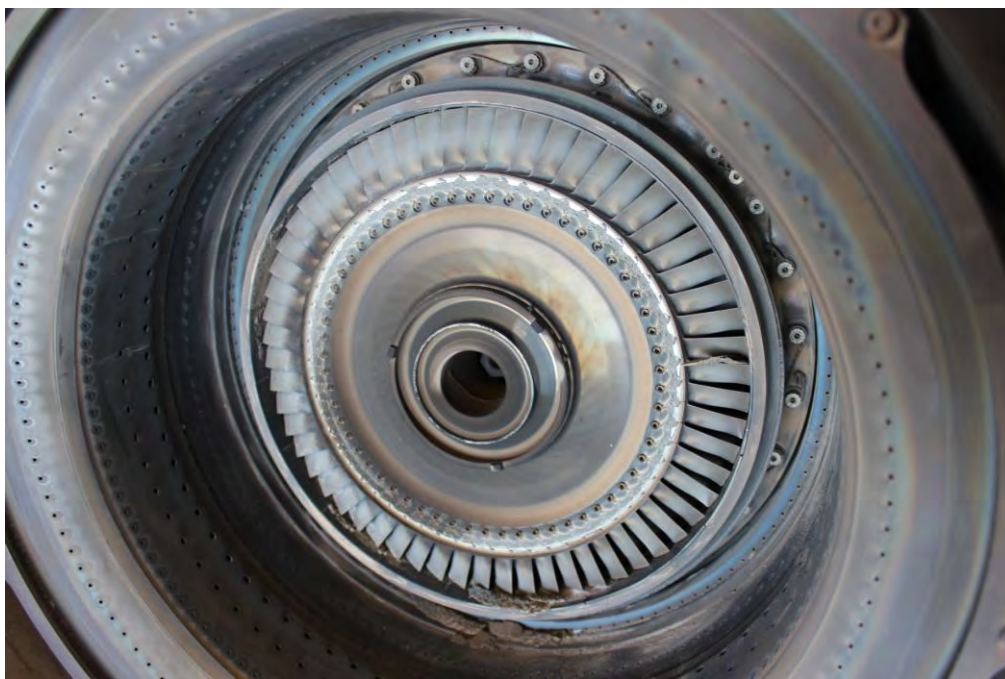
Photo No. 117, downstream side

**Compressor Turbine:** The downstream side of the disc lip adjacent to the retention bolt bore exhibited rubbing marks from contact with the 1<sup>st</sup> stage power turbine vane baffle (Ref. Photo No. 117 & 118, red arrow). The blade root region on the downstream face of the disc and blades displayed a rub from contact with the 1<sup>st</sup> stage power turbine vane (Ref. Photo No. 119 & 120). The upstream side of the disc was unremarkable (Ref. Photo No. 121). A build-up of sand and dirt was adhered to pressure side of the blades (Ref. Photo No. 122).

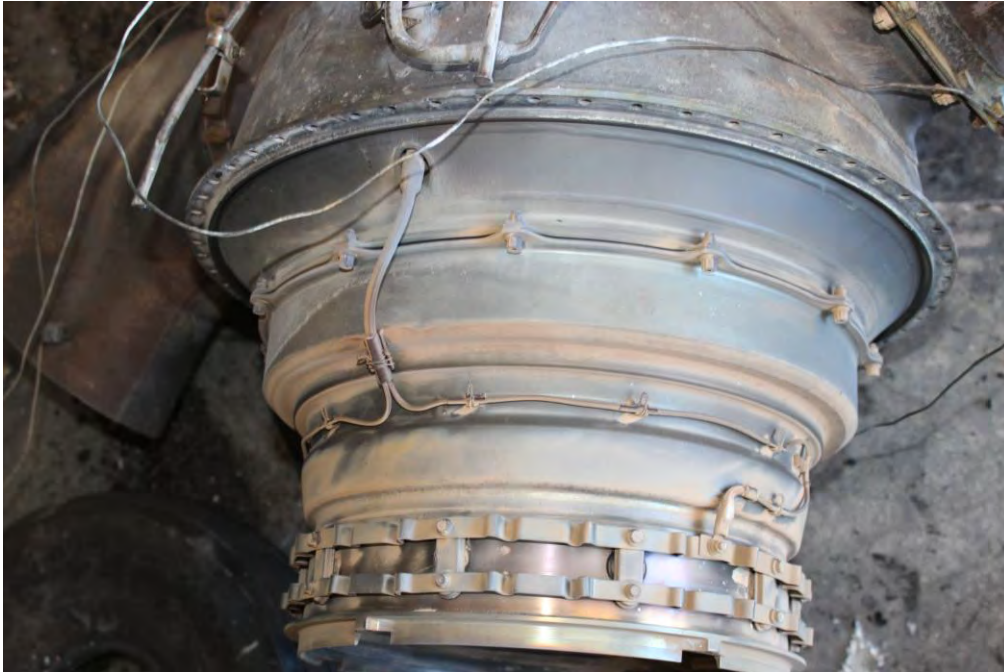
Photo No. 123

**Power Turbine Housing:** The housing was bent at the exhaust duct mating flange, a gap was evident adjacent to all of the housing retention bolts (Ref. Photos No. 123 & 124).

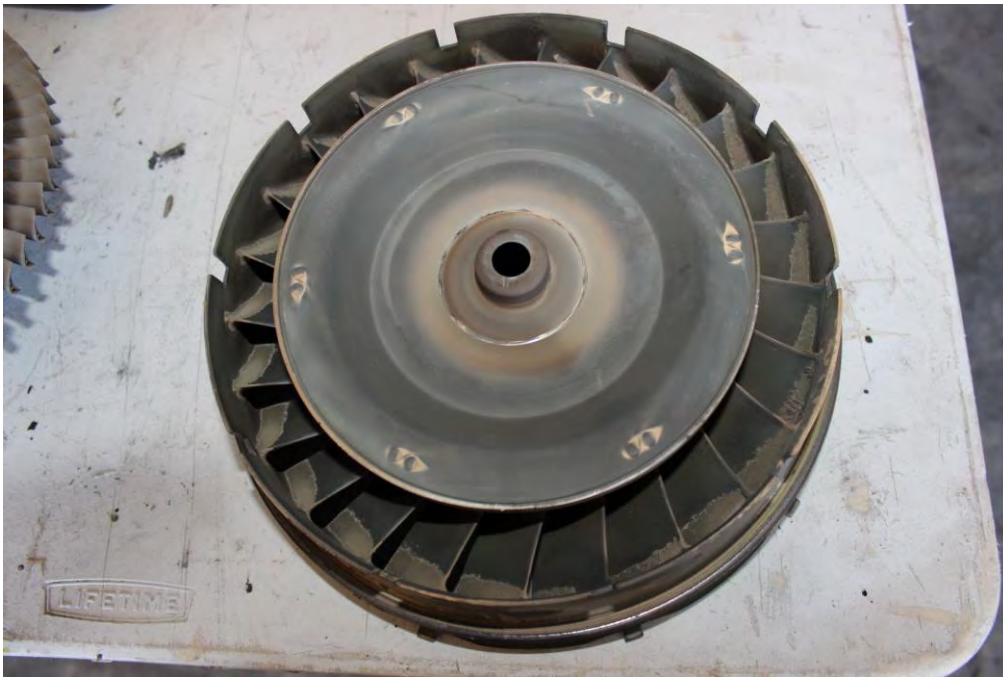
Photo No. 125, upstream side

**1<sup>st</sup> Stage Power Turbine Guide Vane Ring and Interstage Baffle:** The upstream side of the vane exhibited a rub on the inner wall and on the baffle from rubbing with the compressor turbine disc and blades (Ref. Photos No. 125 to 127, red arrows). The downstream side of the vane and baffle exhibited rubs from contact with the 1<sup>st</sup> stage power turbine disc and blades (Ref. Photos No. 128 & 129, red arrows).

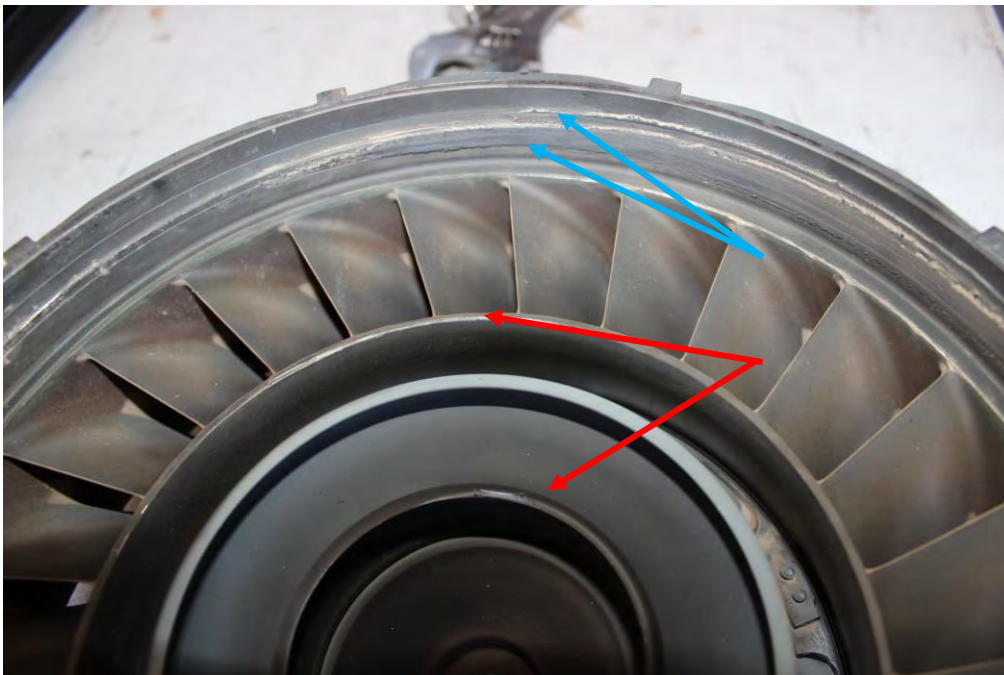
Photo No. 129, downstream side

**1<sup>st</sup> Stage Power Turbine Shroud:** Both lands of the shroud exhibited rubs and material build up from contact with the 1<sup>st</sup> stage power turbine blades tips (Ref. Photo No. 129, blue arrows).

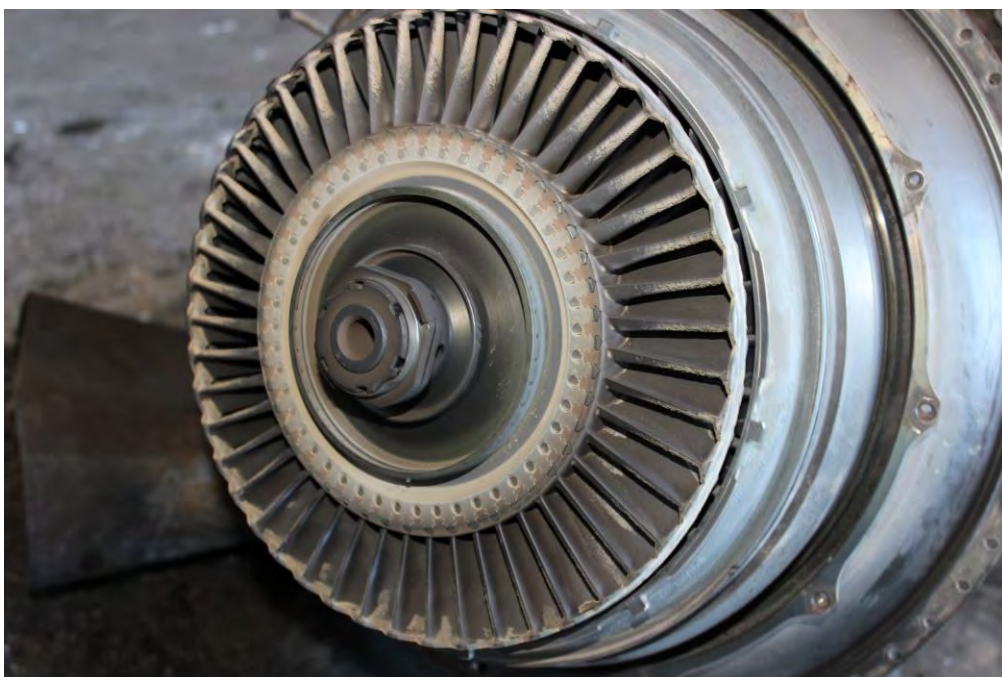
Photo No. 130

**1<sup>st</sup> Stage Power Turbine:** The turbine blades exhibited a tip rub on both lands from contact with the 1<sup>st</sup> stage power turbine shroud (Ref. Photos No. 130 & 131, red arrows). The upstream side of the disc had rubbed with the 1<sup>st</sup> stage power turbine vane baffle (Ref. Photo No. 132, red arrow). The upstream side of the disc face and blade roots had rubbed with the inner wall of the 1<sup>st</sup> stage power turbine vane (Ref. Photo No. 133, red arrow).

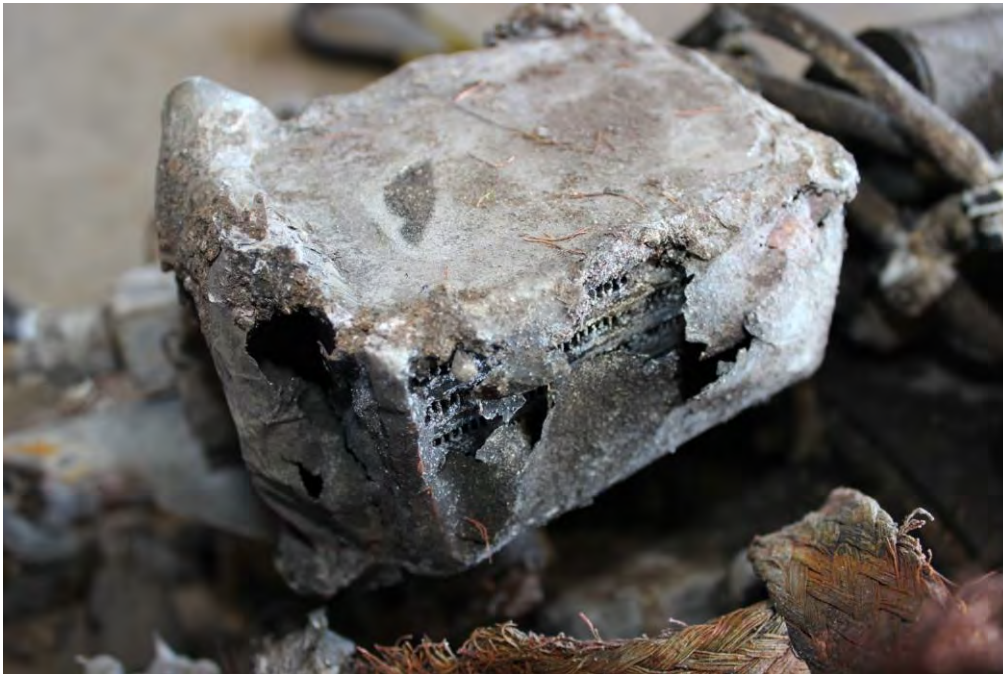
Photo No. 134

**Fuel Heater:** The heater was in place and secure. The housing exhibited heat distress from exposure to the post flight fire (Ref. Photo No. 134).
