**NATIONAL TRANSPORTATION SAFETY BOARD**  
**Office of Aviation Safety**  
**Washington, D.C. 20594**

**POWERPLANT GROUP CHAIRMAN'S FACTUAL REPORT**

**NTSB No: ERA15FA129**

Aircraft: Beechcraft 1900C, Venezuelan Registration Number YV1674

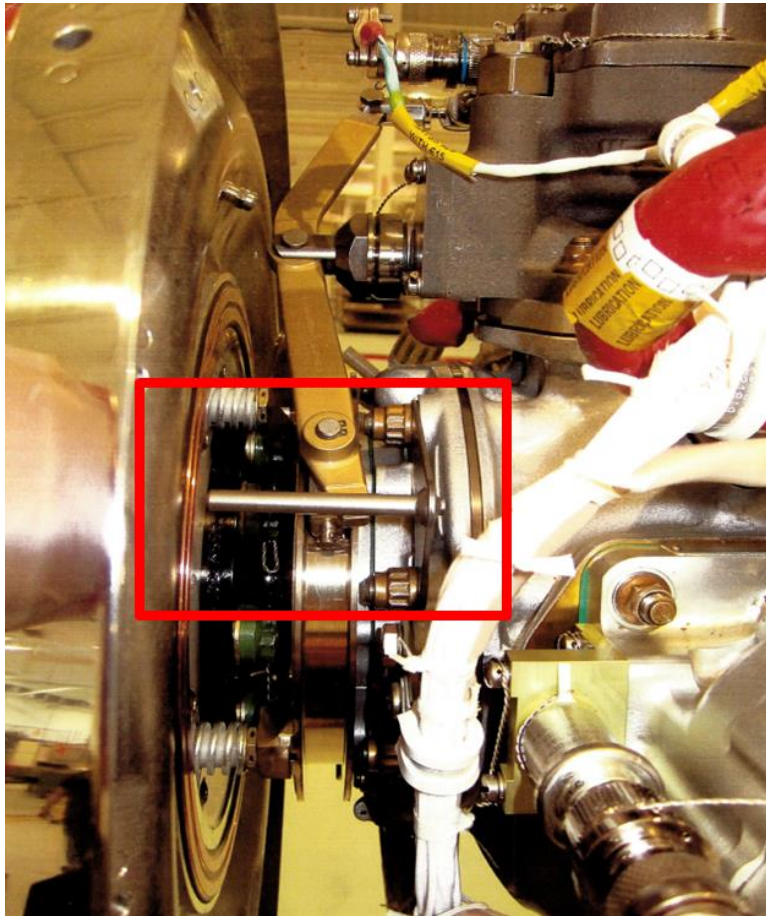
As noted earlier in this report, the propeller governor guide pin was found under the reversing lever arm as opposed above the reversing lever arm as called out in the aircraft maintenance manual. The guide pin acts as a mechanical stop that holds the beta carbon block in place and restricts motion of the lever arm for proper feedback of the propeller control system (**Photo 15**). By placing the guide pin below the lever arm the mechanical stop is no longer present and the linkage and carbon block could move in the radial direction. This radial movement could cause the beta valve to stroke outward (forward) and reduce propeller oil pressure and moves the propeller blades toward the feather position.

**Photo 15- Exemplar Photo With Guide Pin in the Correct Position**
