## NATIONAL TRANSPORTATION SAFETY BOARD

### Group Chairman's Factual Report

## AIR TRAFFIC CONTROL

ERA15FA313

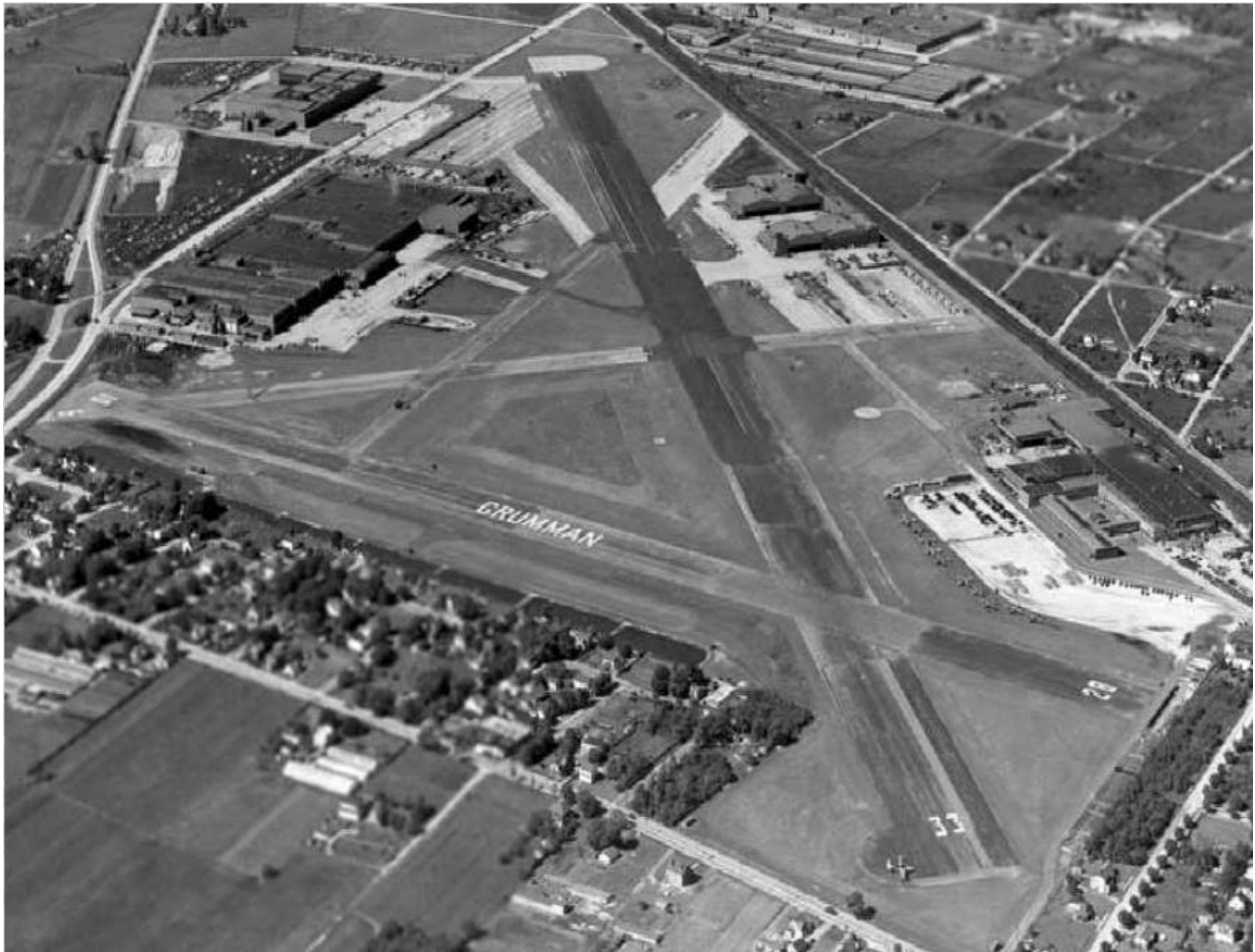
Bethpage was still shown on the radar map, the airport had been closed for a number of years and the runway area was occupied by buildings. The RVM depicted an airport that no longer existed. See figures 2 through 5.

Figure 2 – An undated photograph of the Bethpage airport from the 1940s. The accident site of N5946C was near the top center of this photograph.

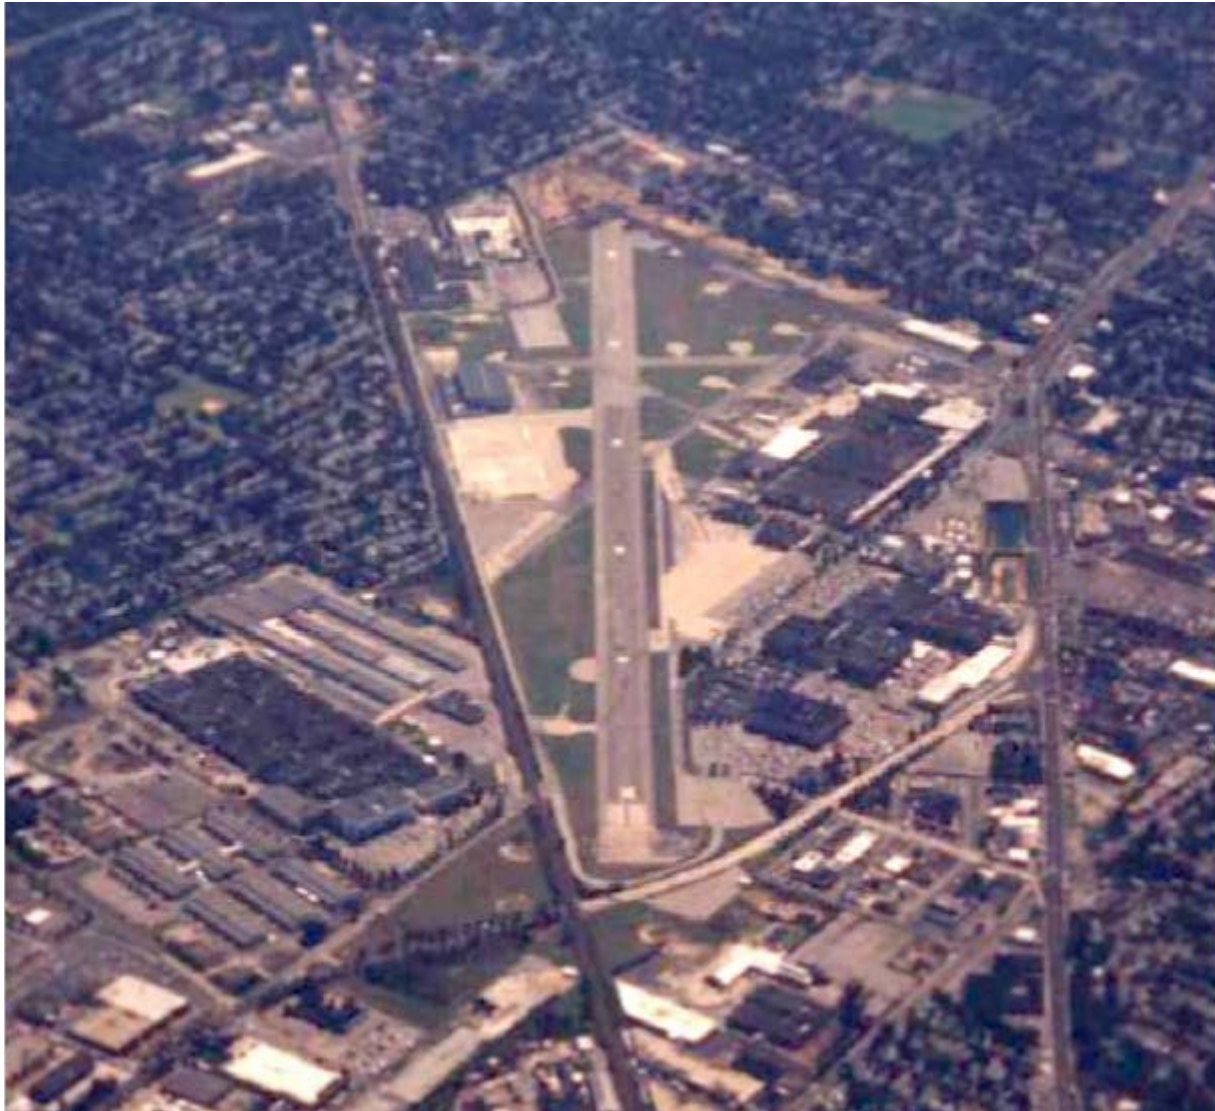
Figure 3 – A southeast aerial view of the closed Bethpage airport in 1997.
