# AIR SAFETY INVESTIGATION RECIPROCATING MULTI-ENGINE ACCIDENT REPORT

| 15082701 | C-MIKE |
| ERA15FA326 | |

| 1980 PA-44-180 | 44-8095021 | N553MD | | Destroyed | No |

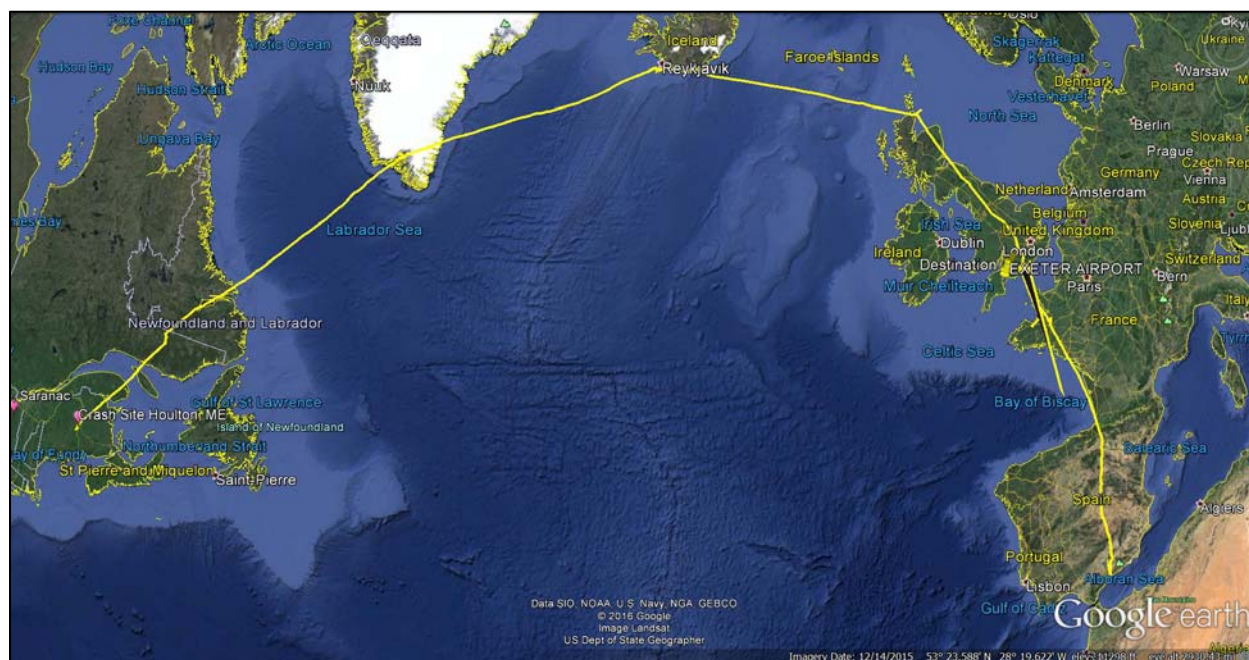
The airplane was scheduled to be delivered by the pilot to a customer in Florida on the day of the accident. Preliminary radar and air traffic control (ATC) communication information from the Federal Aviation Administration (FAA) revealed that, the airplane had departed Keflavik International Airport (BIKF), Keflavik, Iceland, about 0428 on August 26, and had made intermediate stops in Narsarsuaq, Greenland, and CYJR prior to departing on the accident flight. The layover times of the two stops were each about 4 hours.

During the approach to HUL the pilot was in contact with controllers. The airplane was instructed to maintain 3,500 feet until it reached the initial approach fix (CIYEP), and was cleared for the approach. The airplane descended to about 3,000 feet, crossed CIYEP, reversed course, and tracked approximately along the final approach course of 049 degrees. The intermediate minimum descent altitude prior to CIYEP was 3,000 feet, but the airplane passed CIYEP about 2,500 feet. The airplane continued its descent on the inbound course, and the final radar target was at 1,500 feet about 2.5 miles from the landing runway.

The aircraft struck trees at about 1.25 miles from the approach end of runway 5.
