## ENGINE EXAMINATION REPORT

| ENGINE MODEL | IO-550-N |
| AIRCRAFT MAKE & MODEL | Cirrus SR22 |

NTSB ACCIDENT # ERA15FA330

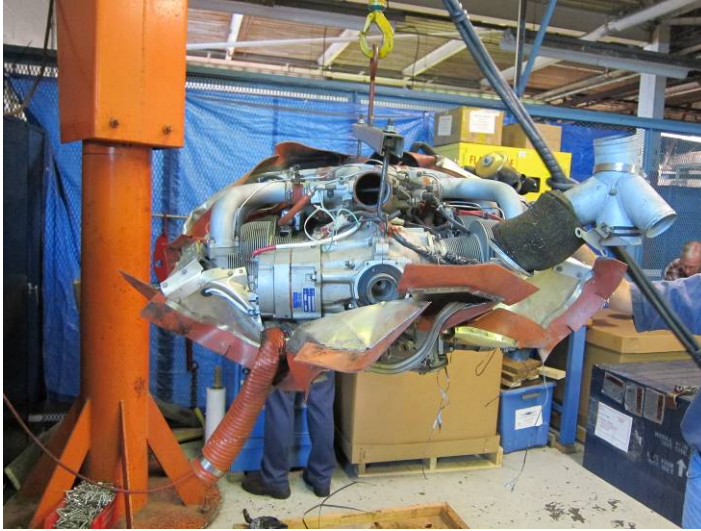
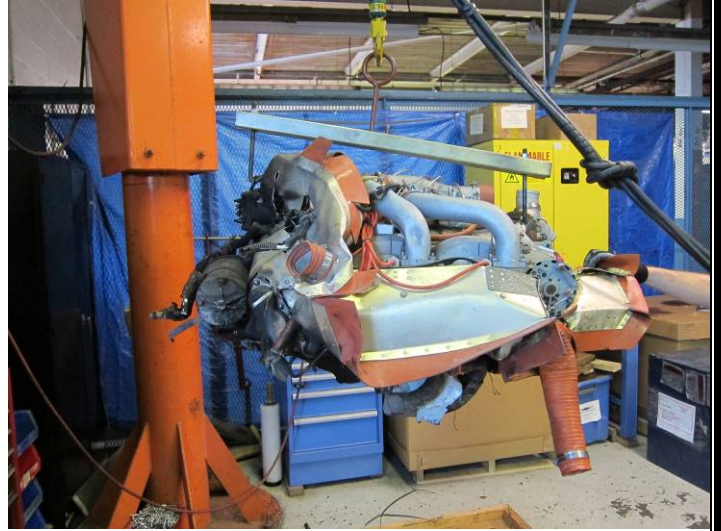
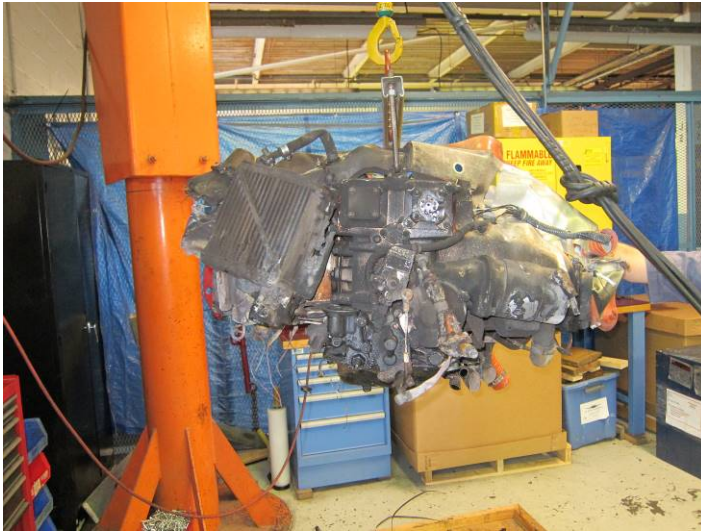
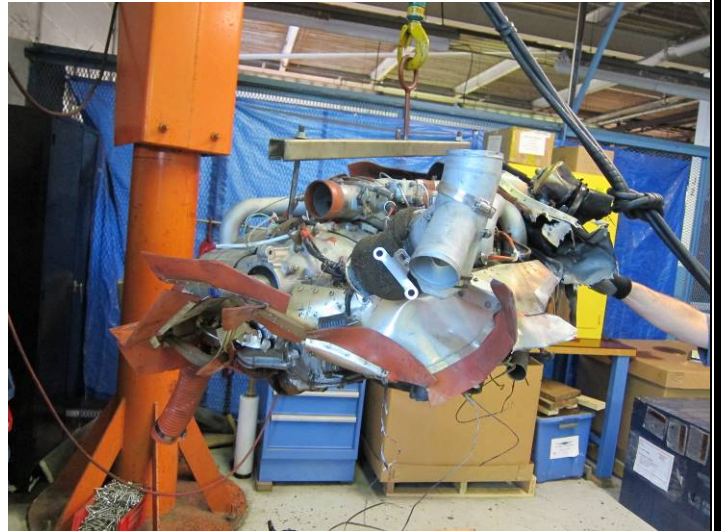
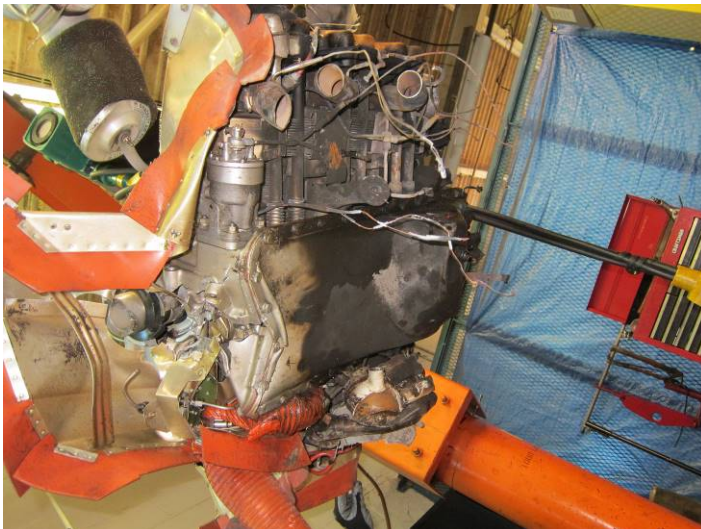
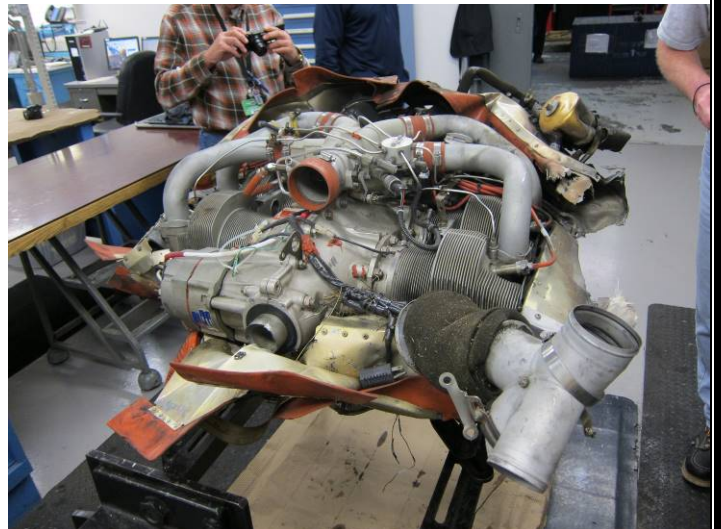
The engine displayed impact and thermal damage signatures; the thermal damage signatures were concentrated to the rear of the engine. The crankcase was fractured at the lower forward portion of the crankcase and portions of the internal components were exposed. The propeller flange had fractured from the rest of the crankshaft which was consistent with impact damage. All six cylinders remained attached to their cylinder bays and displayed varying amount of impact and thermal damage signatures.

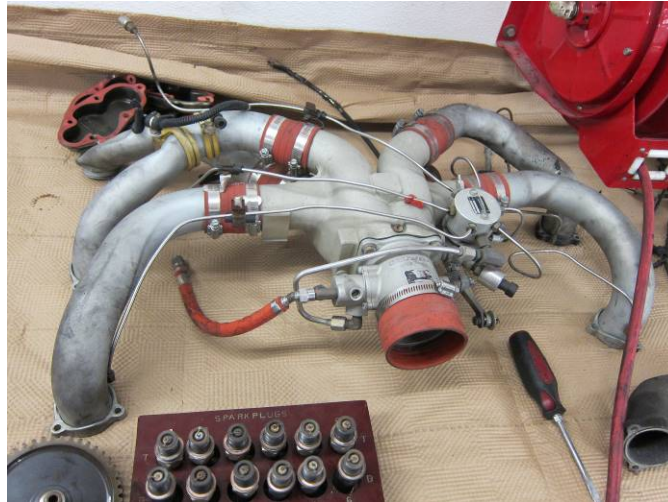
#### INDUCTION SYSTEM

Condition: The induction system displayed impact and thermal damage signatures concentrated to the rear portions of the induction system. There were no signs of induction leaks or any other anomalies noted with the induction system.

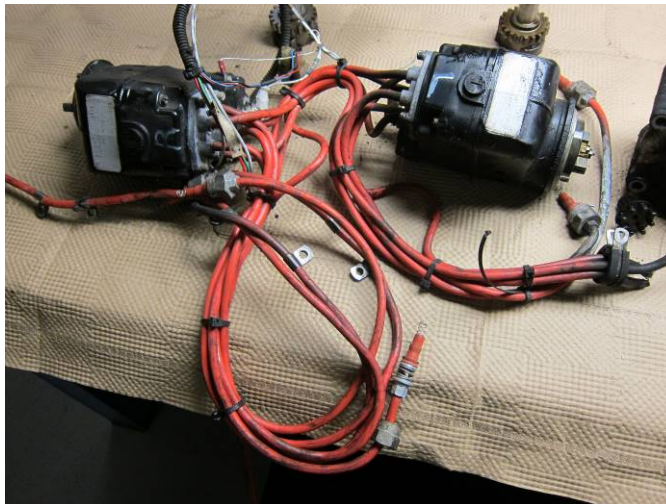
The ignition harness remained attached to both of the magnetos and to each of the spark plugs. The ignition harness displayed thermal damage to several of the ignition leads. There were no anomalies noted with the ignition harness.

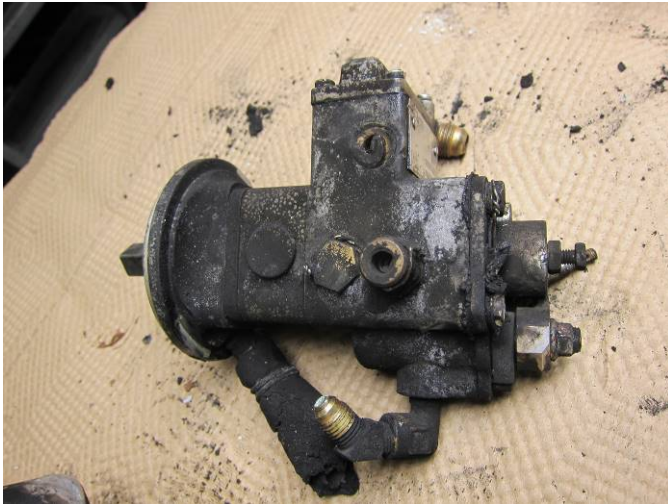
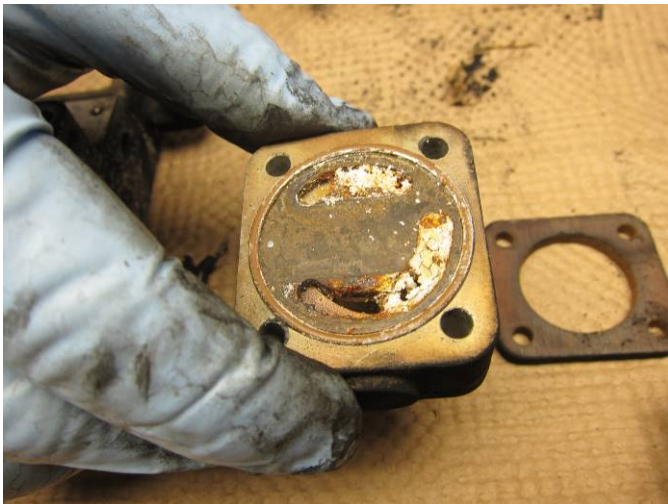
The fuel pump remained attached to its installation point and displayed thermal and impact damage signatures. The fuel pump was removed and it was noted that the fuel pump drive coupling remained intact. It was noted that the fuel pump drive was not capable of rotation by hand. The fuel pump was disassembled and the internal components were visually inspected. All of the internal components displayed thermal damage signatures and normal operating signatures. There were no anomalies noted.

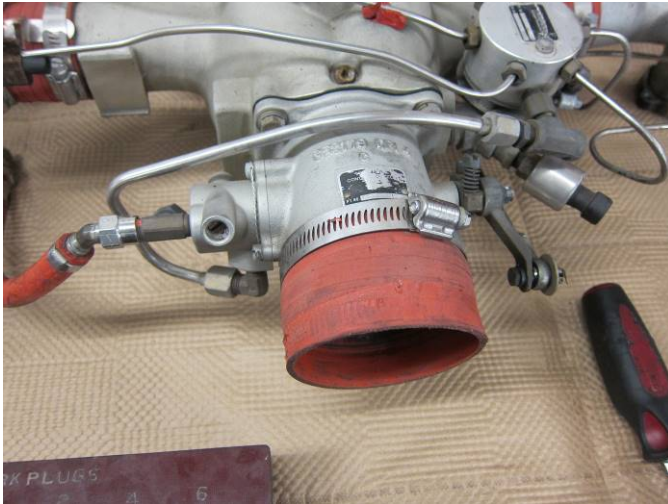
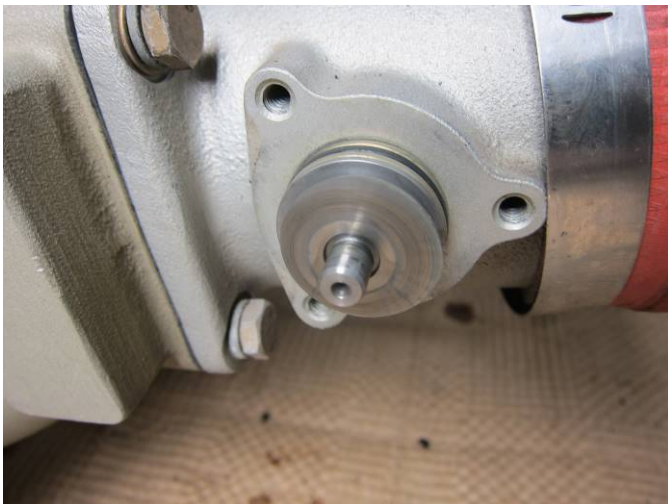
The throttle and fuel metering assembly remained attached to its installation point and was undamaged. The fuel metering portion of the assembly was disassembled and the internal components were visually inspected. There were no anomalies noted with the throttle and fuel metering assembly.

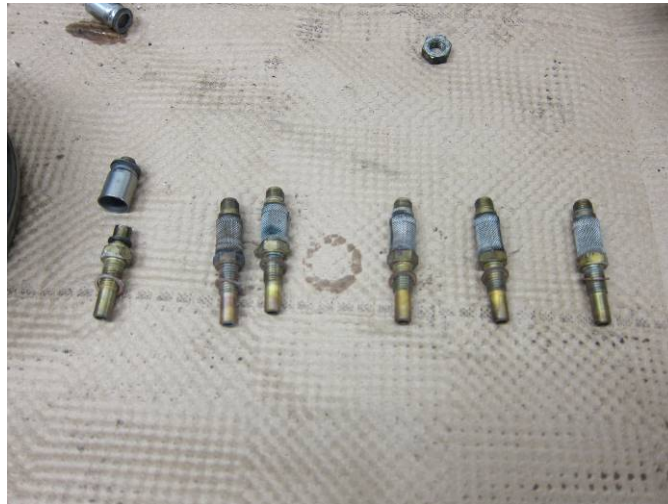
| Position | #1 | #3 | #5 | #2 | #4 | #6 |
|---|---|---|---|---|---|---|
| Condition: | All of the fuel nozzles remained installed in their cylinders and the #1 fuel nozzle displayed impact damage signatures; the #1 nozzle was broken approximately in half. The nozzles were removed and visually inspected. There were no anomalies noted with the nozzles. | | | | | |

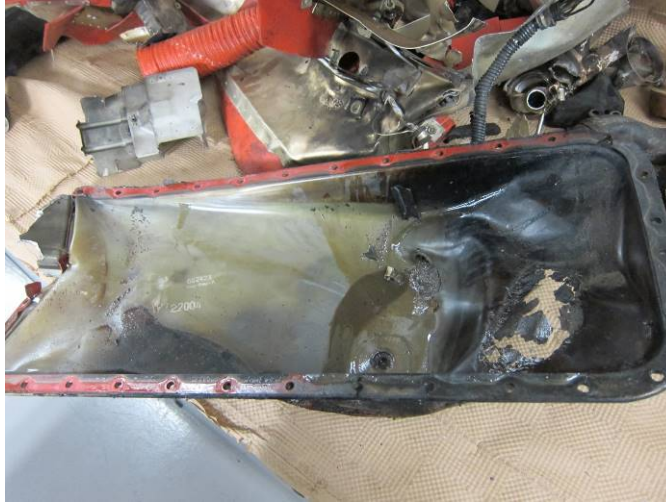
#### OIL SUMP

Condition: The oil sump displayed impact and thermal damage signatures; the oil sump was breached towards the rear of the oil sump. There were no pre-impact anomalies noted with the oil sump.

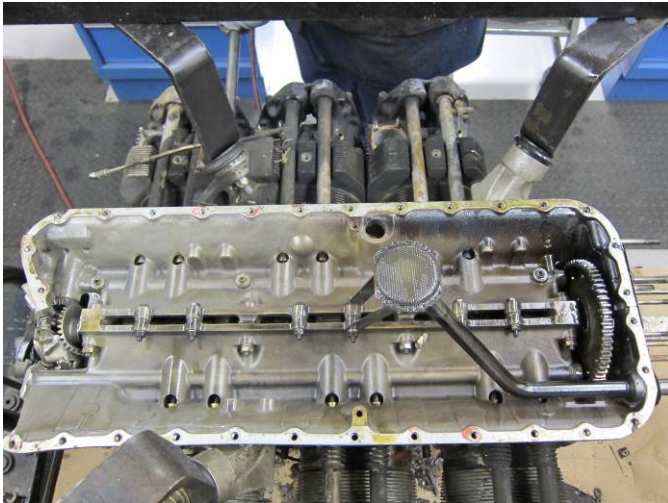
#### OIL PICK-UP TUBE & SCREEN

Condition: The oil pick-up tube and screen were intact and undamaged. The oil pick-up screen was clear of any contaminants. There were no anomalies noted.

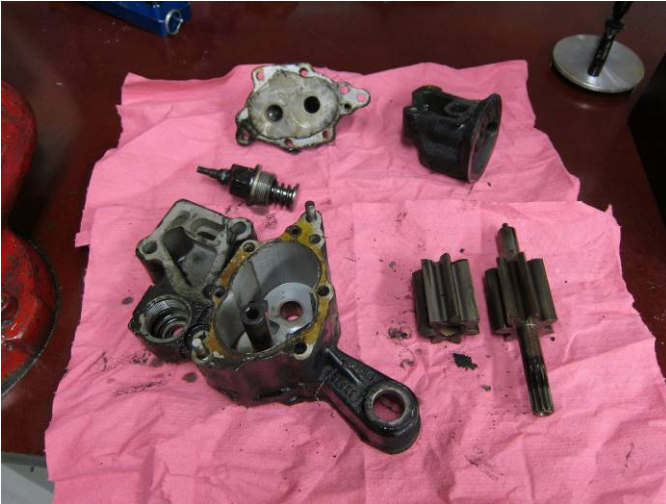
## OIL PUMP

**Condition:** The oil pump displayed thermal damage signatures and remained intact. The oil pump was disassembled and the internal components were visually inspected. The oil pump housing displayed scoring consistent with hard particle passage. The oil pump gears and pressure relief valve displayed normal operating signatures.

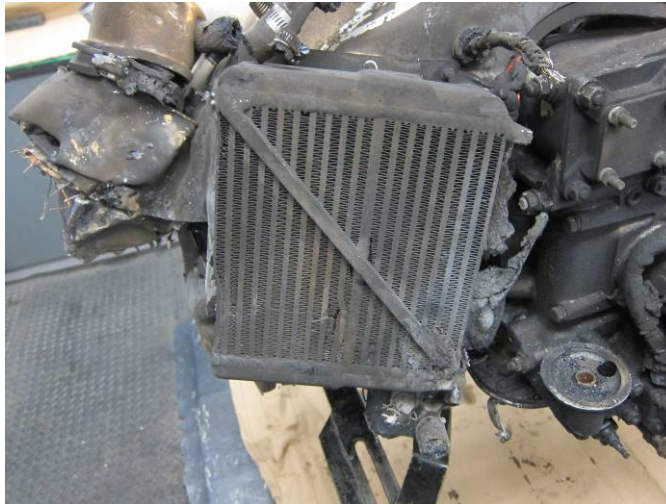
The oil cooler remained partially attached to the engine and displayed impact and thermal damage signatures. There were no pre-impact anomalies noted with the oil cooler.

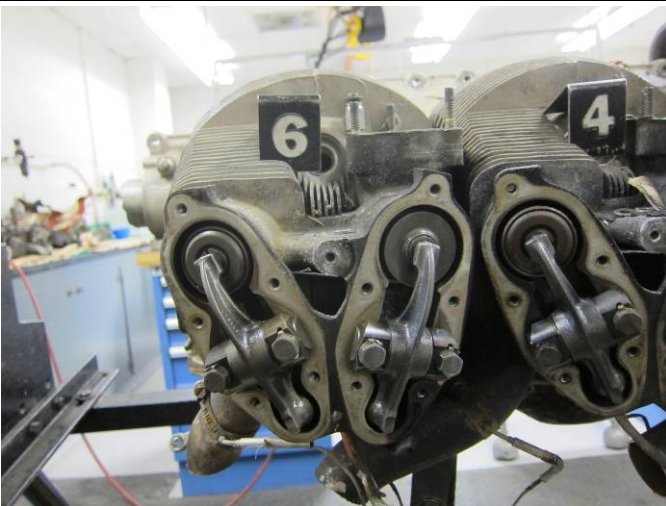
Condition: The cylinder remained attached to its cylinder bay and displayed some impact and thermal damage signatures. The cylinder was removed from the engine and visually inspected. The cylinder bore displayed normal operating signatures. The valve heads displayed normal operating and combustion signatures. The overhead components (valves, springs, and rocker arms) displayed normal operating and lubrication signatures.

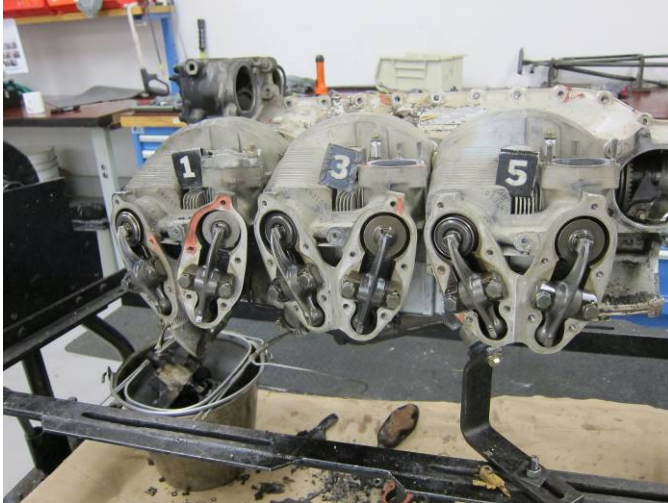
### ROCKER ARMS AND SHAFTS

Condition: All of the rocker arms displayed normal operating and lubrication signatures. There were no anomalies noted with the rocker arms.

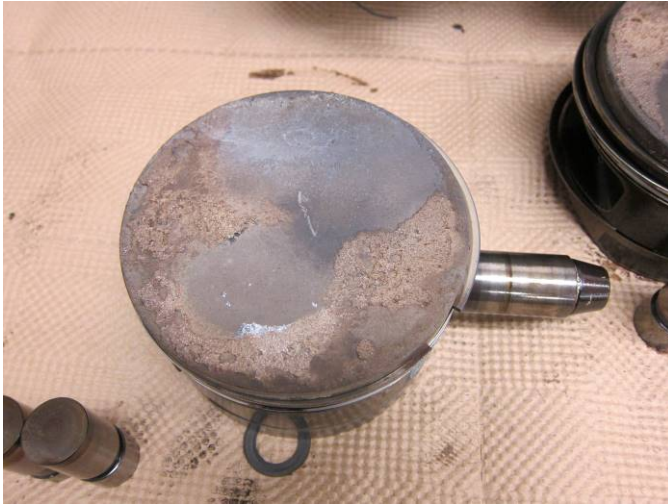
#1 Piston

Condition: The pistons remained intact and were undamaged. The piston faces displayed normal operating and combustion signatures. The piston rings were capable of normal movement in their grooves. There were no anomalies noted with the pistons.

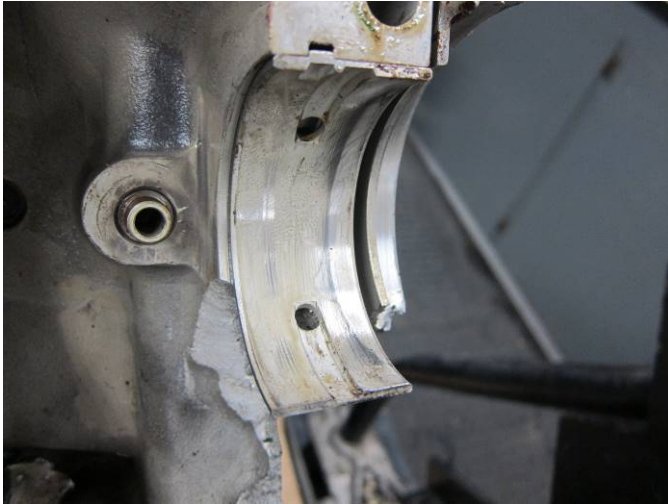
Due to the impact damage to the forward portion of the crankcase both of the bearings were displaced. The bearings displayed normal operating and lubrication signatures. There were no signs of bearing shift or lubrication distress. There were no anomalies noted.

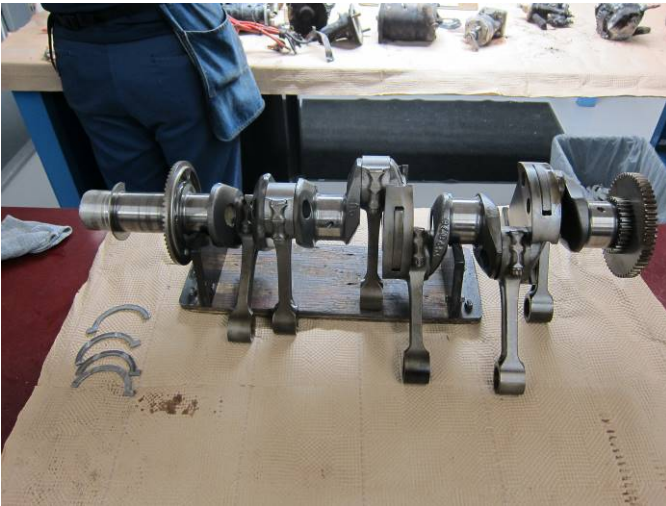
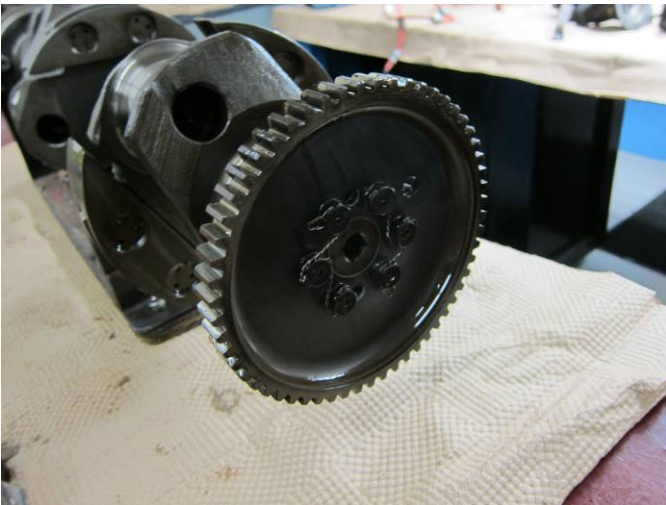
Condition: The propeller flange had broken free from the rest of the crankshaft and was not shipped with the rest of the engine. The fracture was consistent with impact damage and there were several cracks at a 45-degree angle noted near the fracture point. The rest of the crankshaft remained intact and the crankshaft gear remained secured to the crankshaft. All of the main bearing journals and connecting rod journals displayed normal operating and lubrication signatures.

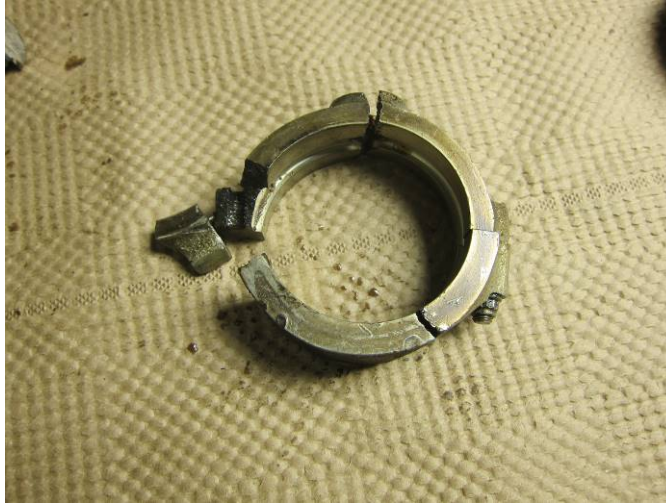
### TRANSFER COLLAR

Condition: The transfer collar was fractured into several pieces which was consistent with impact damage. There were no pre-impact anomalies noted with the transfer collar

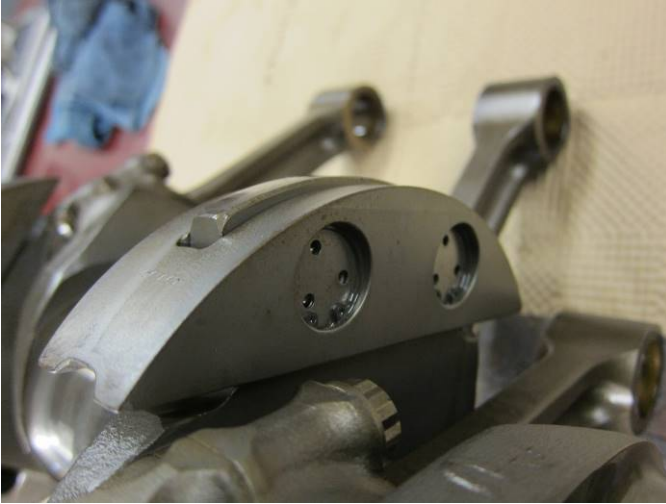
Condition: All of the counterweights remained attached to their hangers and were undamaged. The counterweights were capable of normal movement on their hangers. There were no anomalies noted.

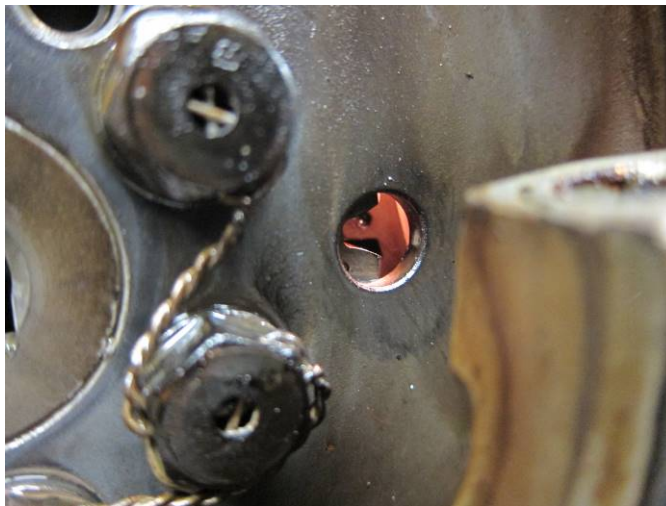
## INTERNAL TIMING

Condition: The internal timing was verified to be correct.

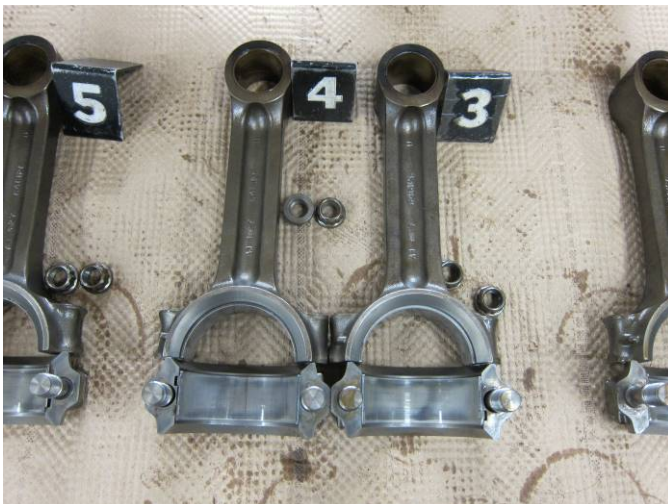
The connecting rod remained intact and undamaged. The connecting rod displayed normal operating signatures. There were no anomalies noted.

The connecting rod bearing displayed normal operating signatures and normal lubrication signatures. There were no signs of lubrication distress. There were no anomalies noted.

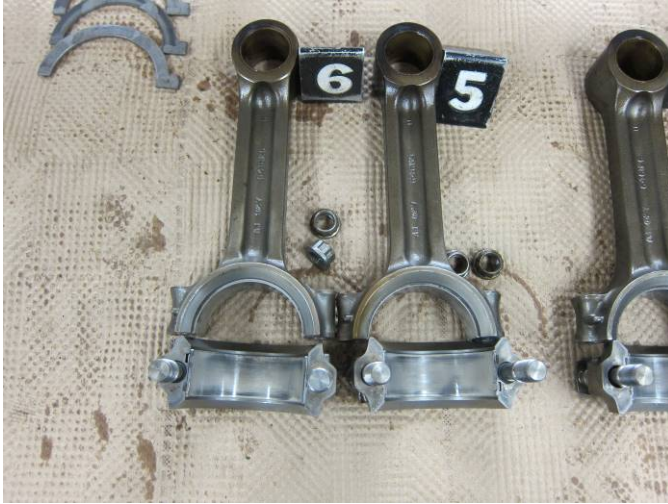
The connecting rod remained intact and undamaged. The connecting rod displayed normal operating signatures. There were no anomalies noted.

The connecting rod bearing displayed normal operating signatures and normal lubrication signatures. There were no signs of lubrication distress. There were no anomalies noted.

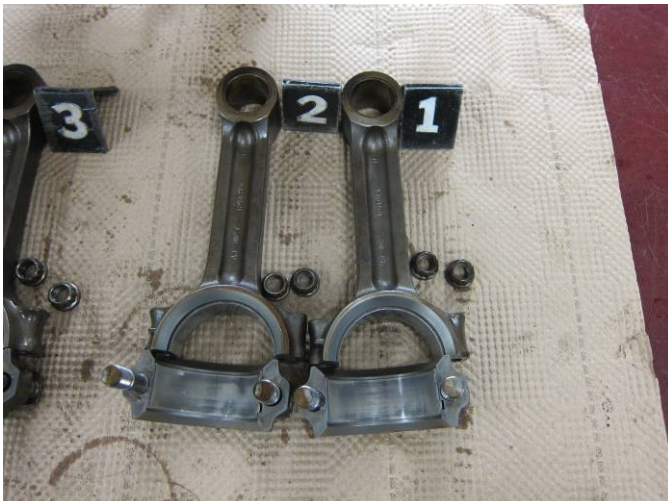
## #2 CONNECTING ROD

The connecting rod remained intact and undamaged. The connecting rod displayed normal operating signatures. There were no anomalies noted.

The connecting rod bearing displayed normal operating signatures and normal lubrication signatures. There were no signs of lubrication distress. There were no anomalies noted.

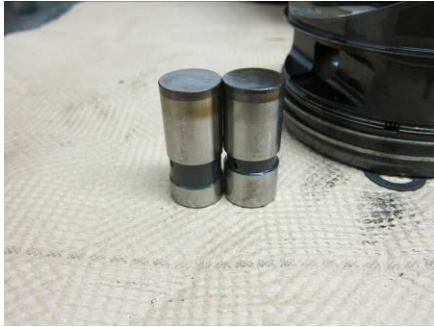
#1 Lifters

| LIFTERS | #1 | #3 | #5 | #2 | #4 | #6 |
|---|---|---|---|---|---|---|
| Condition: | All of the lifters were undamaged and displayed normal operating and lubrication signatures. There were no anomalies noted. | | | | | |

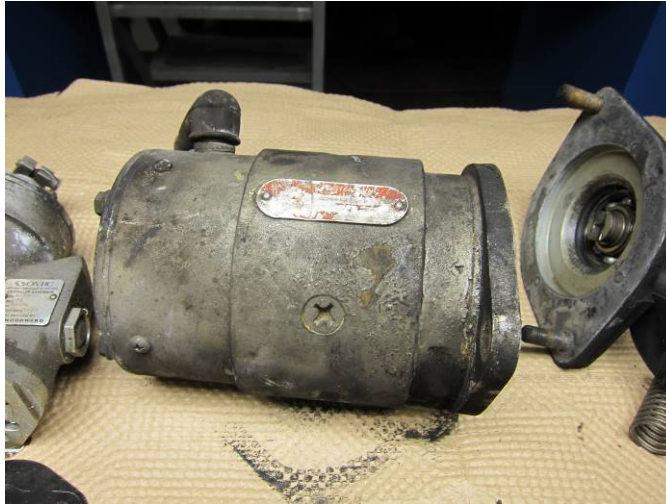
The starter displayed impact and thermal damage signatures. There were no anomalies noted with the starter.

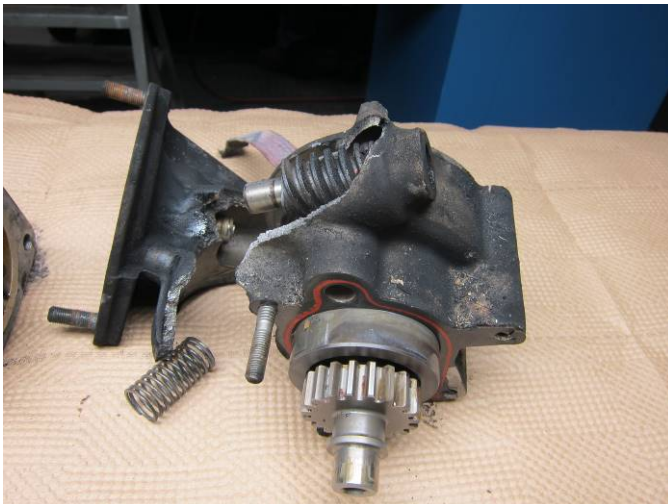
#### STARTER ADAPTER

The starter adapter remained attached to its installation point and displayed impact and thermal damage signatures. A large portion of the starter adapter housing had broken free from the rest of the adapter and some of the internal components were visible. There were no pre-impact anomalies noted with the starter adapter.
