# Continental Motors

## ENGINE FIELD INSPECTION REPORT

| ENGINE MODEL | IO-520-BA10B |
| FILE NUMBER | 14-374 |

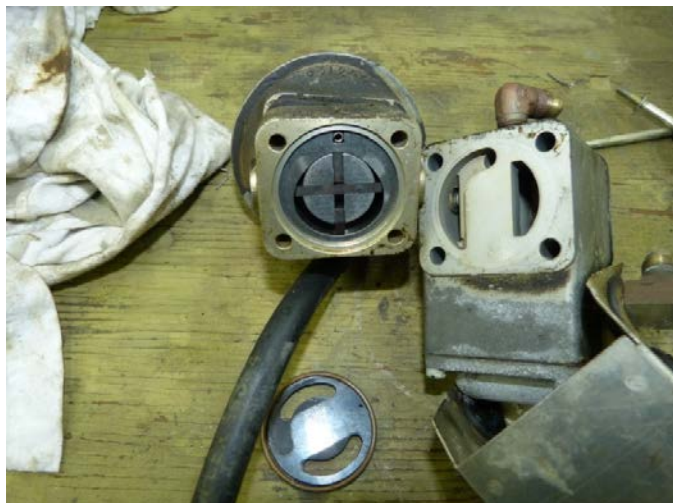
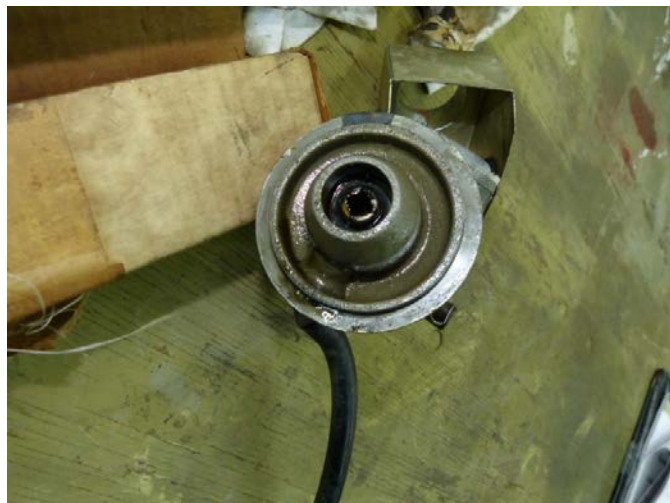
## THROTTLE BODY METERING UNIT

The metering unit was not damaged. The throttle and mixture controls were hooked up and were free to move. Some debris was observed on the fuel screen.

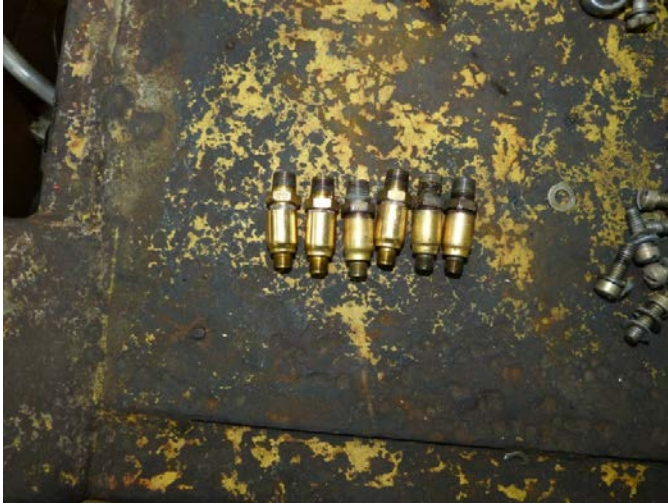
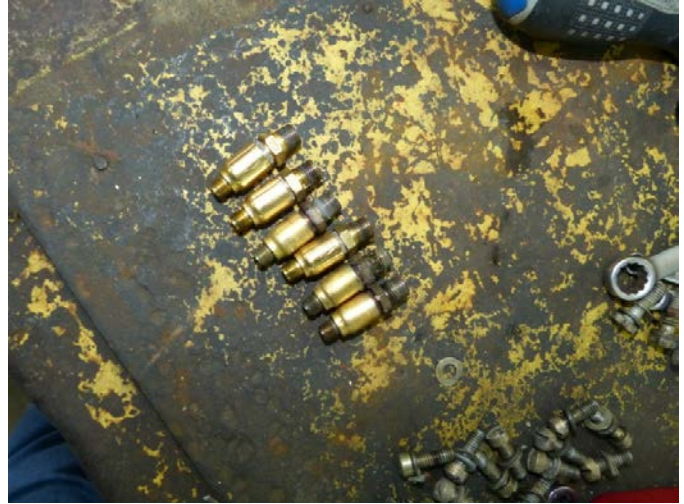
| Condition: | The number one injector was bent. The remainder of the injectors were not damaged, and were clean and clear. | | | | | |

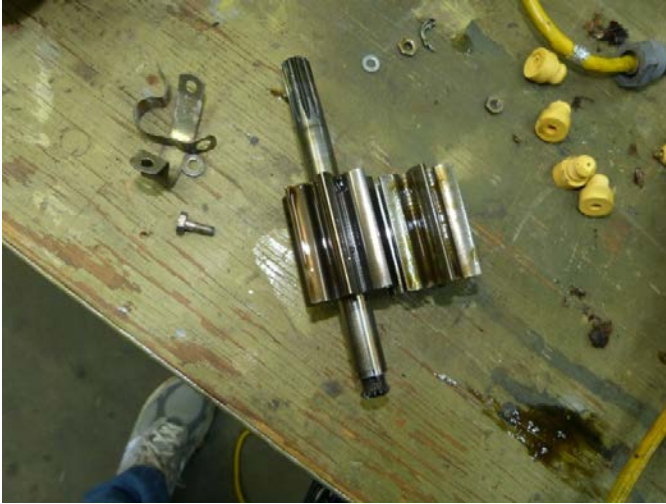
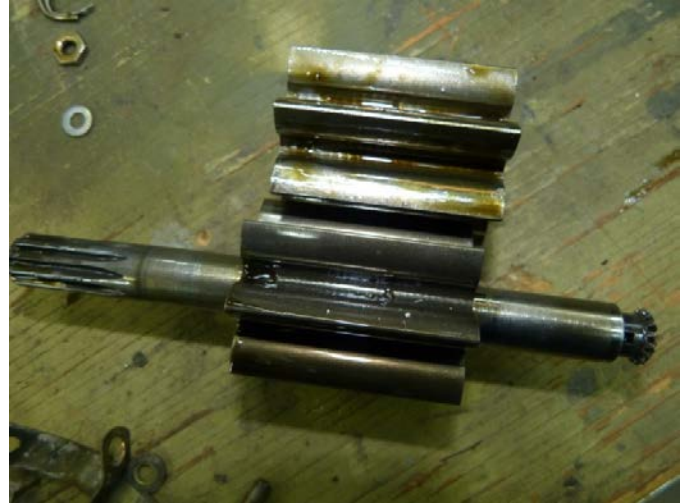
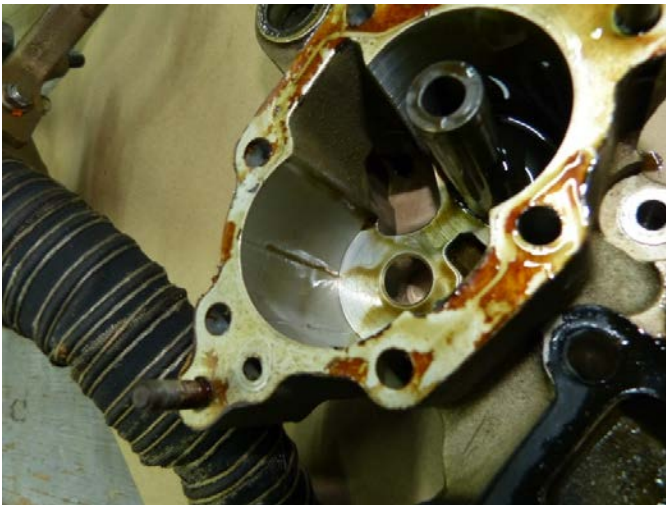
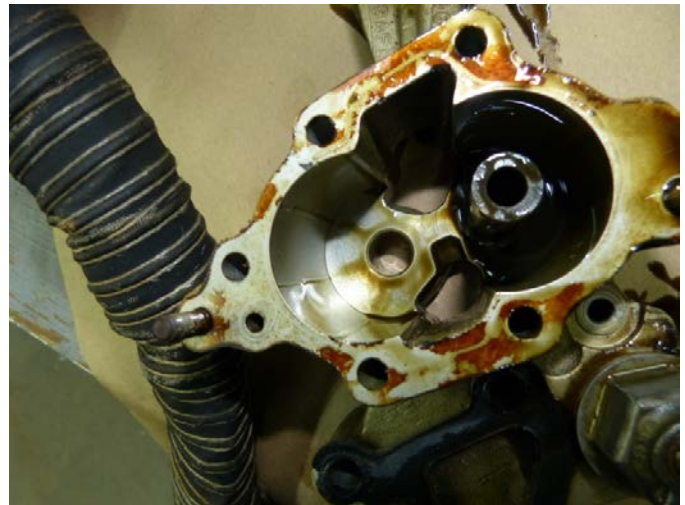
**Condition:** The oil pick-up screen and tube were not damaged. Some metal was observed on the screen.

**Condition:** The oil pump was in place and not damaged. The gears were coated with oil and were free to rotate. Some indications of hard particle passage were noted.

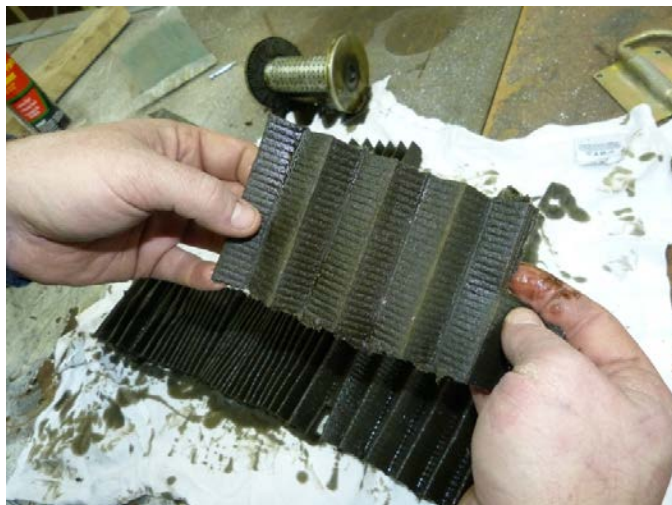
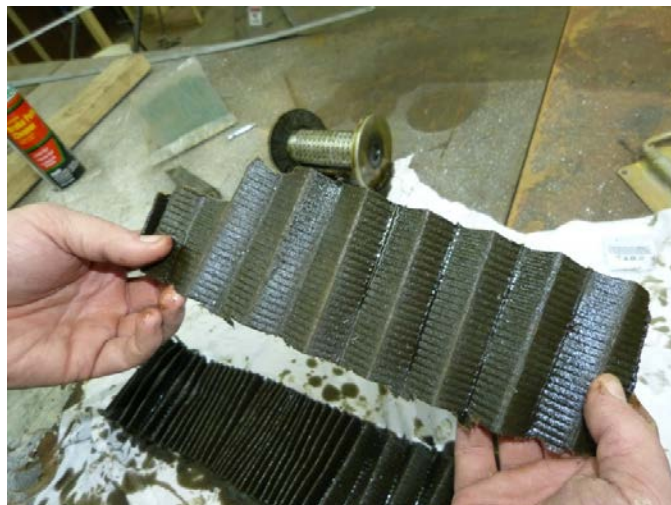
## OIL FILTER

The oil filter was in place and dented. The filter was cut open and small amounts of metal were observed in the element.
