**MANDATORY SERVICE BULLETIN**

**MSB 99-3C**

**SUBJECT: CRANKSHAFT INSPECTION**

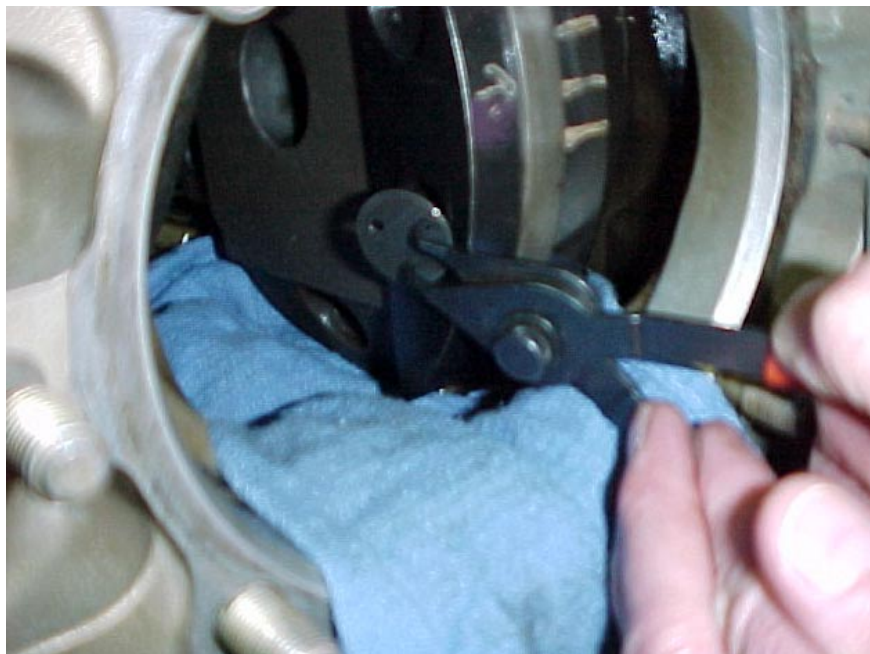
**FIGURE 2. REMOVING COUNTERWEIGHT RETAINING PLATES**

10. Position the crankshaft so that the rearward retaining rings and plates of a counterweight on the number two crankshaft cheek can be removed. Using a pair of snap ring pliers, remove and discard two retaining rings. Using a long, blunted tip awl and ball peen hammer tap the retaining plates to loosen them. Remove retaining plates with a pair of 90° offset snap ring pliers, a scribe with a hook fashioned into its end or a retrieval magnet. See Figure 2. Discard the retaining plates. Using a retrieval magnet, remove the counterweight pins. See Figure 3. Document the pin positions. They must be placed back in the same position from which they were removed.

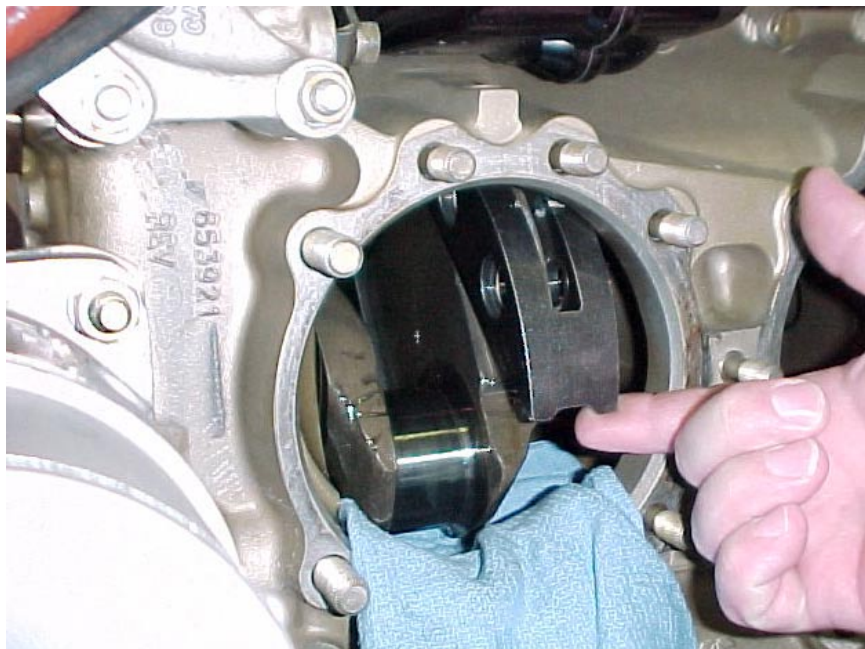
**FIGURE 4. STARTING COUNTERWEIGHT THROUGH CYLINDER OPENING**

11. Looking from the rear of the engine forward, turn the crankshaft in the counterclockwise direction far enough that the lower end of the counterweight can be started out through the cylinder opening by hand. See Figure 4. Now turn the crankshaft in the clockwise direction and remove the counterweight. See Figures 4, 5, 6 and 7.
12. Using the procedure in steps 10 and 11 remove the remaining counterweight on the number two crankshaft cheek and remove the two counterweights on the number five crankcheek.
13. Some counterweights may not clear the crankcase and cannot be removed. If so, position as shown in Figure 8 for the inspection.

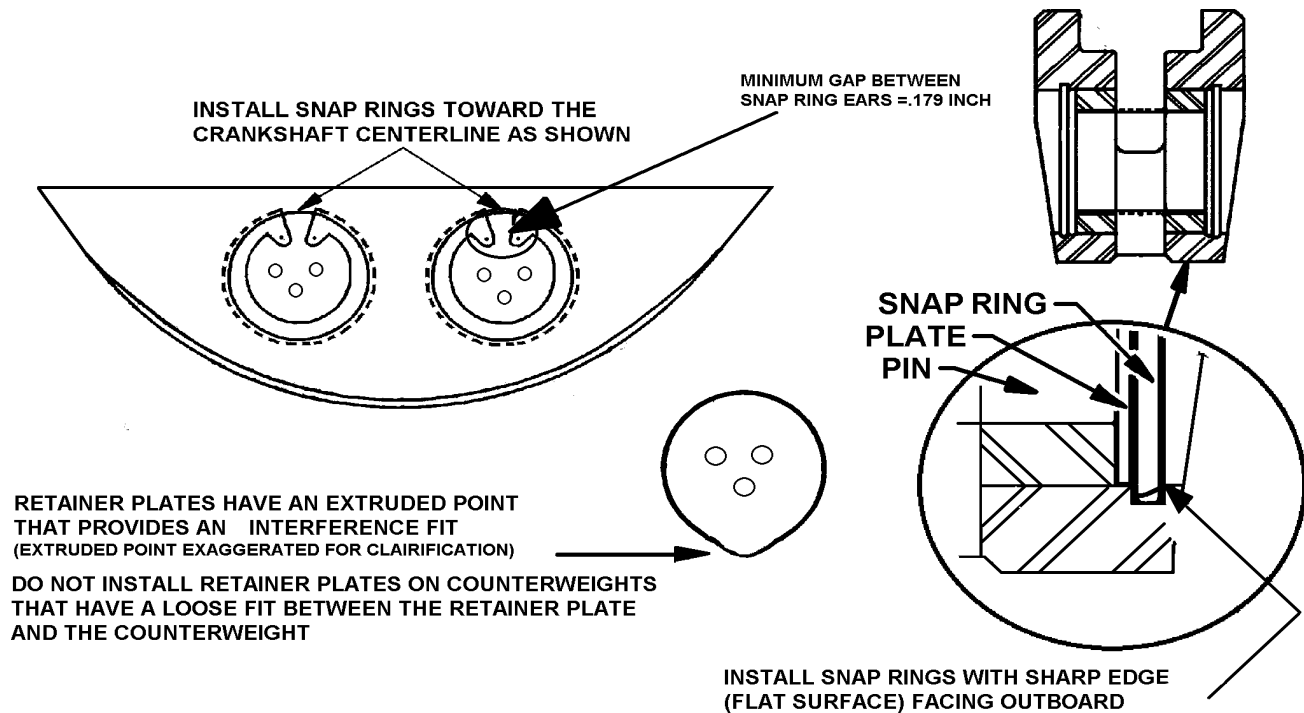
**FIGURE 12  
COUNTERWEIGHT INSTALLATION**

**Do not use plates that have a loose fit. Failure to properly install counterweight retaining plates and snap rings may result in engine damage and possible failure.**

**Note:** Use an inspection mirror and flashlight to verify that the entire circumference of each snap ring is fully seated in the counterweight snap ring groove.

5. Visually and dimensionally inspect all snap rings to insure the snap ring is correctly installed and fully seated in its groove. See Figure 12.
6. Apply 50-weight Aviation grade oil to the number one and three crankshaft connecting rod journals.
7. Position the number one and three connecting rod caps with bearing insert and bolts installed (position number facing up) on the respective crankshaft connecting rod journals.
8. Install the number one and three connecting rods, with bearing insert in place, on the respective crankshaft connecting rod journal while supporting the connecting rod cap and bolts.

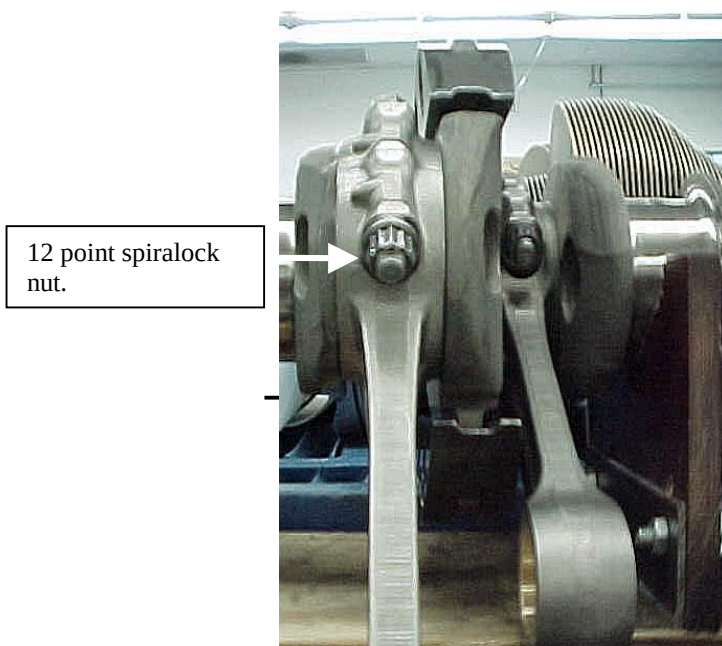
**FIGURE 13. TWELVE POINT SPIRALLOCK NUT**

For connecting rods using either P/N 643215 or P/N 654490 self-locking connecting rod nut (Spirallock nut), torque to the value specified in Table 1. See Figure 13.
