**ERA15LA184**

**Shelter Island, New York**

**Cessna 162 (Skycatcher)**

**NTSB ENGINE EXAMINATION REPORT**

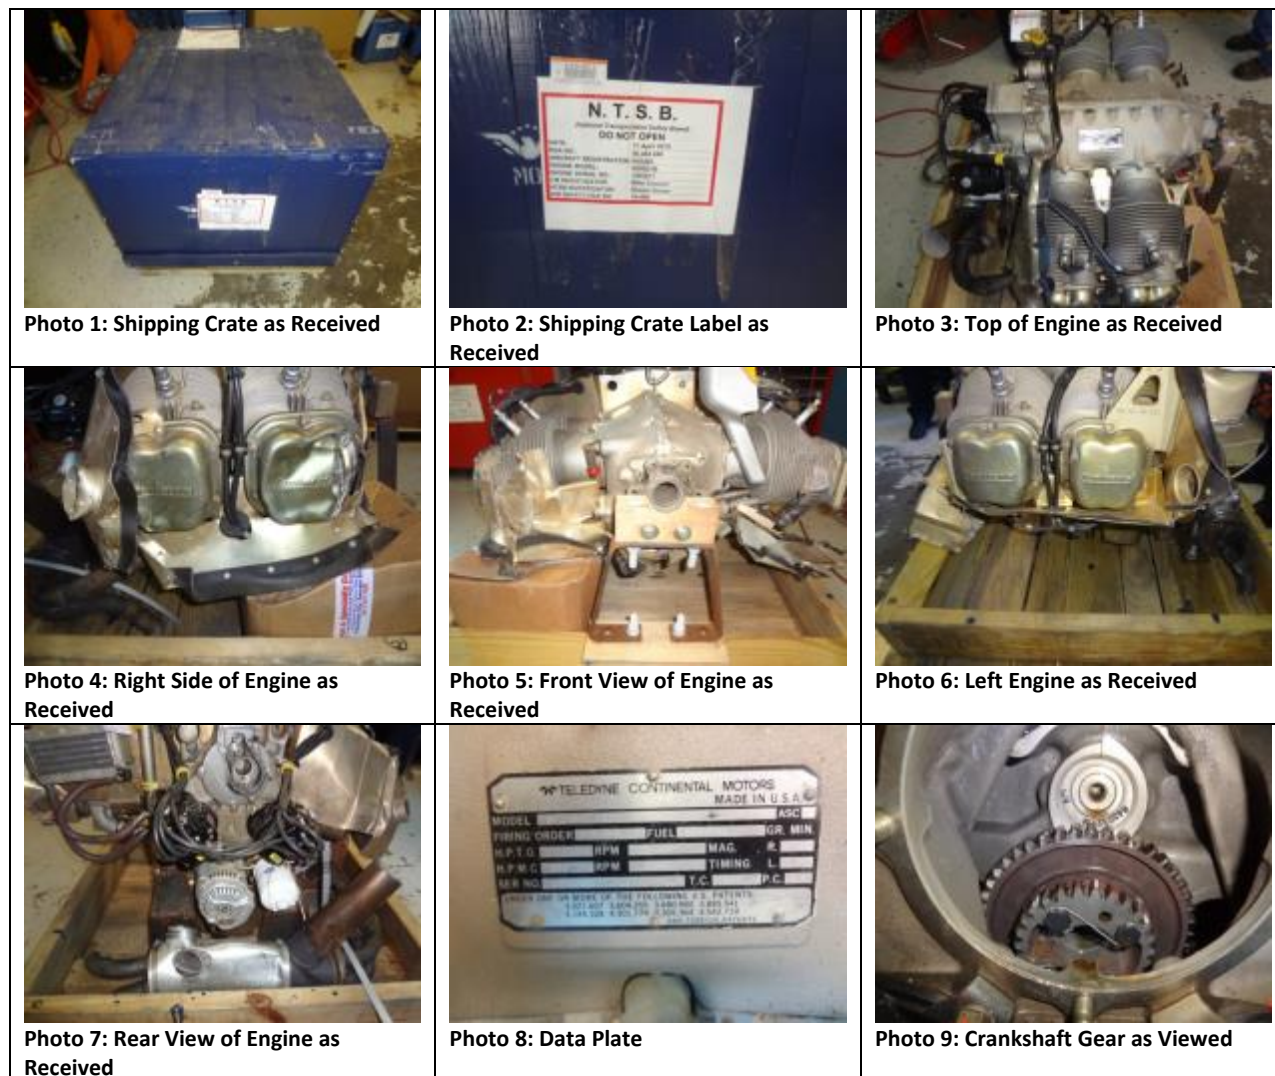
The engine was mounted to a portable cart utilizing the remaining three (3) mount legs for further examination and engine run preparation.
