## Accident / Incident Summary Report

Report No.: 15-078

Lewis Ag Aviation Inc.  
Ayres S2R T34 Reg. N524SL  
Climax, Georgia  
9 July 2015  
PT6A-34 Engine  
S/N 56452

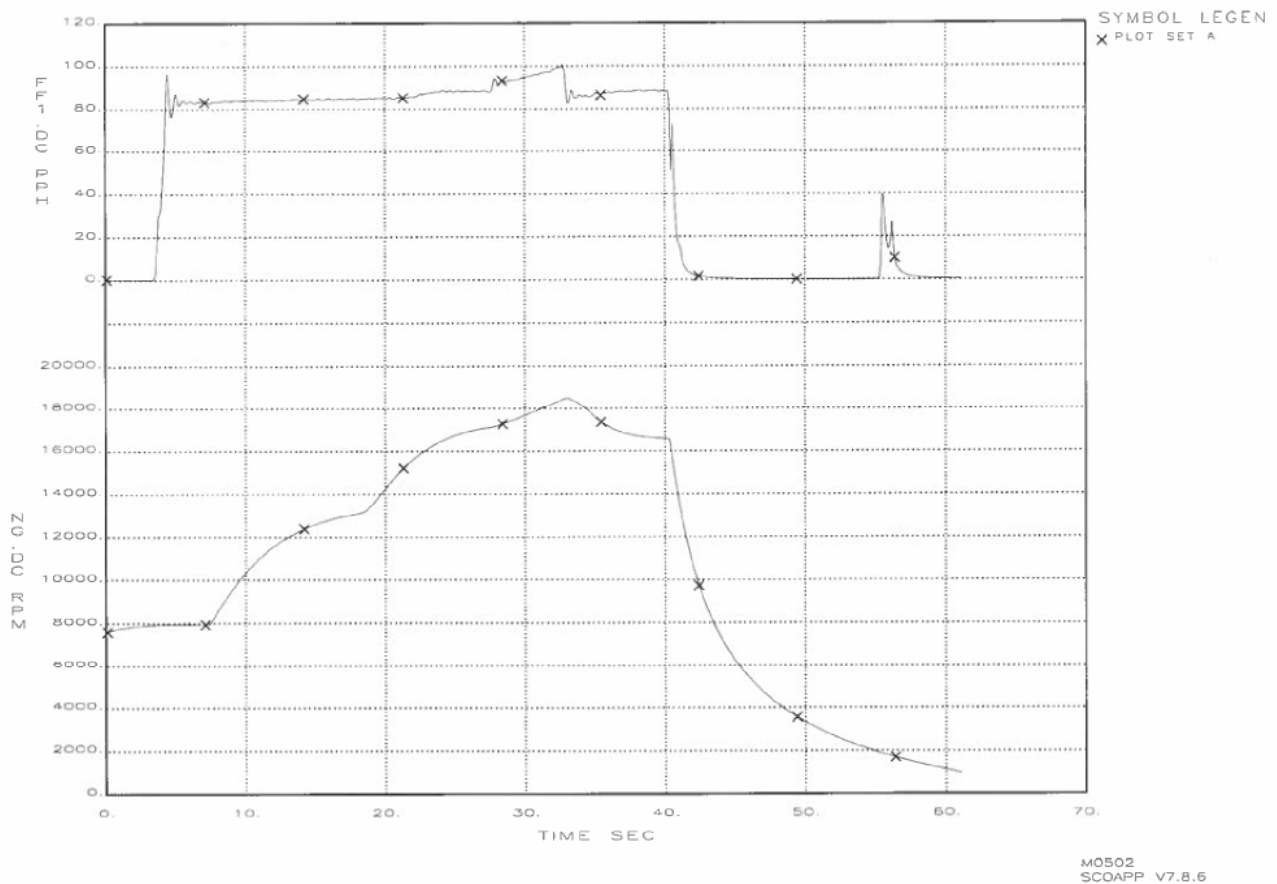
P&amp;WC Log of Engine Test, W/O 188032, dated 14 October 2015, Page 3.

The first start attempt resulted in a hung start. All pneumatic lines were checked and the P3 filter was checked with no anomalies found. The second start attempt again resulted in a hung start.

| TIME | HG.BARO | V.RGB G | NG | T1 F | FF 1 | NG.COR | T1 F | T5 F | Plen PSI | HG P3 | . |
|---|---|---|---|---|---|---|---|---|---|---|---|
| 17:11:03 | ALL P3 LINE CHECK, FOUND ACCEPTABLE | | | | | | | | | | |
