# Continental Motors

## ENGINE FIELD INSPECTION REPORT

| ENGINE MODEL | TSIO520-UB |
| CMI FILE NUMBER | 15-297 |

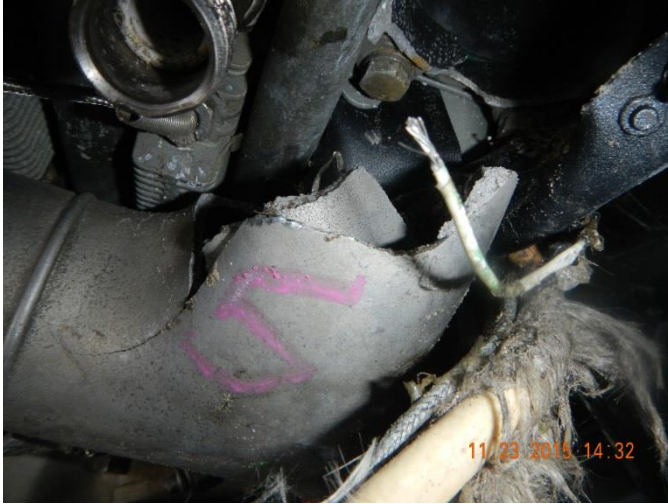
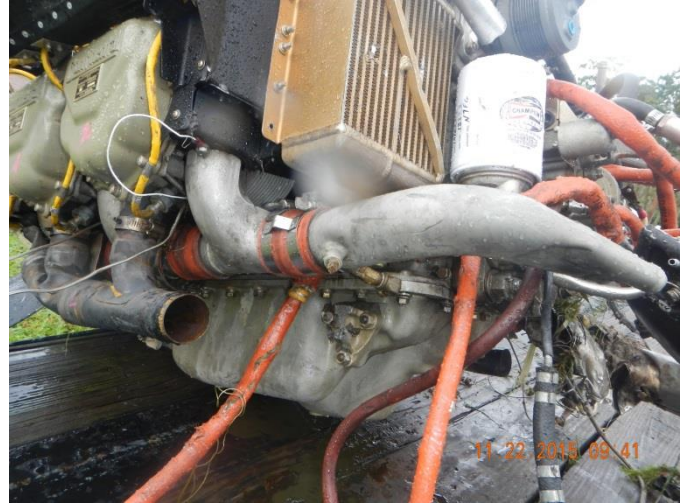
## IGNITION SYSTEM

The CMI left magneto remained intact and attached at its mount. The right magneto was intact but was displaced slightly towards the right due to failure of the mounting ring at the upper hold down clamp. The CMI ignition harness remained intact with the exception of the individual ignition lead for the # 6 cylinder lower spark plug. This ignition lead was cut / pinched during impact and separated from its spark plug.
