**NATIONAL TRANSPORTATION SAFETY BOARD**

**MATERIALS LABORATORY FACTUAL REPORT**

Report No. 16-113

Place : Orlando, FL  
Date : November 20, 2015  
Vehicle : N7FG, Beech A36TC  
NTSB No. : ERA16FA043  
Investigator : Timothy Monville

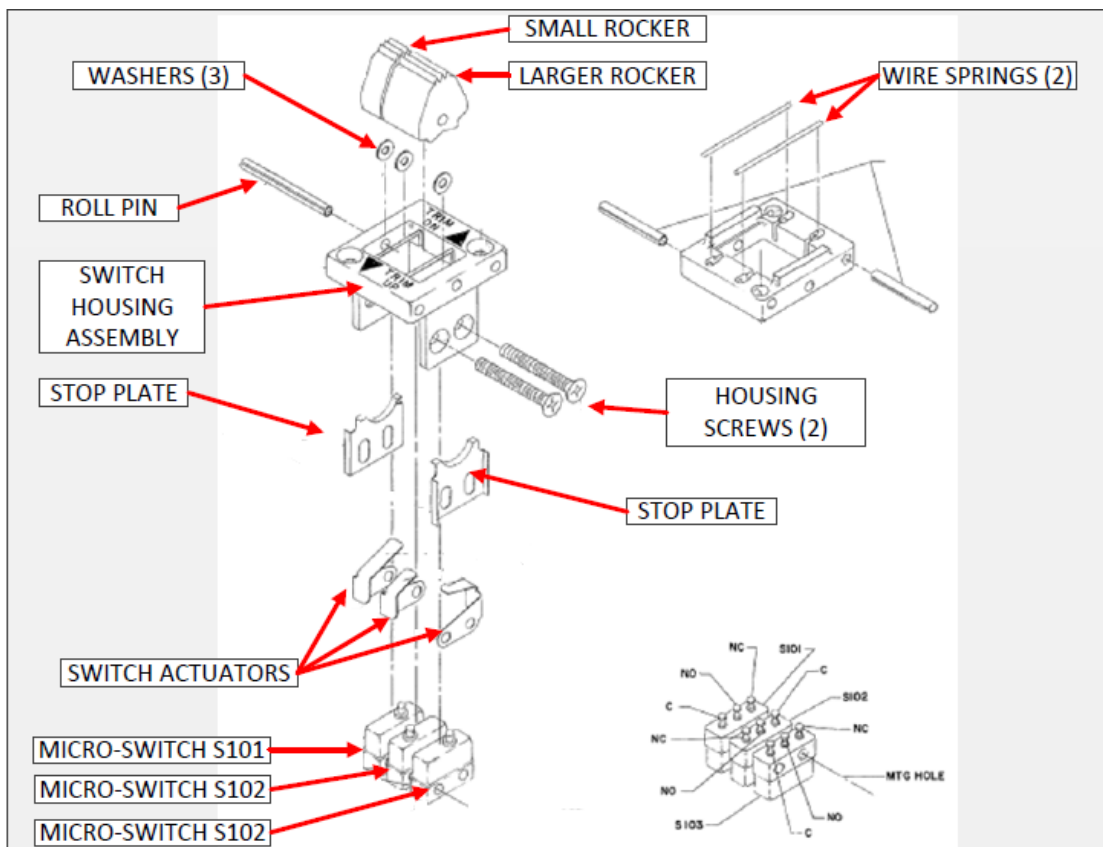
Figure 2. Schematic of switch assembly. Labels and arrows are for clarification purposes only.

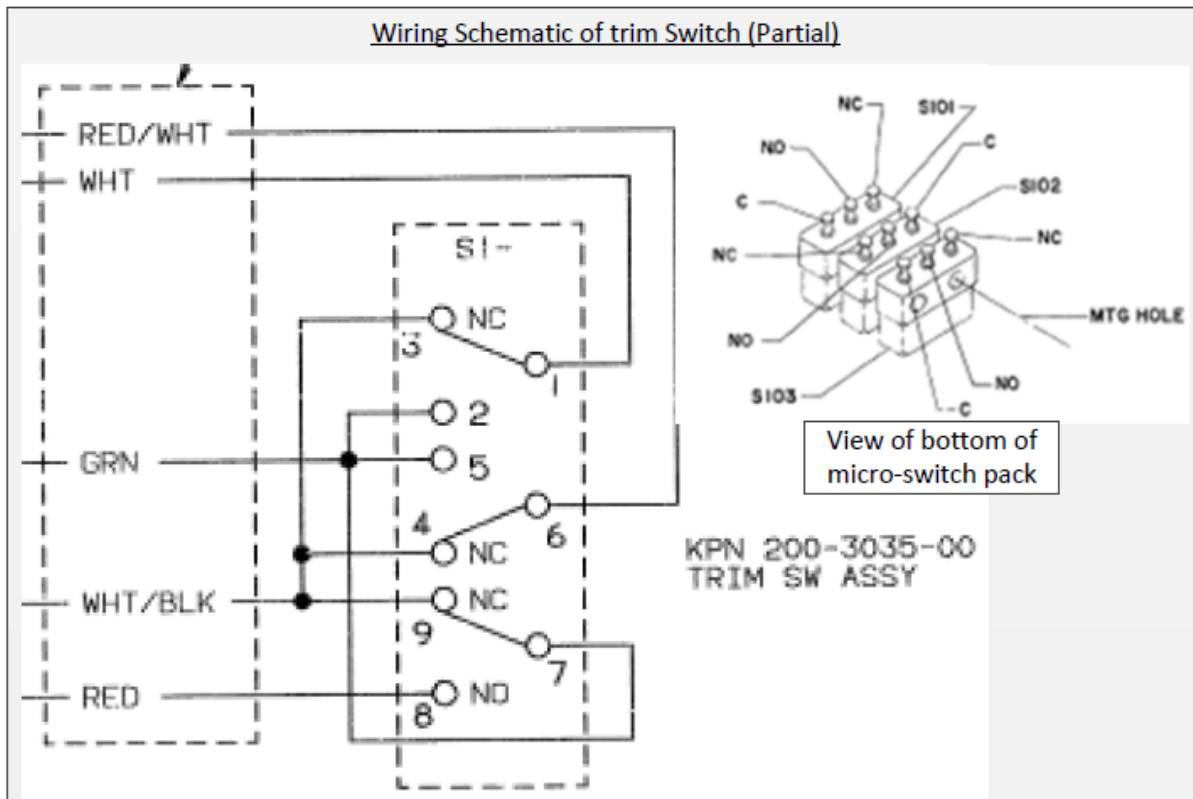
Prior to and after disassembly, electrical conductivity was measured using a digital multimeter at each micro-switch wire connection as listed in tables 1 - 4. All micro-switch wires were firmly attached (soldered) to their respective poles as shown in figure 8. Figure 9 is a wiring schematic of the three micro-switches. The as-received switch electrical testing results are listed in table 1 while tables 2 and 3 list test results when the large rocker was rotated to the trim-up and trim-down positions respectively. With the micro-switches removed (all three as a group) from the switch assembly housing, the position of each micro-switch (S101, S102, & S103) was determined by measuring and recording the continuity between all of the wires coming out of the switch. These test results are listed in table 4.

Figure 9. Switch wiring schematic.
