# Physical Analysis Report on ERA16FA063

Prepared by Binghamton University  
for the National Transportation  
Safety Board, April 5, 2016

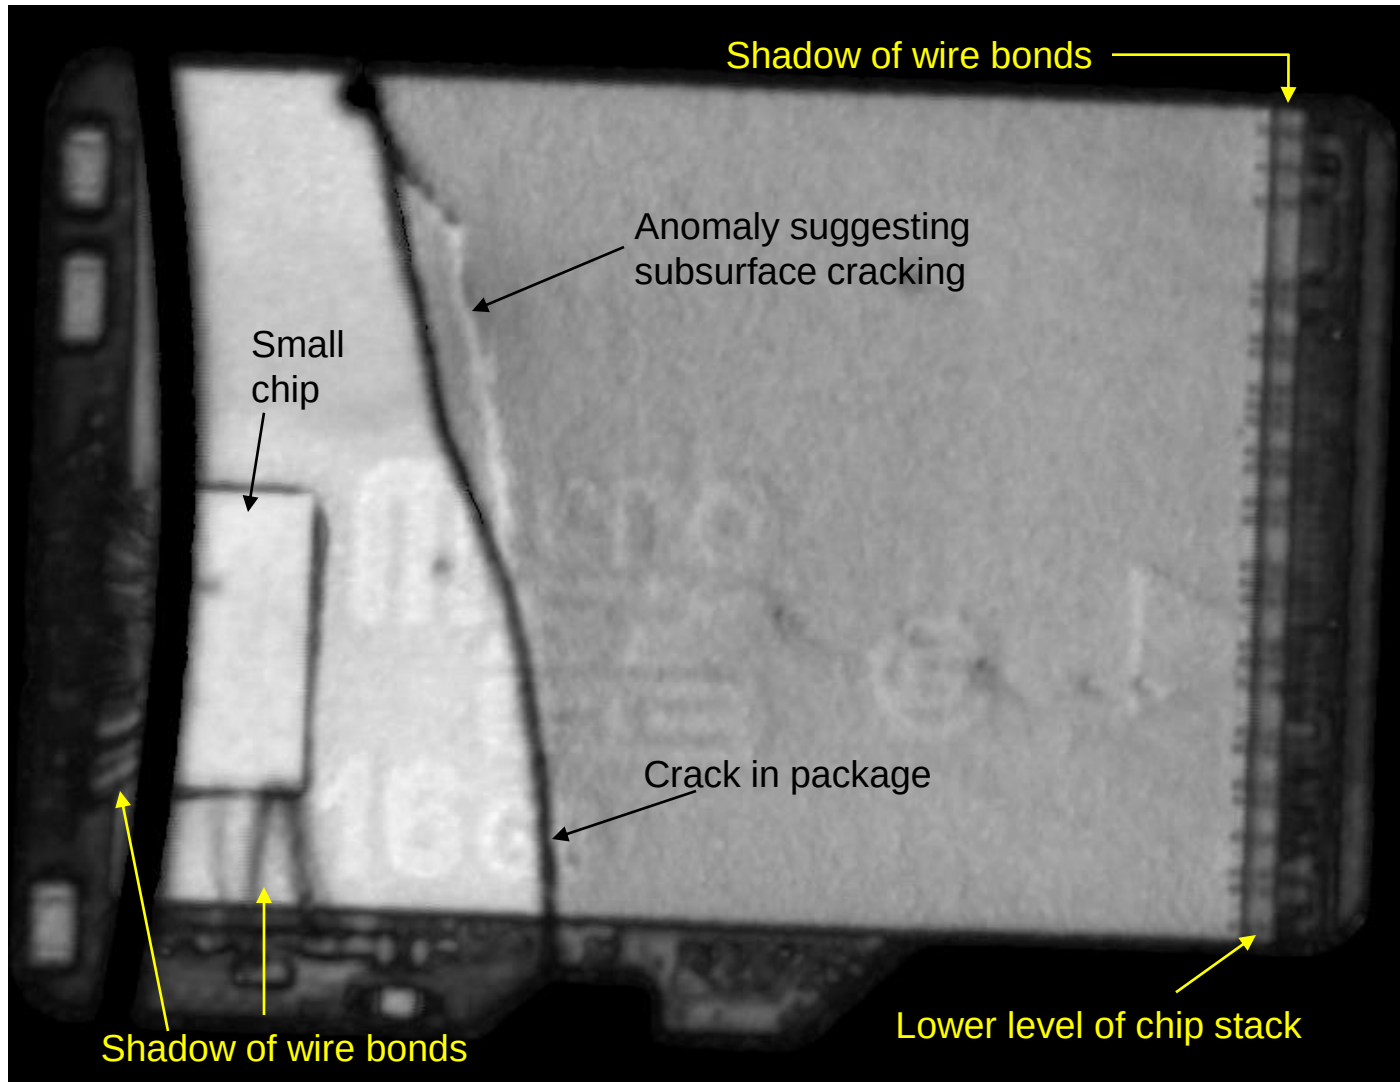
# C-SAM of the Module

- Surface of the chips clearly visible as is the shadow of the wire bonds
    - Stacked configuration is confirmed
    - Chips occupy almost all of the area of the package, including region through which the crack exists
    - Additional anomalies appearing to be crack lines suggest extensive damage to the chip stack
    - B-scan confirms additional cracking below the surface of the package
