# NATIONAL TRANSPORTATION SAFETY BOARD

## MATERIALS LABORATORY FACTUAL REPORT

Report No. 16-059

Place : Clermont, Florida  
Date : March 12, 2016  
Vehicle : EAB Sheehen Dane RV-8A, N838RV  
NTSB No. : ERA16FA127  
Investigator : Millicent Hoidal, AS-ERA

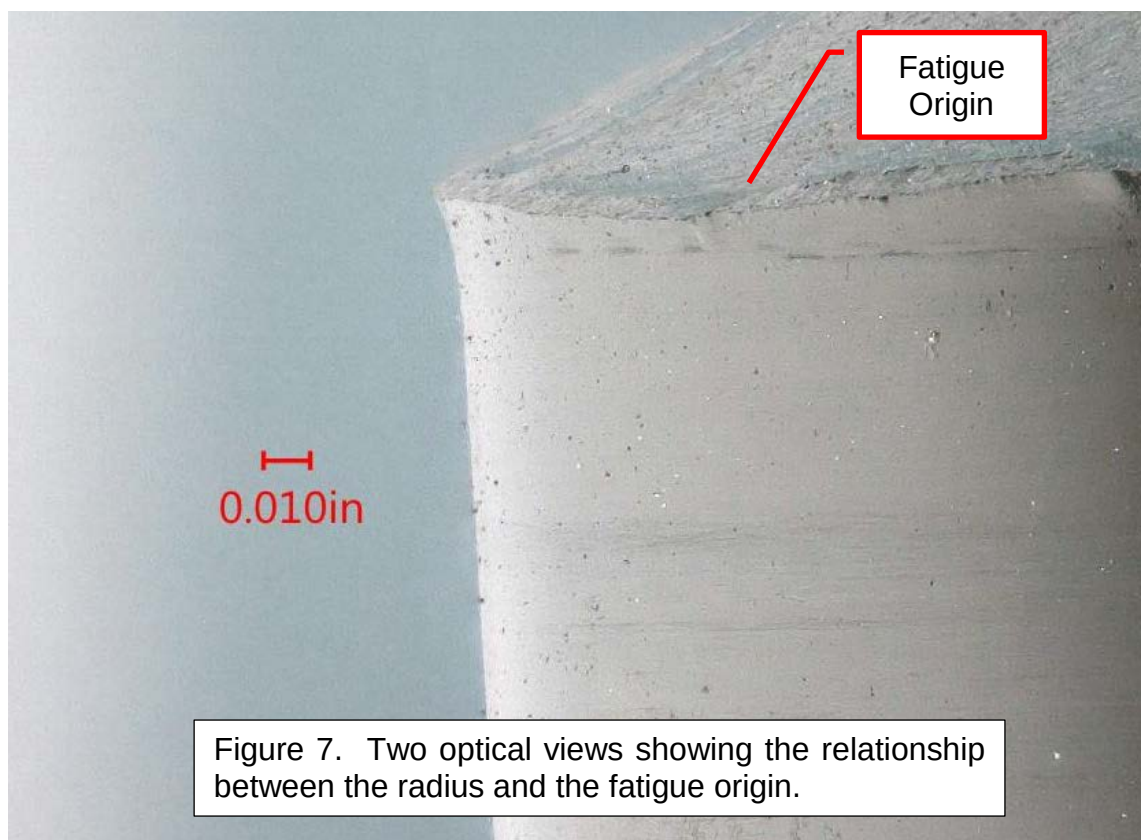
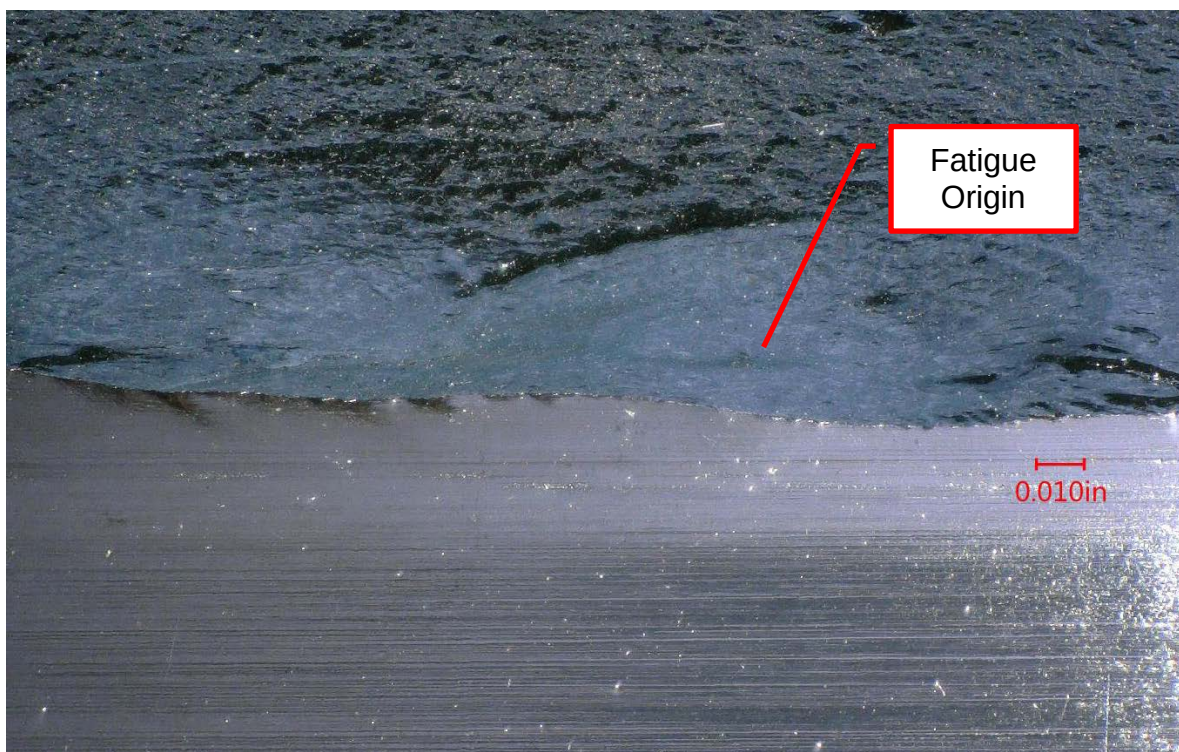
A metallographic section was cut longitudinally through the #2 rod journal near the fatigue origin. The section was progressively polished to near the origin location. No inclusions or foreign material was noted at or near the origin location in any of the successive polish steps. The steel was very clean and only one inclusion was noted on one polish step anywhere in the sample.

Etching the metallographic specimen with 2% Nital<sup>9</sup> revealed the case and core microstructure as shown in the lower view of figure 8. Both case and core microstructures were tempered martensite with the case structure containing individual white etching iron nitrides and etching darker. Both typical of the specified heat

Figure 8. Metallographic images on a radial cross section through the journal near the fatigue origin. Upper view unetched. Lower view has been etched with 2% Nital to reveal the nitride case and core microstructures. Fracture surface in profile at top, journal surface at right.
