## Component Examination Report

| Engine Model: | IO-520-BB12B | | | Engine S/N: | 578107 | | | | | |
| Aircraft Make/Model: | Beech A36 | | | Aircraft S/N: | E-681 | | Reg. #: | N4314S | | |

## ENGINE FIELD INSPECTION REPORT

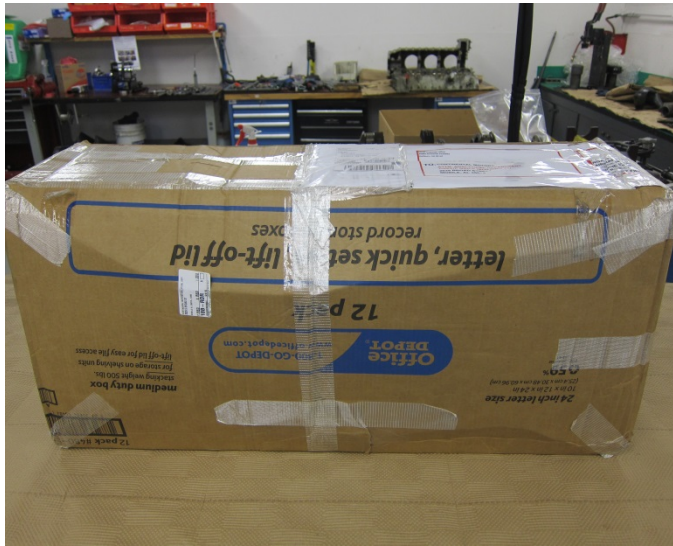
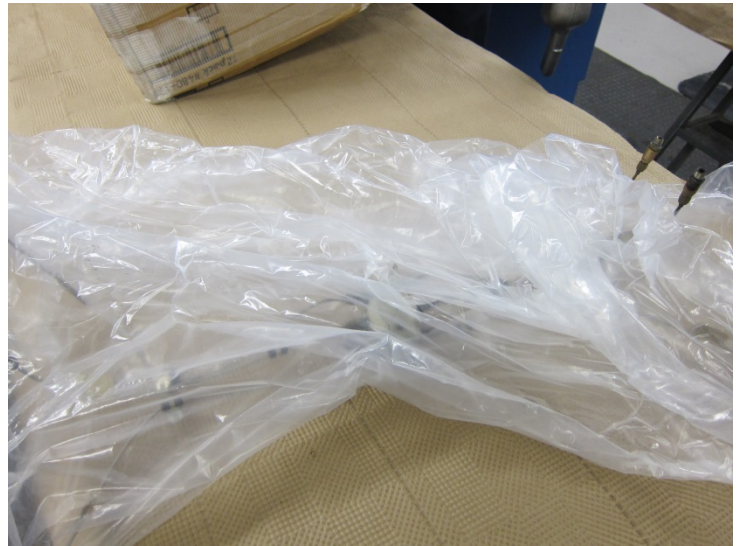
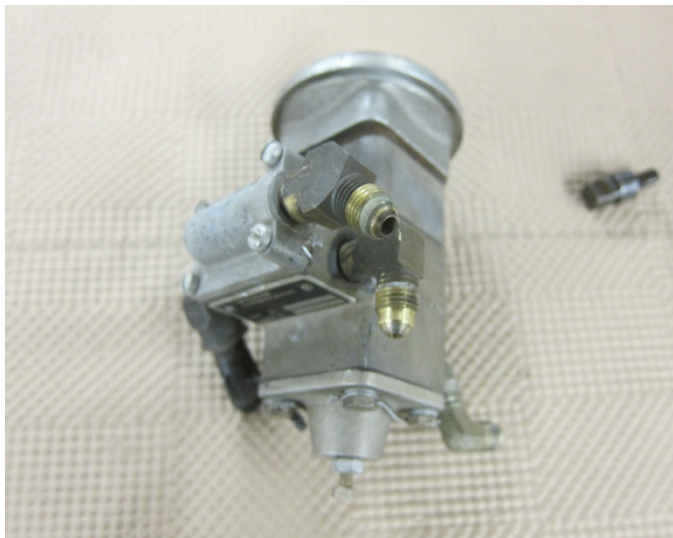
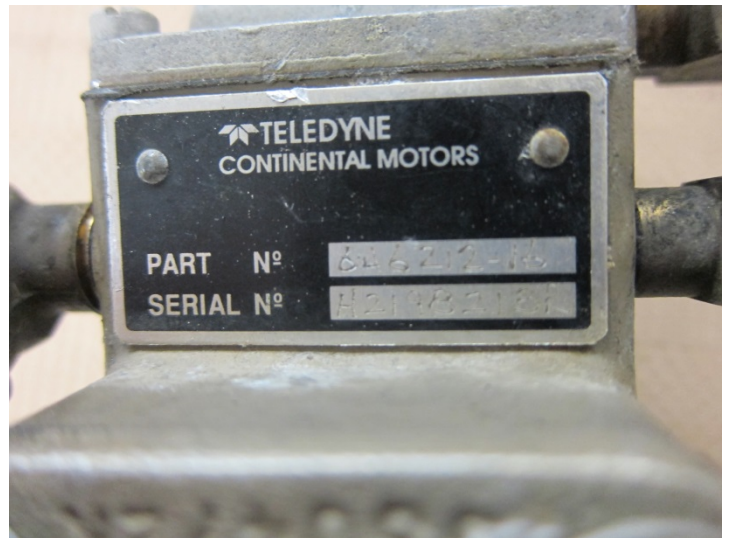
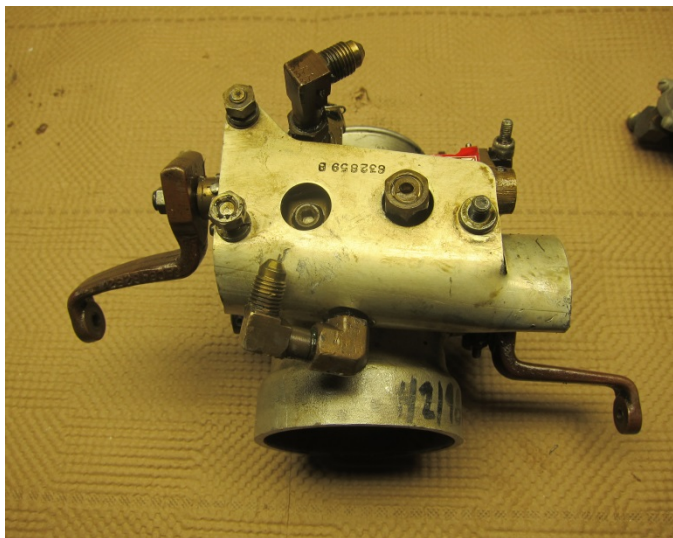
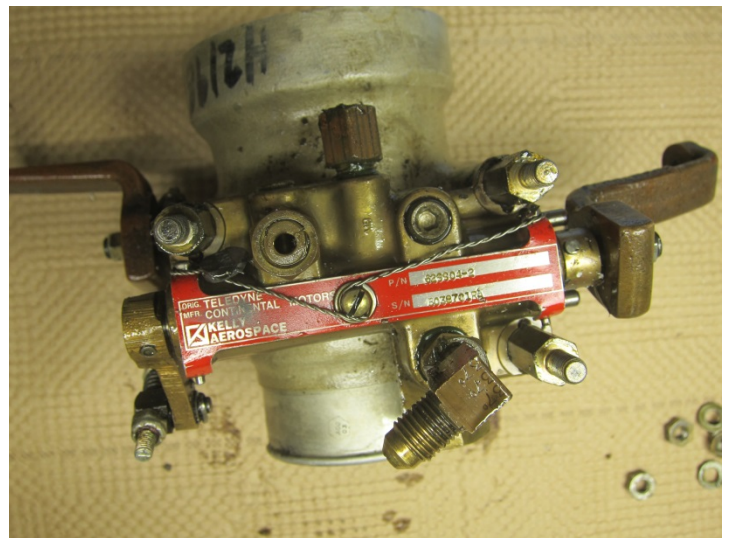
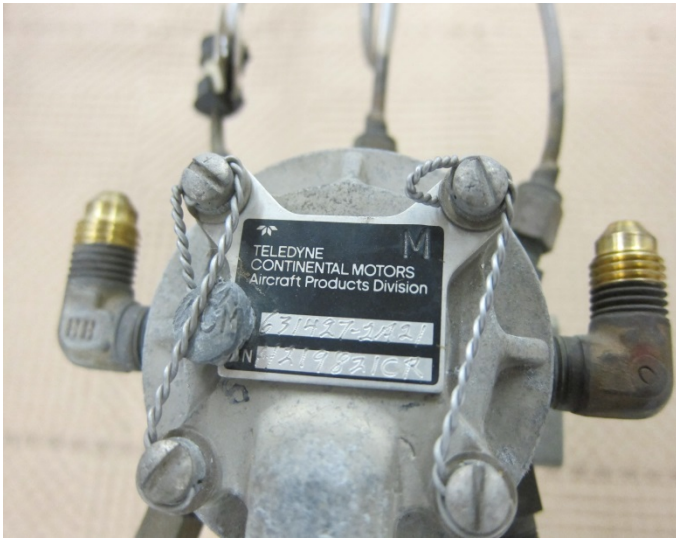
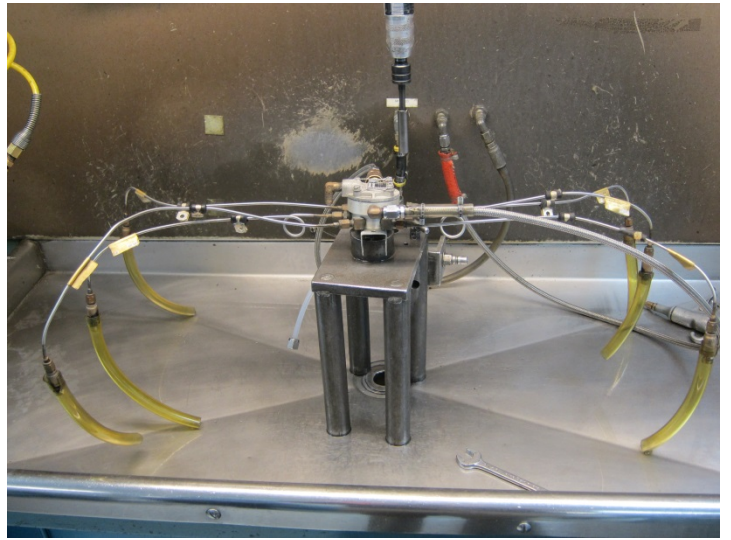
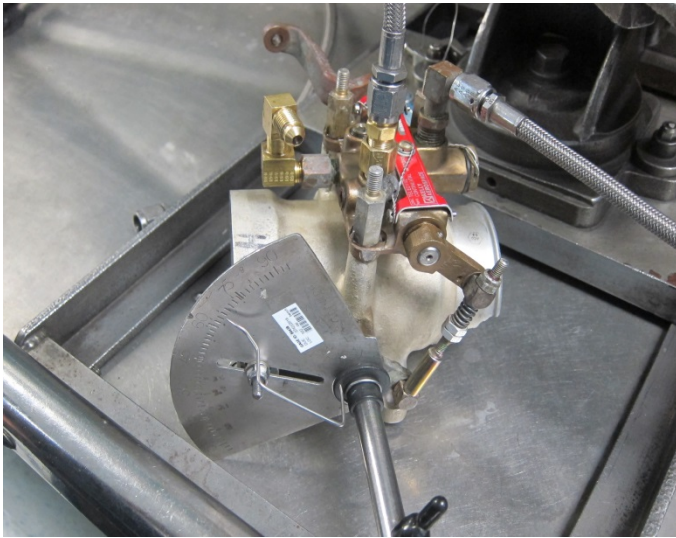
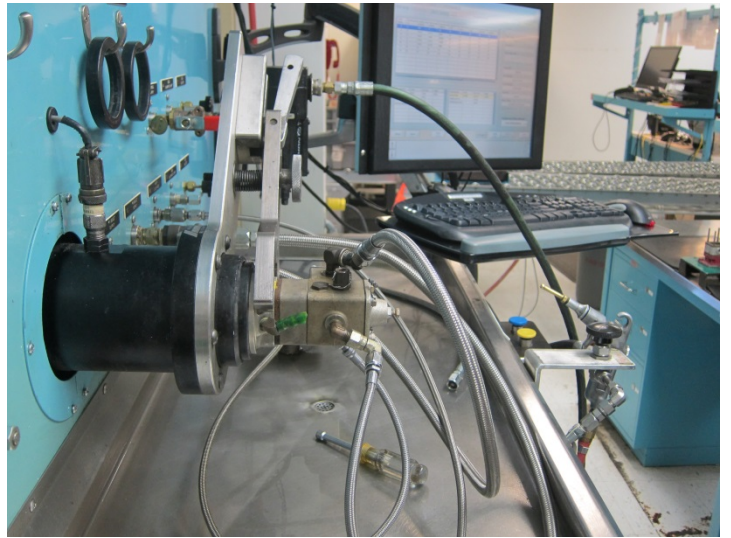
| Analytical Report: | The components were tested with FAA oversight (Mr. Jack Clark, Birmingham FSDO). The components were tested on Continental Motors production test stands using production specifications. Though the components did not meet production specifications throughout their entire test ranges, they were capable of performing their normal functions adequately and any differences between the specifications and the observed values can be attributed to normal adjustments that are conducted in the field by maintenance personnel. No pre-accident anomalies were noted with any of the components that would have precluded their ability to perform normally. | | | | | | | | | |
| Comments: | The observed test values (fuel flows and/or pressures) are attached to the end of this report. | | | | | | | | | |

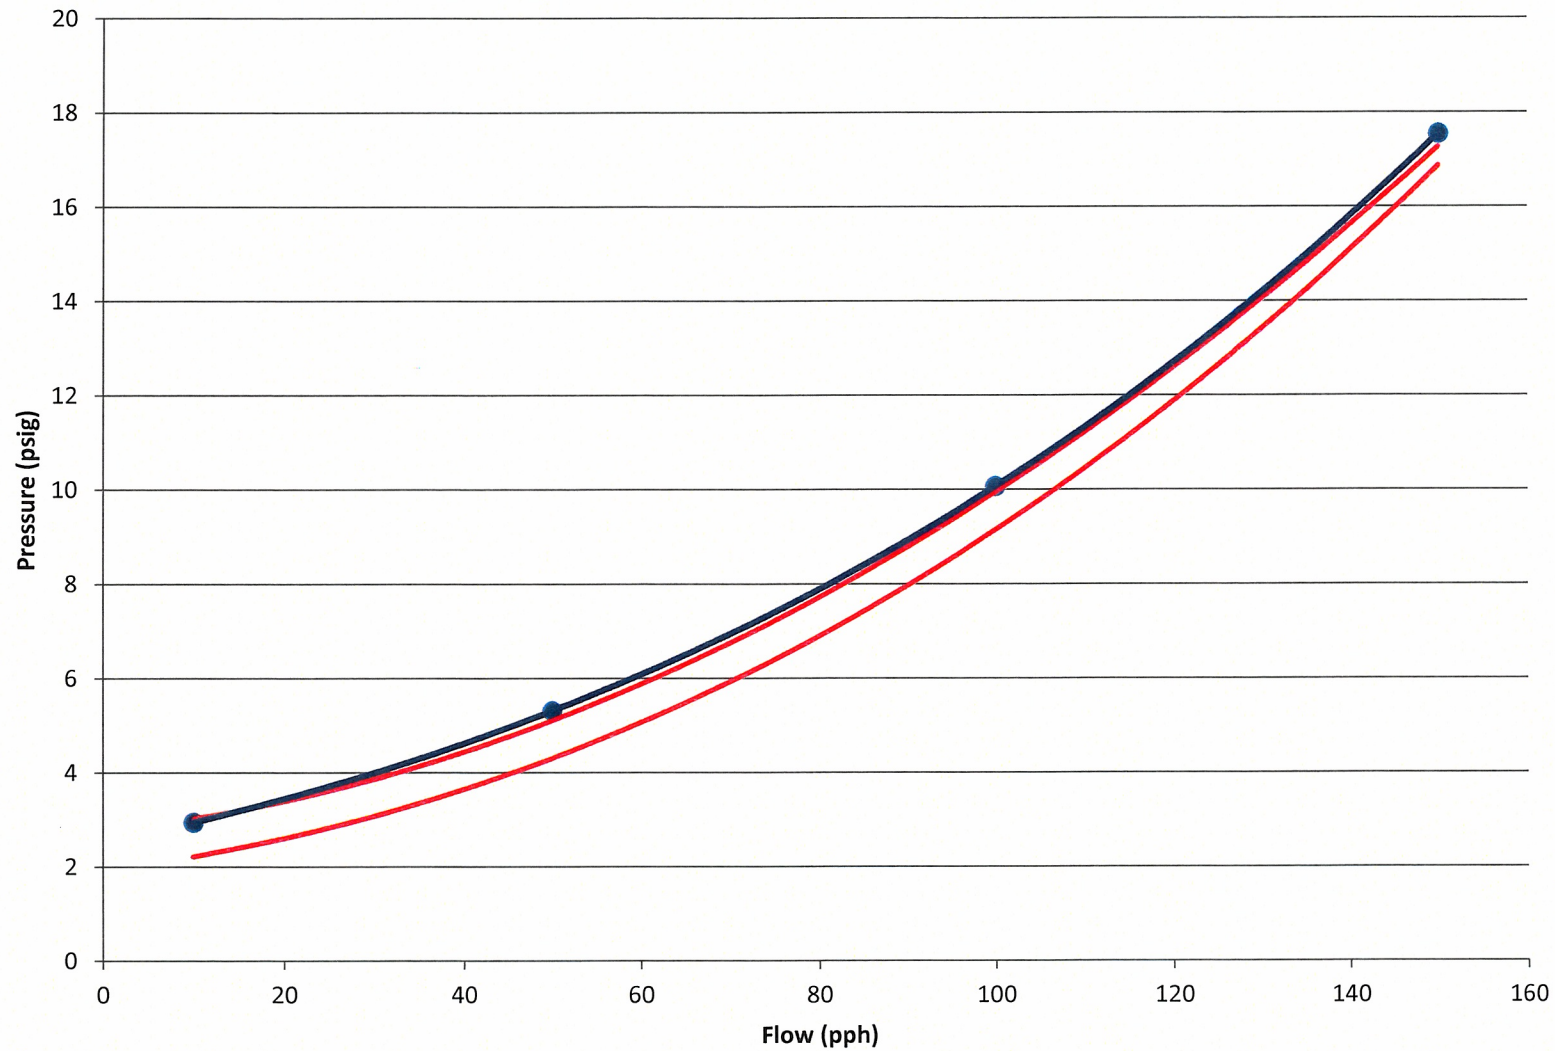
### Manifold Flow Calibration Report

**FUEL FLOW TEST  
FAILED!**

Data for Test Point "3" out of limits  
 Data for Test Point "4" out of limits  
 Data for Test Point "5" out of limits  
 Data for Test Point "6" out of limits

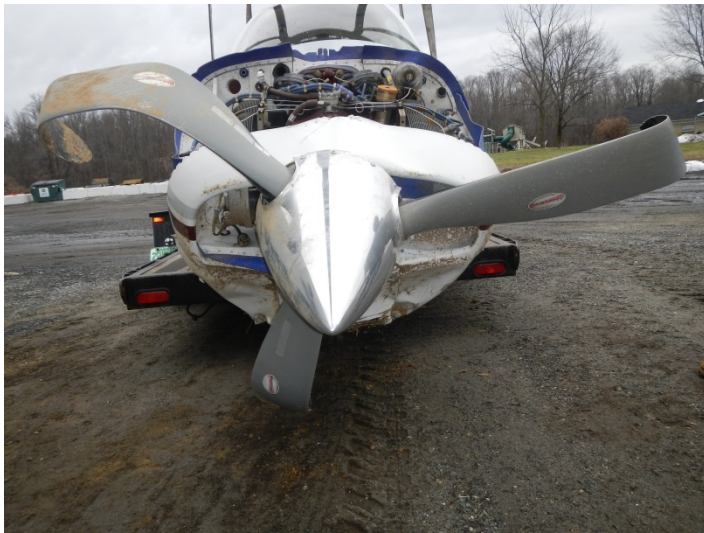
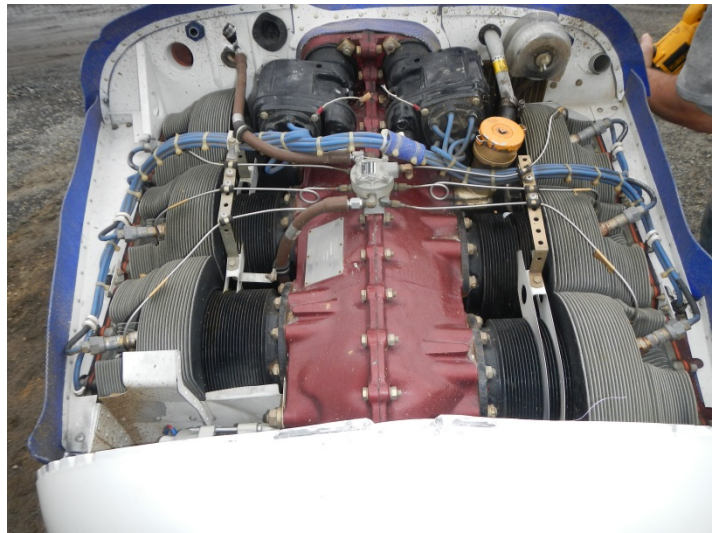
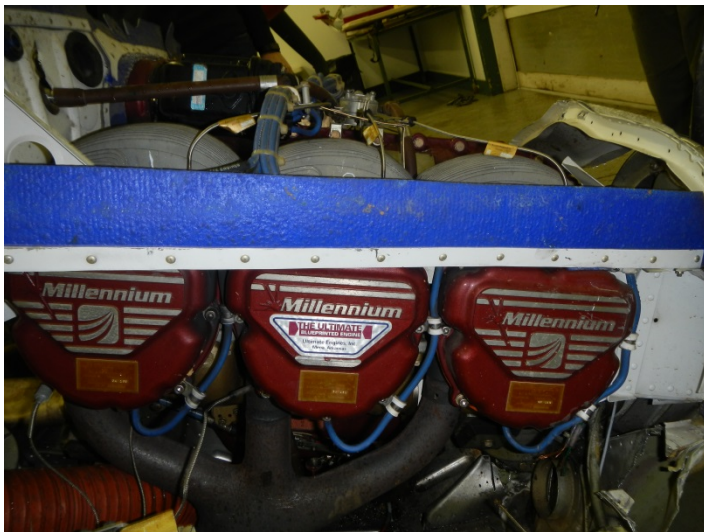
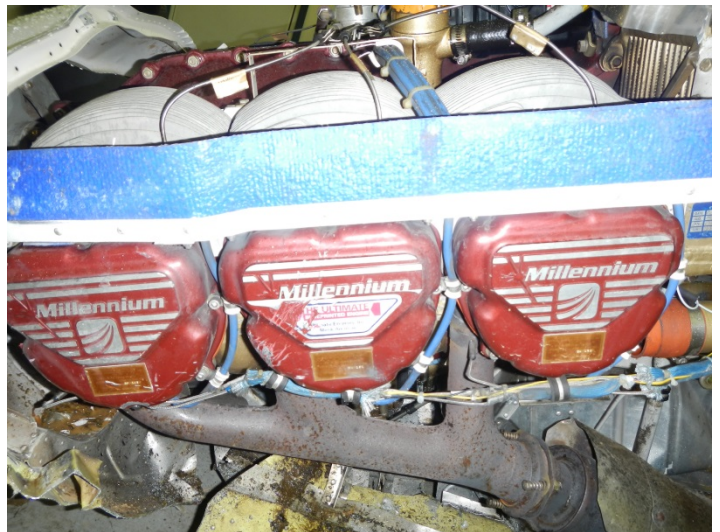
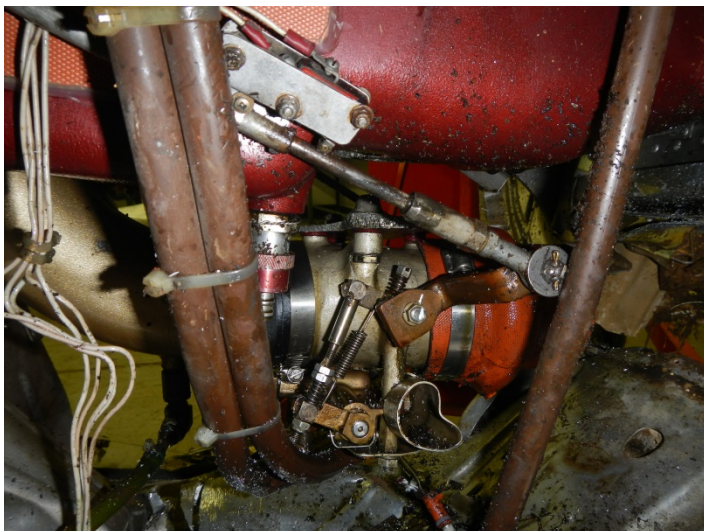
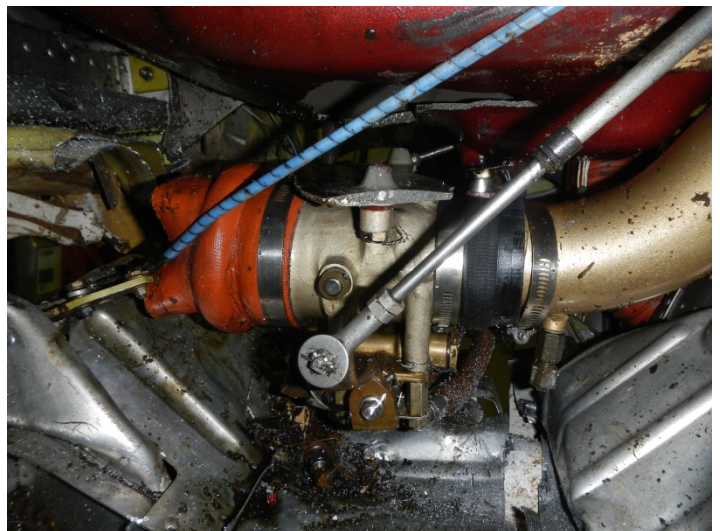
The engine's bottom side sustained impact-related damage that displaced the induction system, fractured the oil sump, and damaged the engine nacelle, all of which precluded a test run. Besides the impact-related damage, no pre-accident anomalies were noted that would have prevented the engine from being able to produce full, rated power. The engine's fuel system components were removed from the aircraft for further examination and testing at the Continental Motors facility.

The top cowling was removed and no external anomalies were noted with the engine. The throttle body/metering unit sustained impact-related damage that fractured a portion of the throttle body, fractured the oil sump area to which it was mounted, and displaced the induction tubes. The starter motor was separated from the adapter and the adapter's motor mount was fractured.

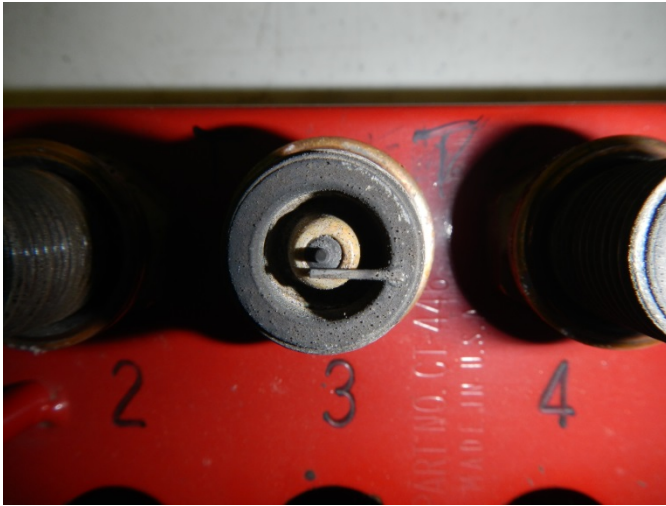
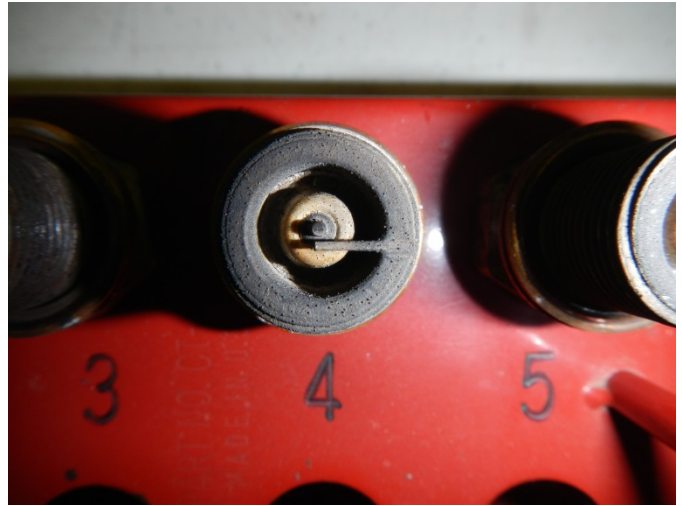
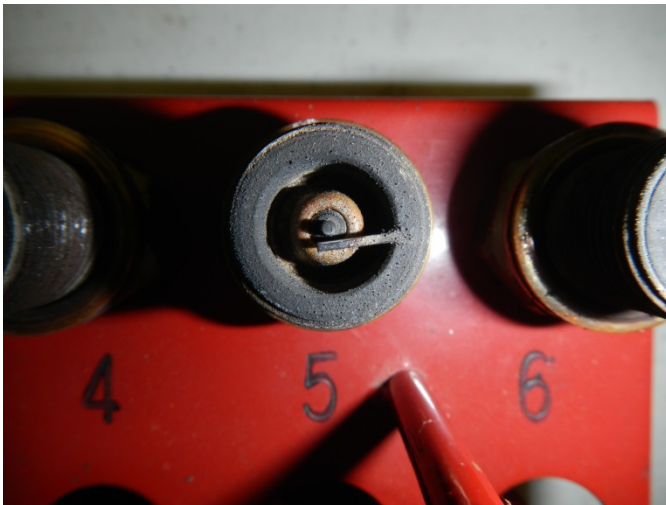
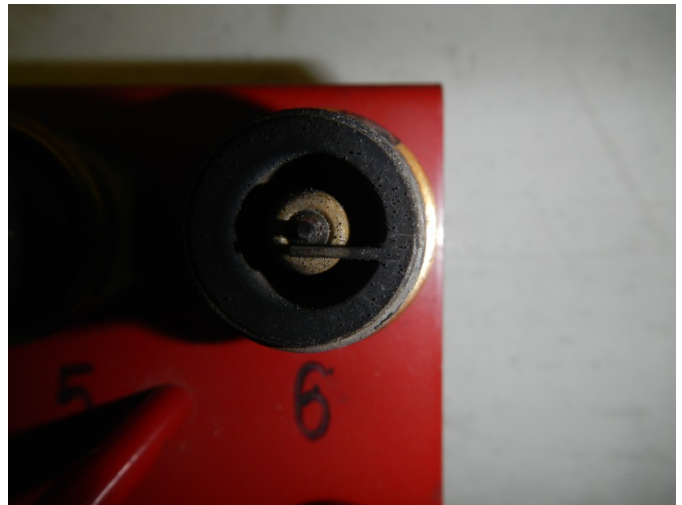
Condition: The exhaust system remained intact with no signs of pre-accident anomalies noted.

Condition: The intake filter was distorted and contained dirt and debris from the accident site. The induction box was displaced and distorted. The throttle body was fractured and the throttle body inlet and outlet were partially displaced from their intake tubes. The wye plenum was displaced and separated from the intake manifolds. The intake risers remained attached to their respective cylinders. No pre-accident anomalies were noted with the induction system.

**Condition:** The magneto remained in place on the topside of the engine with no signs of slipping or rotation on the mounting pad noted. The ignition harness remained attached to the magneto. Manual manipulation of the magneto revealed that it was secured in place. The top sparkplugs were removed from their cylinders and were attached to their respective terminals. The magneto's impulse coupling produced an audible snap during propeller rotation and a spark through the ignition system in firing order with no pre-accident anomalies noted.

**Condition:** The ignition harness remained secured to both magnetos and the terminals remained secured to their respective sparkplugs. There were no signs of pre-accident anomalies noted with any of the leads.

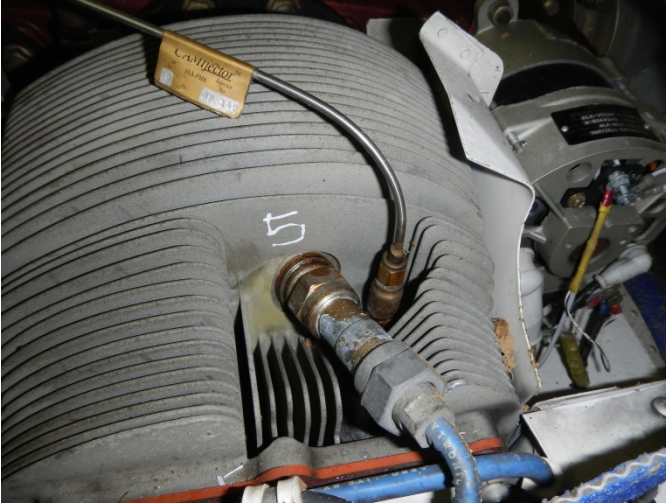
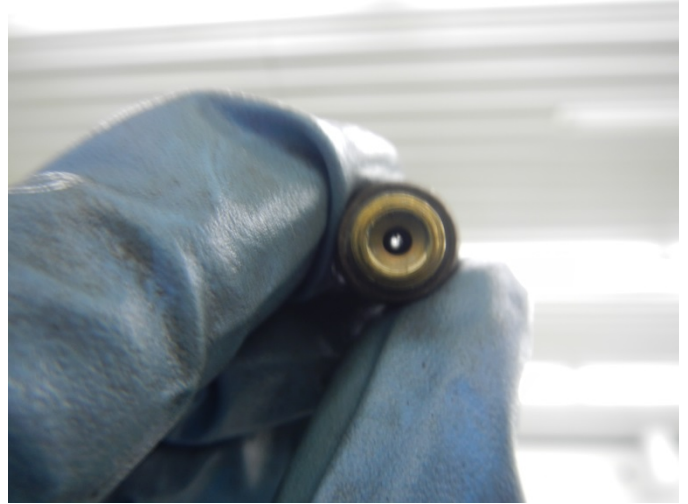
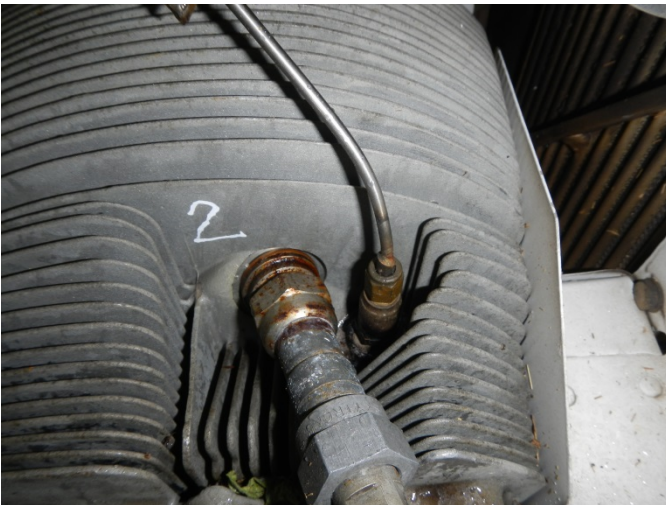
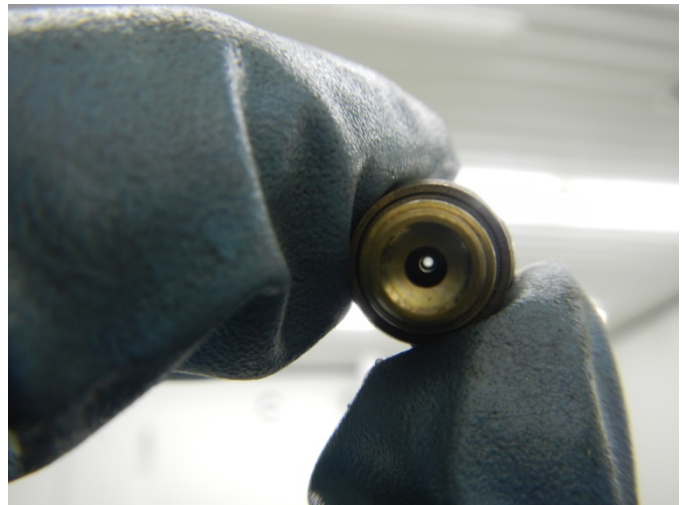
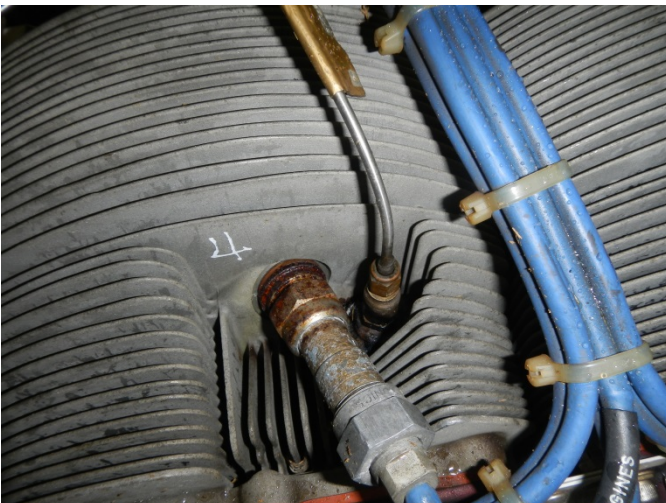
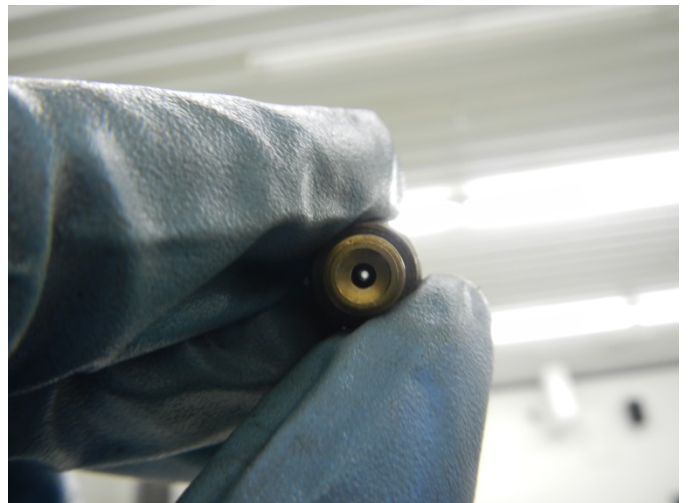
**Condition:** The engine-driven fuel pump remained secured to the backside of the engine with no external signs of operational distress noted. Residual fuel poured from the fuel pump fittings when the fuel lines were removed. The drive coupling was intact. Manual rotation of the drive coupling while installed in the fuel pump drive shaft resulted in a free rotation of the shaft with residual fuel coming from the fuel pump cavity. No pre-accident anomalies were noted. The fuel pump was retained by the NTSB for further testing at the Continental Motors factory.

Following the removal of the engine drive fuel pump, the aircraft's electric fuel boost pump was operated using battery power. Residual fuel was pumped in a steady stream from the fuel supply line to the engine driven fuel pump. No pre-accident anomalies were noted with the aircraft's fuel supply system.

The throttle body remained in place and secured to its mountings on the bottom side of the oil sump; however, that section of oil sump was fractured and separated from the engine. The fuel inlet and return lines remained attached to the metering unit, but the outlet fitting (to the fuel manifold valve) was fractured. The throttle and mixture control cables remained attached to their respective levers/shafts. The throttle and mixture control cables were displaced in the engine nacelle due to the distortion of the airframe structure and movement of the control levers through manual manipulation of the cockpit controls was not possible. The cables were removed as were the attached fuel lines. The throttle and mixture control levers were manually rotated through their normal range of motion with no signs of slipping or binding noted. Residual fuel poured out of the fuel fittings during the removal of the unit. The inlet fuel screen remained in place and secured with safety-wire. It was not removed. The throttle body/fuel metering unit was shipped to Continental Motors for testing.

The fuel manifold valve remained secured to the topside of the engine. The fuel inlet and injector lines remained attached to the manifold valve, though the fuel supply line was fractured at the metering unit fitting. The fuel manifold valve cap remained secured to the body and the safety-wire was in place. No pre-accident anomalies were noted. The unit was not disassembled as it will be returned to Continental Motors for flow testing. Residual fuel poured from the inlet fitting when the manifold valve was removed from the engine.

The fuel injector nozzles were attached to their injector lines and their respective cylinders. The bases of the #2, #4, and #6 fuel injector nozzles showed signs of blue staining and dark discoloration. The fuel injector nozzles were removed and examined; none displayed any signs of blockage. The fuel injector nozzles were reattached to the fuel injector lines for shipment to Continental Motors for testing.

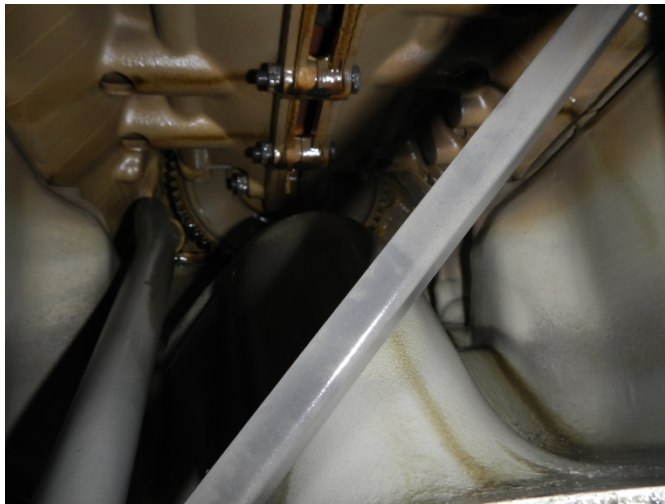
#### OIL PICKUP TUBE & SCREEN

**Condition:** The oil sump remained secured to the bottom side of the engine, but it was fractured in the area to which the throttle body mounts. The bottom side of the engine was visible through the fractured sump and no pre-accident anomalies were noted.

**Condition:** The oil pickup tube and screen were not viewed in their entirety; however, there were no pre-accident anomalies noted with the visible portions.

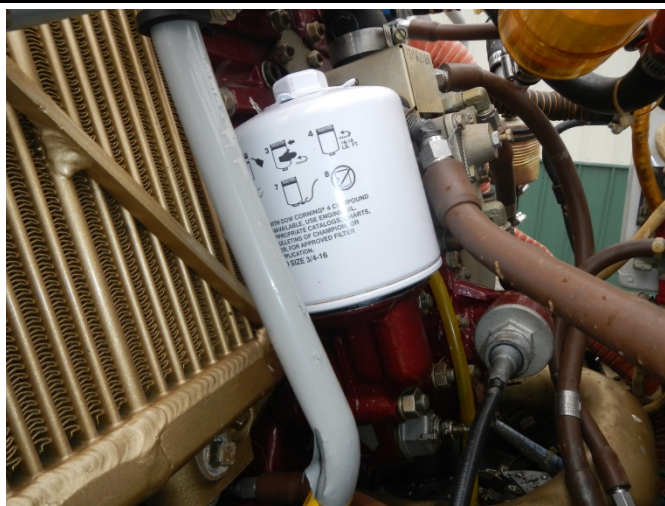
## OIL COOLER

Condition: The oil filter remained secured with safety-wire and had the following date and tachometer time written on the side: "11-5-15 1176.71". There were no external anomalies noted.

Condition: The oil cooler remained attached to the back left side of the engine with no signs of pre-accident anomalies noted.

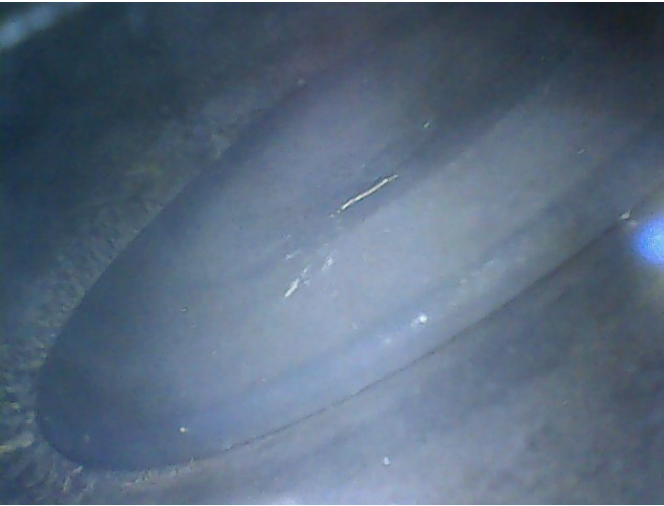
### CYLINDER #3

Condition: The cylinder remained secured to the crankcase and there were no external signs of operational distress. The torque putty was not present on the cylinder attaching hardware. The cylinder was borescope inspected through the top sparkplug hole and no pre-accident anomalies were noted with the cylinder barrel, cylinder head, piston, valves, or valve seats. A thumb compression test resulted in strong suction and compression from the cylinder.

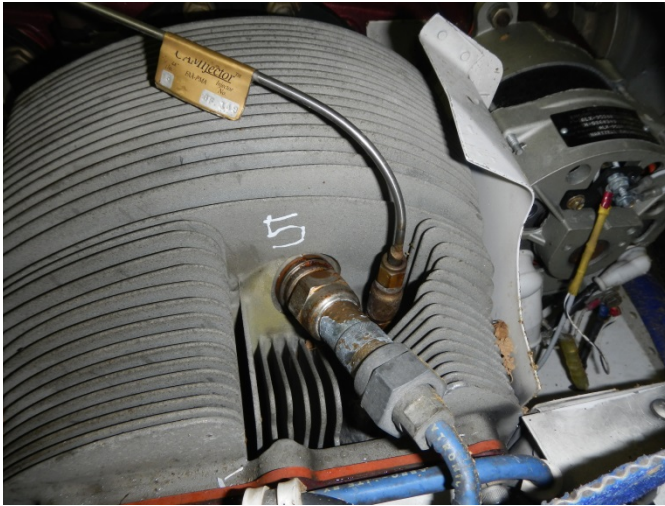
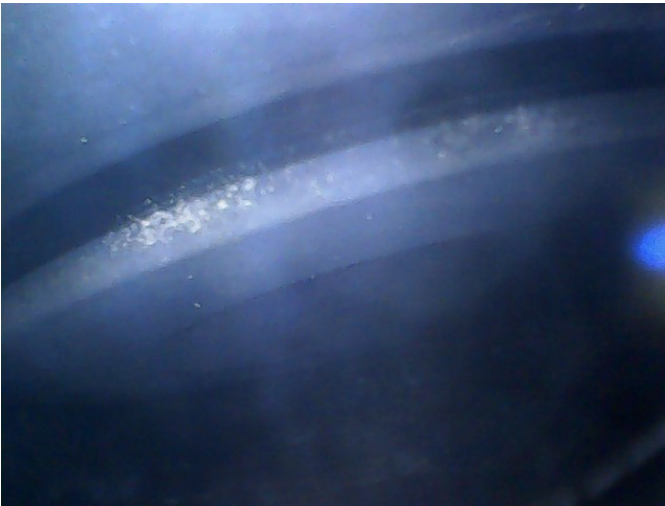
### CYLINDER #5

Condition: The cylinder remained secured to the crankcase and there were no external signs of operational distress. The torque putty was not present on the cylinder attaching hardware. The cylinder was borescope inspected through the top sparkplug hole and no pre-accident anomalies were noted with the cylinder barrel, cylinder head, piston, valves, or valve seats. A thumb compression test resulted in strong suction and compression from the cylinder.

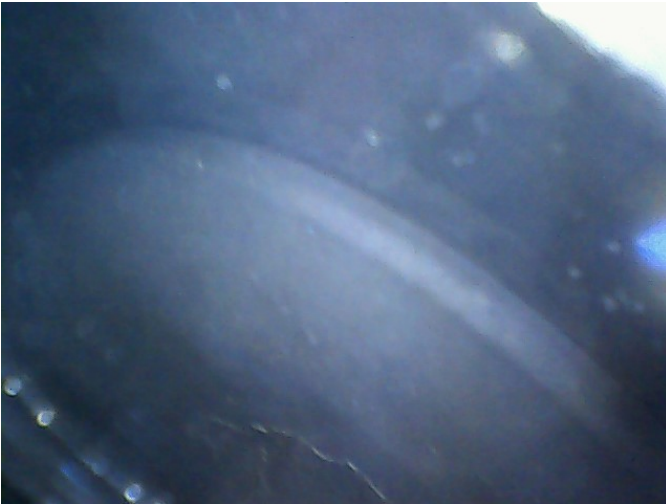
### CYLINDER #2

Condition: The cylinder remained secured to the crankcase and there were no external signs of operational distress. The torque putty was not present on the cylinder attaching hardware. The cylinder was borescope inspected through the top sparkplug hole and no pre-accident anomalies were noted with the cylinder barrel, cylinder head, piston, valves, or valve seats. A thumb compression test resulted in strong suction and compression from the cylinder.

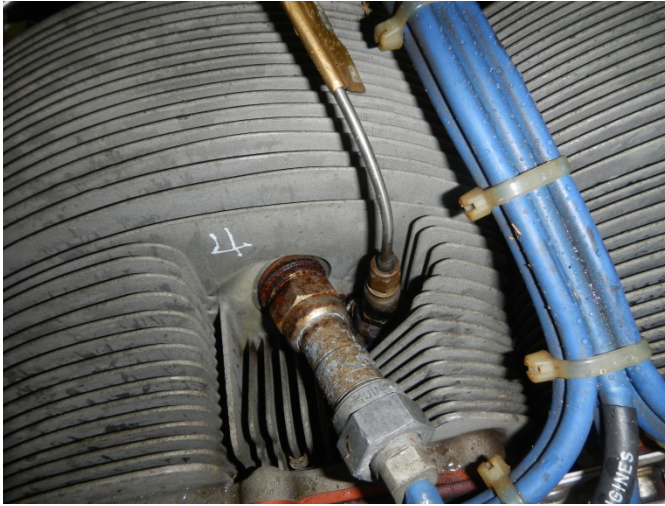
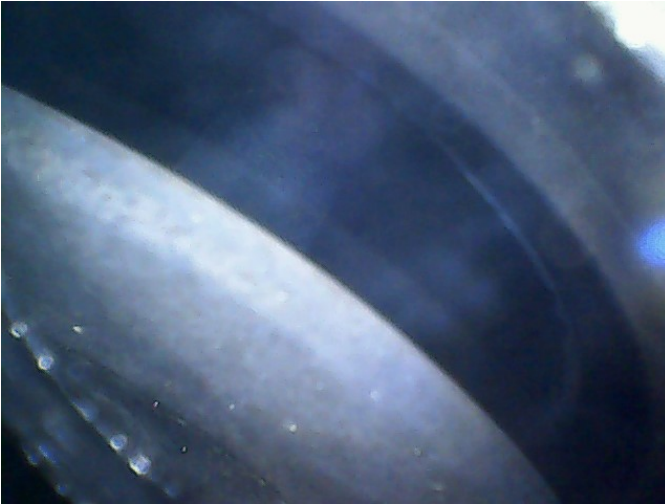
### CYLINDER #4

Condition: The cylinder remained secured to the crankcase and there were no external signs of operational distress. The torque putty was not present on the cylinder attaching hardware. The cylinder was borescope inspected through the top sparkplug hole and no pre-accident anomalies were noted with the cylinder barrel, cylinder head, piston, valves, or valve seats. A thumb compression test resulted in strong suction and compression from the cylinder.

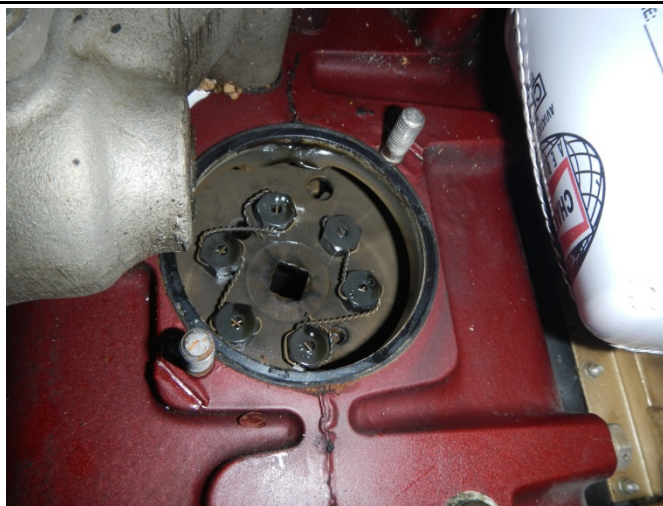
**Condition:** The crankcase remained intact and did not display any external signs of operational distress. Examination of the bottom crankcase halves through the fractured oil sump also revealed no pre-accident anomalies.

**Condition:** The crankshaft was not observed in its entirety, but rotation of the propeller confirmed crankshaft continuity back to the crankshaft gear/accessory section and out to each piston. No binding was noted during crankshaft rotation.

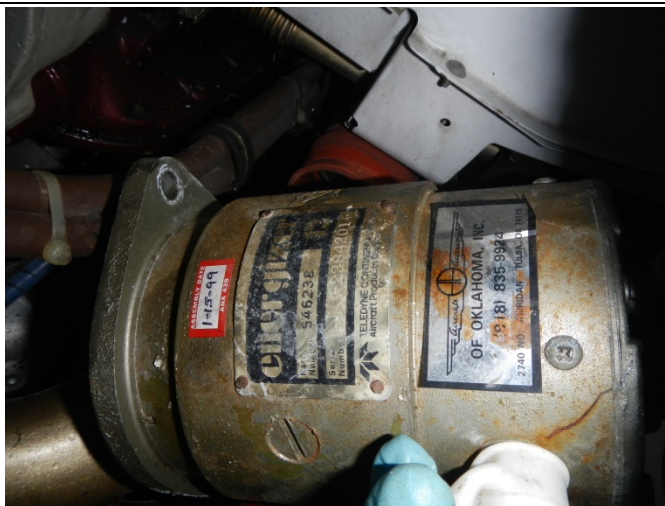
The starter motor was separated from the adapter, but the electrical cables remained attached to the unit. No pre-accident anomalies were noted.

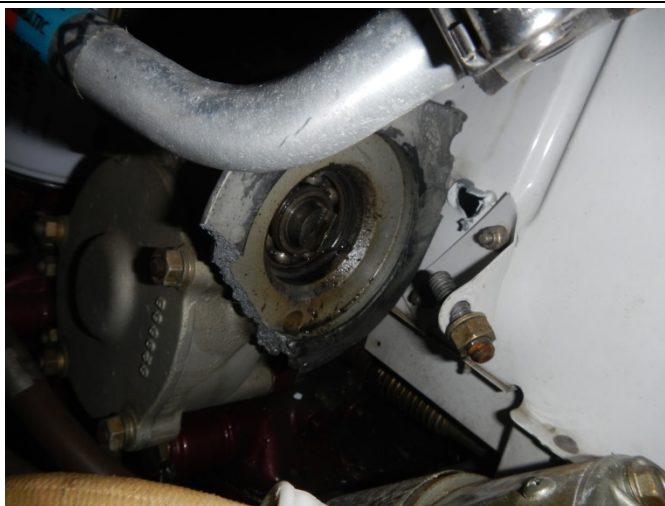
**STARTER ADAPTER**

The starter adapter remained attached to the backside of the engine, but the motor mounting flange was fractured. No pre-accident anomalies were noted with the unit.

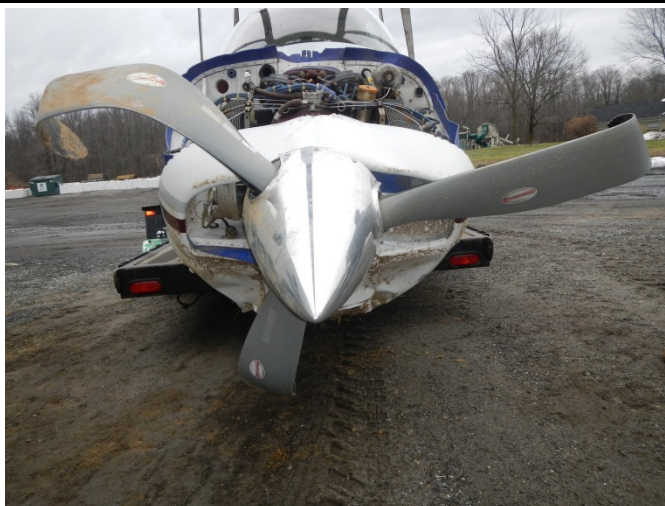
The propeller hub remained secured to the crankshaft's propeller flange and all three blades remained attached to the hub. The blades were labelled A, B, and C for the purposes of the examination. The outboard sections of all three blades were curled toward low pitch and all displayed leading edge and chord-wise gouges near the tips. The blade that was labeled A was loose in the hub indicating that its pitch change link was fractured.
