**NATIONAL TRANSPORTATION SAFETY BOARD**

**SURVIVAL FACTORS**

**Specialist's Factual Report**

**ERA16LA195**

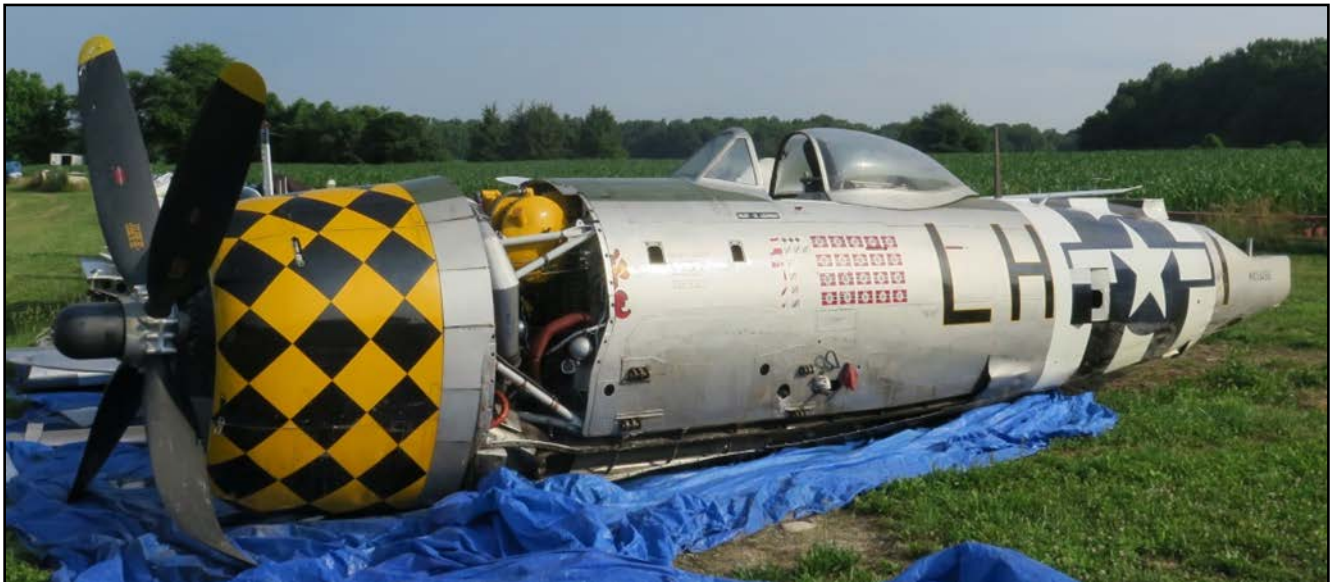
**Photograph 1 - Republic P-47D.**

The airplane was a 1945 Republic P47D (N1345B) (photograph 1) with a single cockpit seat.

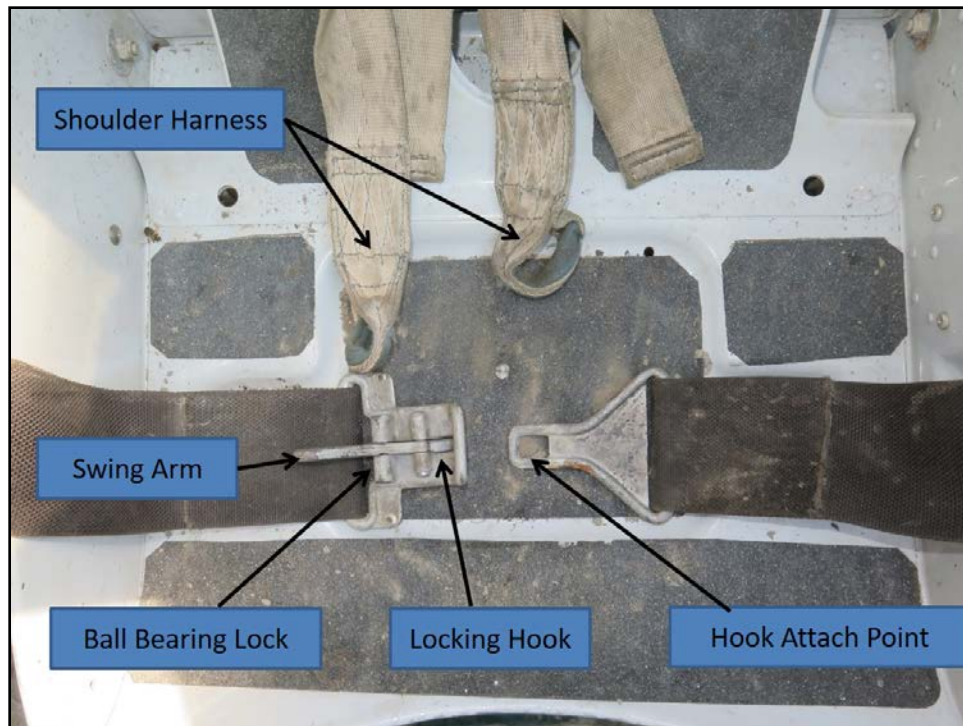
**Photograph 4 – Pilot seat restraint.**

The seatbelt restraints system consisted of a lapbelt and shoulder harness. The left (male) portion of the lapbelt attaches to the right (female) portion of the lapbelt and is locked in place with a metal hook. The swing arm presses between two ball bearings on each side of the swing arm (photograph 4) and the compression of the ball bearing locked it in place. The lapbelt was attached to the seat in the rear corners of the seat pan with bolts. A data tag was sewn into the webbing of each lapbelt, but was illegible. The shoulder harness attaches to the back of the seat with the end portions being reinforced loops that slide over the male metal tongue to complete the system (photograph 5).

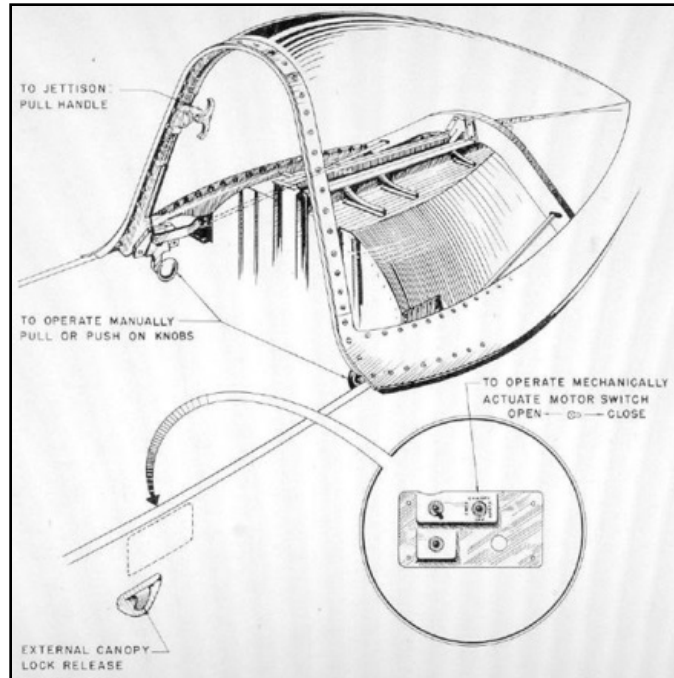
**Figure 1 – Cockpit canopy controls.**

The cockpit canopy was designed to be operated (figure 1) either manually, or by an electric motor. The motor could be controlled from an internal switch in the cockpit, or by an external switch located forward of the left cockpit window in an access panel. The limits of canopy travel are controlled by two switches mounted on the deck behind the pilot seat. The entire operating mechanism is covered by the tail of the canopy in the closed position.
