| | | <h1 style="text-align: center;">MATERIALS EVALUATION<br/>REPORT</h1> <p style="text-align: center;">Materials Engineering Department</p> | | | |
| <b>TITLE</b><br><b>METALLURGICAL INVESTIGATION OF A<br/>COMPRESSOR DIFFUSER, P/N 23064637,<br/>INSTALLED IN AN M250 C47B ENGINE, S/N<br/>CAE847731</b> | | <b>SIGN</b><br><i>Signature on File</i> | | | |

Report Request ID: 11681  
 Traceability ID Number: Not Applicable  
 Part Name: Compressor Diffuser Assembly  
 Part Number: 23064637  
 Part Serial Number: GY27720R  
 Processes: Not Applicable  
 Part Time: Unknown  
 Engine Model: M250-C47B  
 Engine Serial Number: CAE847731  
 FPA Number: Not Applicable  
 Supplier: Not Applicable  
 Supplier Location / Vendor Code: Not Applicable  
 Evaluations: Failure Analysis

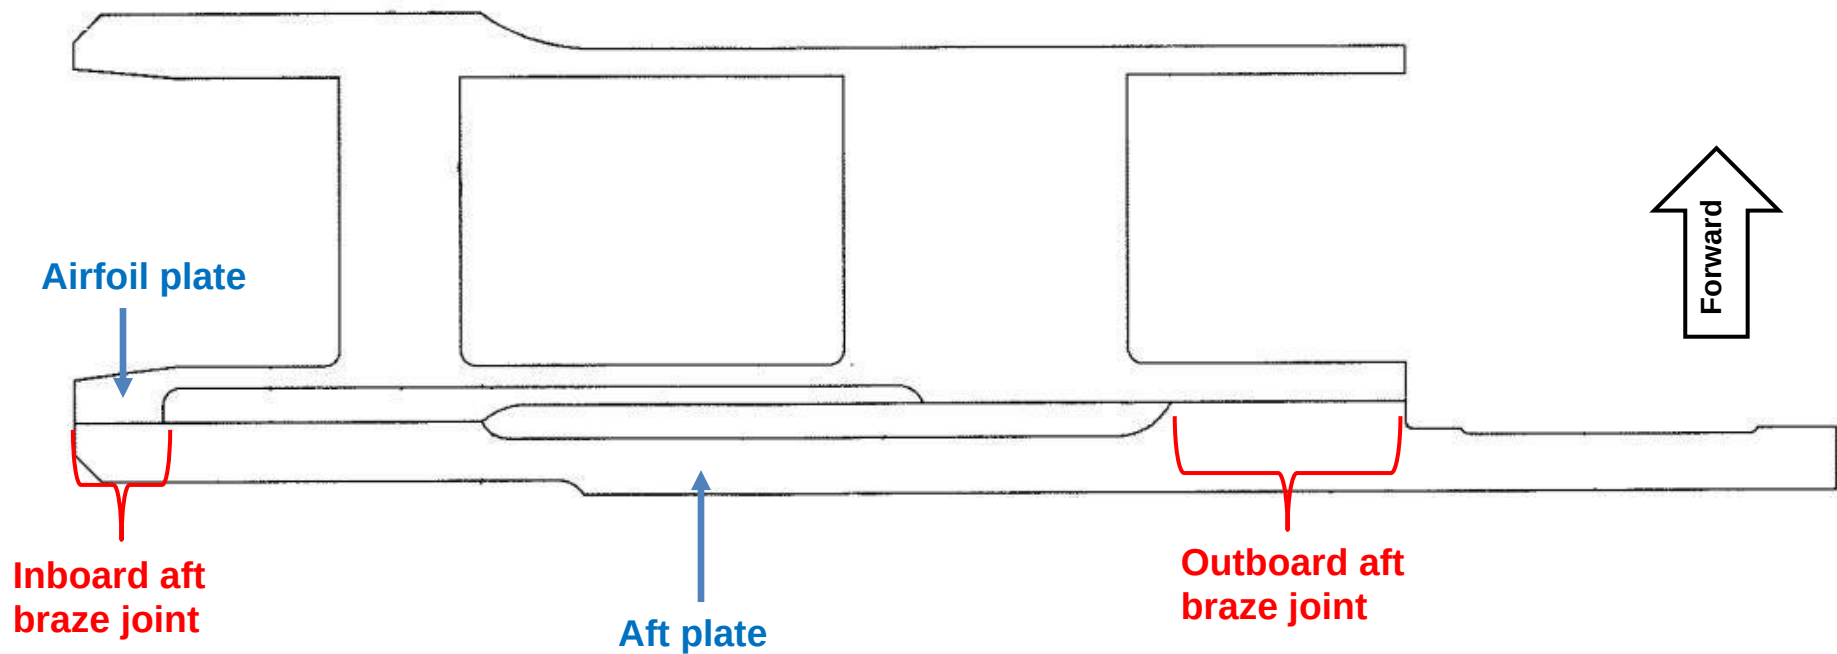
Figure 1 and Figure 2 show the forward and aft sides of the compressor diffuser in the as-received condition. Figure 3 shows a representative schematic of the compressor diffuser, which includes the location of the airfoil plate, aft plate, and applicable braze joints, as specified by the component definition. Figure 4 through Figure 7 show radial views of the aft side of the compressor diffuser over approximately 360°. The inboard rim of the compressor diffuser at the 0° position (see bottom image of Figure 4) exhibited separation at the inboard aft braze joint between the airfoil plate and the aft plate, which extended around approximately 40% of the circumference, starting counter-clockwise from the 300° position to the 80° position (see region A in Figure 2). The inboard rim of the compressor diffuser at the 90° and 180° positions (see bottom images of Figure 5 and Figure 6, respectively) exhibited no evidence of voids or debonding at the inboard aft braze joint, but the inboard rim at the 270° position (see bottom image of Figure 7) exhibited a crack through the inboard aft braze joint.

**Figure 3.** Schematic showing the location of the airfoil plate, aft plate, and applicable braze joints of the compressor diffuser as specified by the component definition. Schematic not to scale.
